Centre for Archaeology Report 56/2005

## **Dendrochronological Research in Devon: Phase 1**

Cathy Groves  
(with contributions from John Thorp)

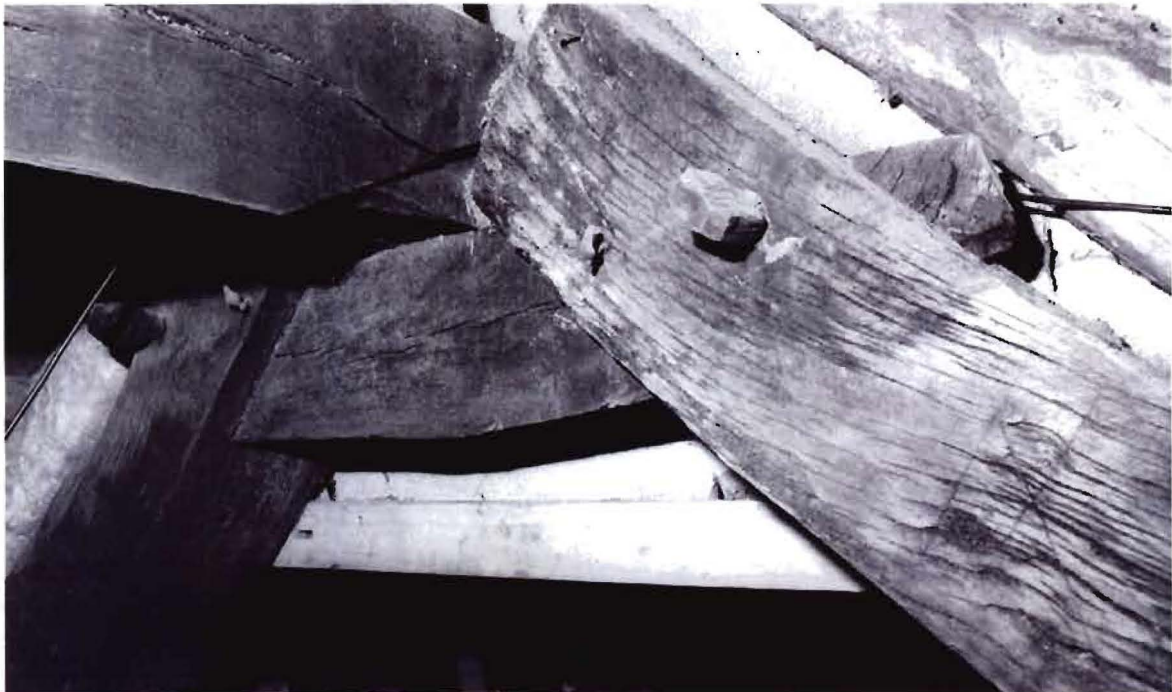
**Figure 3b** Chimsworthy, Bratton Clovelly: truss 5 from the north (photograph J R L Thorp)

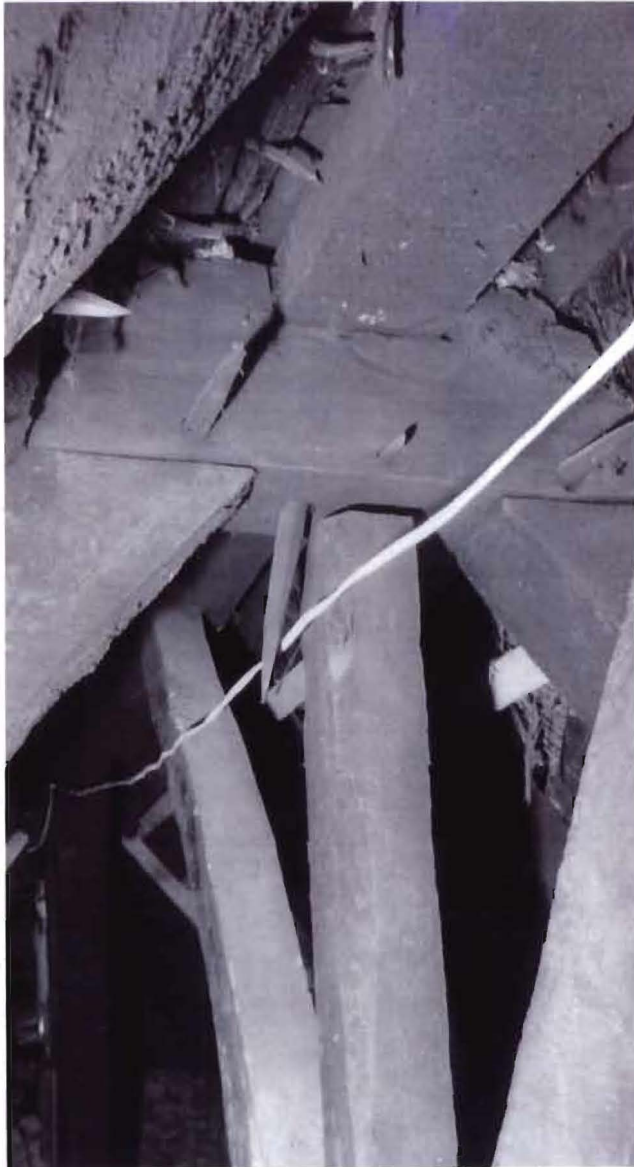
**Figure 3c** Old Rectory, Cheriton Bishop: truss 3 from the west (photograph J R L Thorp)

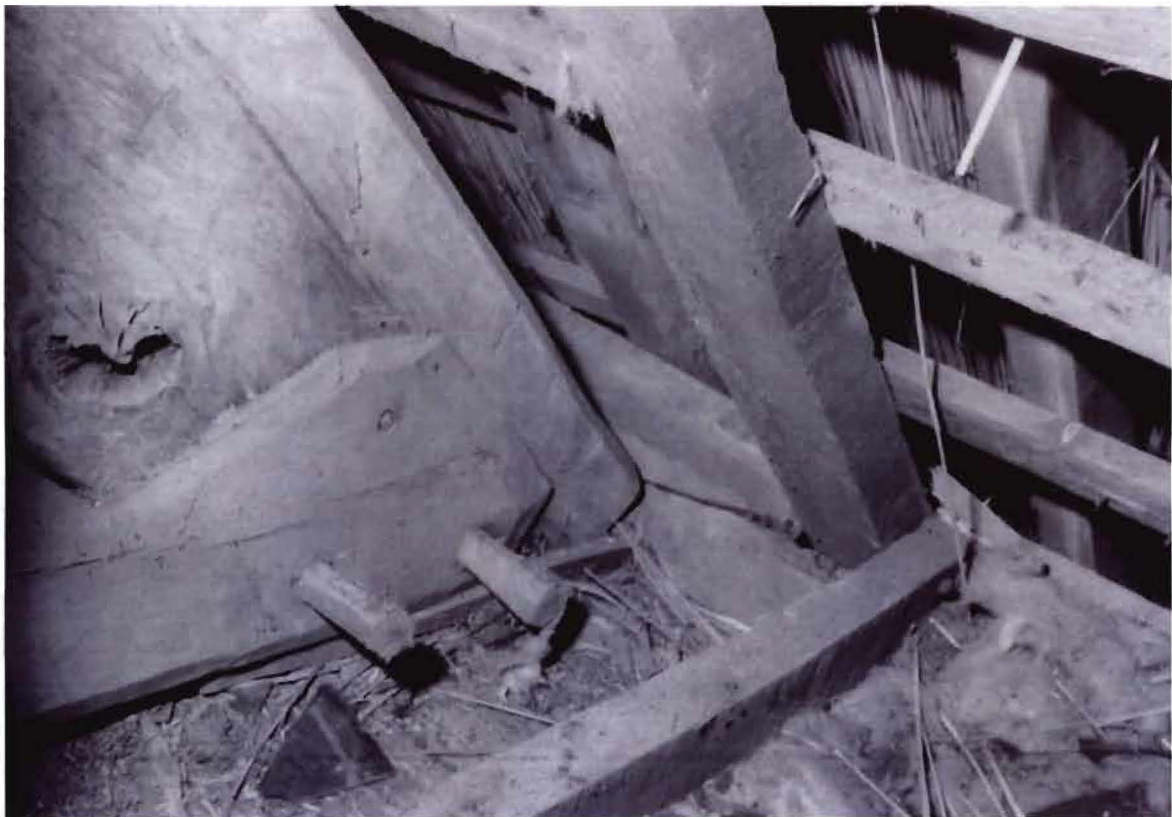
**Figure 3g** Chaffcombe Manor, Down St Mary: truss 1 from the east (photograph J R L Thorp)

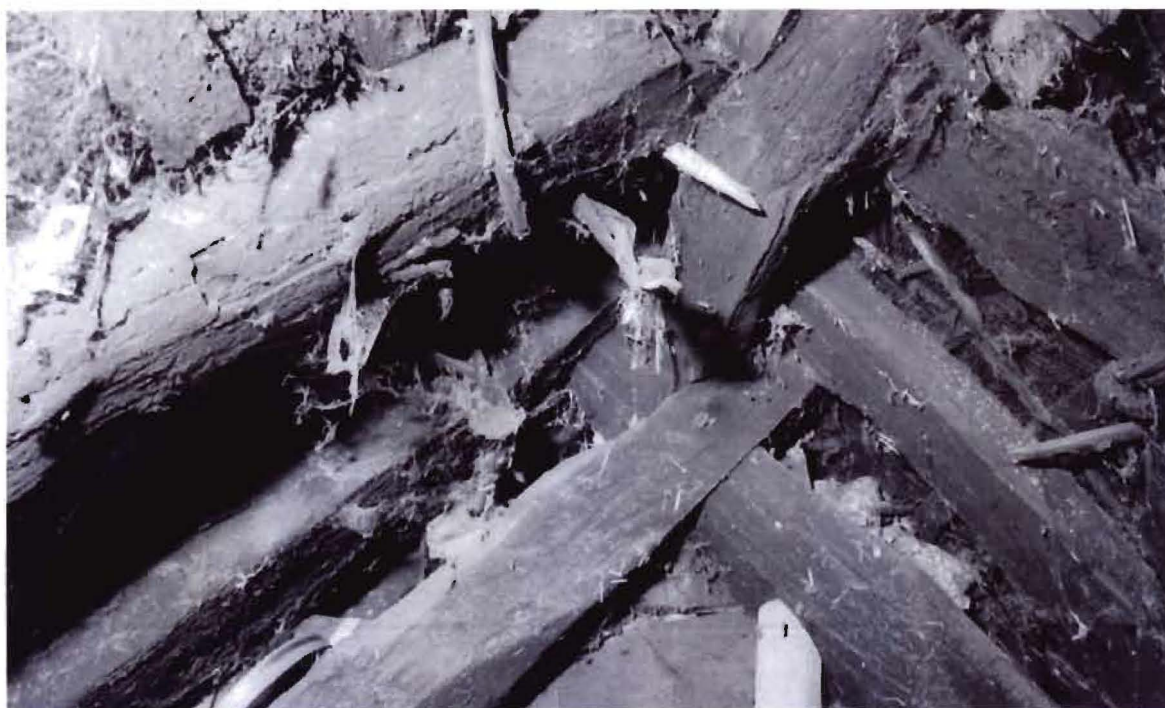
**Figure 3i.1** West Hele, King's Nympton: truss 3 from the east (photograph J R L Thorp)

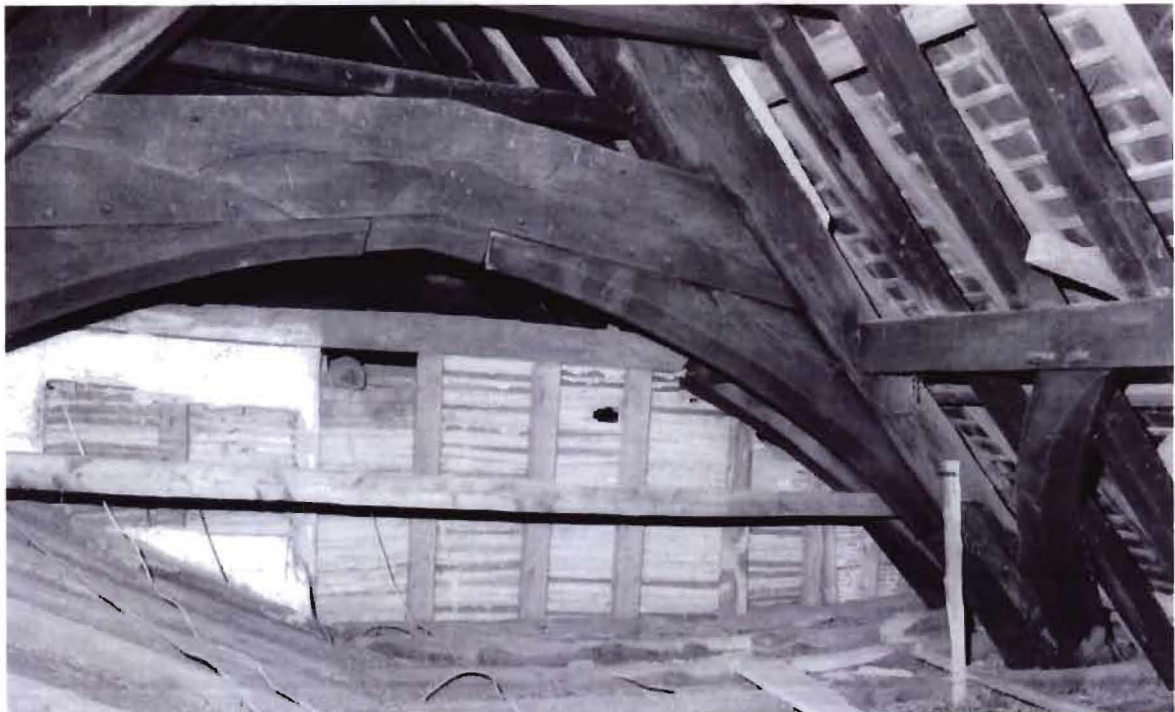
**Figure 3j** Bury Barton, Lapford: truss 3 from the east (photograph J R L Thorp)

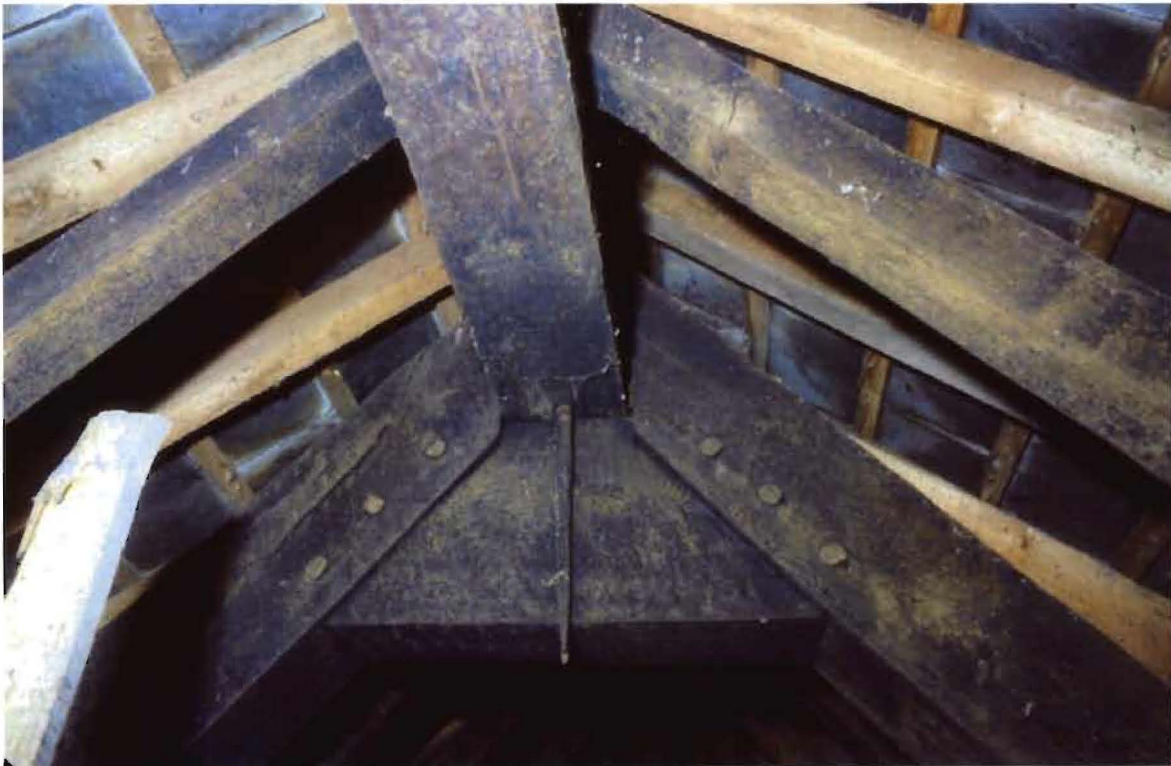
**Figure 3l** Rudge, Morchard Bishop: truss 3 from the east (photograph J R L Thorp)

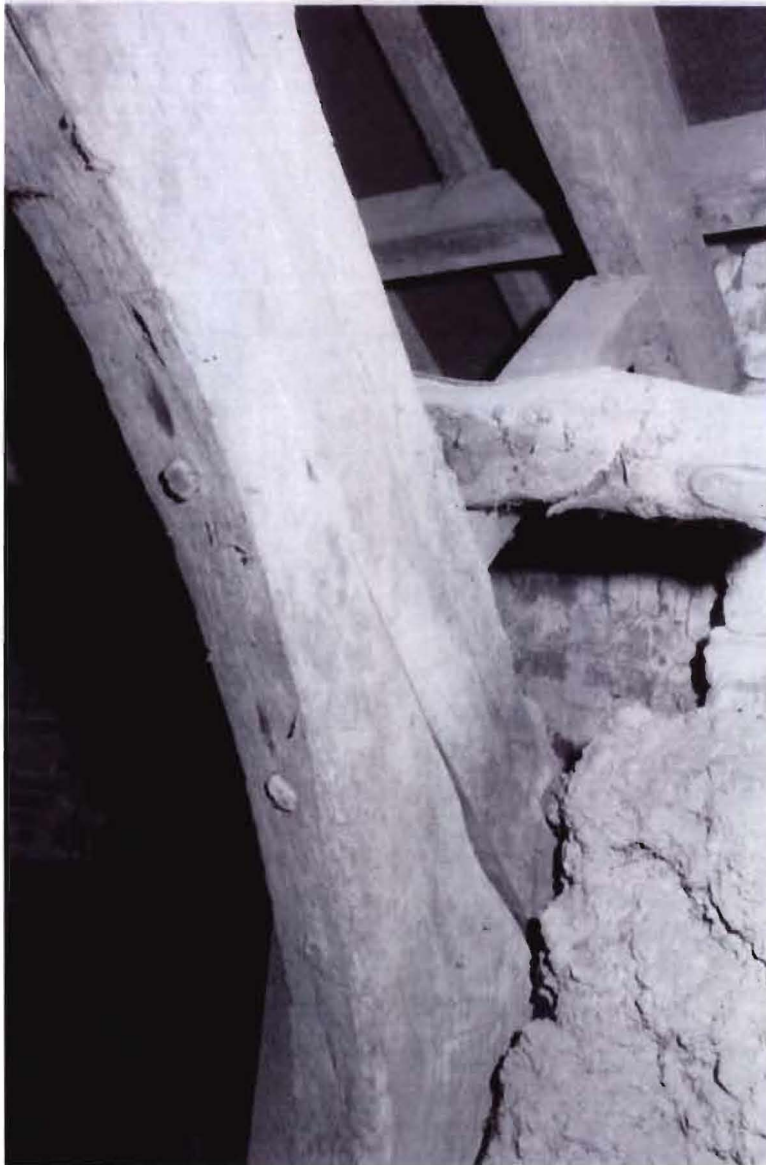
**Figure 3m** Cleavanger, Nymet Rowland: truss 1 from the west (photograph J R L Thorp)

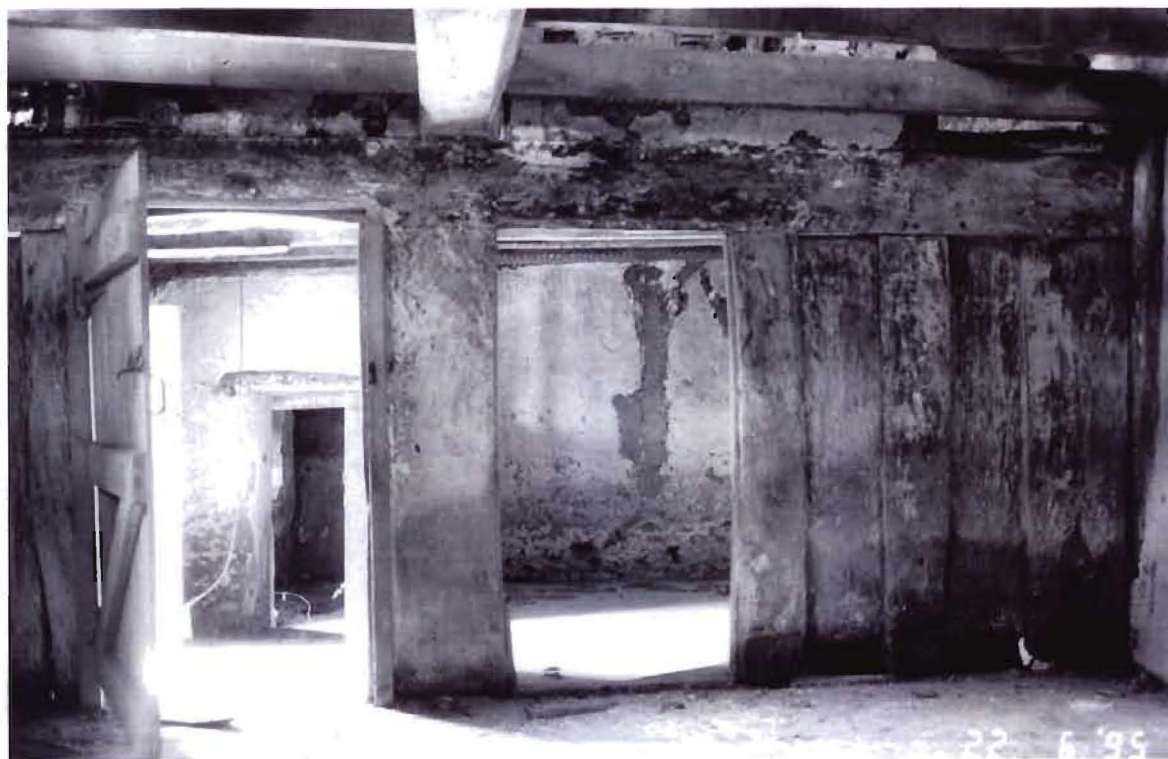
**Figure 3n.2** Ivy Cottage, Bremridge Farm, Sandford: east face of screen (photograph J R L Thorp)

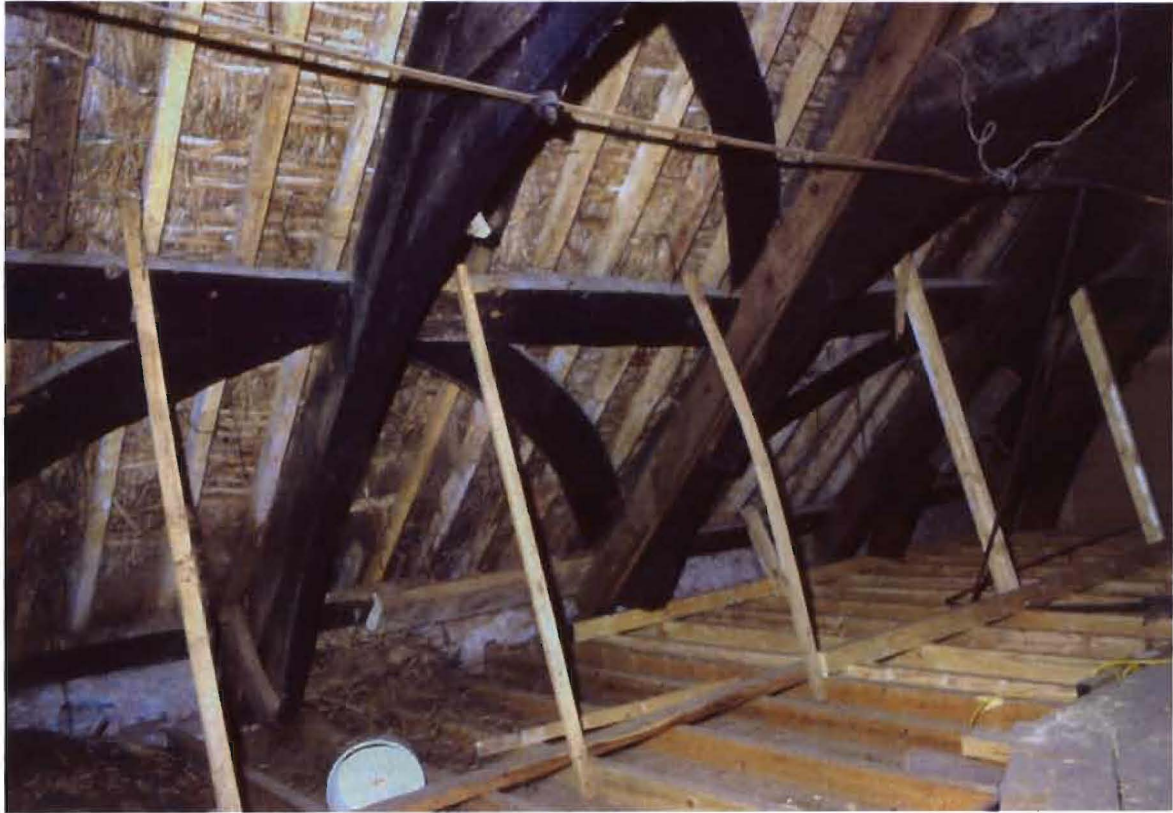
**Figure 3s** Traymill, Thorverton: south side, trusses 4 to 7 (photograph J R L Thorp)

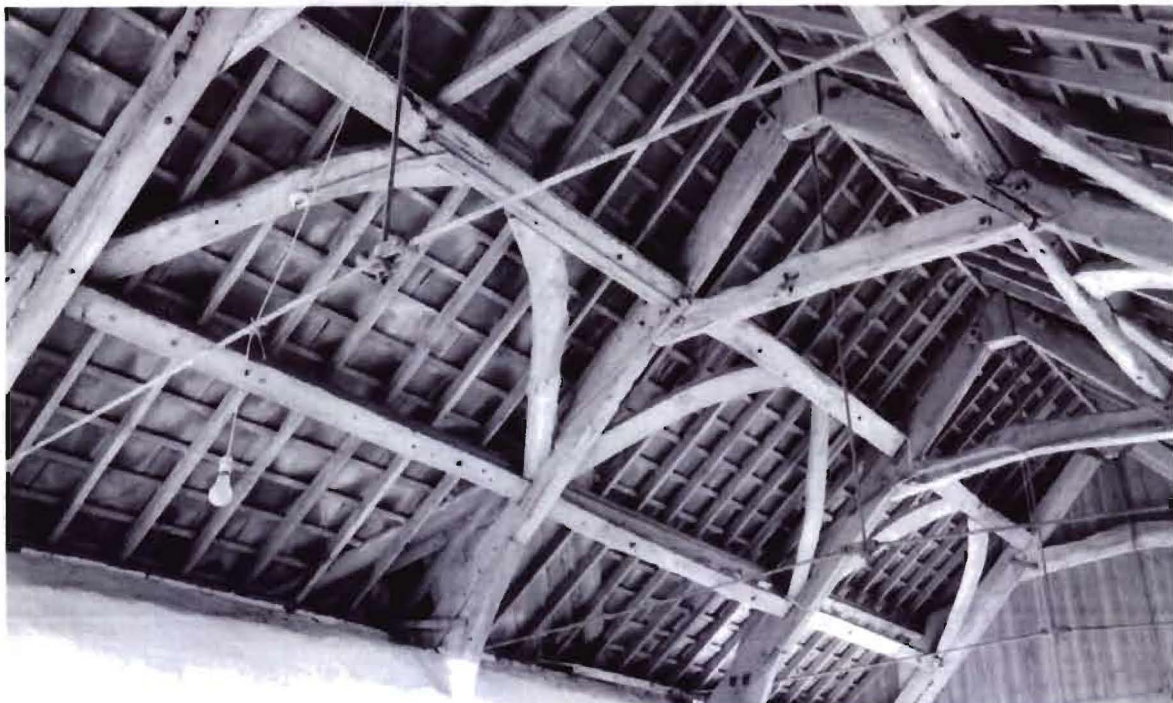
**Figure 3t** Glebe House barn, Whitestone: trusses 2 to 5 from the north-west (photograph J R L Thorp)
