BOAR'S HEAD MILLS

A SURVEY AND INVESTIGATION OF THE COTTON MILLS AND ANCILLARY BUILDINGS

NBR No 33050
NGR SK 3538 3857 (Long Mill)
ISSN 1749-8775
Research Department Report Series 35/2006

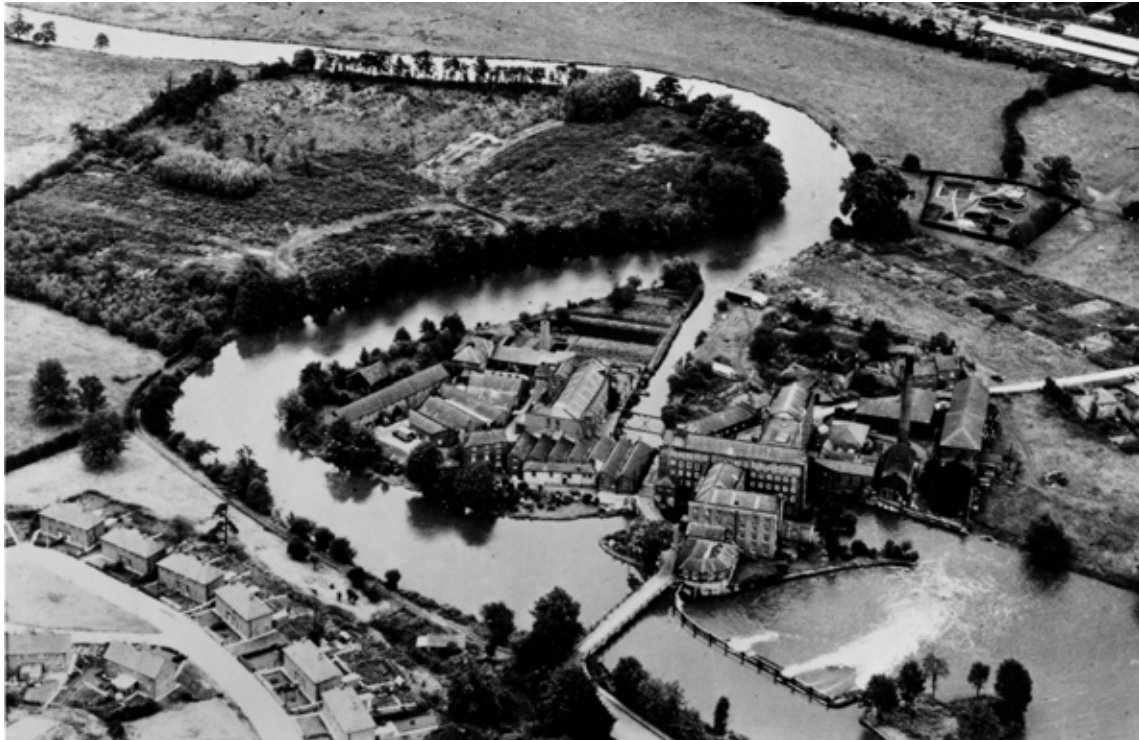
Fig 2. A mid-20th-century aerial view of the Boar's Head Mills from the south-west. Inter-war houses (bottom left) have appeared in the grounds of the Evans mansion, Darley House, and have also sprung up on the opposite side of the river. At this date the mill leats powered a series of turbines. (BB001872; courtesy of John Nelson)

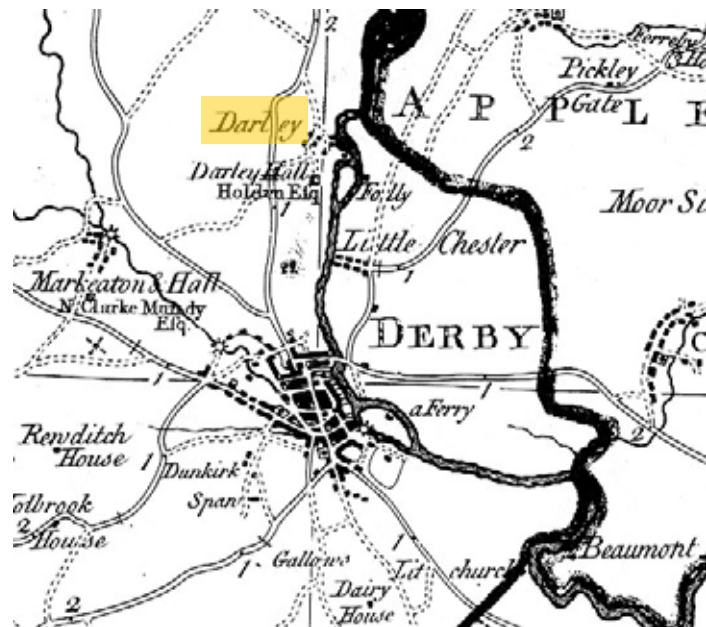
Fig 3. Darley (highlighted) as depicted in relation to Derby on the 1791 revision of Burdett's Map of Derbyshire.

Darley Abbey (which 19th-century and earlier sources usually refer to simply as Darley) is an outlying settlement within the medieval parish of St Alkmund, Derby, occupying a site on the western bank of the River Derwent roughly 2km north of central Derby (Fig 3). A house of Augustinian canons, initially located closer to Derby, was established at Darley *circa* 1146 and was dissolved in 1538. The conventual buildings are thought to have lain on flat land close to the Derwent, but despite the survival of one substantial 15th-century building (now the Grade II listed Abbey public house) their precise disposition remains uncertain.¹⁸

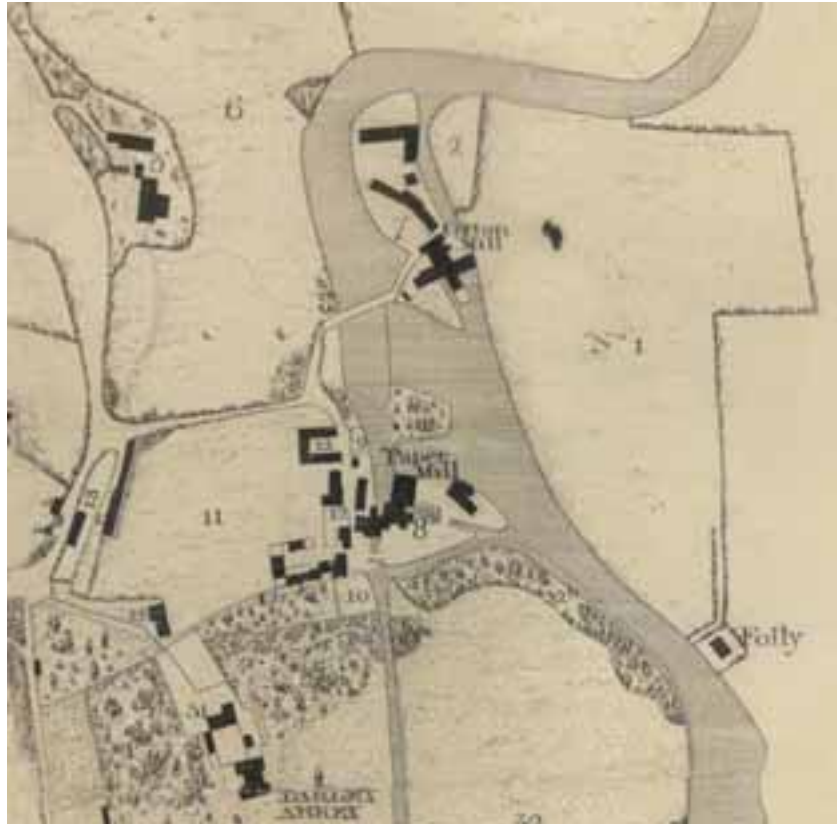
Fig 4. The cotton mill complex and its immediate neighbourhood as shown on the 1811 Liberty Map. The large T-plan building (numbered 5) roughly west of the cotton mills is the Evans mansion, Darley House, built 1785. Early workers' housing, including The Square (numbered 12), can be seen close to the Evans paper mill. The future Evans residence, Darley Hall (bottom), is marked 'Darley Abbey'. (Derbyshire Record Office)

The fifty years that elapsed between the making of the Liberty Map (Fig 4) and the publication of the *Illustrated Times* article were characterised by continuing expansion. A very considerable programme of works is apparent in the years between 1818 and c1835, during which East, West and North Mills were added, and this impetus continued through to the middle of the century with the construction of a large number of ancillary buildings. Documentary information for this period is scanty, but some of the most significant additions are summarised in a series of entries in a contemporary Stock Book maintained by the firm.⁹⁸ The first was East Mill, commenced in 1818, and completed at a cost of £3,017 16s 7½d. It was followed, from 1821, by West Mill, the cost of which totalled £4,676 5s 9½d. On a much smaller scale, an addition to the Dinner House was built in 1820 for £190 15s 0d.⁹⁹ The latest entry in the Stock Book is dated 1826 and North Mill is nowhere mentioned, nor was it referred to in 1833, when the Evanses were consulted by the Factories Inquiry Commissioners; instead they described West Mill as their 'third and last' addition to the original mill.¹⁰⁰ It is also absent, together with the accompanying further diversion of the leat, from George Sanderson's *Map of the country twenty miles round Mansfield*, surveyed 1830-34 (see Figs 6 & 7), though on stylistic grounds it cannot be many years later.¹⁰¹ Although the new channel passed close alongside North Mill it did not supply power to it directly. Instead power seems to have been derived initially from the existing wheels.

This house pre-dates the gassing shed (see below), to which it is attached on the west side, and was built at some date between the compilation of the 1811 and 1846 maps (Figs 4 & 7). It appears to be indicated on Sanderson's survey of 1830-34 (Fig 6). There are few stylistic indicators of date. The building is rendered externally, with the exception of the dentilled eaves, and the hipped roof has a modern covering of concrete tiles. There is a three-bay south front to Old Lane, the central and west bays extending further to the rear than the remaining bay, giving an L-plan overall. This accommodated a parlour to the right of the central entrance, a stair behind the parlour, and a kitchen or living room to the left of the entrance, possibly with a small scullery to the rear originally. In 1846 there were structures to the rear – probably single-storeyed service buildings – but these have been either incorporated in or, more probably, replaced by the present flat-roofed range. The stair has been remodelled to rise from the flat-roofed extension.

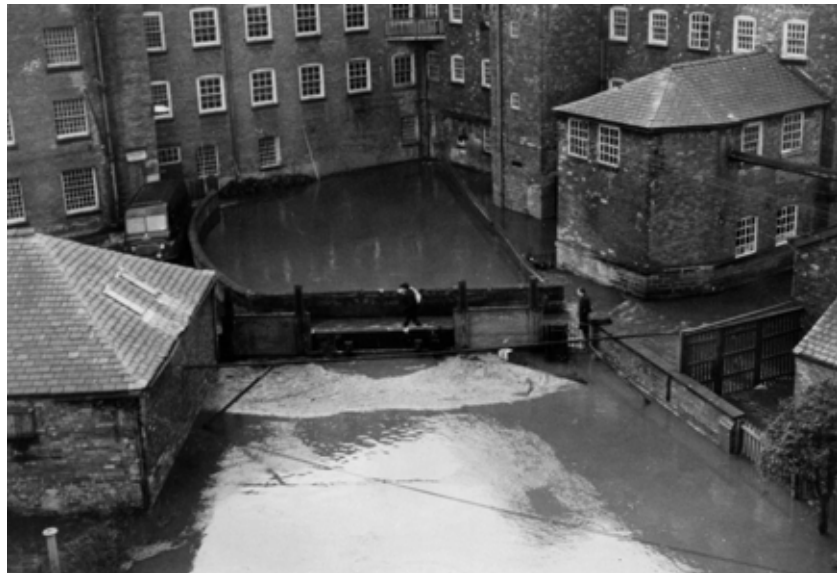
Fig 5. Flooding was a recurrent hazard of water-powered sites, with the potential to interrupt production and sometimes worse. Here the leat upstream of Middle Mill is seen spilling over onto Old Lane. (BB001871; courtesy of John Nelson)

The first indication of work connected directly with the cotton mill is a series of accounts for a 'Flood Water Wheel & House at East side of the Mill'. A flood wheel is one set at a higher level than normal, allowing it to be used when the river is in spate (see Fig 5). The evidence of Long Mill (discussed in detail below) indicates that the original wheel was located on the east side, so it would appear that the flood water-wheel was added alongside. The

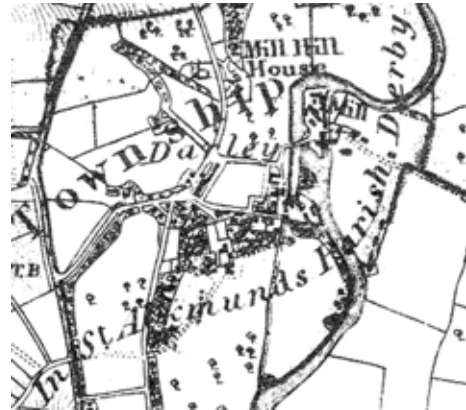
Fig 6. Sanderson's 1835 map shows a leat aligned roughly north-south. North Mill is absent.

The earliest phase corresponds to the taller western portion of the present structure, and was erected between 1811 and the early 1830s, appearing on Sanderson's map of 1830-34 (Fig 6), and more clearly on the 1846 map (Fig 7). It is distinguished by straight joints from the adjoining portion to the east, and is thought to have been a sawmill. The principal elevation faces into the site to the north. On the ground floor each bay has a cart entrance. These retain their original form with the exception of the second from the east, which has been widened on the east side. On the floor above there was a window in each bay, the lintels to which have drafted margins. The westernmost window has been replaced by a large taking-in doorway, and another such doorway has been inserted at mezzanine level beneath the next window to the east. On the west elevation there is a semicircular-headed opening on the ground floor, set below a first-floor entrance with a lintel in the same style as those of the windows. An external

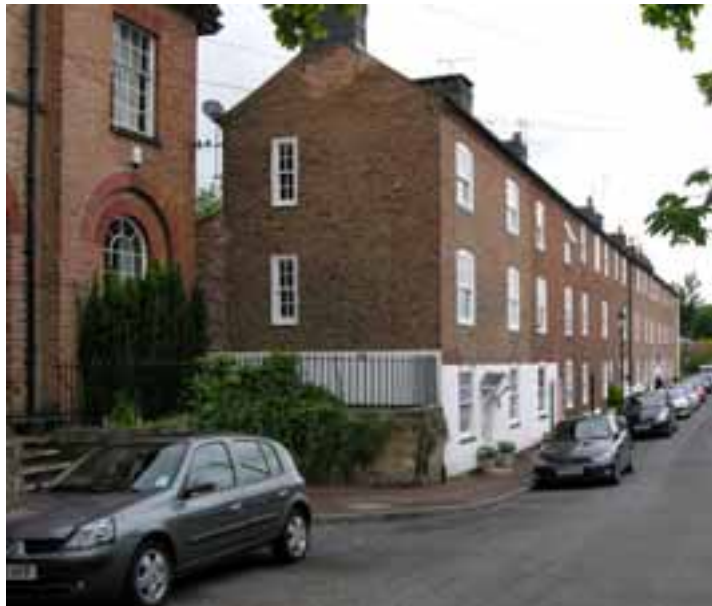
Fig 11. Brick Row from the south. The schoolroom occupied the top floor in the middle of the row. To the left is the more elaborate school of 1826.

Nos. 3-16 Brick Row, also built by the Evanses, form a single three-storey terrace built in two phases (of five and eight houses respectively) in 1797-8 and 1798-1800 (Fig 11). Each block incorporated a schoolroom on the second floor, later converted to provide additional bedrooms. These schoolrooms either replaced or supplemented the attic room in Long Mill, used as a school from 1792 or shortly afterwards (see pp 31-2). In 1826 a more substantial school was built in Brick Row to a design by the Nottingham architect, Henry Moses Wood (1789-1867). The new school had classrooms on two floors, flanked by houses for the schoolmaster and schoolmistress. The 1862 article maintains that no less than five schools were

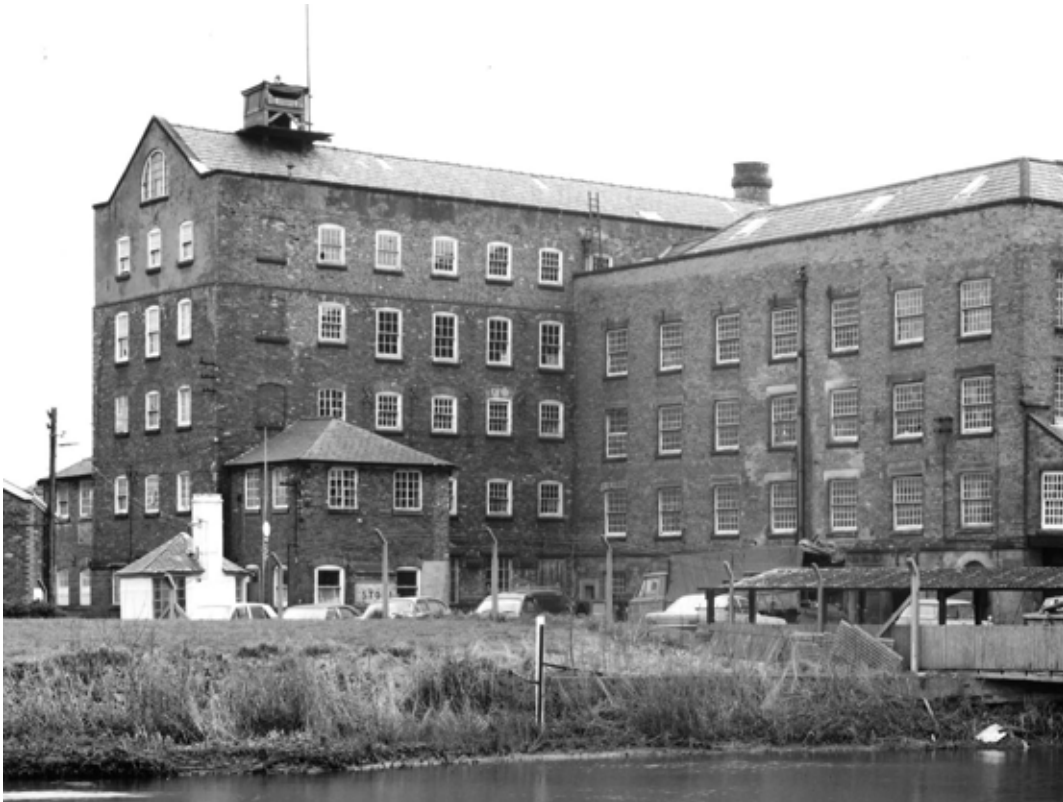
Fig 13. Long Mill from the north-west in 1975, with West Mill to the right. The brickwork of the fourth floor and attic retains traces of render. The structure on the ridge is the Second World War ARP post. (BB82/6265)

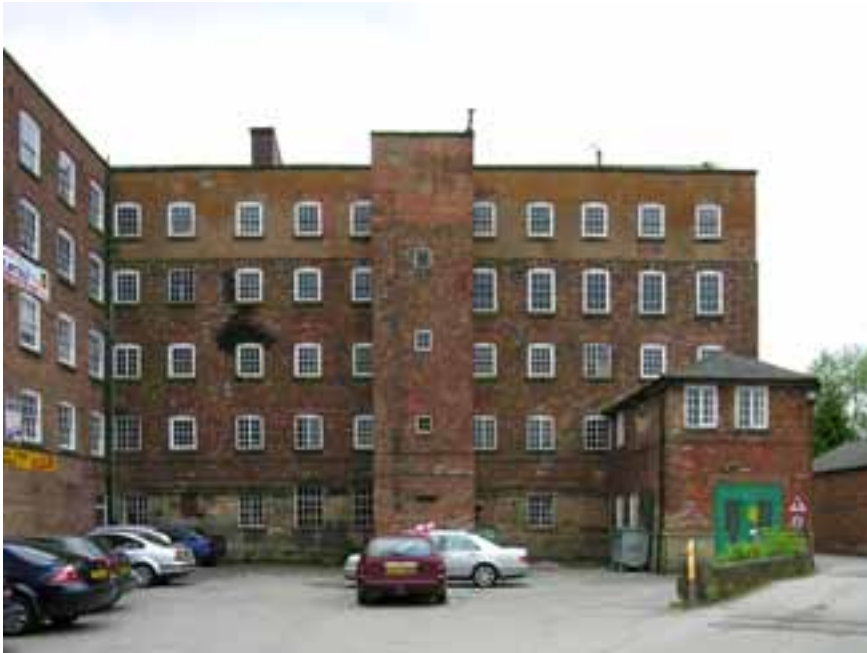
Fig 14. The east elevation of Long Mill, with Middle Mill at right-angles to the left. The leat passed directly alongside the stone ground floor. The stone ground floor and rendered brick fourth floor are clearly differentiated.

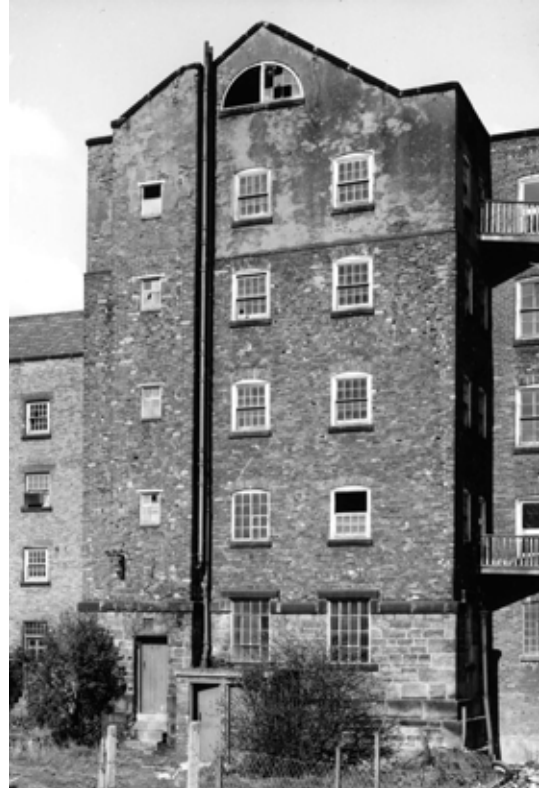
Fig 15. The south gable wall of Long Mill in 1975. (BB82/6264)

Standing on a plinth of large gritstone blocks, the mill has a ground floor of herringbone-tooled coursed gritstone rubble, rising to a lintel-band, the stones of which have diagonal tooling between dressed margins. Above this band the walls are of orange-brown brick, some of them over-fired, laid in an irregular bond. The flank walls rise to a stone-capped parapet concealing gutters at the feet of the roof slopes. The parapets return at either end, where they run into the stone-capped gables. Many of the windows, including most of those on the ground floor, have been altered, but they were originally quite small. On the ground floor these windows have square heads formed by the lintel band externally, but on the upper levels they have segmental brick arches. Inside, many on the ground floor retain segmental brick rear-arches, while on the upper floors they all have timber lintels of which all but those in the stair well are sheeted in metal. Except on the ground floor, where most of the windows retain shelving internal sills, the windows have internal splays running continuously between storeys, without sills in the plane of the wall. Some of the ground-floor windows are protected by iron bars.

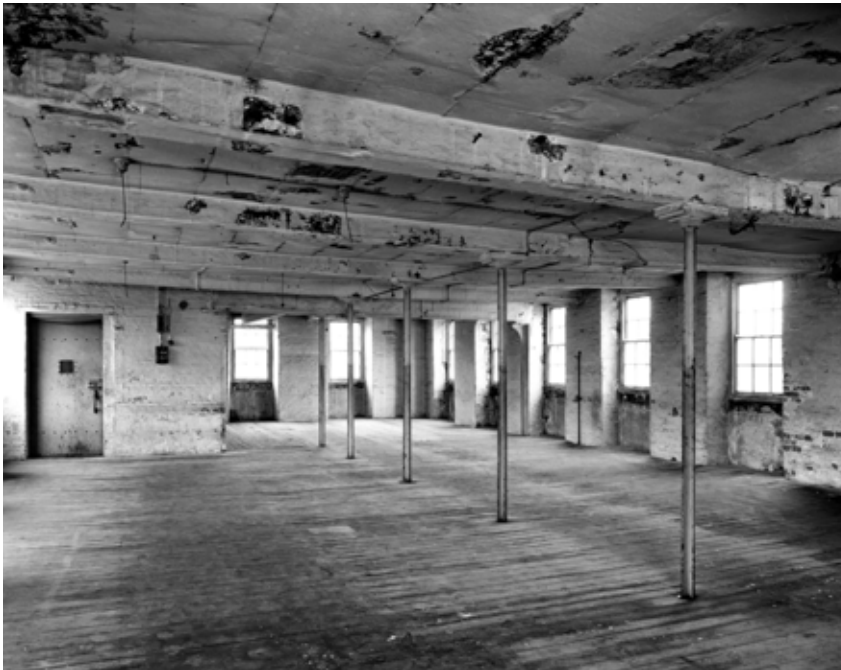
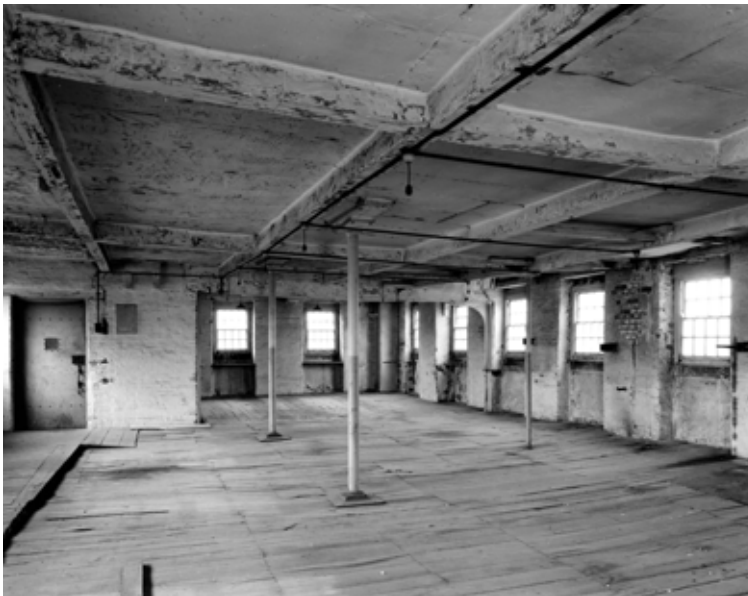
Fig 16. The interior of the third floor from the south-west. (BB001906)

Fig 17. Interior of the fourth floor, from the south. (BB001909)

The working rooms (Figs 16 & 17) were fifteen bays in length, giving internal dimensions of roughly 31.22m by 8.11m (104ft x 27ft) on the ground floor. The ground-floor room was appreciably taller than the others, with 2.87m (9ft 6in) to the underside of the joists, as compared with 2.56m (8ft 6in) on the three floors above. The ceilings are conventionally formed from transverse beams and axial joists, all now concealed by metal sheeting, but on the fourth floor a different arrangement is found. Here there is instead a grid of timber beams. The transverse beams form eight bays of two windows each, plus a short bay at the southern end. Each bay is divided into five compartments by axial beams of the same scantling. The variation in ceiling form is primarily a response to the intervals between the tie-beams, as determined by the mechanical requirements of the roof, but may also reflect lighter anticipated floor loadings at attic level.¹³⁰

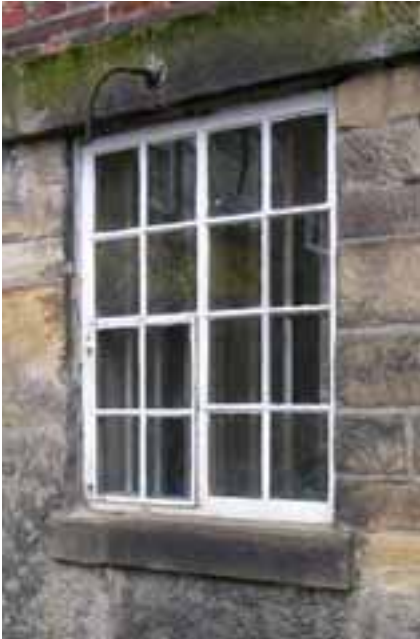
Fig 18. One of the early timber and iron-casement windows on the east elevation of Long Mill.

The small number of early timber fixtures and fittings surviving elsewhere in Long Mill include a series of windows. These consist of two lights, each light two panes wide and four deep, the panes being slightly taller than they are broad, the bottom four panes of one light forming a pintle-hung iron casement (Fig 18). Most of those that survive

(Drawing 4) are on the east side but a number survive in other positions.¹³² They appear to be the same as the windows which George Bassett, ironfounder, of Mayfield near Ashbourne, was asked ('as soon as you can') to provide in February 1799, though there is no reason to suppose that this particular order related to Long Mill.¹³³ That similar windows still formed the majority of those in Long Mill in 1833 is confirmed by the Evans & Co. responses to the Factories Inquiry.¹³⁴ Fewer early doors survive, but on the second floor the doorway linking the stair with the main room retains one consisting of four moulded sunk panels set within a simple cyma reversa architrave.

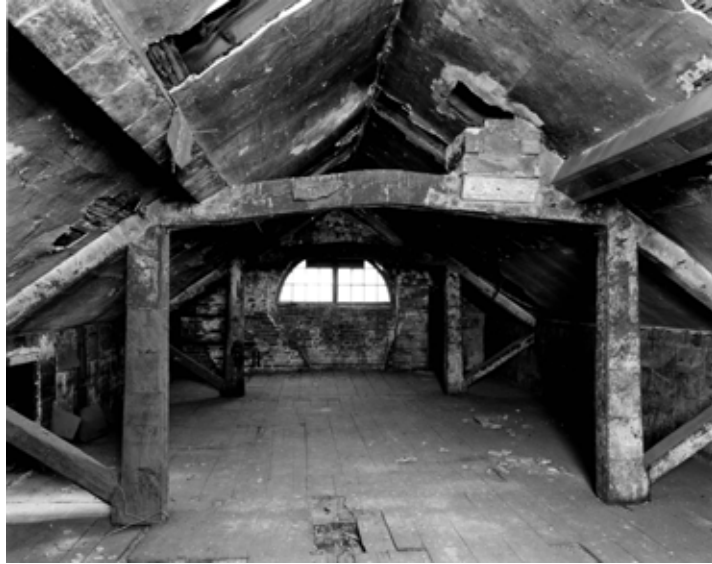
Fig 19. The attic and queen-post roof of Long Mill, from the north. One of the flues inserted in the 1790s to serve the school-room stoves, remains on top of the right-hand end of the collar. (BB001912) See also the cross-section, Drawing 3.

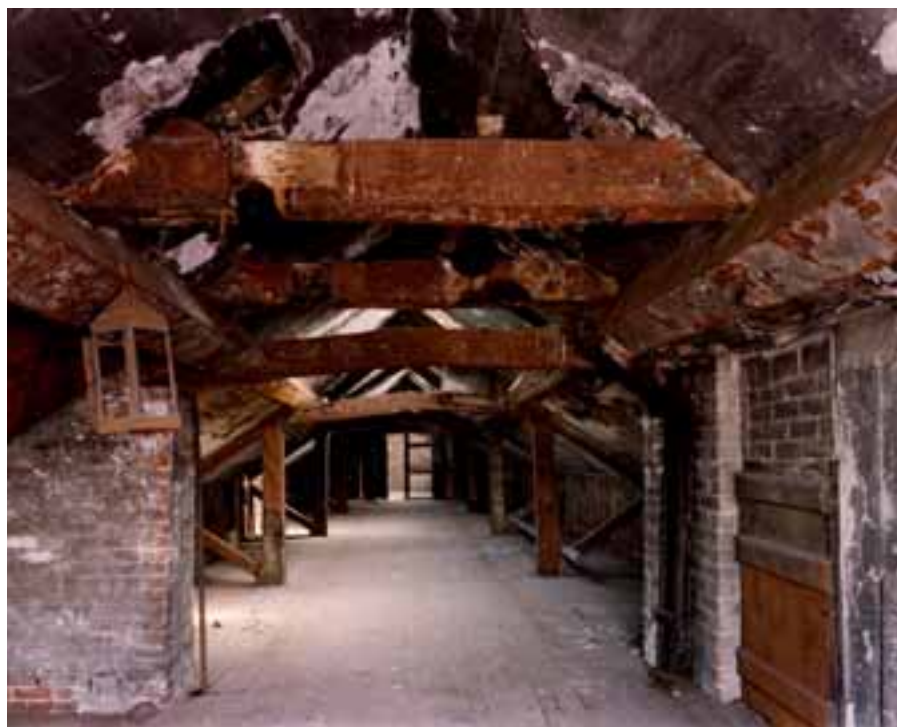
Fig 20. The attic of Long Mill, seen from the north. The metal plates sheathing the truss timbers and other exposed timbers are clearly seen. The two bearers suspended above the purlins in the foreground supported the former cupola housing the mill clock and bell. Traces of line-shafting are also visible. (BB001911)

timbers has also been noted at Lowerhouse Mill, Bollington, and Quarry Bank Mill, Styal, both in Cheshire.¹⁴⁸ The use of metal plates at the Boar's Head Mills has been known for some years, but there has been considerable uncertainty as to its date.

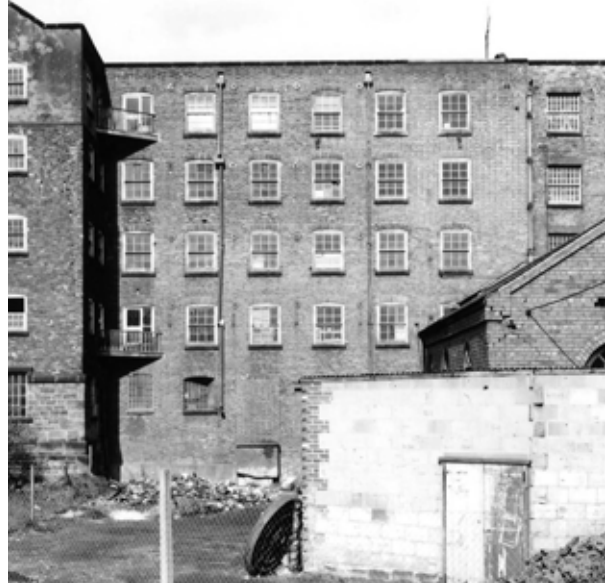
Fig 21. The south elevation of Middle Mill in 1975, with the gabled Long Mill to the left and East Mill (with the small-pane sashes) to the right. (BB82/6263)

Middle Mill (Fig 21; Drawing 2) forms a five-storeyed eastwards extension of Long Mill, which it abuts with straight joints. At 15.90m long and 8.43m wide internally (53ft x 28ft), the ground floor is fractionally wider than that of Long Mill, but only because it has thinner walls. It consists of five regular bays, with a longer sixth bay, partly occupied by a stair, at the eastern end. It was built astride the original leat, which was widened to accommodate a flood wheel in 1796-8. As discussed above (pp 13-15), the date of Middle Mill is uncertain. It cannot reasonably be earlier than the flood wheel and may be contemporary with it. However, it is more likely to be the 'New Wheel House' constructed in 1804-5 at a cost of £1,425 15s 3d (see above, p 15). A range conforming to Middle Mill is depicted on the 1811 Liberty Map (Fig 4) and the building certainly pre-dates East Mill (commenced in 1818) since the latter covers a lunette in its east gable and wraps around part of the easternmost bay. The name Middle Mill can have been adopted only once East Mill had been built.

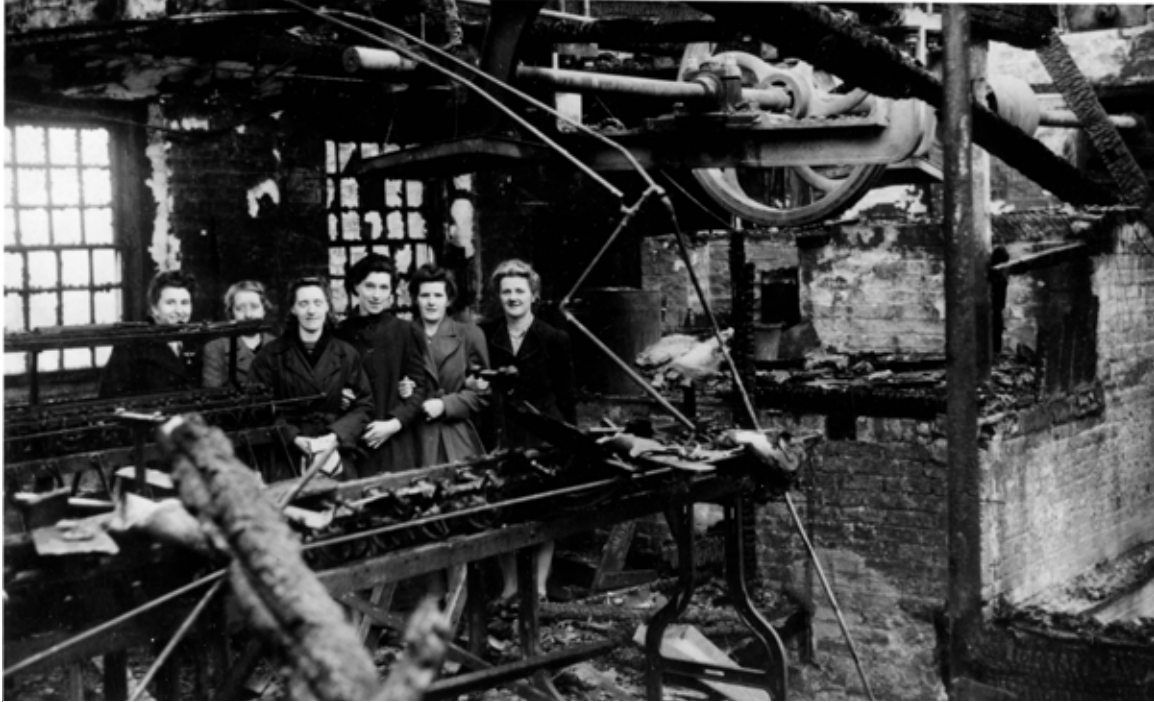
Fig 22. Middle Mill following the fire of 1947. (Photograph courtesy of John Nelson)

Owing to extensive fire damage in 1947 (see Fig 22), little of the original structure of Middle Mill survives except for the walls, and on the south elevation the eastern two bays have been entirely rebuilt at third- and fourth-floor level. The original walls are more lightly built than those of Long Mill, probably to lessen the weight carried by the wide segmental arches that span the two wheel-pits. The walls are of brick throughout, but the bond varies. On the ground floor English bond is used, on the floor above it is monk bond (a variation of Flemish bond in which headers alternate with two stretchers) and irregular English garden-wall bond above. Stone is reserved for window sills, the voussoirs of the two keyed arches and the copings, which have been re-set (with some modern replacements on the south side) on the rebuilt parapets.

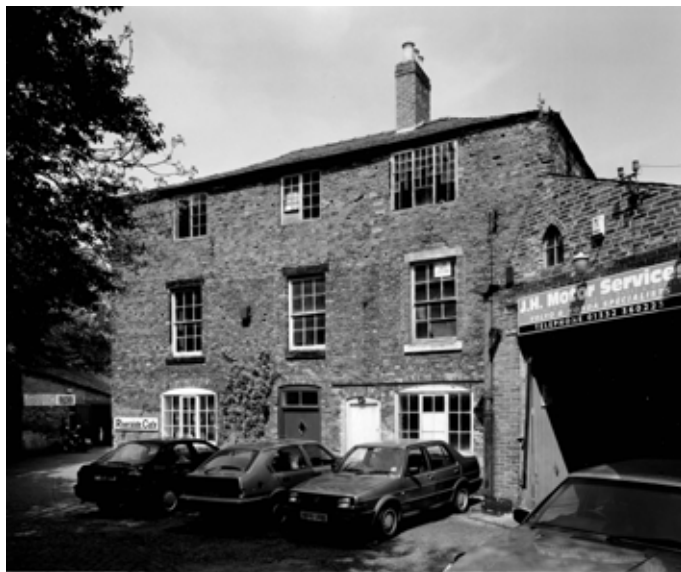
Fig 24. The concave-fronted house viewed from the south. (BB001894)

This is the largest house on the Boar's Head Mills site. It is a plain but substantial three-bay house, its subtly concave front elevation overlooking the approach across the River Derwent (Figs 24 & 25; Drawing 5). Its size and position suggest that it was intended for a mill manager or as a counting house, both paralleled at Arkwright's Cromford Mill. Outram's 1792 map shows a building, distinct from Long Mill, that might be interpreted as corresponding to the present house, but the depiction is too crude for any confidence to be placed in it. The house may instead be the 'New House in Weir Close', which was charged to

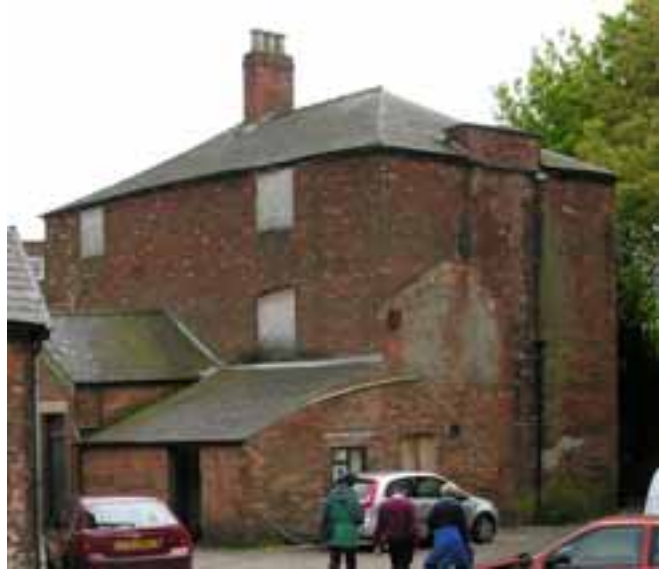
The convex rear elevation had just two windows per floor. On the ground floor one remains in the form of a doorway (above which the original window arch has been retained as a relieving arch) while the other has been blocked. On the first floor the left-hand window retains its original segmental head of brick headers, but the other has been altered. The second-floor windows resemble those on the front elevation.

Fig 25. The house seen from the NW.

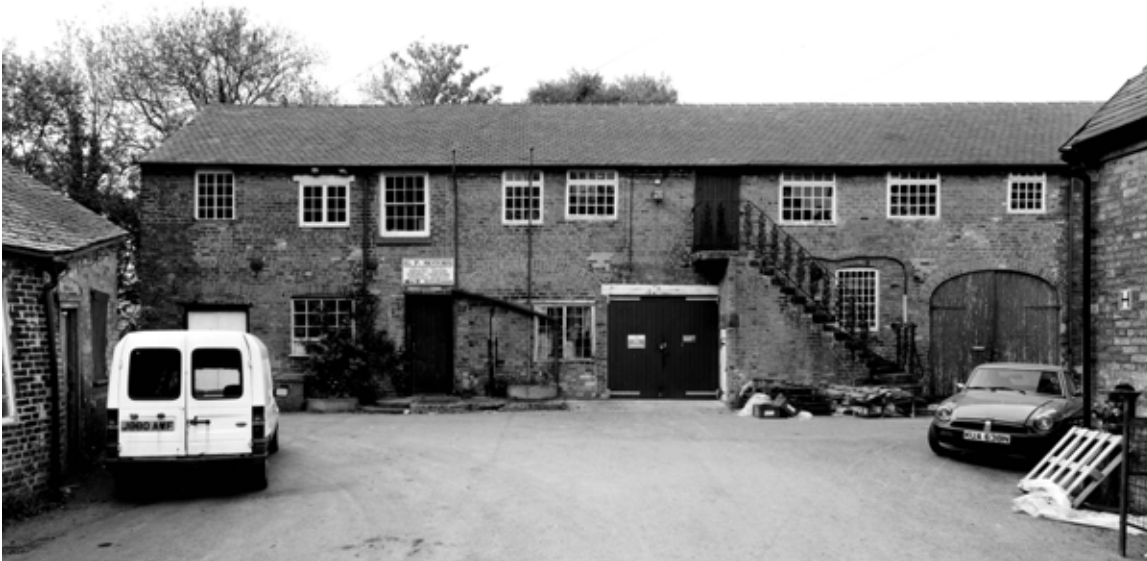
The east-west range (see Figs 26 & 27) is of exceptional importance as one of only two known surviving instances of a type of proto-fireproof construction pioneered by the Strutts in the 1790s, and the only known example in which the technique is applied to part of the building rather than the whole. The purpose of the innovation was to minimise the quantity of timber employed in the construction of upper floors, and to reduce the vulnerability to fire of the remaining timbers. Portions of the upper floor consist of brick jack-arches springing from timber skewbacks attached to the lower edge of transverse timber beams, the whole covered with lath and plaster on the underside so that no wooden surfaces remain exposed. The axial thrust exerted by the vaults is restrained by the use of wrought-iron tie-rods (two in each bay). The surface of the floor above is of brick laid on sand.¹⁵⁴

Fig 26. The western portion of the proto-fireproof range from the south. (BB001900)

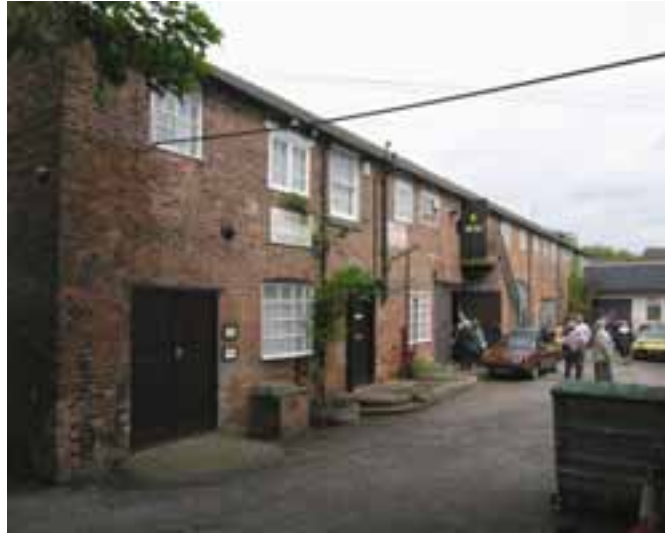
The conventionally built bays at either end appear to have mirrored each other in general terms. Each had a front entrance close against the large cart openings; these are distinguished from the contemporary windows by their lower heads. That to the east survives in an altered form, but that to the west has been replaced by an entrance slightly further east, and only the western springing of the arch survives. Beyond these doorways there was a pair of windows. To the east these have been replaced by a single large doorway, and only the arched heads remain; to the west the inner window survives (with a raised sill

Fig 27. View from the SW, showing the full extent of the range, and the attached shed at the eastern end.

and a modern bowed frame), while the outer one has been converted into a doorway. To the rear each pair of bays has three ground-floor windows. The two outer windows in each case are opposite the front windows and appear to be original, whereas both inner windows are insertions (that to the east has the deeper form of window head).

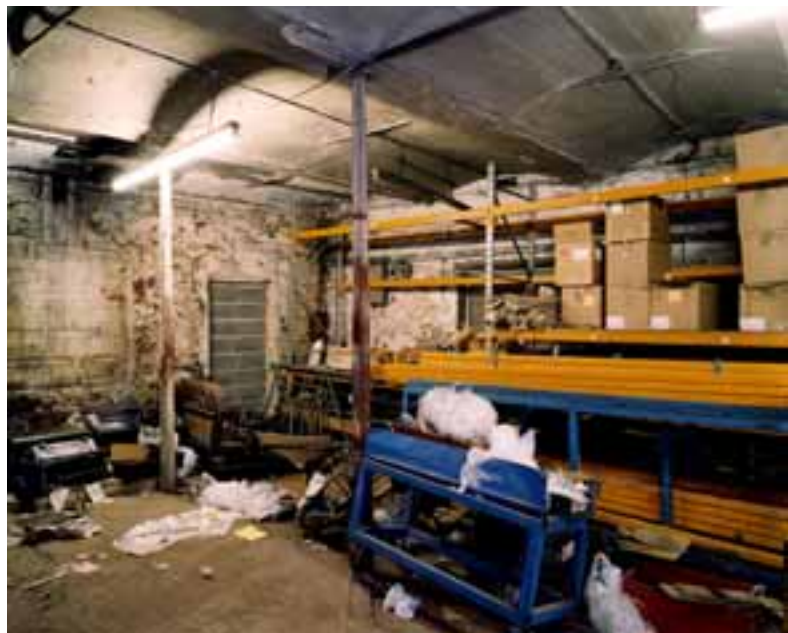
Fig 28. The proto-fireproof ground-floor ceiling of the eastern extension, showing brick vaults springing from timber beams supported on cast-iron columns. (AA051582)

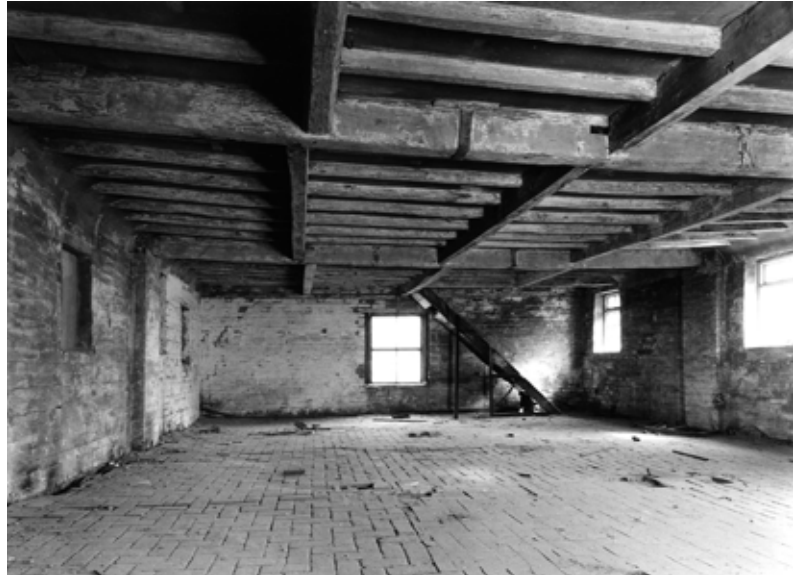
Fig 29. The first floor of the east extension from the west, showing the brick-paved floor and grid of ceiling beams. The makeshift ladder stair at the far end occupies an original stair position.

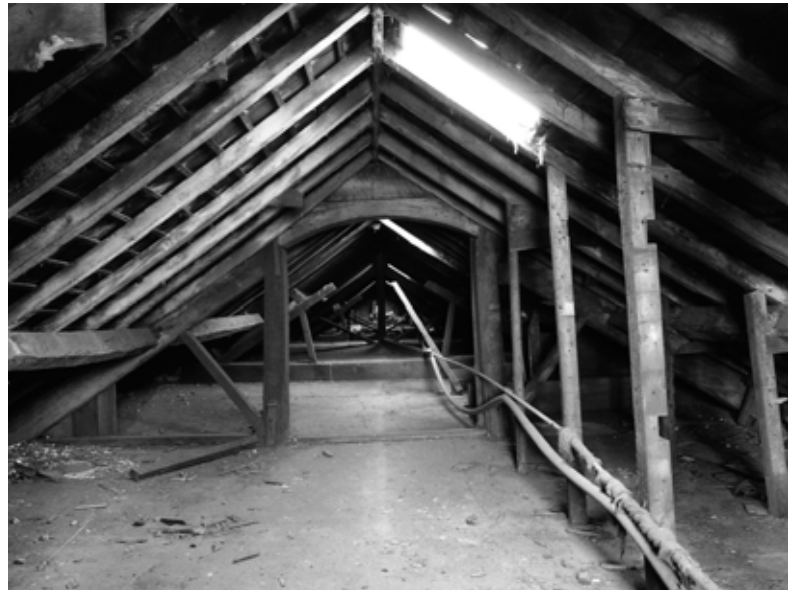
Fig 30. The attic and original roof structure of the east extension, from the east.

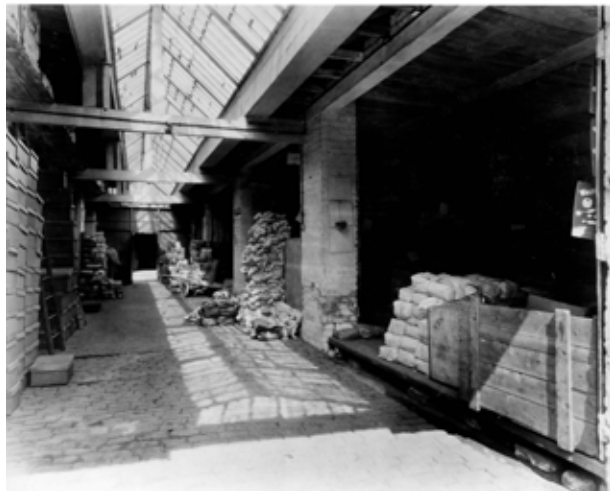
Attached to the eastern extension just described, and projecting southwards, there is a single-storeyed six-bay range (Fig 31) which is now largely enfolded by later buildings to east and west (Drawing 6). A range is depicted in this position on the 1811 Liberty Map, and for reasons given above it is probably the 'Shed in wood yard' of 1799-1800. There is, however, a gable scar on the south wall of the east extension, indicating a slightly lower roof line. The present building appears to represent a raising of the original structure rather than a comprehensive rebuilding.

Fig 31. The open-fronted shed, as depicted in a photograph dating from c1930, by which time a north-lit roof linked it with the adjoining building to the west. (BB001860; courtesy of John Elliott)

originally backed onto the mill leat, are insertions, which were blocked up during the 20th century. The four-bay interior originally formed a single space, but a brick partition has been inserted (on the evidence of straight joints) between the second and third bays from the north. The roof trusses are of king-post form, with raked struts, and have been reinforced by timbers bolted onto either face. They carry a single set of purlins. The roof probably had a hipped southern end. This is suggested by the fact that the southern bay is longer than the others and although the end wall remains *in situ* it rises only to tie-beam level.

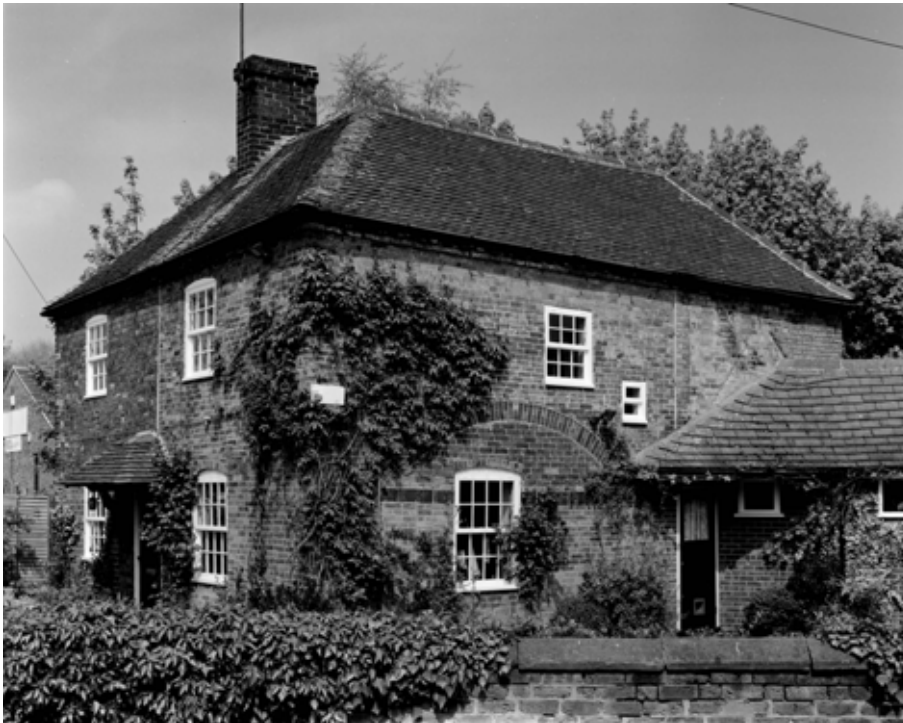
Fig 32. The present house attached to Darley Abbey Pottery. (BB001887)

The earliest part of the building (the outline of which is depicted on Drawing 1) is a two-storeyed structure, roughly square on plan, distinguished by a blocked cart opening in its southern elevation (Fig 32). It would appear to be an industrial building, which has been extended and adapted to provide domestic accommodation. The brickwork is in English garden-wall bond, rising to a dentilled eaves course, and incorporates windows placed irregularly, one on each floor, in the west elevation. These have segmental arches of brick headers. To the east of the ground-floor window there is a run of brick closers suggesting a blocked window or doorway. The cart opening has a pronounced segmental arch which has been infilled to create a window; a first-floor window is offset to the east. Given the oddly isolated position of this building it is possible that it was

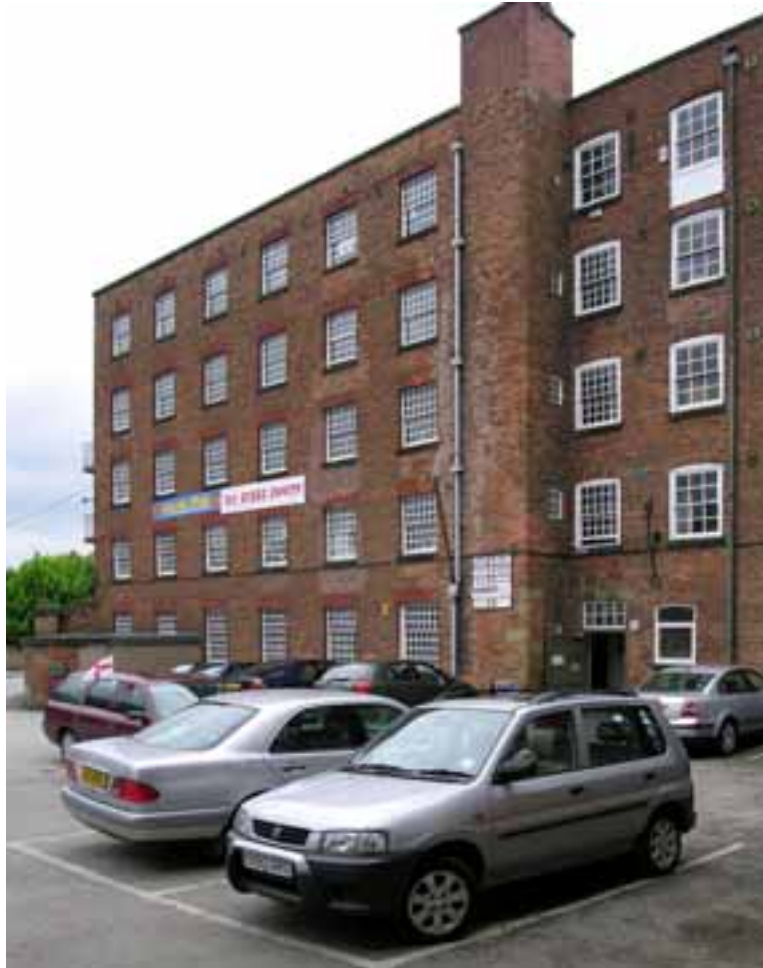
East Mill (Fig 33; Drawings 2, 10 & 11) forms an eastwards extension of Middle Mill, the gable of which it covers, and consists of six bays and five storeys. The Stock Book notes only that it was commenced in 1818 and cost £3,017 16s 7½d.¹⁷³ It is appreciably wider (17.43 x 9.82m internally on the ground floor, excluding the privies) than the earlier Long and Middle Mills. Thus while the south wall forms a continuation of the south wall of Middle Mill, the north wall is advanced and indeed overlaps the earlier structure to the extent of about half a bay's length. The overlap accommodated privies (later converted to house a hoist). The walls are of red brick, laid in English garden-wall bond. Rounded gritstone quoins are confined to the ground floor of the north-west corner, where they ease access to the entrance to

Fig 33. East Mill from the NW. East Mill is wider than Middle Mill (right), which it overlaps to the extent of its privy tower.

Middle Mill. The original windows are confined to the north and south walls (with the exception of the small west-facing windows serving the privies) and have flat arches of gauged brick, stone sills and original small-pane sashes (seven panes wide and three over three panes deep).¹⁷⁴ Two windows in the eastern gable – one on the third floor and a lunette on the fourth – are later insertions characterised by the use of larger brown bricks. The present fire-escape doorways are also insertions.

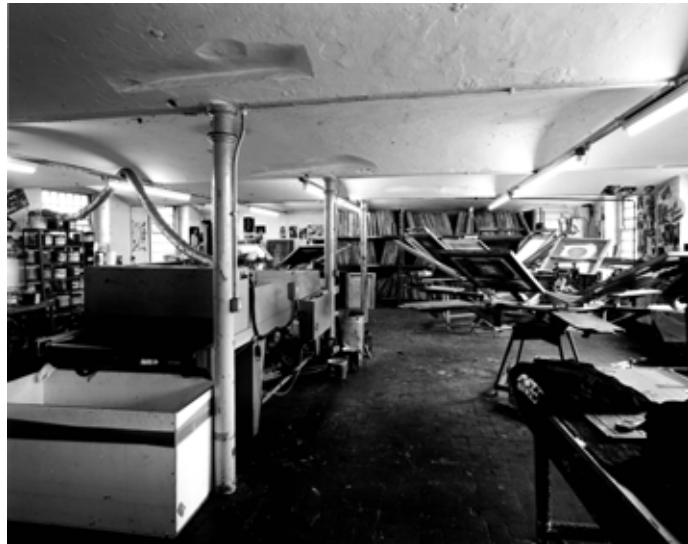
Fig 34 (top). Fireproof brick vaults on the second floor of East Mill, showing cut-outs for a central axial overhead line-shaft.

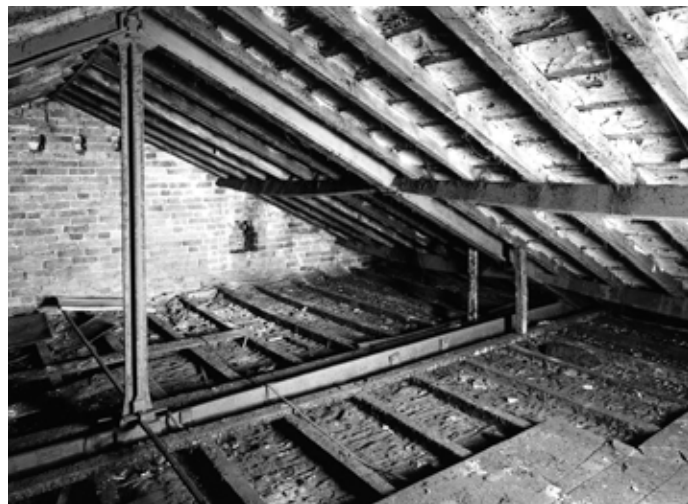
The cast-iron roof trusses are of a particularly unusual form (Fig 35; Drawings 10 & 11). The principal rafters rise from iron shoes resting on brick corbels, and are linked by a low collar with spandrel braces. Both the collar and the principals are of a simple inverted-T section, but the collar is in two parts, thickened and halved together. The junction is made fast by keyed tie-rods. The same method may be employed to secure the beams, but if so it is concealed within the floor structure on the lower levels. The collars are supported in mid-span by slender columns lacking the necking ring of those on the lower floors. A cruciform-section king-post rises from the centre of the collar. There are two ranks of fish-bellied cast-iron purlins, the web stiffened by short flanges of different lengths, giving a flattened C-section. They rest against lugs cast into the web of the principals, which are reinforced by a stiffener on the soffit at this point. The common rafters, battens and ridge-board are of timber, the rafters located between cleats cast into the upper flange of the purlins. The fourth-floor ceiling also incorporates timber. It is joisted conventionally, the joist ends resting on the flange of the collar and being underdrawn in lath and plaster, giving some slight protection against fire.

Fig 35 (bottom). The easternmost cast-iron roof truss, showing fish-bellied purlins and timber common rafters. One of the flues is visible in the gable to the right of the king-post.

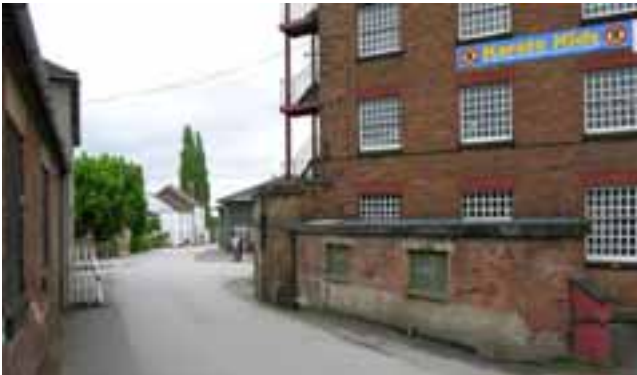
Fig 36 (above). The single-storey structure adjoining the north side of East Mill, and the remaining gate pier for a short-lived eastern perimeter to the mill site.

In the angle formed by the north wall and the gate pier at the eastern perimeter of the site there is a single-storeyed structure, currently with a felted flat roof (Fig 36). It has an irregular plan, largely determined by the road passing along its north-east side, and is clearly recognisable on both the 1846 map and the 1862 bird's-eye view (Figs 7 & 8). It has brick walls incorporating a rounded corner to the north, and a large entrance, probably an enlargement of an original feature but now blocked, taking up most of the

west wall.¹⁷⁶ Two windows have been inserted in the north wall; they have bull-nosed brick sills and concrete lintels. The absence of evidence for original windows raises a question as to the original function of this structure. It is possible that it was built as a stove to heat the mill. Some support for this interpretation can be found in the nearby east gable of the mill. This carries up three flues, two to the north and one to the south of centre, which discharge into the roof-space (see cross-section). Since this arrangement precludes smoke flues it is likely that they were for hot air.

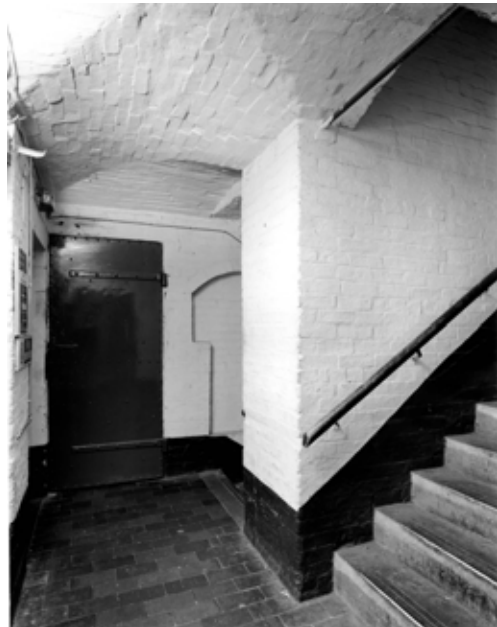
East Mill utilised the same power source as Middle Mill, and circulation depended on the same stair (Fig 37). The latter was positioned in the north-east corner of Middle Mill, where it served both mills equally well. A large segmental-arched doorway (now reduced in size) was inserted in the gable wall of Middle Mill to link the two mills at this point. This fact, coupled with the fireproof construction of the stair, suggests that the

latter dates from the addition of East Mill and not before. It is also conveniently placed for the privies, which occupy the overlapping portion of Middle Mill. The gritstone treads rise around a substantial brick pier standing on a gritstone base. There are half-landings against the north wall on each storey and two quarter-landings composed of large gritstone flags between storeys. The half-landings have groin-vaulted brick ceilings and doorways opening onto both mills. Those leading to East Mill are broken through the original gable wall of Middle Mill. They have iron doors and door surrounds, the latter incorporating fish-bellied lintels, as also found (inserted) in Long Mill.

Fig 37 (right). The East Mill stair from the west. (BB001922)

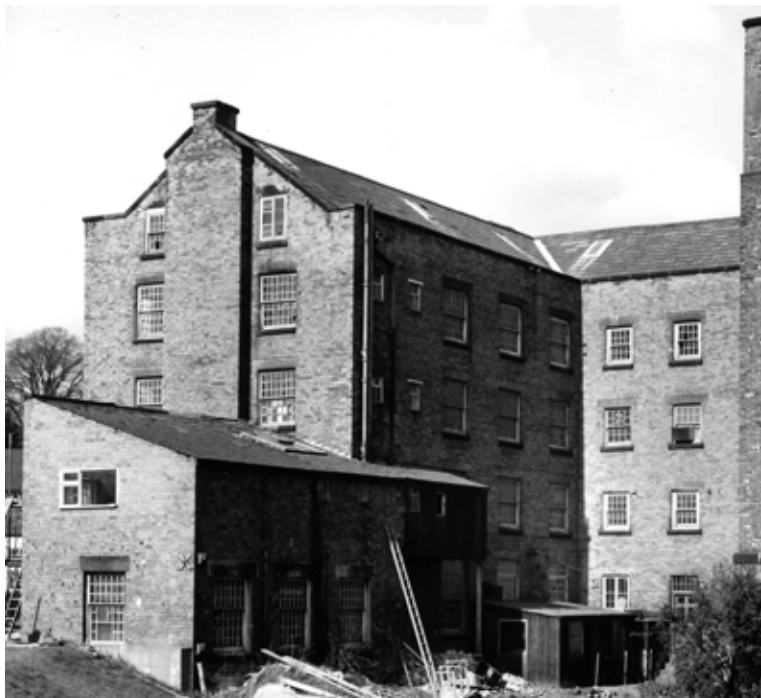
Fig 38. West Mill from the south-east in 1975, showing the L-shaped plan. The leat passed beneath the right-hand range. (BB82/6264)
