BOAR'S HEAD MILLS

A SURVEY AND INVESTIGATION OF THE COTTON MILLS AND ANCILLARY BUILDINGS

NBR No 33050
NGR SK 3538 3857 (Long Mill)
ISSN 1749-8775
Research Department Report Series 35/2006

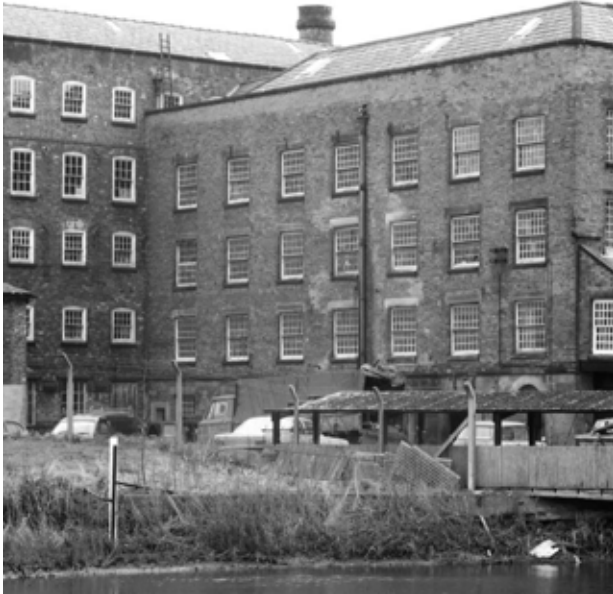
Fig 39 (left). The north elevation of West Mill in 1975. The rainwater fall pipe roughly marks the junction between the two phases of construction. (BB82/6265)

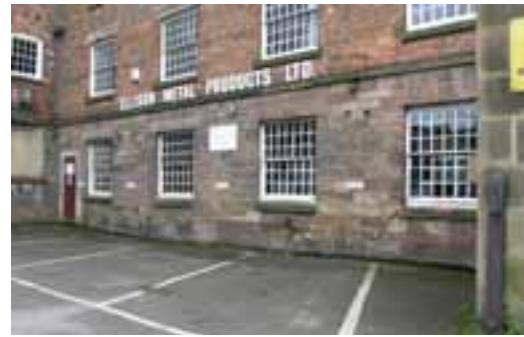
Fig 40 (above). The stone ground floor of the four eastern bays, showing (at ground level) the twin arches to the former wheel pits.

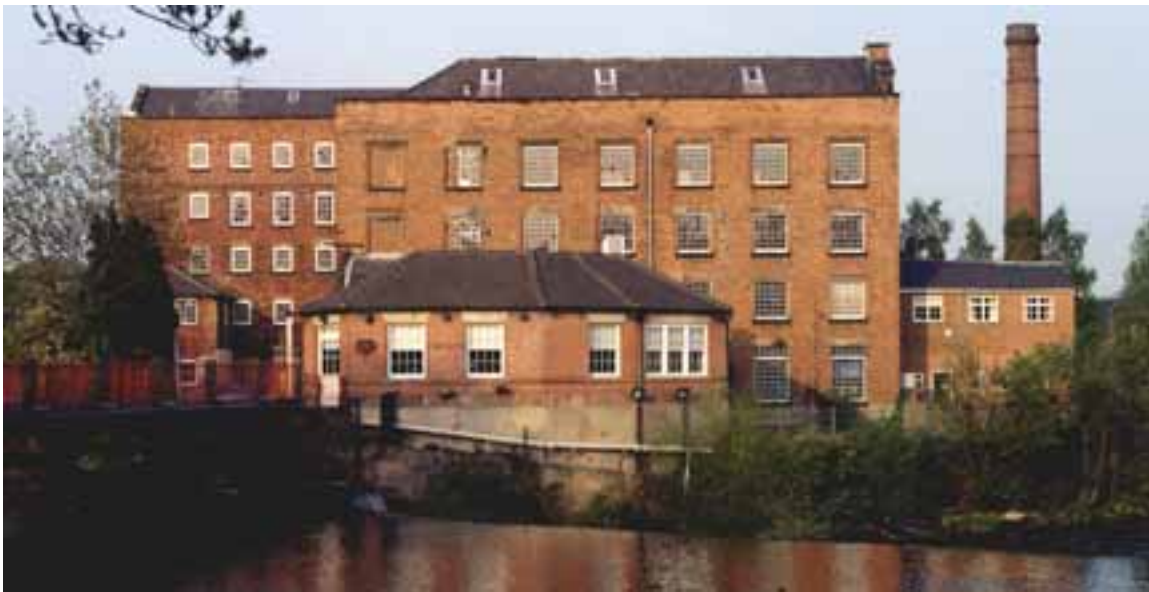
Fig 41. The west elevation of West Mill, showing the blind windows (and parts of windows) corresponding to the stair compartment at the north end. The single-storey building in the foreground is the former mill dining room, now a restaurant. (BB001880)

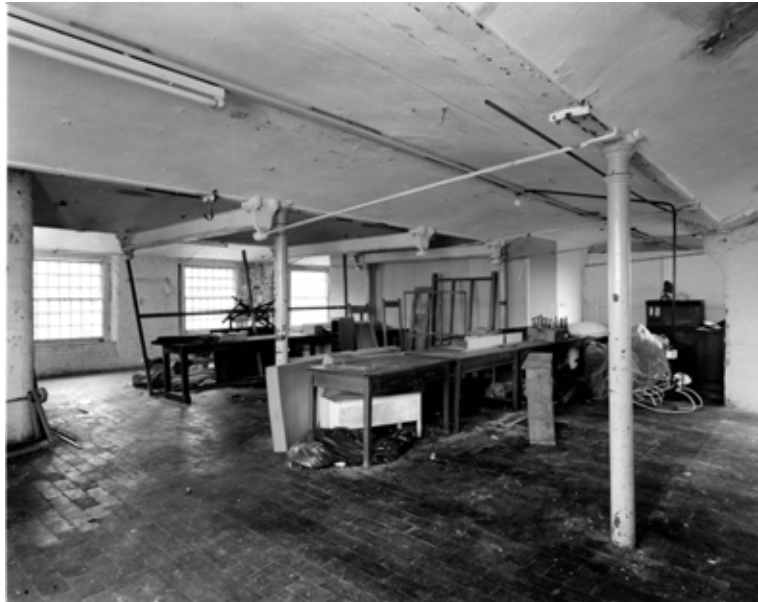
Fig 42. Interior of the east-west arm of West Mill from the south-west, with the stair compartment showing to the left. The columns, the beams they support and the brick vaults are original features, but the transverse tensioning beneath the vaults is later. (BB001919)

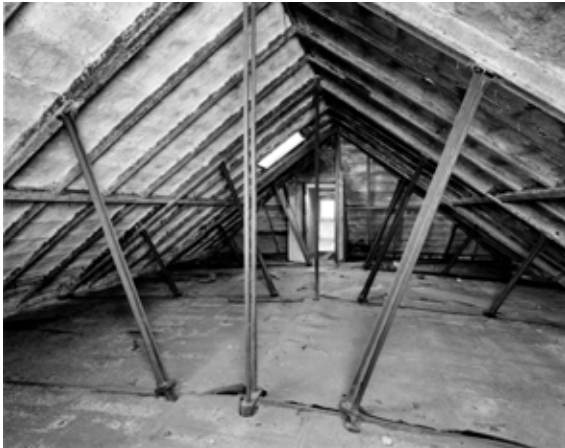
Fig 43. The roof of the east-west arm. (BB001914)

On either side of this partition the roofs have a number of features in common, but also incorporate significant differences. All the roof elements are cast iron and of inverted-T cross-section unless stated otherwise. The trusses of the east-west range rest on stone pads and have cranked tie-beams composed of two members bolted at mid-span (Fig 43 & Drawing 9). Two pairs of cruciform-section raked struts rise from the tie-beam to the principal rafters, which meet at vertical bolting faces and support a slender cast-iron ridge. The tie-beams are suspended at mid-span by an axial pair of wrought-iron square-section king-rods. The upper ends of the rods are formed into eyes, which are

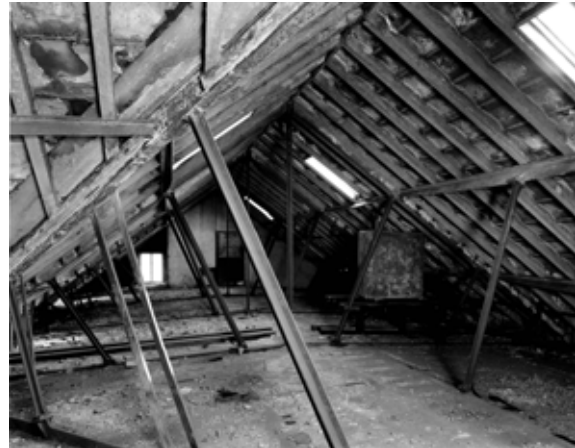
Fig 44. The roof of the north-south arm. (BB001916)

The roof over the north-south arm (Fig 44) has a truss set diagonally between the internal and external corners formed by the two ranges, and a further four bays to the south. The differences, when compared with the roof of the east-west arm, principally concern the form of the purlins and the substitution of timber for a number of features. The ridge, common rafters and battens are of timber. There are two sets of purlins. Where the east-west arm has cast-iron common rafters and purlins of inverted-T section with a parallel-sided flange, the north-south arm has timber common rafters and two pairs of T-section purlins with a fish-bellied web. The diagonally-set truss is associated with half tie-beams extending north and west from its mid-point. These are strutted in the normal way, but the west tie has had the longer, inner strut removed to ease access to an inserted chute.¹⁸⁰

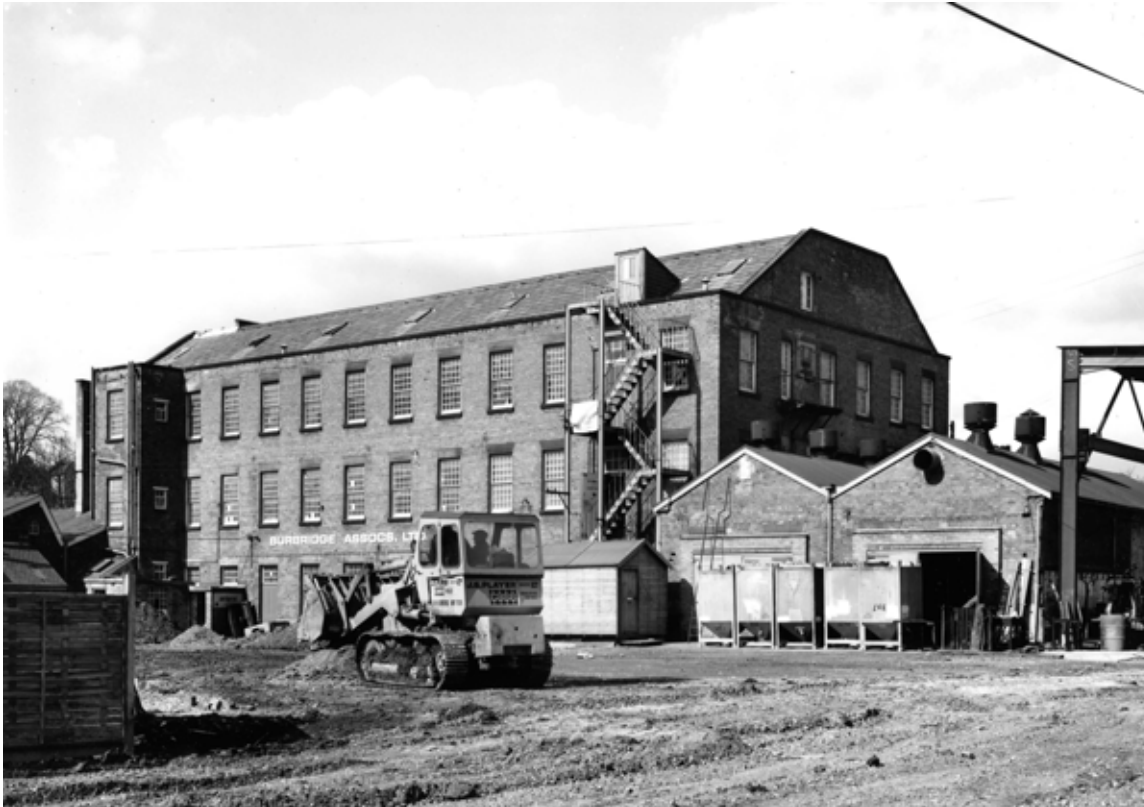
Fig 45. North Mill in 1975, viewed from the south-east (BB82/6272).

North Mill (Fig 45; Drawings 12 & 13) lies to the north-east of Long Mill on land made available for building when the original leat, realigned between 1798 and 1800, was again diverted. The new watercourse approached from the east and passed close to the south elevation before turning sharply southwards a little short of its western end. The mill was formerly attached at its south-west corner to a contemporary return range, now demolished, further details of which are given below. The name North Mill has been adopted for convenience. It has been used in the past, though whether as a proper name or merely as a descriptive label is unclear.¹⁸² Some previous accounts (including the recently superseded Statutory List) refer to the building as the Dye House. The 1862 article about the Boar's Head Mills indicates the presence of a dye house by this date,¹⁸³ and there is some evidence at the east end of the building to suggest that dyeing may have been undertaken here. It is unlikely, however, that North Mill was designed primarily for this use. Purpose-built dye-houses were generally single-storeyed, because of the weight of water handled, and usually incorporated a high roof to allow adequate ventilation.

The engine-house and boiler-house were added at the east end of North Mill, the junction being marked by straight joints. Their twin gables (see Fig 45) projected the same distance forwards (south) of North Mill, but the four-bay boiler-house projected further to the rear than the three-bay engine-house. The brickwork is in English garden-wall bond; the original roof covering has been replaced with felt, resulting in the removal of at least one louvre (visible in aerial photographs) from the boiler-house. The front gables each had two windows apiece, with wedge-shaped stone lintels; those to the engine-house have been restored, while those to the boiler-house have been replaced by a large mid-20th-century doorway, leaving just the lintels *in situ*. To the rear the engine-house had a single tall window, while the boiler-house had a pair of semicircular-arched windows.

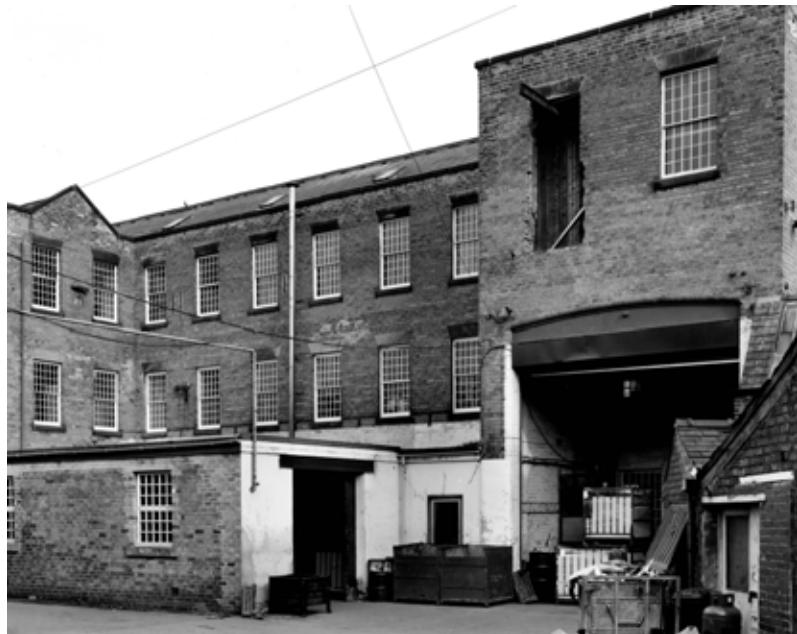
Three full-height projections from the main range appear to be original elements of the design. On the front a privy tower projects from the second bay from the west. This has a window of the standard type facing south and lighting a passage on each floor, and small windows with timber lintels, serving privies placed on either side of the passage, facing east and west. Its absence from the 1846 plan (Fig 7) may perhaps be explained by its small size. To the rear there are short, wide projections at either end (Fig

Fig 46. The rear elevation of North Mill, from the north-west. (BB001896)

46). These are vaulted and roofed parallel to the main range but the resulting asymmetrical M-profile roof is disguised by flat-topped gables extending the whole length of the end elevations and, on the east elevation only, by what was originally a uniform

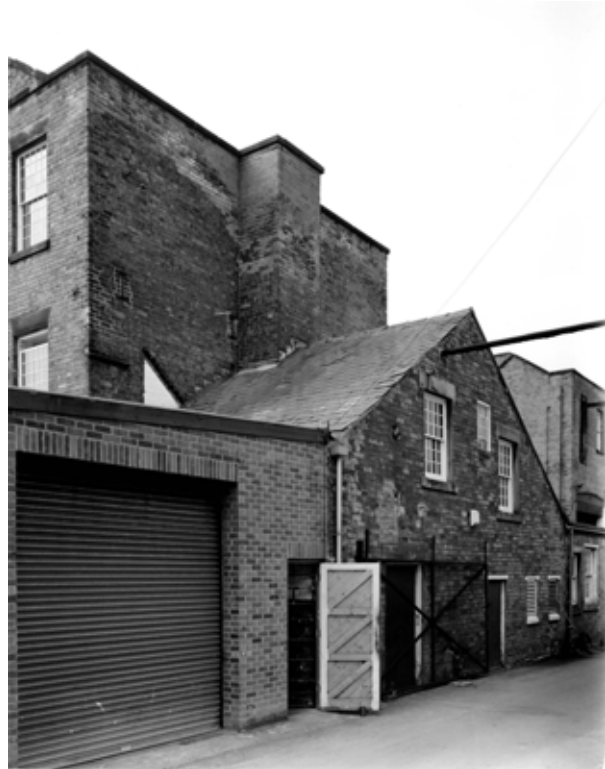
Fig 47. The more easterly of the two ranges projecting on the north elevation of North Mill, from the north-east (BB001897).

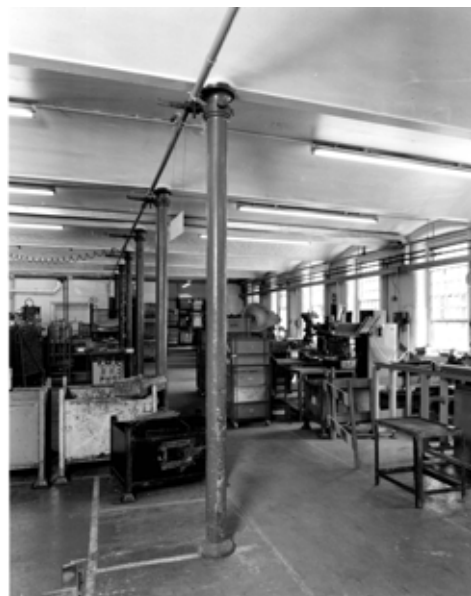
The fireproof structure of the main range (Fig 48) consists of thirteen closely set brick vaults carried on cast-iron beams, supported at mid-span by circular-section cast-iron columns of the same form as occurs in West Mill. The hog-backed profile of the beams can be seen above an exposed section of the ground-floor ceiling in the stair compartment on the north side. The beams have a broad bottom flange and a narrow top flange; the latter represents a departure from the form adopted in West Mill.

Fig 48. The ground-floor interior of North Mill, from the west. (BB001926)

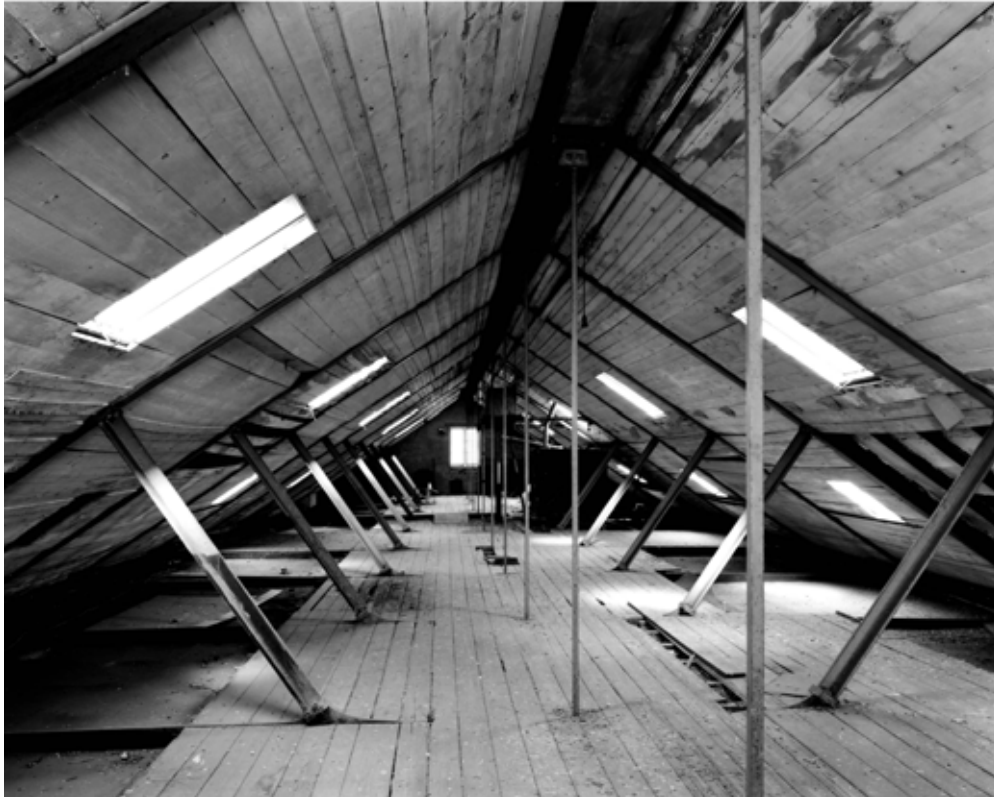
Fig 49. The main roof of North Mill, viewed from the west. (BB001931).

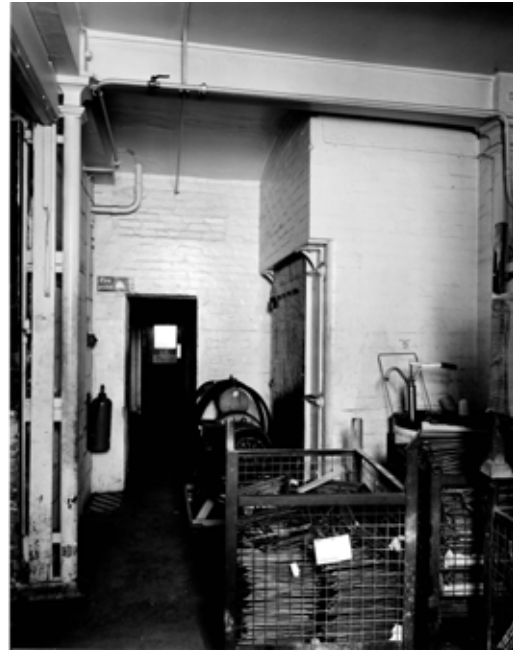
Fig 50. The westernmost bay of the ground floor, from the north. (BB001928)

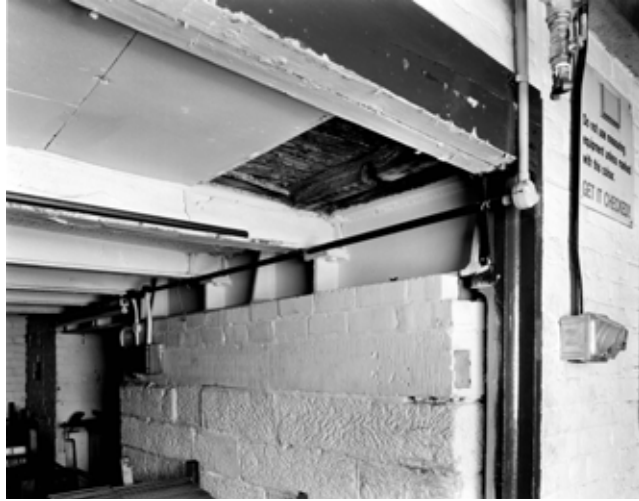
Fig 51. The space beneath the raised ground floor of the north extension. (BB001927)

Behind the lintel there is a low space (Fig 51) beneath a floor composed of closely spaced fish-bellied cast-iron beams, laid north-south and supporting a timber-joisted floor of reeds (presumably with a screed of lime-ash above), which are plastered on the underside. The purpose of this space is unclear; a doorway and two small windows in the north wall are all later insertions. A contemporary gritstone stair compartment, the long wall of which is overlain by an iron wall-plate with cast-in seatings for the beams, occupies the south side of this low space. The structure is cut into the pre-existing wall to the south, through which a doorway was inserted, giving access to the stair from the western fireproof bay of the adjoining range.

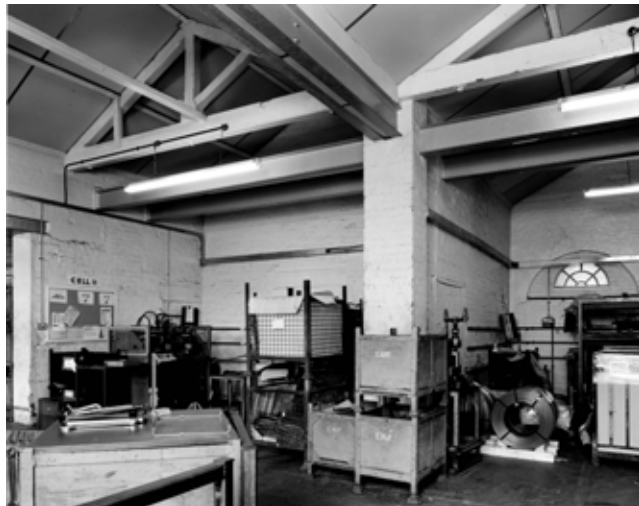
Fig 52. The interior of the engine house (left) and boiler house (right). (BB001925)

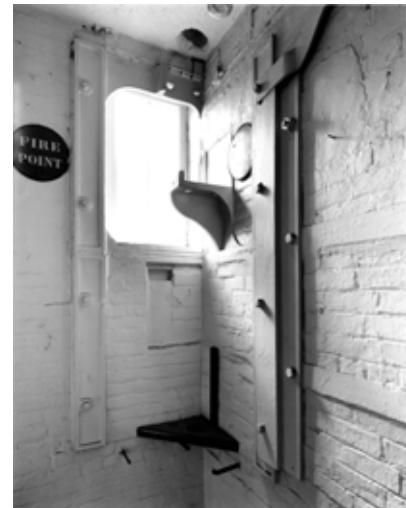
The position of the upright shaft is indicated by a complex arrangement of cast-iron columns and beams, associated with a large bearing in the west wall and a series of brackets for bearings on the intermediate landings of the stair (Fig 53). Since there is no evidence for either water or steam power at this end of the building, it would appear that motive power was supplied from the main mill complex, probably in the form of a culverted line-shaft. The position of the upright shaft is indicated by a large casting projecting from the external face of the west gable. Internally, on the ground floor, this is associated with a framework of D-section columns, paired and linked at the capitals, and supporting axial iron beams, at least some of which are of broadly the same sectional form as the main floor beams. A bearing box in the west gable is placed immediately south of the centre-line in the building, and appears to relate to another on the opposite gable, indicating line-shafting close against the central rank of columns.

Fig 53. One of the bearing boxes indicating an upright shaft position in the stair well at the western end of North Mill. (BB001930)

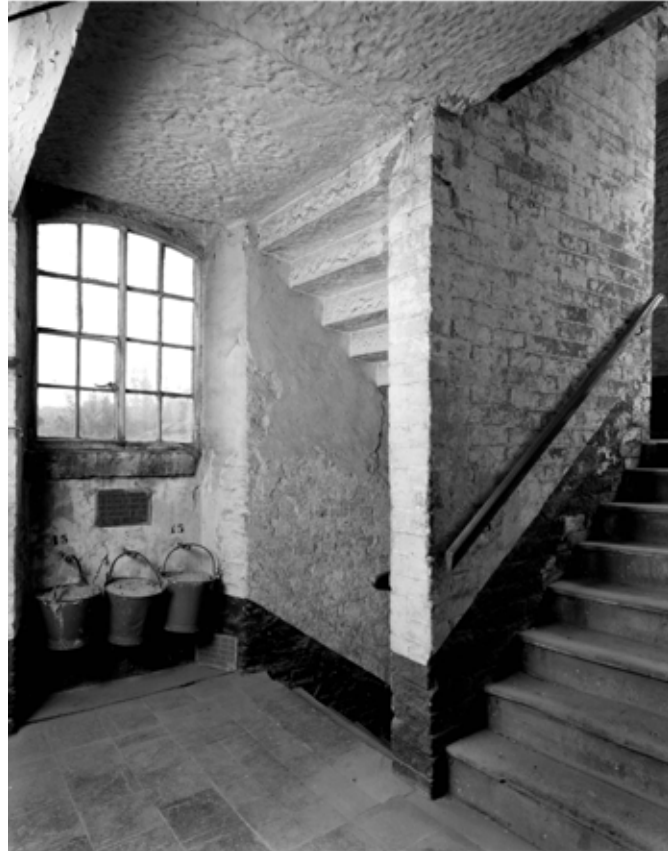
Fig 54. The stair in the north-west corner of Long Mill. An exposed timber beam is visible top left, and timbers used to form the windows were left similarly un-plated, but the stair is considerably less vulnerable to fire than the timber stairs commonly found in early cotton mills. (BB001904)

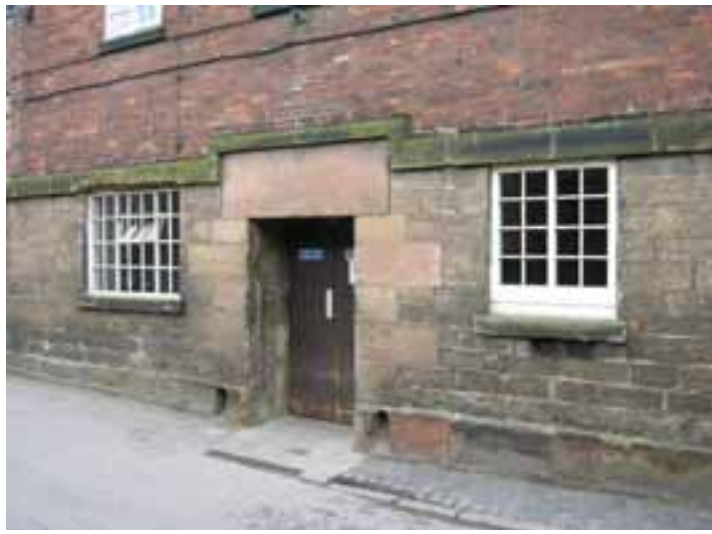
The manner in which the new north entrance breaks the lintel band is repeated in a series of windows in Long Mill, where probably around the same time a series of ground-floor casements were replaced by sashes more in keeping with those adopted on East and West Mill. On the western side all four windows north of West Mill, and on the eastern side the two windows immediately south of the water tower, were altered in this way. The heads were raised to lintels set immediately above the original lintel band, and the surrounds were roughly chamfered. The openings were fitted with cast-iron frames which were four panes wide and tall, the central four panes top-hung and opening outwards.

Fig 55. The inserted north entrance to Long Mill. The window to the left, widened leftwards probably at the same time, lights the counting house.

The mill entrance is in the centre of the north wall, and has a neatly quoined ashlar surround (see Fig 55). The lintel is unusually massive, resulting in the projecting lintel band being raised in the same manner as over the altered ground-floor windows. Since there is no indication that the lintel and quoins are not contemporary with each other, this may suggest that the opening has been inserted. An alternative original entrance position might be posited in the second bay from the north on the western side. The doorway in this position, now internal, has no historic features visible, but it faces the original approach from the opposite bank of the Derwent and would allow for a stair rising on its north side.¹²⁸

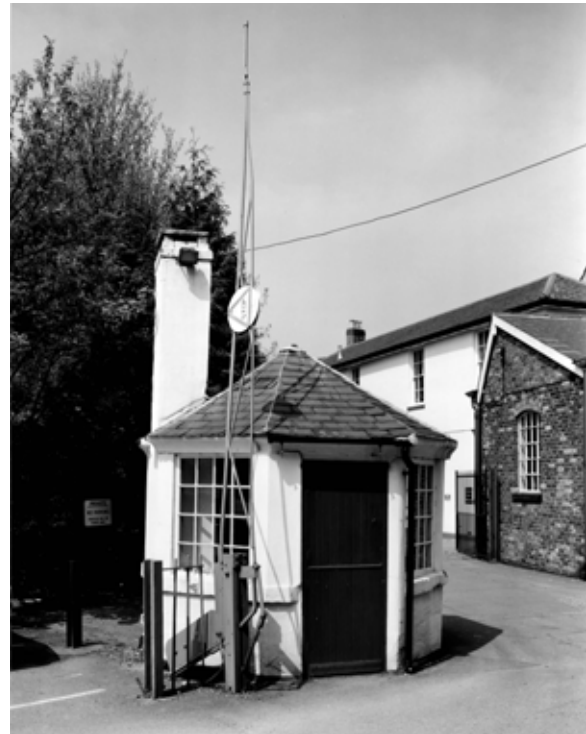
Fig 56. The watch house from the south. The present entrance is a later insertion. (BB001892)

The building is rendered externally and incorporates a sill band and covered eaves cornice in stone. The original entrance was in the eastern facet, where straight joints are visible in the render beneath the present window, and where there is a lowering of the plinth for a threshold. The south elevation, which incorporates the present doorway, was originally blind, as were the north and the west. The other facets were each occupied by a

The small octagonal watch house (Fig 56 & Drawing 18) appears to be absent from the Liberty Map but appears on the redrawn 1846 map and is also clearly depicted in the 1862 view (Figs 7 & 8). Whether its omission from the Liberty Map (Fig 4) can be taken as proof that it dates from after 1811 is unclear, in view of its small size and the fact that it has an eaves cornice matching those on the two pre-1811 wings projecting from the north end of Long Mill. A building of similar size is shown on the Liberty Map in a different position, closer to the bridge, and it is just possible that it has been re-sited. Its position close to the river crossing suits its present use as a tollhouse, but since the through route eastwards from the mill is a later 19th-century creation this is unlikely to be its original function. It may more aptly be termed a 'watch house'. This is the name given to a building erected to serve the Paper Mill in 1805-6, and which presumably afforded shelter to a night-watchman.¹⁹⁰ The employment of a night-watchman at the cotton mill is documented in 1791 and 1803.¹⁹¹

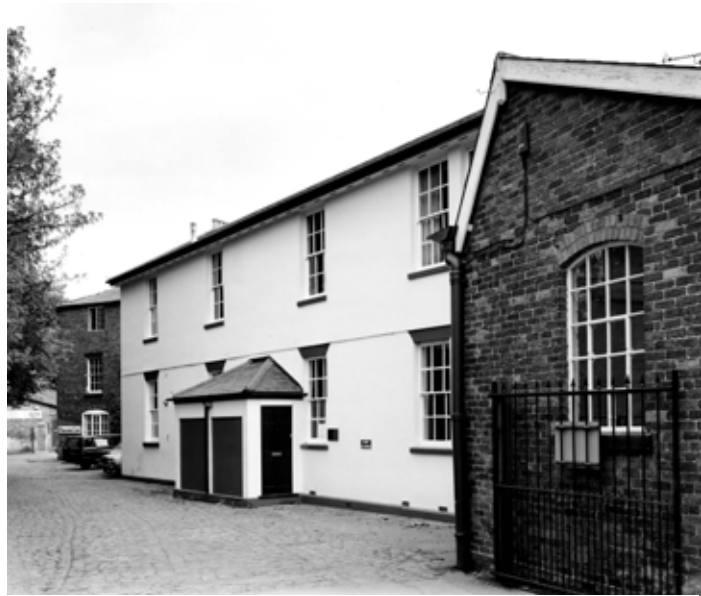
This building, probably dating from *circa* 1825-30, faces west onto the roadway linking Old Lane with the northern part of the site (Fig 57 & Drawing 12). A building in the same position, and following the same orientation, appears on Sanderson's map of 1830-34. It was originally single-storeyed, but was raised to two storeys after 1969. The upper floor reproduces the stuccoed exterior of the original work on three sides, but its rear wall is of exposed blockwork and the windows have horned sashes.

Fig 57. *The Offices, originally single-storeyed, now raised to two storeys. (BB001893)*

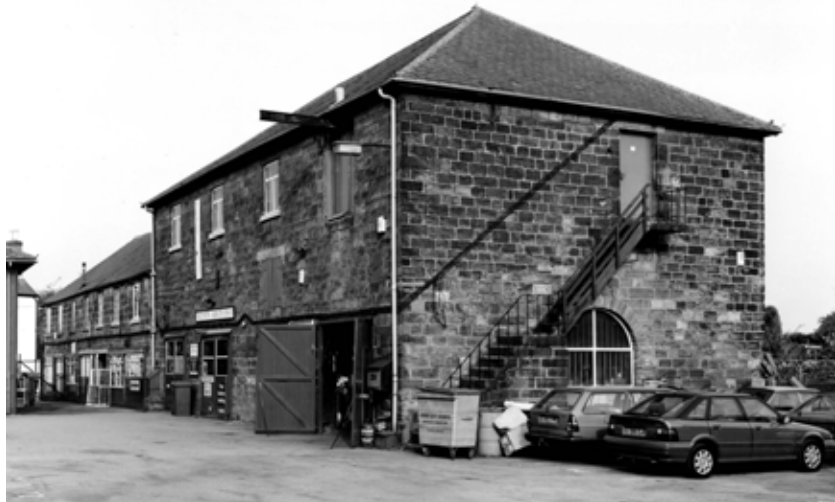
This two-storeyed range (Fig 58 & Drawing 14), which stands on the southern perimeter of the site, is unique in the Boar's Head Mills complex in having walls constructed wholly of gritstone. It is of four principal phases, built in line, all of which have walls of squared, coursed gritstone with irregular tooling. Given the proximity of the three known coppice barns, two of which (19, 20)

Fig 58. The western block, with the lower eastern block beyond. (BB001882)

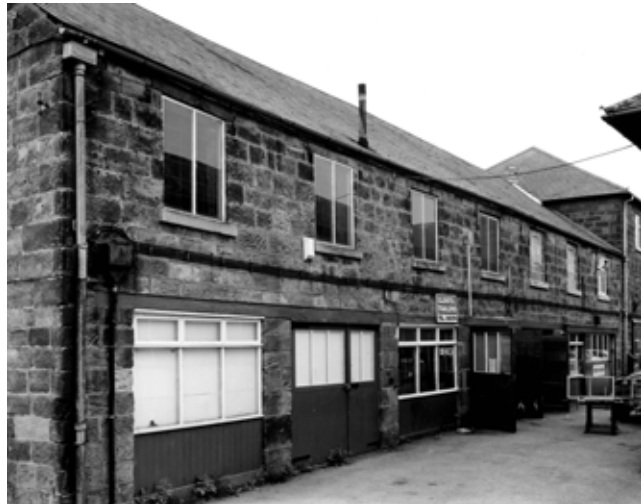
Fig 60. The eastern addition from the north, showing the formerly open-fronted ground floor. (BB001883)

The two additions (Fig 60) broadly replicate the arrangement of the original block, though without the generously proportioned ground floor of the latter. The eastern one was open-fronted on the ground floor of the north elevation, with four cart openings, spanned by timber lintels resting on square stone piers. Two of these openings have been converted into windows. The first floor was reached by the present stone stair

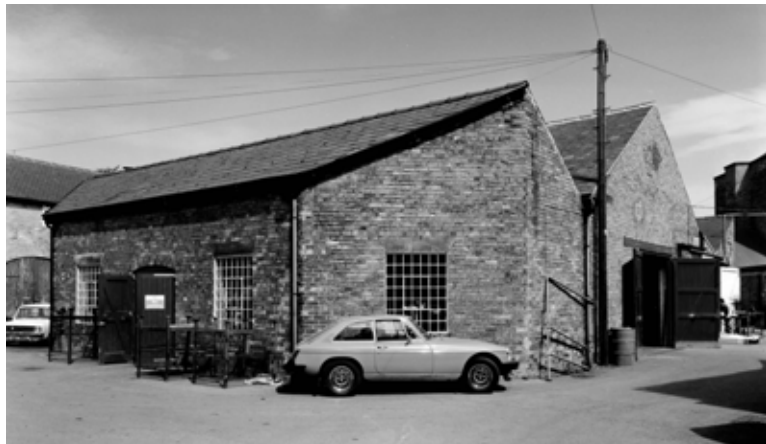
This single-storeyed block (Fig 61; Drawing 6) extends westwards from the shed (5) attached to the proto-fireproof building, tapering slightly towards the west on plan, with more pronounced canted corners at the western end. It consists of three principal phases, the earliest of which is the wide central portion. Absent from the 1811 Liberty Map, this appears to be marked on Sanderson's survey of 1830-34. It consists of four bays and was originally open-fronted to the east. The western range, with its two canted corners easing movement around the increasingly congested site, was added before 1846 and was fully enclosed. The passage – wide enough for vehicles – which separated the earliest part and the shed was roofed by 1862, but continued to be used as a passage.

Fig 61. The earliest part of this range of buildings is the taller block to the rear. Canted corners on the nearer block assisted vehicular movement around this cramped part of the mill site. (BB001899)

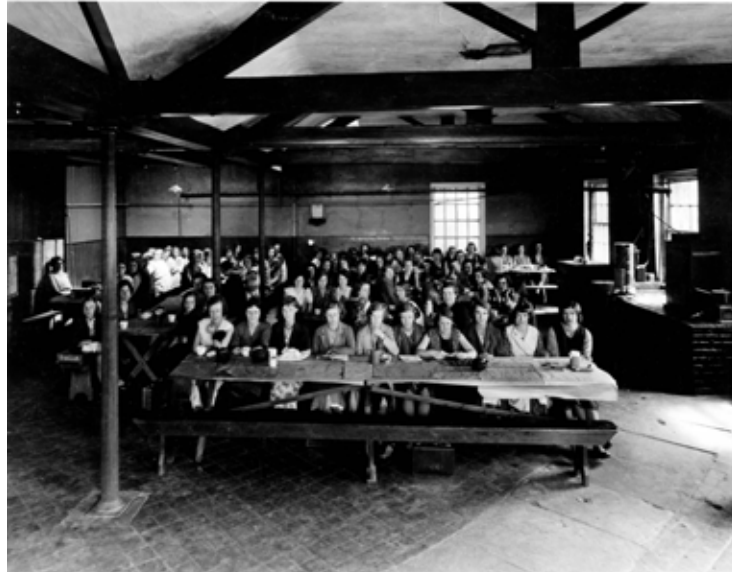
Fig 62. The interior of the Dining Room c1930, showing exclusively women millworkers. A tea urn stands to the right. (BB001861, courtesy of John Elliott)

Inside the building two fluted cast-iron columns with simple moulded caps support the valley beam (Fig 62). The roof trusses to either side are underdrawn leaving only the tie-beams exposed. Central bolts on the tie-beam soffits indicate that they are of king-post form. A photograph, probably dating from the 1930s, shows the canteen in use, with women millworkers seated on benches at long trestle tables. The roof was then underdrawn a little above tie-beam level, revealing the expanded bases of the king-posts, and raked struts.¹⁹⁵

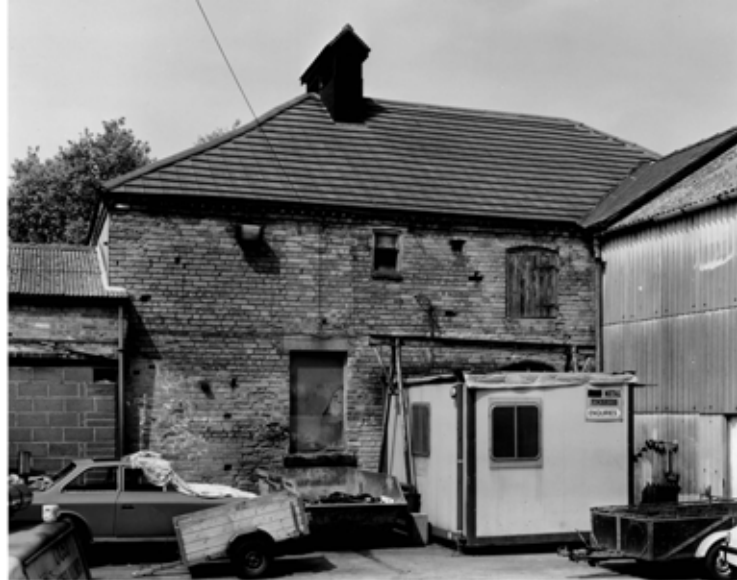
The two-storeyed stable building (Fig 63) has a three-bay south front; to the rear the eastern and central bays project slightly further than the western bay. Horses were stalled in the flanking bays, while the centre provided a lobby and stair. The walls are in Flemish stretcher bond on a base of coursed gritstone, and rise to a cogged and stepped eaves. The north elevation is now obscured by a facing of modern concrete bricks and much of the west elevation is covered by a 20th-century infill block. The semicircular-headed central south entrance is formed of

Fig 63. The stable from the south. (BB001898)

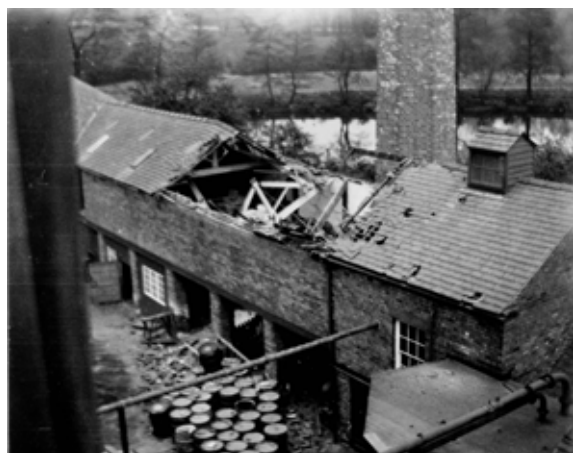
Fig 64. The now-demolished range south of the stables, as seen following damage caused by an explosion in 1938. (BB001867; courtesy of John Nelson)

In 1934 the bridge across the Derwent was demolished and in the following year the present steel and concrete bridge was completed.¹⁰⁹ At the eastern end of the bridge there are two cast-iron gate piers, octagonal in section with moulded caps and necking rings. The shafts are cast with the name of 'HILL & SMITH L^{TD} | BRIERLEY HILL'.¹¹⁰ In May 1938 there was a gas explosion which damaged the range extending southwards from the Stables.¹¹¹ Much of what we know of this range derives from photographs taken in the aftermath of the explosion (see Fig 64).

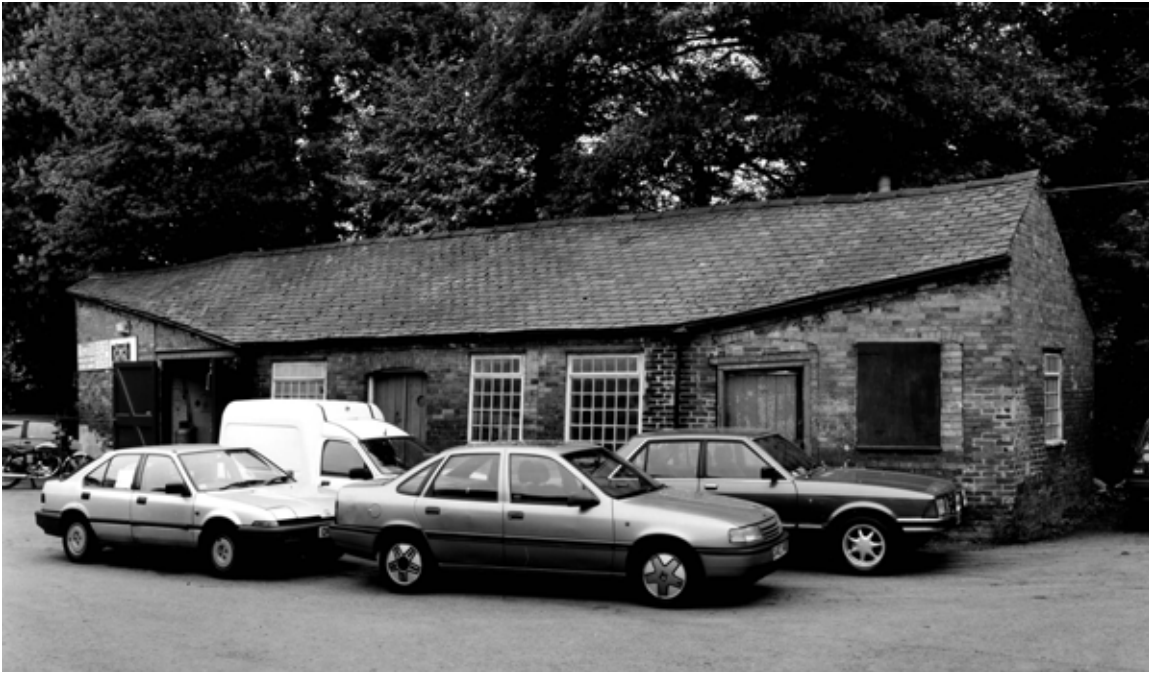
Fig 65. The Fire Station from the east. (BB001901)

The Fire Station is a single-storeyed building extending four bays from north to south (Fig 65; Drawings 6 & 17). The brick bond consists of a course of alternating headers and stretchers for every five stretcher courses, and rises to a stepped brick eaves. The end bays are both canted on the east elevation, in order to ease passage around the mill

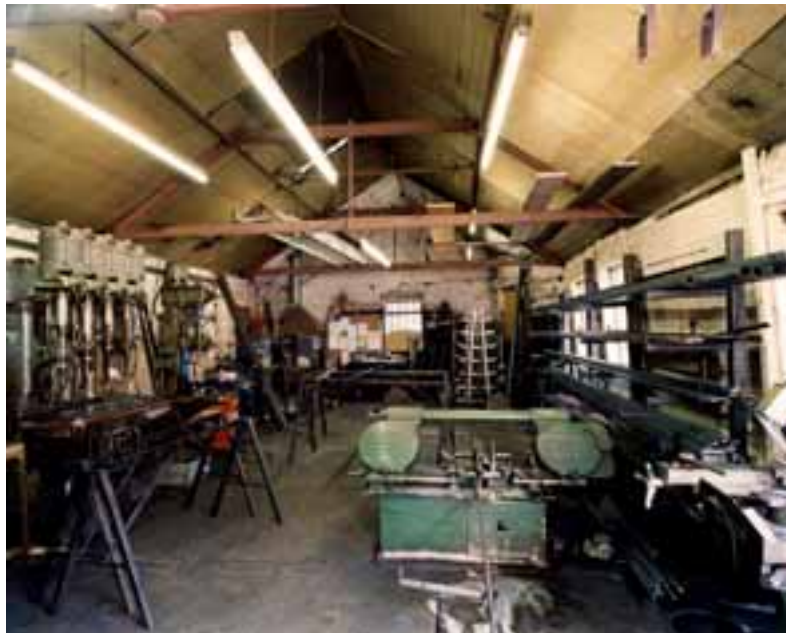
Fig 66. Interior of the Fire Station from the south, showing the cast and wrought-iron tie-beam and collar trusses. (AA051584)

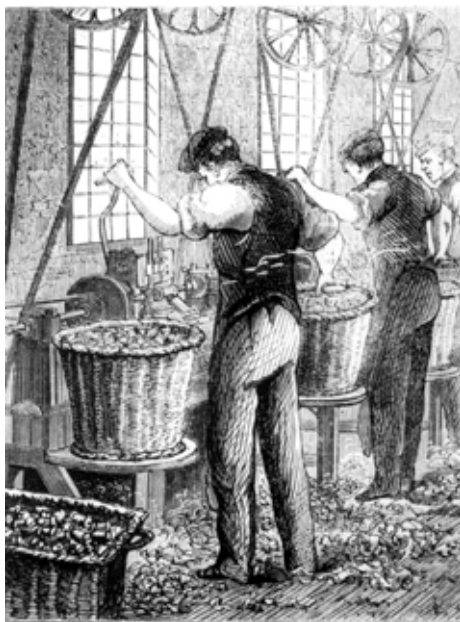
Fig 67 (left). The interior of the bobbin shop, as depicted in the Illustrated Times article in 1862. (Derby Local Studies Library)

The Bobbin Shop is a single-storeyed range consisting of four bays gabled north-south. It is set at a little distance south of East Mill, from which it is separated by a two-bay range, function unknown, which is gabled at right-angles (Drawings 15 & 16). Given the similarity between the roofs of the two ranges it is likely that they are close in date, and the junction between them on the west side is bonded. The 1846 map (Fig 7) shows a small building roughly corresponding to the position of the two-bay range. This is probably an earlier structure; the two ranges of the Bobbin Shop, which are probably nearly contemporary, are likely to date from shortly after the 1846 map was prepared. The four-bay range was the subject of an interior view in the 1862 article (Fig 67), but is shielded from sight in the bird's-eye view of the same date.

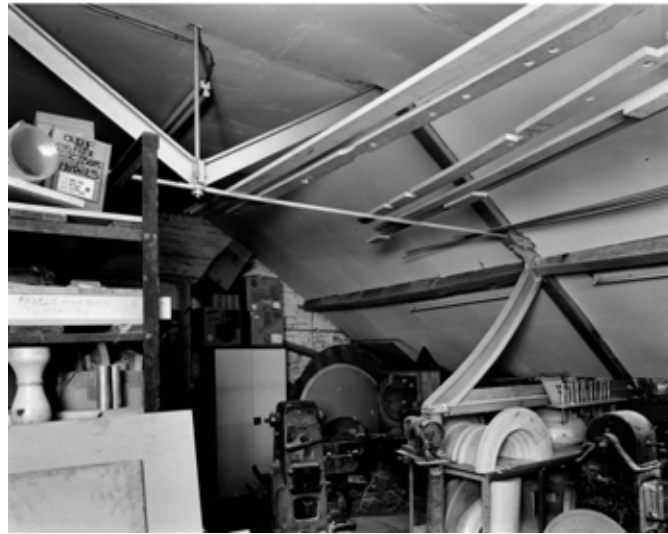
Fig 69. Interior of the two-bay range, showing the unusual form of the cast and wrought-iron roof truss. (BB001933)

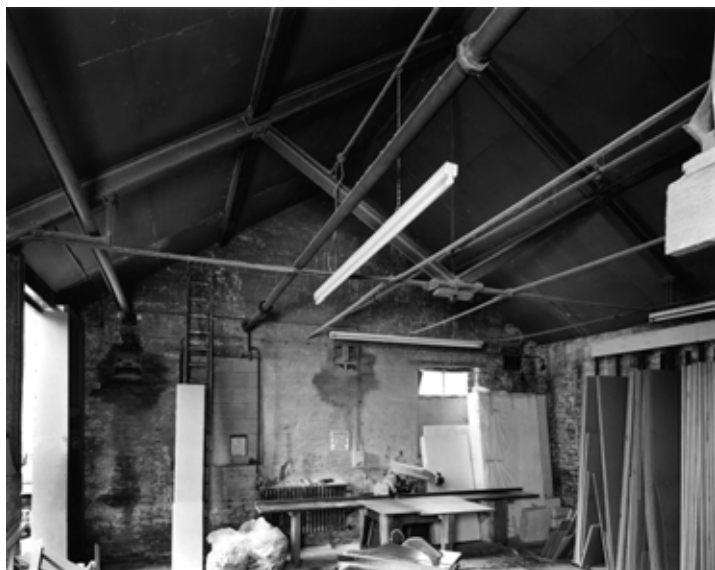
The trusses (Fig 70; Drawing 16) have cast-iron principal rafters and V-struts, and wrought-iron tie-rods, king-rods and axial ties. Bolted to the lower ends of the principals are

Fig 70. The interior of the four-bay range from the north. (BB001932)

line-shafting hangers, which correspond to bearing boxes on the gables. A further box on the south gable is not matched by any hangers. Belt take-offs, illustrated in the 1862 article, powered individual lathes. These may have been associated with a series of stone machinery bases arranged in ranks in the otherwise Staffordshire clay-tiled floor. The bases conform to the arrangement of bearing boxes, but they are oriented parallel to the gables, whereas the illustration shows the lathes placed parallel to the flank walls. Power appears to have been taken from East Mill along the east side of the two-bay range. A bracket for line-shafting remains *in situ* towards the south end of the east wall.

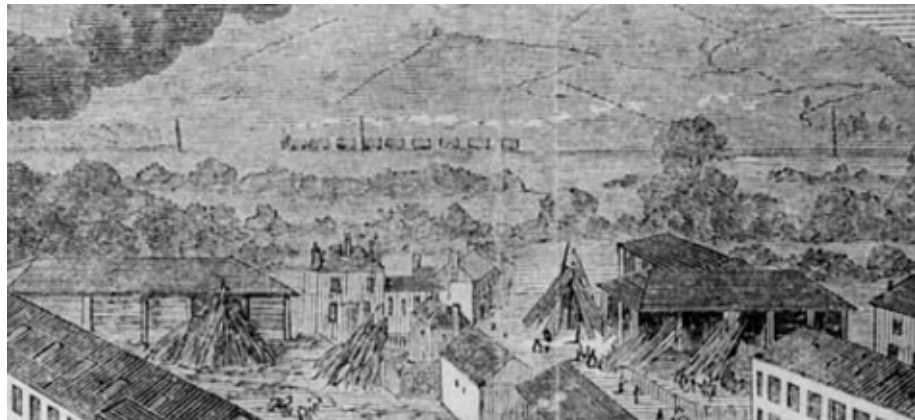
Fig 71. Detail of the 1862 engraving in the Illustrated Times showing coppice barns and stacks of stored timber in the yards. (Derby Local Studies Library)

other (22) was also present by that date, as the viewpoint does not permit it to be shown. According to the view (Fig 71), two more similar buildings existed towards the eastern perimeter of the site, on the northern side of the road, but of these only the southern example is confirmed by the 1881 Ordnance Survey map (Fig 9). The surviving buildings are characterised by brick piers with rounded corners, the intervals between the piers being open. The deeply oversailing roofs afford shelter for the open sides and have the slates laid so as to permit ventilation between them. They were used to store and season the poles used in the manufacture of turned products.

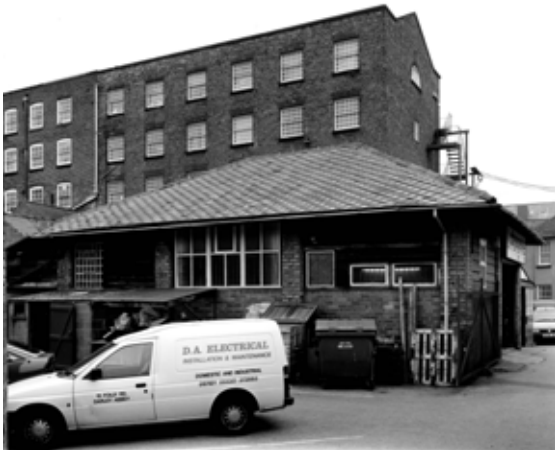
Fig 72. The coppice barn (22) from the south-east. The roof slates are laid so as to permit ventilation. (BB001885)

Positioned just to the east of the Bobbin Shop (21), this three-by-two-bay coppice barn may have been intended specifically for the storage of coppice timber used in the manufacture of bobbins and reels (Fig 72). It was built between 1846 and 1881, and may therefore be contemporary with the Bobbin Shop. The trusses are under-drawn at tie-beam level, but there are bolts visible in the centre of the tie-beam soffits, indicating a king-post form (Fig 73). Each hipped end incorporates a half-truss and angle-ties. The interval (about a bay's length) between the building and the Bobbin Shop to the west was infilled by 1881, on the basis of map evidence. Later alterations, probably c1969, included infilling the open bays of the coppice barn to incorporate high-level windows.

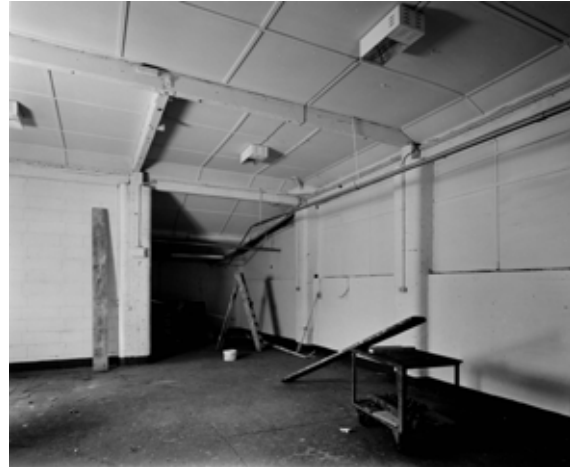
Fig 73. The interior of the coppice barn (22). The roof has been underdrawn, but would originally have been exposed. (BB001886)

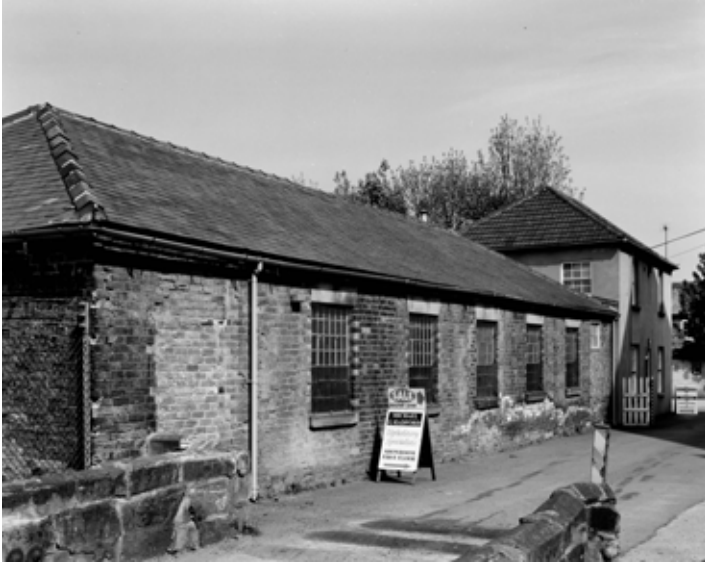
As originally built the gassing shed (Fig 74) had a central entrance facing Old Lane to the south, flanked by windows in each bay. The north elevation was largely blind: most of the windows are recent insertions, though one (at the east end) incorporates a 19th-century cast-iron frame and another, indicated by an area of blocking immediately west of a large inserted entrance, is possibly original. The windows on the south front (two of them are now blocked) had stone sills and wedge-shaped stone lintels, one of which has been re-used for the window now occupying the former entrance. The roof is carried on a series of king-post trusses. The king-posts, which are through-bolted at the base, have expanded heads and feet; raked struts rise to the single set of purlins.

Fig 74. The gassing shed from the west, with the house, 5 Old Lane, beyond. (BB001888)

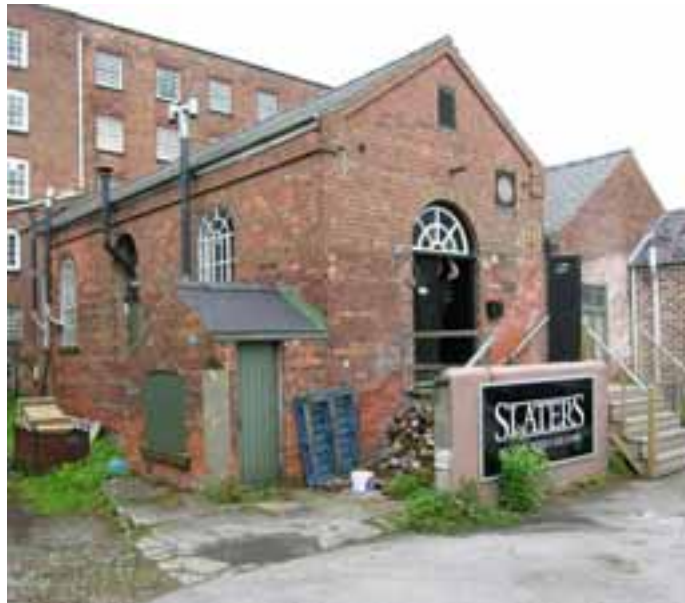
Fig 76 (above). The engine house from the south-west with the Bobbin Shop to the right. The paving immediately to the left of the engine house marks the former edge of the leat passing beneath Middle Mill.

This building covers the western elevation of the Bobbin Shop, where a series of windows were blocked as a result, and slightly oversails the south gable of the earlier building. The engine-house consists of a tall single storey raised over a low basement, and is four bays in length, with an additional bay at the north end forming a narrow link with Middle Mill (Fig 76; Drawing 15). The irregular shape of the west side of the building, the northern bay of which is canted, was determined by the existing tail-race to the west. The exterior is in wire-cut brick and incorporates a blue brick damp-proof course and a plain projecting band at eaves level, the latter returning as a raking band across the verges of the south gable. The entrance on the south gable has a semicircular-arched head framing a fanlight, and is raised at the head of a flight of steps, now buried beneath later concrete staging. Above it there is a small louvred opening. The windows are distributed along the west elevation and have similar heads, stone sills and cast-iron frames. In the link block there is an arched doorway which formerly opened onto timber staging overhanging the leat.

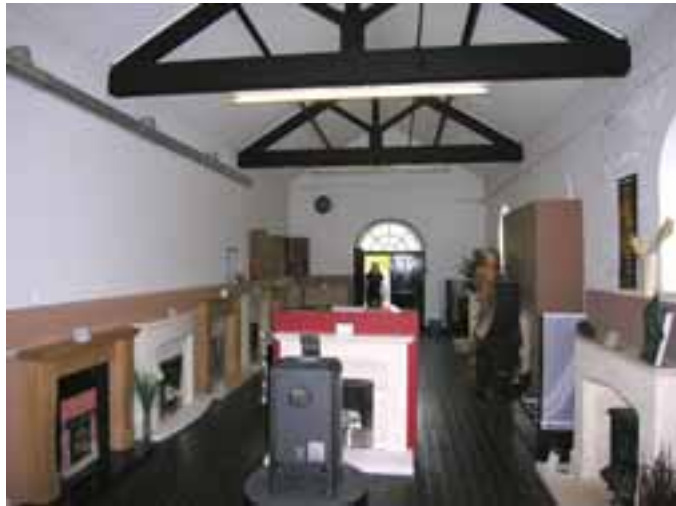
Fig 77. The interior of the engine house (now a fireplace showroom) from the north in 2006.

The interior (Fig 77) is open to the roof and includes a range of features in keeping with the characteristically high level of finish accorded to steam engine-houses throughout the 19th century. An early photograph, a copy of which is displayed at the mill, shows internal details prior to the removal of the engine (Fig 78). The three strutted king-post roof trusses, the king-posts of which are through-bolted at the base, consist of stop-chamfered timbers. The single set of butt purlins is similarly treated and the common rafters are concealed by beaded tongued-and-grooved boarding, laid diagonally. The link bay formed a separate plastered room with a higher floor level, from the south-east

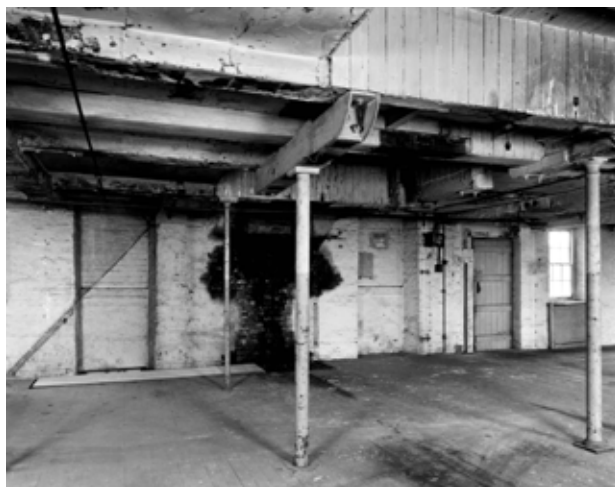
Fig 79. Evidence for the removed rope race transmission in Long Mill. (BB001907)

Sufficient information survives, in the form of notes by George Watkins and the 1944 plans (Figs 80-84), coupled with the evidence of surviving features, to reconstruct most elements of the 1897 transmission system. In keeping with contemporary practice, this made extensive use of rope races in place of the upright shafts which previously carried power from floor to floor. Rope races were installed in Middle Mill and on both sides of Long Mill, where patches in the floors and traces of inclined boxing are clearly visible (Fig 79). A culverted shaft carried power under Old Lane to the western end of North Mill, where auxiliary power was provided latterly by a gas engine.

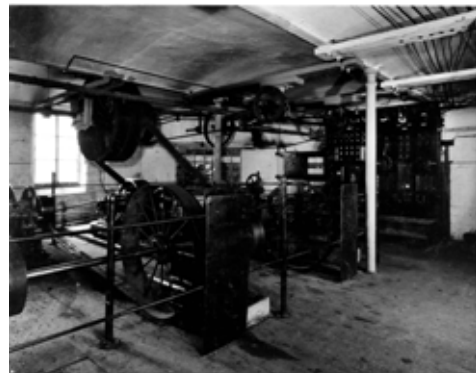
Fig 85. The turbine room in West Mill, c1930. (BB001863, courtesy of John Elliott)

Five turbines and dynamos, for electricity generation, replaced the water-wheels in the early 20th century – two in Middle Mill and three in West Mill, as indicated on one of the

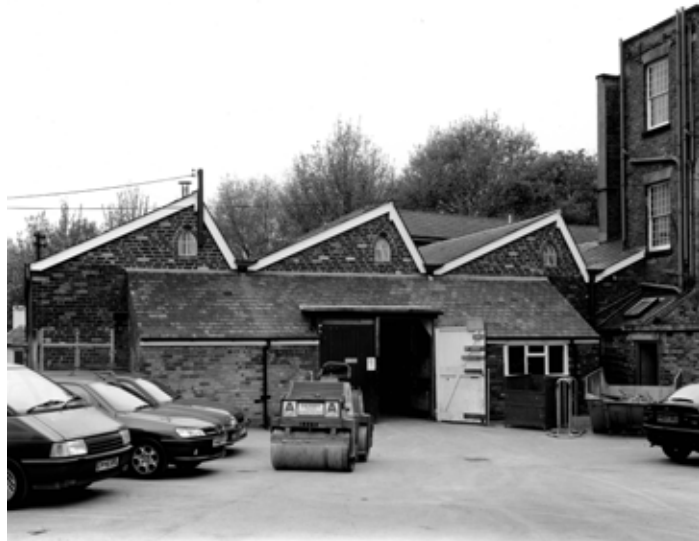
Fig 86. The east elevation of the Polishing Shed, showing the north-lit roof and Gothic-style gable windows. (BB001890)
