BOAR'S HEAD MILLS

A SURVEY AND INVESTIGATION OF THE COTTON MILLS AND ANCILLARY BUILDINGS

NBR No 33050
NGR SK 3538 3857 (Long Mill)
ISSN 1749-8775
Research Department Report Series 35/2006

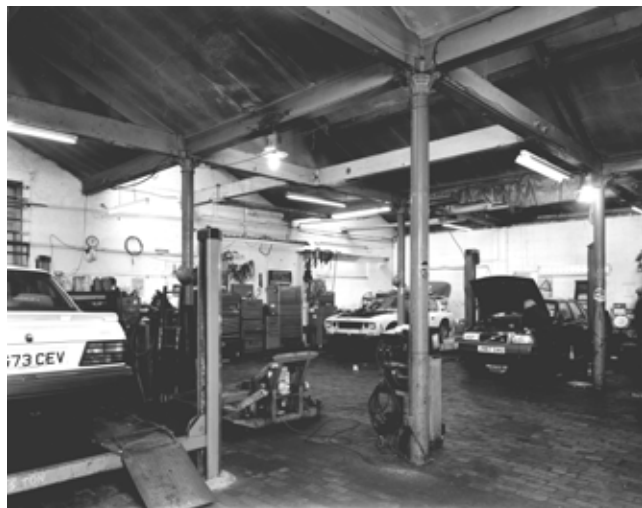
Fig 87. The interior of the Polishing Shed, from the north-west. (BB001891)
