Research Department Report 43/2006

# **Craster, Northumberland: an archaeological investigation of a World War II radar station complex**

NGR: NU 2546 2040

*In 2003-2005 English Heritage undertook investigations into the World War II Chain Home Low radar station on The Heughs, near Craster. Field survey recorded the two principal buildings of the radar station in detail (the TxRx block and the Standby Set House) and identified the remains of other buildings which would have formed part of the complex, including the bases of Nissen huts forming the accommodation and ablutions blocks. A number of surviving weapons pits sited in strategic locations around the radar station complex were recorded. These formed part of the wider coastal defences of the area. Aerial photography was consulted in conjunction with the field survey. The former revealed the position of some ephemeral features, for example, barbed-wire entanglements which defined the perimeter of the compound. Documentary research demonstrated that the radar station at Craster was built in late 1941 and continued in operation until July 1944. Oral testimony was gathered from local people who had been resident in Craster duri

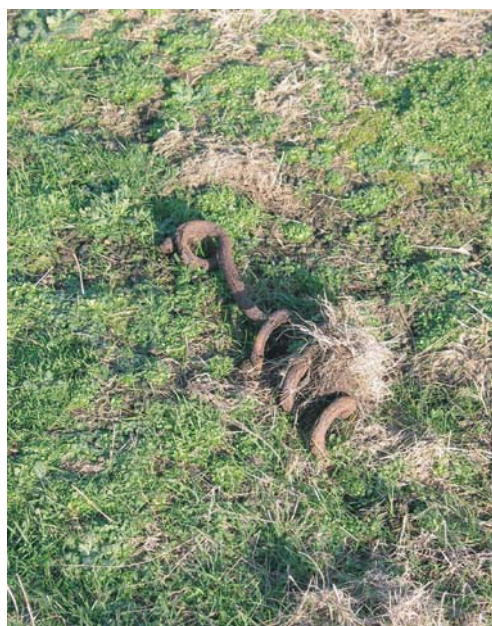
*Figure 8*  
An example of a metal picket found on the site (not in situ). This would have supported a barbed-wire entanglement.

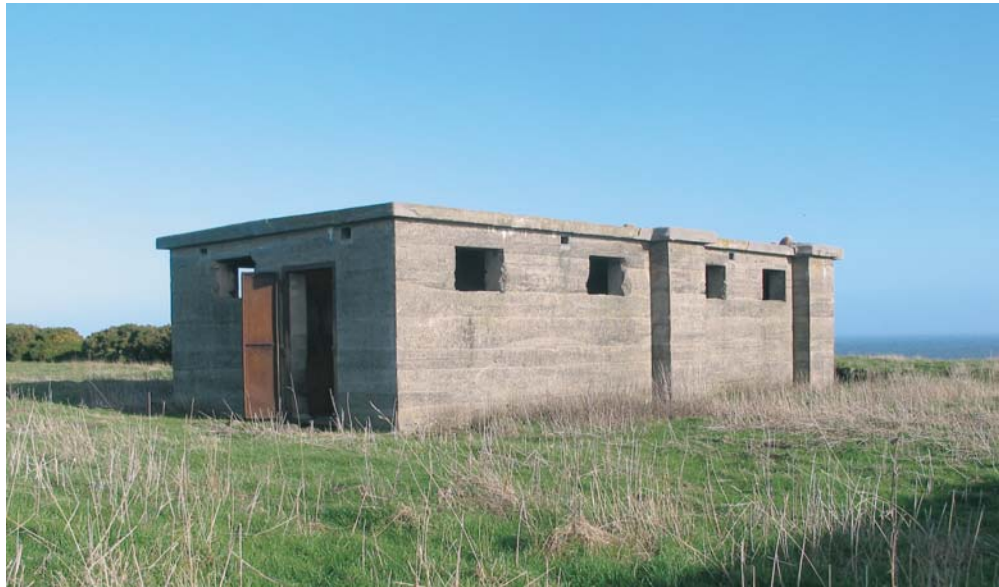
*Figure 10  
The TxRx Block  
viewed from the  
south-west. Note the  
surviving metal door  
at the western end of  
the building.*

The exterior doors of the TxRx block were metal and provided blast protection. They were hung in pairs and the metal frames are still *in situ*. At the western end of the building, one of the doors is still *in situ* (Figure 10), while the second lies on the ground a short distance away. Of the doors in the northern wall, there is similarly one of the pair still *in situ*, although it is badly corroded; the location of the missing door is not known.

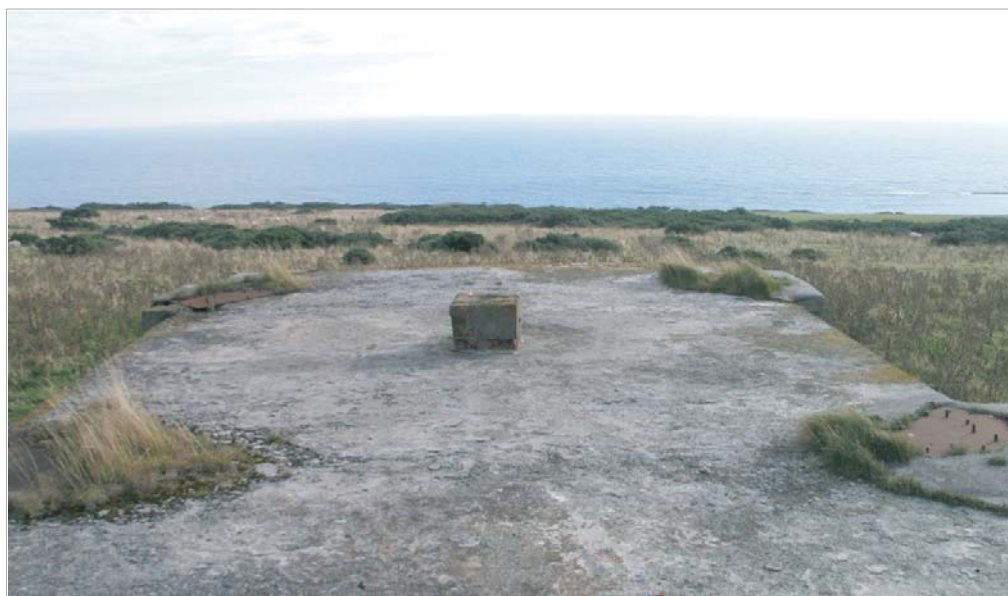
*Figure 11  
The roof of the TxRx  
Block, looking east,  
with the metal footing-  
plates for the roof-  
mounted gantry*

Pairs of small rectangular openings, slightly over 0.2m across, are situated just below the roof overhang in each of the east, west and south walls. These would have provided ventilation for the building. A pair of bolts was recorded just to the north of the window in the eastern wall of the building, the fixings for a ladder which would have given access to the roof for

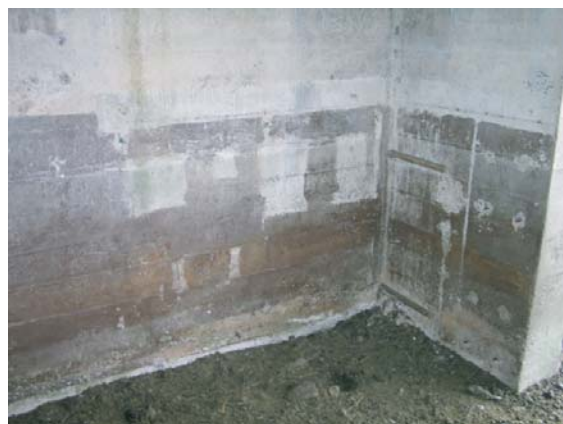
Figure 12a  
The gaps in the  
paintwork show the  
position of equipment  
and wiring within the  
TxRx Block

Although all the original fixtures and fittings have been removed from within the TxRx building, there is still evidence to indicate the location of much of the cabling and the position of equipment attached to the wall (Figures 12a and 12b). The original paint survives in reasonably good condition over most of the interior walls; the lower part of the walls were painted with a brown paint (to a height of 1.24m), while above this and over the ceiling, a cream paint was used on top of a layer of fine cork chippings, giving a textured finish. The purpose of the chippings under the paint was to reduce noise (R J C Thomas, *pers comm*) and possibly to absorb the radio waves.

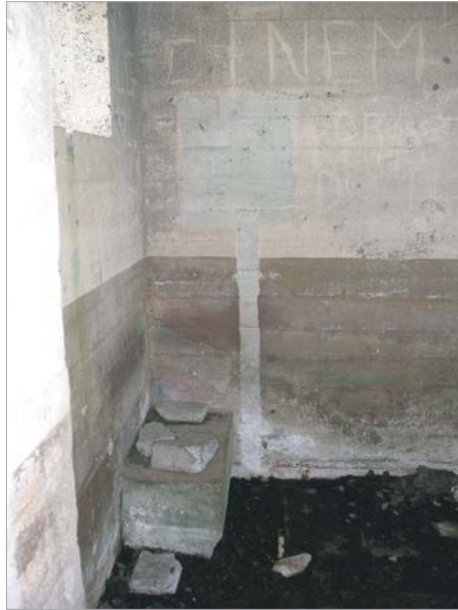
*Figure 12b*  
The interior of the eastern room of the TxRx Block, showing further evidence of the positioning of equipment within the building

Although the floor of the TxRx block is covered by a layer of mud and organic material, the original wooden-lined cable ducting in the floor survives underneath. The concrete floor is spanned by recessed timber battens, indicating that wooden floorboards would have been laid on top. Small fragments of brown 'plain' linoleum found in the building would tend to

indicate that polished linoleum was used as a floor surface. Additionally, evidence of vertical cable-housing survives adjacent to the walls, although these had been cut close to ground, presumably when the structure was gutted. In the south-western corner of the building, as mentioned above, are the remains of a series of five vertical cables and the wooden battens with which they were fixed to the wall (Figure 12a). This was the point at which the power entered the building and then was distributed to the electrical equipment in the three rooms.

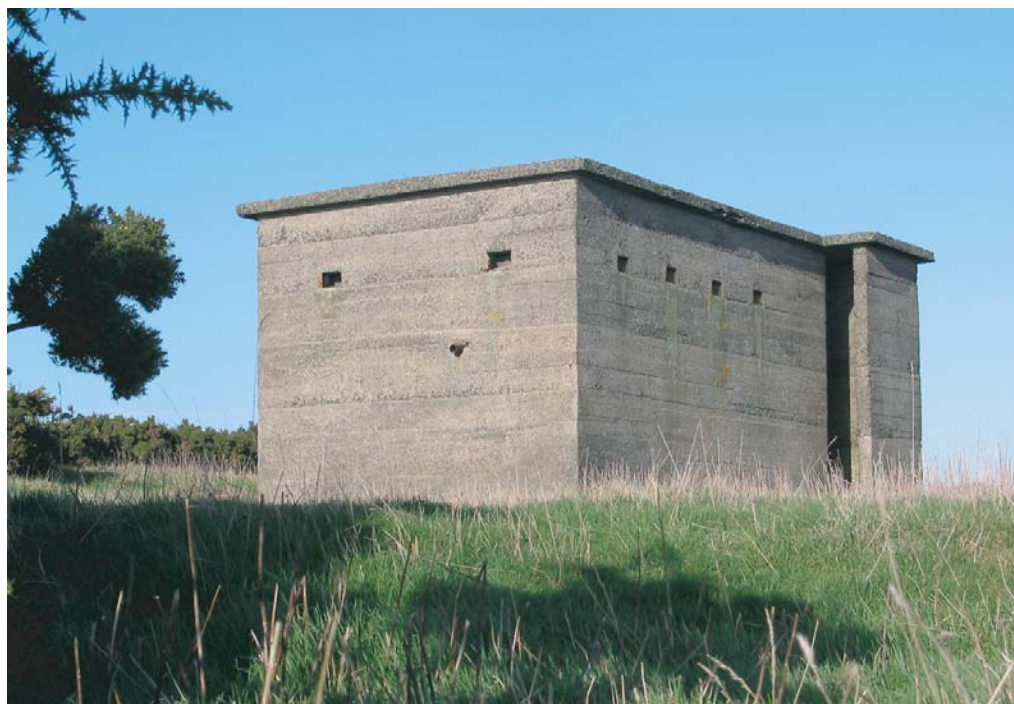
Figure 14  
The Standby Set  
House viewed from  
the south-east

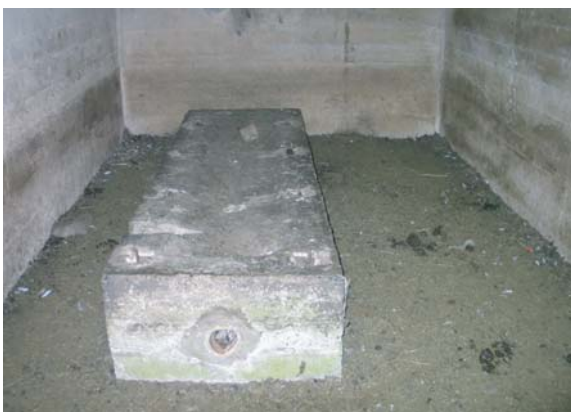
Figure 15  
The machine bed,  
which supported the  
generator in the  
Standby Set House

The Standby Set House was an essential component of the CD/CHL radar station, as it provided an emergency power supply for the TxRx block. The building would have housed a large, water-cooled generator; the standard models were a Nunn three-phase generator and a Lister 15kVA unit (Dobinson 2000a, 124). The generator would have produced sufficient power to keep the TxRx block operational in the event of a mains electricity supply failure. At Craster, the Standby Set House is located approximately 25m to the south of the TxRx block. It has two parts, the main room, which would have housed the generator, and the annexe across the northern end, part of which may have acted as a fuel store. This is an unusual variant, as it is more usual for the fuel store to have been housed in a separate building (see below).

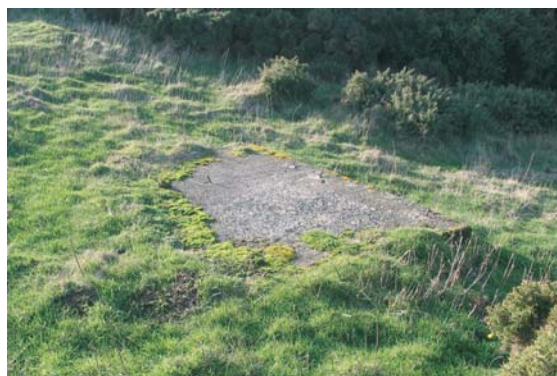
Figure 17  
The concrete plinth  
(S1) with *in situ*  
holdfasts

S1 is a small rectilinear concrete plinth, measuring approximately 2.5m by 1.8m. There are a number of holdfasts set into the concrete (Figure 17) and the aerial photograph shows a small building on it (Figure 18). The holdfasts indicate that the plinth held a superstructure,

presumably of corrugated iron similar to that of the Nissen huts. As such it would have been no more than a fairly insubstantial structure (not strong enough to mount a radar on) and probably accommodated ancillary equipment, such as a fire bucket or sand for smothering a fire. Given the electricity and quantities of fuel in close

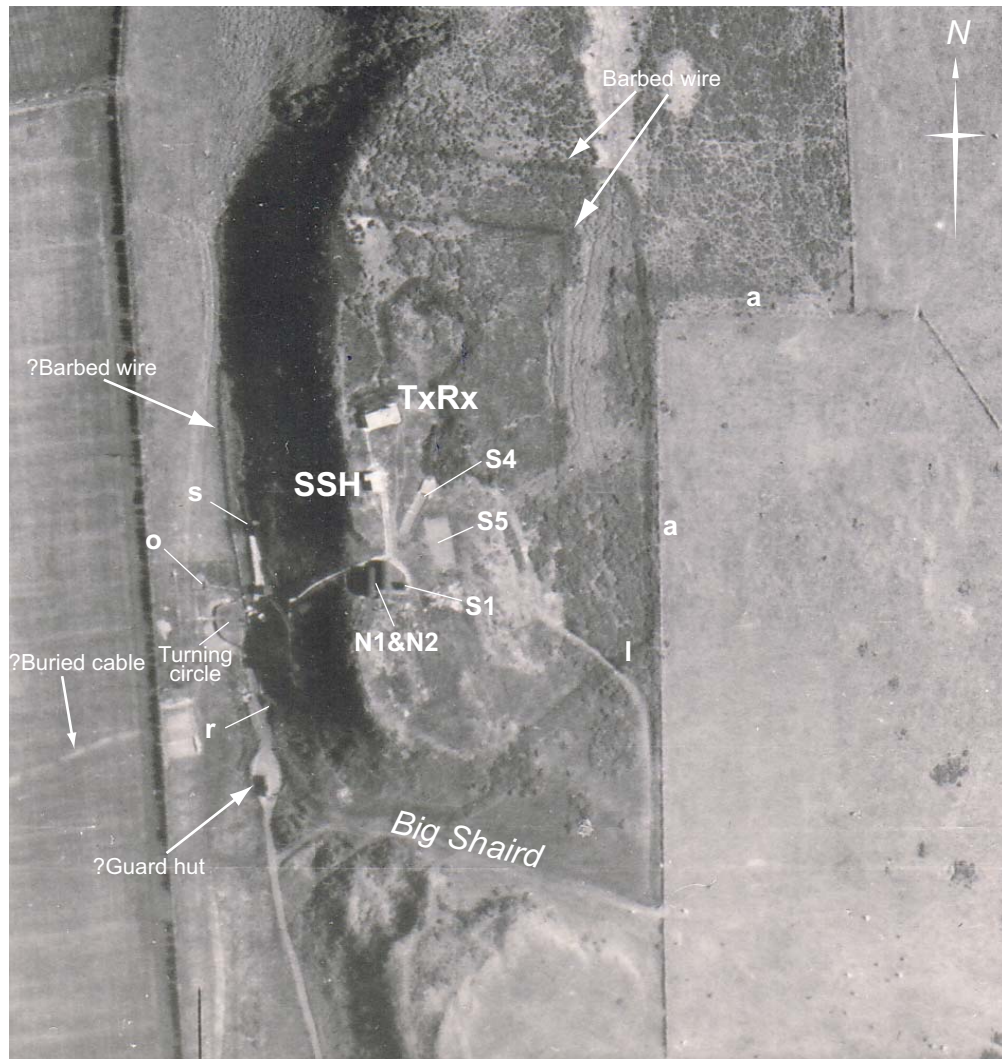
Figure 18  
Annotated 1946 aerial  
photograph of the site.  
The annotations relate  
to features mentioned  
in the text. (© Crown  
copyright. NMR RAF  
106G/SCOT/UK121  
Frame 3412 20-Jun-  
1946)

Evidence from a 1946 aerial photograph (RAF 1946; Figure 18) shows that the whole radar station complex at Craster was originally surrounded by at least two lines of barbed wire entanglements (see Figures 7 and 18). No trace of these lines survive on the ground, although examples of angle-irons and pickets, which would have supported the barbed wire, were found scattered across the area to the east of the operational buildings (Figure 8). There are also a number of sawn-off, *in situ* angle-irons around the TxRx block building (Figure 5); these are discussed more fully below. The outer line of barbed wire appears to have run alongside

Opposite the site of the Nissen huts (N3-N6), in the valley at the foot of The Heughs, is a semi-circular area defined by a ditch with a small, narrow causeway on its west side (labelled 'Turning circle' on Figures 7 and 18). Fragments of stone survive in the inner face of the northern ditch, indicating that it was formerly revetted. The two sections of ditch are separated by a small baulk of earth, which creates a narrow causeway, giving access to the level area enclosed by the ditches. The semi-circular platform has clearly been built up against the base of the slope to make a level area. The material for this may have come from the ditch. There is no ground evidence of any structures having been located on this platform, and none is visible on the 1946 aerial photographs. Its function may have been to provide a turning circle for vehicles, although a slight drop in height from the track (which is still marked by a low scarp) would seem to cause an unnecessary inconvenience. The radar-station complex would have regularly required various supplies, particularly during construction, and later on fuel and food, thus creating a need for a delivery point. The position of the platform would have been convenient for access to the accommodation buildings as well as being close to the foot of the path leading up The Heughs to the operational buildings.

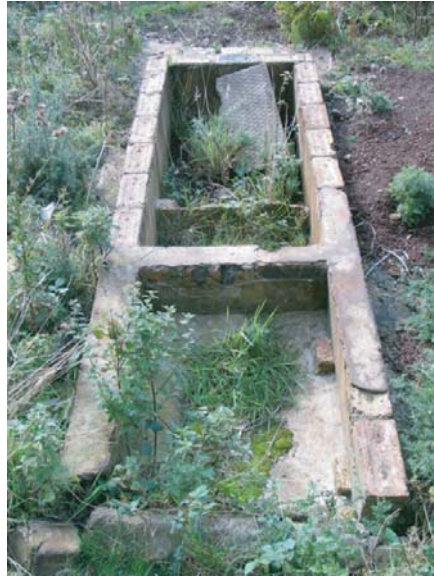
Figure 19  
A 'fat trap', part of the drainage system associated with the ablutions block

The southernmost structure (S2) is different in form to the other four and appears to have been the ablutions block serving the huts (see below). It measures approximately 15m by 4m and its outline is mostly turf-covered but in places there is concrete flooring exposed and imprints of small sub-divisions, which may indicate toilet or shower cubicles. Small recesses in the edge indicate that this structure was timber-framed and was probably clad in corrugated sheeting. Between this (S2) and the southern of the former Nissen huts (N6) are the remains of a concrete path. At its eastern end and between the two buildings, is a rectangular brick-built structure, which is part of the drainage system; at the time of the survey it contained a slab of non-slip tile which would have been used within the showers (Figure 19). At the west, its remains are collapsing due to erosion on the steep slope. Its location might imply that the southernmost of the Nissen huts acted as a mess or kitchen and shared a common drain with the ablutions block. Prior to the current survey, the remains of brick stands, probably for a water tank were observed south-east of the rear of the

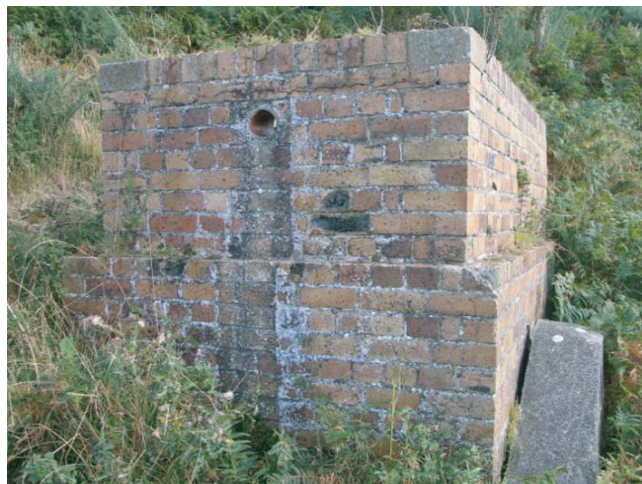
Figure 20  
Settling tank forming part of the drainage system from the ablutions block

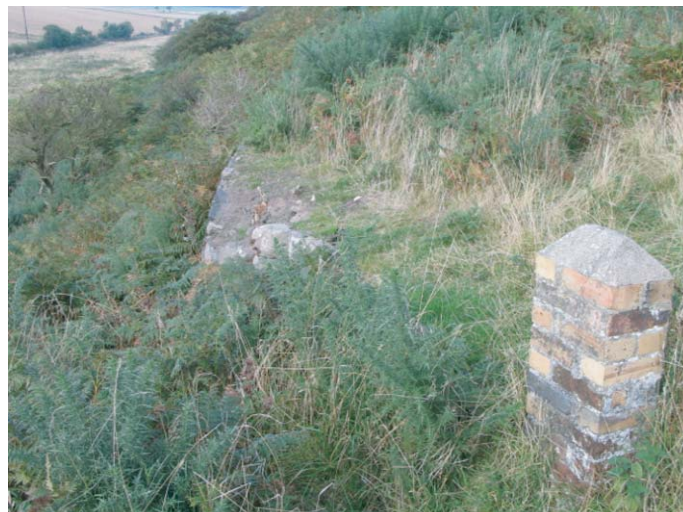
*Figure 21*  
A brick pier at the top of the steps connecting the Nissen huts with the foot of The Heughs

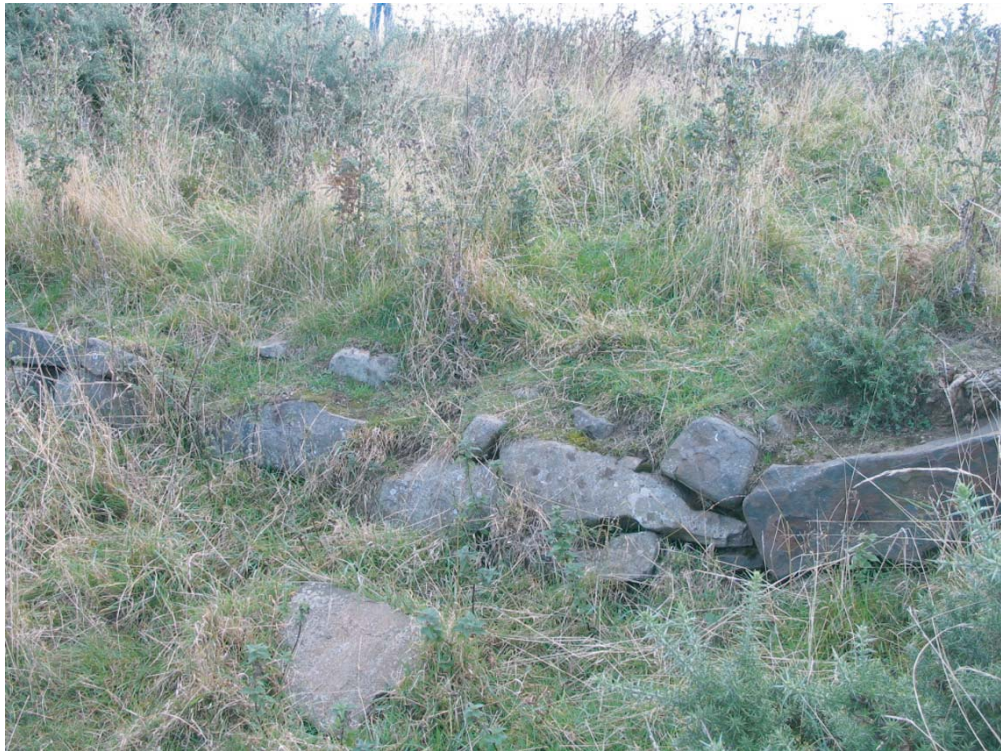
*Figure 22*  
Section of drystone  
walling defining and  
revetting the western  
edge of one of the  
terraces below the pair  
of Nissen huts (N1 and  
N2)

Mediterranean countries. A short flight of steps was found to give access to the terrace in front of the main group of Nissen huts. These terraces can be best explained as attempts by the POWs to create gardens in and around their temporary 'home'. Undertaking the creation and cultivation of these garden terraces would have given the prisoners a constructive occupation, as well as providing a source of food through the growing of vegetables. Oral testimony confirms that the prisoners attempted to grow vegetables, but failed due to the unsuitable nature of the soil (Mrs W Hogg, *pers comm*). The prisoners were mostly 'trustees' who were allowed to move about relatively freely – local residents recall the prisoners working on nearby farms and filling 'jerry cans' of water from Craster, loading them onto a truck taking them back to the camp (Mr W Archbold and Mrs W Hogg, *pers comm*). This may indicate that there was no piped water to the radar station or later POW camp.
