**NOS. 11 & 12, HIGH STREET
WISBECH
FENLAND DISTRICT
CAMBRIDGESHIRE**

**SURVEY AND ANALYSIS
HISTORIC BUILDINGS REPORT**

Research Department Report Series 75/2006

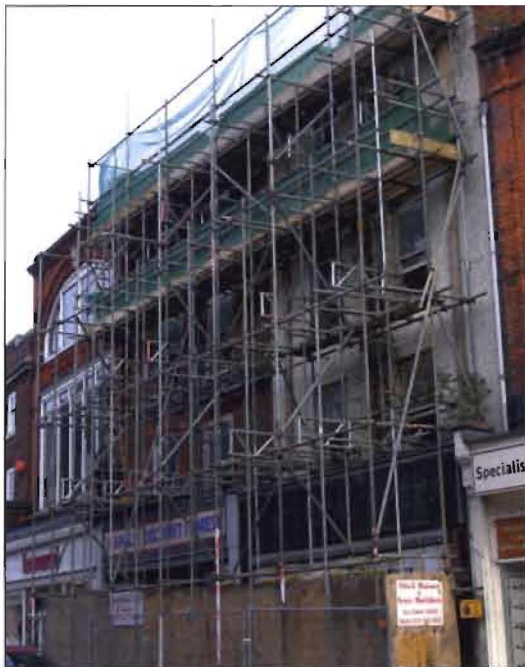
***Figure 1. The main north-west front, now covered in scaffolding.
Pete Smith 5/10/2006***

No. 11 retains its original early 18th-century brick façade on the three upper floors. It has brick bands which define the floor levels, and high quality rubbed brick lintels. The original flush frames for the sash windows survive though the sashes themselves have been replaced with 20th-century plate-glass sashes with horns. The brick parapet has been re-pointed and a small section of it was lost when the roof collapsed. The rear wall of this building has been rebuilt or at least re-faced in old bricks in the 20th century, two of the original sash windows appear to have been retained or re-used.

The facades of these buildings make an important contribution to the urban landscape of this historic market town. Like many listed buildings sited at the heart of such urban conurbations these two buildings retain their plan form and most of their external structure only on the three upper floors, the ground floors having been lost to the pressures of commercial retailing. The repairs, which will need to be carried out to the roof, could result in the loss of some original structural timbers. The single most important element of these listed buildings is the façade of No. 11 and every effort should be made to retain as much of this original structure as possible.

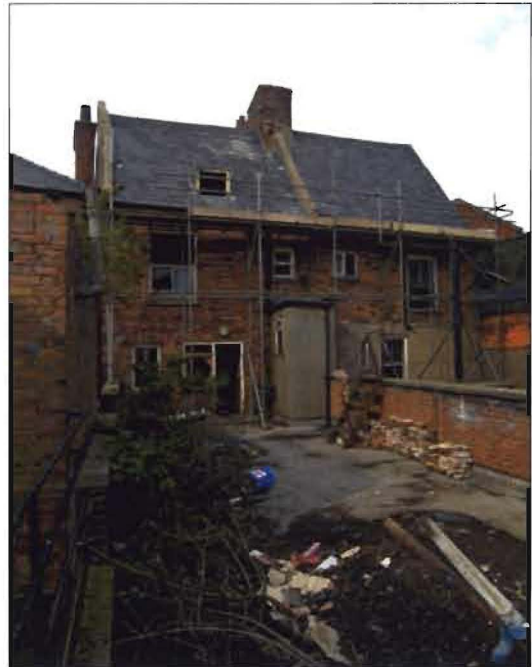
***Figure 2. The rear south-east front, from the roof of the ground floor rear extensions.
Pete Smith 5/10/2006***

The attempt to join two different roof types has caused the rear slope of the rear roof to sag and put pressure on the rear wall of the building. This probably explains why the rear walls of both these buildings had to be rebuilt at some time in the 20th century. The roof itself has been strengthened at the same time.

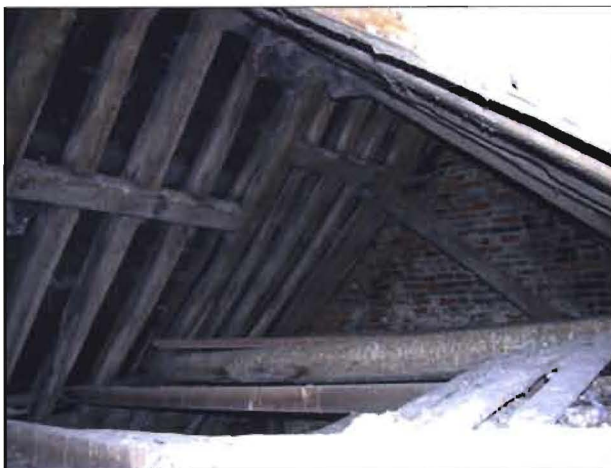
Figure 7. Interior of rear roof.
Pete Smith 5/10/2006
