ST JOHN'S HOSPITAL AND CHANTRY, CIRENCESTER, GLOUCESTERSHIRE TREE-RING ANALYSIS OF TIMBERS

SCIENTIFIC DATING REPORT

Research Department Report Series 14/2007

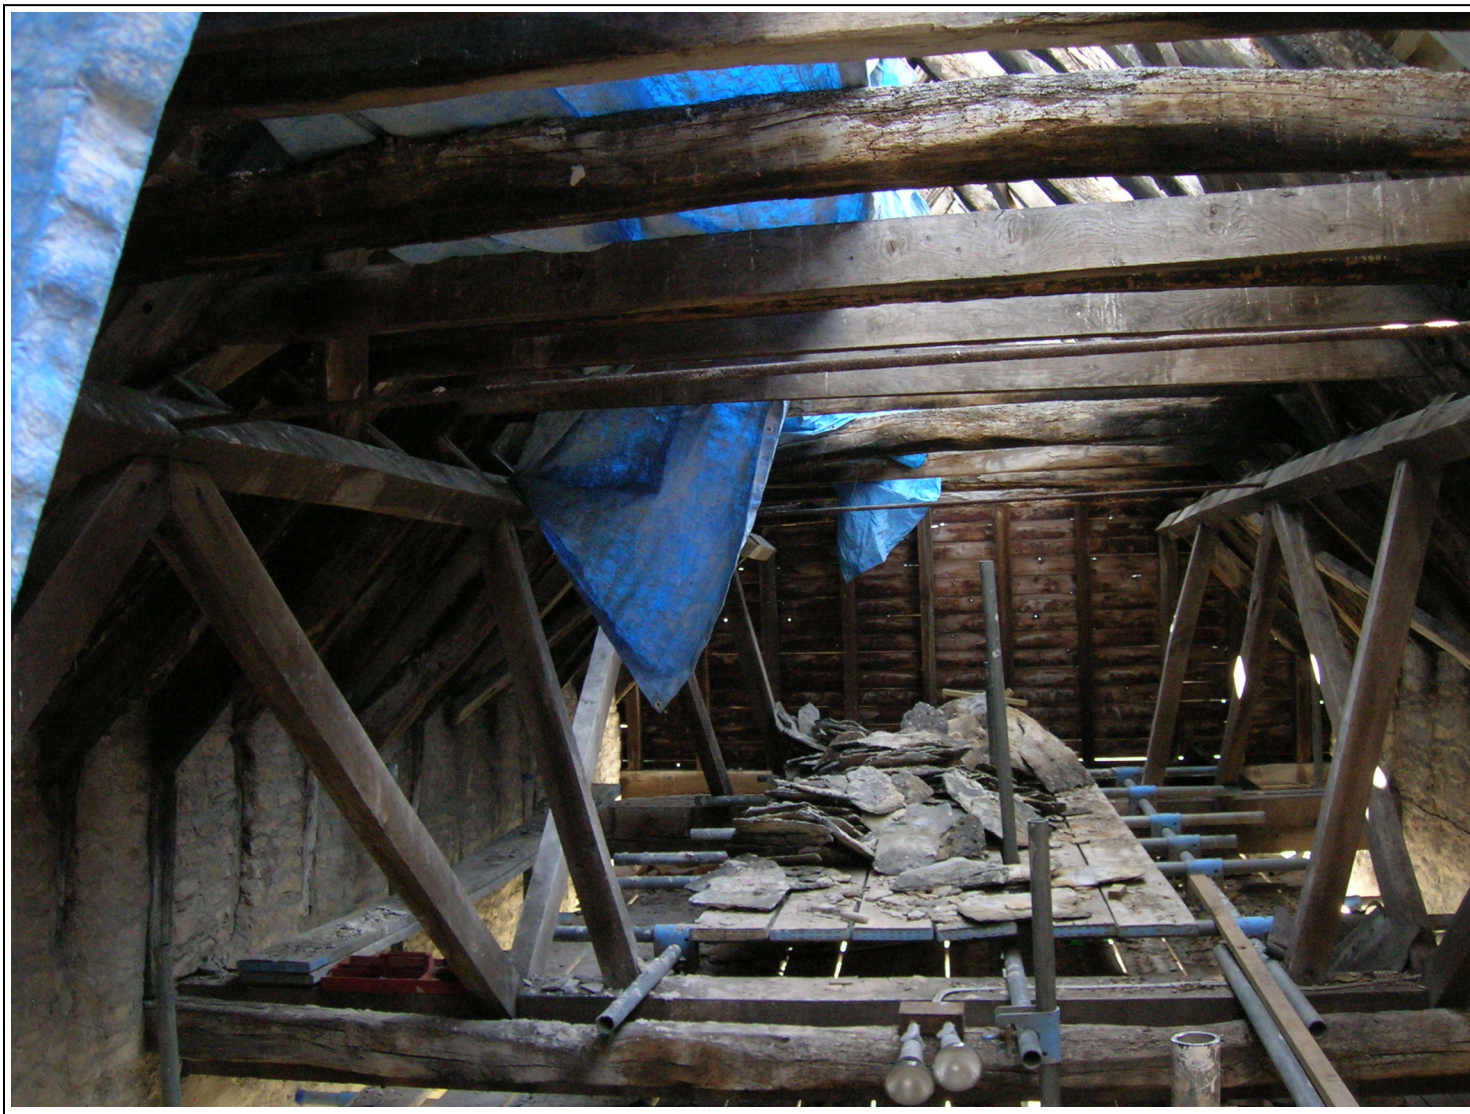
Figure 3: The roof, looking east

The extant roof structure includes 40 trussed rafter pairs, thought to represent a single phase of construction (Fig 3). Originally each rafter pair would have consisted of rafters, collar, sole-plates, and ashlar pieces, although some have since lost several of these primary elements and one couple is completely missing. There is no ridgepiece, with the rafter couples meeting at halved pegged apex joints. The collars are jointed to the rafters by each end of them being fitted into a slot in the rafter and fixed with a single peg. On the inside of the walls can be seen the ashlar pieces. These are jointed to the rafters in a similar fashion as seen elsewhere within the roof, scarcely a half lap and single pegged. Carpenters' marks were noted on some of the timbers although no discernable sequence could be seen.

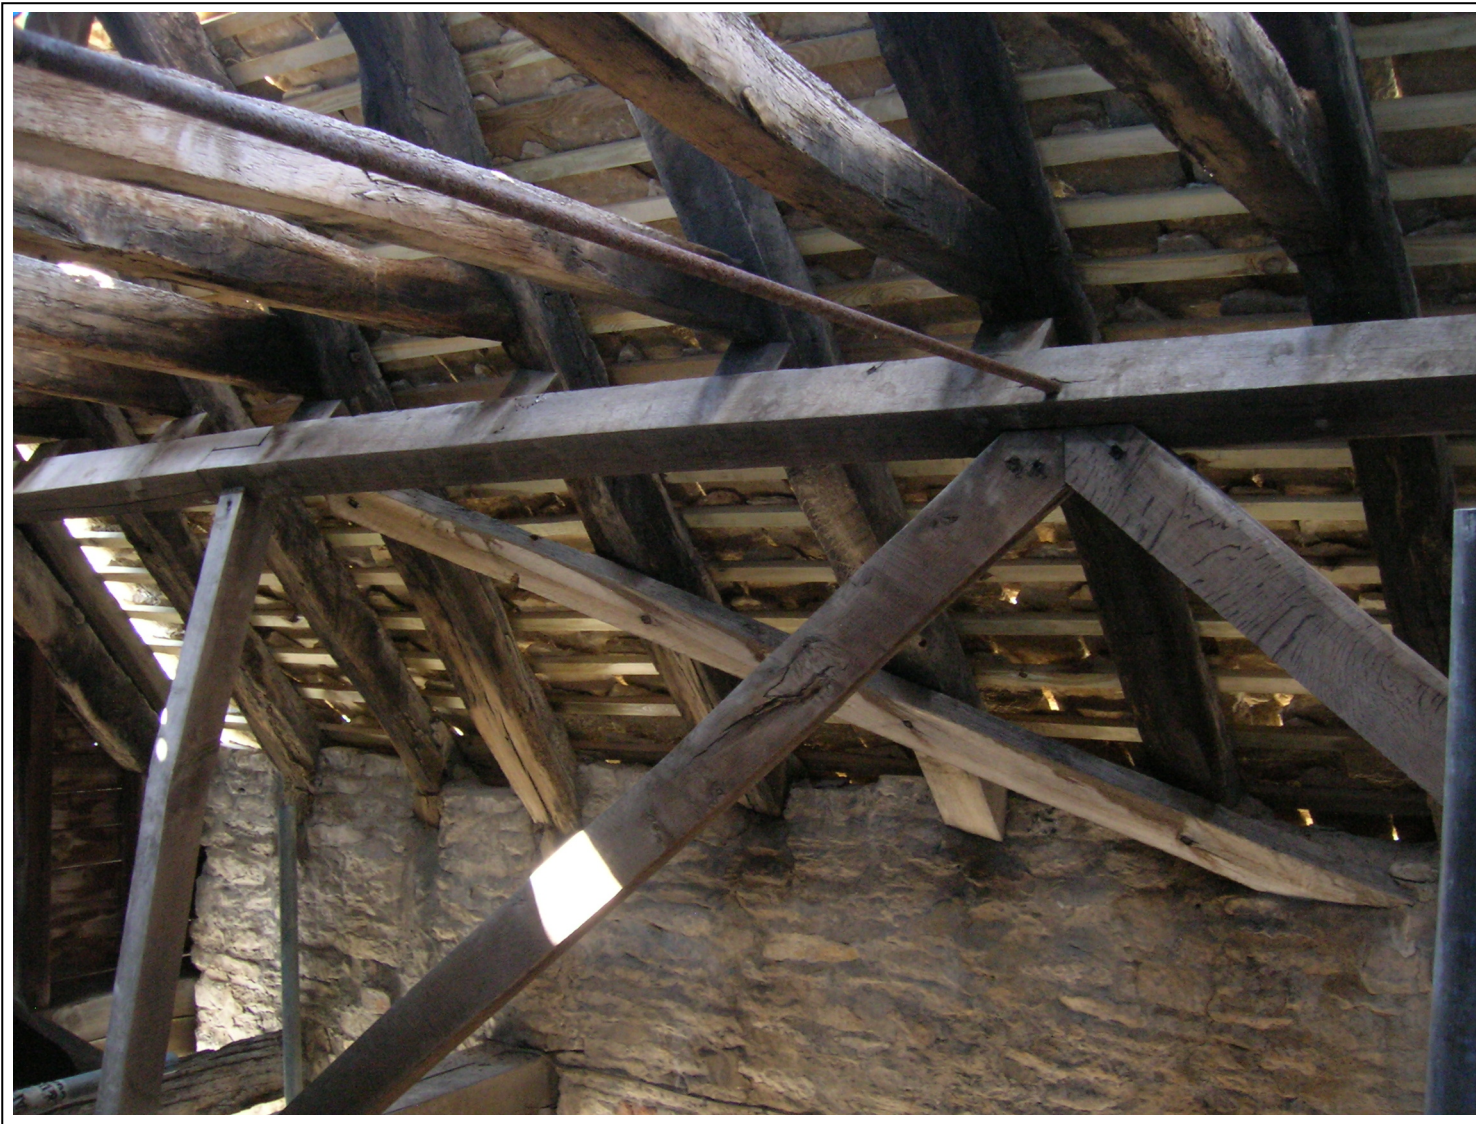
Figure 4: North side, showing one of the 'inserted' nailed-on braces

In addition to the rafter couples, there are other timbers which are clearly inserted (Fig 4), probably in a bid to strengthen the roof, as there is evidence that it began raking towards the west, possibly after the removal of the masonry west gable end. There is a pair of crude braces fitted to one of the rafter couples and supported on an inserted tiebeam. Other insertions include the introduction of a type of 'aisle purlin' on both sides of the roof at the western end. These are supported by braces which again rise from inserted tiebeams. Additionally, half rafters have been added throughout the roof in a more upright position than those raking rafters next to them. There are also twentieth-century repairs relating to the refurbishment of the building in the AD 1960s.

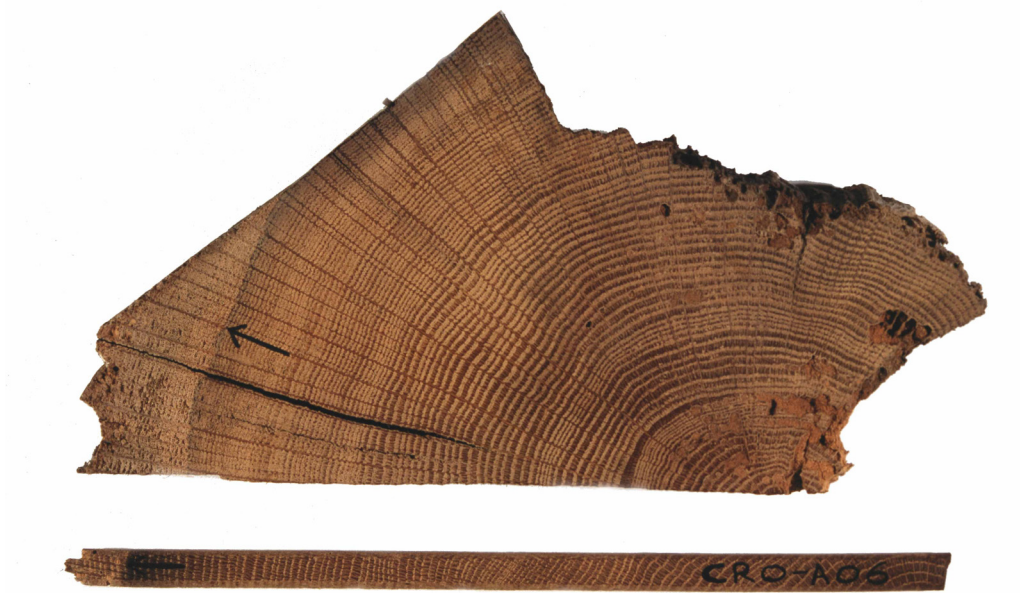
Figure 2: Cross-section of a rafter showing the presence of sapwood rings in the left hand corner, the arrow is pointing to the heartwood/sapwood boundary (H/S). Also a core with sapwood; again the arrow is pointing to the H/S. The core is about the size of a pencil.

Even more precise estimates of the felling date and range can often be obtained using knowledge of a particular case and information gathered at the time of sampling. For example, at the time of sampling the dendrochronologist may have noted that the timber from which the core of Figure 2 was taken still had complete

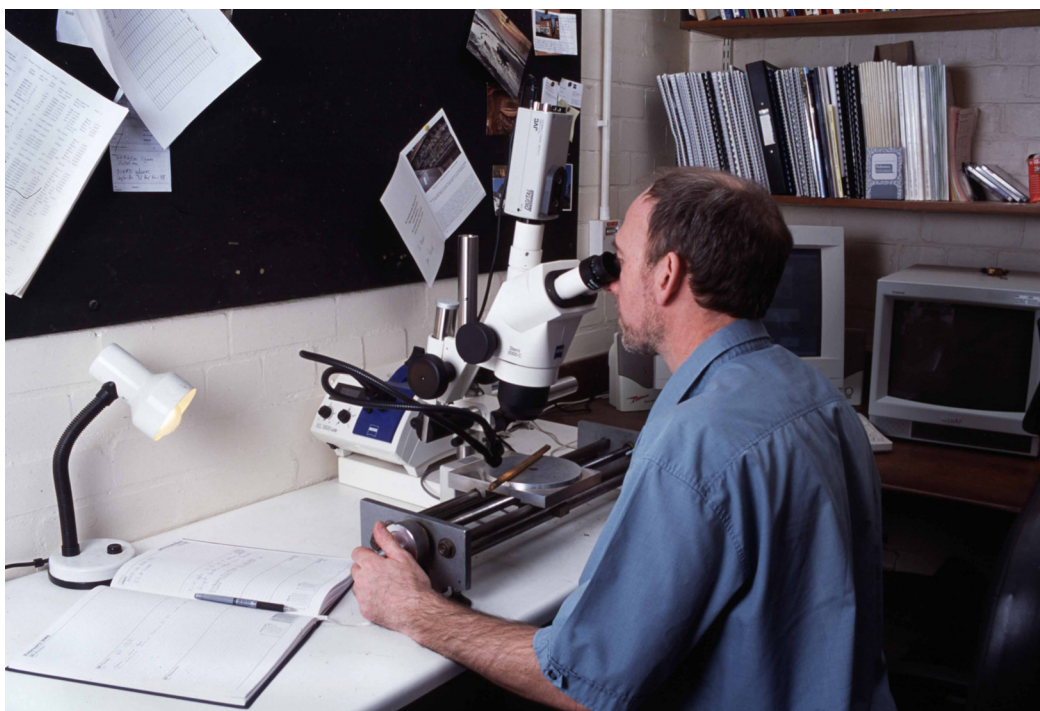
Figure 3: Measuring ring widths under a microscope. The microscope is fixed while the sample is on a moving platform. The total sequence of widths is measured twice to ensure that an error has not been made. This type of apparatus is needed to process a large number of samples on a regular basis.

2. **Measuring Ring Widths.** Each core is sanded down with a belt sander using medium-grit paper and then finished by hand with flourgrade-grit paper. The rings are then clearly visible and differentiated from each other with a result very much like that shown in Figure 2. The core is then mounted on a movable table below a microscope and the ring-widths measured individually from the innermost ring to the outermost. The widths are automatically recorded in a computer file as they are measured (see Fig 3).

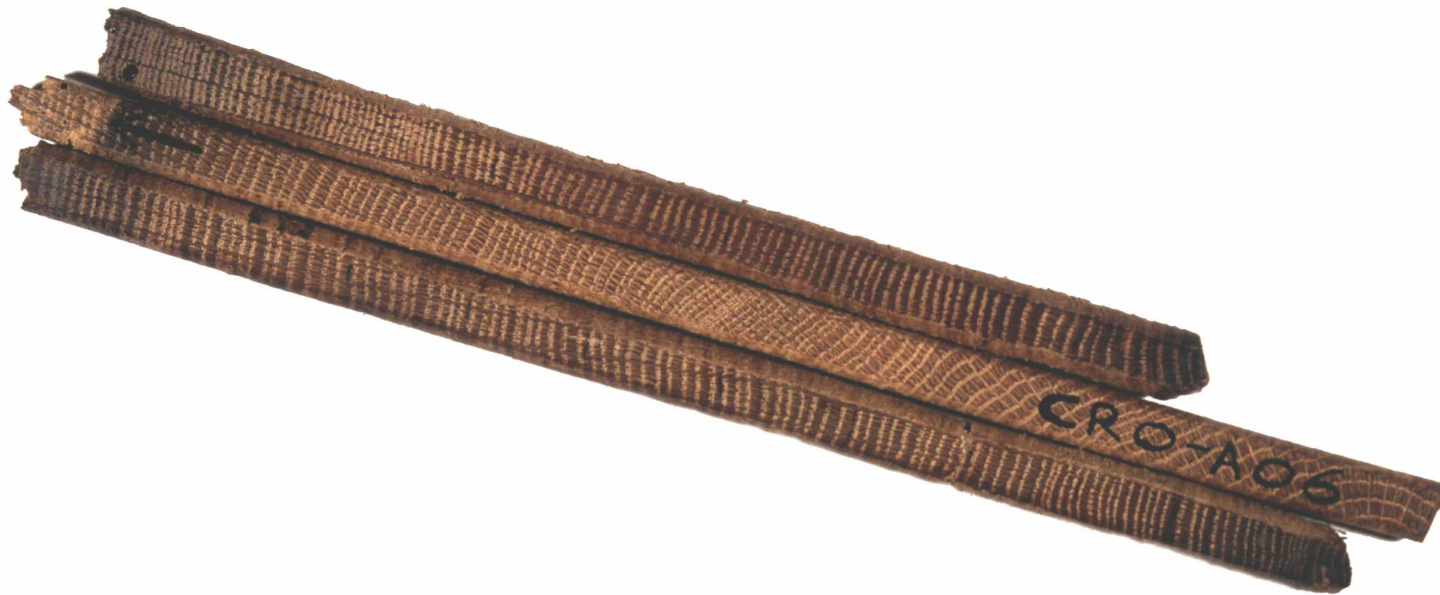
Figure 4: Three cores from timbers in a building. They come from trees growing at the same time. Notice that, although the sequences of widths look similar, they are not identical. This is typical.
