H M TOWER OF LONDON (TOL99 & TOL100)
LONDON BOROUGH OF TOWER HAMLETS
THE TREE-RING DATING OF THE
WHITE TOWER

SCIENTIFIC DATING REPORT

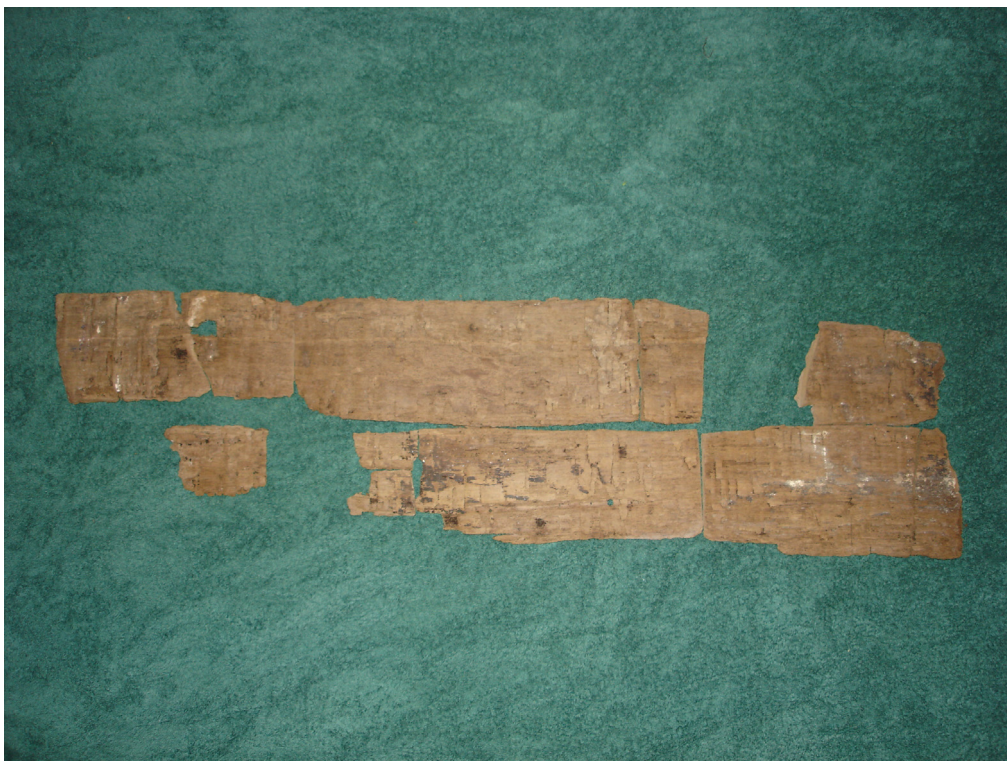
Figure 15: Photograph of board found in drain at second-floor level, east side (**wt22**)
