**St Oswald's Church, Widford, Oxfordshire  
Report on Geophysical Survey, March 2007**

Magnetometry and earth resistance surveys were conducted around St Oswald's Church, Widford, Oxfordshire to investigate both the source of damp affecting the N wall of the church and to identify any archaeological remains in the vicinity. There was no geophysical evidence for land drains, broken or otherwise, to the N of the church but an area of low resistance is thought to be associated with a nearby spring. A concentration of anomalies around the church is indicative of settlement activity, though the responses were not clear enough to suggest to what period they may relate.

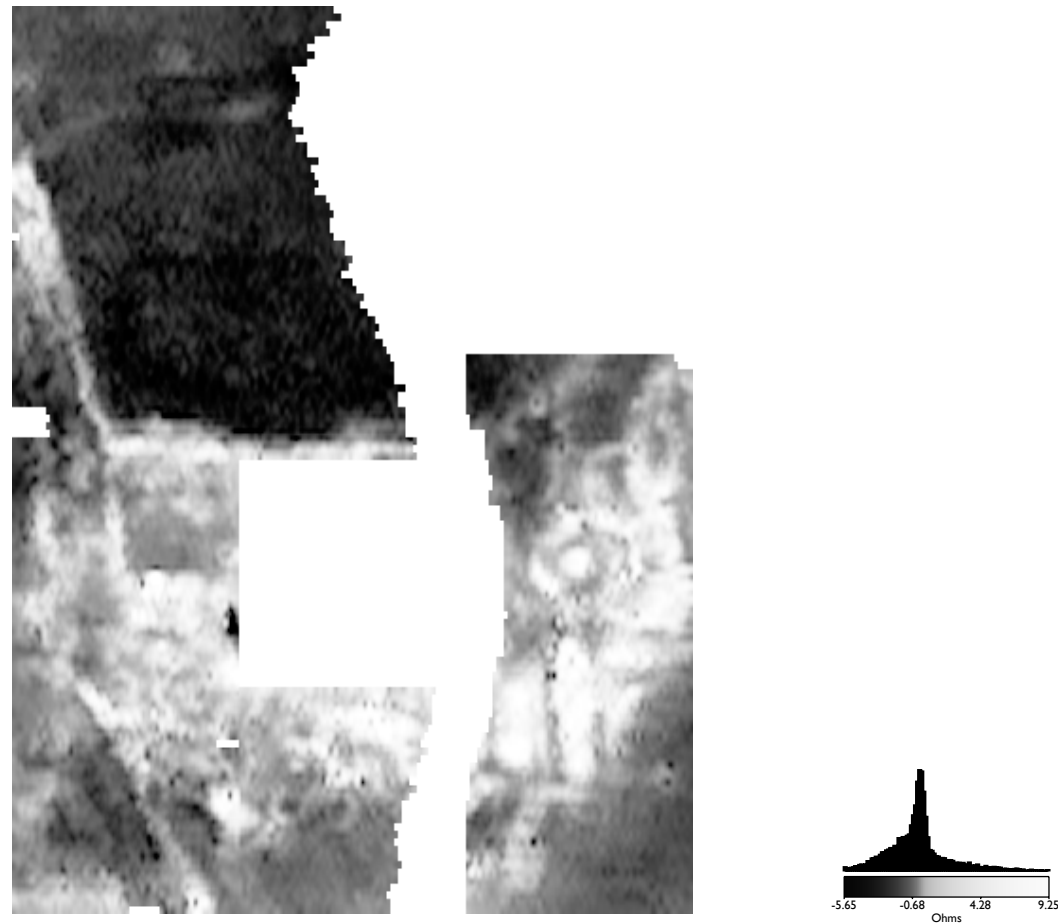
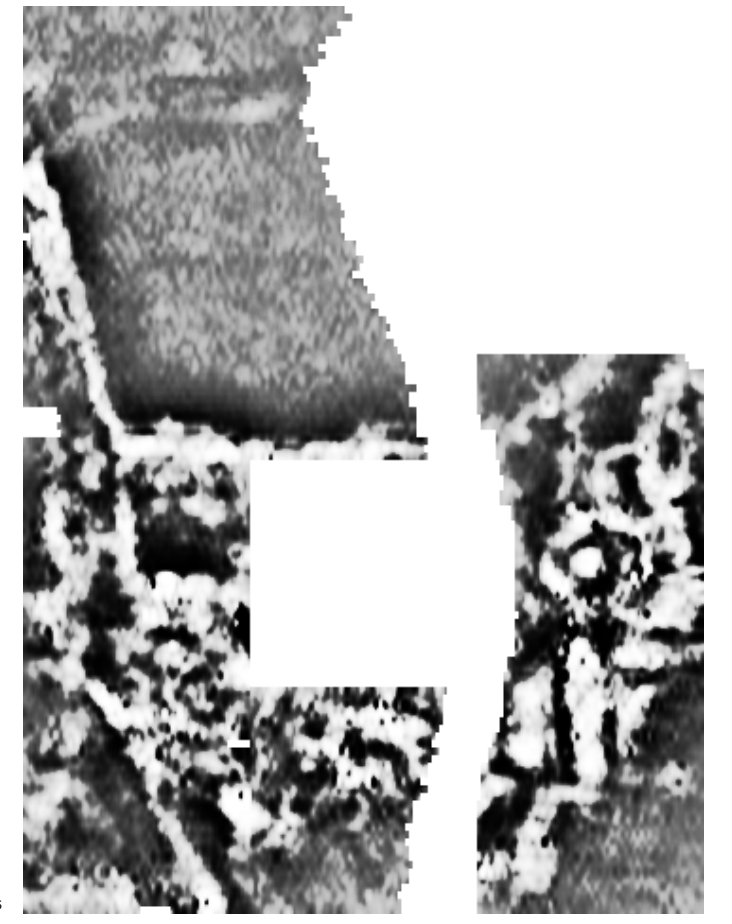
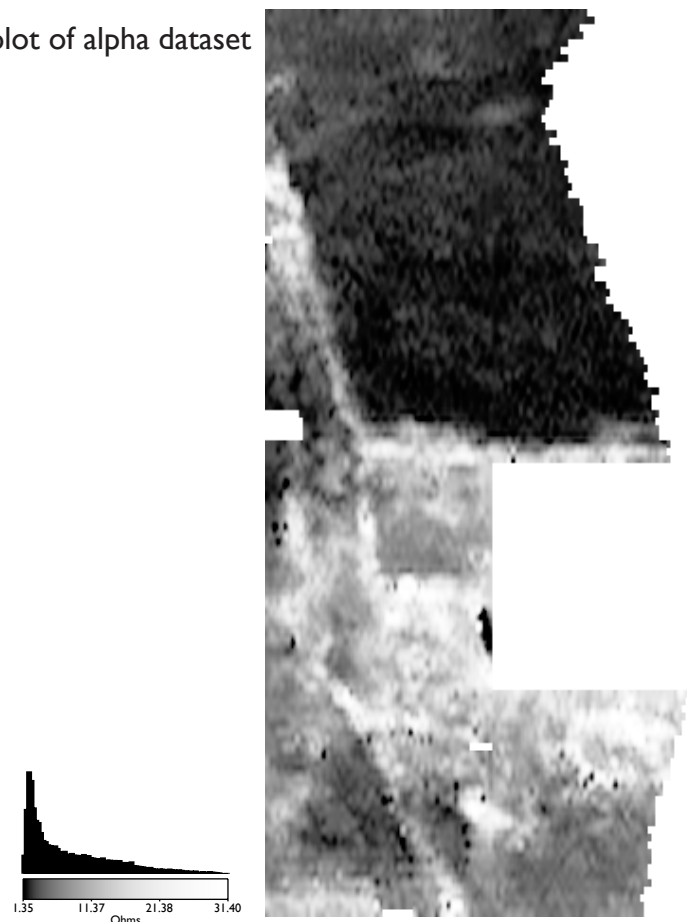
A) Traceplot of combined data

B) Greyscale plot of combined data

C) Greyscale plot of high-pass filtered combined data

D) Greyscale plot of alpha dataset

E) Greyscale plot of beta dataset

The filtered combined data-set is presented as an equal area greyscale plot superimposed over the OS base map (1:1000) in Figure 2. Plots of both alpha and beta data-sets are additionally presented as equal area greyscale, at a scale of 1:1000 in Figure 3 along with a traceplot and equal area greyscale plot of the raw combined data-set and an equal area greyscale plot of the filtered combined data-set.
