# THE OLD RECTORY, EPWORTH, NORTH LINCOLNSHIRE

## TREE-RING ANALYSIS OF TIMBERS

### SCIENTIFIC DATING REPORT

Research Department Report Series 64/2007

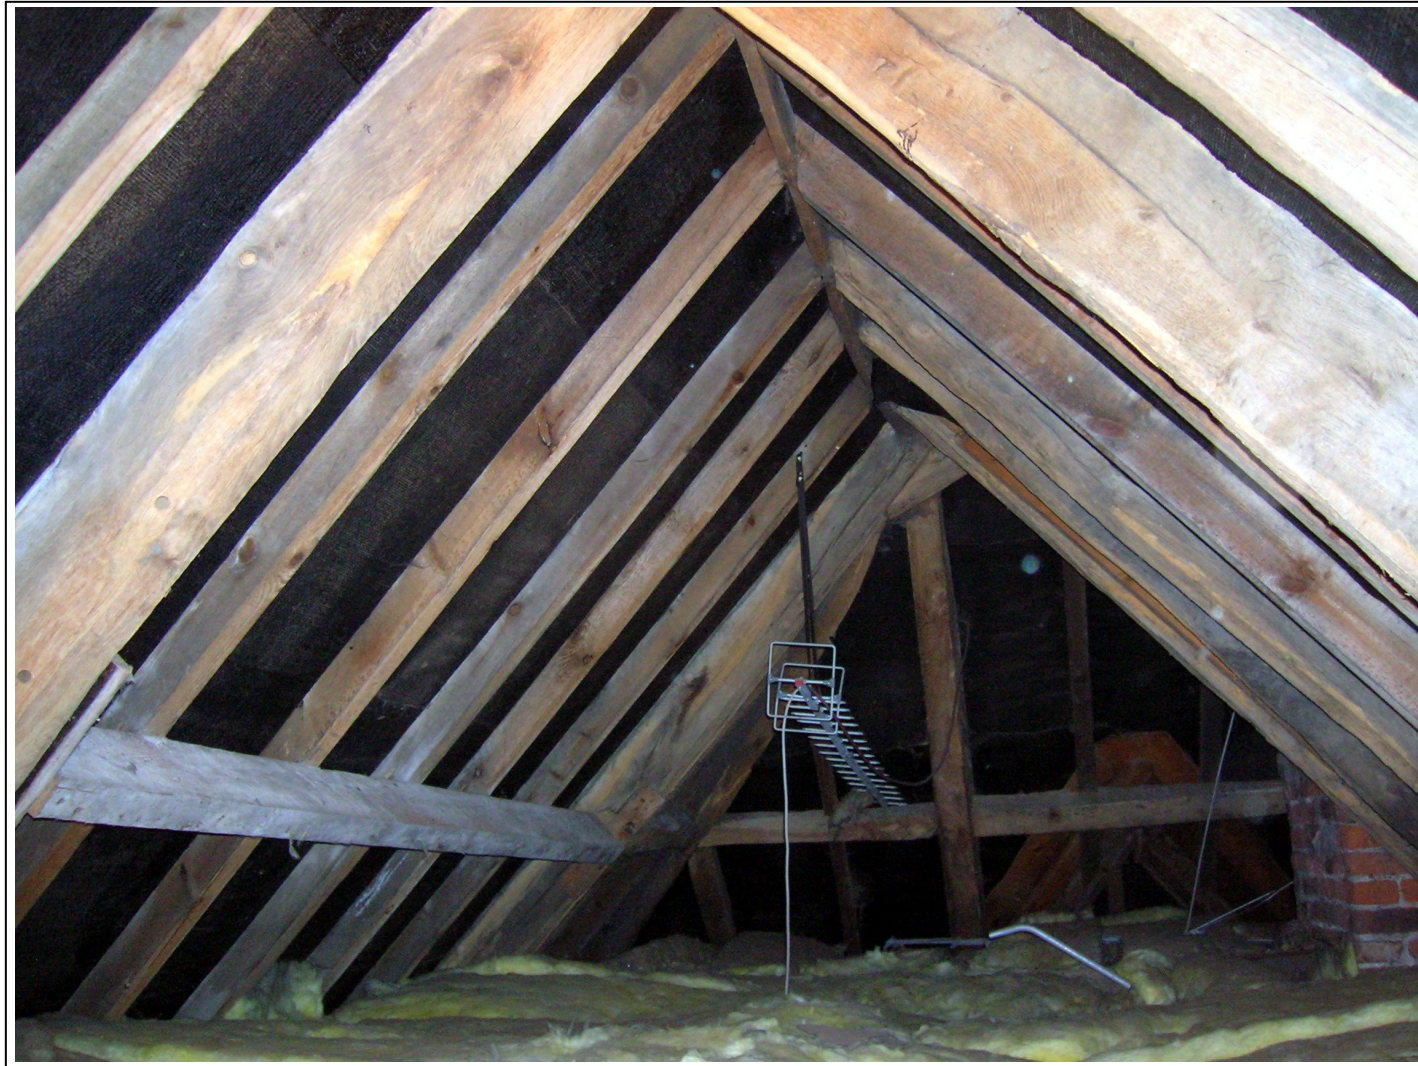
Figure 3: The Old Rectory; roof, looking west

The house is of local red-brown brick, in Flemish bond on the south front and in English garden wall bond on the other elevations. The property has a pantile roof, in two ranges with valley gutter, that was re-roofed in AD 1956 with some replacement of roof timbers and tiles. The roof is hipped on the west side and has a concrete coping detail to the east side. The roof structure is a collared rafter roof with pegged butted purlins (Fig 3). The dormers are additions of AD 1956.

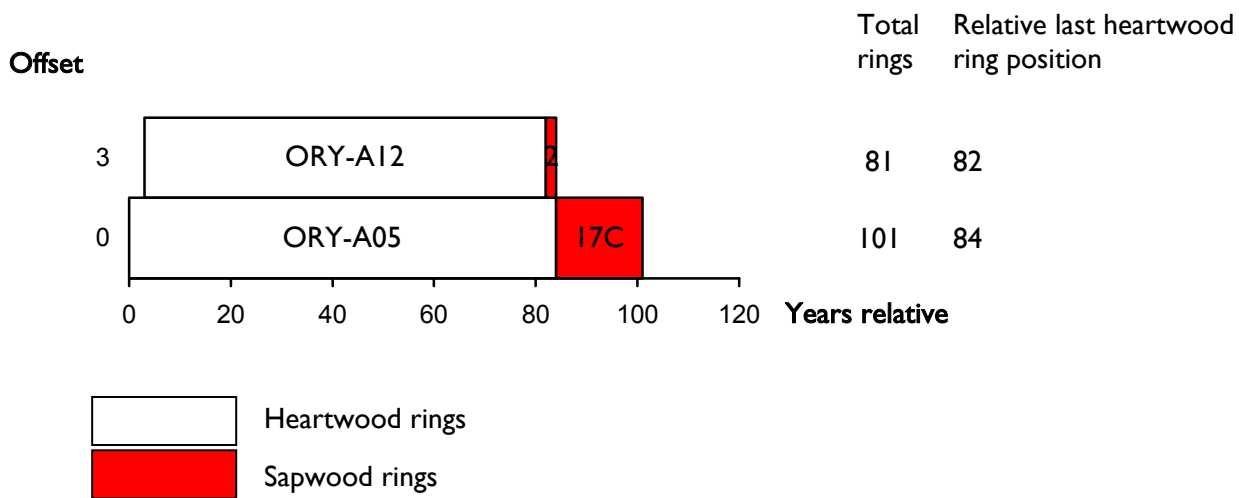
C = complete sapwood retained on the sample, last measured ring is the felling date

Figure 8: Bar diagram of samples in undated site sequence ORYASQ01

Two samples, both from the roof, matched each other and were combined at the relevant offset positions to form ORYASQ01, a site sequence of 101 rings (Fig 8). Six other samples, five from the roof and one from a ceiling beam, matched each other and were combined at the relevant offset

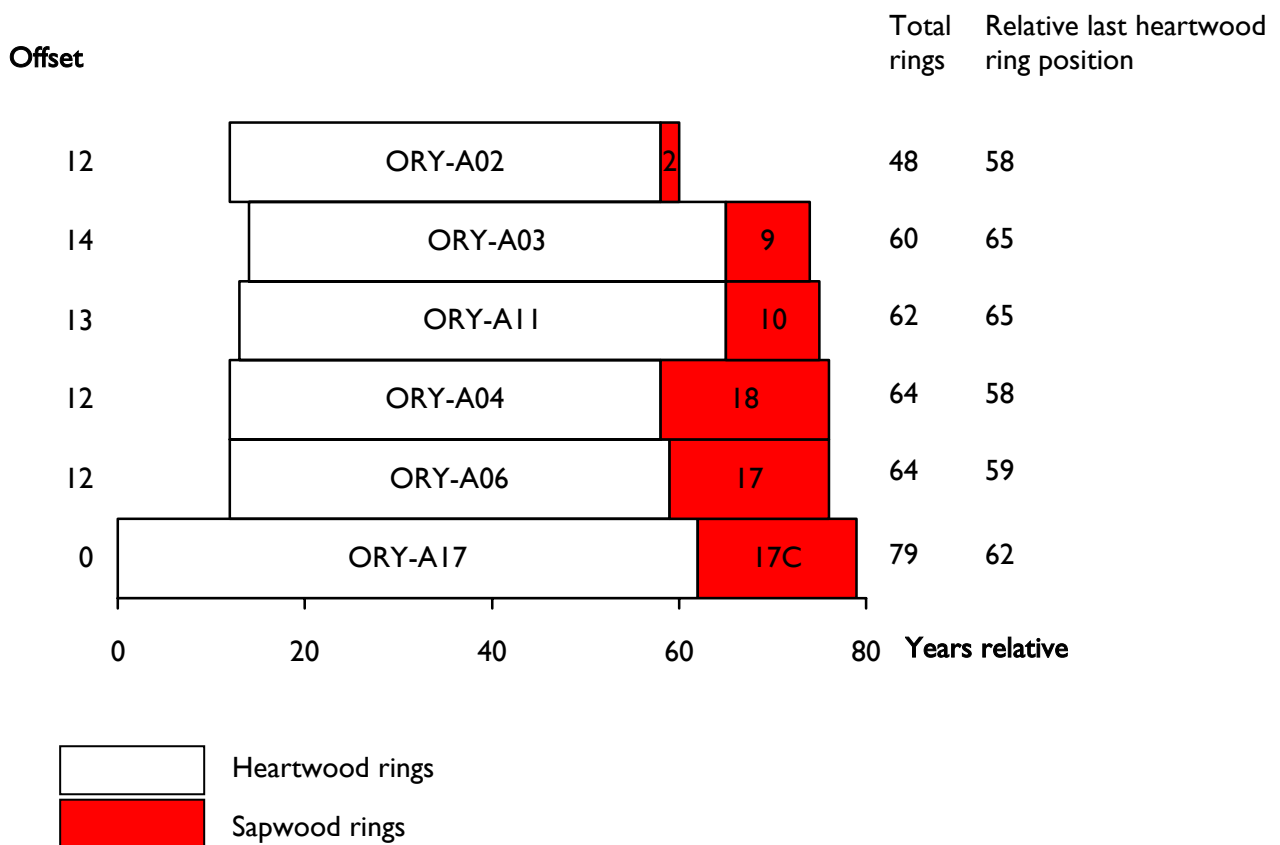
C = complete sapwood retained on the sample, last measured ring is the felling date

Figure 9: Bar diagram of samples in undated site sequence ORYASQ02

positions to form ORYASQ02, a site sequence of 79 rings (Fig 9). Attempts to date these site sequences by comparing them against a series of relevant reference chronologies for oak were unsuccessful and both remain undated.

Interpretation of the relative heartwood/sapwood boundary ring positions of the six samples contained within site sequence ORYASQ02 does suggest a single felling for the six timbers represented. This does demonstrate that at least one of the ceiling beams is likely to be of the same date as the roof structure, although unfortunately, it is not possible as yet to say what this date would be. It is unfortunate that the one obviously reused ceiling beam did not match any of the other samples, which would have at least given us a date relative to the rest of the timbers, if not an absolute date.

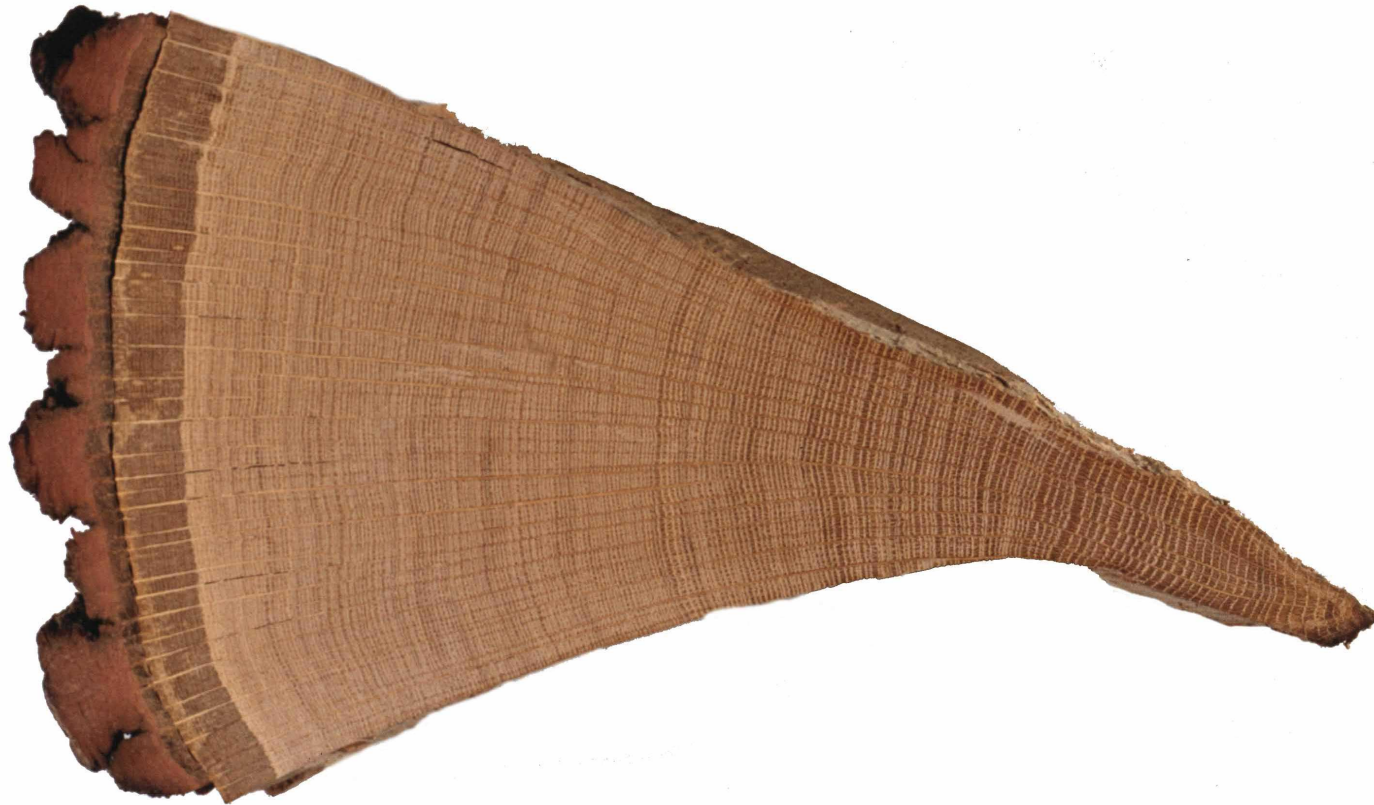
**Figure 1:** A wedge of oak from a tree felled in 1976. It shows the annual growth rings, one for each year from the innermost ring to the last ring on the outside just inside the bark. The year of each ring can be determined by counting back from the outside ring, which grew in 1976.

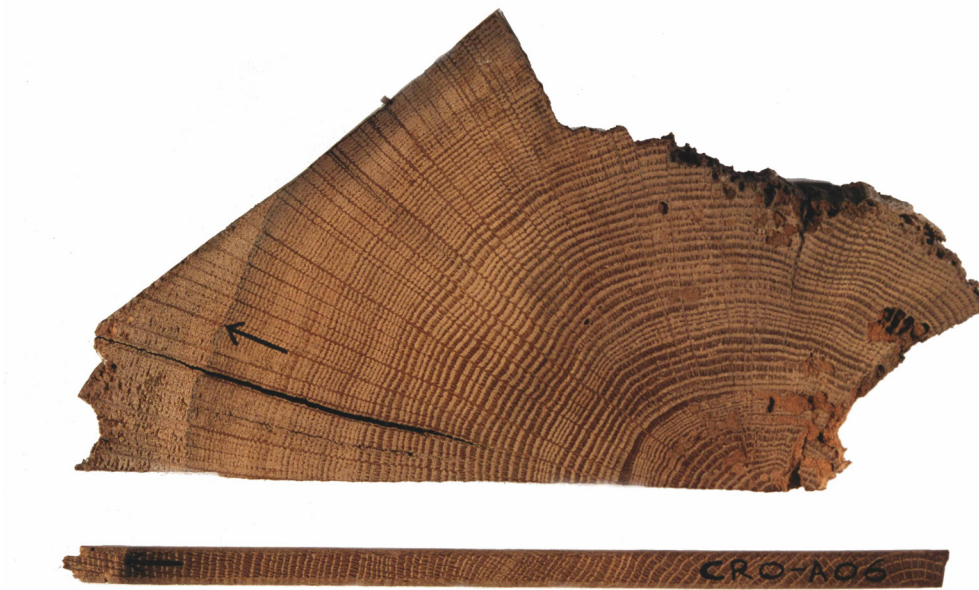
**Figure 2:** Cross-section of a rafter showing the presence of sapwood rings in the left hand corner, the arrow is pointing to the heartwood/sapwood boundary (H/S). Also a core with sapwood; again the arrow is pointing to the H/S. The core is about the size of a pencil.

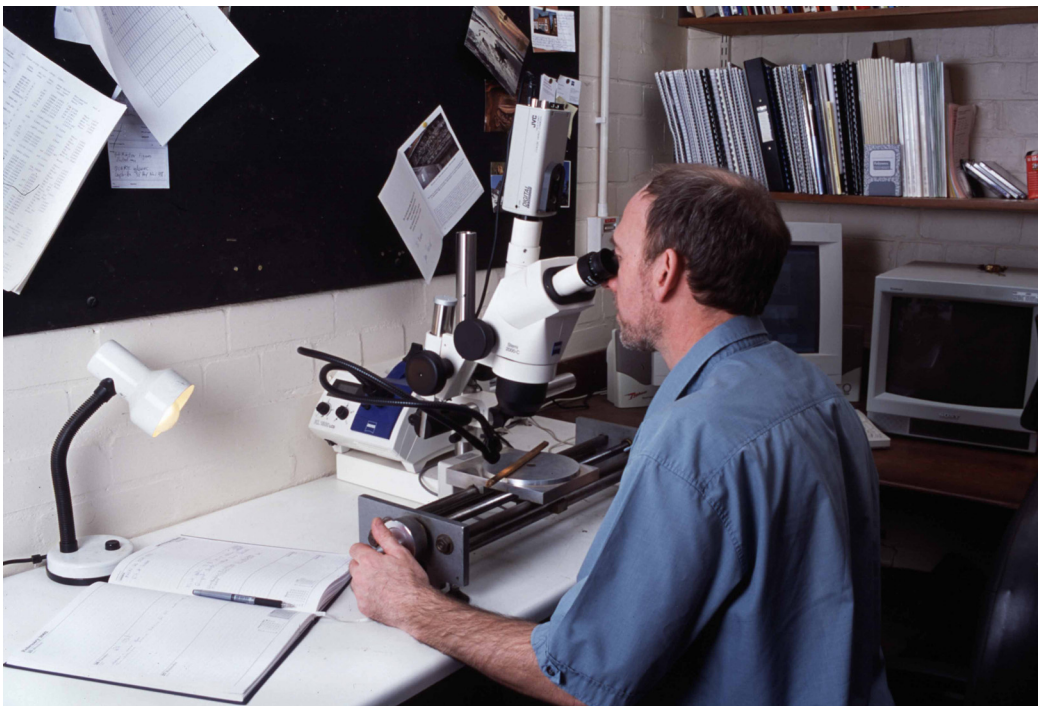
**Figure 3:** Measuring ring widths under a microscope. The microscope is fixed while the sample is on a moving platform. The total sequence of widths is measured twice to ensure that an error has not been made. This type of apparatus is needed to process a large number of samples on a regular basis.

2. **Measuring Ring Widths.** Each core is sanded down with a belt sander using medium-grit paper and then finished by hand with flourgrade-grit paper. The rings are then clearly visible and differentiated from each other with a result very much like that shown in Figure 2. The core is then mounted on a movable table below a microscope and the ring-widths measured individually from the innermost ring to the outermost. The widths are automatically recorded in a computer file as they are measured (see Fig 3).

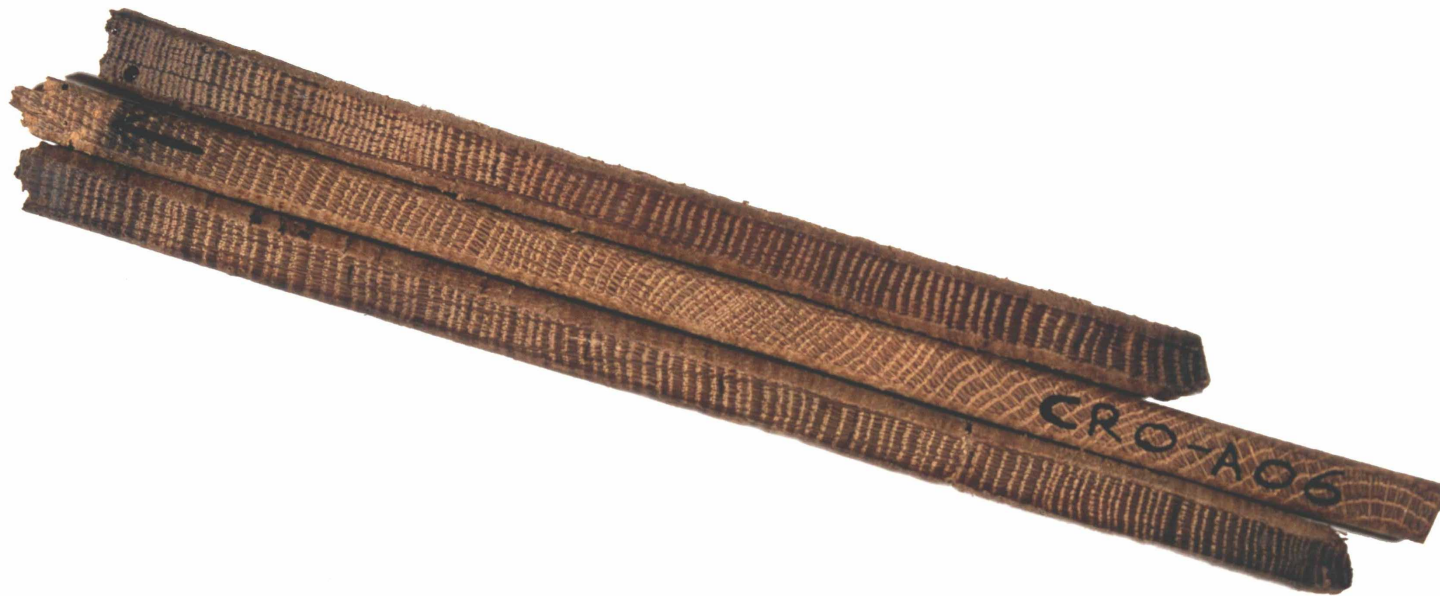
**Figure 4:** Three cores from timbers in a building. They come from trees growing at the same time. Notice that, although the sequences of widths look similar, they are not identical. This is typical.
