ST MICHAEL'S MOUNT, MARAZION,
NEAR PENZANCE, CORNWALL
TREE-RING ANALYSIS OF TIMBERS
FROM THE CHEVY CHASE ROOM
SCIENTIFIC DATING REPORT

Research Department Report Series 67/2007

Dendrochronological analysis was undertaken on samples taken from the roof structure in the Chevy Chase room of this building.

No timbers were grouped and attempts to individually date the samples were unsuccessful.

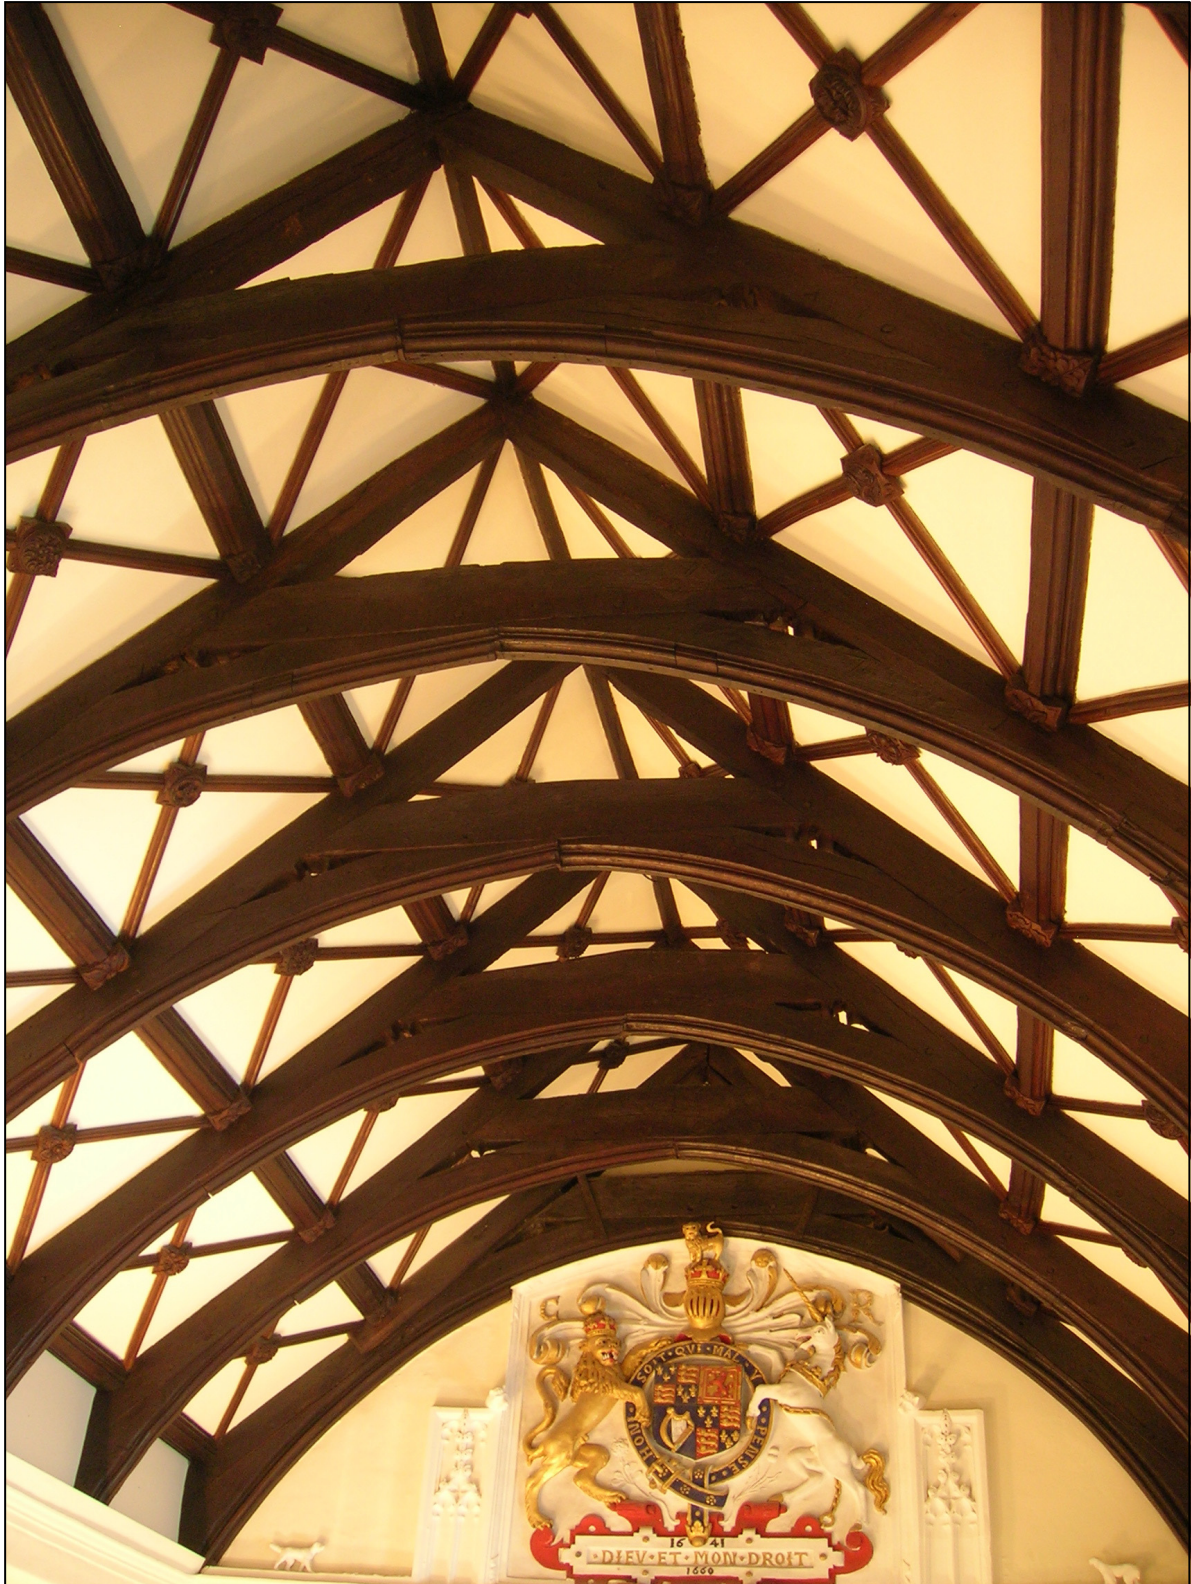
Figure 4: Chevy Chase room, roof structure (viewed from the west)

In the outer angle between the west and south range is a square block; thought to have once been a tower with garderobe, it is now known as Sir John's Room. Behind this is a lobby and behind the lobby is the Library, an eighteenth-century remodelling of another tower. At the rear right-hand corner of the Breakfast Room is the former monks' refectory, which has been known as the Chevy Chase Room since the seventeenth century. Around the room is a seventeenth-century frieze depicting the Chevy Chase, a seventeenth-century coat of arms and eighteenth-century plasterwork. The roof structure in the Chevy Chase Room is thought to be the only surviving medieval roof in the building. It is of arch-braced type, and is believed to be a fifteenth-century re-roofing (Fig 4).

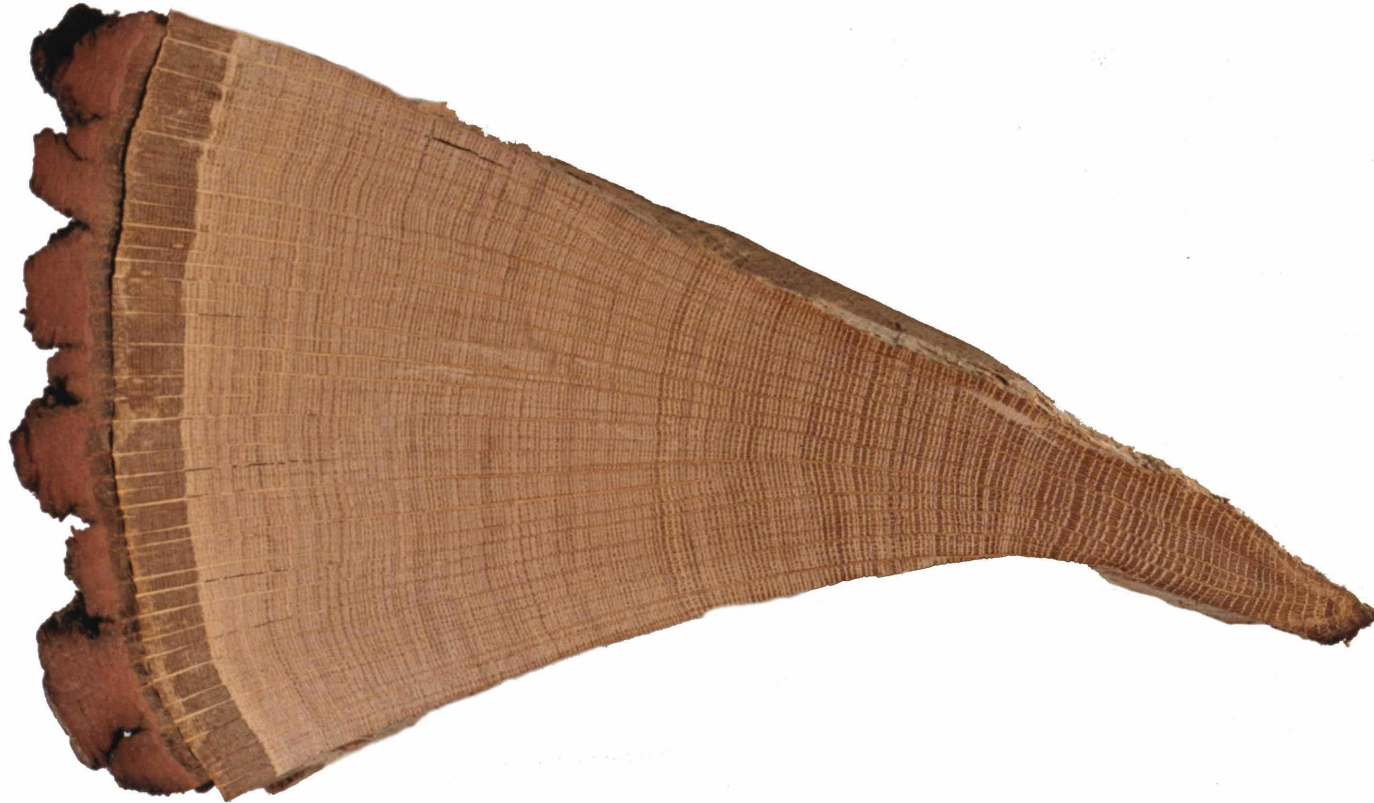
Figure 1: A wedge of oak from a tree felled in 1976. It shows the annual growth rings, one for each year from the innermost ring to the last ring on the outside just inside the bark. The year of each ring can be determined by counting back from the outside ring, which grew in 1976.

If the bark is still on the sample, as in Figure 1, then the date of the last ring will be the date of felling of the oak from which it was cut. There is much evidence that in medieval times oaks cut down for building purposes were used almost immediately, usually within the year or so (Rackham 1976). Hence if bark is present on several main timbers in a building, none of which appear reused or are later insertions, and if they all have the same date for their last ring, then we can be quite confident that this is the date of construction or soon after. If there is no bark on the sample, then we have to make an estimate of the felling date; how this is done is explained below.

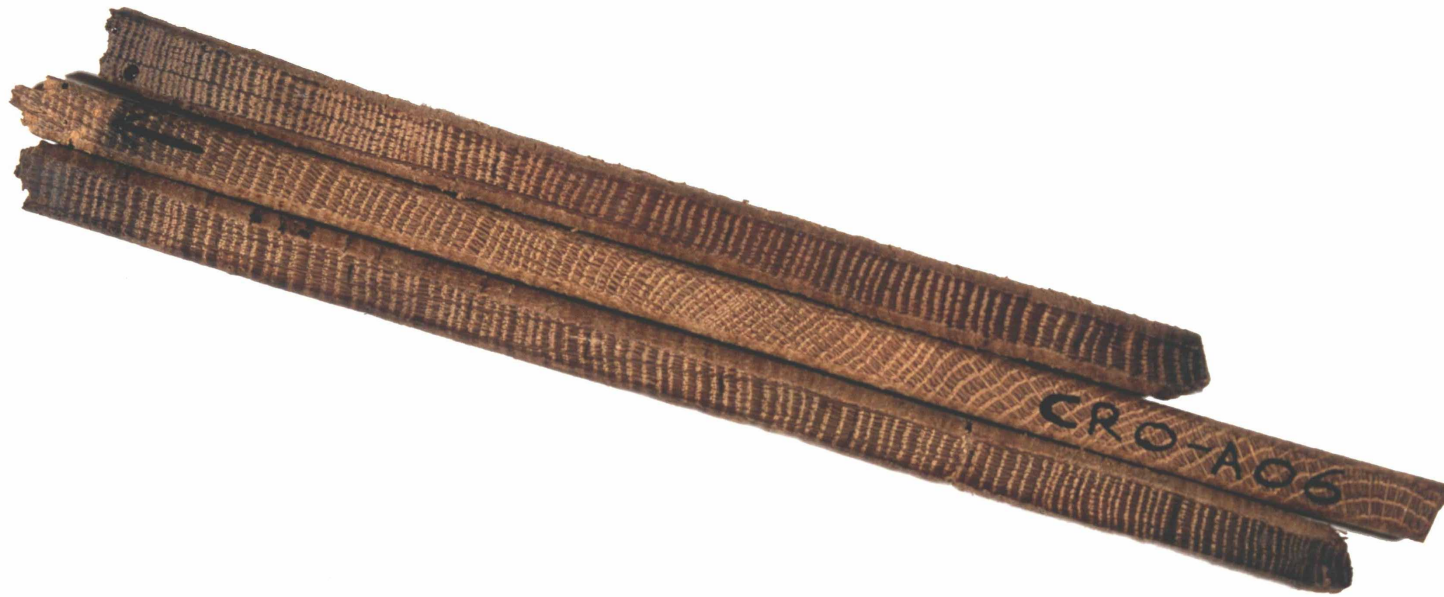
Figure 4: Three cores from timbers in a building. They come from trees growing at the same time. Notice that, although the sequences of widths look similar, they are not identical. This is typical.
