RAF COLTISHALL, NORFOLK A PHOTOGRAPHIC CHARACTERISATION

A photographic characterisation

Research Department Report Series 68/2007

County: Norfolk
District: Broadland
Parish: Coltishall, Burton with Lamas and Scottow
NGR: TG 270 225
NMR No: TG 22 SE 35
Date of Investigation: March-November 2006
Investigated by: Wayne Cocroft
Report author: Wayne Cocroft
Photography by: Steve Cole and Damian Grady

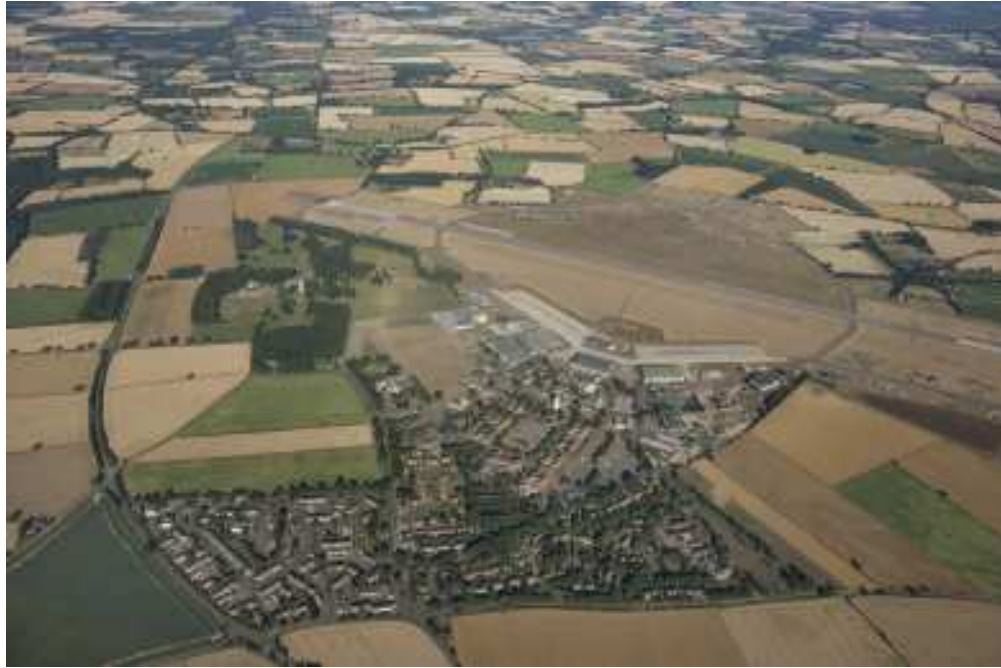
Figure 1 RAF Coltishall, from the south west. This view shows the impact of the airfield on this rural landscape. Towards the bottom of the photograph is Frogge Lane whose route has been cut by the airfield. Running from the bottom left to the top centre another ancient route may be seen snaking diagonally across the landscape, its line was partly lost in the construction of Scottow Hall and later by the airfield. To the left is Scottow Road, this was constructed in the 1960s to link the villages of Buxton and Lamas to the B1150. (c) English Heritage NMR24369/012

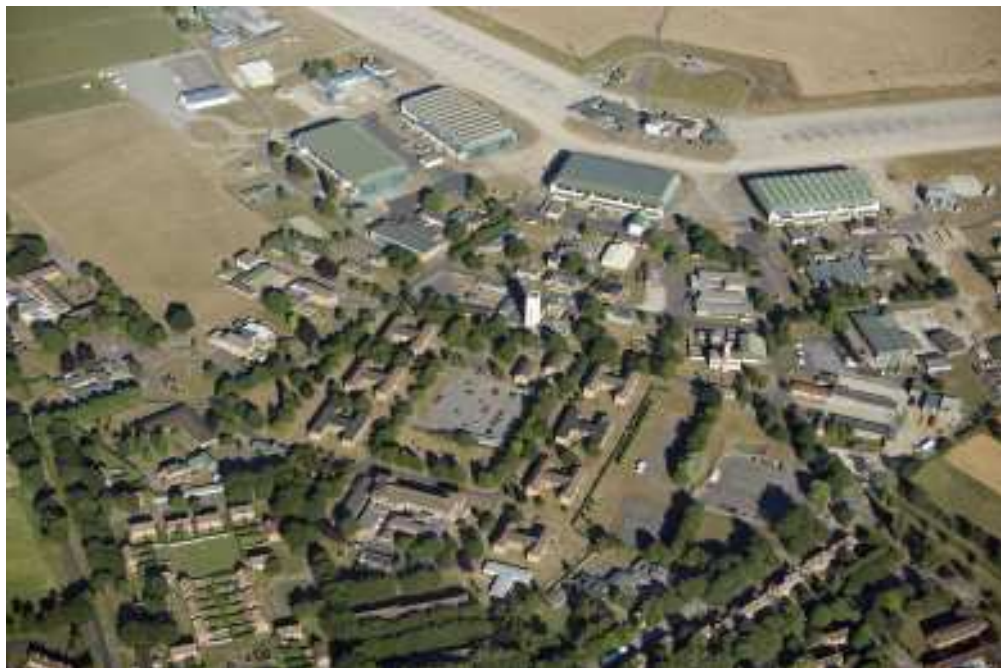
Figure 2 RAF Coltishall, from southwest. To the top is the Watch Office, or Control Tower, and four C type hangars, between them and the H-shaped barrack blocks is the technical area, including the parachute packing building, engine maintenance building and stores. (c) English Heritage NMR24369/038

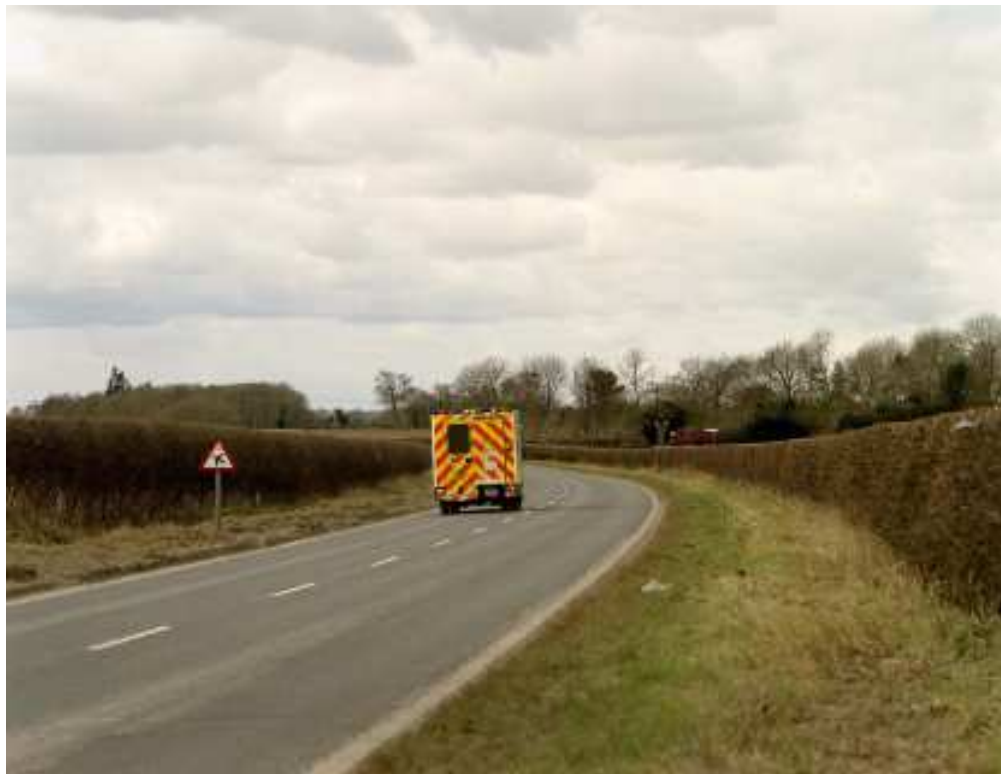
Figure 4 Scottow Road to the north of the airfield, built in the 1960s to link the villages of Buxton and Lamas to the B1150. This replaced an earlier route to the south which had been severed by the construction of the airfield. (c) English Heritage AA054358

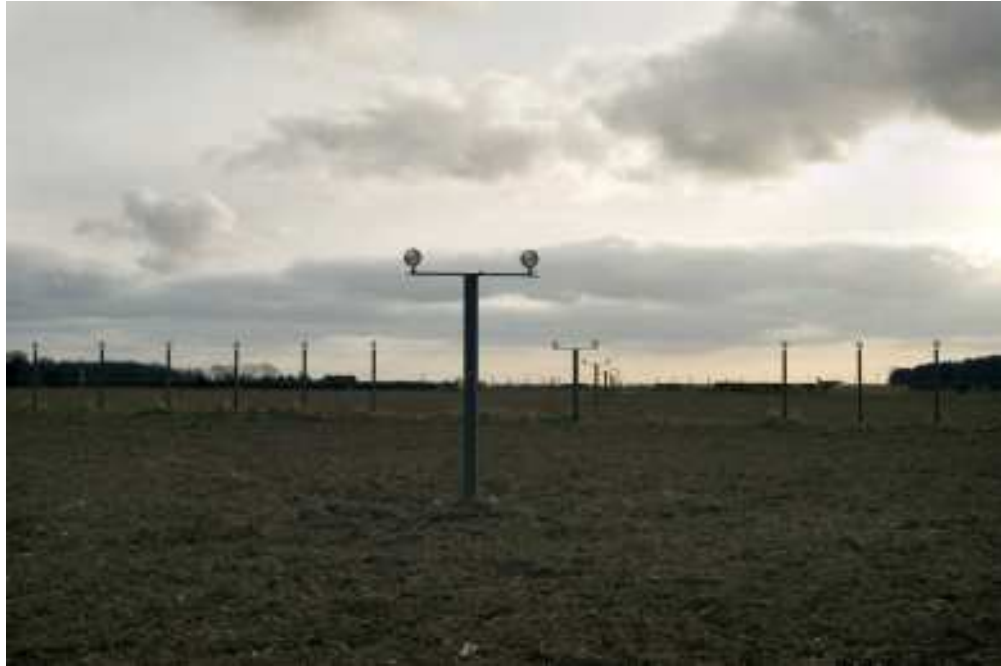
Figure 5 Runway approach lighting to northeast of runway off Scottow Road. (c) English Heritage DP029257

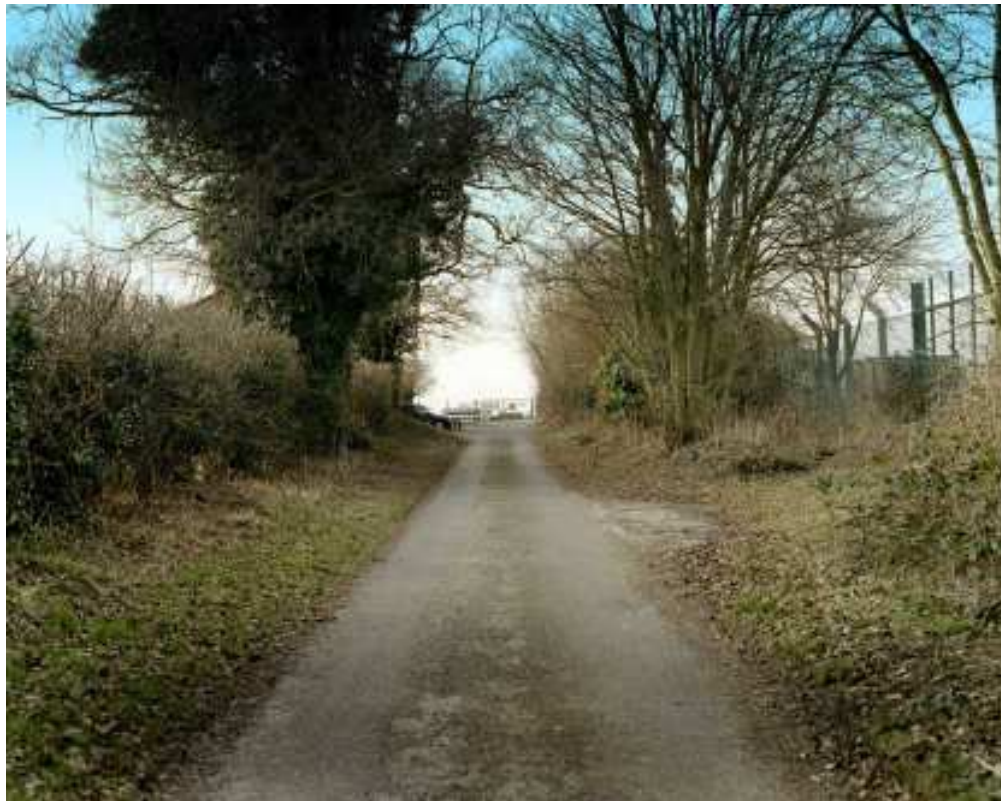
Figure 6 Frogge Lane, to the north of Herne's farm, cut by the construction of the airfield. (c) English Heritage AA054478

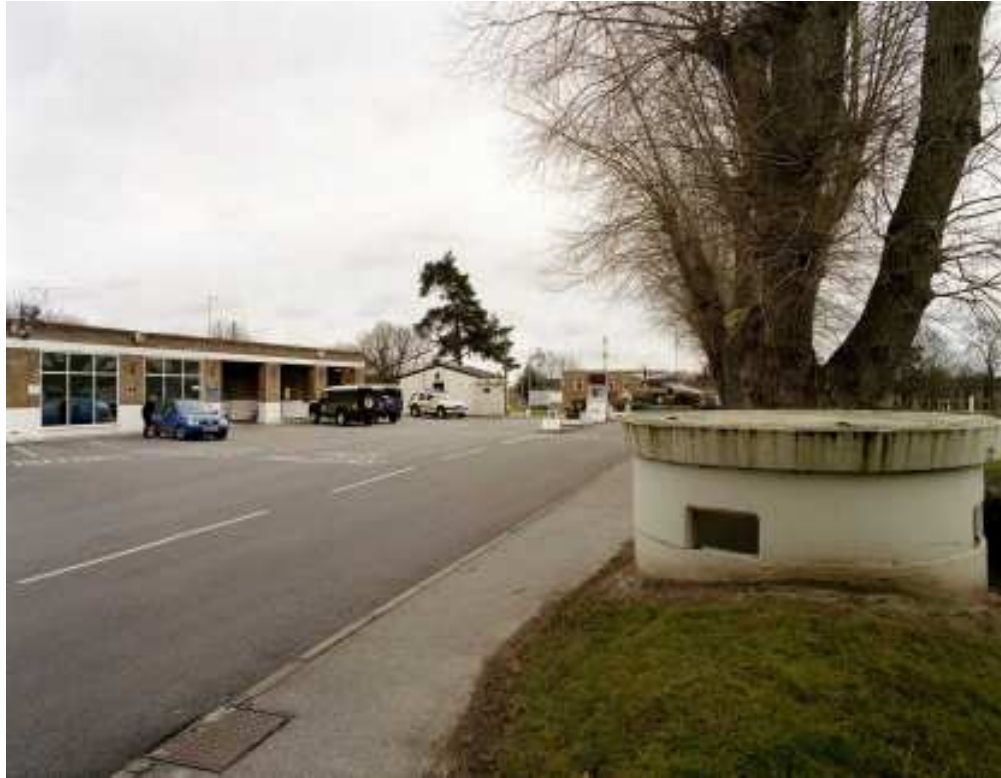
Figure 11 Main gate, showing the original guard room whose open veranda has been partly enclosed. To the right is a prefabricated Yarnold Shelter, these were constructed in the 1980s to guard against possible terrorist attack. (c) English Heritage AA054382

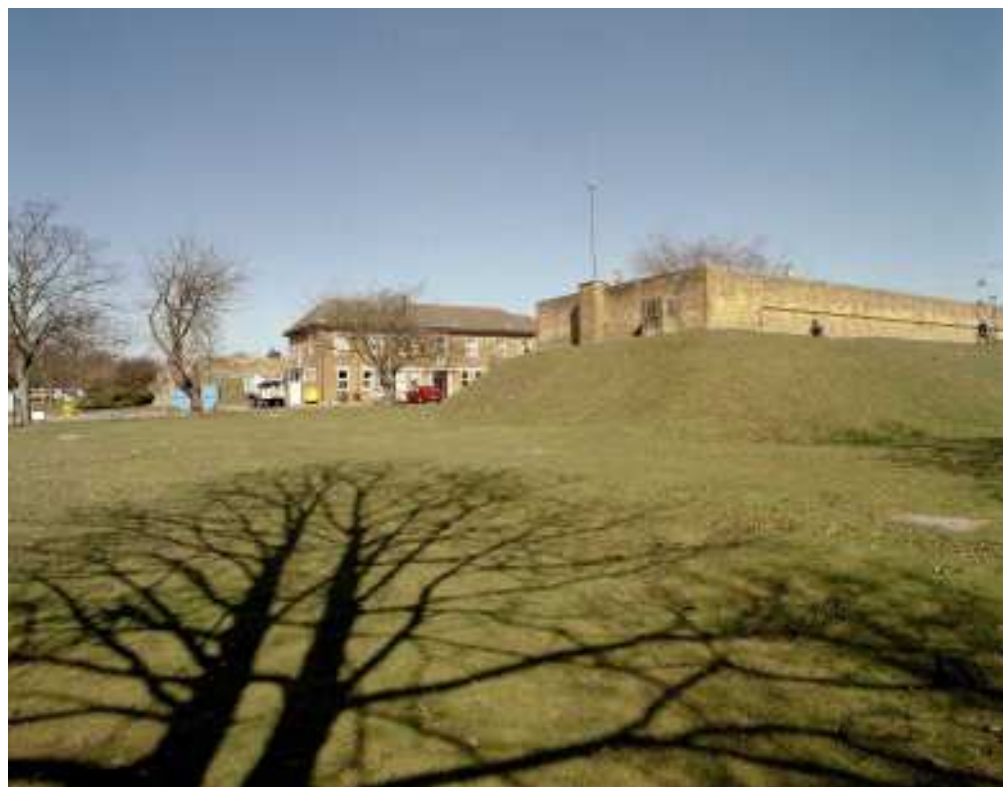
Figure 27 Wartime protected operations block and to its rear is the station hospital and wartime decontamination block. (c) English Heritage AA054436

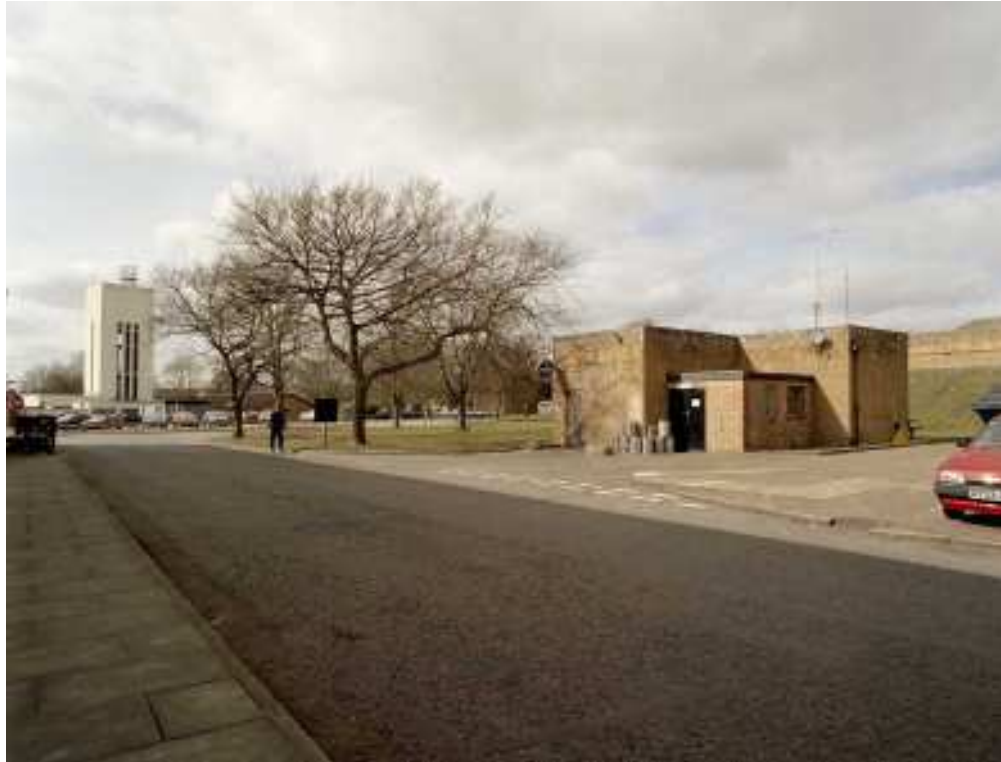
Figure 28 Building 23, station mortuary last used as a rugby club house. (c) English Heritage AA054392

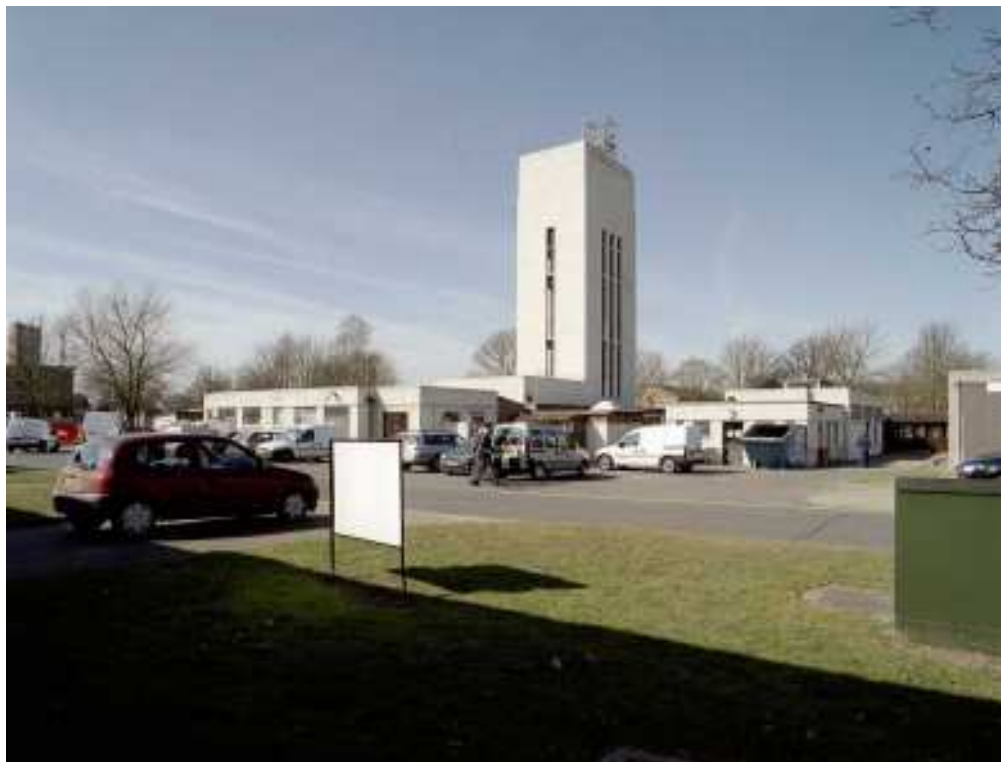
Figure 29 Station water tower. (c) English Heritage AA054435

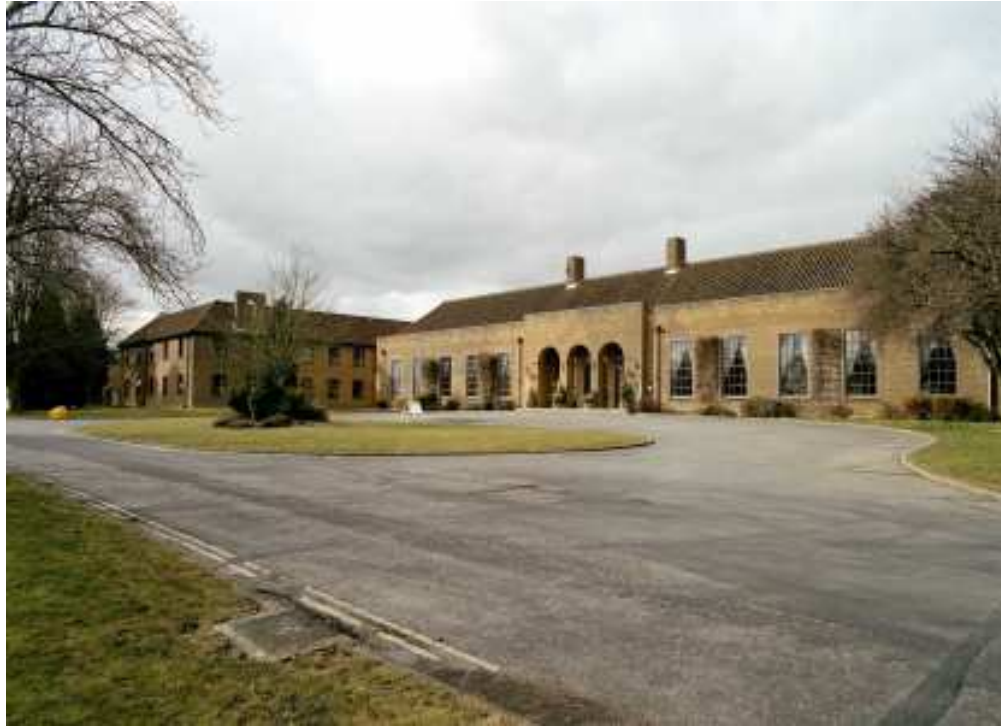
Figure 30 Building 50, The officers' mess, this fine neo-Georgian style building is typical of the care taken over the design of many permanent RAF airfields during the late 1930s. Traces of wartime camouflage may still be seen on its walls. (c) English Heritage AA054416

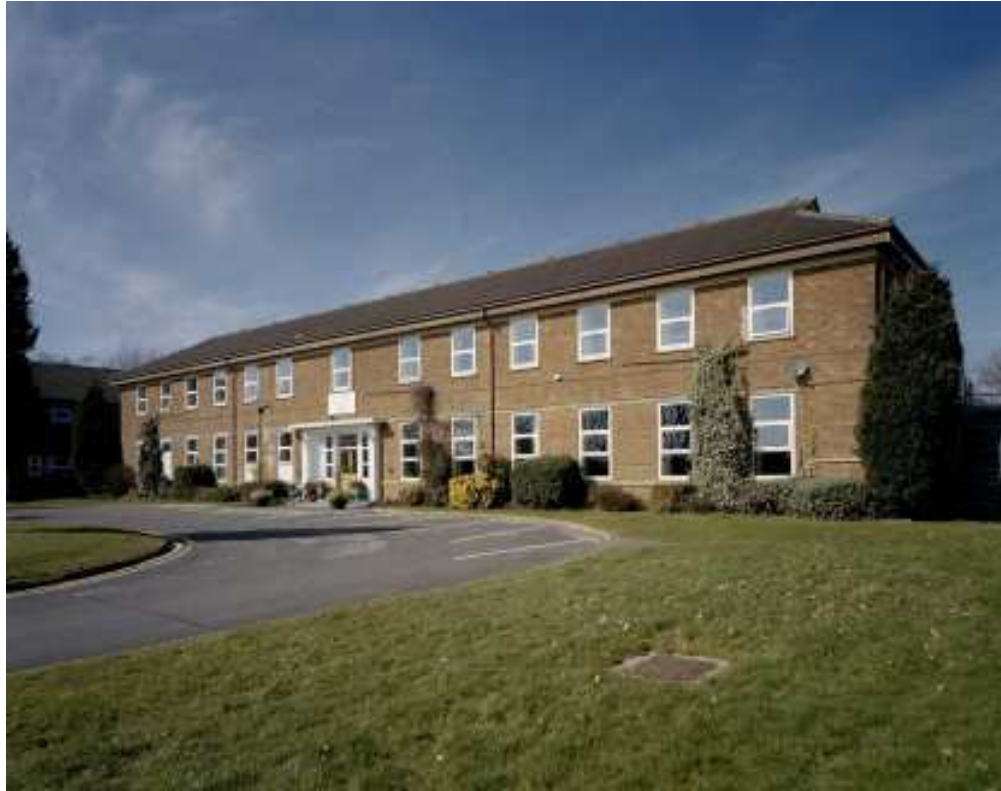
Figure 49 The sergeants' mess, this building originally had a flat roof. (c) English Heritage AA054438

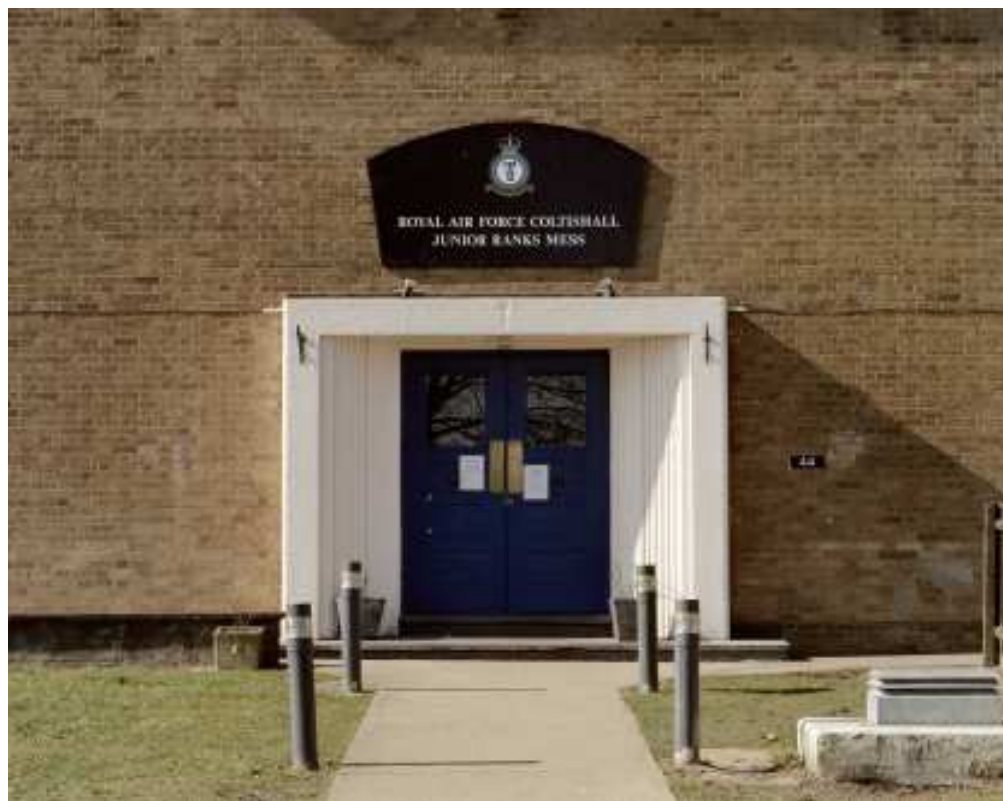
Figure 58 Building 44, the 1930s airmens' institute, this building also originally had a flat roof. (c) English Heritage AA054449

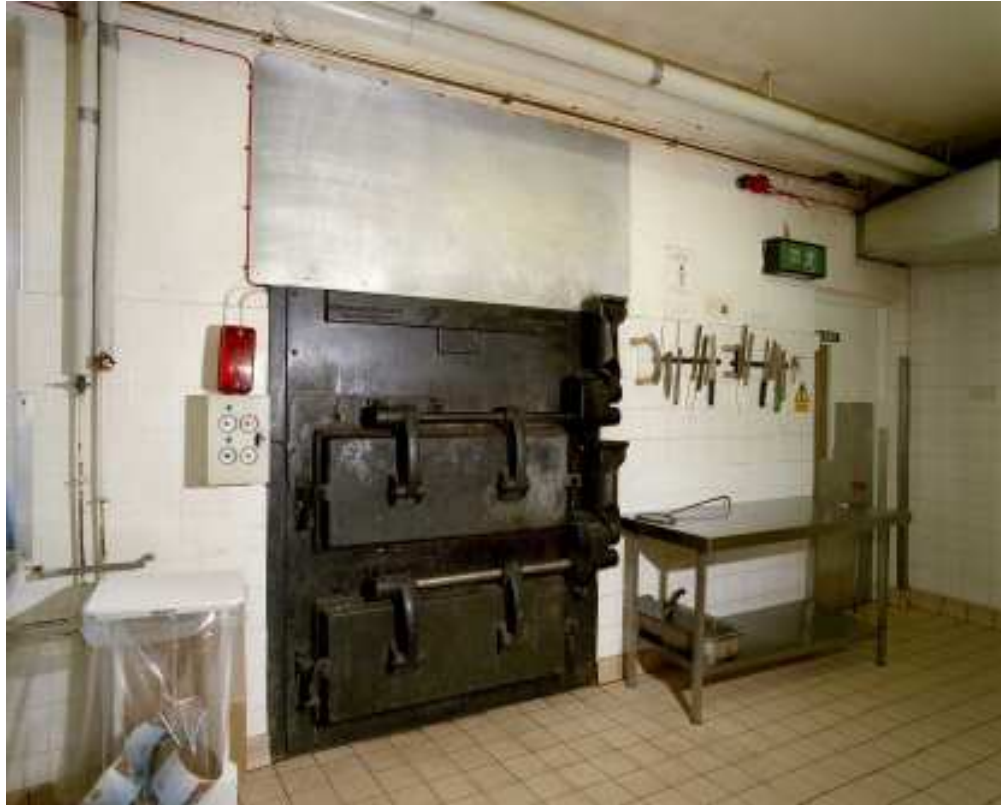
Figure 65 The Junior Ranks Mess, kitchen, west end, late 1930s Collins Cantilever Oven by Thomas Collins Co Ltd, Telephone Bristol 57061, it was originally coal fired oven. (c) English Heritage AA054452

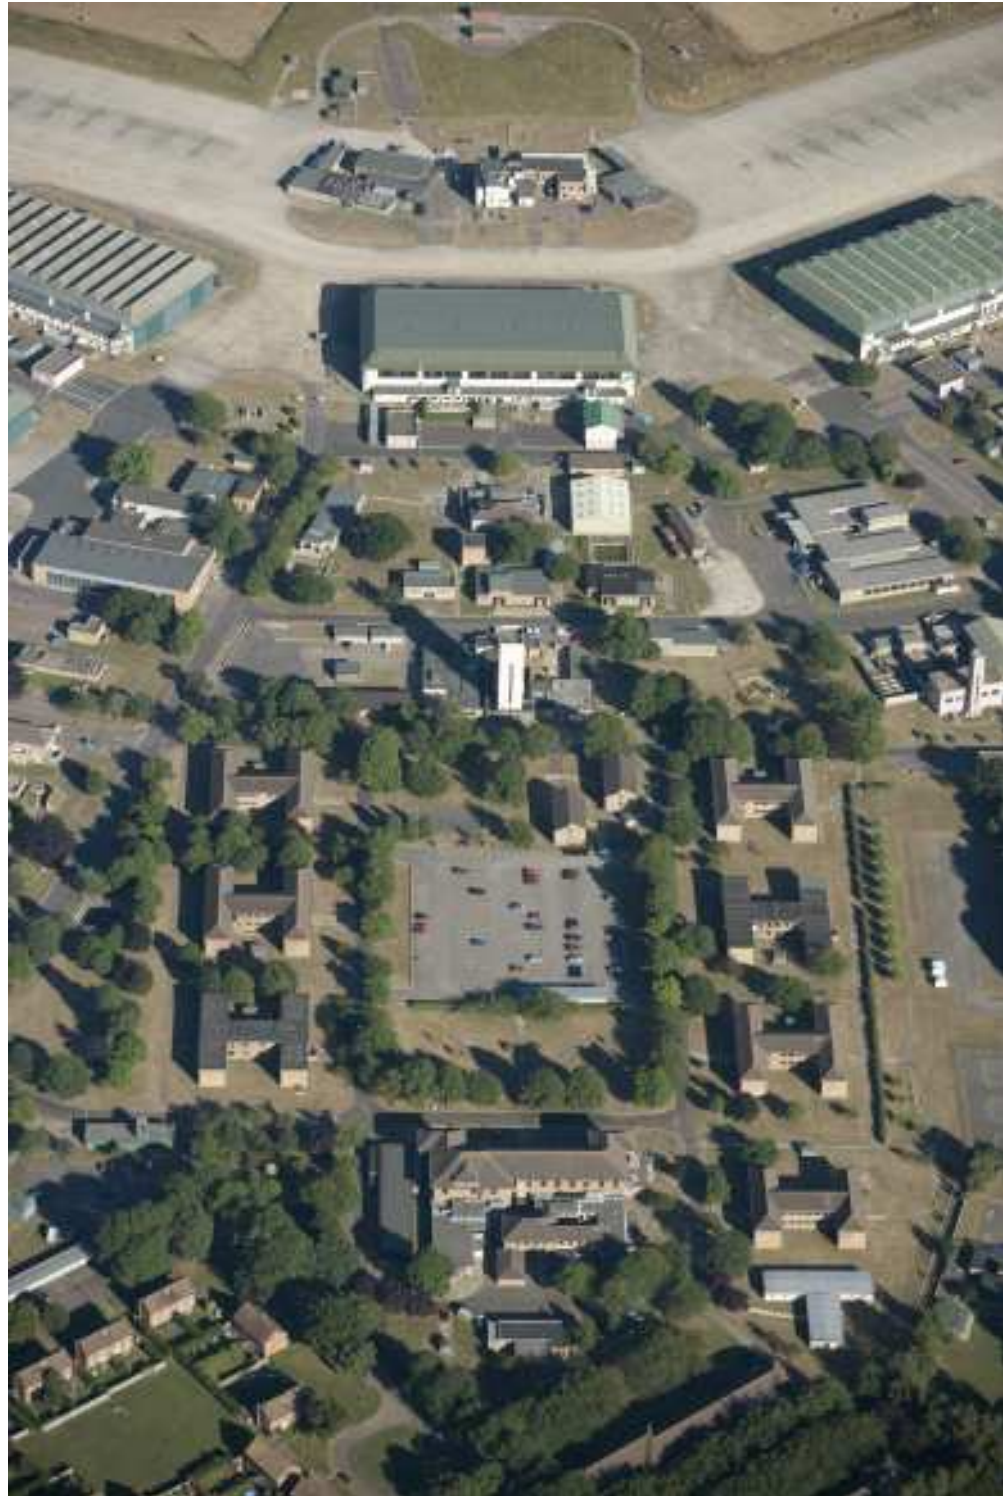
Figure 71 This view from the north west shows the careful symmetry of the 1930s design, with an axis running from the control tower (top) through Hangar 2, the former parade ground, latterly used as a car park, to in the foreground the large airmen's institute. To either side are the H-shaped barrack blocks, these were all originally flat roofed, a number have subsequently been given gable roofs. (c) English Heritage NMR24369/037

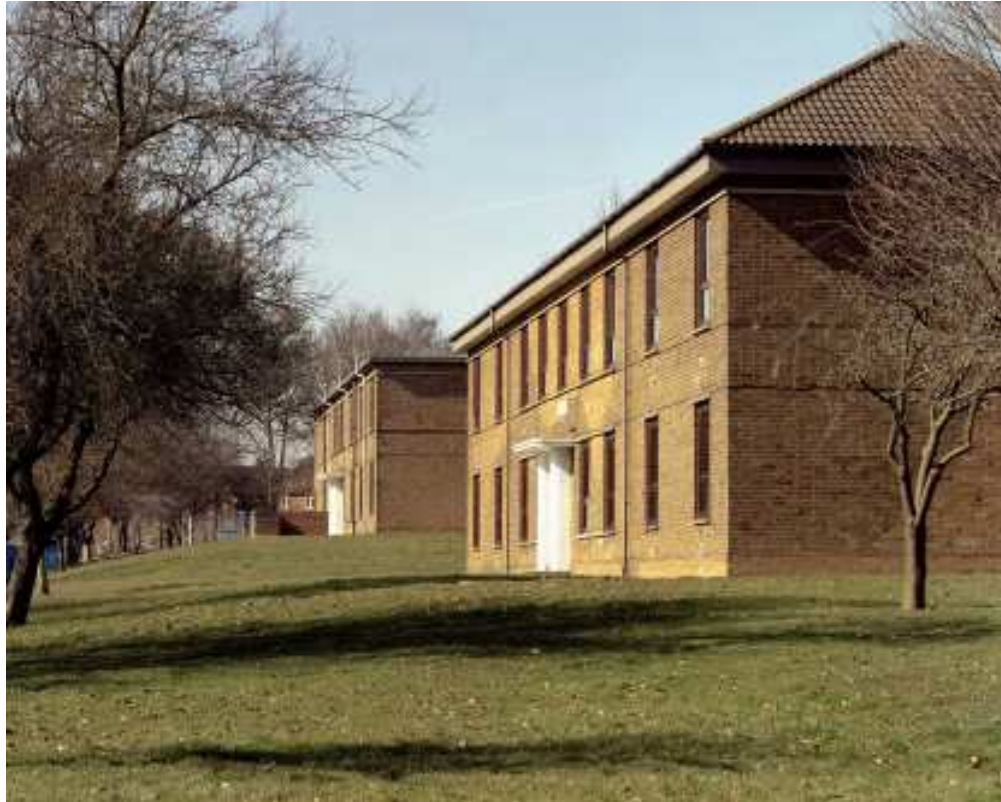
Figure 72 1930s barracks to the northeast of the parade ground, in the foreground Braham, Building 27B and to its rear 27A. These buildings originally had flat incendiary bomb proof roofs that have been replaced by later gable roofs. (c) English Heritage AA054446

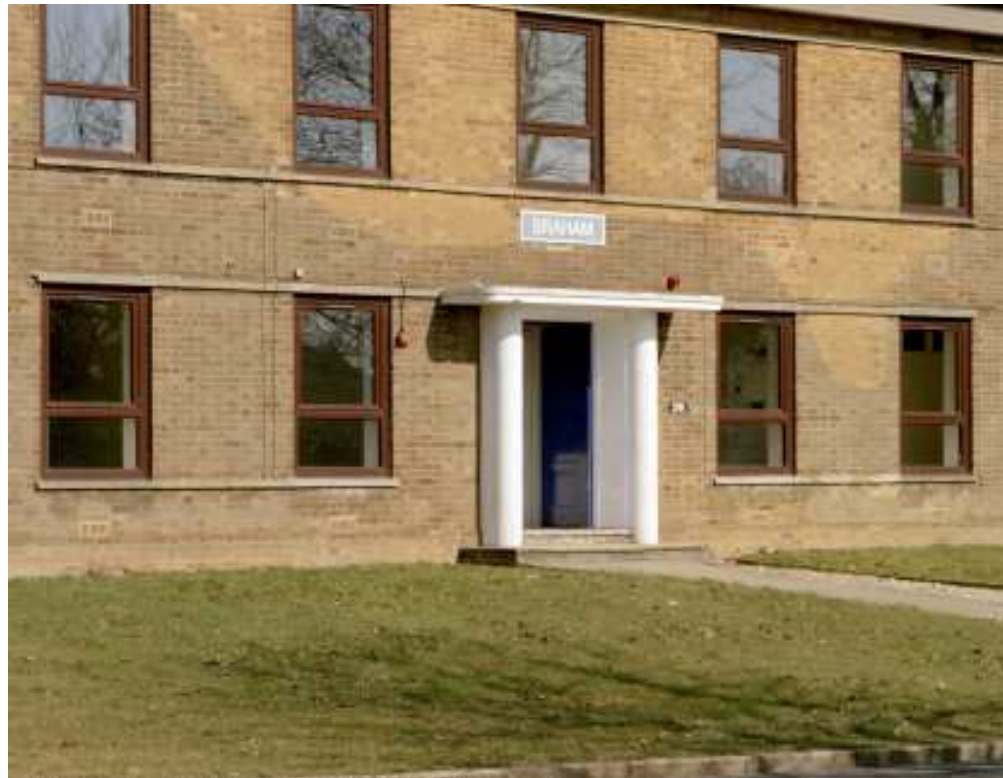
Figure 74 Braham, Building 27B, 1930s barracks to the northeast of the parade ground. Traces of wartime camouflage paint is still visible on many of the barrack buildings. (c) English Heritage AA054448

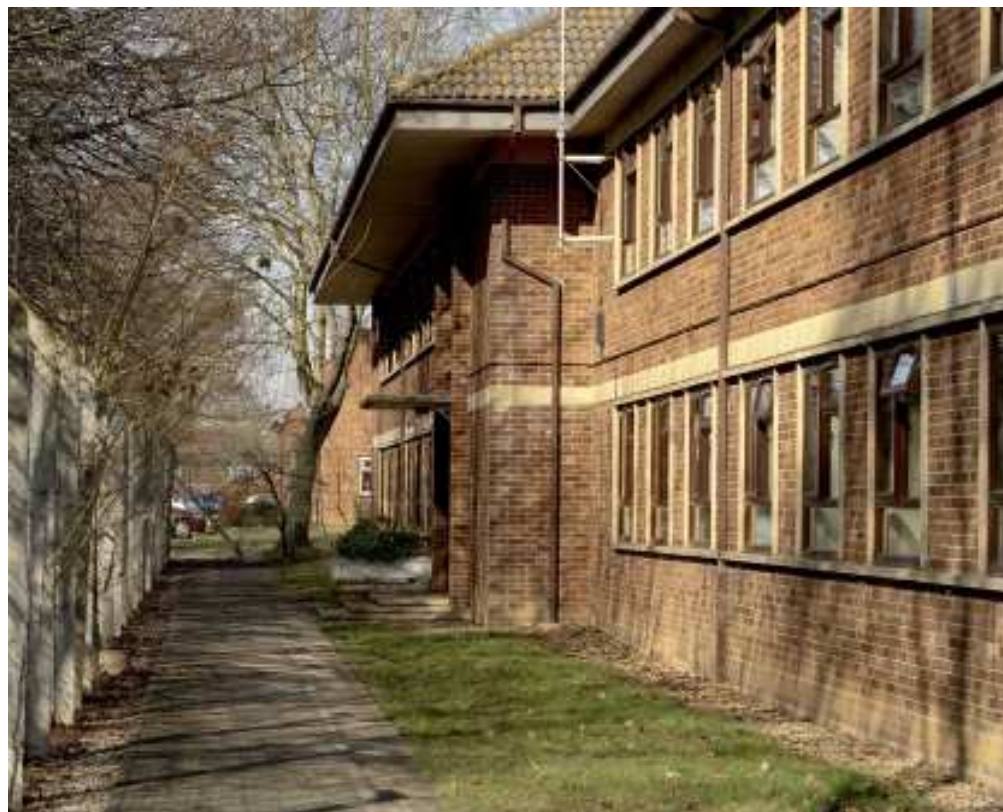
Figure 75 Salmon block, Building 202A, to the north west of the Airmens' Institute, is a relatively unusual example of a permanent 1950s barracks buildings. It too originally had a flat roof that has been replaced with a gable roof. (c) English Heritage AA0544460

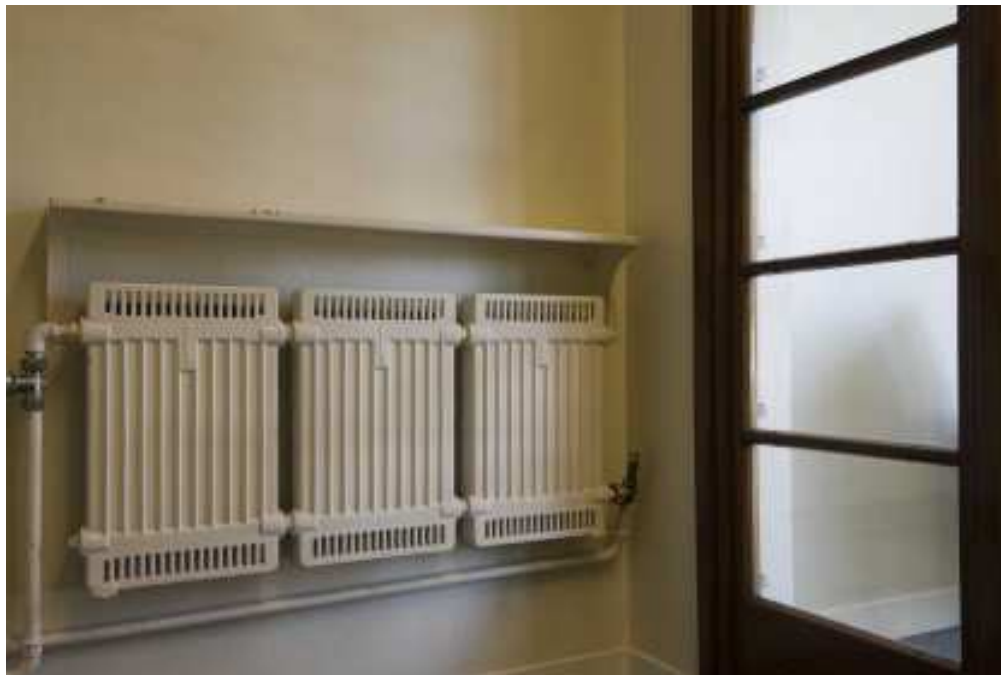
Figure 77 Hanbury block, main entrance, detail of 1950s radiators. (c) English Heritage DP027333

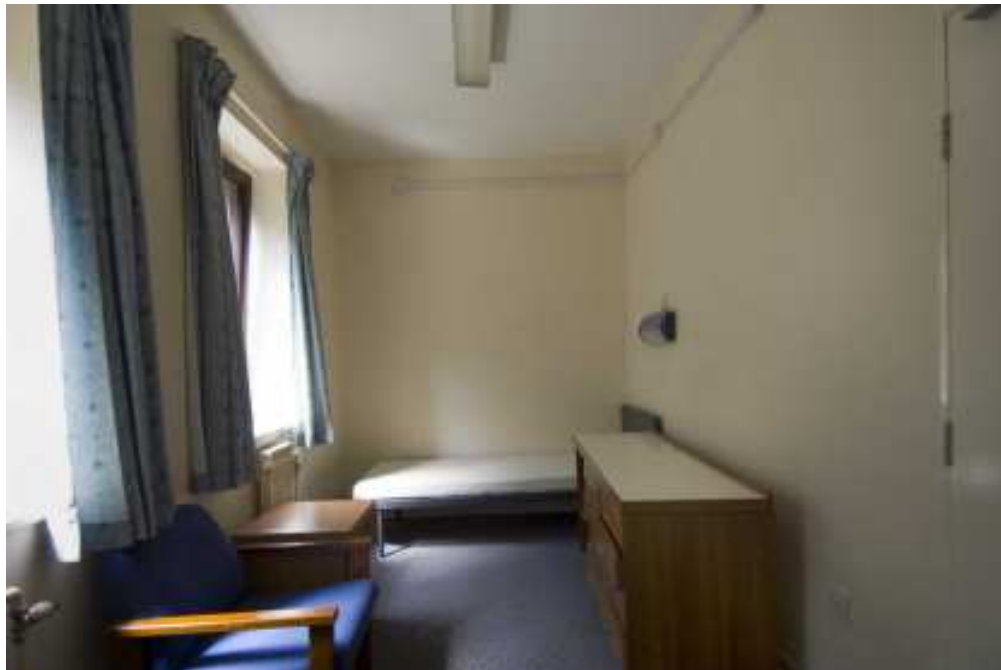
Figure 80 Hanbury block originally comprised a number of large open plan barrack rooms. To meet changing social expectations these have subsequently been converted into double or single living units. (c) English Heritage DP027329

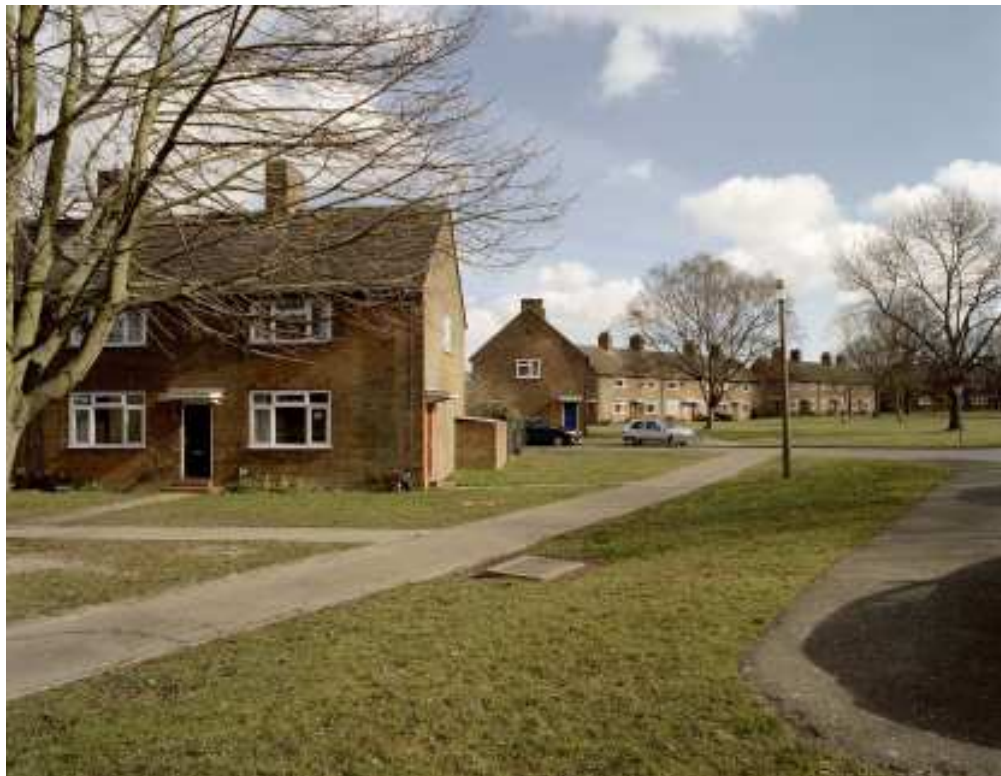
Figure 88 Cromes Place, 1930s Airmens' housing, many of the houses still retain traces of wartime camouflage. (c) English Heritage AA054359

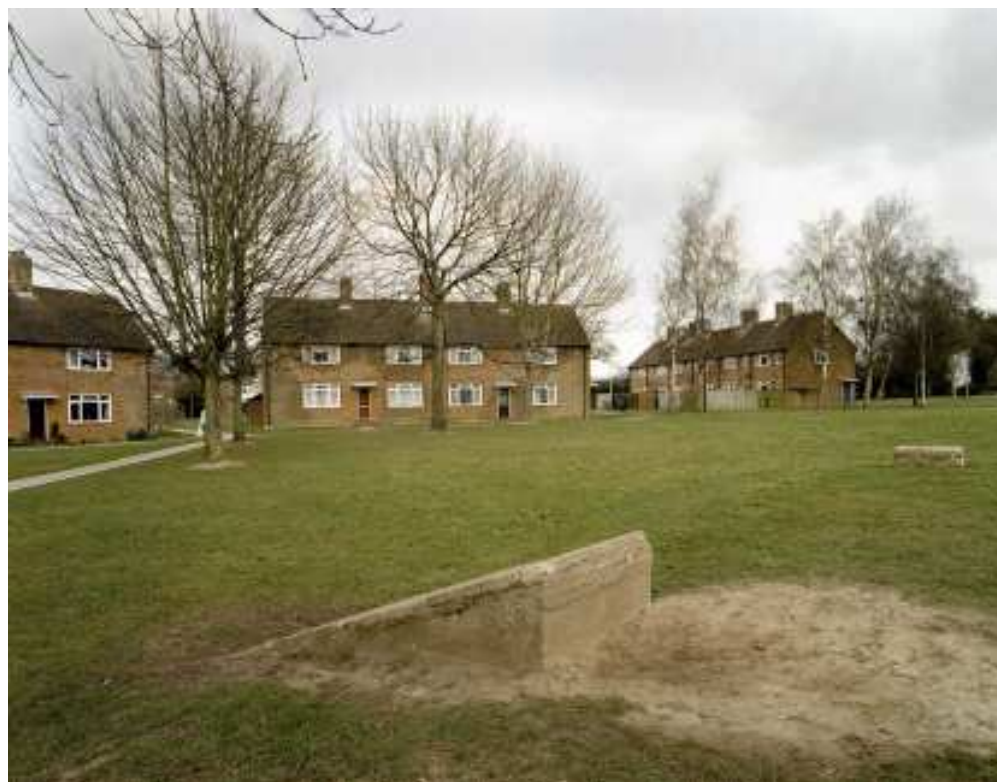
Figure 89 Cromes Place, 1930s Airmens' housing, in the foreground are the remains of a communal air raid shelter. (c) English Heritage AA054377

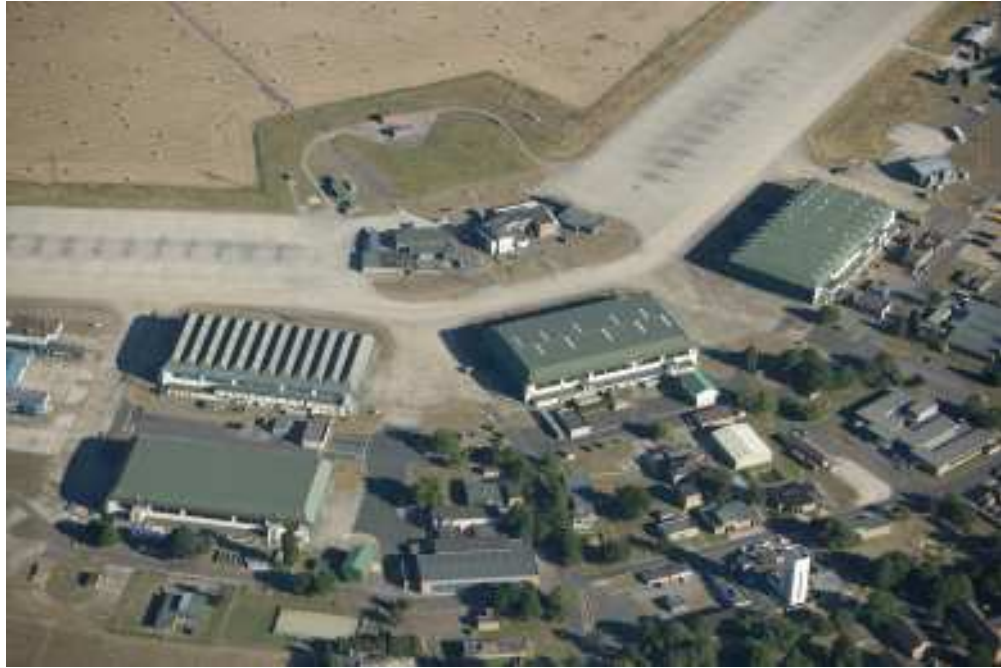
Figure 111 Close up of the hangars and technical area from the north west. To the top is the Watch Office and to its left the fire station. In the lower centre is the Propulsion and Aircraft Components Flight (PACF) Adour Engine Assembly Facility and above it the Brake Parachute Packing Building. To their right is the survival equipment section. The tall white structure is the station's water tower. (c) English Heritage NMR 24369/036

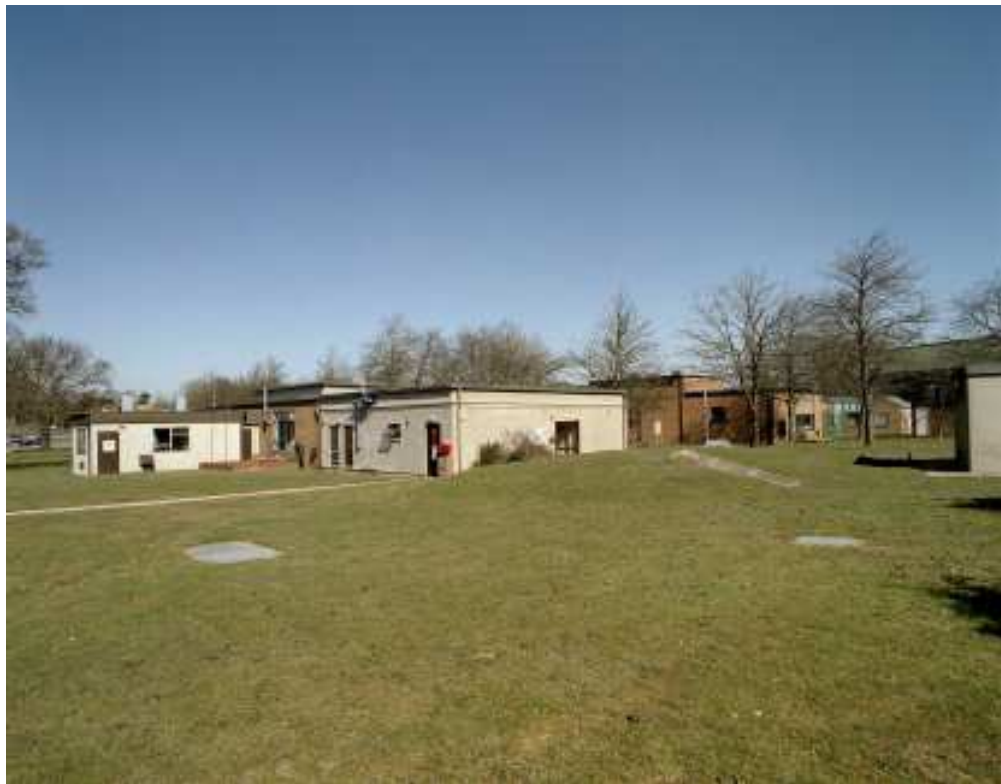
Figure 112 Survival Equipment Section, to its left is the immersion coverall repair bay and to the rear right the Parachute Brake Bay, from south east. (c) English Heritage AA054426

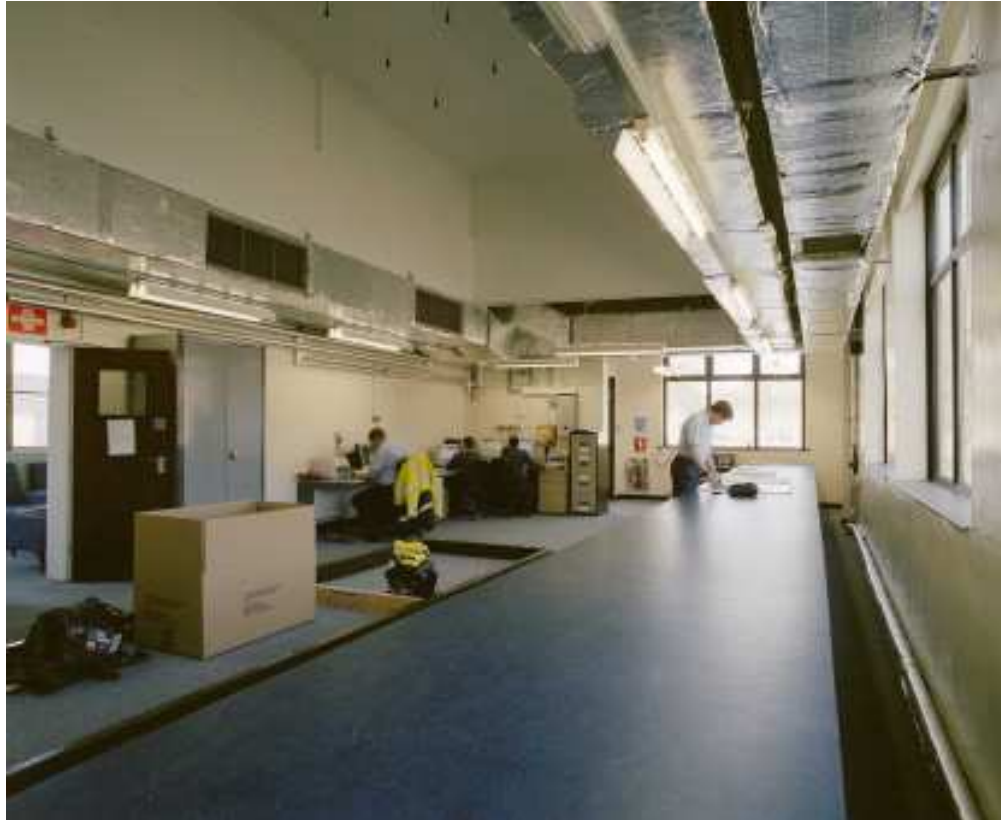
Figure 113 Survival Equipment Section, parachute packing table, note the pulleys in the ceiling used to suspend parachutes. (c) English Heritage AA054433

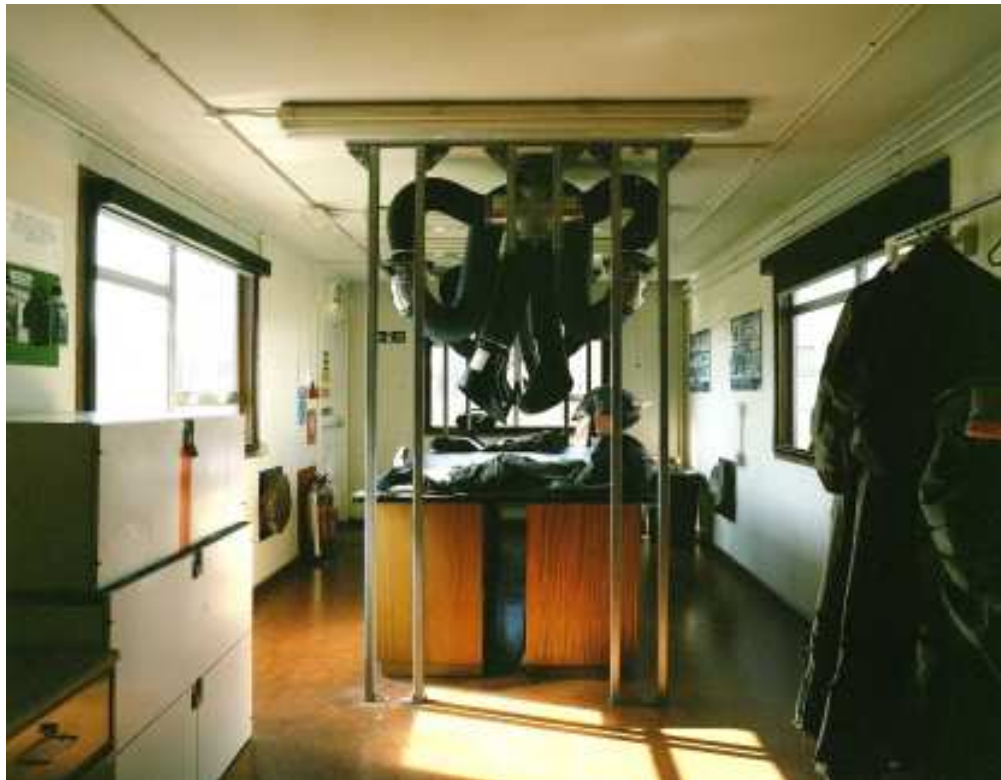
Figure 114 Survival Equipment Section, immersion coverall repair section. Above the central work bench are extractors to remove the fumes created by the bonding agents used to repair the suits. (c) English Heritage AA054434

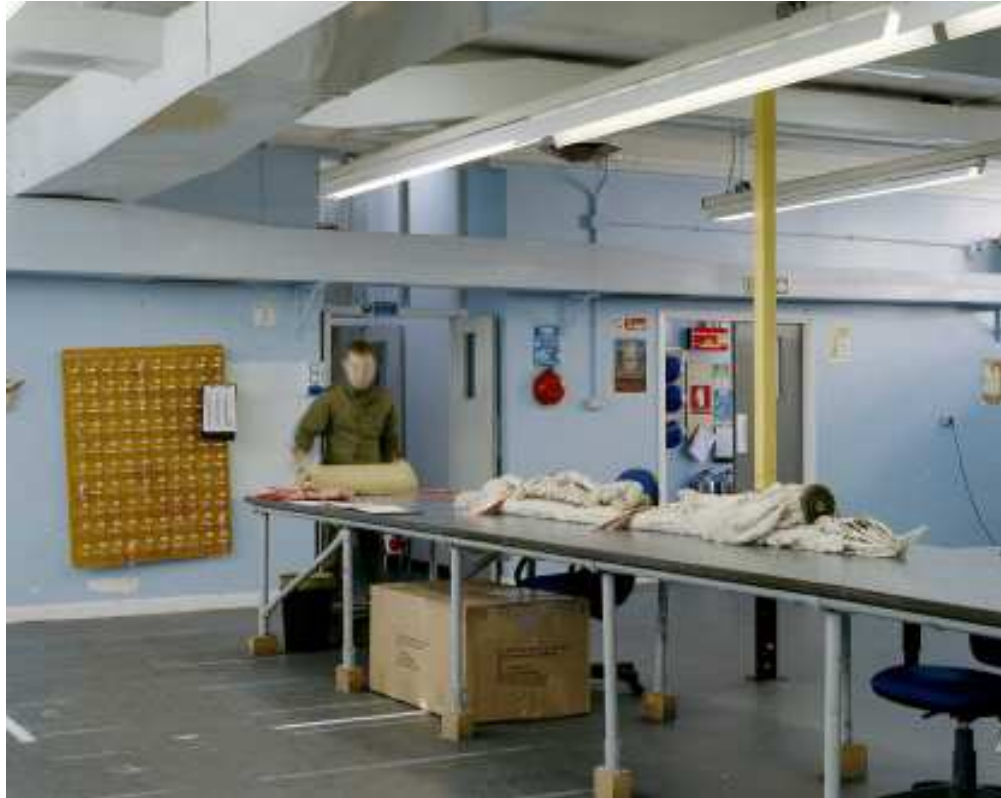
Figure 115 Parachute Brake Bay, packing a brake parachute. (c) English Heritage AA054428

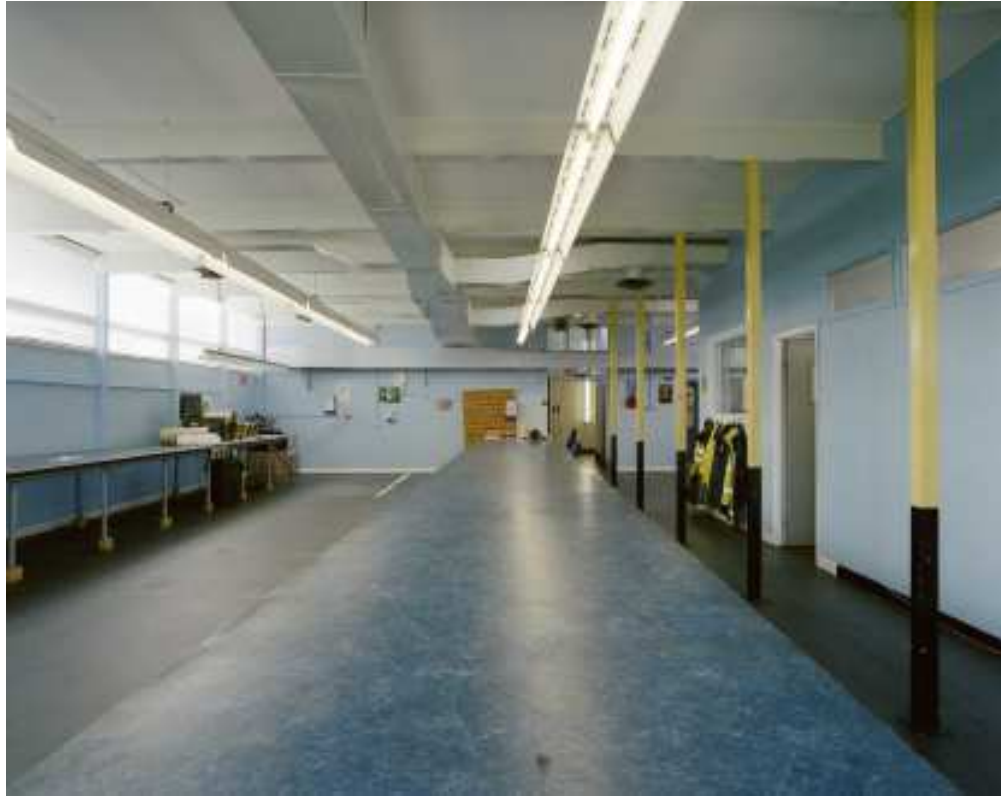
Figure 117 Parachute Brake Bay, brake parachute packing table. (c) English Heritage AA054433
