RAF COLTISHALL, NORFOLK A PHOTOGRAPHIC CHARACTERISATION

A photographic characterisation

Research Department Report Series 68/2007

County: Norfolk
District: Broadland
Parish: Coltishall, Burton with Lamas and Scottow
NGR: TG 270 225
NMR No: TG 22 SE 35
Date of Investigation: March-November 2006
Investigated by: Wayne Cocroft
Report author: Wayne Cocroft
Photography by: Steve Cole and Damian Grady

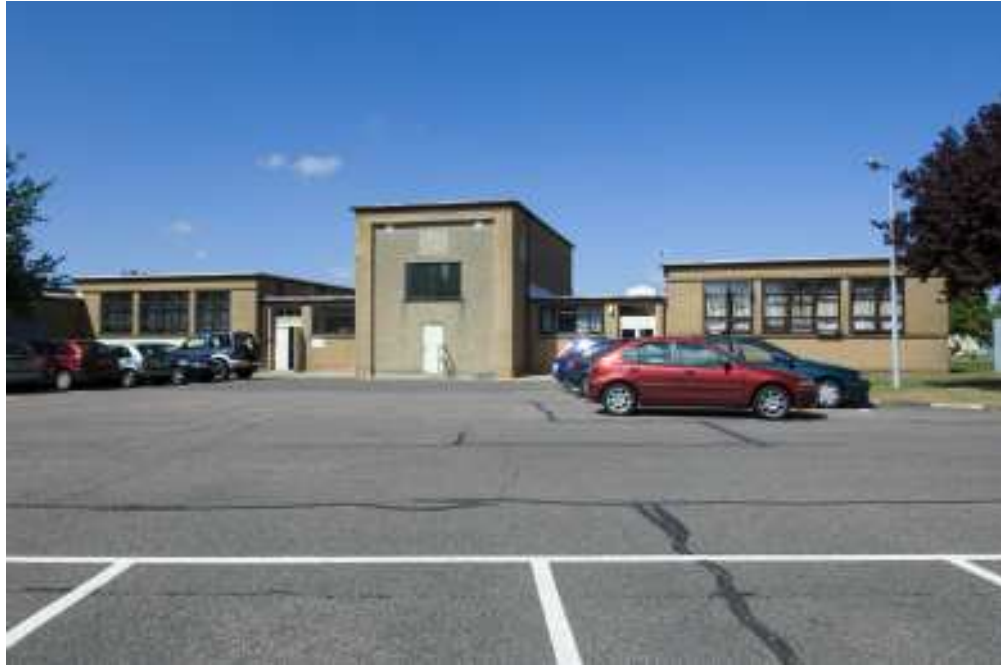
Figure 121 Supply and Movements Squadron, late 1930s reinforced concrete stores building. (c) English Heritage DP027354

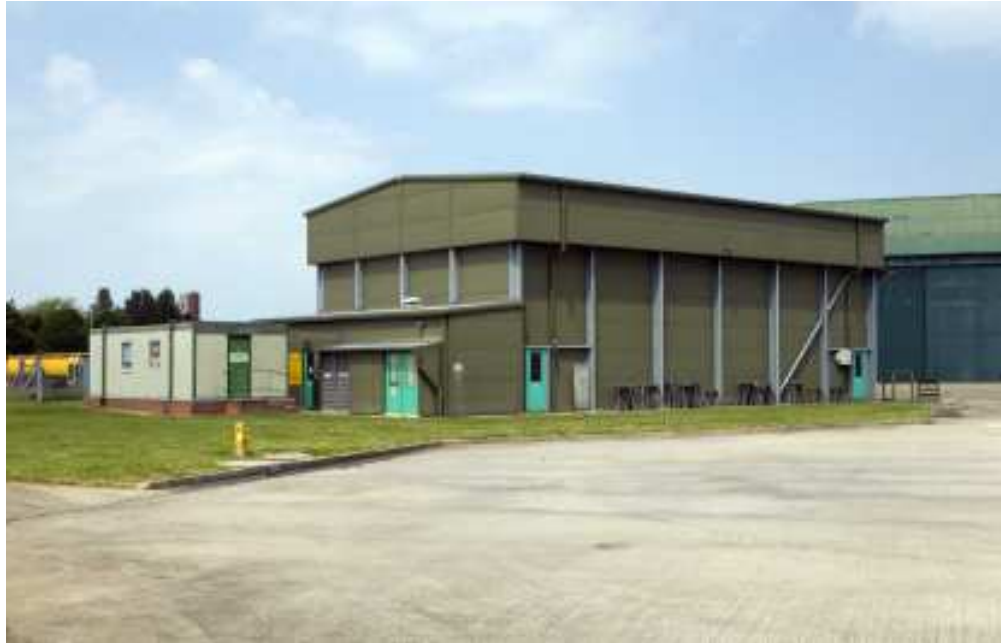
Figure 129 Building 378, Jaguar Paint Facility, this structure was purpose-built for spraying Jaguar aircraft . (c) English Heritage DP027167

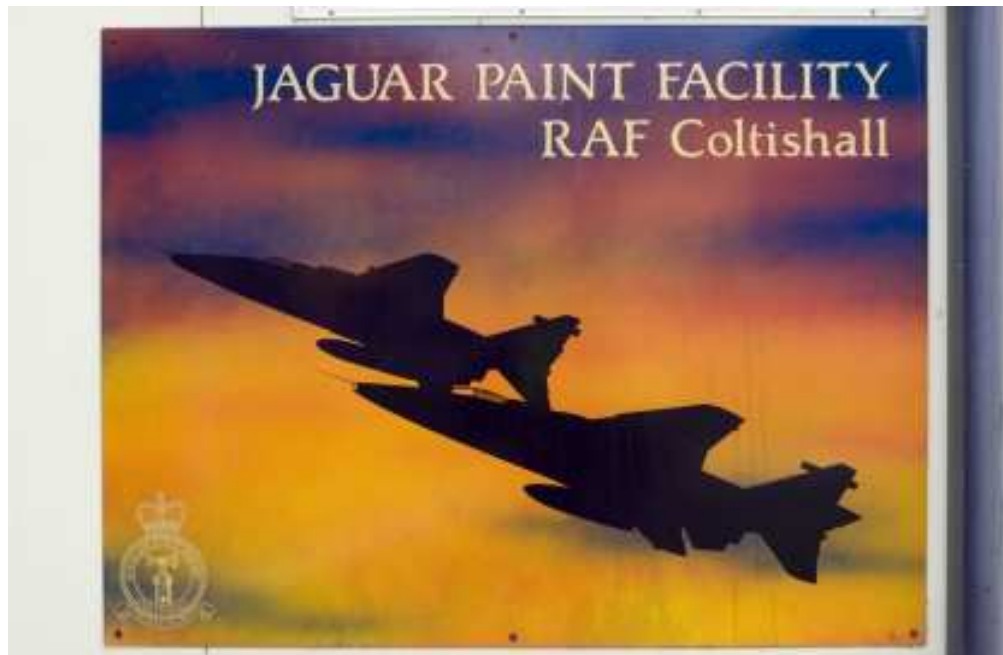
Figure 130 Building 378, Jaguar Paint Facility. (c) English Heritage AA054473

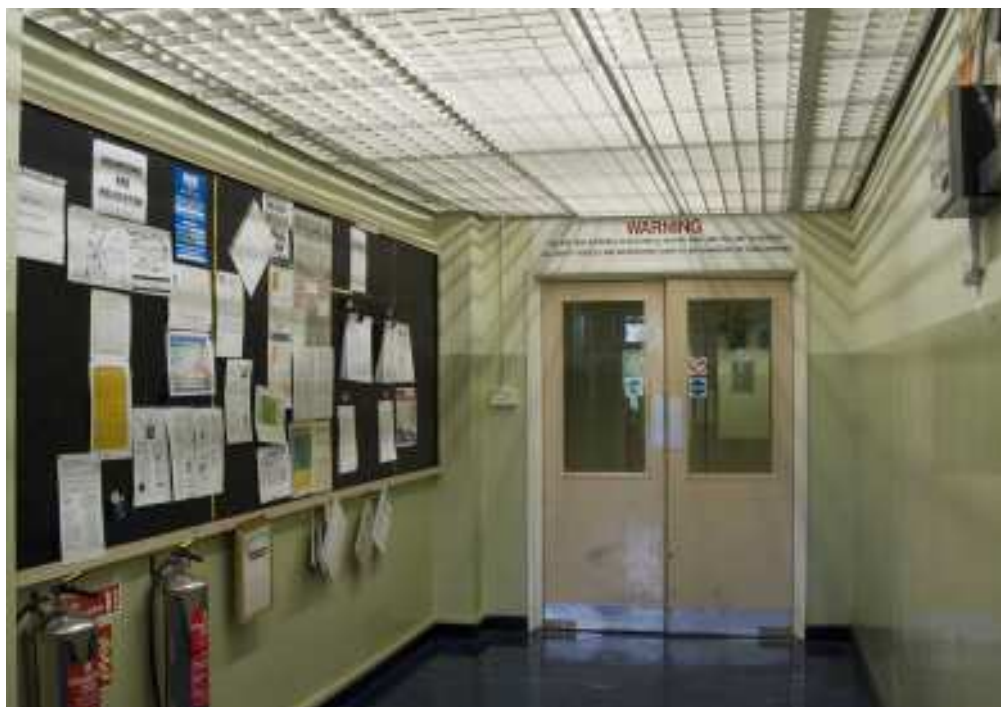
Figure 138 Building 295, Headquarters Electrical Engineering Squadron. (c) English Heritage DP029239

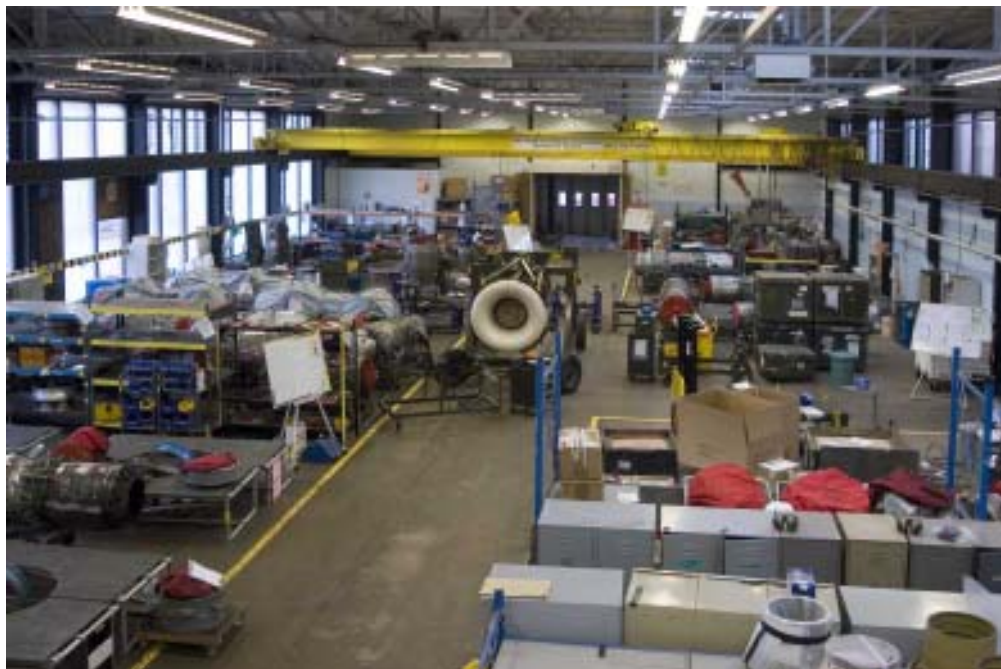
Figure 148 Propulsion and Aircraft Components Flight (PACF) Adour Engine Assembly Facility. Each Jaguar aircraft was powered by two Rolls-Royce Turbomeca engines, these were subject to regular checks rebuilding to ensure that the maximum number of aircraft remained in serviceable condition. (c) English Heritage DP029247

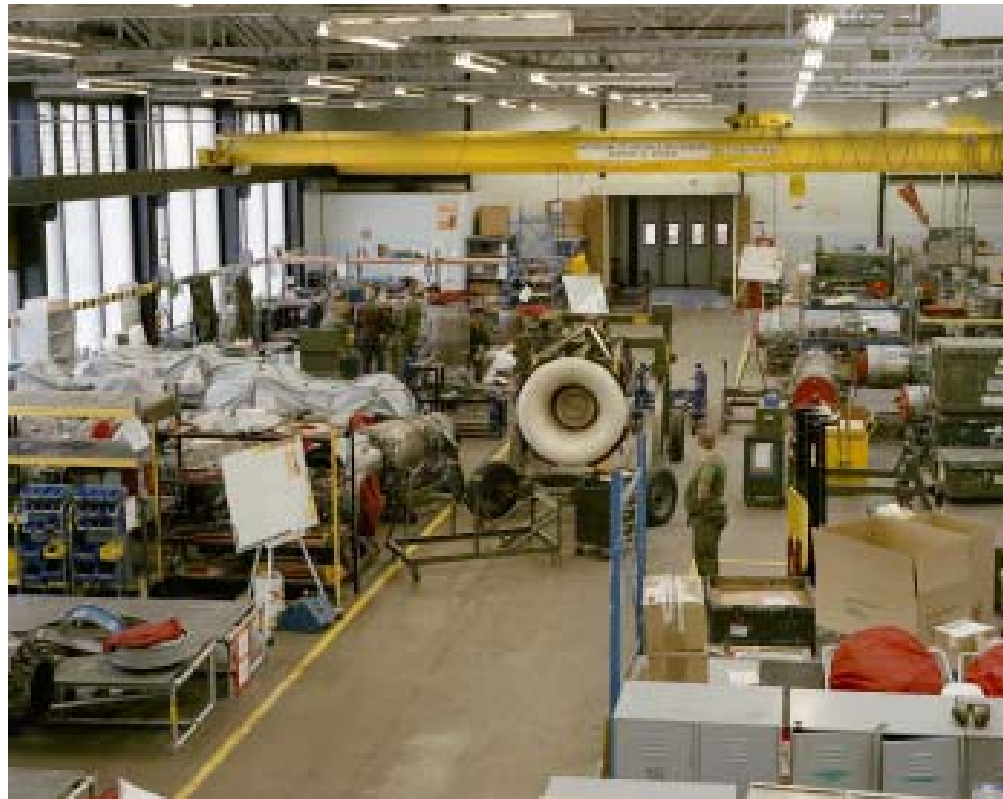
Figure 149 Propulsion and Aircraft Components Flight (PACF) Adour Engine Assembly Facility interior. A complete engine, engine 2056E, waits on a handling trolley for its journey to the Uninstalled Engine Test Facility (UTEF). (c) English Heritage AA054464

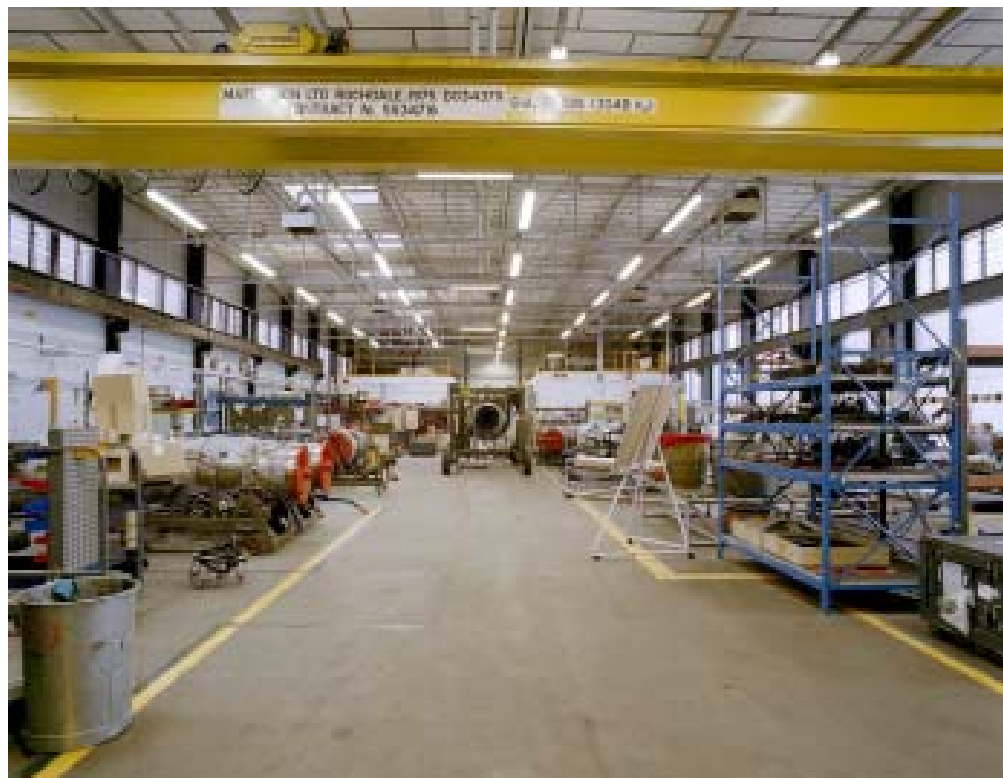
Figure 150 Propulsion and Aircraft Components Flight (PACF) Adour Engine Assembly Facility. The overhead crane was built by Matternson, Rochdale, 1975 DO34379 Contract No S534716 SWL 3 tons 3048 kg. (c) English Heritage AA054467

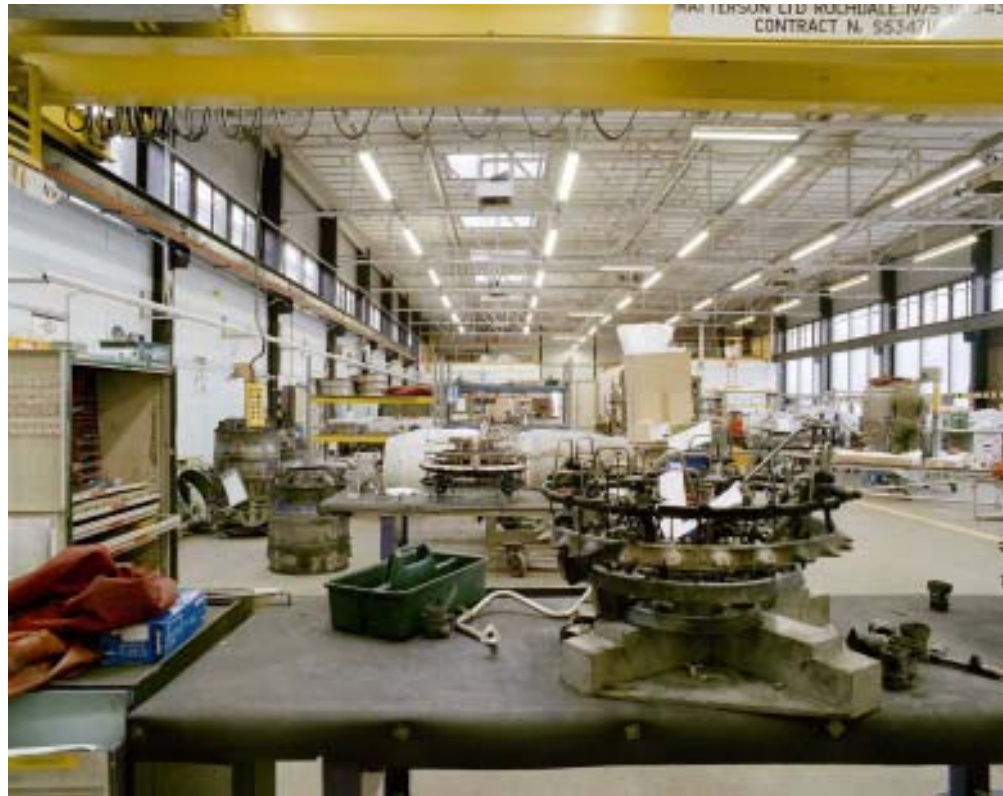
Figure 151 Propulsion and Aircraft Components Flight (PACF) Adour Engine Assembly Facility. In the foreground is an after burner from one of the jet engines, this was a component that most often needed attention. (c) English Heritage AA054466

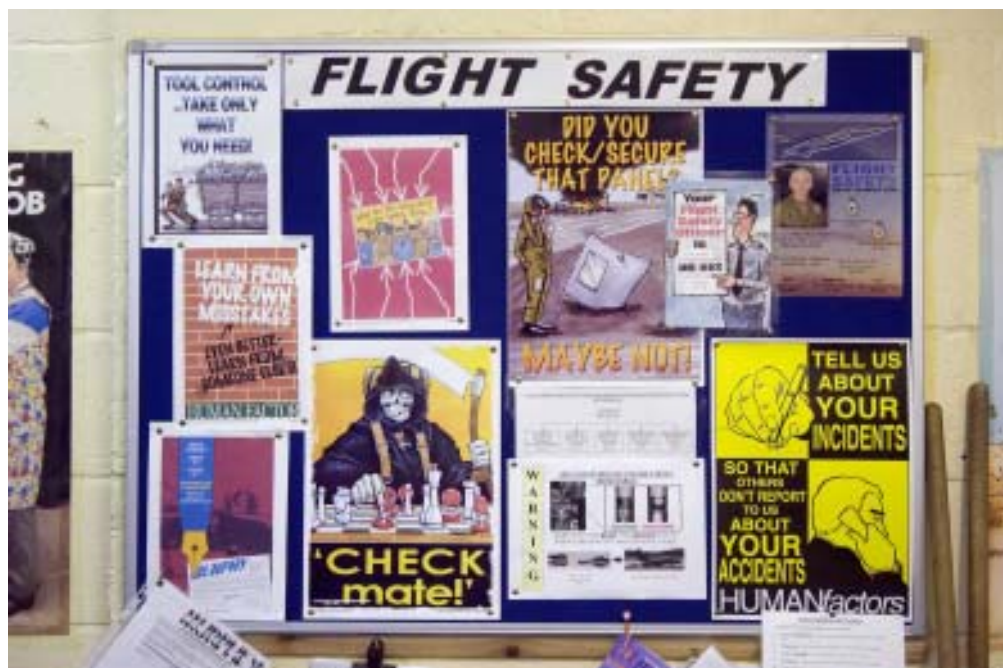
Figure 152 Propulsion and Aircraft Components Flight (PACF) Adour Engine Assembly Facility, safety notices. (c) English Heritage DP029251

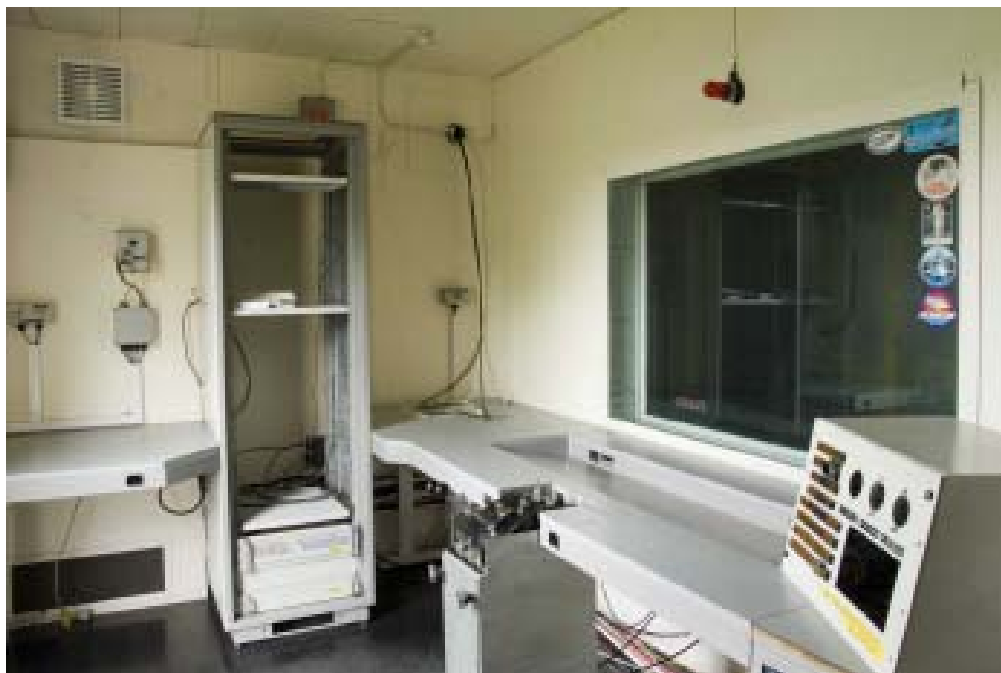
Figure 161 Uninstalled Engine Test Facility (UETF), control room. (c) English Heritage DP027323

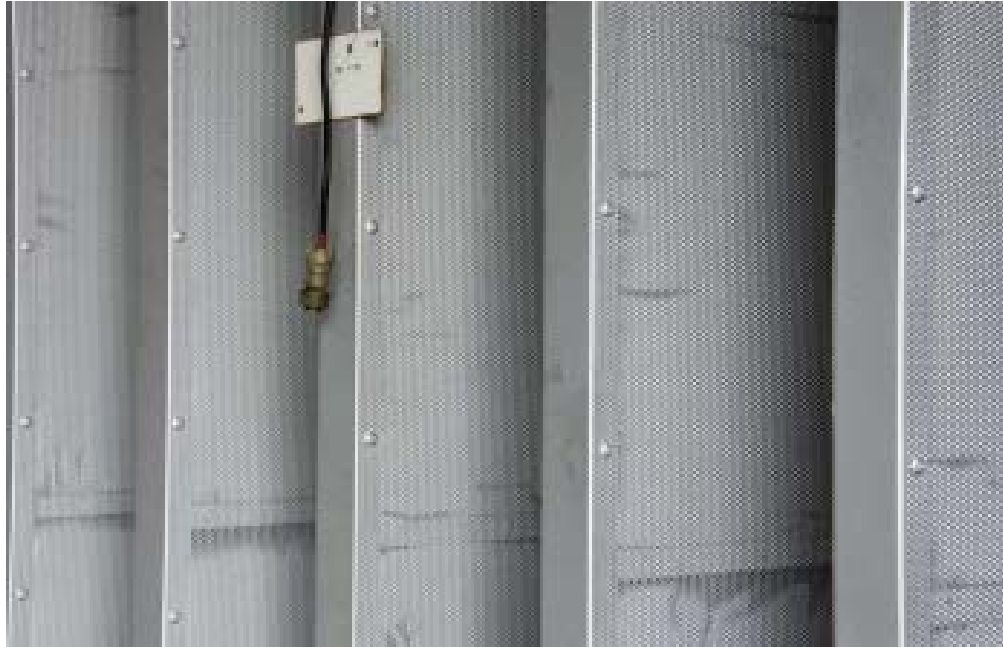
Figure 165 Uninstalled Engine Test Facility (UETF), detail of the air intake at the southwest end of the building. (c) English Heritage DP027324

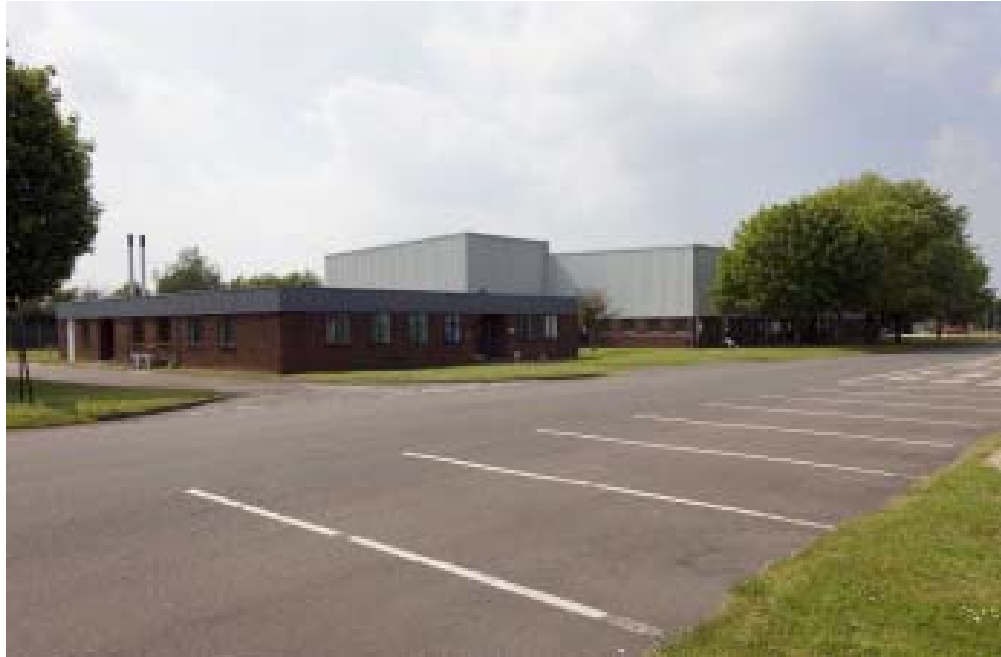
Figure 166 Building 349, Jaguar Flight Simulator operated by Thames Merlin Training Services, from south east. This building was specially constructed about 1975 to meet the training needs of the Jaguar pilots. (c) English Heritage DP027204

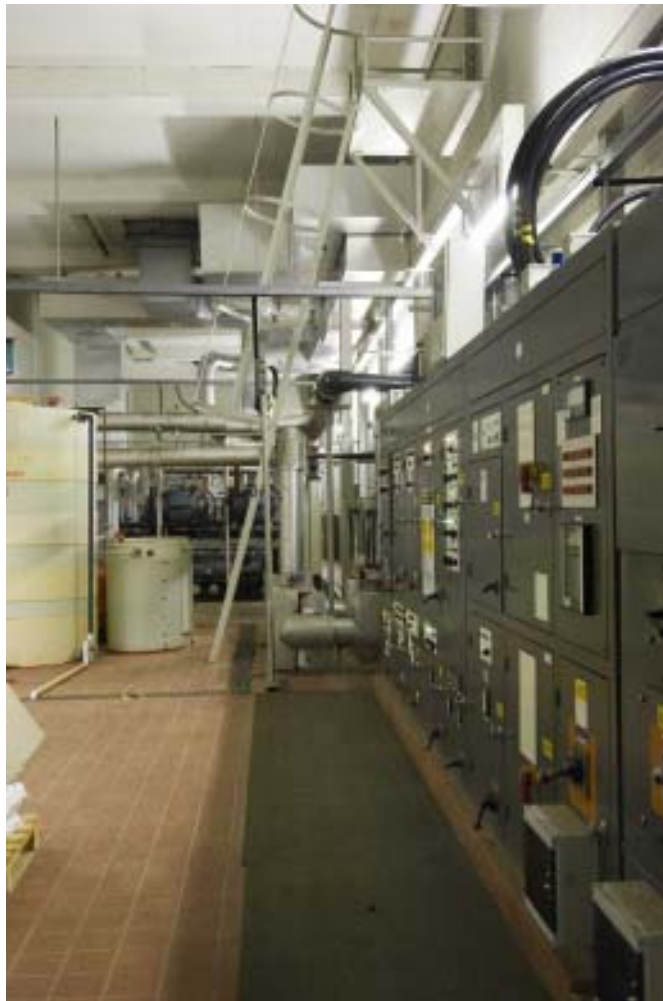
Figure 167 Building 349, Jaguar Flight Simulator, part of the cooling plant that was initially required to cool the heat generated by the lights over the large terrain model. (c) English Heritage DP027203

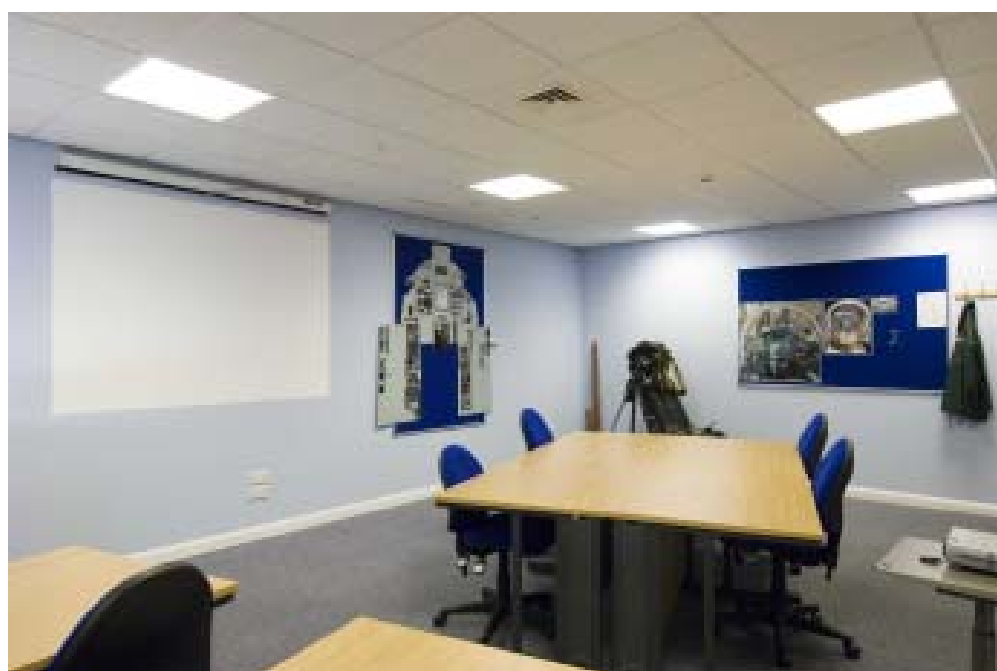
Figure 169 Jaguar Flight Simulator building, Classroom 1 with ejector seat and diagram showing the aircraft's cockpit layout. (c) English Heritage DP027201

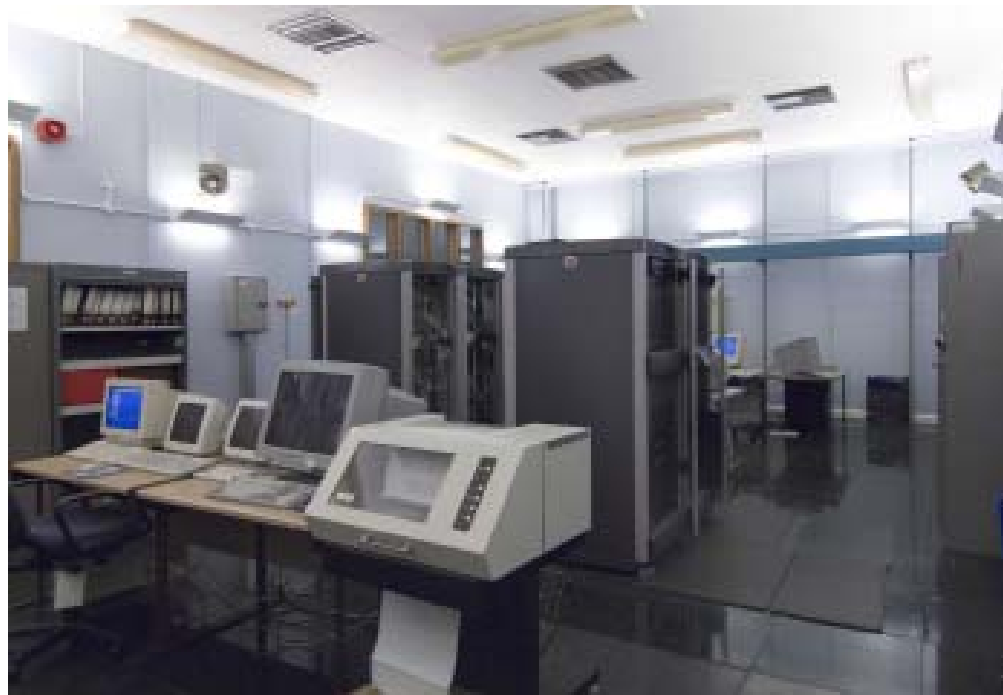
Figure 171 Jaguar Flight Simulator building, main frame computer used to mimic the aircrafts operating systems and to project images of changing terrain on to hemisphere in front of the simulator. (c) English Heritage DP027200

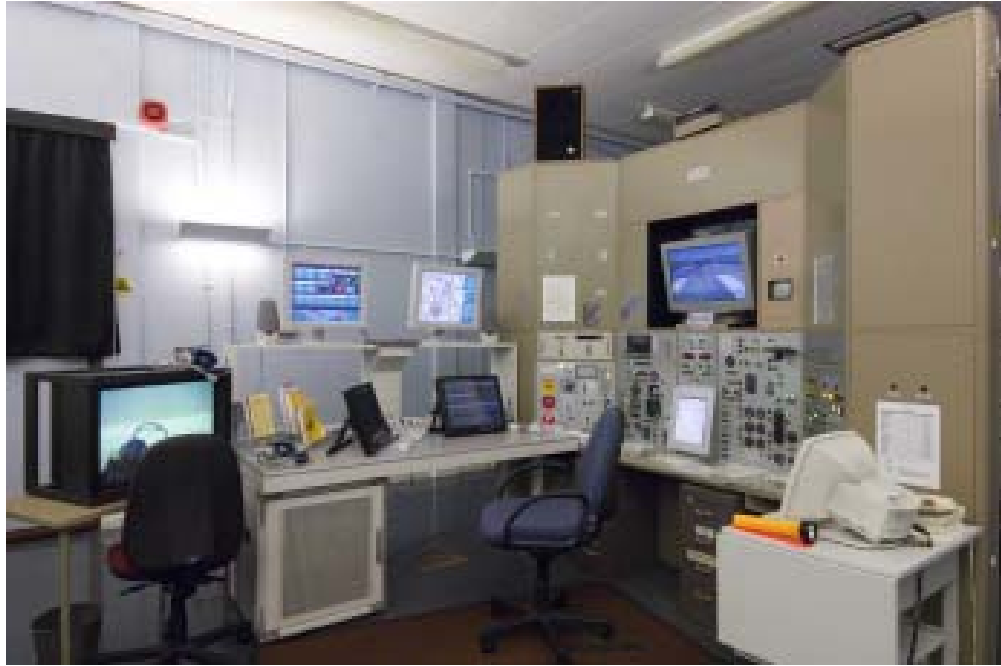
Figure 172 Jaguar Flight Simulator building, from these consoles the instructors were able to present the pilots with a variety of virtual missions and emergency scenarios. (c) English Heritage DP027196

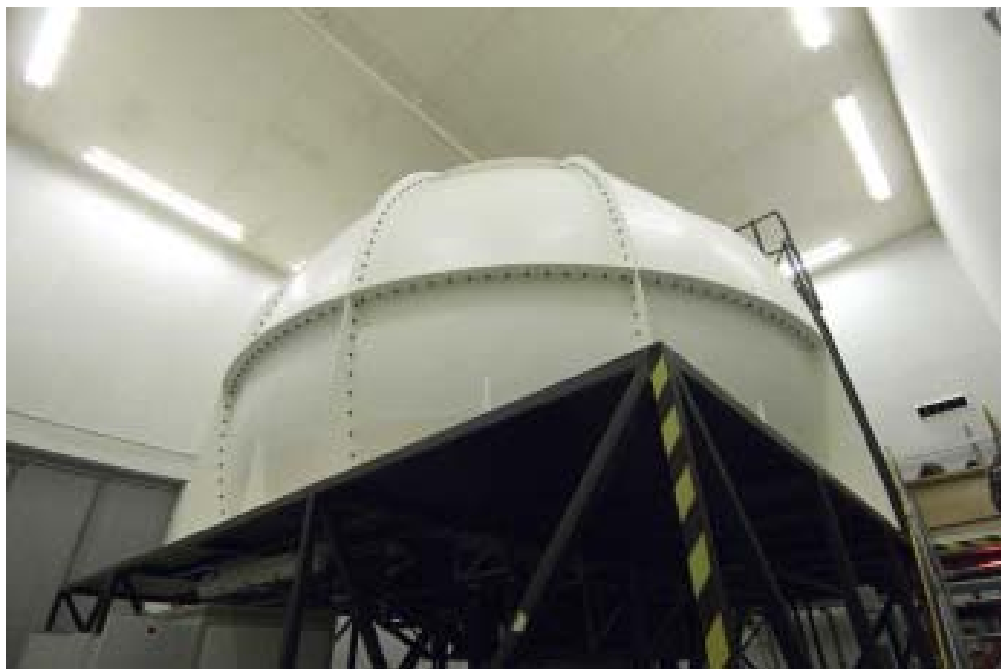
Figure 173 Jaguar Flight Simulator building, rear of fibreglass hemisphere into which images of the moving terrain were projected. (c) English Heritage DP027195

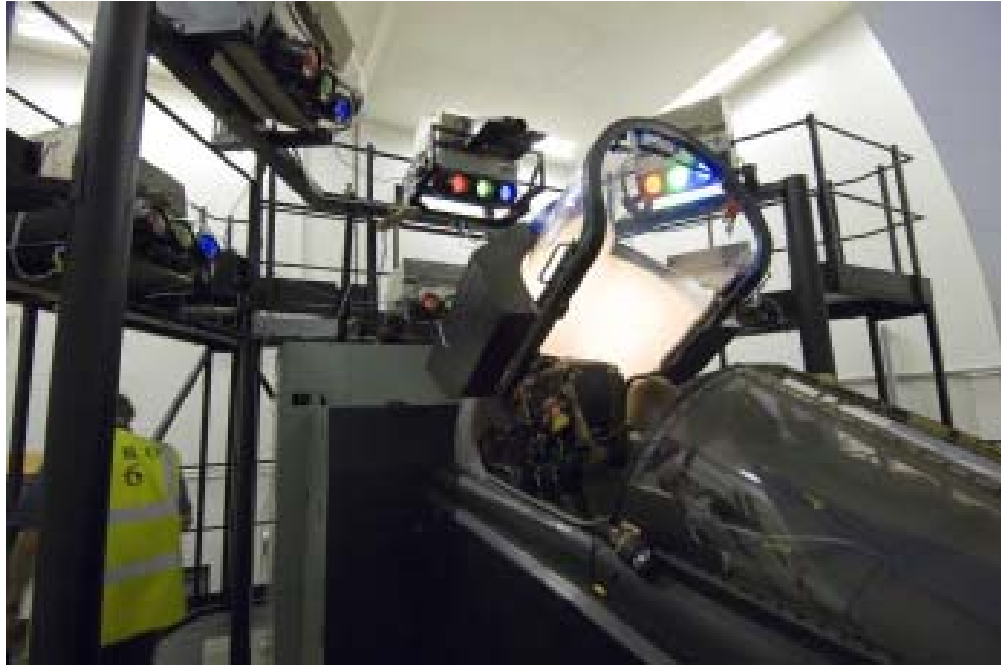
Figure 174 Jaguar Flight Simulator building, training cockpit and to the rear the projectors used to project the moving images on to the hemisphere. (c) English Heritage DP027194

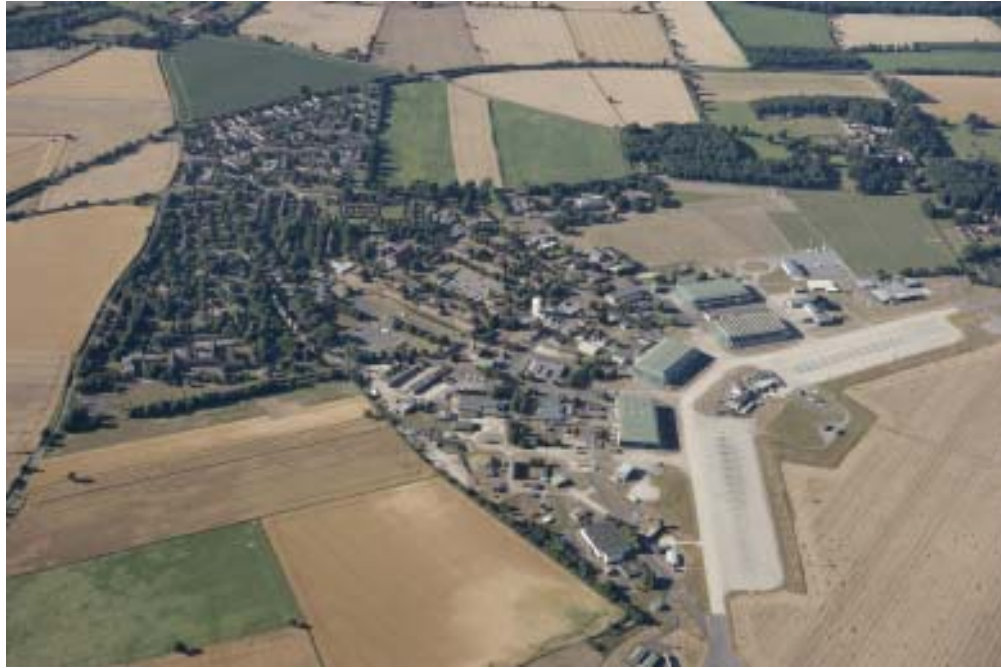
Figure 186 This view from the south shows the sweep of the hangars and to their right the 1950s aircraft servicing platforms. In the foreground is hangar 3 and above it hangars 2 and 1 with hangar 4 to the rear. In the original scheme it was intended to build another hangar to the right of hangar 3 but before completion it was destroyed German bombing. (c) English Heritage NMR 24369/017

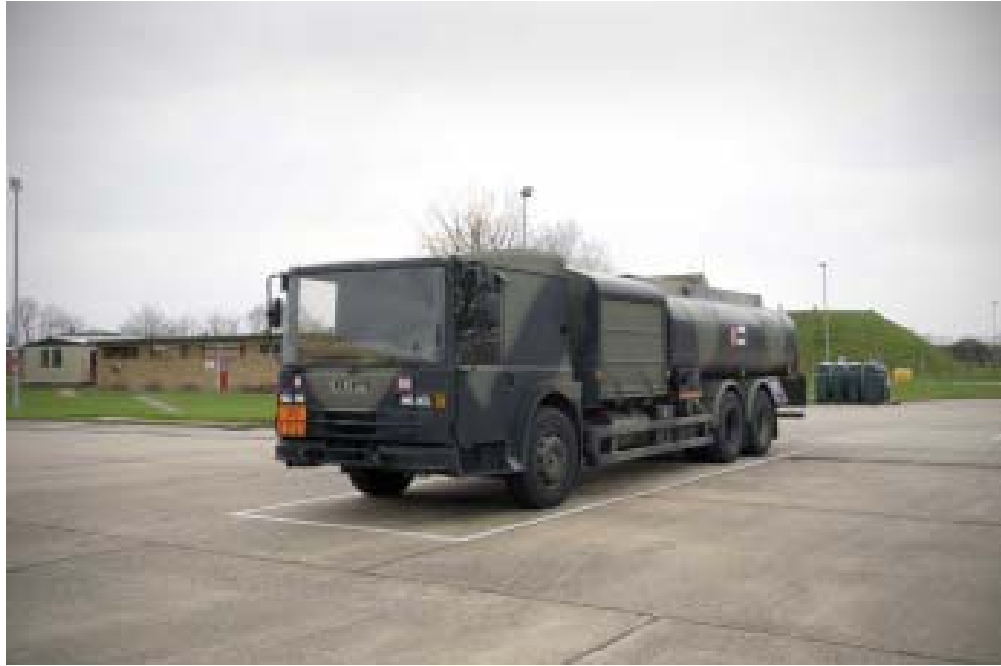
Figure 192 Fuel bowzers to the rear of Hangar 3. (c) English Heritage DP027319

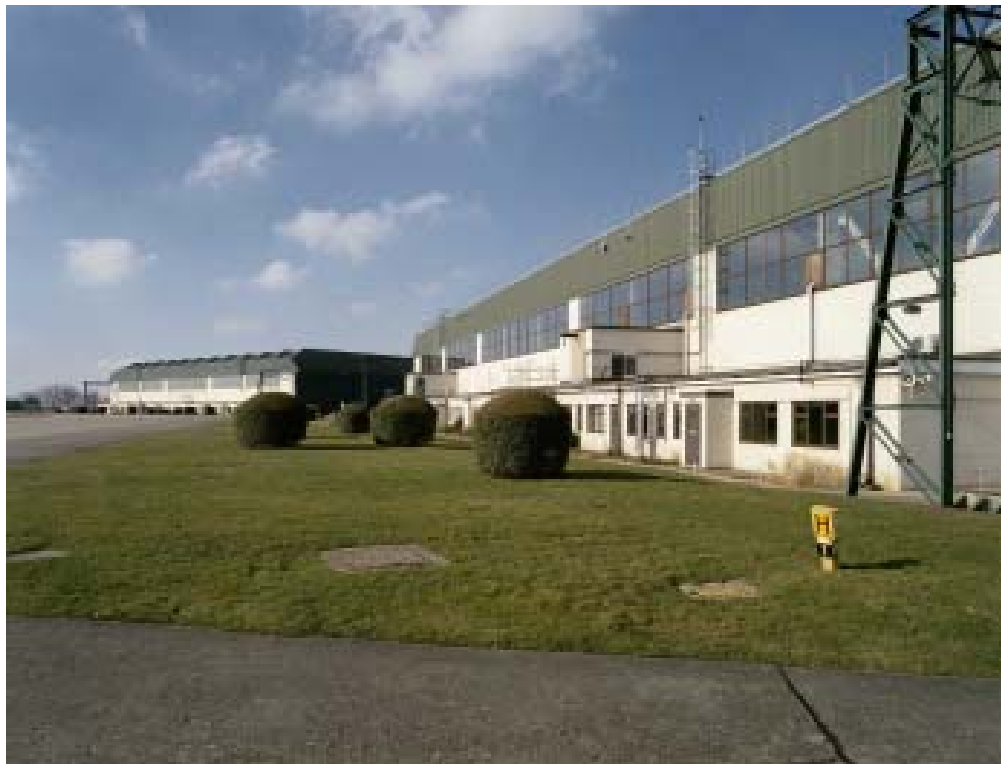
Figure 195 Hangar 2 and to the rear Hangar 3. All the hangars at Coltishall are standard Air Ministry Type C Protected Type, they have concrete lower walls with a glazed panel above and were originally clad in asbestos sheeting. As may be seen in the far hangar the asbestos sheeting roof was left exposed above the doors. (c) English Heritage AA054396

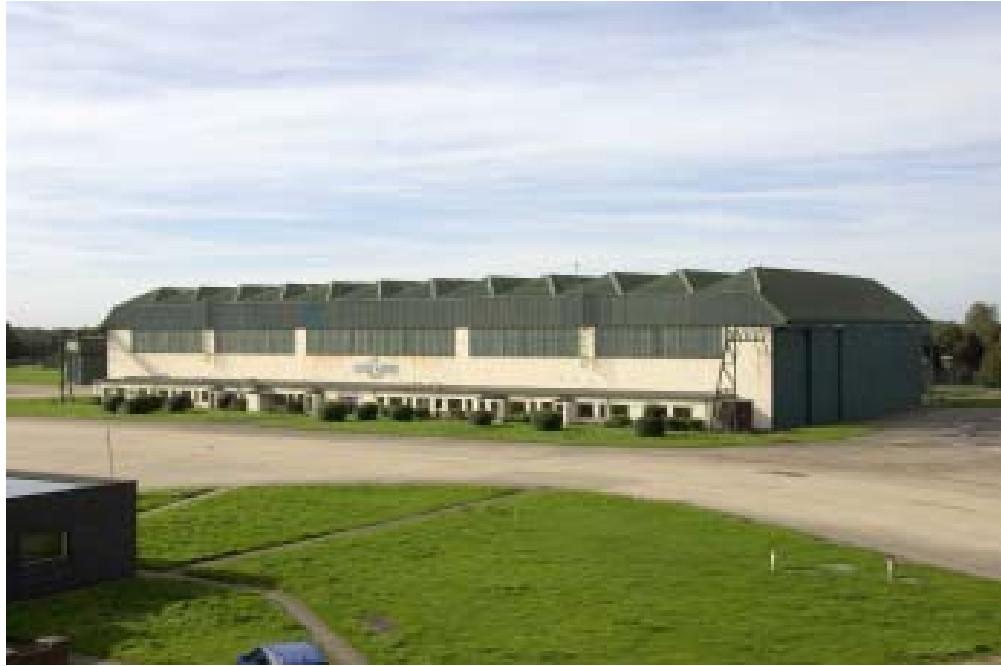
Figure 196 Hangar 3, C Type hangar from the Watch Office. (c) English Heritage DP035652

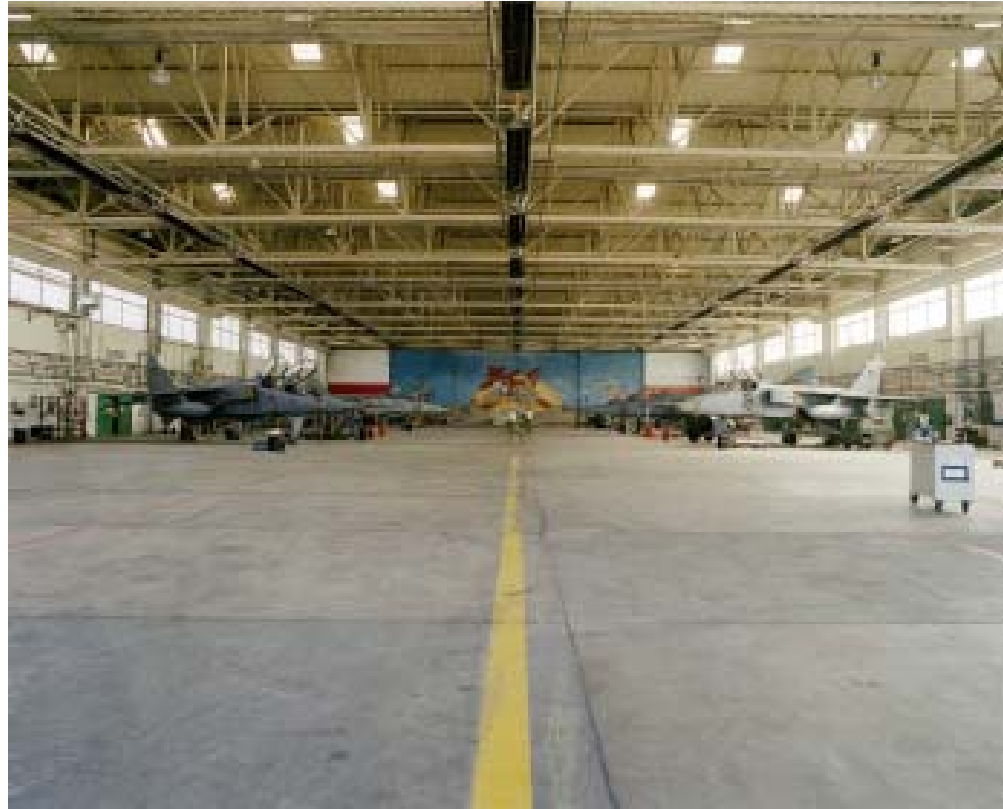
Figure 205 Hangar 1 showing its east doors with a large mural painted shortly after 41 Squadron returned Operation Granby, the 1991 Gulf War to liberate Kuwait. At the centre of the design is a large double armed Cross of Lorraine taken from the Squadron's badge and derived from its association during the First World War with the town of St Omer, France, the cross being part of the town's arms. (c) English Heritage AA054397

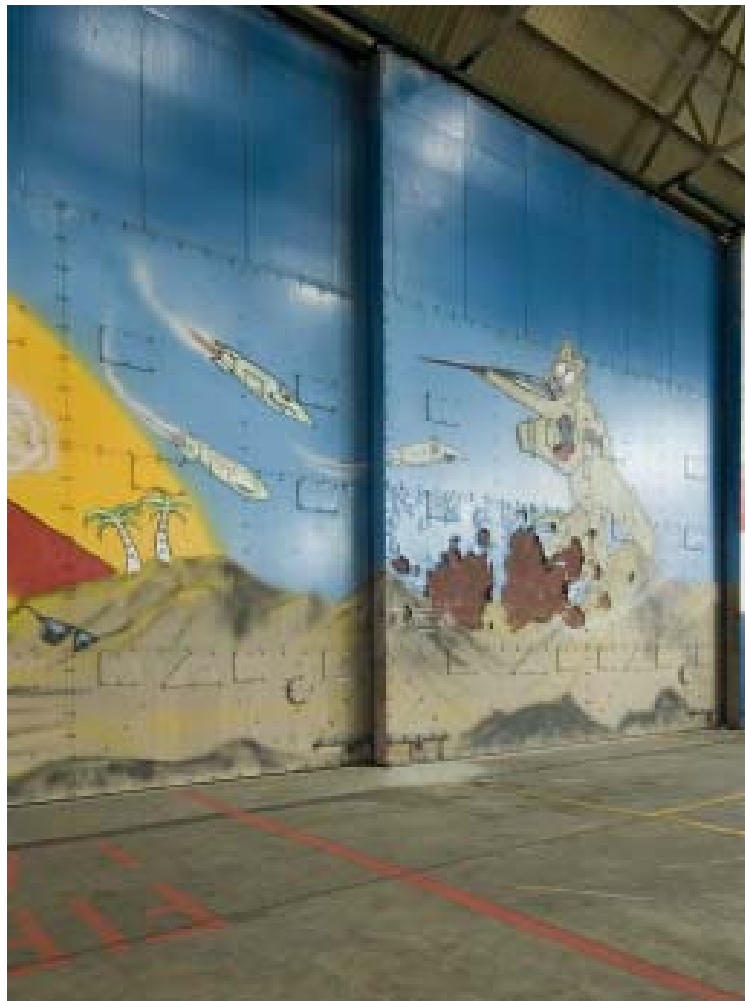
Figure 209 October 2006, Hangar 1 east doors detail of painting showing deterioration of the paint work a few months after the RAF's withdrawal. (c) English Heritage DP035655

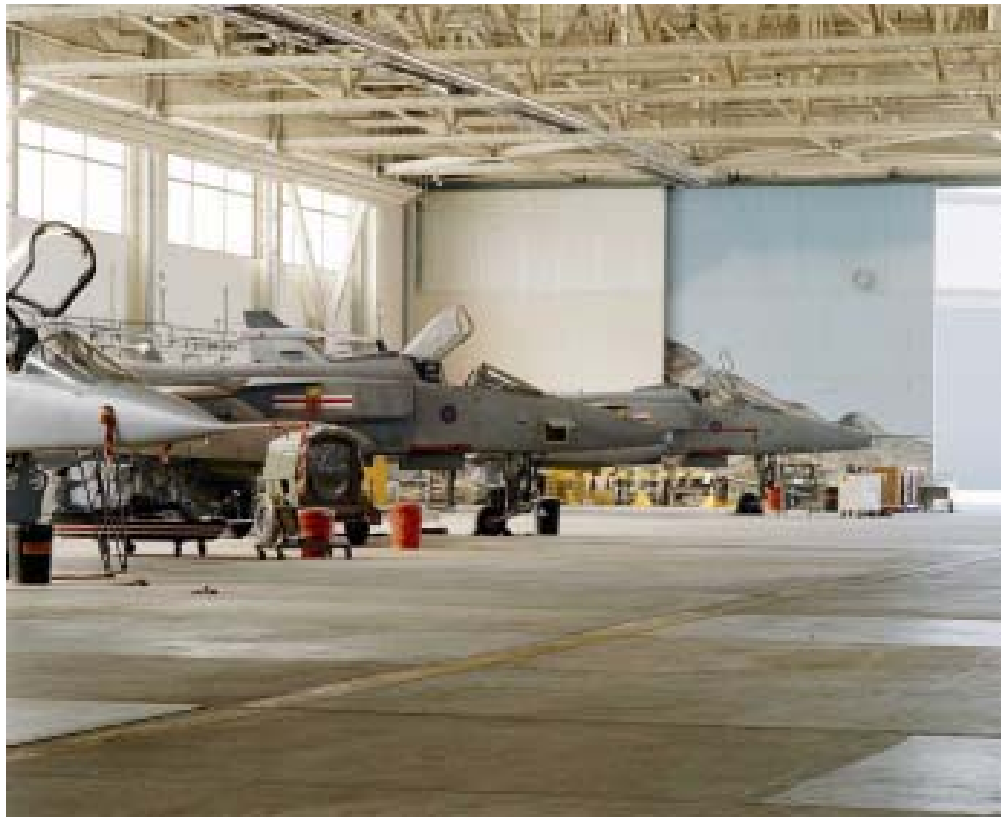
Figure 213 Hangar 1 interior looking towards the west doors, Jaguars undergoing servicing. (c) English Heritage AA054402

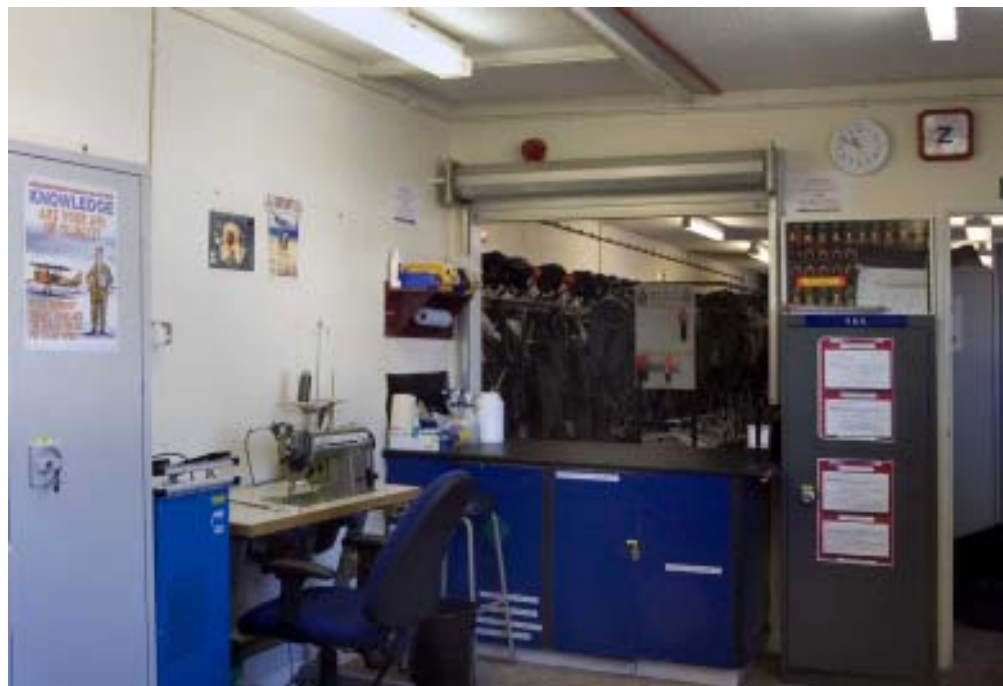
Figure 219 Hangar 1, upper floor, north side, 41 [F] Squadron Aircrew Equipment Assembly (AEA) section, after flight counter. In this room the aircrews' survival equipment was maintained and stored. (c) English Heritage DP029263

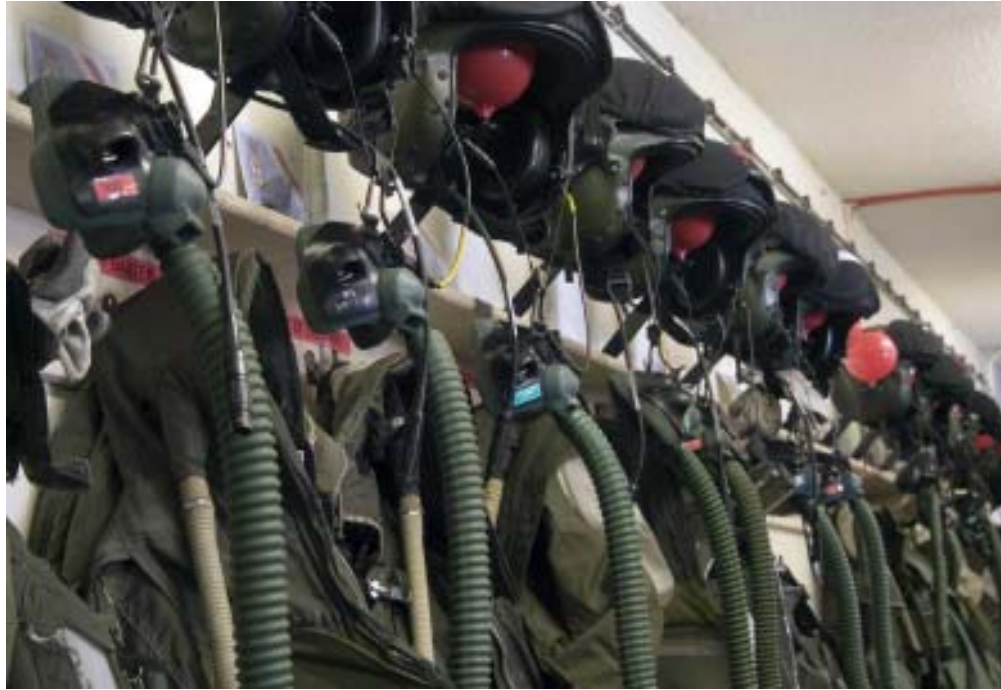
Figure 220 Hangar 1, upper floor, north side, 41 [F] Squadron Aircrew Equipment Assembly (AEA) section, after flight counter. In this room helmets and night flying goggles were serviced and running repairs carried out to webbing harnesses. Across the counter smaller items of survival equipment were issued to the pilots. (c) English Heritage DP029267

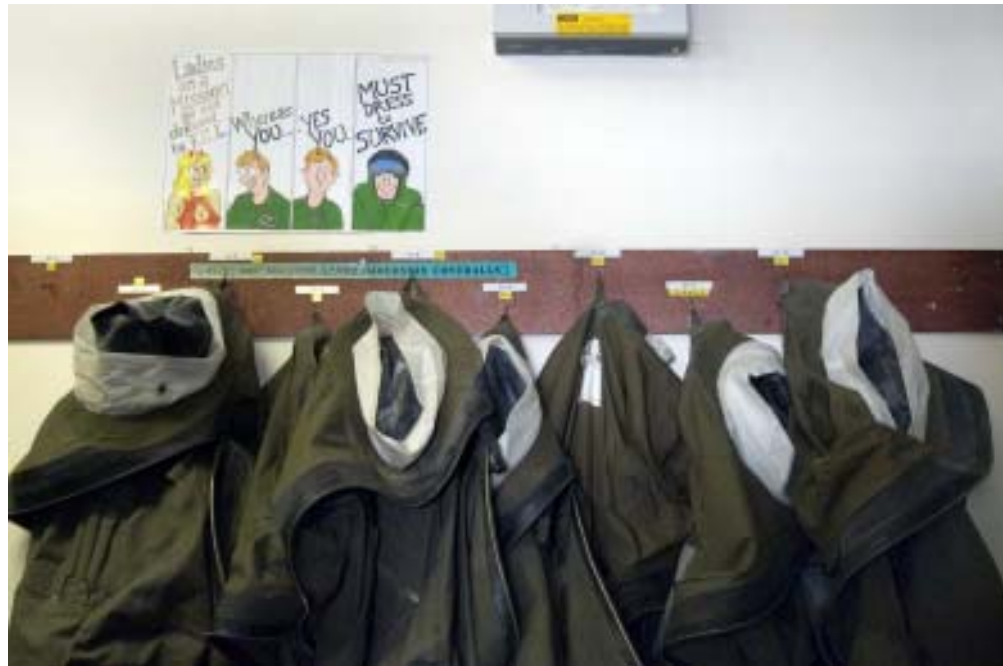
Figure 222 Hangar 1, upper floor, north side, 41 [F] Squadron Aircrew Equipment Assembly (AEA) section. This room, the transition area, was also the changing area where aircrews dressed in immersion suits and life vests prior to flight. (c) English Heritage DP029264

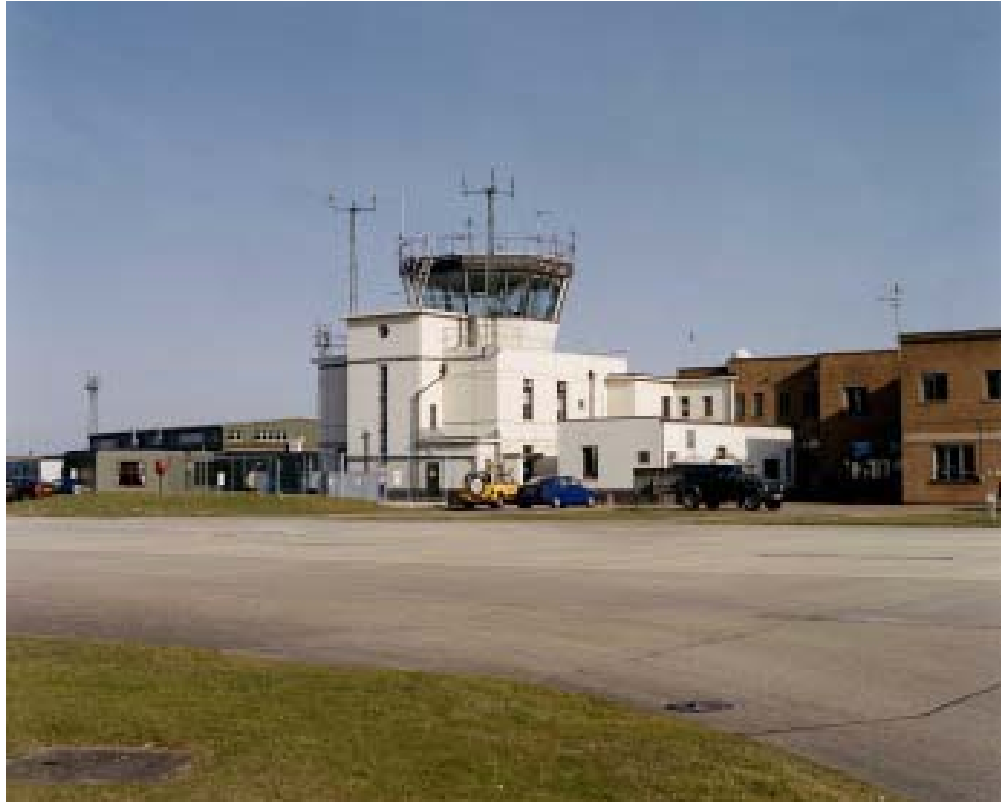
Figure 230 Watch Office, rear view from west showing the later 1950s extension to the right, with the meteorological briefing room on its upper floor. (c) English Heritage AA054461

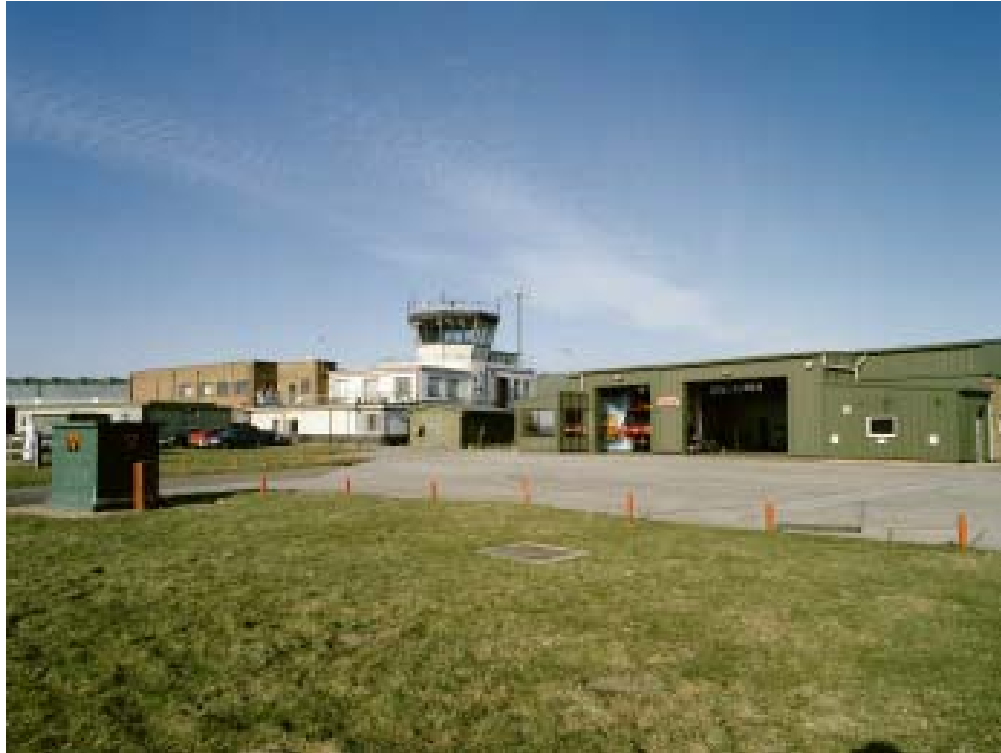
Figure 231 The Watch Office is a standard Air Ministry 2328/39 design constructed from 14 inch thick reinforced concrete walls. Originally on the ground floor were telecommunications and teleprinter rooms and a pilots' rest room, on the first floor, the meteorological officer's bedroom, control officer's rest room, and the signals office and in the front of the building the control room. It was also equipped with hydrogen bottles for weather balloons. Post-war modifications include the meteorological section and a briefing room to the left, an extension to the front to the front of the structure and the Visual Control Room on the roof. (c) English Heritage AA054410
