RAF COLTISHALL, NORFOLK A PHOTOGRAPHIC CHARACTERISATION

A photographic characterisation

Research Department Report Series 68/2007

County: Norfolk
District: Broadland
Parish: Coltishall, Burton with Lamas and Scottow
NGR: TG 270 225
NMR No: TG 22 SE 35
Date of Investigation: March-November 2006
Investigated by: Wayne Cocroft
Report author: Wayne Cocroft
Photography by: Steve Cole and Damian Grady

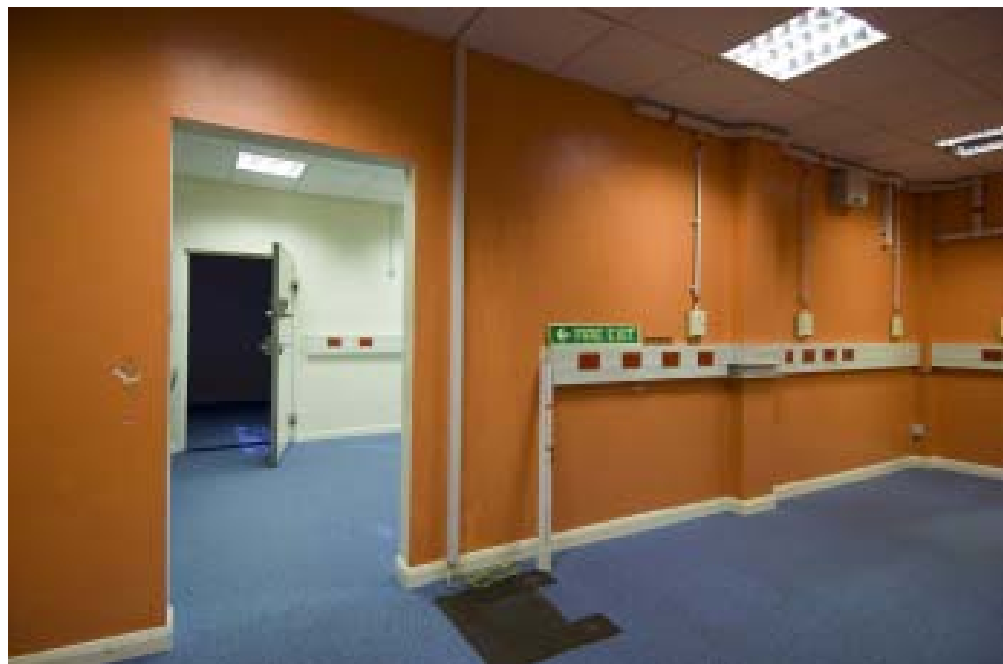
Figure 238 Watch Office, October 2006, stripped middle floor, formerly occupied by the approach controllers. (c) English Heritage DP035644

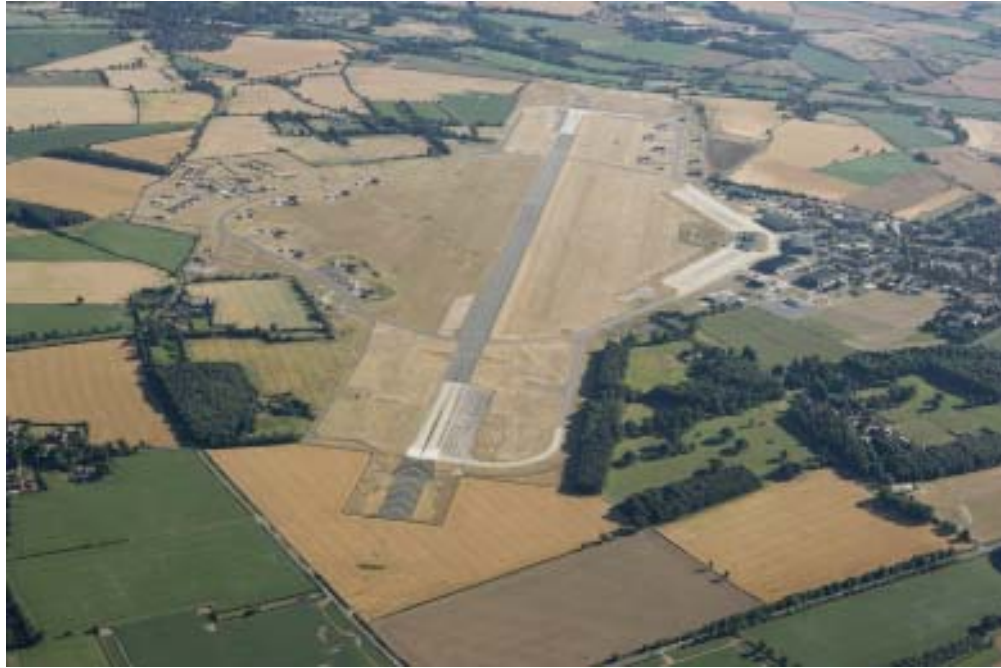
Figure 248 RAF Coltishall viewed from the north east looking along runway 22. To the right are the airfield's domestic and technical area, including a control tower four large hangars. To the left are the wartime bomb stores and post war missile storage area. The original flying field was grass during the war this reinforced by steel matting and after the war in anticipation of the introduction of jet fighters replaced by a concrete runway and taxiways. In the mid-1950s the dispersed concrete blast protection walls were built to protect aircraft against low level strafing attacks. (c) English Heritage NMR 24369/009

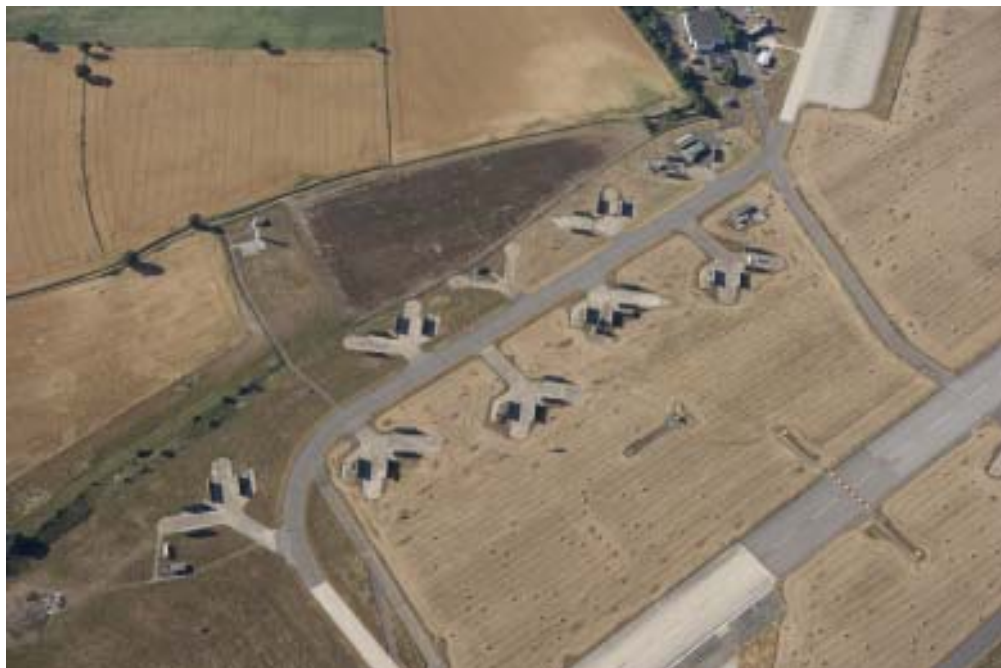
Figure 249 Group of 1950s blast protection wall in the south west corner of the airfield. The blast walls gave protection against low level attack for a squadron of aircraft. The black and yellow chequered line on the runway marks the position of the south west Rotary Hydraulic Arrestor Gear, between it and the blast walls are the remains of the Instrument Landing System. To the rear is the Watchman radar tower. (c) English Heritage NMR 24369/018

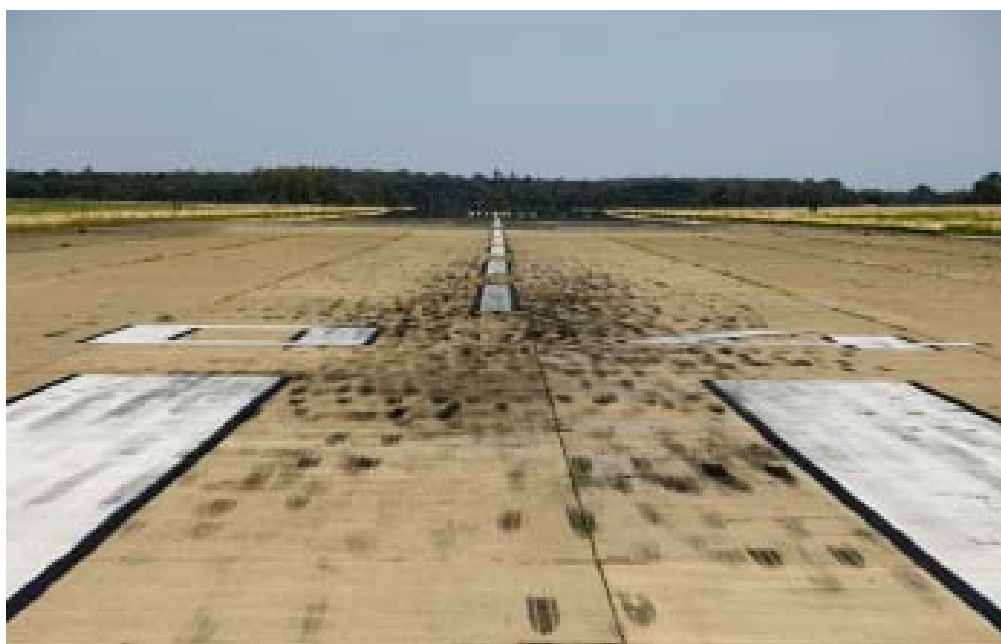
Figure250 The main runway 04/22(m) oriented southwest to northeast, length 7,500 feet (2,286m) looking to the north east. It was formerly protected by Rotary Hydraulic Arrestor Gear (c) English Heritage DP035664

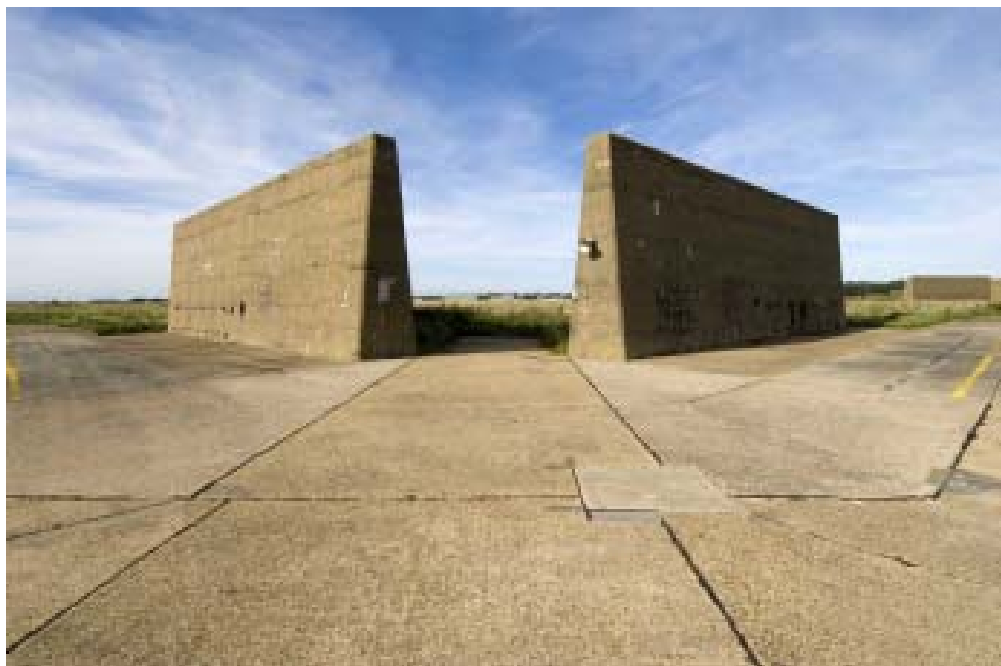
Figure 252 Eastern group of blast walls, 48 and 49 looking west. In 1956, in anticipation of the introduction of Javelin aircraft the airfield's runways and taxiways were strengthened, and two groups of eight pairs of Y-shaped blast walls built. Each group of blast walls was large enough to protect a squadron's aircraft. To either side of the blast walls were prefabricated huts for the aircrew and servicing personnel, their positions occupied by the more recent huts. (c) English Heritage DP035646

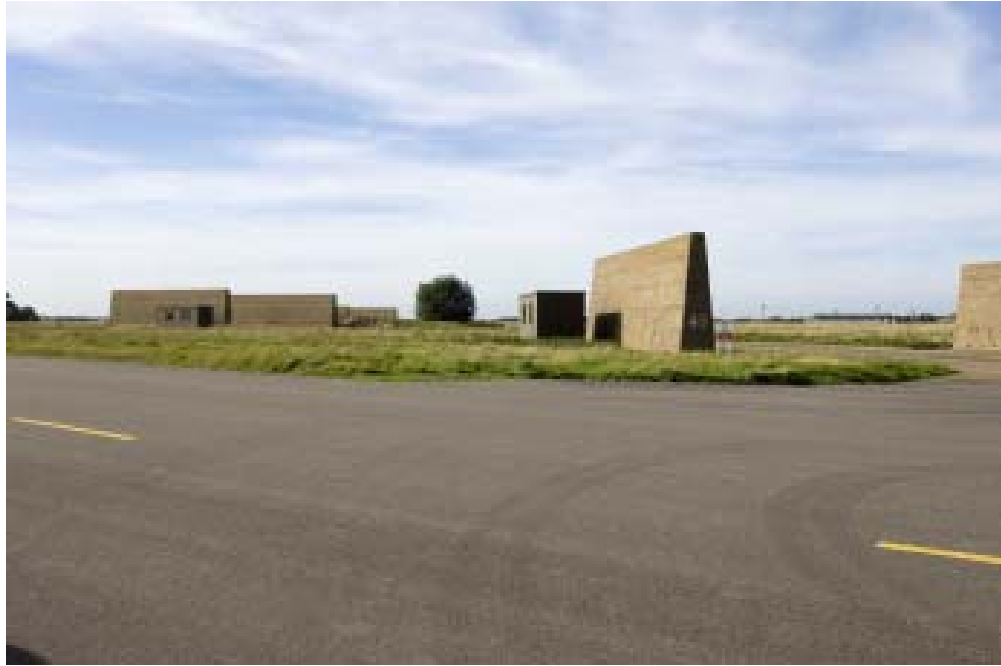
Figure 253 Blast walls 48 and 49. Late 1950s blast protection wall, between each blast wall is rectangular hardstanding that was used for parking a fuel bowser. This was connected to refuelling hoses through the circular hole in the centre of the blast walls, the hoses were supported on steels hoops set into the wall. (c) English Heritage DP035647

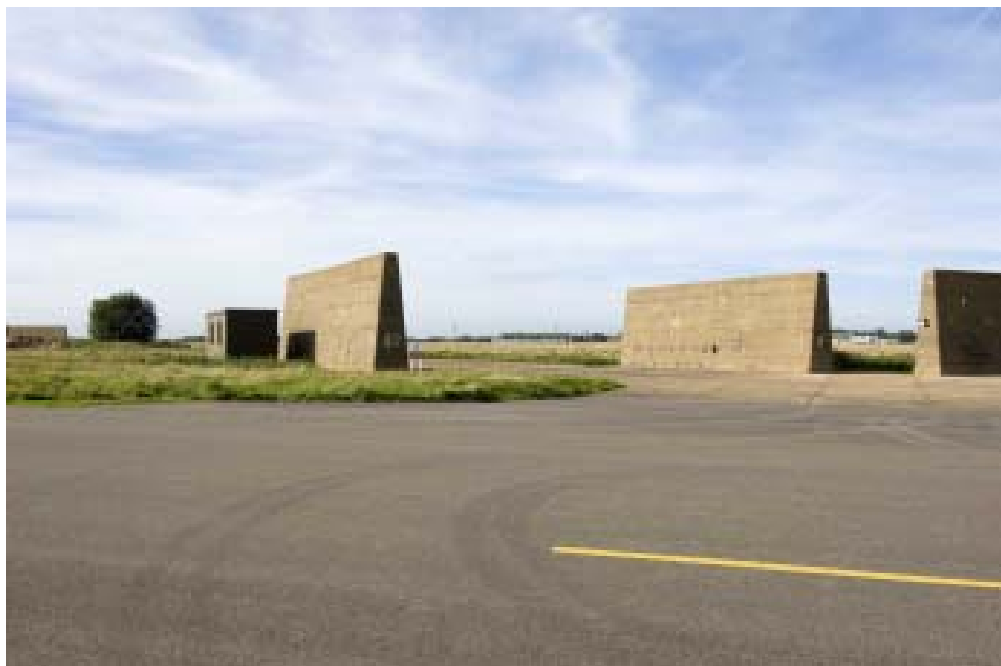
Figure 254 Late 1950s blast protection walls, wall 49 looking west. (c) English Heritage DP035648

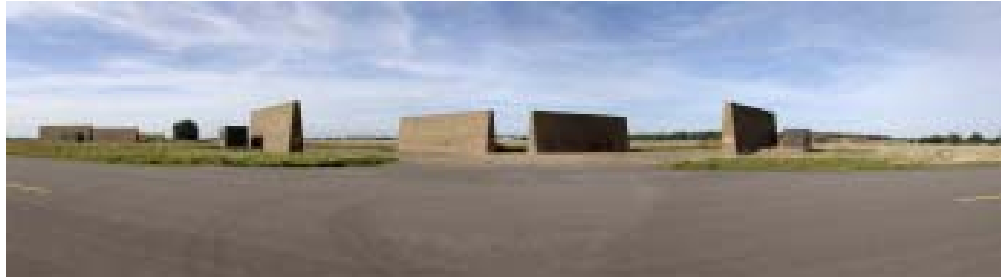
Figure 255 Late 1950s blast protection walls, eastern group walls 48 and 49 looking west. (c) English Heritage DP035649

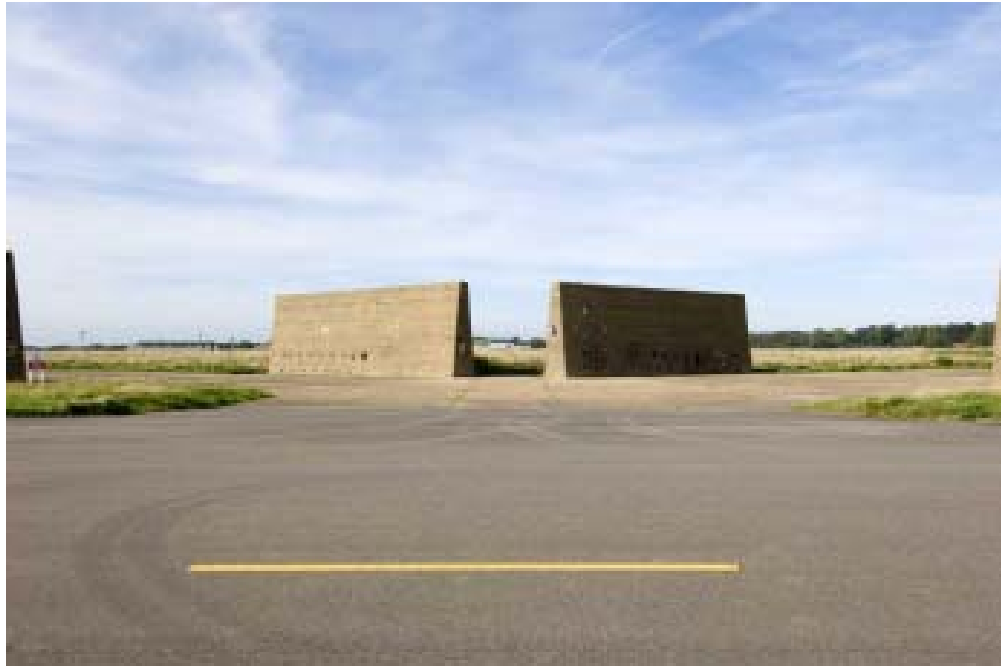
Figure 257 Late 1950s blast protection walls (c) English Heritage DP035650

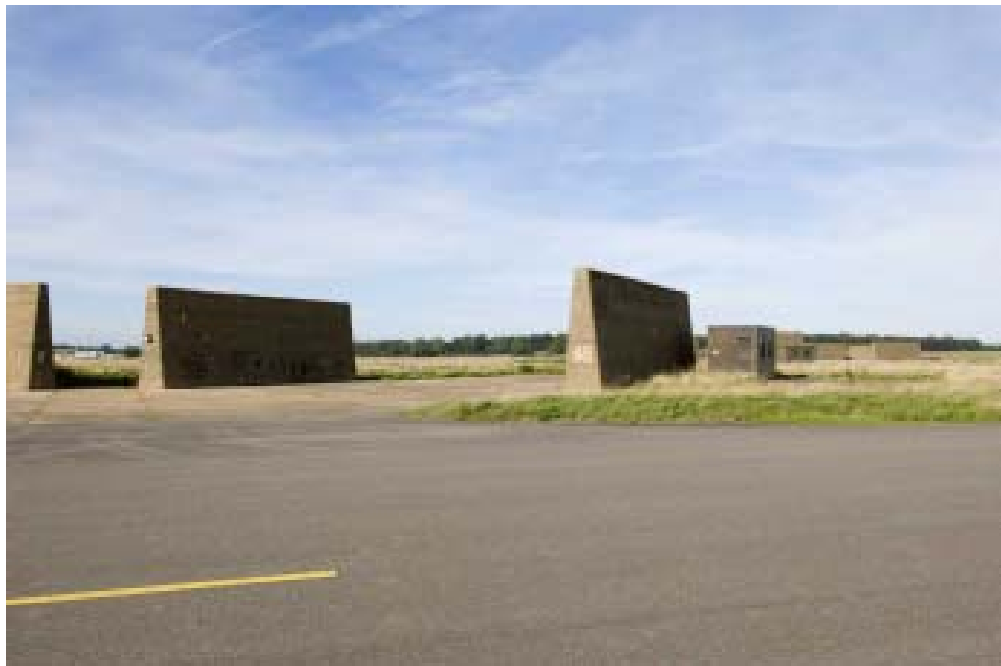
Figure 258 Late 1950s blast protection walls, eastern group wall 48 looking west (c) English Heritage DP035651

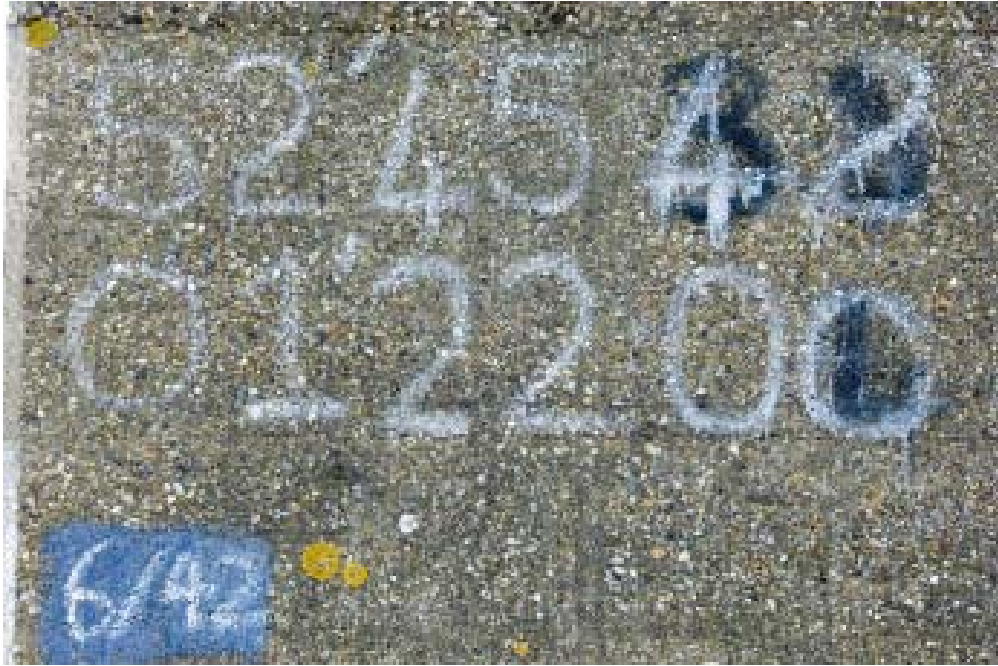
Figure 259 Late 1950s blast protection wall, the numbers refer to the bearing of the shelter's centre line, allowing the aircraft's navigation aids to be set prior to take-off. (c) English Heritage DP027326

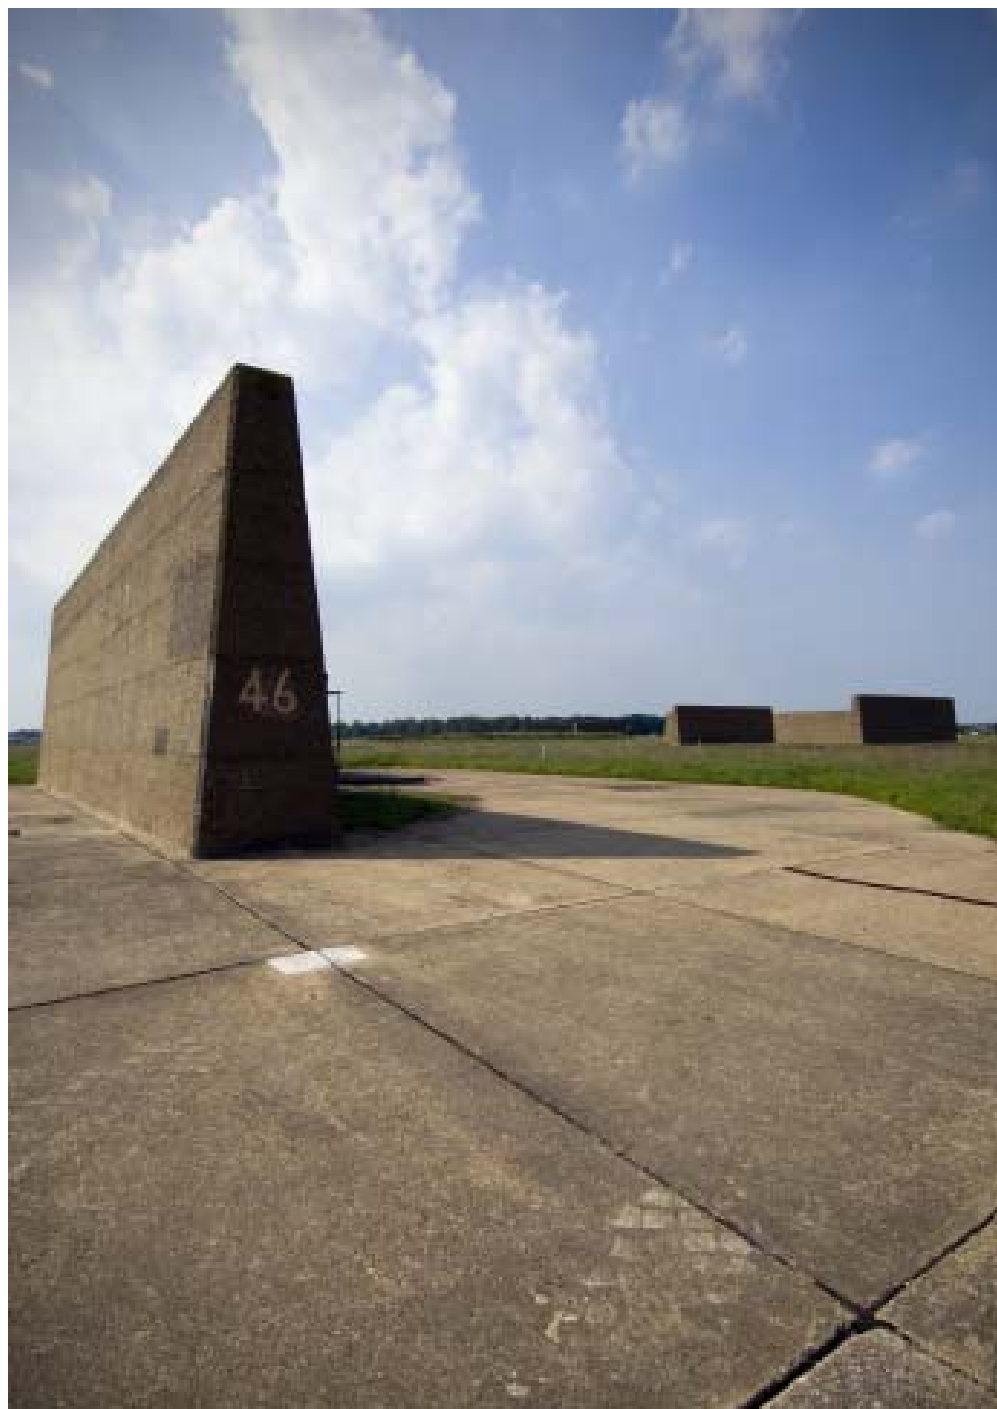
Figure 266 Late 1950s blast protection wal, eastern group wall 46. (c) English Heritage DP027174

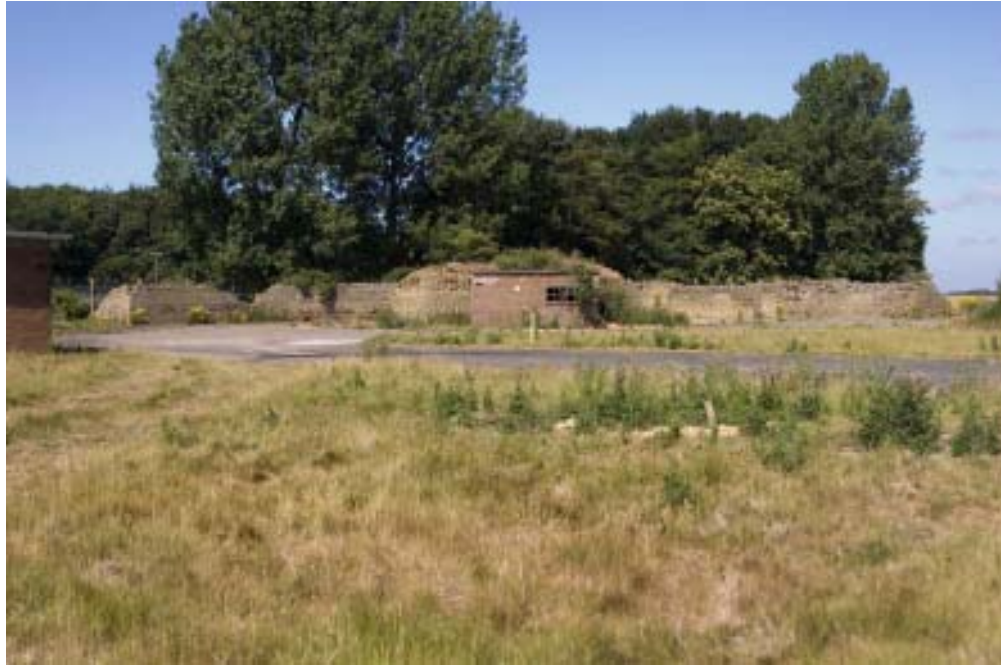
Figure 270 Second World War protected dispersal point to the south of Manor Farm, it has a roughly W-shape plan creating two protected bays with a central covered refuge. Each bay was large enough to take a single seater fighter, such as, a Hurricane, Spitfire or Typhoon (c) English Heritage DP027339

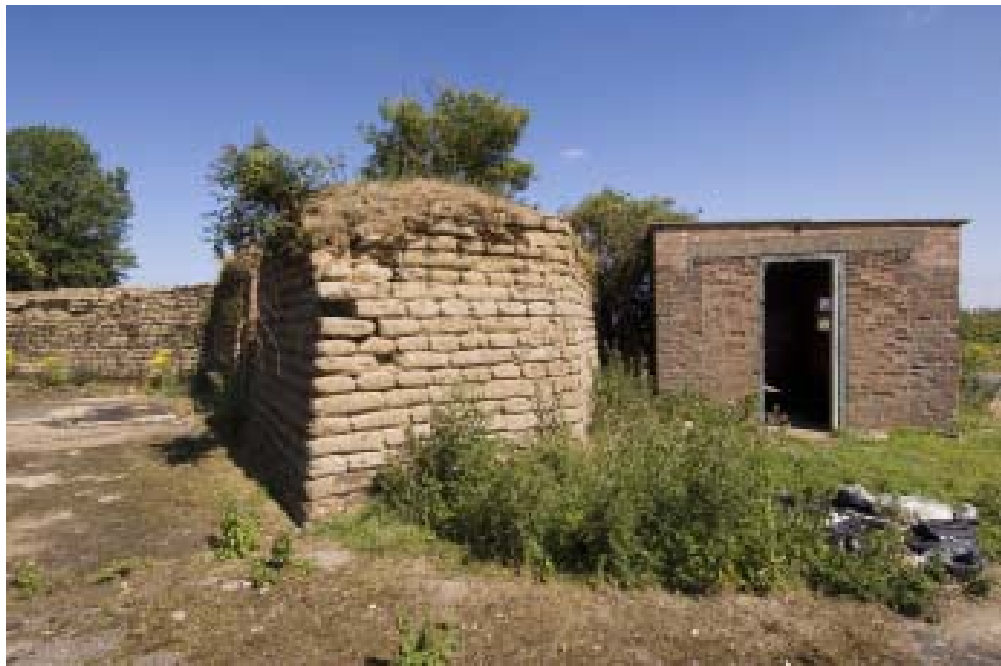
Figure 271 Second World War protected dispersal point to the south of Manor Farm, showing its cement sand bag walls and a small hut that perhaps originally housed an airfield tractor. The door opening has subsequently been reduced and a single door inserted. (c) English Heritage DP027341

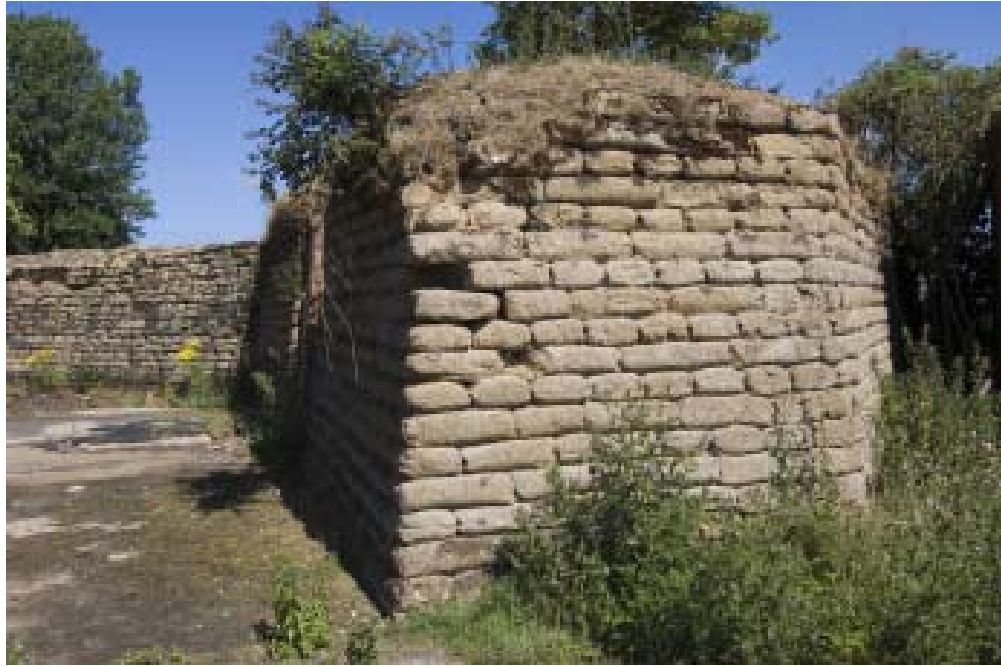
Figure 272 Second World War protected dispersal point to the south of Manor Farm, showing detail of cement sand bag construction technique (c) English Heritage DP027340

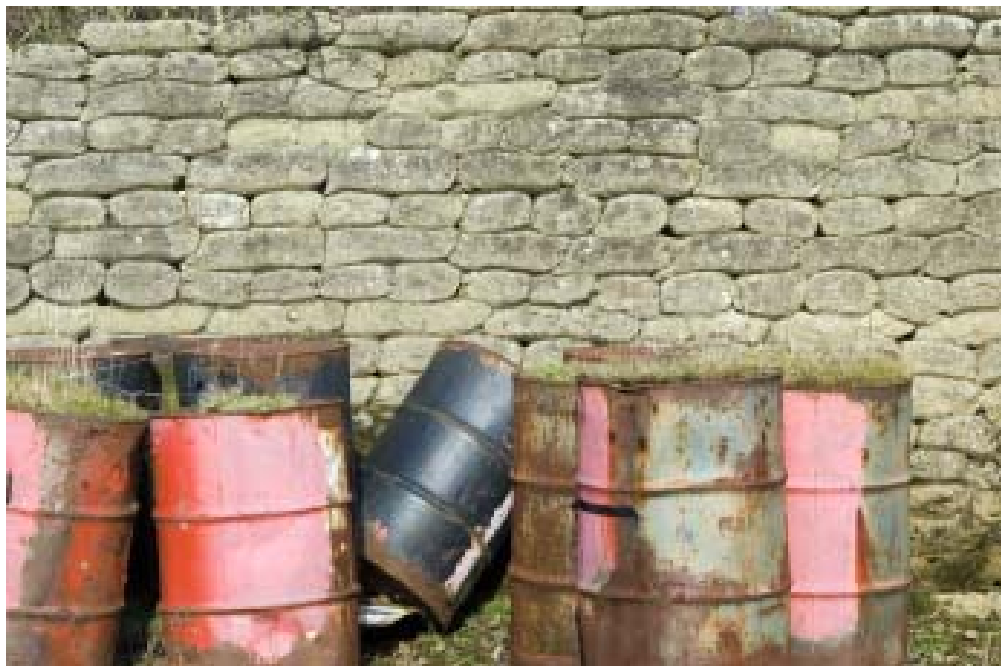
Figure 273 Second World War protected dispersal point to the south of Manor Farm, showing detail of cement sand bag construction technique (c) English Heritage DP029236

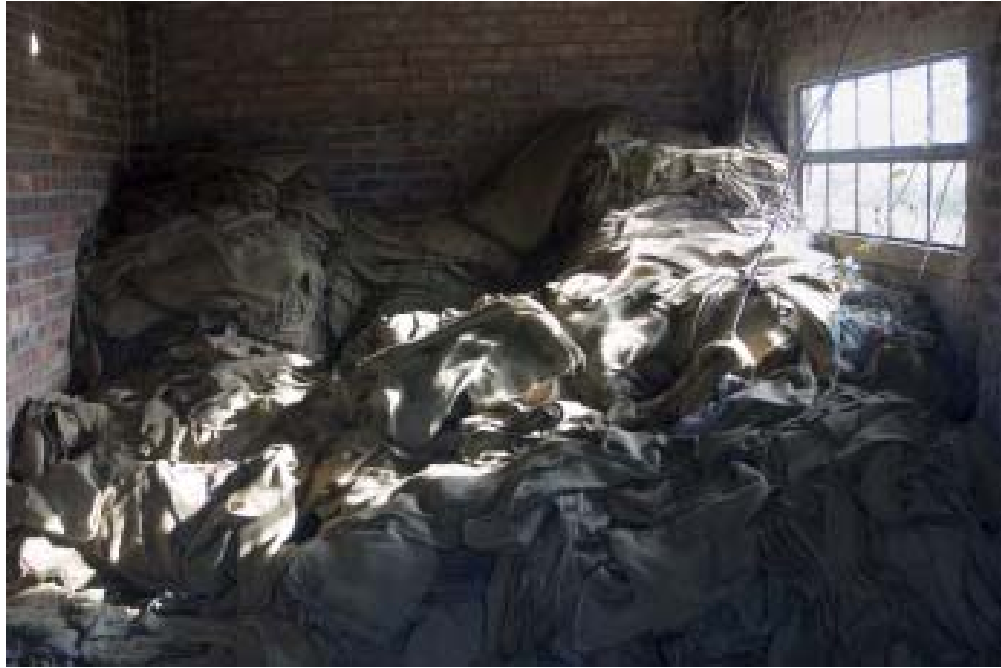
Figure 274 *Second World War protected dispersal point to the south of Manor Farm, empty sand bags dumped in the former tractor shed. (c) English Heritage DP029237*

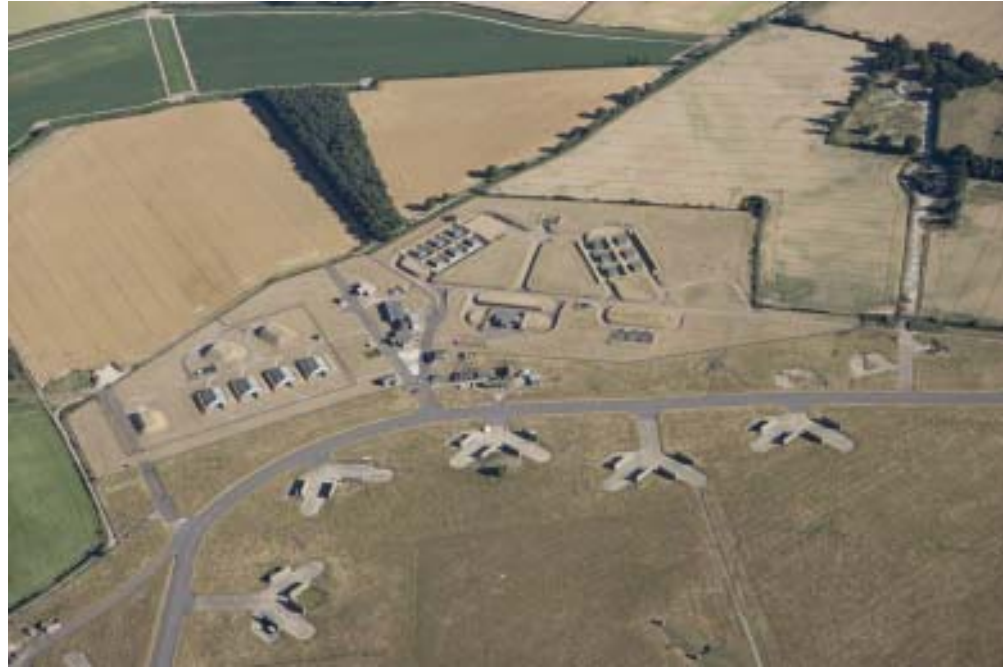
Figure 275 To rear of this photograph is the missile and munitions storage area. At the back are the original wartime bomb store buildings. To the left is the purpose-built 1950s missile storage section, with standard 1970s or 1980s NATO Igloo munitions bunkers to the left and rear. In the centre is the entry control point and offices and to their rear the missile inspection and preparation buildings. In the foreground are the 1950s protective blast protection walls, providing shelter for a squadron of aircraft. The missile section and the protective blast walls were built around 1956 in anticipation of the arrival of the Javelin fighter armed with the RAF's first air to air missile - Firestreak. (c) English Heritage NMR 24369/020

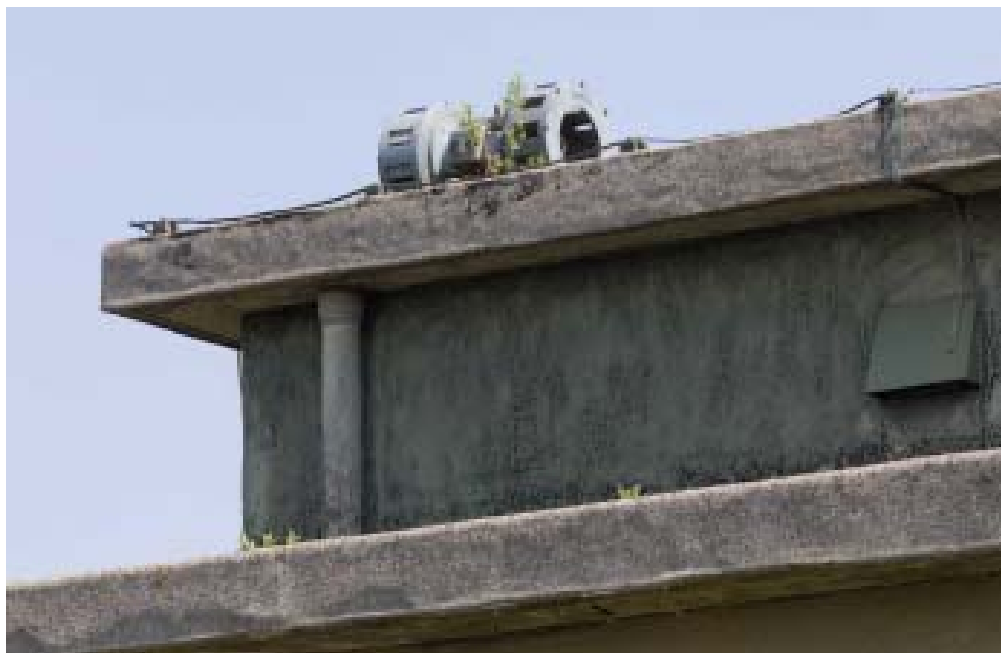
Figure 280 Missile and munitions storage area, 1950s missile inspection and preparation building, Building 227, attack warning siren. If the air field was attacked sirens such as this would have sounded the warning. (c) English Heritage DP027187

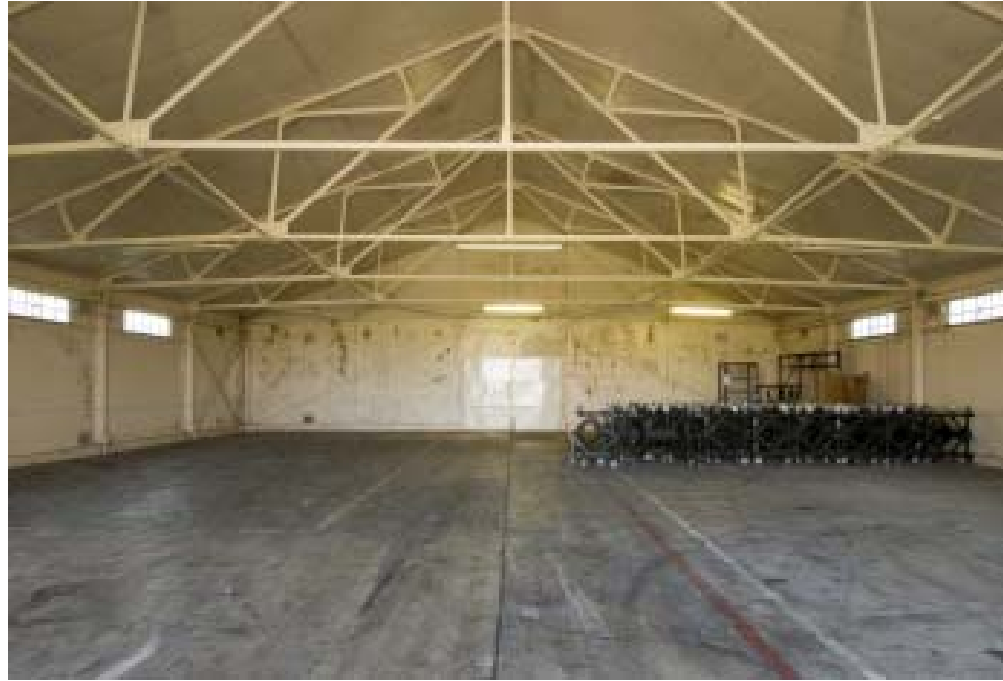
Figure 283 Missile and munitions storage area, 1950s missile storage building 223B interior from west. (c) English Heritage DP027165

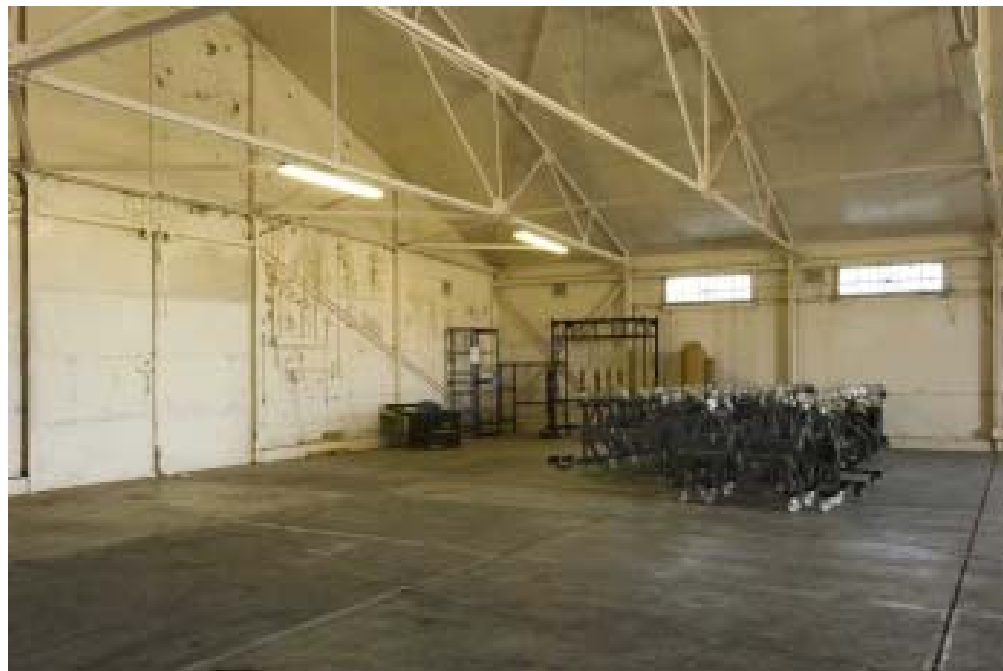
Figure 284 Missile and munitions storage area, 1950s missile storage building 223B interior, from north west. (c) English Heritage DP027171
