TRELUDICK, EGLOSKERRY, CORNWALL SURVEY, INVESTIGATION AND HISTORY OF THE HOUSE AND FARM BUILDINGS

SURVEY, INVESTIGATION AND HISTORY
OF THE HOUSE AND FARM BUILDINGS

Research Department Report Series No. 91/2007

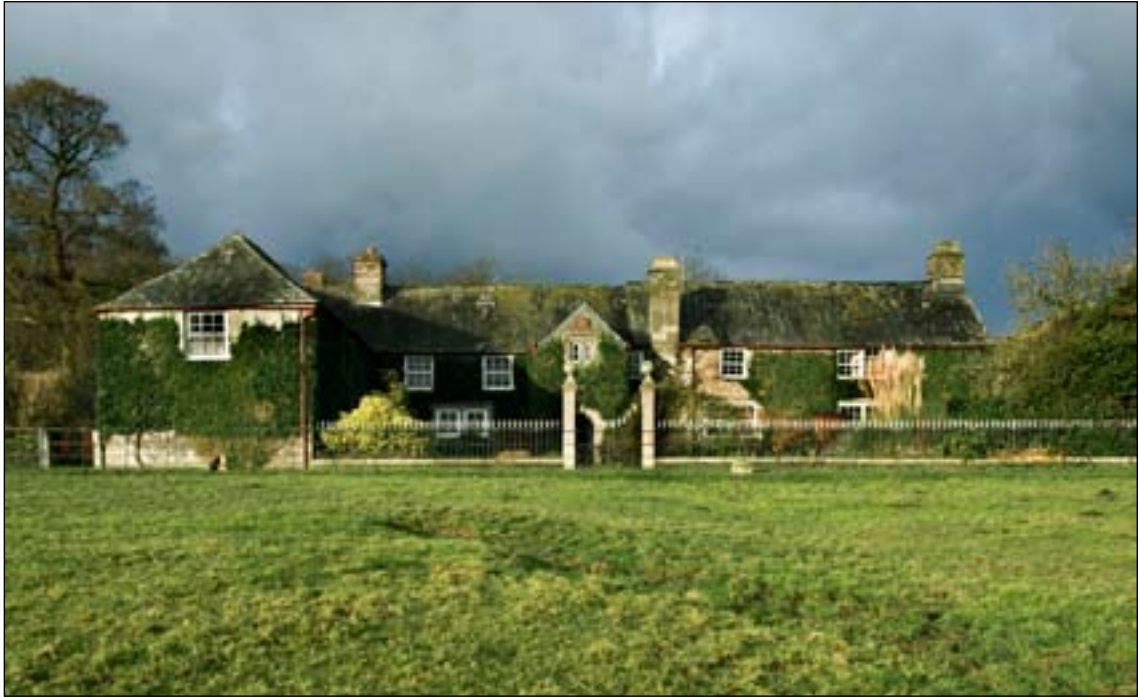
Fig. 3

View of Treludick from the east, showing the principal 17th-century phases. The change in roof height above the hall can be clearly seen. The foreground reveals the earthworks which may be those of the formal garden. [DP031522]

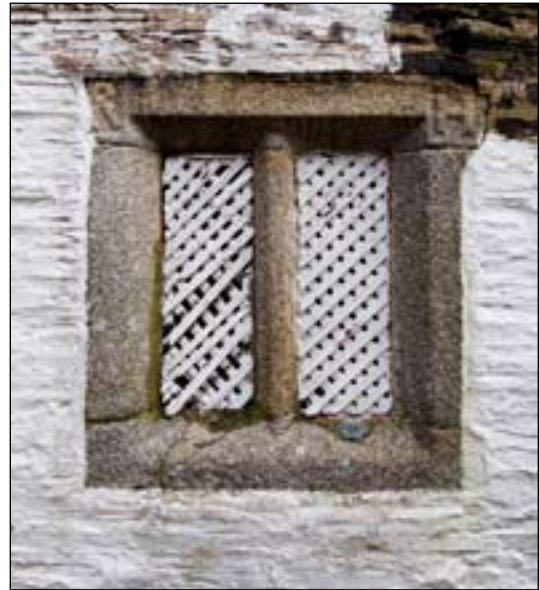
Fig. 5

The granite mullioned window, inscribed 'RH', now sited in the south wall of the southern service wing. [DP031528]

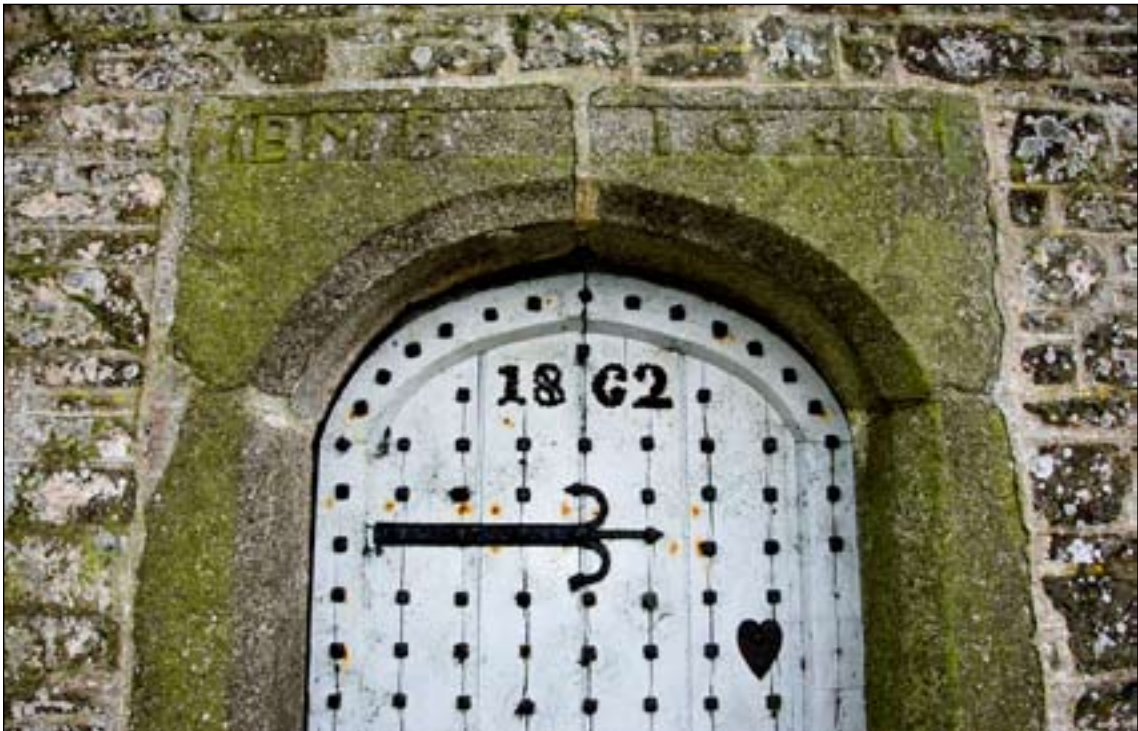
Fig. 8

The granite doorcase, inscribed 'IBMB 1641', now resited to the east elevation of the 19th-century stable block. [DP031652]

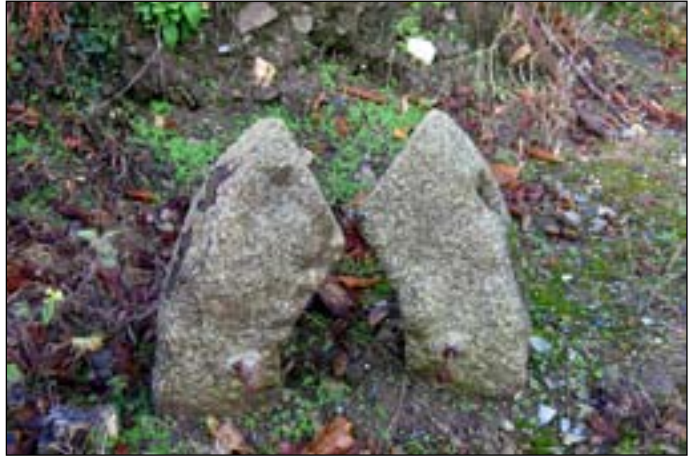
Fig. 10

A discarded granite two-centred door head. [DP047045]

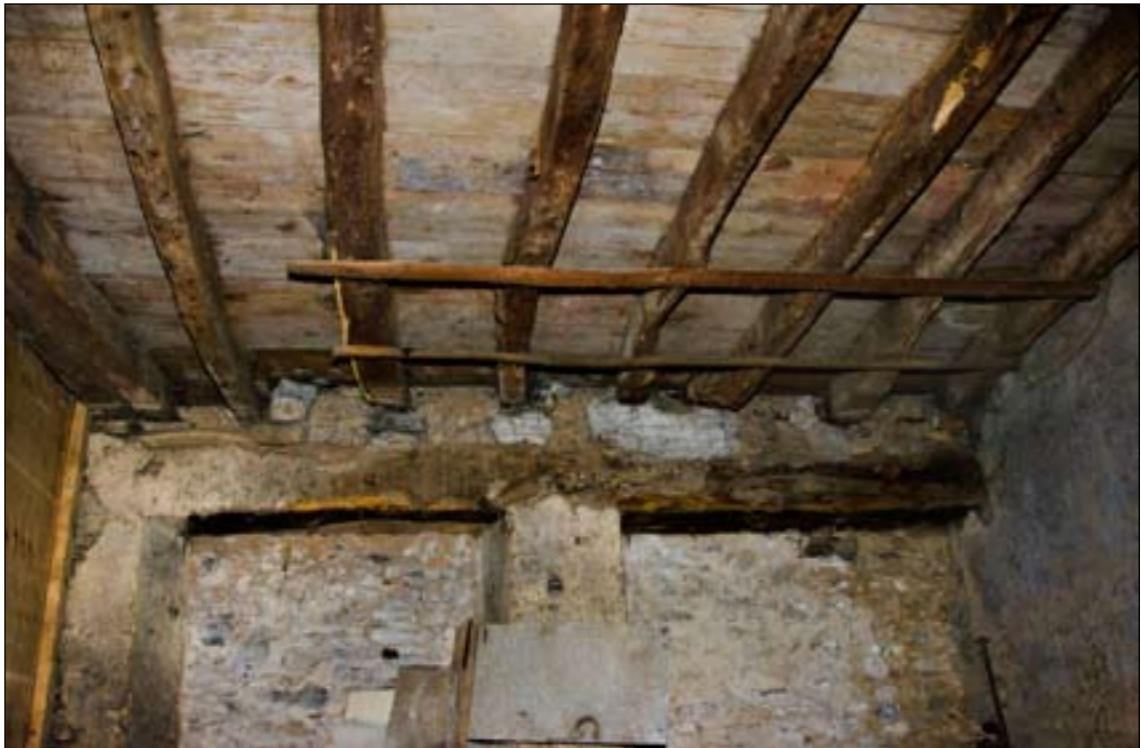
Fig. 11

A large smoke-blackened timber, resited and reused as a lintel in the south service wing. [DP031658]

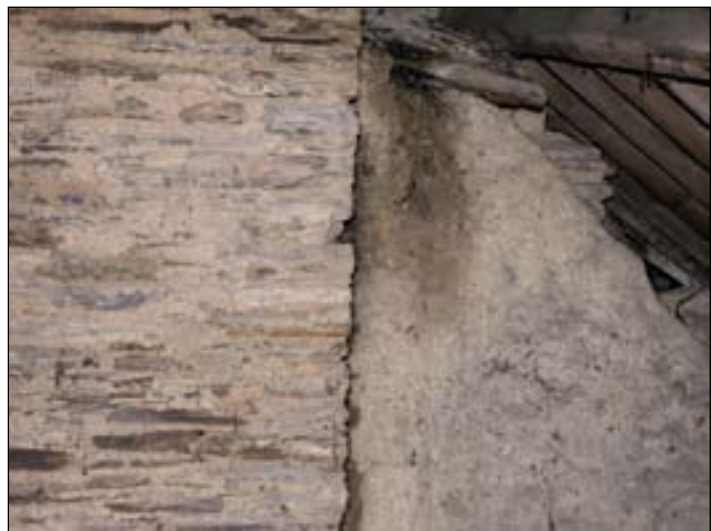
Fig. 13

View from the roof space of the masonry and cob wall to the south of the kitchen, viewed from the north. [DP047046]

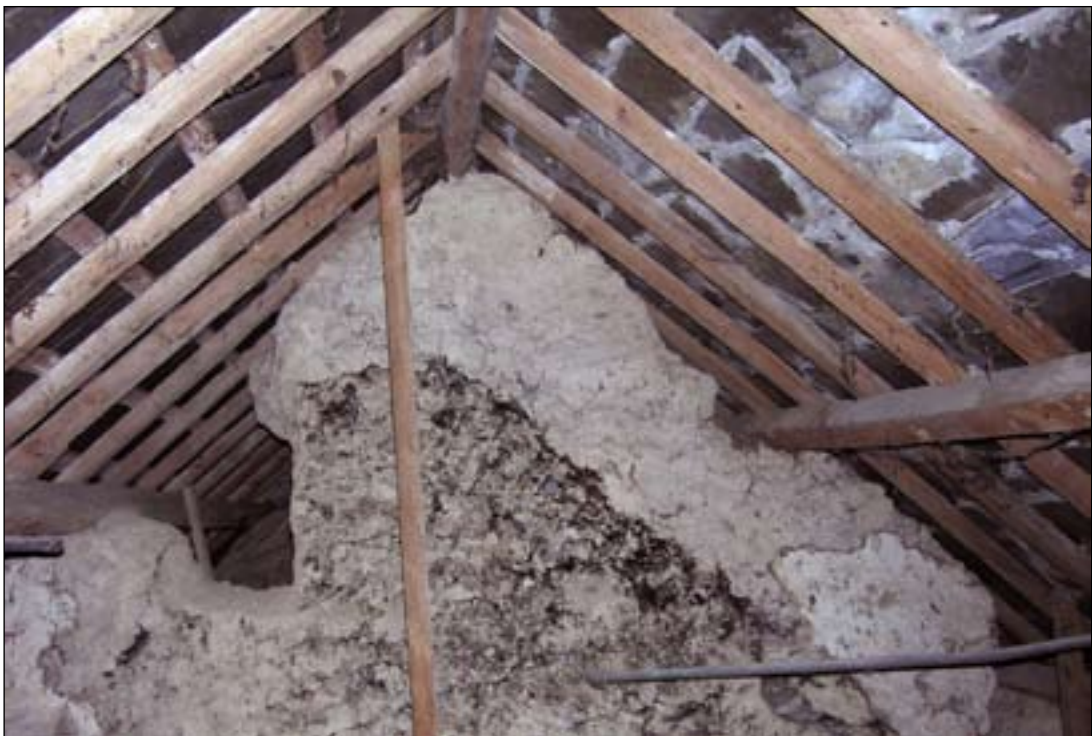
Fig. 15
The two-phase cob wall as viewed from the roof space above the hall, looking north. [DP047048]

The three-roomed plan was completed by a parlour, pre-dating the present parlour, adjoining the north end of the hall: the evidence for this is found in the cob cross-wall between the hall and the parlour. Here, two separate phases of cob can be discerned, one forming a lower gable which would have supported a roof of similar pitch to that provided by the trusses over the lower end of the hall and the kitchen (T5b – T8) and the other following the higher, present pitch of the roof which relates to the c. 1630 trusses over the parlour and the northern end of the hall (T1 – T5a), discussed subsequently. The lower, earlier cob wall retains traces of plaster on its north side, suggesting that a room, plastered to the rafters, existed on the upper floor to the north of the wall before the present parlour roof was raised. The extent of this parlour area north of the hall is unclear due to the rebuilding of the north wall of the house during the construction of the present parlour and rooms above. One might conjecture that it may have contained a winder stair next to a fireplace in order to access the rooms on the upper floor. Equally, a stair may have existed in a projection from the main three-roomed plan, perhaps accessed via the west doorway from the hall. The lower pitch of the kitchen and hall roof, therefore, relates to the three-roomed core of the house before the remodelling of the parlour area occurred in c. 1630 as discussed below; this was thus achieved sometime between 1623 and 1630, most likely in separate but swift campaigns between 1626 and 1630.

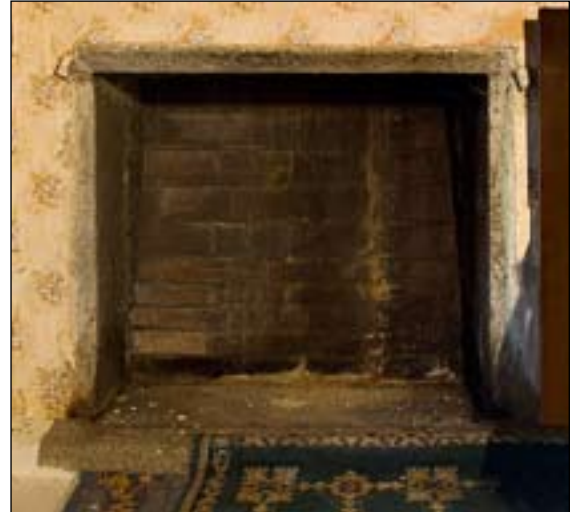
Fig. 17
Granite fireplace surround of the chamber above the old kitchen. [DP031622]

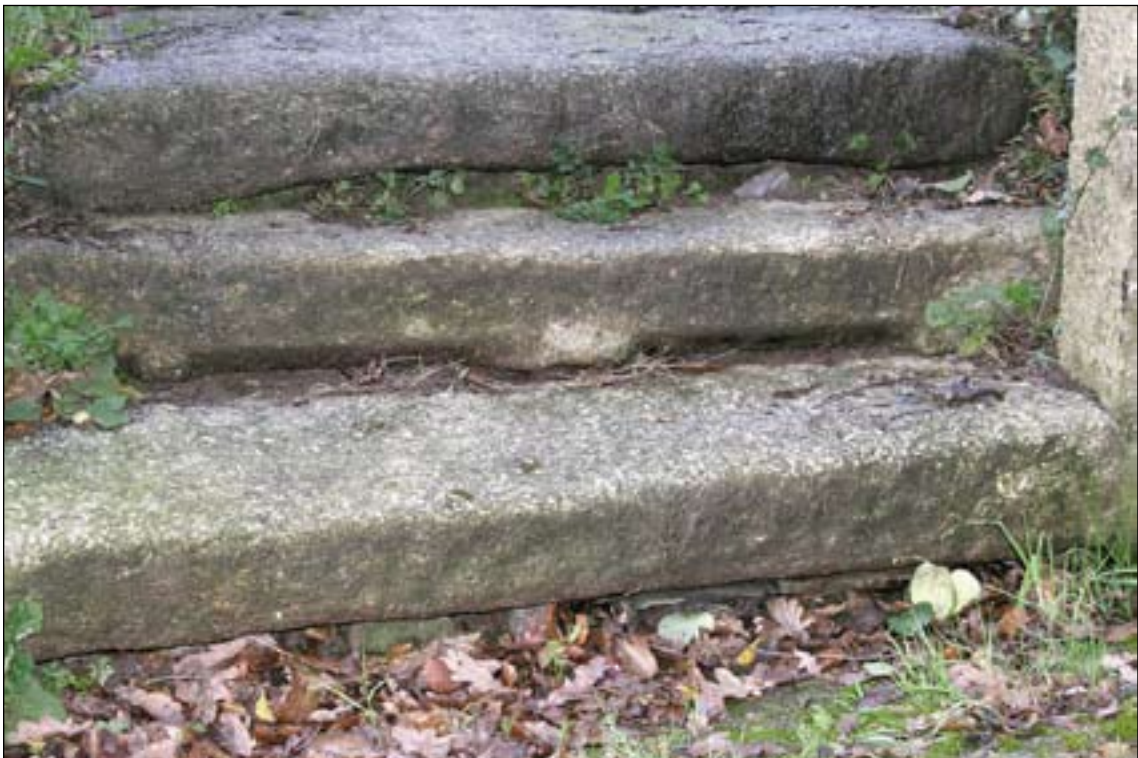
Fig. 18
Granite window lintels reused as steps west of the house, showing the nibs of some mullions. [DP047050]

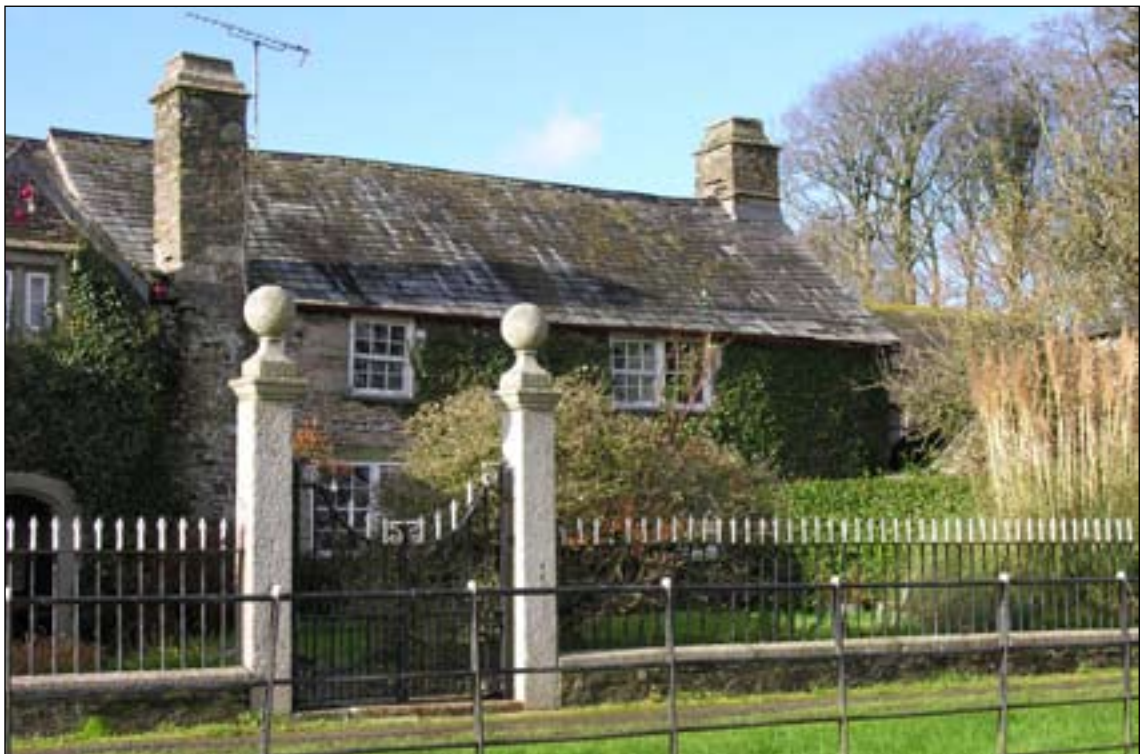
Fig. 19

View of the east elevation, showing the rebuilt parlour end of the house and the change in roof heights. [DP047051]

The most telling evidence for this phase of rebuilding lies again in the roof: from the exterior, it is evident that the roof over the parlour and the northernmost part of the hall is higher than that over the rest of the three-roomed plan. From the roof space, it is evident that all the trusses above this area are of a similar collared and pegged type as occurred in the earlier phase, but they are slightly wider and taller, matching the altered profile of the cob wall between hall and parlour. The trusses above the parlour (T1 – T3) have their collars set slightly higher than those above the

northern end of the hall: the reasons for this will be discussed below. These taller, wider trusses represent an attempt to increase the width and height of the earlier three-roomed plan: the east wall of the new parlour and northern part of the hall was moved slightly eastward to create more space within the house. The disturbance evident in the masonry around the hall's lateral chimney stack (including a substantial ragged joint) was probably caused by this move: the similarities in the capping of the hall and parlour stacks suggest that this was all carried out during the same campaign of c. 1630. Other examples of such capping can be found on the chimney stacks at neighbouring Penheale (Fig. 16) and other high-status Cornish houses such as Trecice.

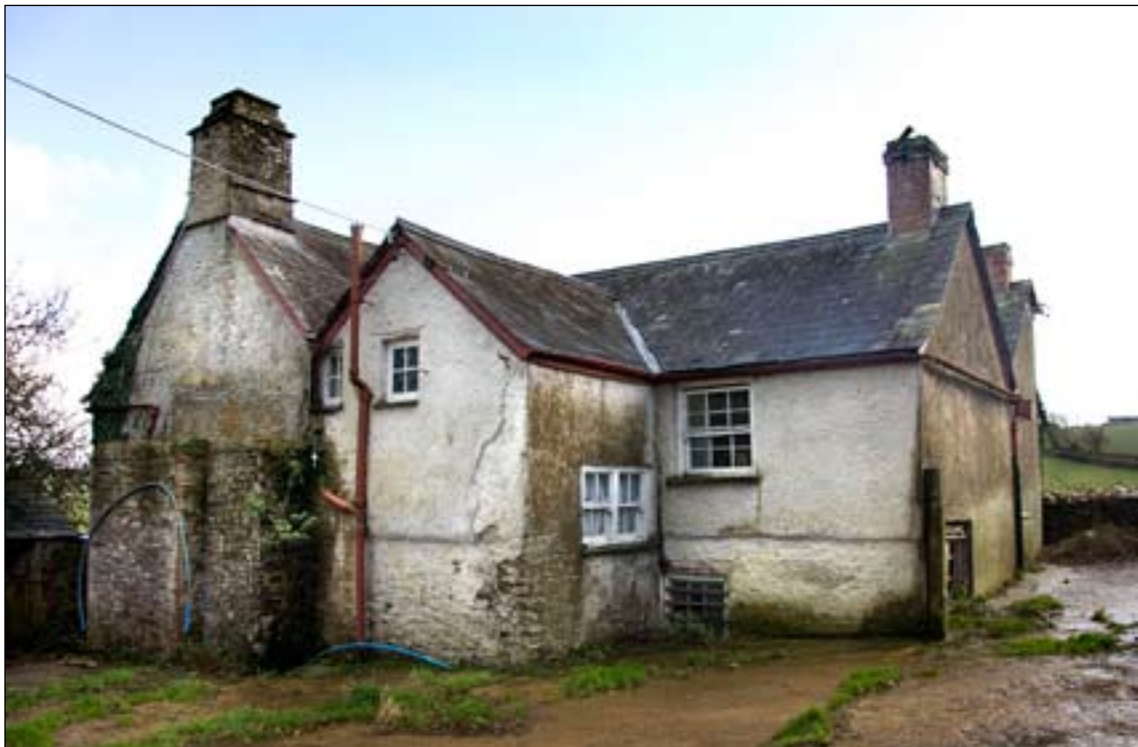
Fig. 20

View of the house from the north, showing the most northerly north-west extension (right of centre) and stair projection (centre). [DP031661]

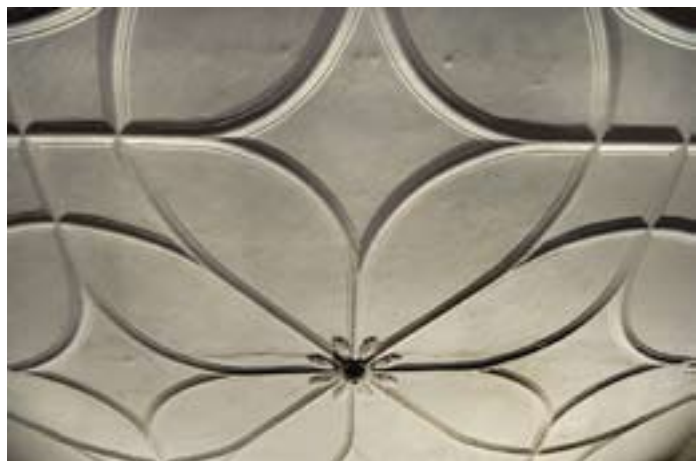
Fig. 22

The parlour ceiling. [DP031531]

The new rooms north of the hall were not only spacious but also attractively decorated with plaster ceilings and decorative doorjambes. The single-ribbed, geometric-patterned plaster ceiling of the parlour introduces a sophisticated and decorative note to Treludick's interior, although the later panelling obscures some of the remaining decoration and the earlier plaster cornice is concealed by the present wooden box cornice. The thin interlinking ribs of the plaster ceiling are consistent with other plasterwork of the late 16th and early 17th centuries in the West Country, including the room which forms part of the present gallery at Penheale. Somerset examples of thin, single ribs like these can be dated to c. 1530-1600, although this large-scale, curvaceous pattern with its elaborate floral sprays could date as late as the middle of the 17th century.²⁸ Devonian examples of circular patterns and floral sprays include a barrel-vaulted chamber at Clysthayes, Silverton (dating from the turn of the century), as well as ceilings at Duns Moor, Silverton, and Forde House, Newton Abbot (both early 17th century, the latter dated 1610), although there are also close similarities with an earlier ceiling at 39, High St, Totnes (dated

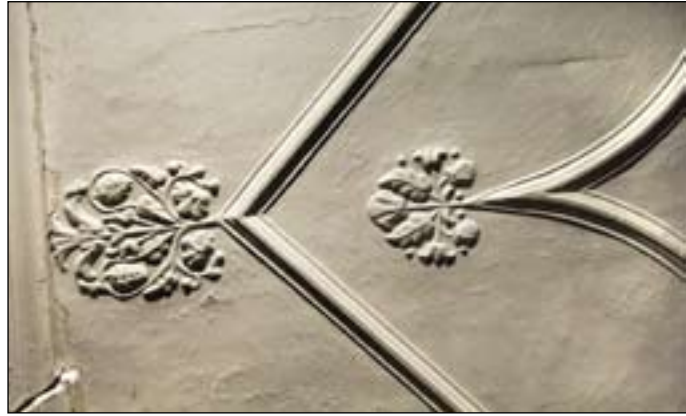
Fig. 23 Detail of the parlour ceiling. [DP031530]

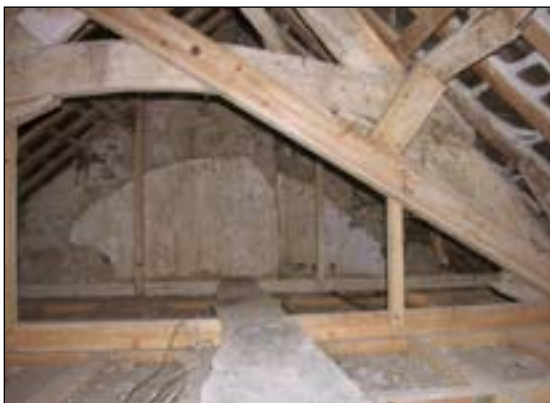
Fig. 24...View into the roof space above the parlour, showing a roof truss with the curved collar and the plaster scar of the barrel vault over the northern chamber. [DP047052]

The two chambers above the hall also had their own decorative plaster ceilings, this time in the form of two contrasting barrel vaults. Neither vault survives, but the lunettes of both are found in the roof space above the current ceiling. The profile of the barrel vault above the northern chamber is discernable on the north face of the mud and stud partition: it is trimmed with an ovolo-moulded rib which matches nicely with the mouldings of the blocked north window. The southern of the two chambers, now the bathroom, had a shallower segmental vault, with a larger,

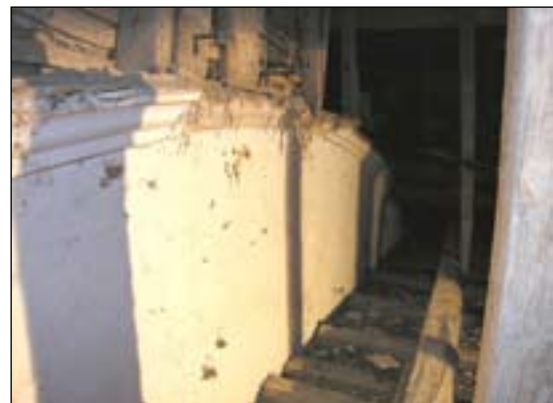
Fig. 25 View into the roof space above the parlour, showing the plaster scar of the barrel vault over the present bathroom. [DP047053]

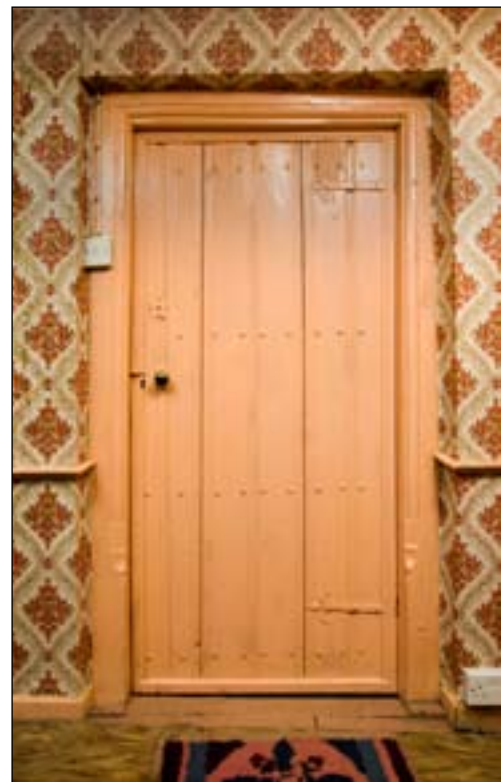
Fig. 27
The door of the chamber over the parlour.
[DP031692]

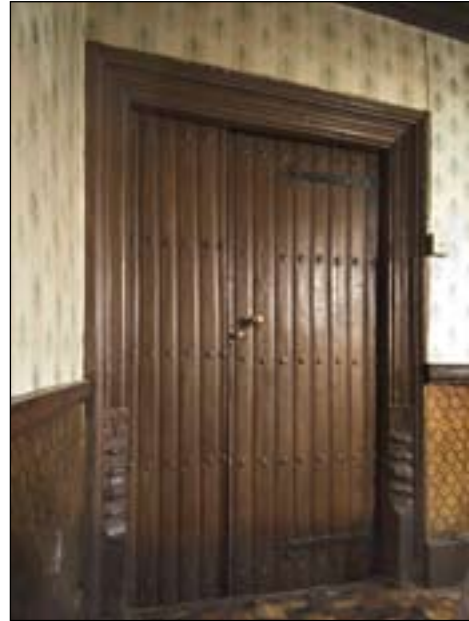
Fig. 29
The door in the north wall of the hall,
leading to the parlour [DP031556]

The door in the north wall, linking the hall with the parlour, is a larger, two-leaf version of the door in the west wall; this now leads into a small room of indeterminate function but may have been the position of a stairway accessing the upper storey of the house before the reconstruction of its parlour area. Later architraves have been added to the outside of each door surround but the original surrounds remain within them. They have a profile of hollow and ovolo mouldings which are appropriate for the last three decades of the 16th century but can also be found in the early 17th century. However, the elaborate patterns used on the stops of the doorframes may be more consistent with the first half of the 17th century, and thus are likely to have been part of the c. 1630 rebuilding.

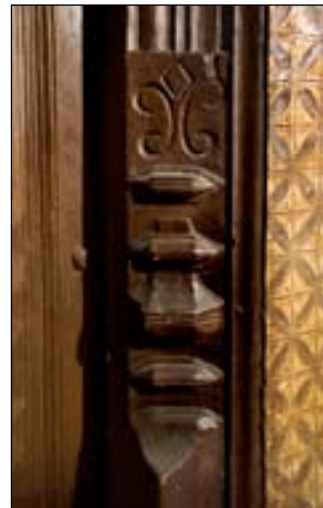
Fig. 31
Detail of stop, door in north
wall of hall. [DP031557]

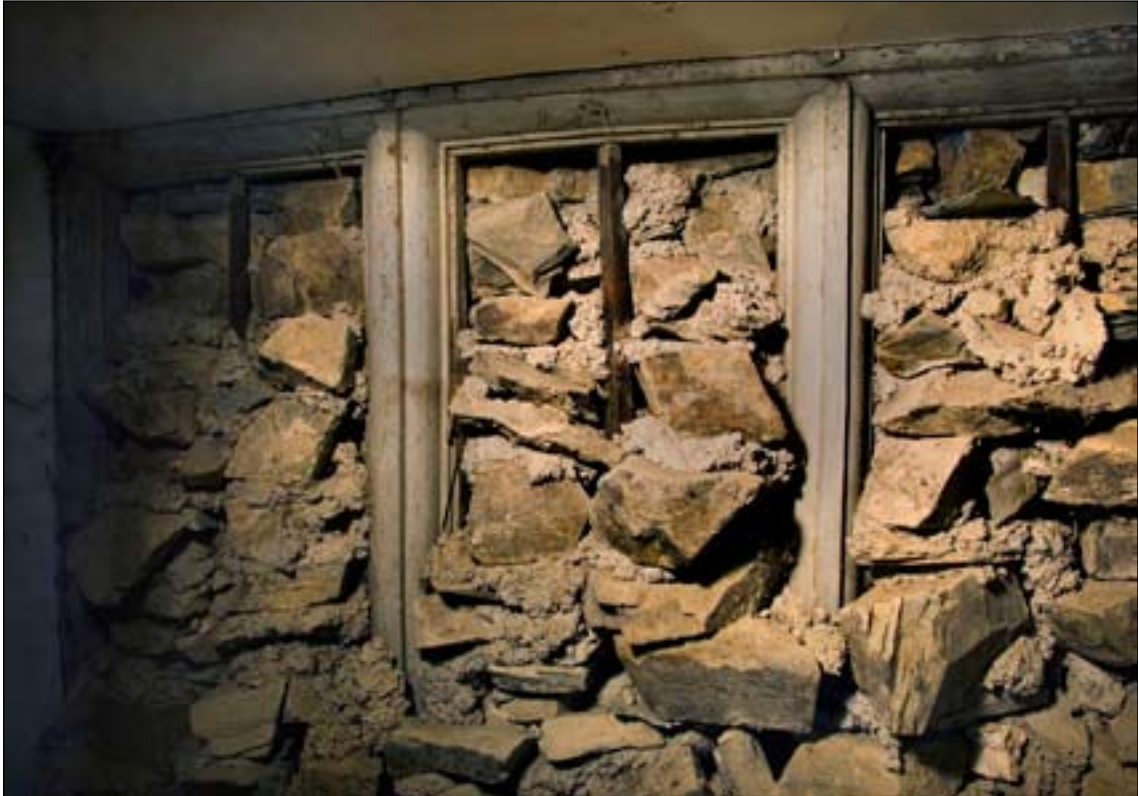
Fig. 32

The blocked wooden ovolo-moulded window in the north wall of the parlour chamber. [DP031690]

Some of the fenestration of the rebuilding of the parlour end of the house may have been rather different from those in earlier parts of the house. A three-light window has been revealed in the north wall of the northern chamber, its blocking evident on the exterior; its sophisticated wooden, ovolo-moulded frame contrasts strongly with the chamfered granite surrounds and mullions of the earlier house. Such timber window mouldings have been described as a 'notably rare feature for Cornwall'.³⁰ Disturbance in the stonework below at ground-floor level suggests that a similar window may have also lit the north wall of the parlour; it is also possible that the east wall may have been similarly fenestrated. However, this part of the east front was completely refenestrated with sashes in the late 18th or early 19th century and again with modern sashes in the 20th century, and no other window surrounds of this type can be found.

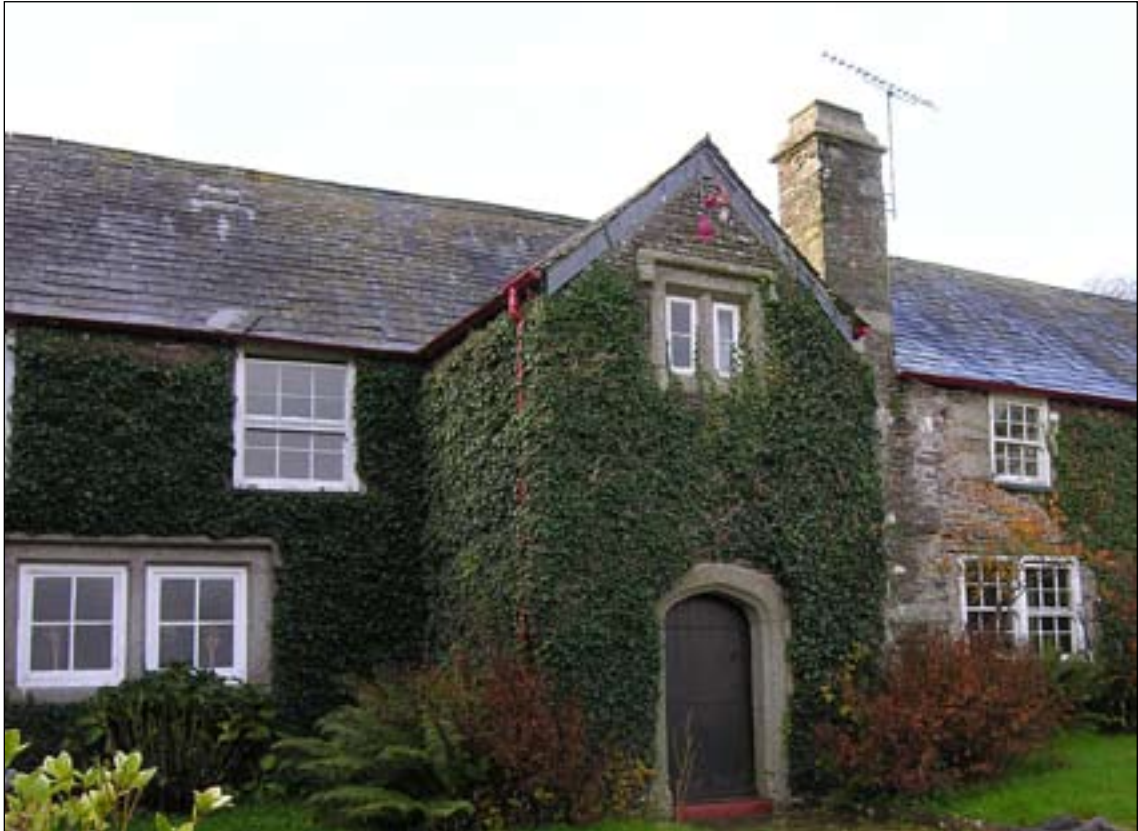
Fig. 33

The porch, from the north-east. [DP047054]

The two-storey porch sits on a similar alignment to the east wall of the reconstructed parlour end of the house, providing an attractive, covered entrance to the hall and a useful closet for the good bedchamber above. Due to the growth of ivy over this part of the building, it is impossible to observe any straight joints in the masonry to aid interpretation of the sequence of events. There are several Cornish examples of the two-storey porch forming the entrance to houses with three-roomed plans illustrated by Chesher and Chesher, all apparently built in the last three decades of the 16th century. These include Stanbury, Morwenstow, of c. 1585, and Trerithick, Altarnum, whose porch bears a datestone of 1585.³¹ However, the form of the porch, with its four-centred arched doorway and room above, is certainly typical for much of the 16th century but can be frequently found as late as the early 17th century. The two-light mullioned window of the room above the porch with its hood moulding certainly recalls the larger, kitchen window of the c. 1623 to c. 1630 phase, but its scale, suitable for a small room over a porch, is closer to the smaller 'RH' window

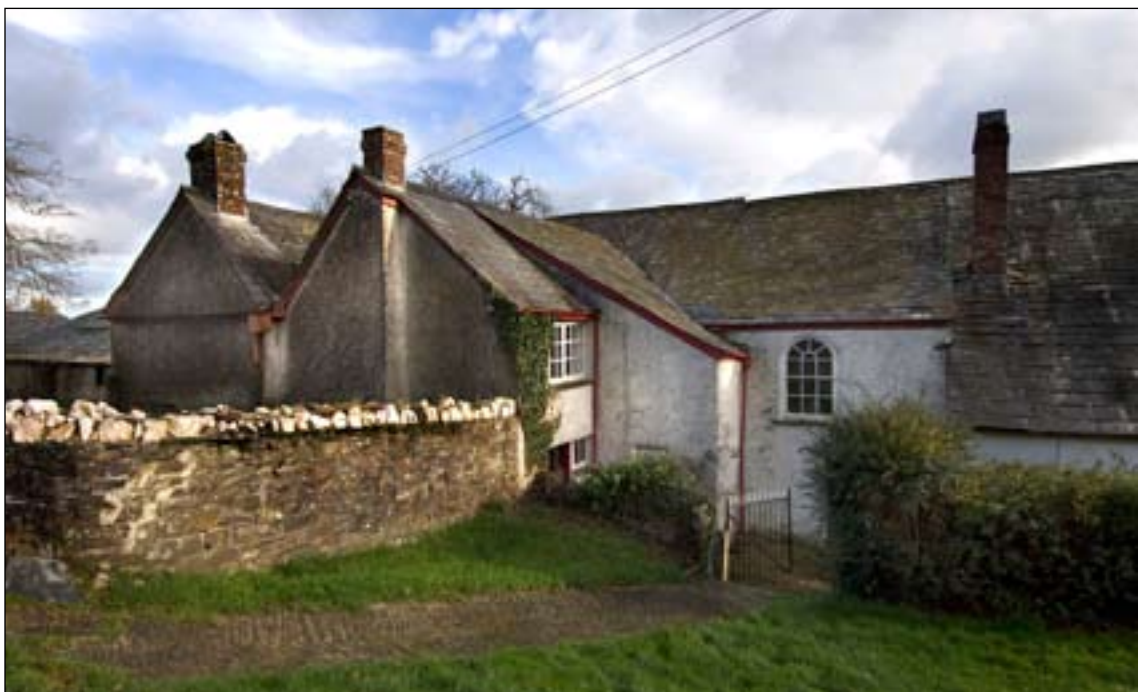
Fig. 34

View of the house from the west, showing the two north-west extensions. [DP031600]

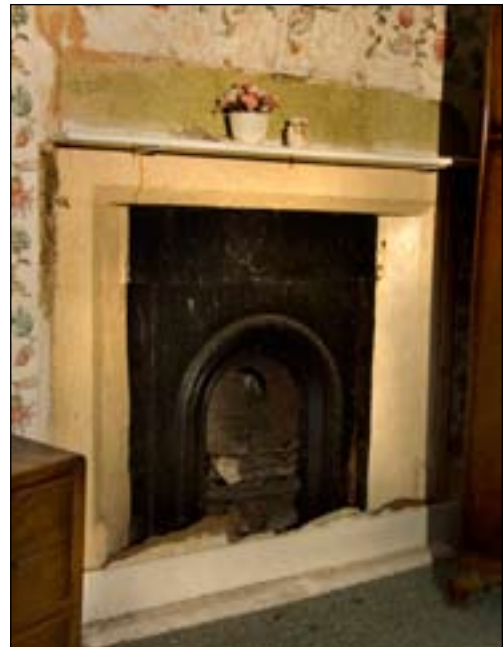
Fig. 36 The granite fireplace of the upper chamber in the southernmost room of the north-west extension. [DP031671]

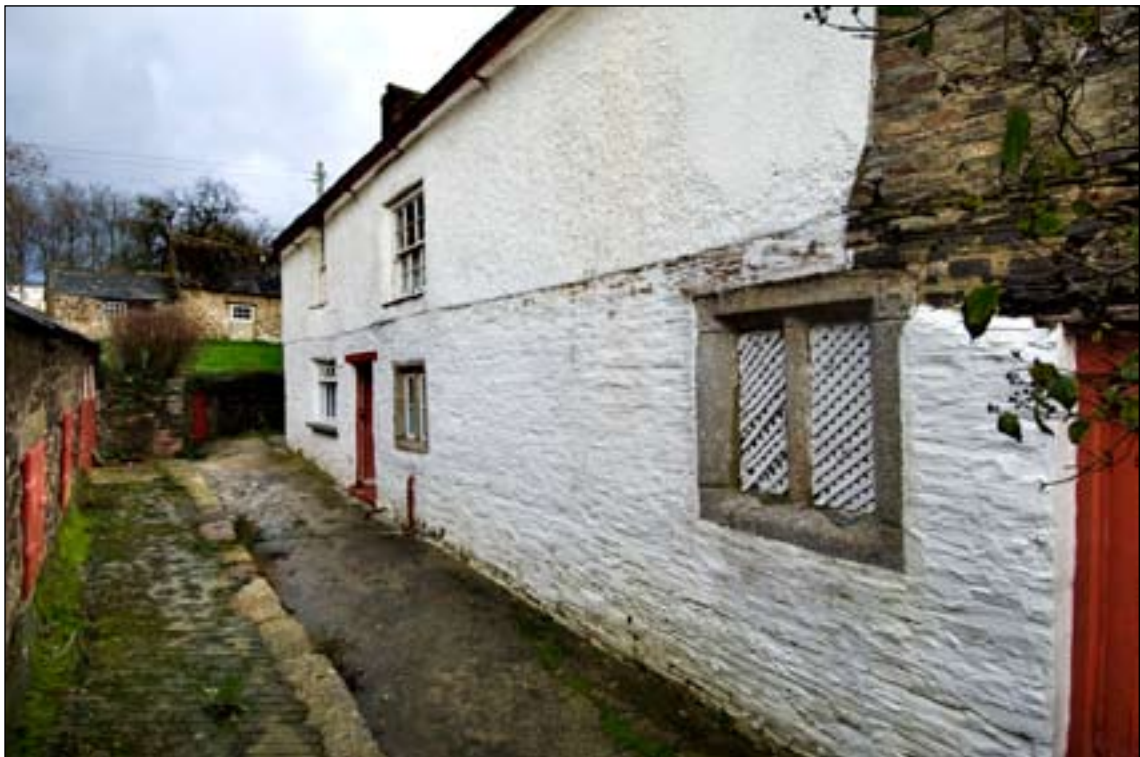
Fig. 37

The south service wing, viewed from the south-east, showing (from right) the door into the unheated ground-floor room with a chimney stack inserted above, the reset 'RH' window and a further reset granite window. [DP031527]

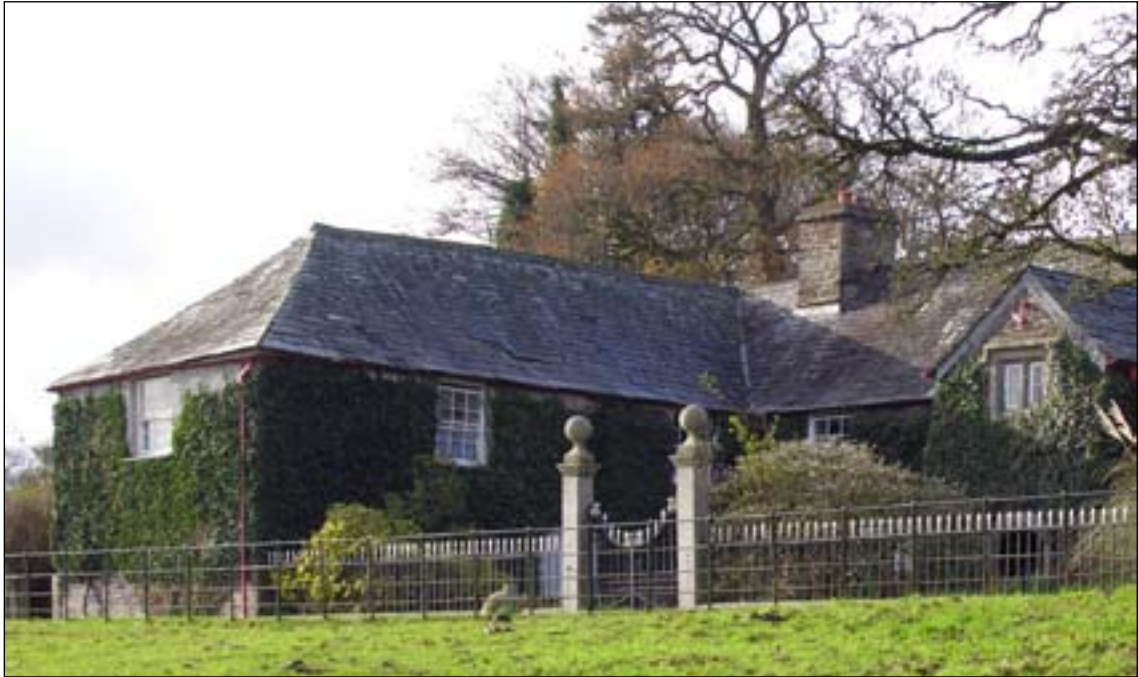
Fig. 38

View of the south service wing from the north-east. [DP047056]

The hipped slate-covered roof, allied with consistent wall thickness, demonstrates that this south service wing was constructed in one campaign, using seven elm lapped trusses, with double-pegged collars, and a double-pegged apex. Most of the trusses exhibit dimpled indentations to aid the carpenters in the erection of the roof: these are similar to those found at Trerithick.³⁴ Two partitions rise through the height of the building up to the height of the collars; the east partition is supported on the western face of the third truss from the east and is plastered on its western side whilst the west partition (supported by the sixth truss from the east and rising to its apex) is plastered on both sides, again demonstrating that the current ceilings are lower than their predecessors.

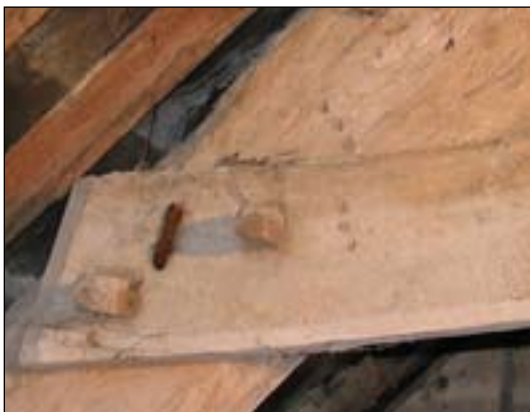
Fig. 39

Carpenters' marks carved into one of the trusses of the south service wing: three dimples on the collar and three on the principal rafter. [DP047057]

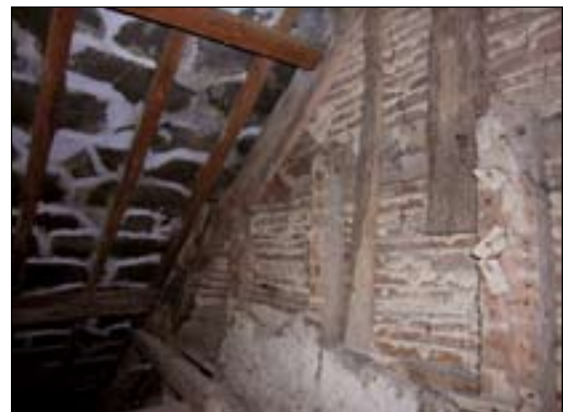
Fig. 40

East side of the western partition in the south service wing. [DP047058]

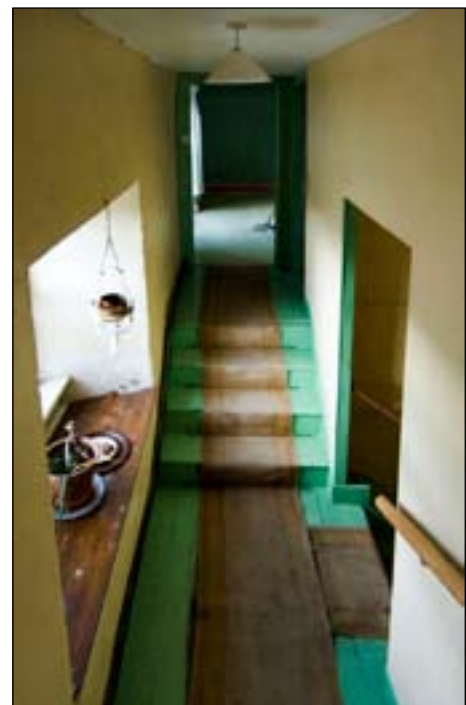
Fig. 42

The mezzanine level of the stair in the south service wing. [DP031611]

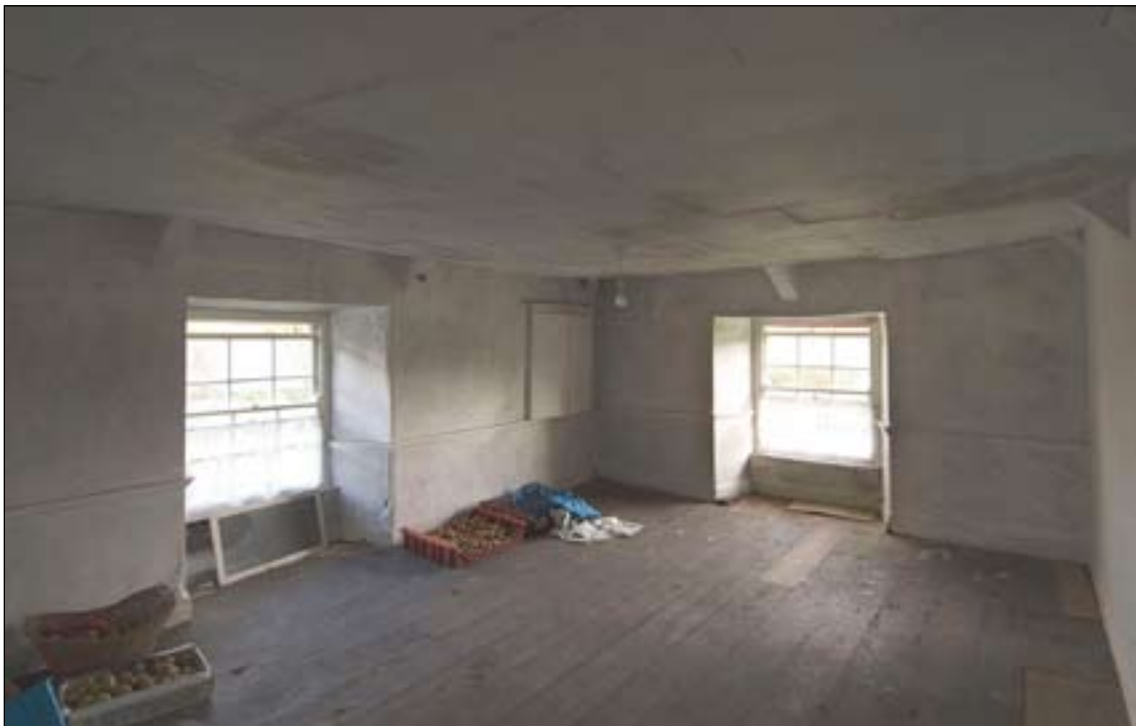
Fig. 43

The east room on the first floor of the south service wing. This was originally unheated; now only the hearth remains internally to indicate the later insertion the chimney stack, clearly visible externally. [DP031612]

The additional accommodation of this new wing does not appear to have been provided for high-status family use; only one chimney stack was initially constructed, in the western gable wall to heat the new kitchen and the chamber above. However, the fireplace in the chamber over the kitchen

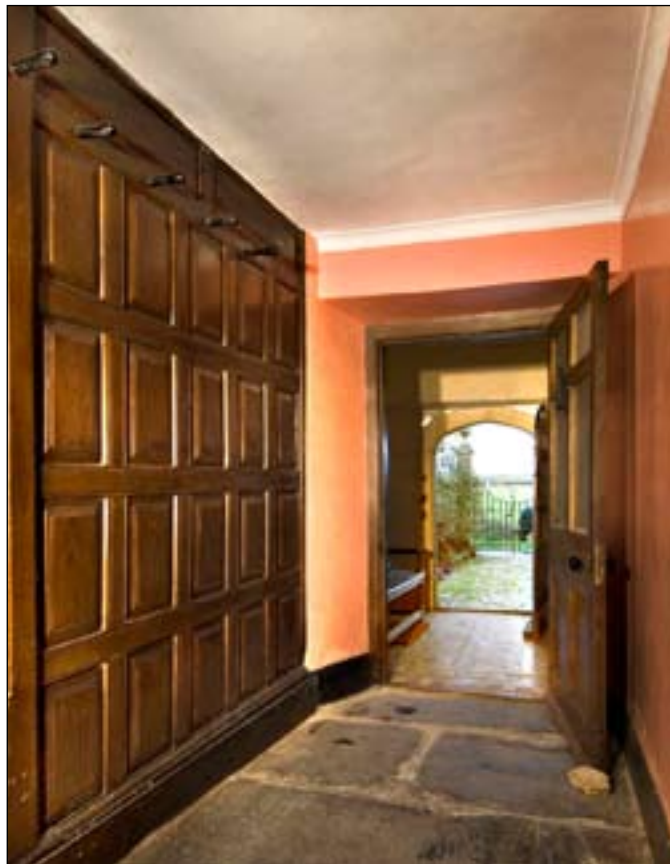
Fig. 44

The through-passage and its 17th-century screen [DP031567]

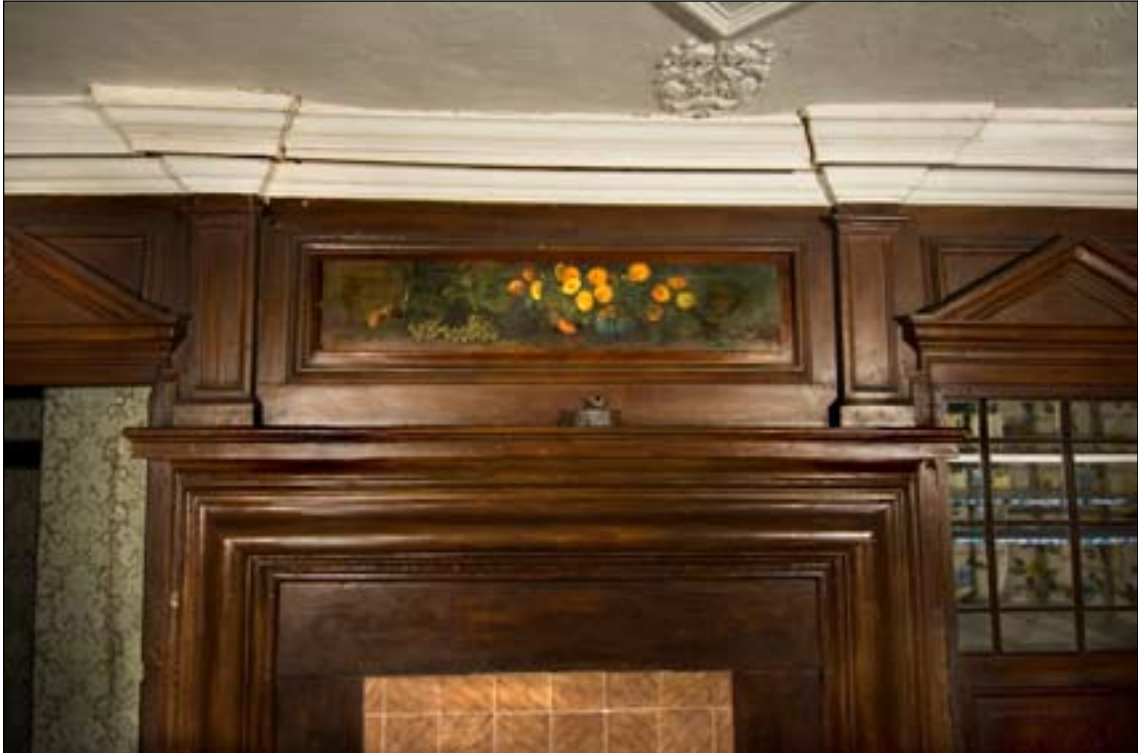
Fig. 45
Parlour fireplace with overmantel and box cornice. [DP031536]

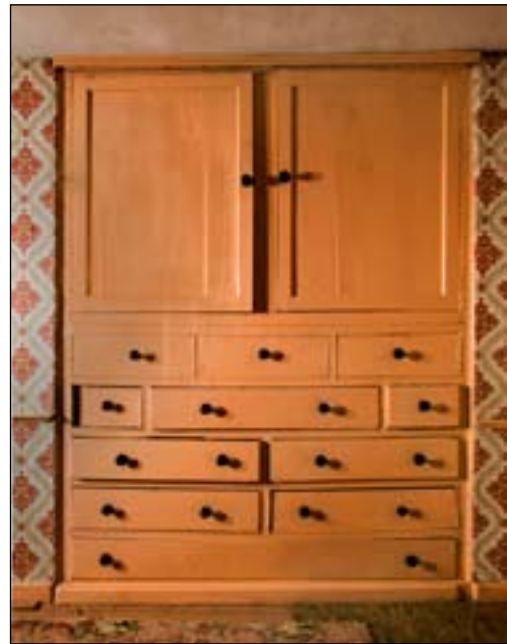
Fig. 47 Cupboard obscuring the ovolo-moulded window in the chamber over the parlour. [DP031689]

It would have been during this refitting of the parlour that the window in its north wall was blocked. The position of this window is hidden on the interior by a display cupboard in its place, but blocking can be seen in the external masonry beneath the blocked first-floor window. Indeed, it may have been at this time that this north window in the north chamber over the parlour was also obscured and hence the present cupboard was fitted over the former opening. The fireplace in this chamber also has a bolection-moulded surround in the manner of the parlour fireplace, but the mouldings appear to be closer to those of the hall fireplace, which is possibly a late-19th or early-20th century reproduction. The chamber over the hall received a similar treatment, with a panelled south wall and a small bolection-moulded fireplace.

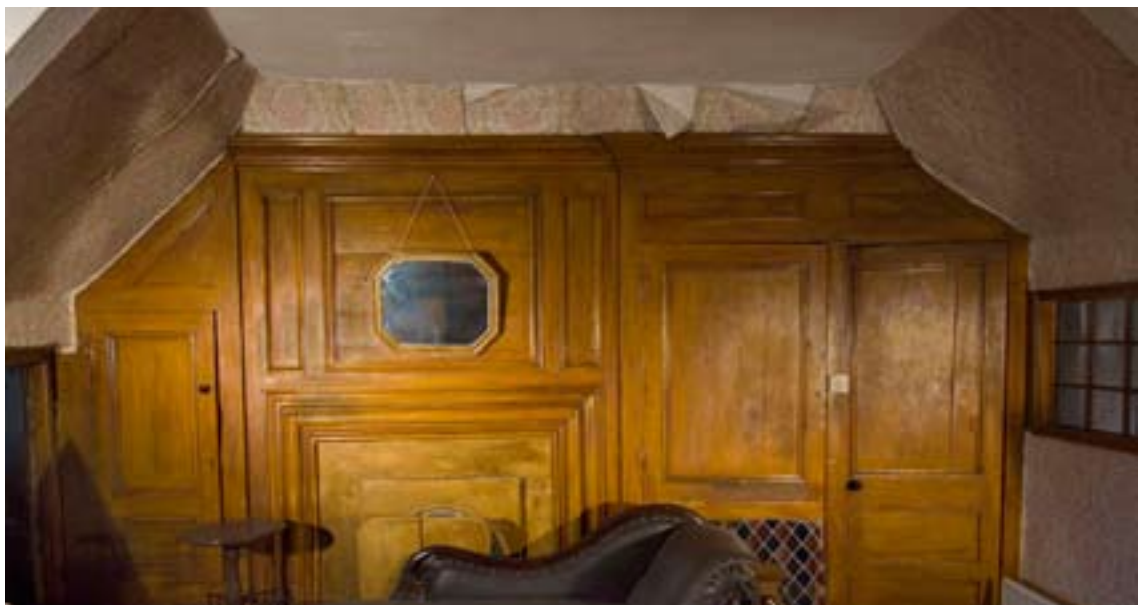
Fig. 48
View of the chamber over the hall. [DP031630]

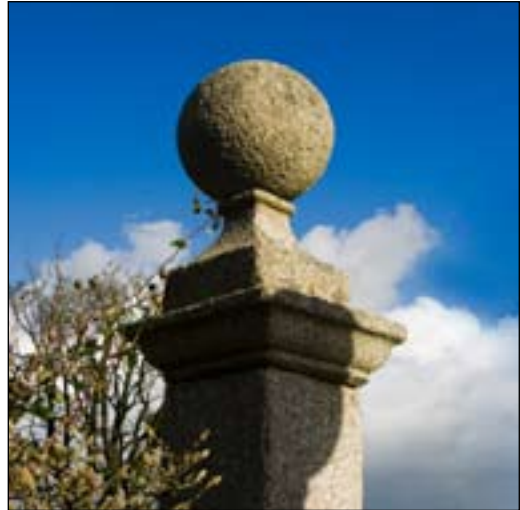
Fig. 49 One of the gatepiers of the forecourt. [DP031627]

The pair of elegantly proportioned gatepiers which frame the entrance to the porch may be the sole survival of an 18th-century scheme for a forecourt or garden in front of the east elevation. The ironwork gates and railings are 19th-century replacements, but presumably there was a previous boundary in this position. The slim piers with their ball finials are reminiscent of a set at nearby Penheale, although these are constructed in brick rather than the granite used at Treludick.

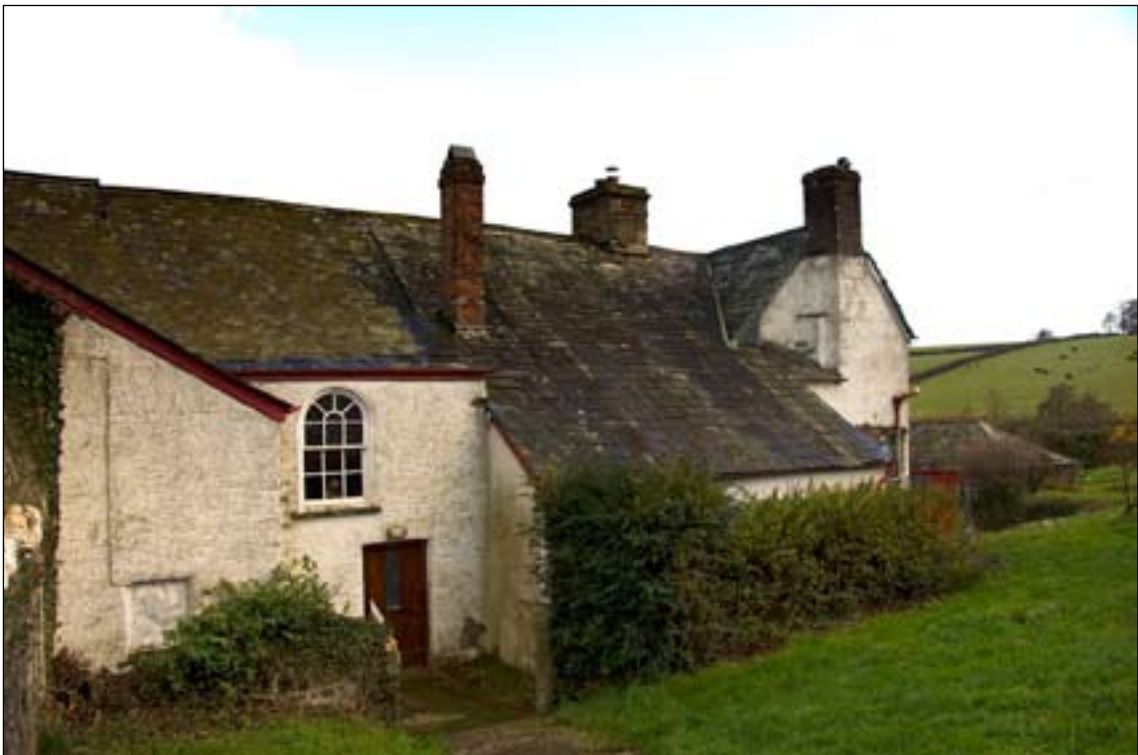
Fig. 50

The house had achieved its present outline by 1839, the date of the Egloskerry tithe map; the precise dates of the western outshots are difficult to determine, but may have been added at any time between the 17th and 19th centuries. There is no access to either of the roofs. One outshot with a catslide roof was built on to the west wall of the old kitchen in order to provide two rooms

View of the western outshots from the north-west. [DP031660]

divided by a thin wall, providing additional space for private or service use, such as a scullery or larder. These may have originally been unheated; the brick stack in the 'piano room' appears to have been a later insertion, perhaps of around 1900, and its chimneypiece seems to have been added in the 1930s. The smaller room is fitted as a study: its window and shelves appear to be
