TRELUDICK, EGLOSKERRY, CORNWALL SURVEY, INVESTIGATION AND HISTORY OF THE HOUSE AND FARM BUILDINGS

SURVEY, INVESTIGATION AND HISTORY
OF THE HOUSE AND FARM BUILDINGS

Research Department Report Series No. 91/2007

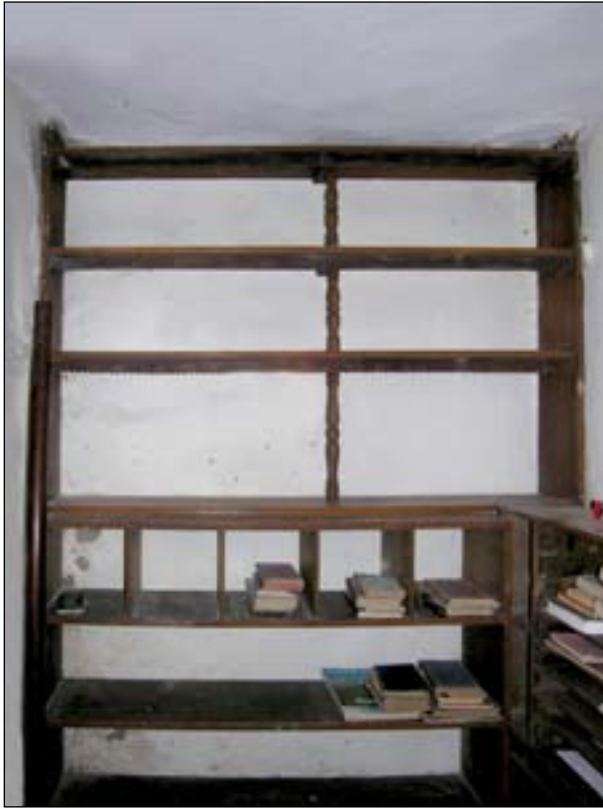
Fig. 51
Shelves of the study. [DP047059]

early 19th century in date. The shelves are constructed from much reused carpentry; this includes three simply-turned balusters, one larger than the others, which might have formed part of an earlier, perhaps 17th century, staircase.

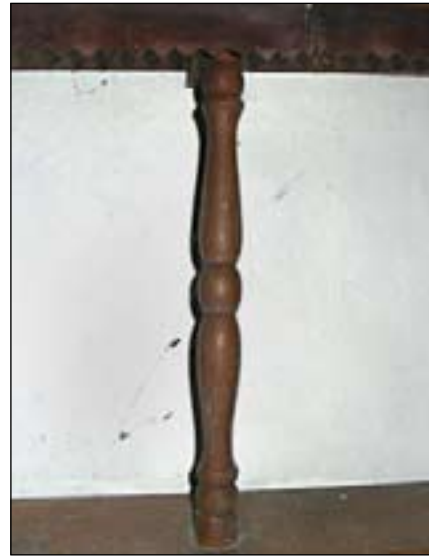
Fig. 52
Baluster reused in the study shelving. [DP047060]

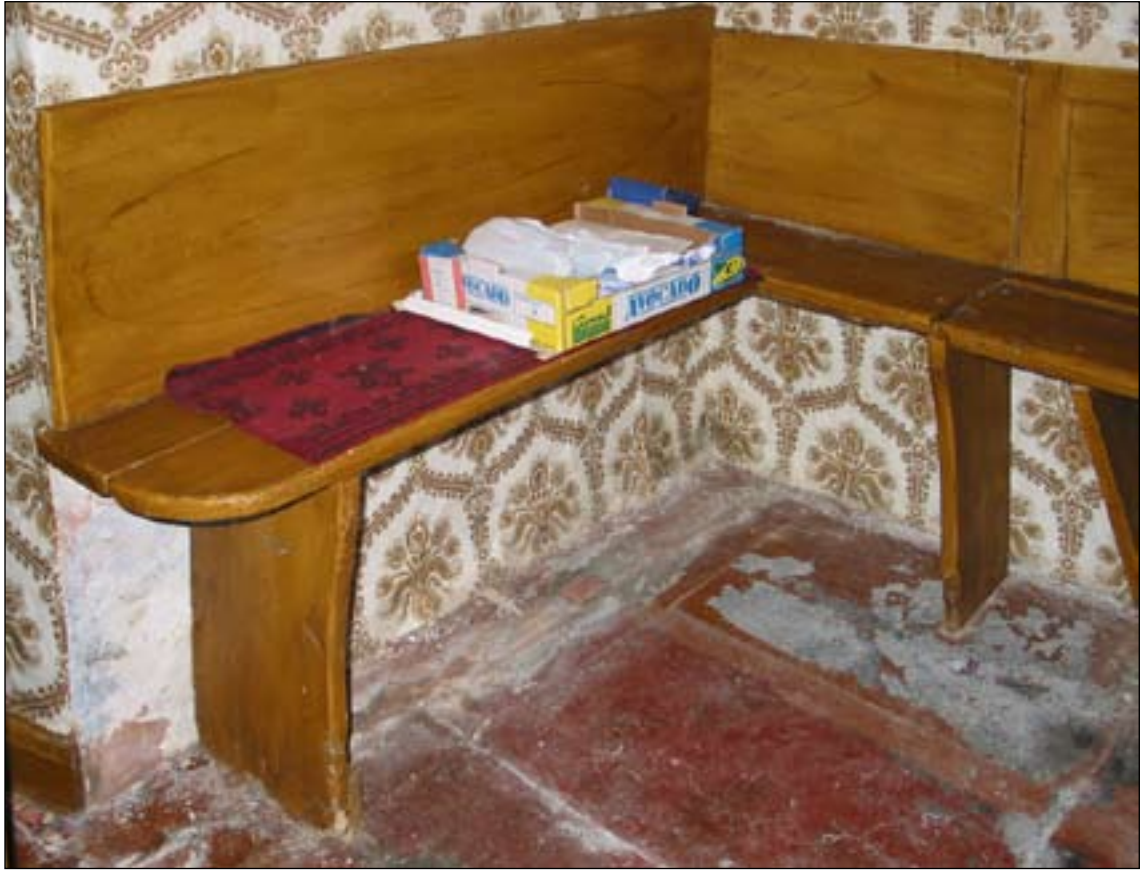
Fig. 54
The kitchen bench. [DP047061]

The old kitchen has a significant number of wooden fittings which appear to date from the late 18th or early 19th century, but may also date as late as the mid-19th century. These include the long bench running along the east wall and extended to the north wall, which provided fixed mealtime seating for many, the cupboards in the north wall, and the fireplace surround (which has long obscured the large, earlier granite lintel). In a similar manner to the shelves in the study and the panelling in the first floor corridor, much of the woodwork has been salvaged and reused: a mixture of different types of panelling, brackets and hinges have been utilised in the construction of the bench and the cupboards. This work is consistent with Treludick's status in the 19th century as a farmhouse, rather than the gentry house it had previously been; it may be concurrent with many of the improvements to the estate, including the rebuilding of the farmyard. The bench itself suggests the necessity to seat as many people as possible for meals, which may date it either to the occupation of Peter Hurdon and his large family in the early part of the 19th century or to its later state as a tenanted farmhouse with many workers to feed.

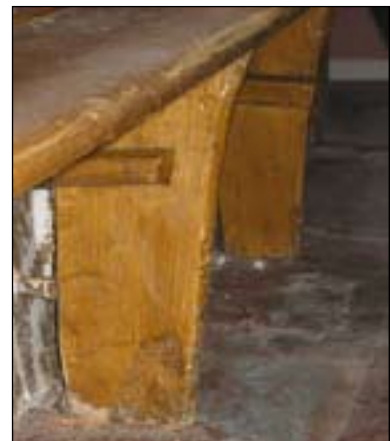
Fig. 55
Detail of the bench supports, similar to those sometimes used for church pews. [DP047062]

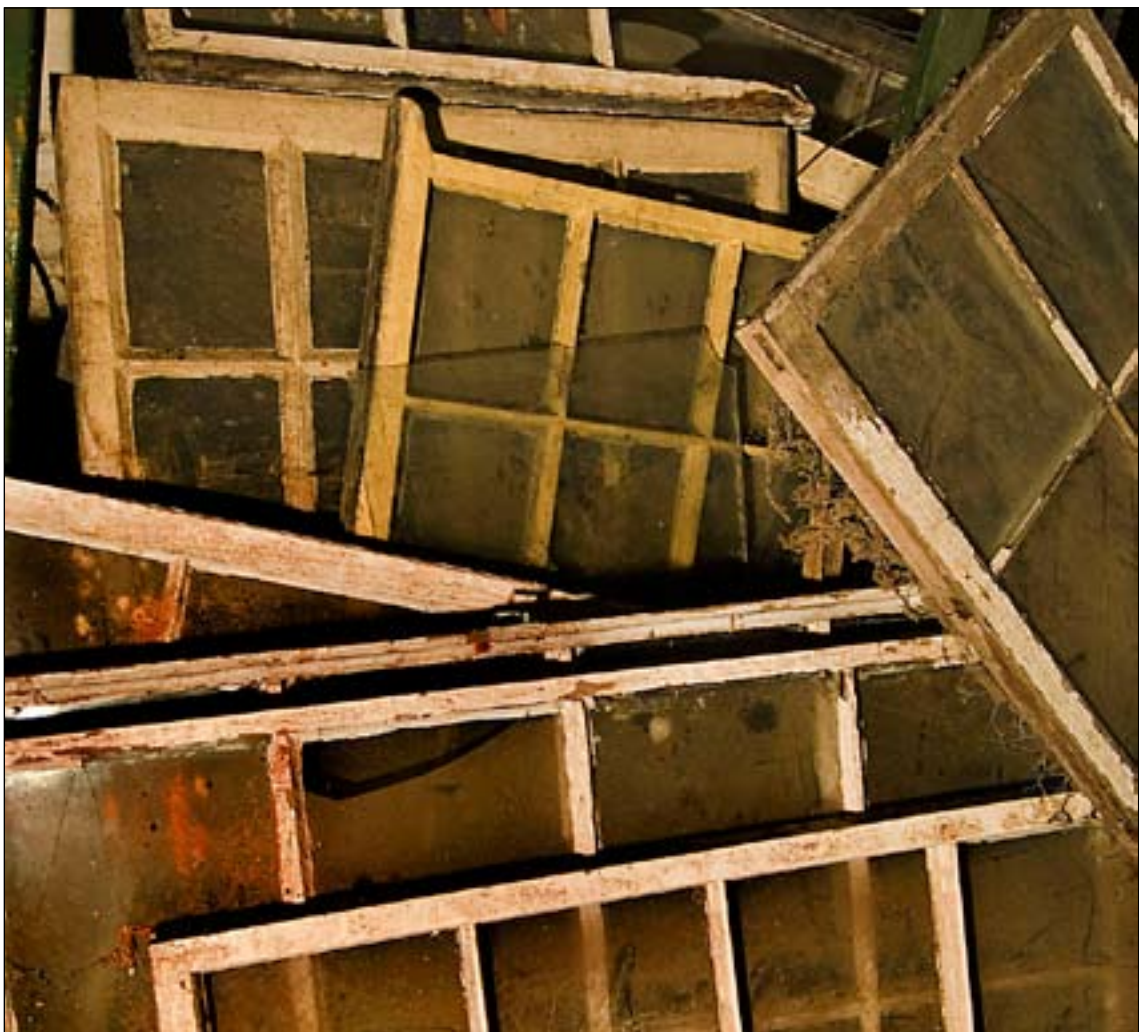
Fig. 56

Discarded sash windows found in a ground-floor room in one of the north-west extensions, showing the variety of 18th- and 19th-century styles which may once have been used at Treludick. [DP031605]

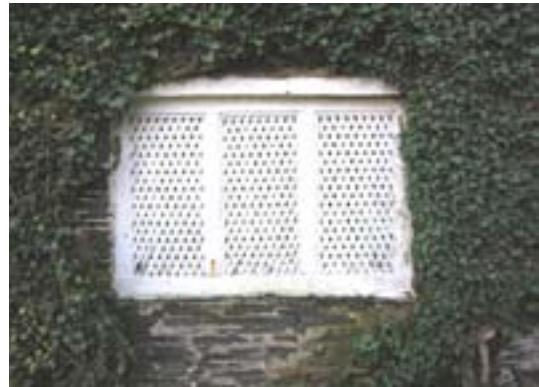
Many of the service features of this wing appear to date from the 19th century, showing a phase of updating and improvement perhaps concurrent with the reconstruction and rebuilding of the farmyard. These include the fitting out of the two ground-floor rooms as dairies, complete with latticework for ventilation across the windows, shutters for the south dairy window, and the cupboards for storage. The present form of the stairs and the woodwork in the small larder for cool storage underneath them also could date from the early 19th century. It is also likely that the flue was inserted into the south wall to serve a new chimney in the easternmost chamber at this time, perhaps converting this room from a farm-workers' dormitory into a bedchamber or office. The original function of the eastern, ground-floor room has not been established: at this period, however, it seems to have been used as an animal shelter or stable, as shown by the drainage channels in the floor. These relate to the south doorway and to the blocking of the north window and door, suggesting a change to animal occupation at the time of its insertion. The construction of the piggery range in the mid-19th century just to the south of this range, with its pump and well, shows a strong desire to improve the productivity and functionality of Treludick as a working farm.

Fig. 57
The north window of the dairy. [DP047063]

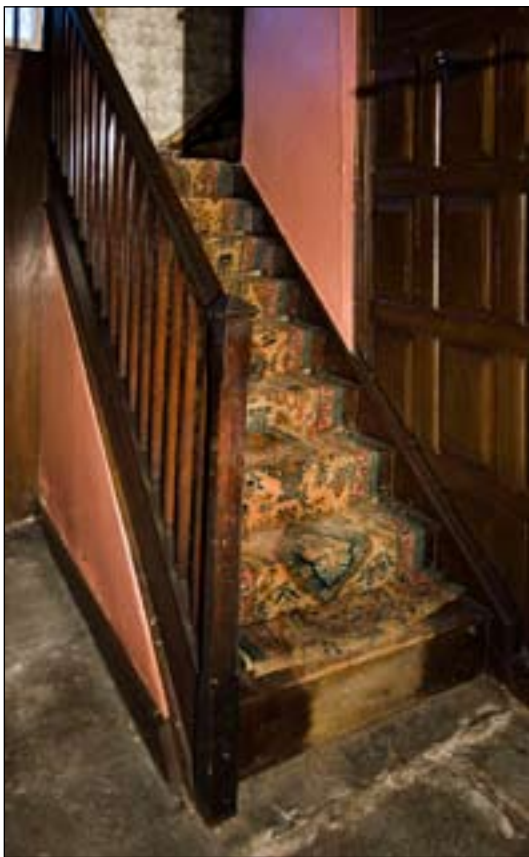
Fig. 59

Around 1900, the two principal staircases in the house (one rising from the through-passage and the other rising from the north-west corner of the parlour) were replaced; the present stairways share a similar, simple baluster design.

The principal staircase in the through-passage.
[DP031573]

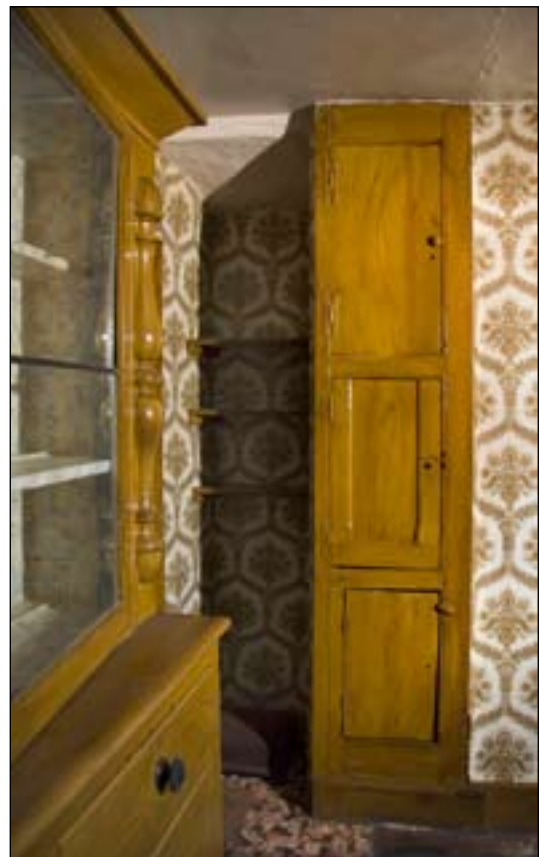
Fig. 60

Much of the woodwork in the southern part of the house was painted with a wood-grain effect, possibly around 1900. This can be seen in the kitchen, particularly on the bench and cupboards, the fireplace of the hall (which may have been added at this date), and on the panelling and fireplace of the chamber over the hall.

Wood-grain paint effect in the old kitchen.
[DP031578]

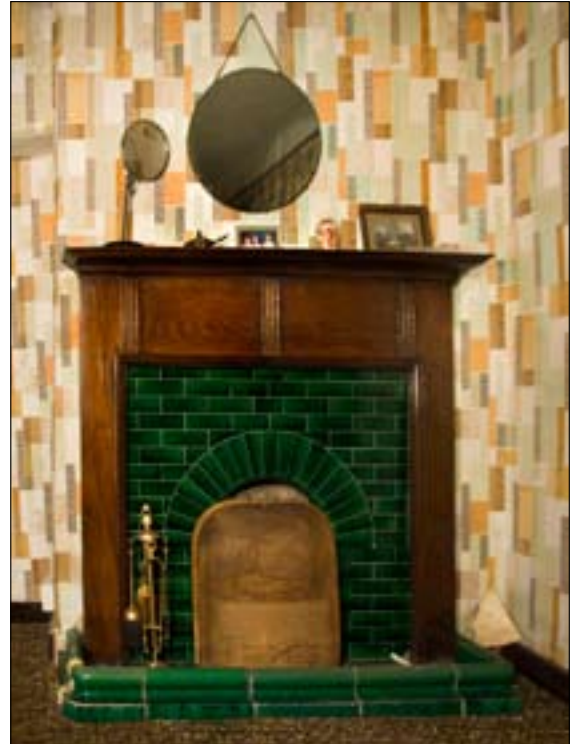
Fig. 61

Substantial redecoration of much of the house was carried out in the second half of the 20th century, perhaps during the 1950s. This includes much of the present carpet, wallpaper and linoleum, as well as the fittings of the bathroom and kitchen. An earlier attempt at improving the house in the 20th century can be seen in the 'piano room', where a fireplace of the 1920s or 1930s was inserted.

Fireplace in the 'piano room'. [DP031585]

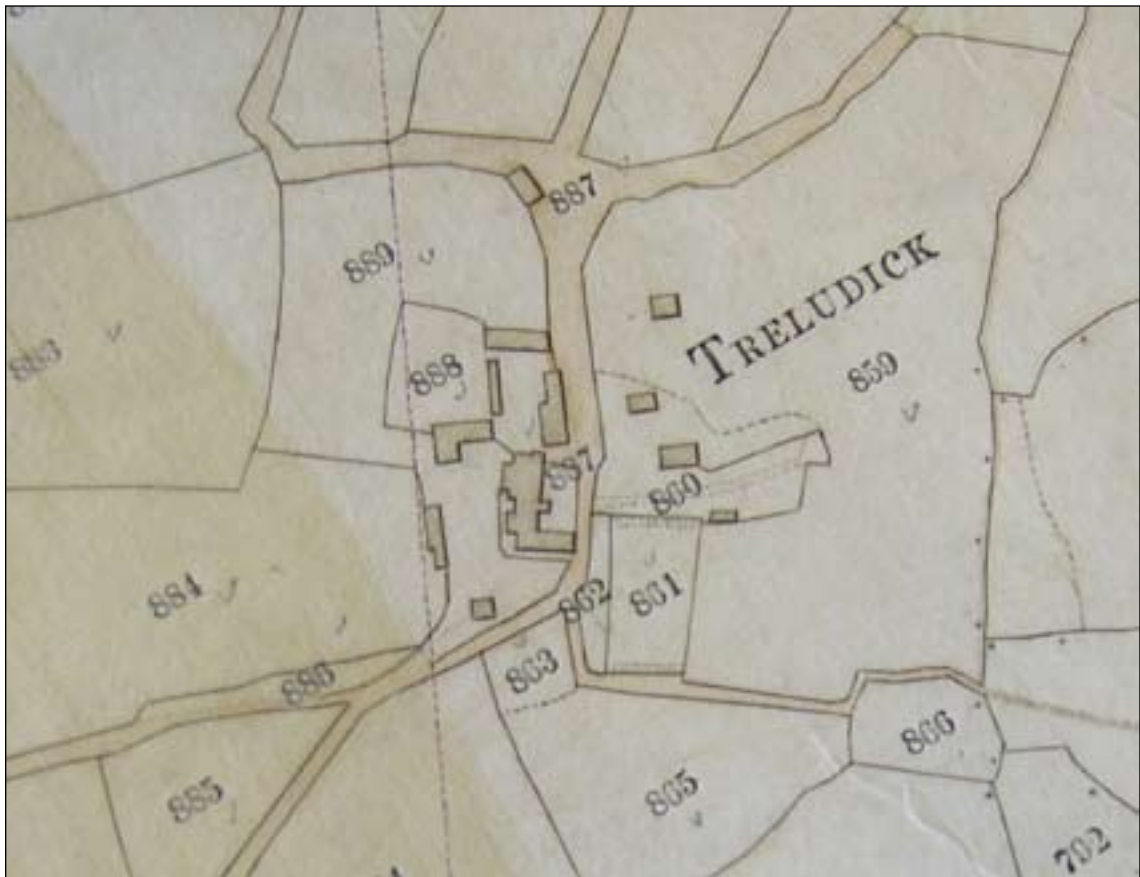
Fig. 63

The form of the farmyard illustrated in the 1839 tithe map of the parish of Egloskerry was the forerunner of that of today, covering a similar footprint but comprised of earlier structures. A building, possibly a stable or barn, lay to the north of the house, forming the eastern range of the yard and of very similar dimensions to the current stable block. To the north, the farmyard was bounded by a long, narrow barn, again following the lines of the present structure, and to the west was a narrow, detached barn. The most substantial of all the farmyard buildings at this date was an L-shaped barn lying to the north-west of the house, at right-angles to the main farmyard. The tithe map clearly shows several parts of the existing farm complex (see the annotated plan overleaf for their location and numbering), notably the cob barn (8), the ruined shelter to the north of the farmyard (12), the small, square barn to the south-west of the house (2), and the barn facing the west elevation of the house (3). These structures are generally constructed of a combination of cob and stone and may date from the 17th century. Several other structures shown in 1839 have left archaeological traces (see appendix), including a building in the former orchard (which is shown on the 1884 Ordnance Survey map, though not on the map in the 1877 sale catalogue) and two buildings in the field east of the house; their purposes are not known.

Detail of Treludick, from the 1839 tithe map of the parish of Egloskerry (CRO TM53).

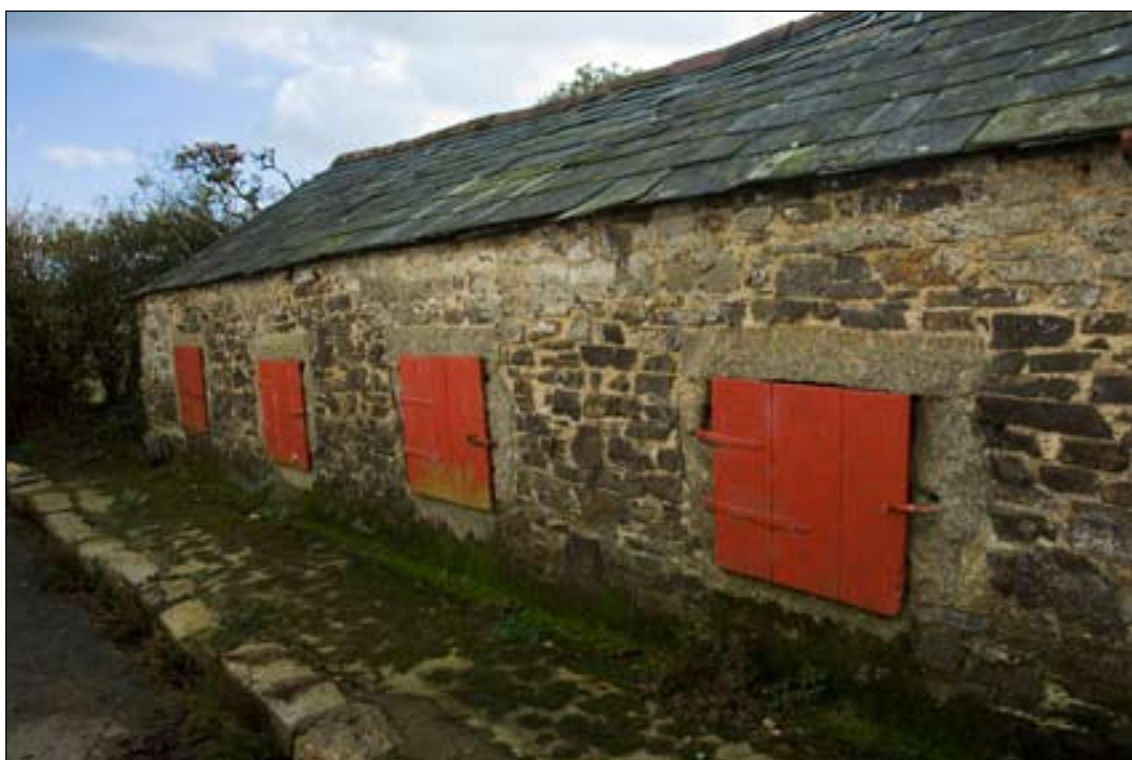
Fig. 65

The mid-19th-century piggery complex is built of rubble with granite dressings and covered with a hipped slate roof under a ceramic ridge. It was built after 1839, not appearing on the tithe map of that year; the rectangular building houses four pigsties with a pump house at the western end. It was constructed close to the south extension of the house, making it convenient for the raising of pigs on kitchen and dairy waste. The four individual sties, divided from each other by timber and slate divisions, had their own doorway in the south wall (two of which have been subsequently blocked) and an external feeding hatch on the north side with an internal granite trough. The feeding passage here was external and uncovered: a raised path edged in granite blocks runs parallel to the north wall to provide easy, level access to the feeding hatches. External pig runs on the south of the complex have gone; this usage is suggested by the remains of a cobbled surface and the enclosure of the area by walls.

View of the pigsties from the north-west. [DP031638]

To the west of this block is a room separated from the sties by a full-height masonry cross wall with opposing doorways to the north and south. This currently houses a pump and granite trough. The six lapped and collared trusses of the building (two over the pump house and four over the pigsties) are similar throughout; the timber used has a local, vernacular flavour. On the north side of the pump house, both trusses rest on a substantial timber plate, suggesting that this flank of the building was originally open to the elements.

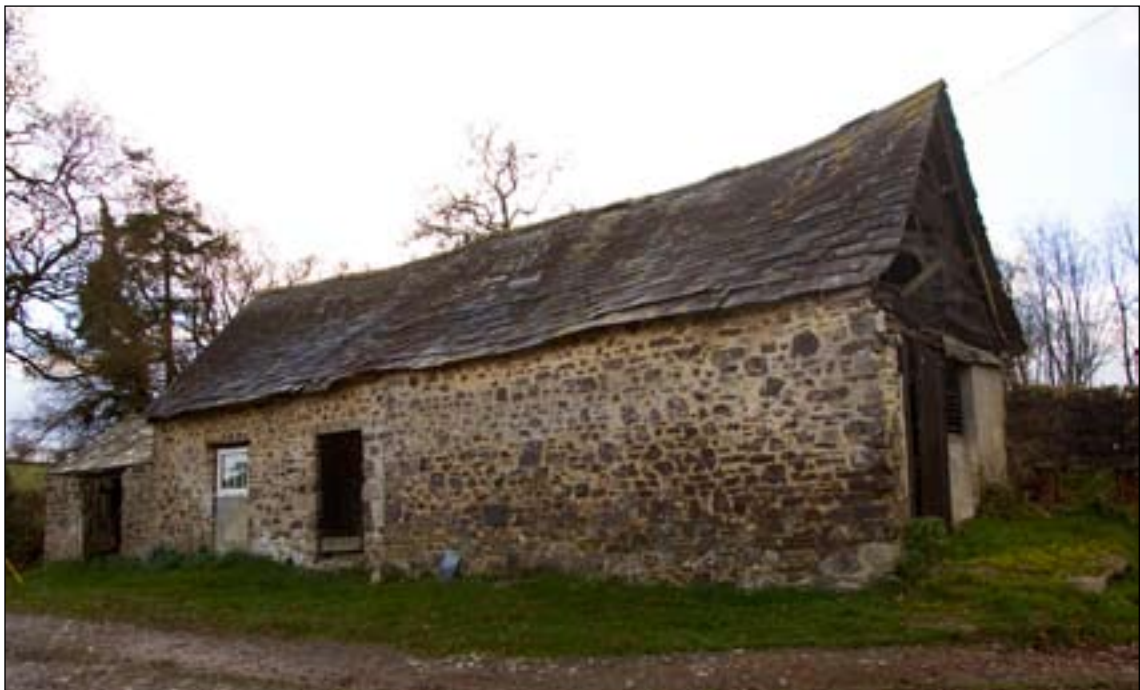
Fig. 66

This long, thin, single-storey barn consists of two sections, divided by a wooden partition, with a slate-covered, gable-ended roof, and a lower addition to its southern end. It is rubble-built with a granite lintel over the central door; all other lintels are wooden. The building is clearly shown on the 1839 tithe map, and may represent a 17th- or 18th-century phase of farmyard development.

The barn to the west of the house. [DP031659]

The doorway of the southern extension is partially blocked; this part of the building was reroofed in the 20th century. The central section, accessed through the granite-lintelled doorway, has a blocked doorway in the east wall, a small window in the south gable and a later, softwood manger at its north end. This section is roofed with three half-lapped, collared trusses; a fourth truss supports the wooden partition.

The northern section of this barn is roofed with two trusses of similar form, with the eastern timbers being carried on a continuous timber wall plate and the rest on thin wooden pads inserted into the rubble wall. The projection of the east wall of the barn corresponds with the position of the wall plate, suggesting that this end of the barn was originally open-fronted. The interior has been modernised with breeze block animal troughs and softwood mangers running down the west wall. Depressions in the ground to the north of the barn and the rather temporary nature of the wooden north wall could imply that the building had once been larger and has been curtailed; however, the tithe map shows a building consistent with the present structure.

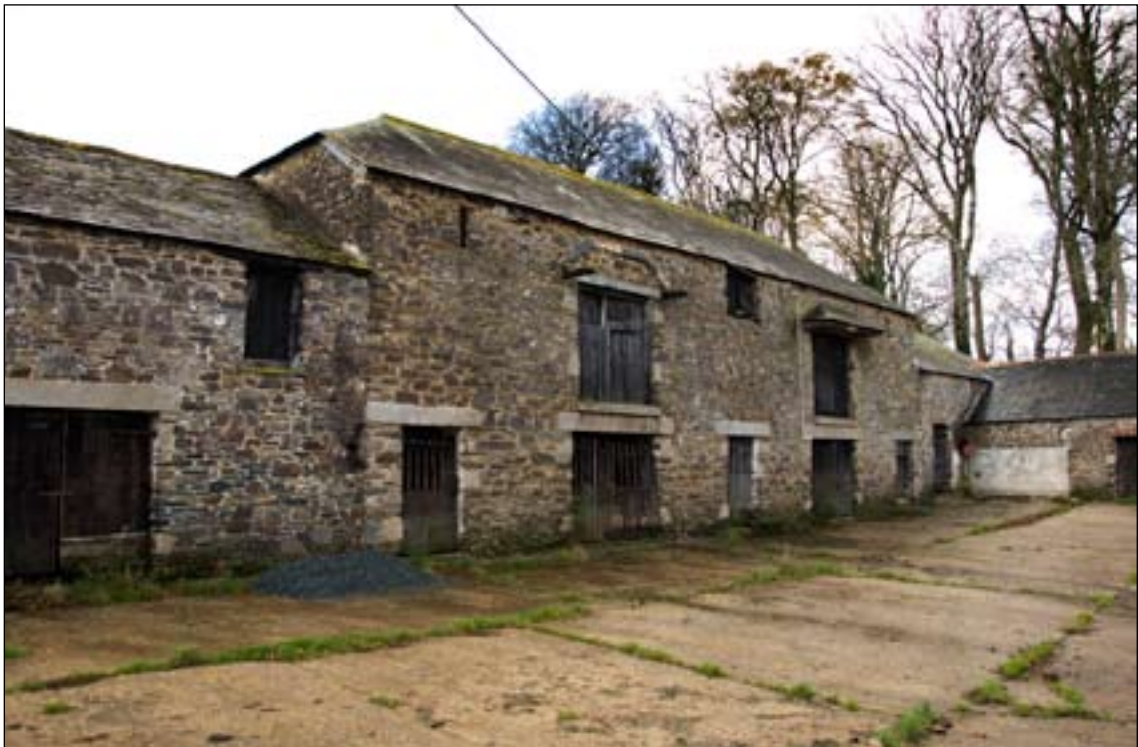
Fig. 67

The construction of the bank barn indicates a major phase of redevelopment of Treludick's farm accommodation during the mid-19th century. This tall barn, with two-storeys facing the farmyard and one facing the hill to the rear, was built on the site of a smaller building shown on the tithe map of 1839. It is characterised by the use of coursed rubble masonry with massive granite lintels over the ground-floor openings, a half-hipped slate roof, and two slate-covered hipped canopies

The bank barn. [DP031668]

over the first-floor doorways (only one of which survives). Shortly after its construction, a lower addition was built onto its south wall in a similar style using granite lintels and a half-hipped roof. A further addition was built to the north of the main barn a little later; its brick, segmental-headed doorway mimics those of the north range of the farmyard (5), suggesting that it was built at a similar date in order to link the north and west ranges together. A smaller and lower addition was made to the south in the late 20th century, built of breeze blocks with a corrugated iron roof.

The main bank barn exhibits typical multi-functionality, with its ground floor probably used for shippon and the spacious upper floor used for storage and different forms of processing. The two pairs of opposed doorways in the east and west walls on the upper floor facing the bank and the farmyard suggest suitability for threshing; a threshing floor remains between the northern pair of doorways but not between the southern. An internal room has been constructed in the north-west corner of the upper floor using stud and plank partitions, creating a separately ceiled-in space probably for grain storage. Line shafting supplied power to this corn bin, to the north wall of the barn, and to the surviving processing machinery near the east wall. A large wooden rack rests across several trusses, suggesting storage for apples. The seven soft-wood tie-beam roof trusses appear to date from a period of mass-production, consistent perhaps of the period c. 1860 to c. 1880; this may imply construction by a large-scale company rather than local builders working with vernacular styles and materials. The similarity in design with Lynher, North Hill, has already been noted. In 1877, it was described as a barn & granary 'with ample Waterpower on the first Floor' and on the ground floor a 'Mill House, Root House, and Cattle Challs for 15 beasts'.⁴⁰

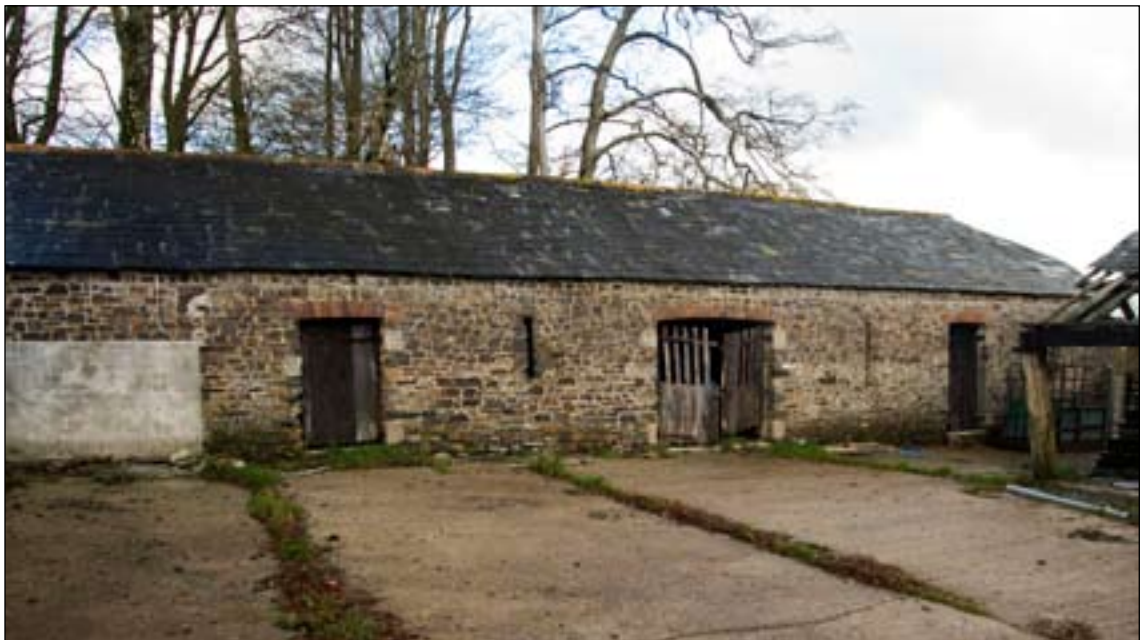
Fig. 68

North farmyard range. [DP031664]

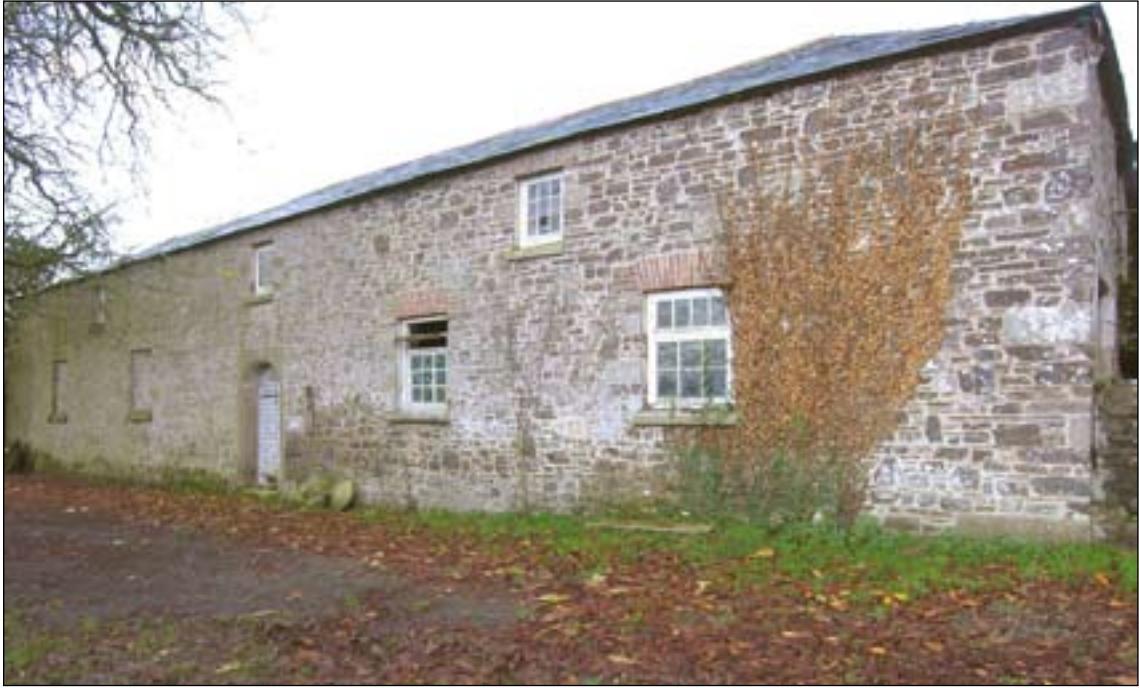
Fig. 69
The stable block, with the reset 'IBMB 1641' doorcase. [DP047065]

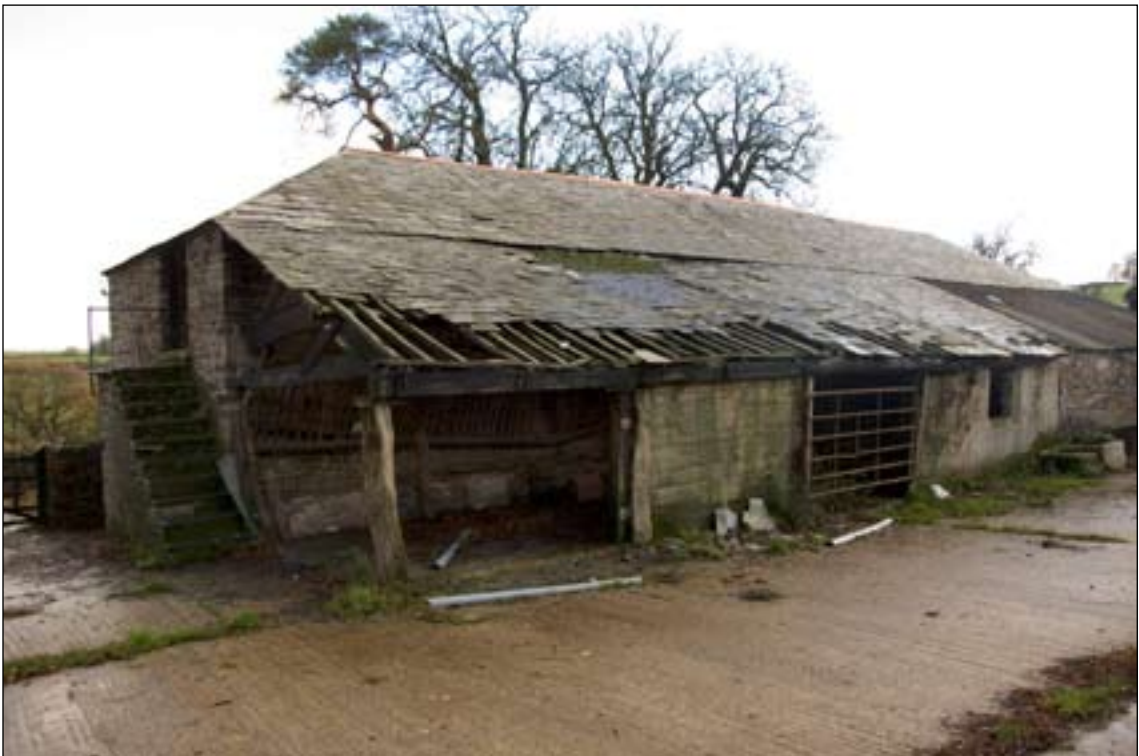
Fig. 70
The linhay portion of the stable block. [DP031665]

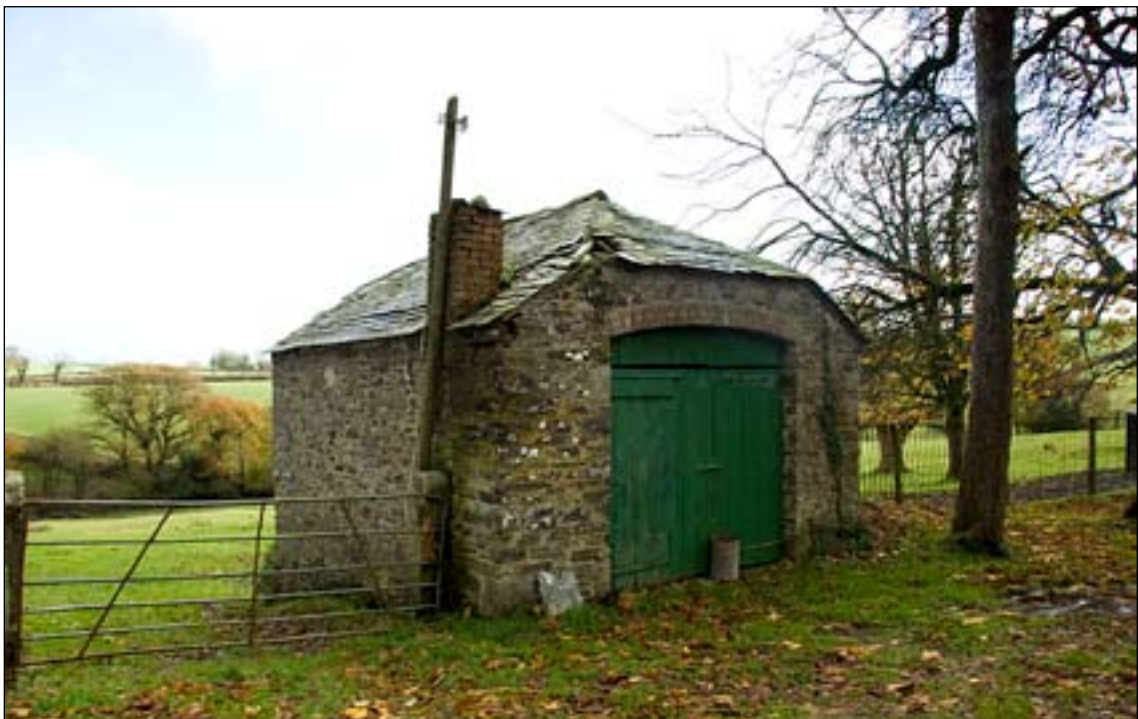
Fig. 71

This small, single-cell building is constructed in the same style as the stables and the north farmyard range, in rubble with brick dressings over the segmental-headed double doorway and half-hipped slate roof; its style, position, and cobbled floor indicate a suitable home for a carriage. The recesses in the north and south walls are lined with timber in order to support tack hooks, and a small chimney stack in the north-west corner might have provided the means for the building to function also as a forge or workshop. The roof is carried on two half-lapped collared trusses with bolted joints.

The carriage shed. [DP031640]

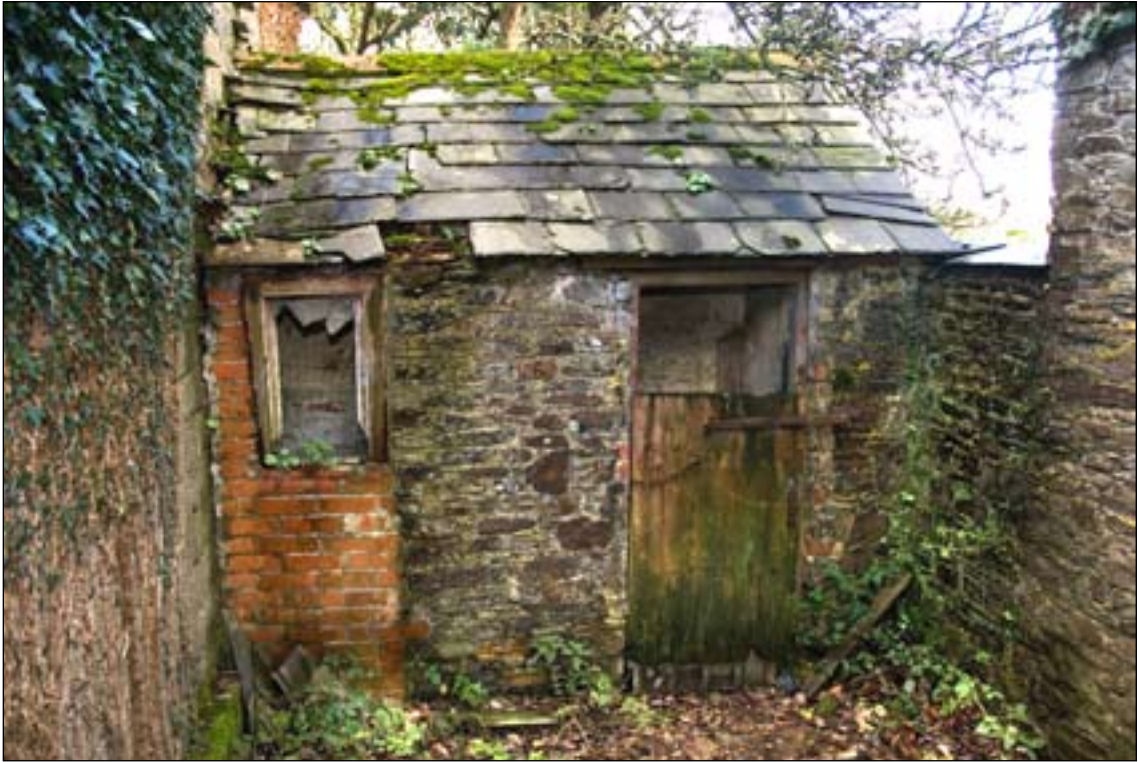
Built onto the south end of the stable and linhay (6) is a small single-storey rectangular rubble structure with two doorways on both east and west. It is built over a deep, fast-flowing watercourse and is most likely to have been a small privy block. Several of the doorways have been subsequently blocked, but their arrangement suggests that the two facing west would have served the farmyard and the two facing east (divided by a wall) the stables to the north and the garden of the house to the south.

Fig. 73
The privy, from the west. [DP031662]

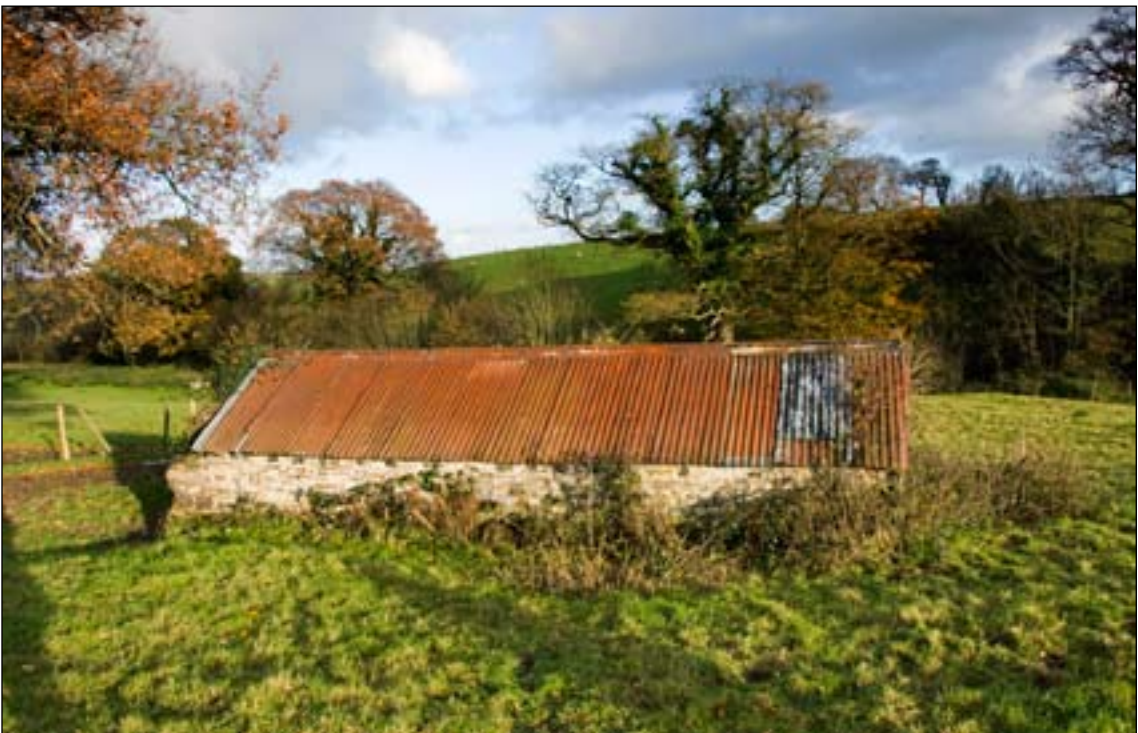
Fig. 74
The wheel house. [DP031649]

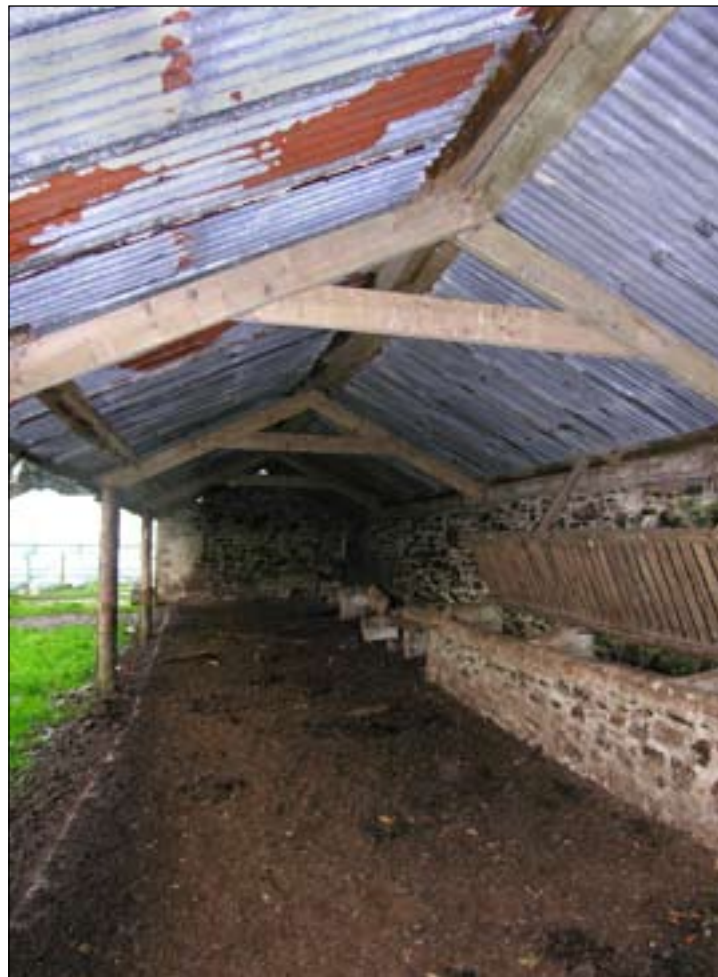
Fig. 75

This rectangular, open-fronted structure is first recorded on the 1888 OS map of Treludick. It is probably the 'Sheeps house' constructed in the last months of 1888 by George Wadge for the Marke estate, at the cost of £16:15:00. His estimate, 'To fell the timber, saw it & fix it, provide ironwork for the roof, build a wall with stone & mortar to be 60ft long & 14ft wide...The end to be boarded with manger on one side', describes the present building well.⁴⁴

Shelter north-west of the complex. [DP047066]

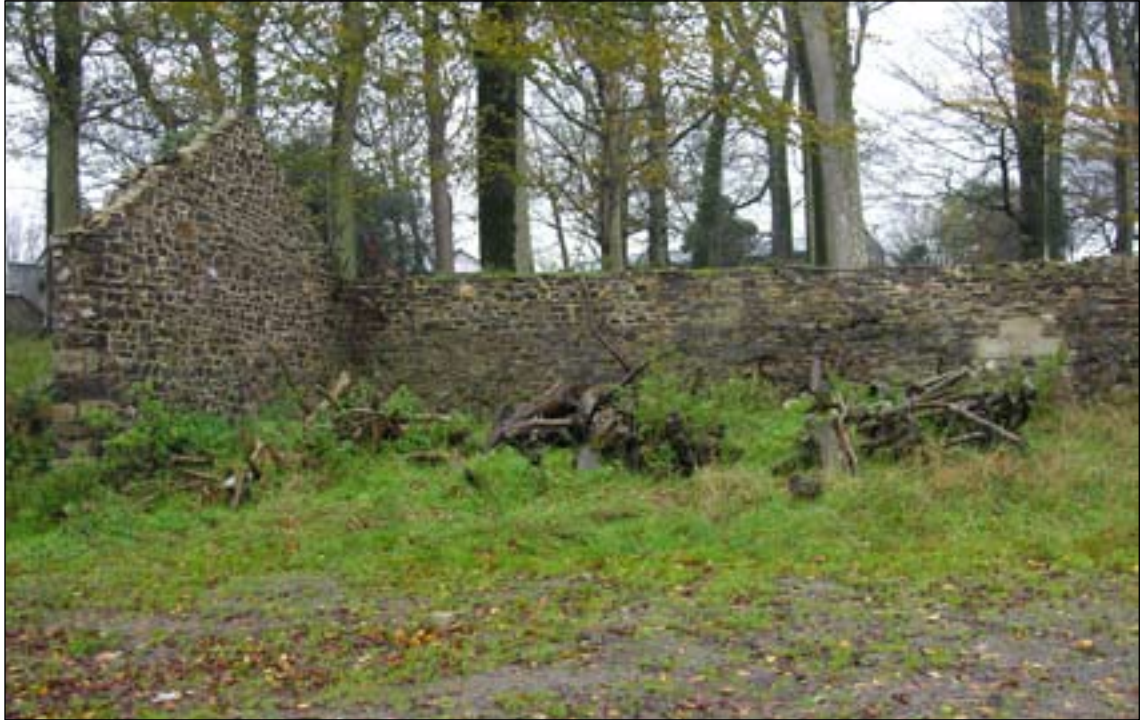
Fig. 76

To the north of the farmyard lie the remains of a rubble-built farm building. The remaining masonry north and south gables and western wall suggest that it was once an open-fronted structure similar to the surviving shelter to the north-west of the farm complex (11). It is clearly shown in the 1839 tithe map, and its use of substantial granite blocks in the gable walls may also suggest origins in the 17th or 18th centuries.

Ruined shelter. [DP047067]
