FORT PITT, CHATHAM, KENT AN EARTHWORK ANALYSIS OF JACKSON RECREATION GROUND

SURVEY REPORT

NGR: TQ 7485 6770

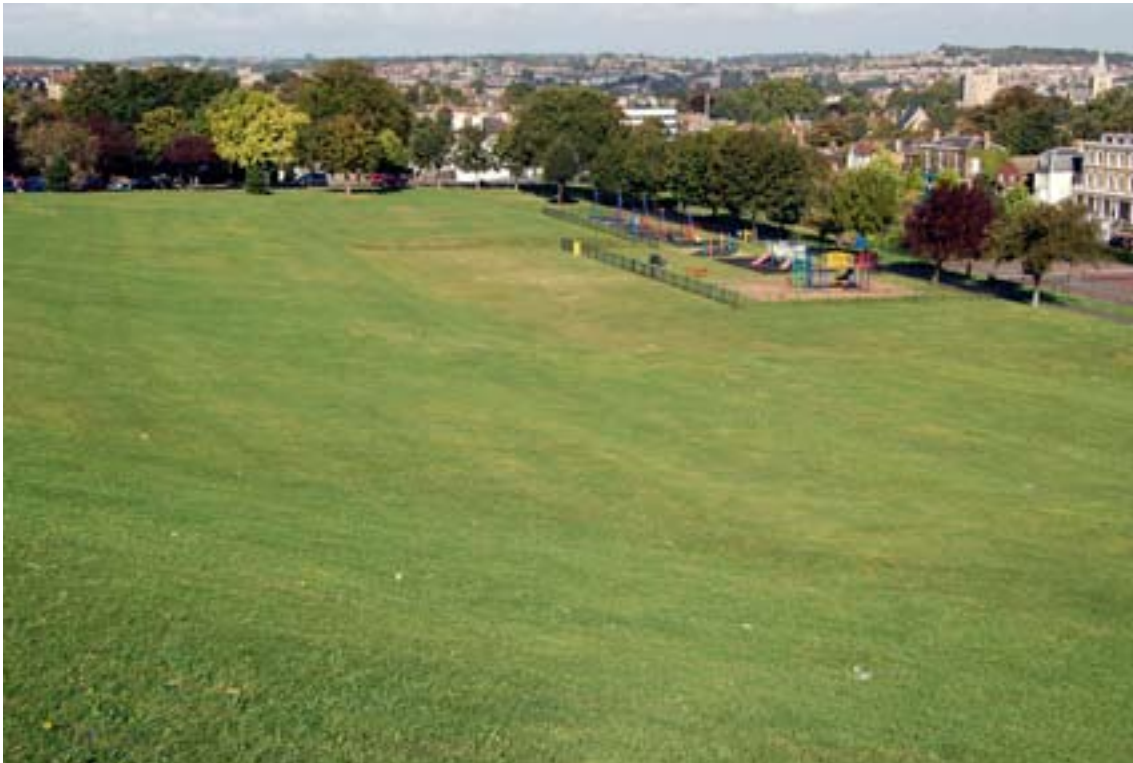
Fig 2: The north-west of the survey area, looking north-west

In the north-west corner of the survey area is a rectangular terrace oriented roughly along the natural slope, west-north-west to east-south-east, and defined by clear slopes measuring a maximum of 120m by 32m. This is also both a negative and a positive feature and is partly occupied by a children's playground. At the western end of this area, on its southern (uphill) side, is a smaller sub terrace, also rectangular, that measures approximately 60m by 20m. On the sub-terrace are the remains of a structure of some form (a) visible at its western end both as a small but well defined scarp and in places by building remains just below the turf. It is less well defined to the east but was 13m wide and approximately 18m long. In the internal angle between the sub-terrace and the main terrace is a very slightly raised area. The triangular area between the playground terrace and the sports field consists of an apparently natural slope crossed by a gentle scarp probably created by the removal of material from below (b). This scarp merges with the natural slope at its western end and in the east appears to run under the central terrace earthworks. It has some slight undulations running down slope and at one point clearly bulged out. There is a secondary scarp above the main slope. Above this the ground is uneven but the only clear feature is a small ridge running down hill (north/south) with a slightly amorphous gully immediately to the west. Below the scarp the ground is more level with an irregular mound approximately in the centre. To the west of this is a shallow spur projecting from the scarp and at the west end of this area are several hollows including one broad flat-bottomed gully running into the recreation ground at right angles to City Way. To the east of the playground terrace is a clear but gentle slope (c) that had been cut by the terrace at its western end. Above this (south) is a second

fainter slope parallel to the first. All the main slopes in this area were similarly oriented running roughly horizontally along the natural slope.

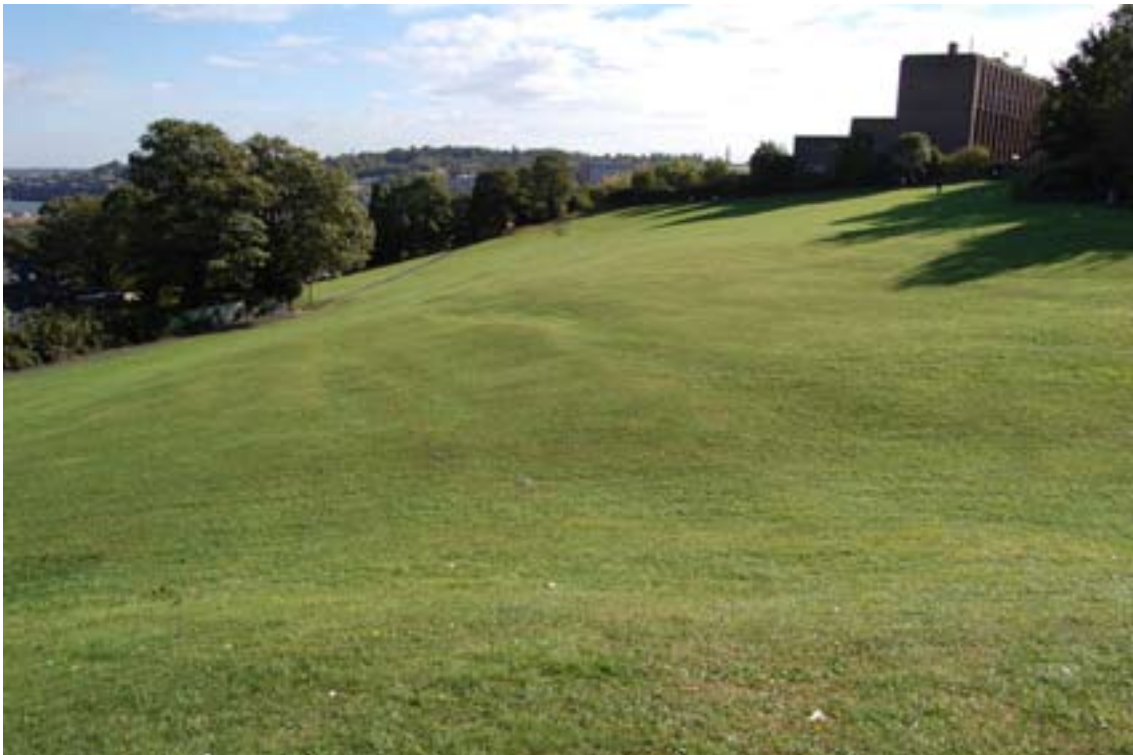
Fig 3: The north-east of the survey area, looking east

Most of the area to the east of the sports field consists of moderately steep natural slopes dropping down towards the north and north-north-west forming a slight bowl. The far eastern boundary of the survey area is marked by a tall retaining wall for the fort moat beyond. There is a clear slope, partially obscured by vegetation, dropping away from this wall forming a faint glacis (d), which runs up the natural slope. At the south end the boundary turns west and running alongside this is a more level area defined by a slightly steeper scarp running east-west parallel to the boundary and about 6m from it (e). Within the corner between these two sections is an entrance into the college. A foot path has been worn into the slope here slightly eroding the east/west slope creating a short slope on the downhill (northern) side. To the west the recreation ground boundary again turns south and another flat area, defined by a west facing scarp running parallel to the boundary and 6-7m from it, runs for about 60m before ending at a north facing cross slope. This level area is cut by a small gully. Just below the corner between these latter two sections are several scooped features that appear to be later than the other slopes and have disturbed them. However, the east to west slope appears to run out into the recreation ground for a short distance rather than running around the corner to meet the north-south slope. Below these features, to the north, is a linear earthwork that ran roughly east west along the slope dropping slightly towards the west (f). This probably originally consisted of a fair sized bank, possibly with ditches on both sides but it had weathered down to a simple slope with flatter areas above and below. At its eastern end it is cut by modern features and abutted those associated with Fort Pitt. At its western end it appears to end at a slight bulge that was part of a complex

series of interrelated earthworks (g). Above the bulge a scarp of a similar size to the linear described, continues along the slope further to the west and above this are a few smaller parallel slopes creating some small terraces. These are all cut at their eastern ends by a sub-rectangular feature (h). At their western ends a series of gullies and banks run diagonally up the steeper ground here from north-east to south-west (i). Some have the appearance of track ruts but others are less regular. Just to the west of these is a short section of another scarp that ran along the natural slope on a similar orientation to the small terraces above the larger slope mentioned above (j). These features ended abruptly leaving a narrow blank area running directly down slope, between them and the earthworks of the sports field. Above these complex earthworks the ground slopes upwards with a few broad, irregular platforms defined by slight scarps.

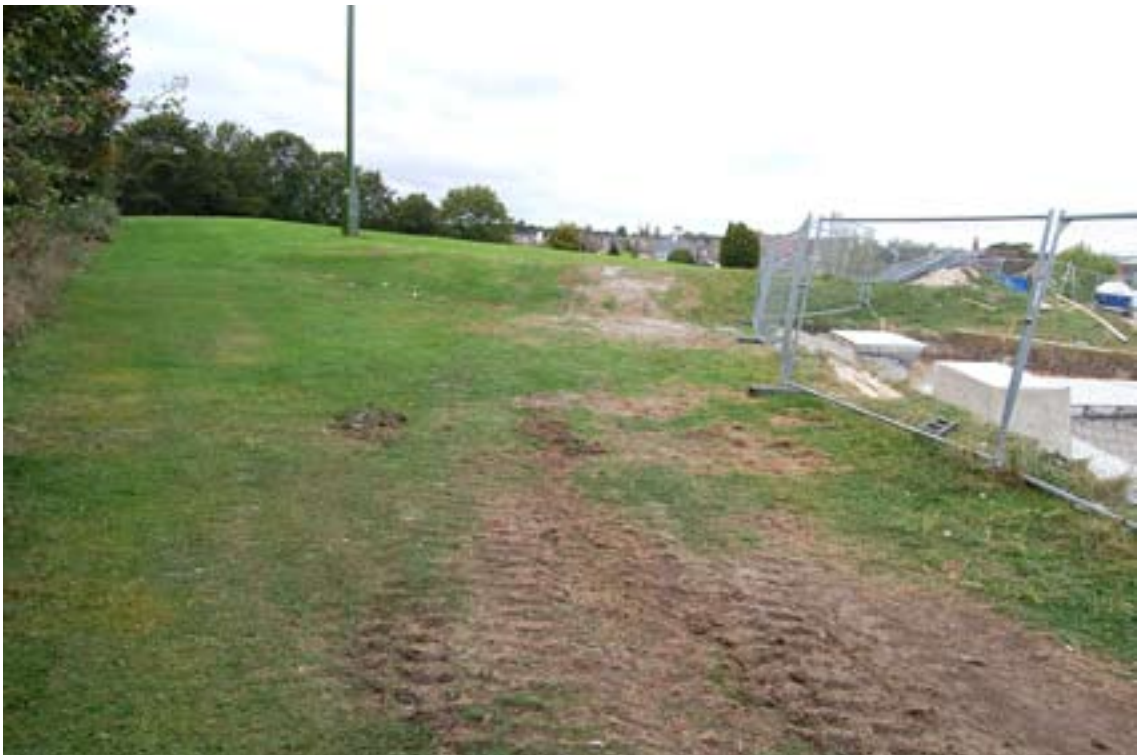
Fig 4: The south of the survey area, looking south west along the south eastern boundary showing the remains of the earthwork that ran across to Delce Tower

The area to the south of the main terrace is near the crest of the natural topography here and slopes down more to the west than the north. A clear bank, oriented north-east to south-west, runs along the south-eastern side of this area parallel to the recreation ground boundary (k). On its north-western side the scarp is uneven, probably as a result of subsequent activity, and merges into the natural slope. To the south-east the scarp is more clearly defined. At the southern end of this feature the ground has been disturbed but the earthwork appears to turn to the south-east and runs into the corner of the recreation ground. Between the bank and the recreation ground boundary is a broad ditch defined by a shallow scarp to the north-west with a narrow flat area between this and the scarp of the bank; the south eastern scarp can be seen but not surveyed due to heavy vegetation. At their northern ends the bank and ditch have been truncated by subsequent activity but the bank clearly aligns with a clear east-north-east facing scarp with a slight counterscarp (l) that also runs parallel to the

south eastern boundary of the recreation ground for about 10m before turning away from it to the north west where it can be seen to continue through the construction site (September 2007) for the skateboard park. A post for a CCTV camera has been installed on the bank at the point where it turns, the cable trench for which is clearly visible as a vegetation mark running away to the west where a junction box has been installed next to the pavement alongside City Way. Below (west of) the south-west end of the bank described above a small south facing scarp runs west before curving around to the north where it forms a shallow gully before petering out. Immediately below this is a small scooped feature. From here a southwest facing scarp runs into a series of north-north-west facing scarps that ran parallel to City Way (m) becoming increasingly faint, until they reach the haul road for the skateboard park construction site. Within the triangular area defined by this feature, the slight bank to the east, and the haul road to the north, were a few vague and intermittent features, the best preserved of which could be seen to form ridges on two general alignments; east to west (n) and north-north-west to south-south-east (o). They were too faint to record accurately but their general alignments were surveyed. In the eastern part of the area, an apparent series of sub rectangular platforms could be seen defined by slight scarps and ridges, the clearest of which was to the south. However, as several of the defining features align with the general trend of ridge features in this area they are unlikely to be platforms. To the west two scoop features immediately above the main scarp down to City Way were recorded but were clearly associated with modern works. Across the survey area several concrete bases with fixings were recorded, these were apparently for park benches, now gone.

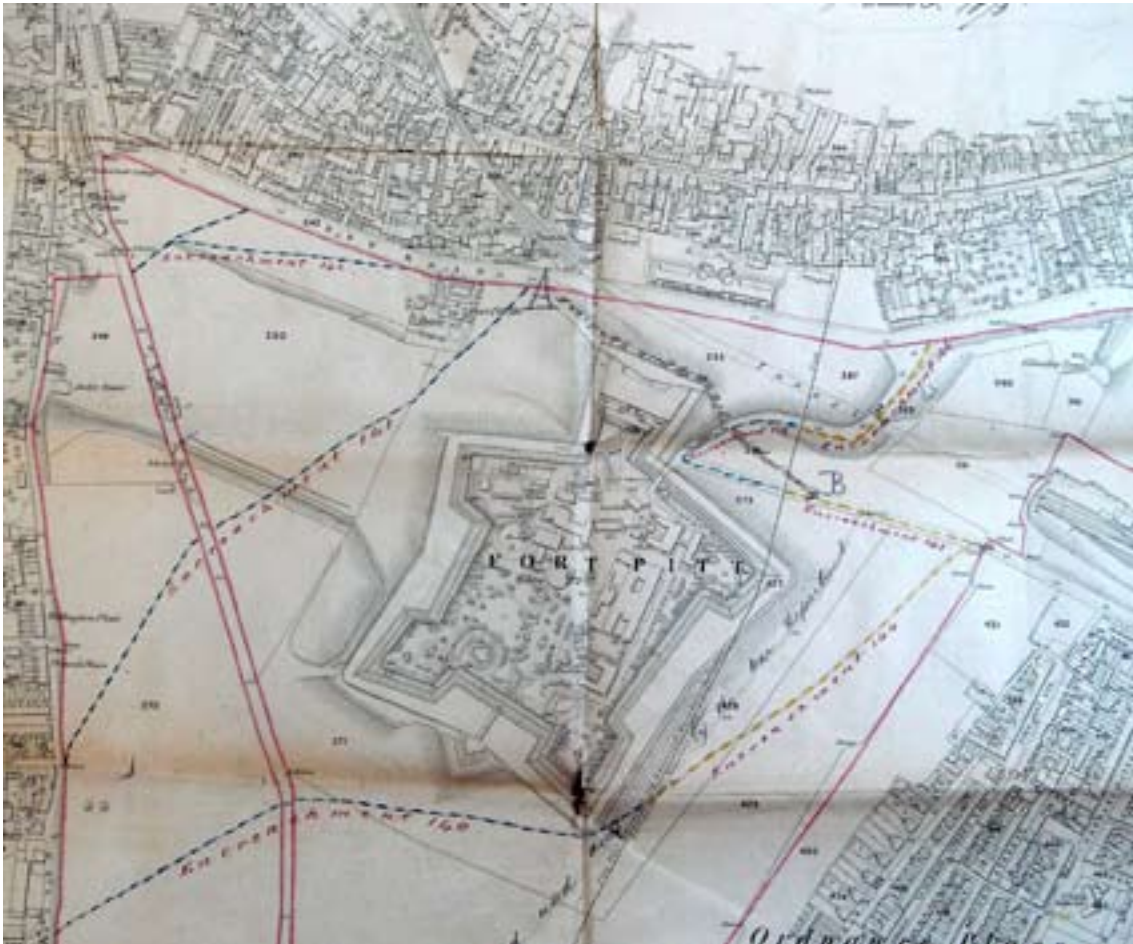
Fig 6: Annotated Ordnance Survey 25 inch map, 1875 (TNA: PRO, WO 32/18207)

An annotated 25 inch Ordnance Survey map of 1875, based on the 1866 survey, (TNA: PRO, WO 32/18207; Fig 6) shows the same information as above but the footpath is noted as an encroachment, suggesting that it was of relatively recent origin. It also shows the fort itself including works in the survey area which are broadly the same as those shown on the 1813 map, though considerably more detailed. The fort was surrounded by a moat with an external retaining wall. This appears to be on the line of the current boundary of the recreation ground. Beyond this the map shows a clear glacis much of which is still preserved as earthworks (d, e, f). On the north west corner of the main fort is a projecting outwork of some form, slight traces of which are also preserved. More complex outworks are recorded outside the south west bastion. These seem to be a small south facing bank some of which seems to remain and, to the south of this outside the study area, a substantial cut feature that must have been seriously damaged when the access road to the college was inserted on this line in the 1960s. A path

is shown leading to the north running parallel to the outer wall of the fort here in a gully or trench defined by slopes to east and west. The western slope is shown with a substantial counter-scarp probably forming a glacis and the path peters out where this bank turns from running slightly east of north to running west of north. This outwork then turned to the west-north-west, where a small ramp is shown running up onto the top of the glacis, and then ran towards Delce Tower. This section is shown as having a ditch behind the glacis but has been destroyed by the sports field and skateboard park.

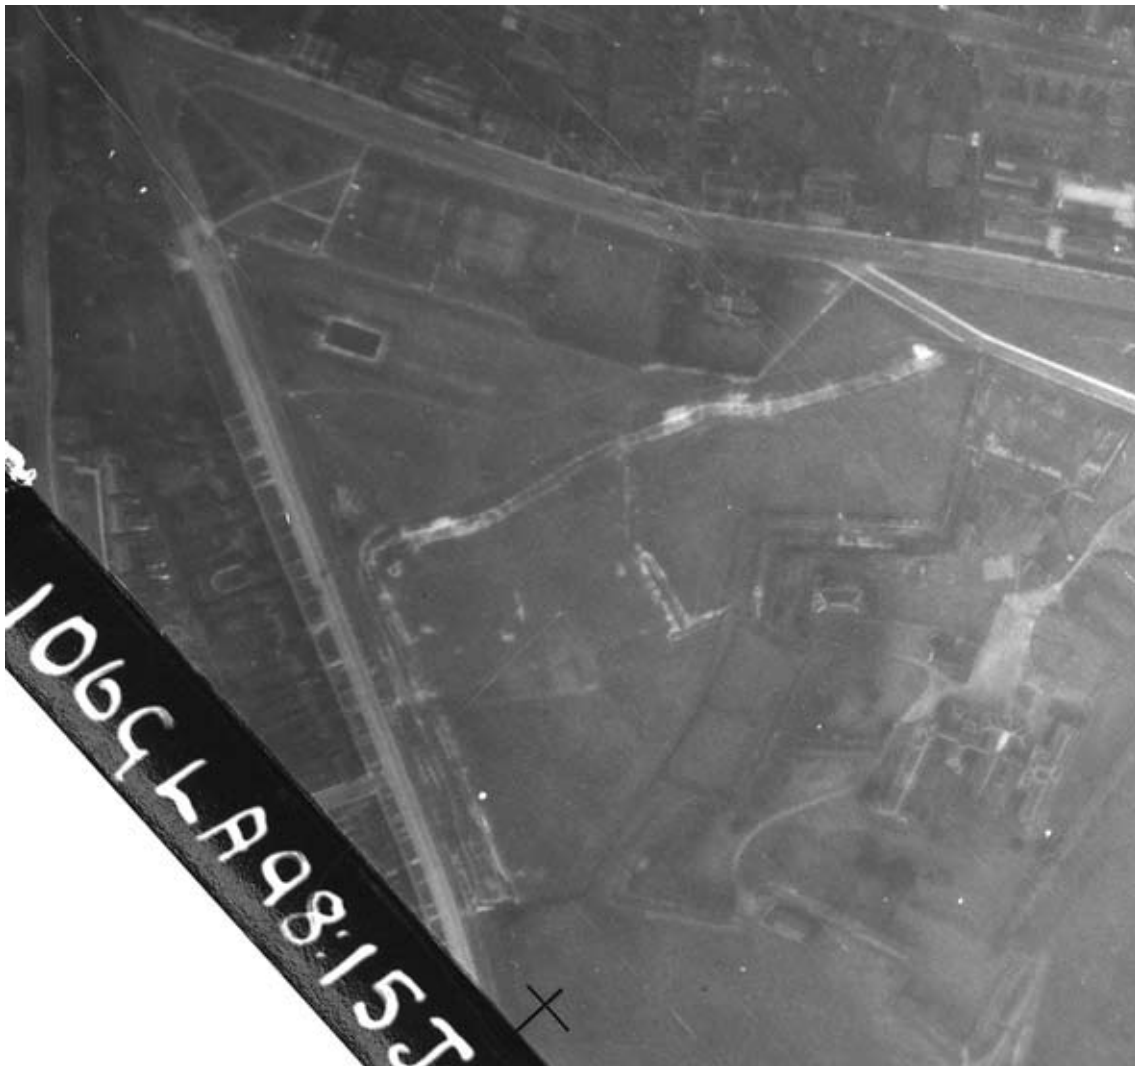
Fig 7: Aerial photograph of 1945 (RAF/106G/LA/98 1077, 15 Jan 1945, English Heritage (NMR) RAF photography)

Photographs from January 1945 (RAF/106G/LA/98, 1077; Fig 7), though poor, show, in addition to the above features, that elsewhere in the park most of the modern elements described above are visible including the terrace containing the bowling green and tennis courts. The moats along the western side of Fort Pitt appear to be open and the line of the earthwork originally running across to Delce Tower can be seen. The far south of the study area is defined by the cut used by the access road to the current Mid-Kent College from City Way and an earthwork is visible on this alignment (and in later photographs) though it is narrower and appears more in keeping with the fort out works.

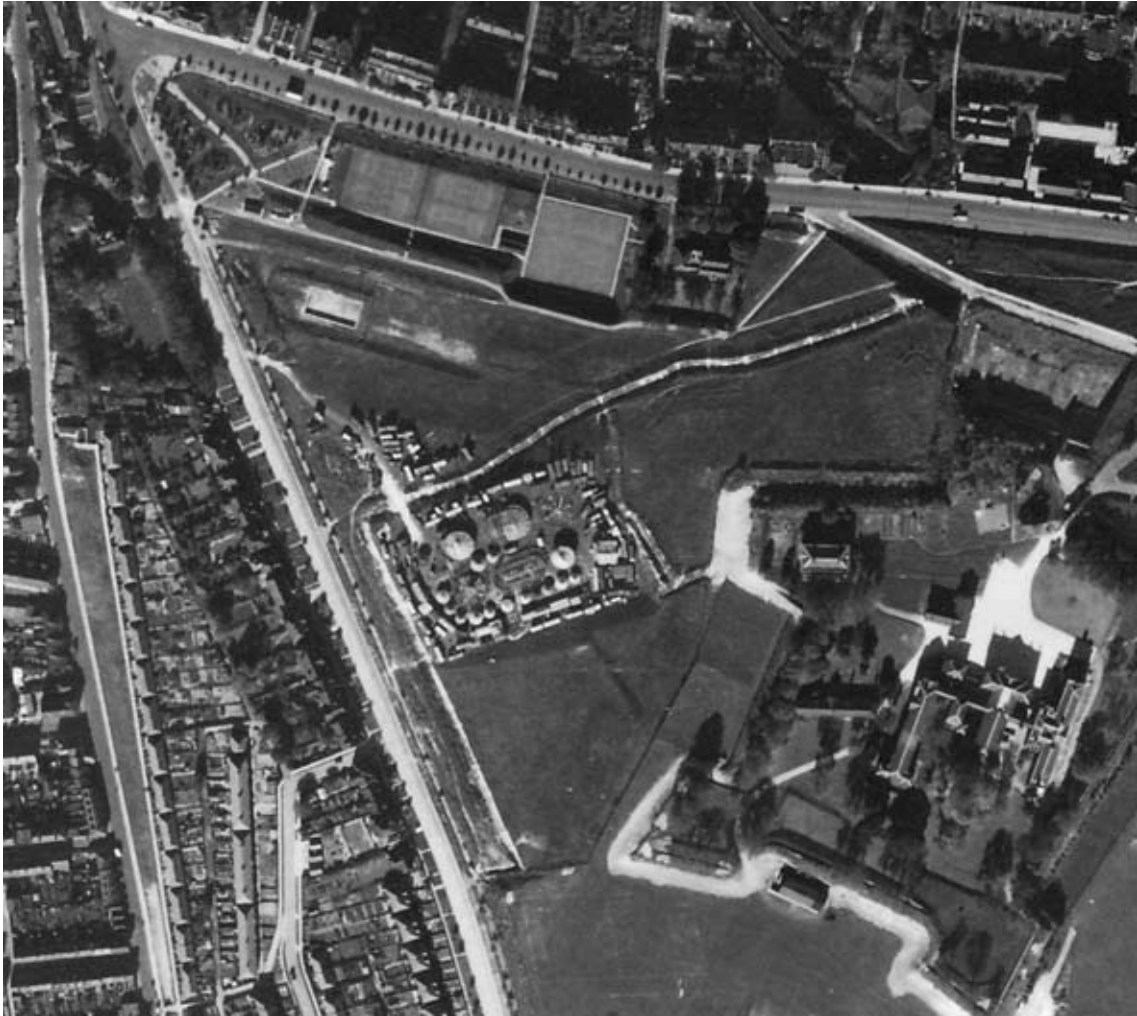
Figure 8: Aerial photograph of 1946 (RAF/CPE/UK1789 4174, 11 Oct 1946, English Heritage (NMR) RAF photography)

Most of these works are visible on the photograph of 1946 (RAF/CPE/UK1789 4174; Fig 8) which is dominated by a fair taking place on the sports field and several rides and numerous stalls can be seen. A track runs southwards onto the field from City Way, clearly to allow access as many vehicles appear to be parked next to it on the moderately sloping ground below the field. This track shows brightly, presumably from the exposed chalk, and much of the wear must have been contemporary with the photograph. The intermittent use of this area by travelling fairs may account for some of the very minor earthworks in the area. Access onto the sports field was by a casual track that is visible on aerial photographs. Between the track and City Way a disturbed area is visible which was also present in 1945 but its nature could not be determined. To the north of this, between the large rectangular feature and City Way, the ground appears to be disturbed and a cut feature is visible. Taken together these might suggest outlying defensive works relating to City Way. The rectangular feature probably constructed in early 1942 on the terrace above the tennis courts clearly shows as a substantial negative feature, most likely a reservoir. On the lower part of the terrace to the east of the probable reservoir there appear to be large worn areas, also faintly visible in 1945 but their origin is unknown. Large pale areas around the west and south west bastions of Fort Pitt itself suggest that moat in these areas had recently been infilled. The remains of the earthwork that

connected Fort Pitt with Delce Tower can clearly be seen and there appears to be a gap in the earthworks about halfway between the top edge of the sports field and the outer boundary of the fort. This is not original and probably marks the line of a later path or service trench crossing the area.

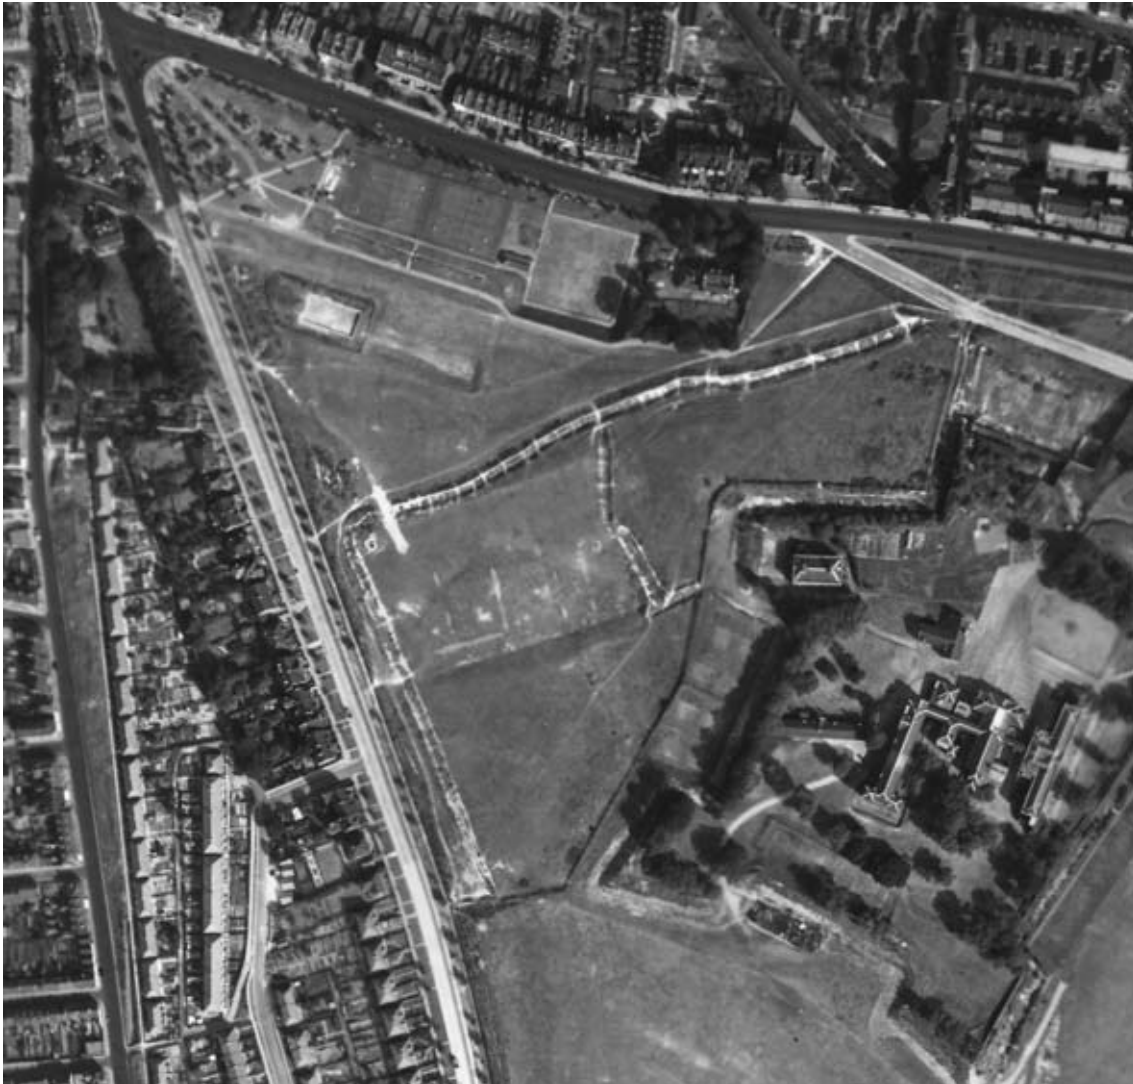
Fig 9: Aerial photograph of 1947 (RAF/CPE/UK2301 5123, 9 Sept 1947, English Heritage (NMR) RAF photography)

The clearest image of the wartime defensive earthworks is on the aerial photograph of 1947 (RAF/CPE/UK2301 5123; Fig 9). It can be seen that the main section, which ran from the north eastern corner of the recreation ground west south west and across the face of the downhill slope to the sports field consisted of a ditch with a substantial bank on the downhill (northern) side and a smaller bank on the uphill side in the more open eastern area. Semi-regular paths appear to have been worn across this feature which can be seen in 1946 and possibly in 1945 and it is possible that intermittent barriers existed, such as coils of barbed wire which could be extended at short notice to create an unbroken barrier. The barrier running parallel to City Way appears to be less substantial, using the slope up to the sports field at its northern end, and apparently consisted of two linear features, probably fence lines, possibly with a shallower ditch between them.

At the southern end of this feature the ground appears more disturbed and a clear ditch is visible where it meets the east-west cutting running across from City Way to the point of the south west bastion of Fort Pitt. A path ran to the north and west of these linear features which is also visible in 1945, and around the north western corner of the sports field this had caused considerable erosion. Immediately to the north of this area was a diamond shaped area of disturbed, scrubby ground also present in 1945 and 1946. In the latter image less scrub is visible and the feature may have been relatively recent. The track used by the fair to gain access to the sports field is also clearly visible. Above this area, on the corner of the sports field, the structure noted above is visible. This appears to be unroofed and consist of two interlocking 'L' shaped walls. Across the sports field numerous pale scars can be seen some of which can be seen on the wartime images, and so will relate to military activity. Some do not and may be marks remaining from stalls and other features associated with the fair. Elsewhere little has changed although the pale scars around the bastions of Fort Pitt already appear to have grassed over.

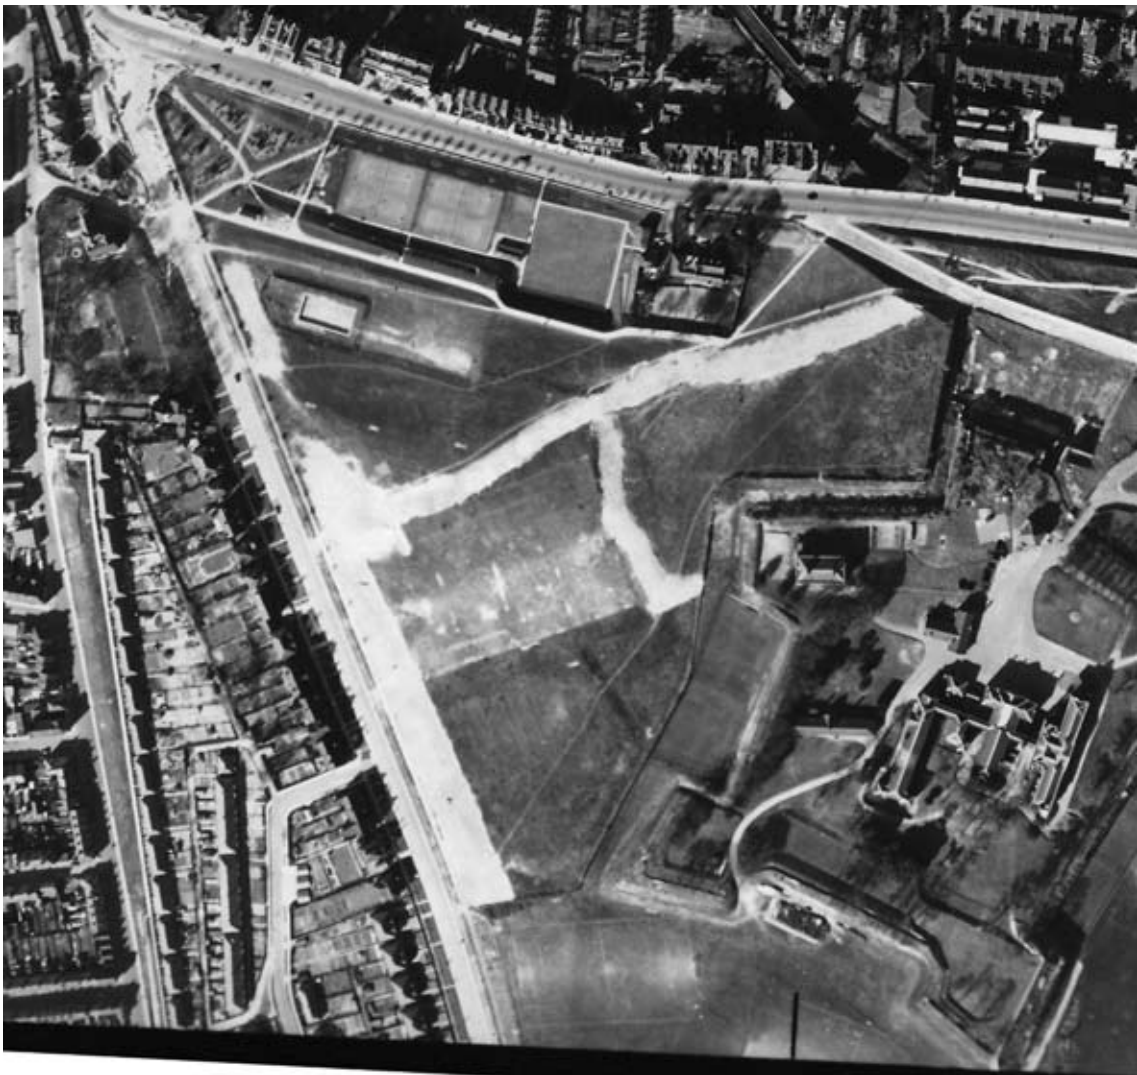
Fig 10: Aerial photograph of 1948 (RAF/CPE/UK2534 5208, 24 Mar 1948, English Heritage (NMR) RAF photography)

The most significant features of the 1948 photographs are the large areas of pale ground where the Second World War defences had been, clearly resulting from works to reinstate the recreation ground (RAF/CPE/UK2534 5208; Fig 10). The areas of chalk to the east of City Way, north of the main defences, suggest that the features here may have been defensive. Some attempt also appears to have been made to level up the sports field. Photographs from 1950 show that it took some time for the ground to recover (58/491, 7 Apr 1950, 5020).

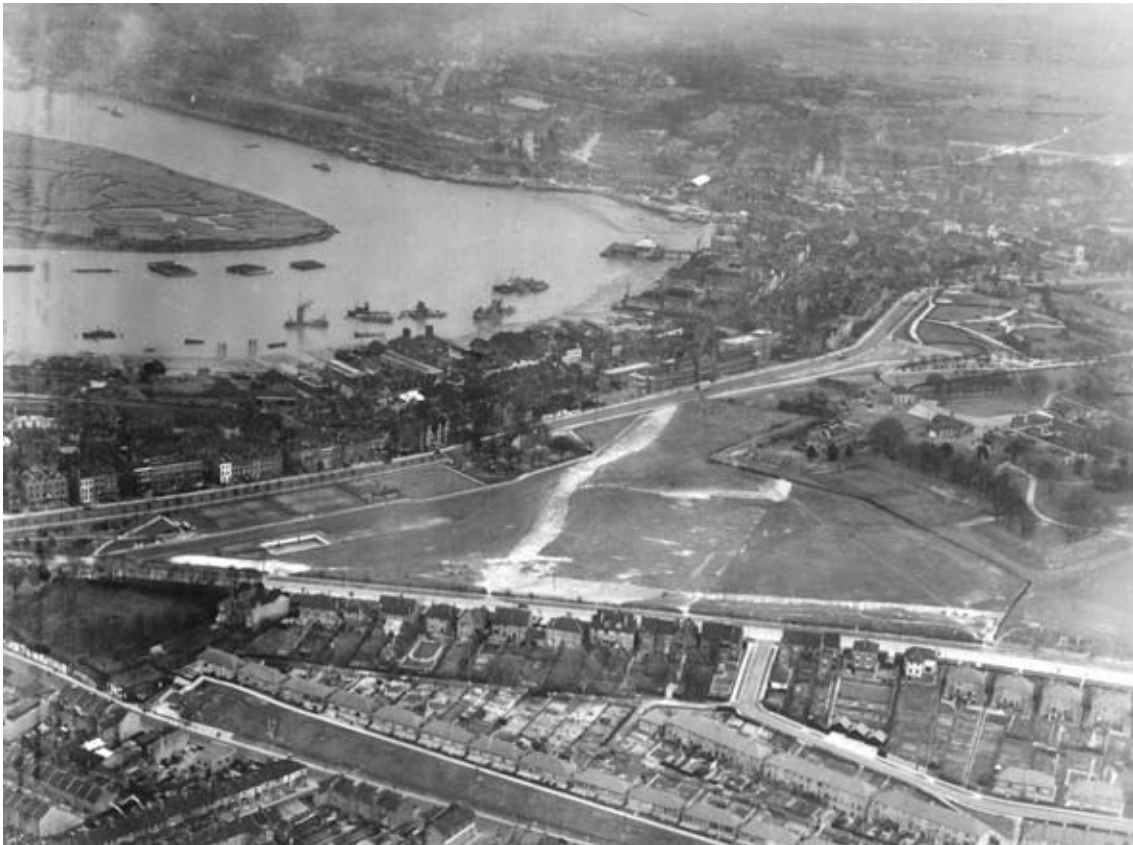
Fig 11: Oblique aerial photograph of 1948 (RAF.CPE/UK/2440 0073, 4 Feb 1948, English Heritage (NMR) RAF photography)

Oblique photographs from a few weeks earlier in 1948 add a little additional information (RAF.CPE/UK/2440 0073, Fig 11). The form of the structure on the corner of the sports field can just be seen and confirmed as two interlocking 'L' shaped walls, apparently about chest height. The sunken structure in the north-west of the recreation ground can also be seen and appears to be holding some water and probably has ladders running up the sides. The area of Delce Tower is visible immediately to the left of and slightly below the reservoir. The base of the tower and a wall running north away from the tower (to the left) can be seen, both of which are shown on maps as early as 1813 and which still survive.
