ST ANDREW'S CHURCH, CHEDDAR, SOMERSET TREE-RING ANALYSIS OF FURTHER TIMBERS FROM THE NAVE ROOF AND CEILING

SCIENTIFIC DATING REPORT

Dr Martin Bridge

NGR ST 4595 5302

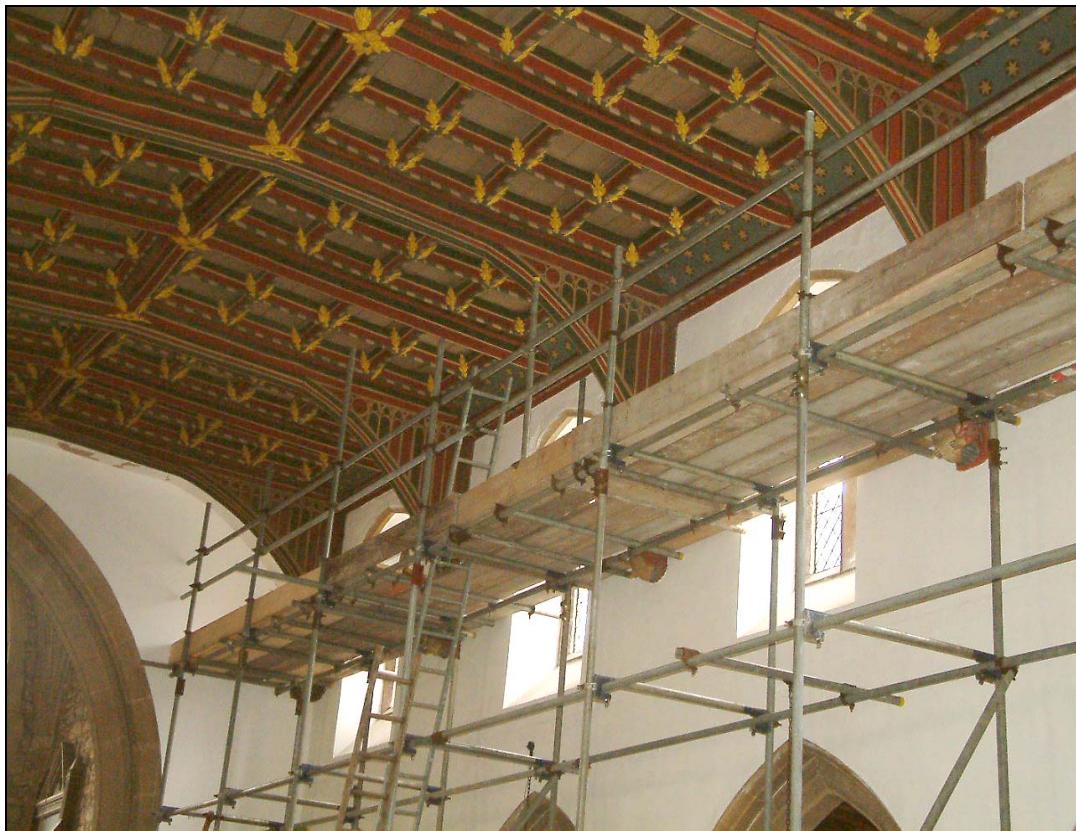
Figure 2: View of the nave ceiling looking north-west (photo Amanda Grieve)

St Andrew's Church (NGR ST 4595 5302; Fig 1) is a grade I listed parish church. It was mostly built in the fourteenth and fifteenth centuries and was restored by William Butterfield in AD 1873. The nave ceiling is thought to be fourteenth-century and was coloured and gilded in the Butterfield restoration (Fig 2). An opportunity arose to sample the ceiling and wallplates of the roof in October 2003, but on that occasion, no ceiling timbers could be sampled, and none of the wallplates yielded any dates (Bridge 2004). Following this study, access to the roof timbers in the space over the ceiling was arranged, and a follow up investigation undertaken.

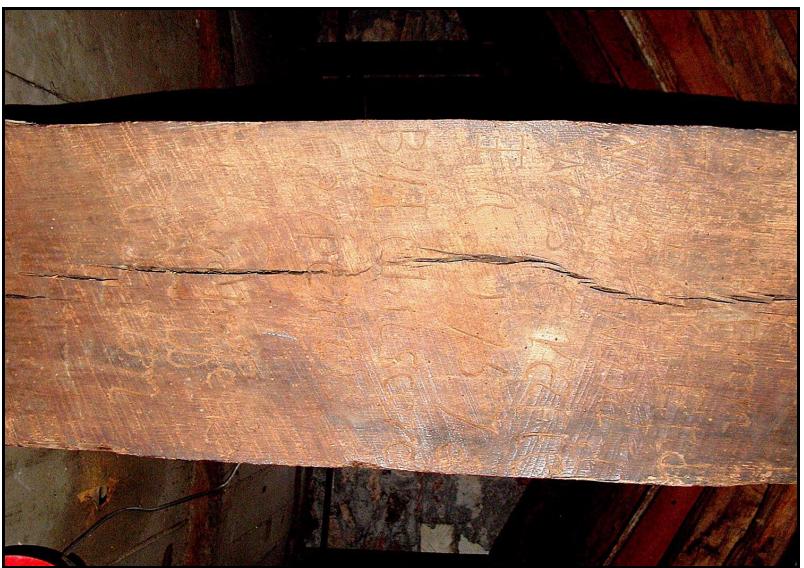
Figure 3: Post to the second truss from the east end showing the inscription detailed in the text

All timbers sampled were of oak (*Quercus* spp.). Trusses were numbered from the west end in line with the system used in the previous study. Two inscriptions were found in the roof, one reading 'The roofs of this church were chemically treated, defective oak replaced and leads repaired 1948-50, John Scourse & Son Ltd' and the other, on the post to truss 5 (Fig 3) – 'The six beams from the East End Westward was [sic] crafted in 1757 bye John Score Carpenter Richard Jeffries sexton'.

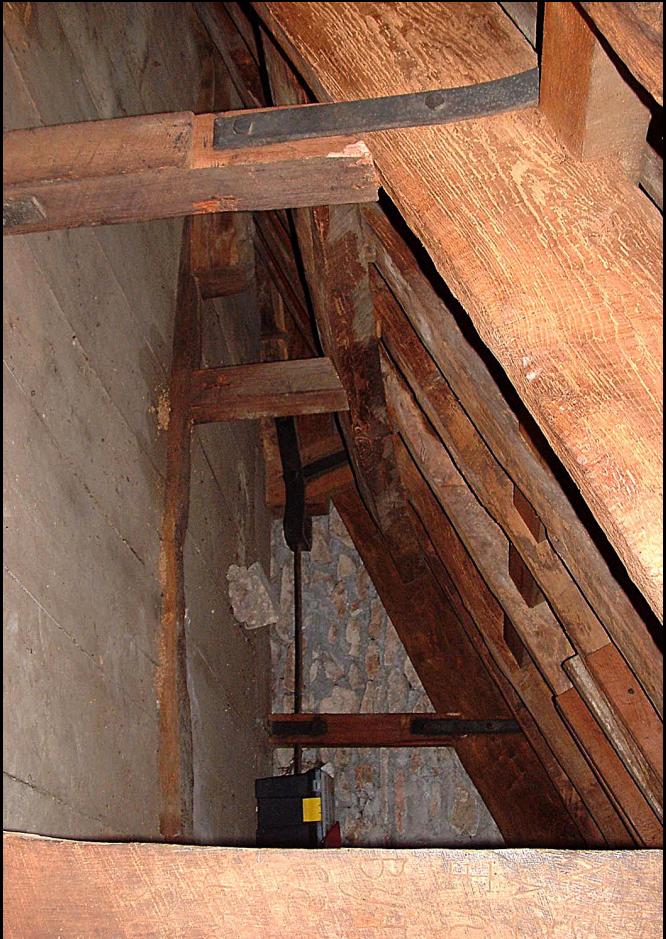
Figure 4: View of the northern side of the nave roof showing its general construction and the upper side of the ceiling boards

Details of the positions of the samples and basic data about them are given in Table 1. The general form of the trusses is shown in Figures 4 and 5, with the approximate positions of the samples being shown in also in Figure 5. The principal rafter illustrated in Figure 4 shows the general fast-grown nature of the material. Usually, series with less than
