# ASHBY DE LA ZOUCH CASTLE, LEICESTERSHIRE A MULTIDISCIPLINARY INVESTIGATION OF THE CASTLE GARDEN

### A Multidisciplinary Investigation of the Castle Garden

NGR: SK 3613 1661

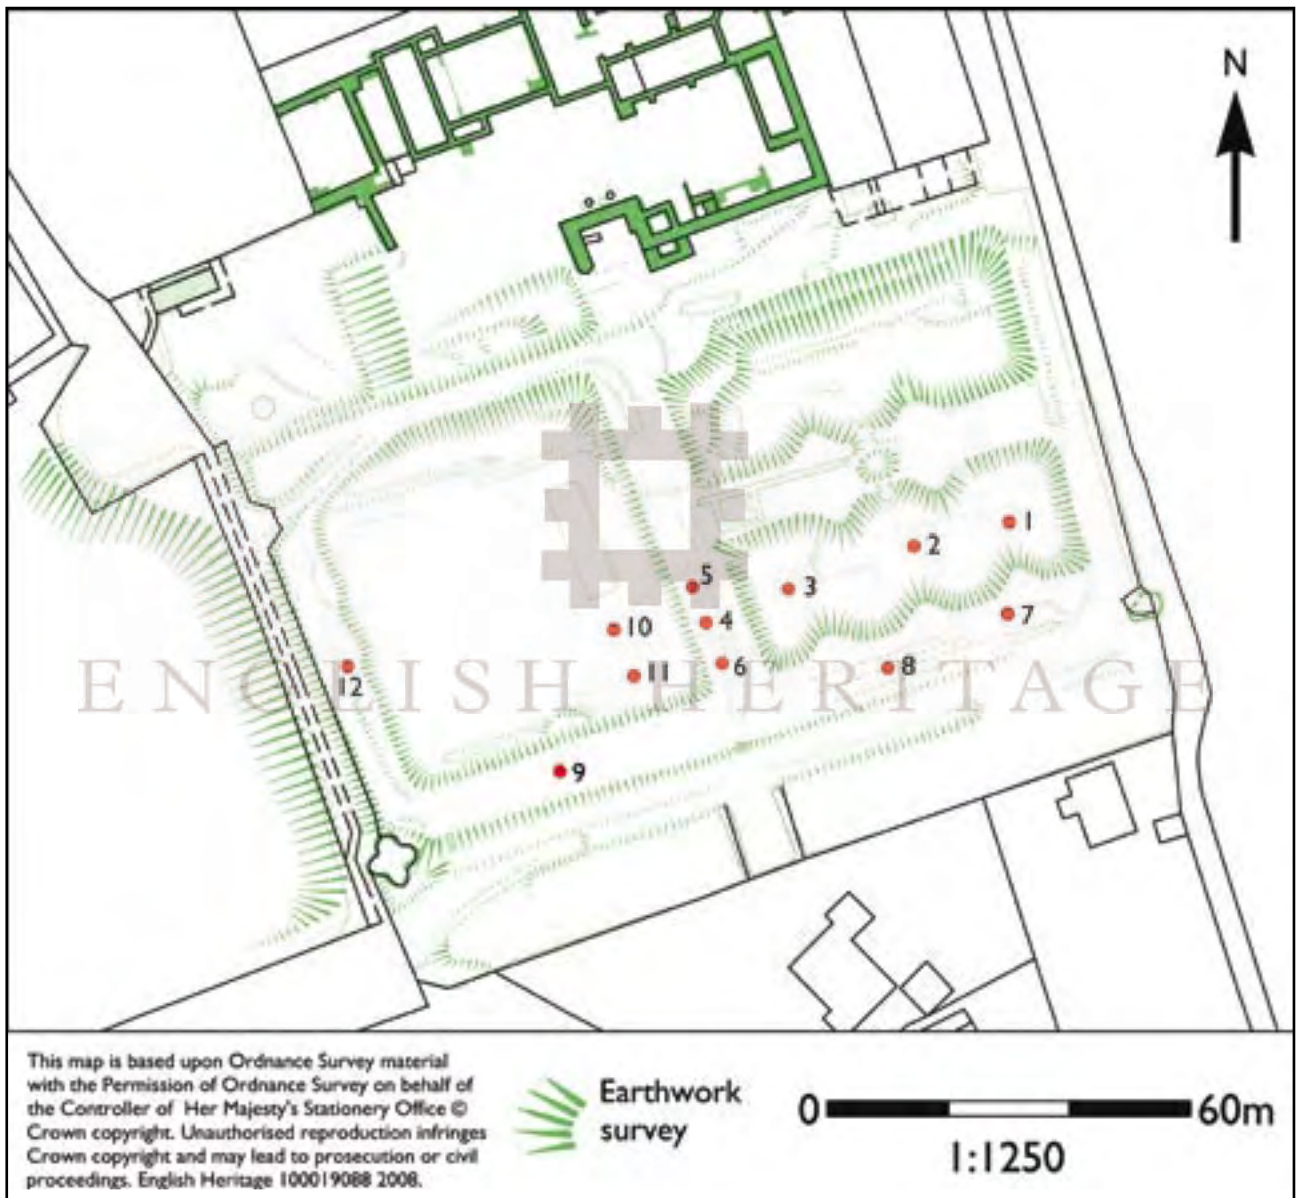
Figure 9: Core locations (not to scale)

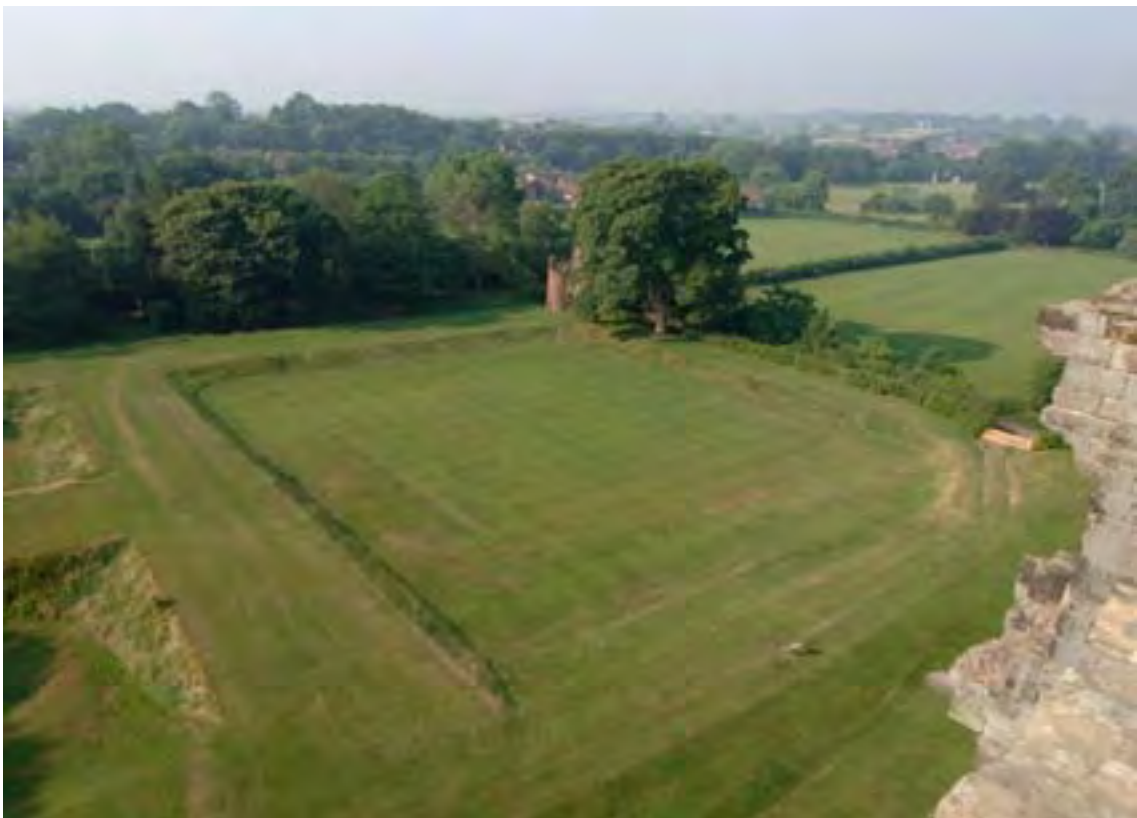
*Figure 19: Western sunken garden*

The western garden consists of a square sunken area, measuring 57m by 52m, with sloping sides surrounded by terraced walkways (Figure 19). The sunken area varies between 0.8m and 1.1m in depth and there is a drop in height of roughly 1.4m from north-east to south-west, echoing the natural slope.

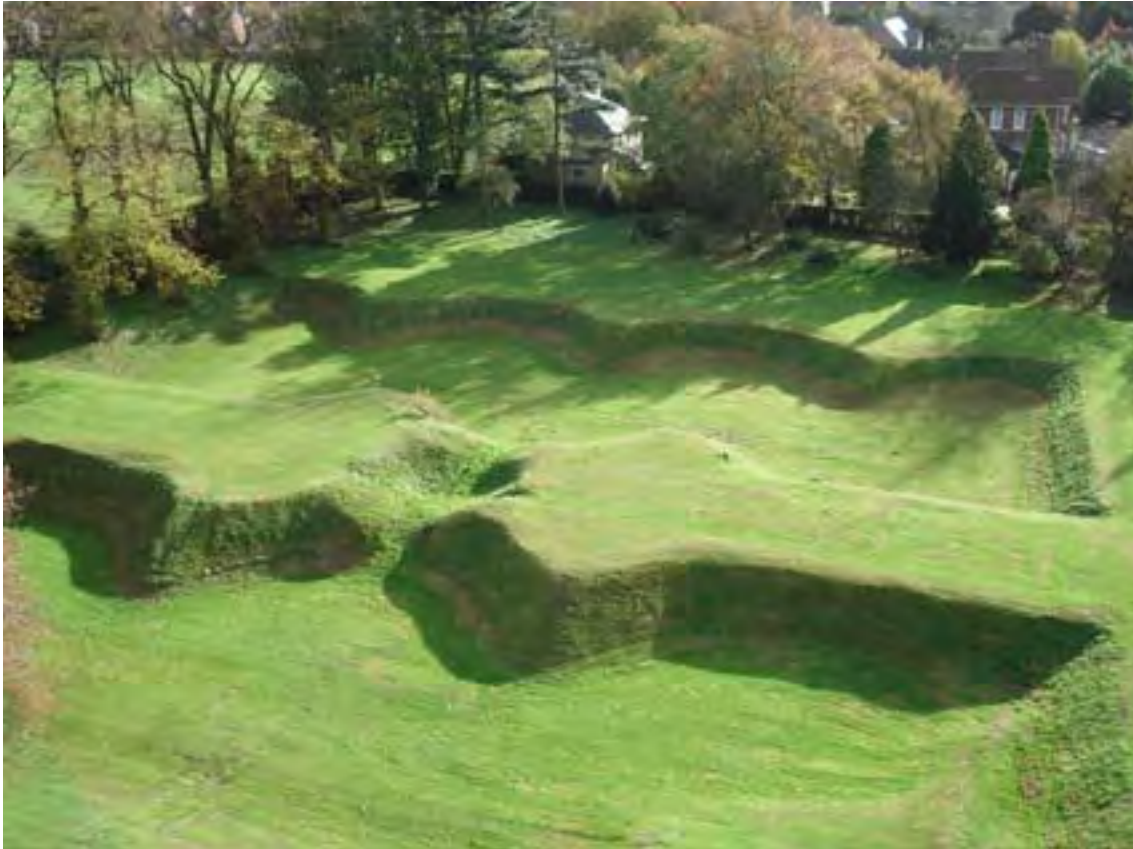
Figure 20: Eastern sunken garden.

The eastern sunken garden is slightly larger than its western counterpart, measuring approximately 58m by 59m. It is divided into two roughly equal-sized sections by a terraced walkway which runs west to east across its centre (Figure 20). The walkway is approximately 9m wide (the same width as the main walkway which divides the two garden compartments), apart from where it widens towards the centre due to the spurred design.

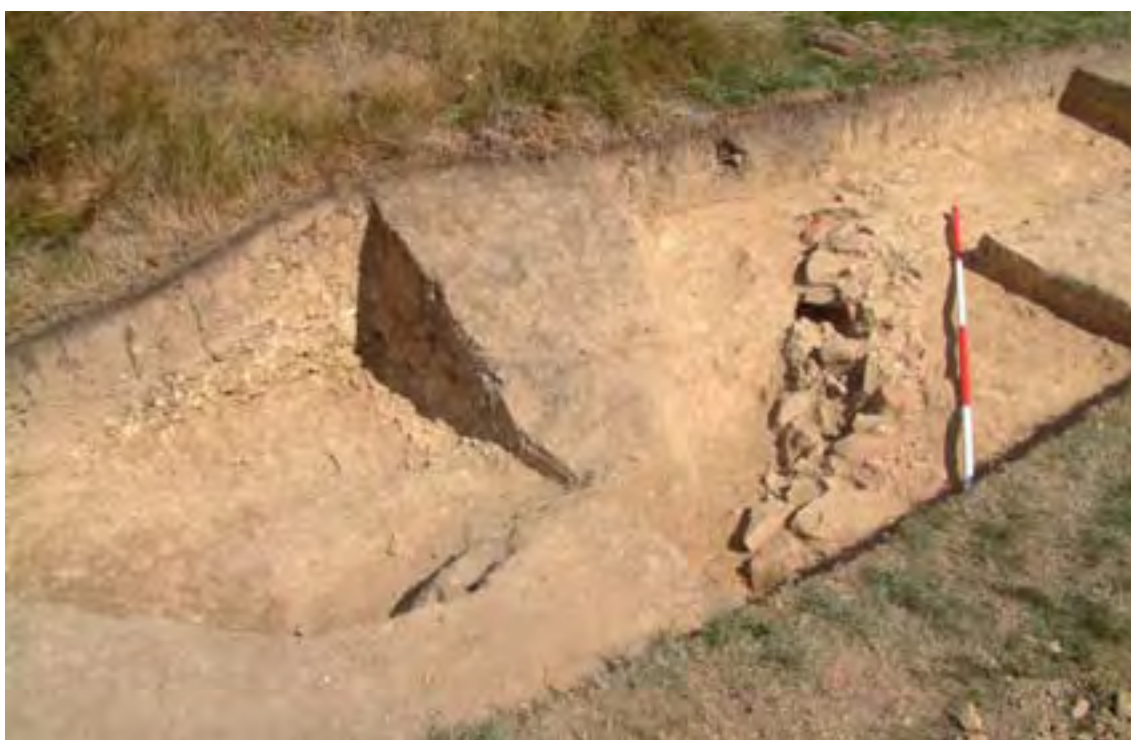
*Figure 21: The drain excavated in Trench 2 suggesting that the spurs were originally more angular.*

The excavation of Trench 2 also revealed more information about how the sunken area was created. The bottom 0.5m of the spur was cut out of the natural sandstone and then, at the western end at least, the ground was raised, with some of the material being deposited before the garden building was inserted (see Appendix 5, p. 110). This may have been to create a level surface or to introduce topsoil. It seems that the drain around the bottom of the spur was covered by these layers, which contained 16<sup>th</sup>- and 17<sup>th</sup>-century pottery, and was not intended to be seen. 17<sup>th</sup>- and 18<sup>th</sup>-century material in these layers, including pipe stems, was thought to be intrusive. This area of the enclosed garden appears to be the least altered by later garden phases and the few internal features within this section of the compartment probably reflect modern activity on the site (see Section 6.4).

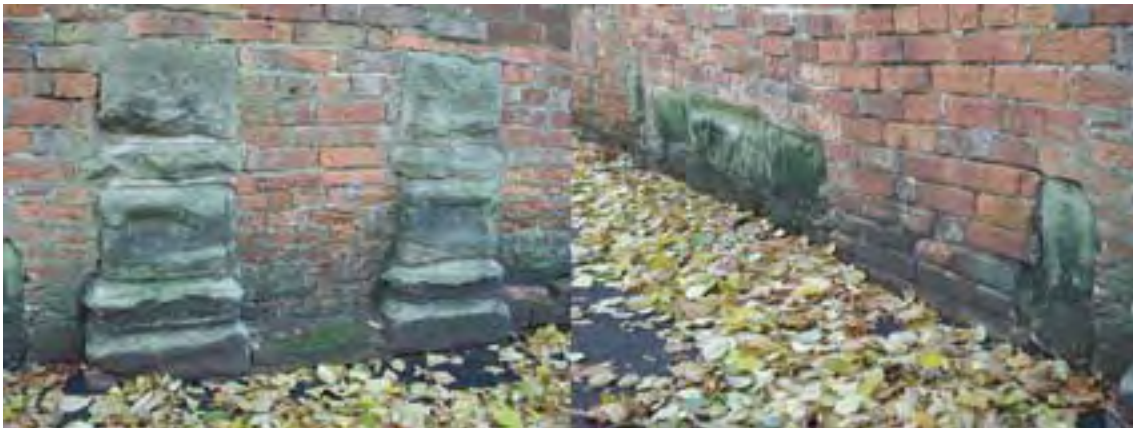
*Figure 22: Masonry, probably reset, marking the possible position of gateways into the garden from Mount Walk.*

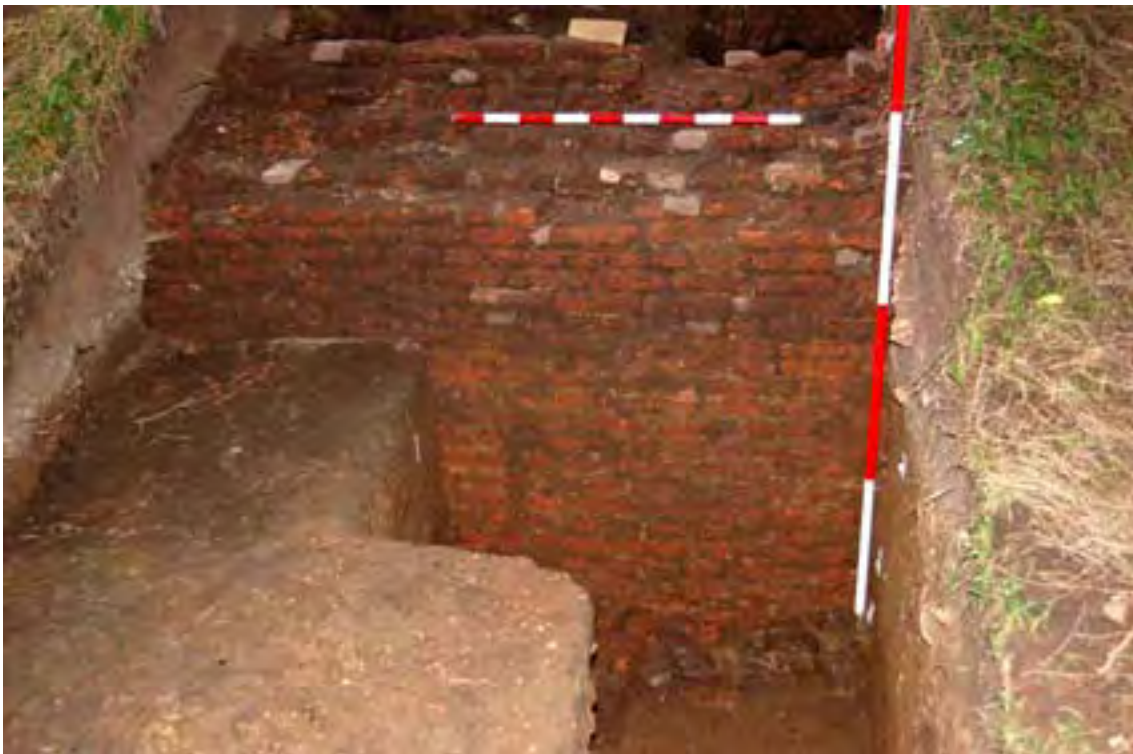
*Figure 23: The foundations of the garden wall exposed in Trench 1.*

and by the magnetometer and earth resistance surveys (Figures 7 and 8 - [M5] and [R12] and Appendix 4). The excavated portion of the wall was 0.95m wide and surviving to 1.45m (or 20 courses) in height though brickwork and scarring on the western garden building reveals that the wall originally rose to approximately 2.6m above the main garden terrace. The wall was constructed on a footing of loose, unmortared rubble in English Bond with a lime mortar (Figure 23 and Appendix 5, p. 108). Like the remains of the eastern wall, this wall also tapered, its substantial width and deep foundations reflecting its role in retaining the terrace (see Appendix 5, p. 108).

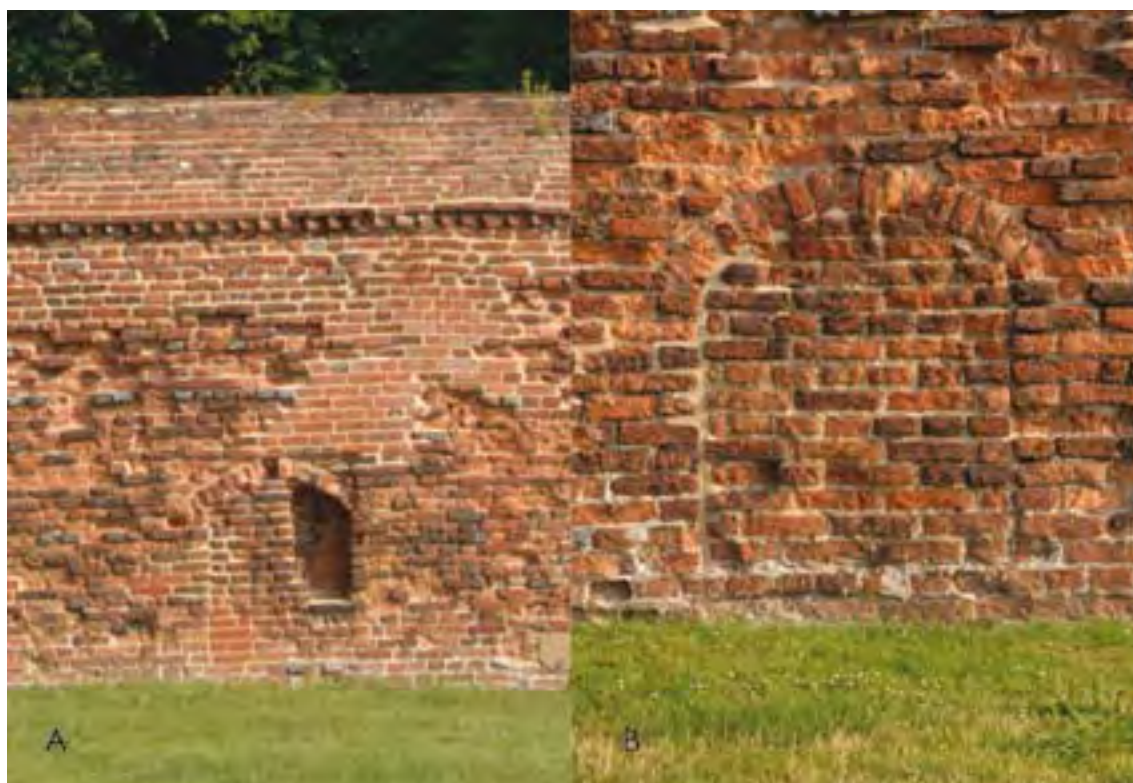
Figure 24: A - Section of the northern boundary wall showing one of the partially blocked bee boles, the dog-tooth string course and the ornamental coping. B - Detail of blocked bee bole.

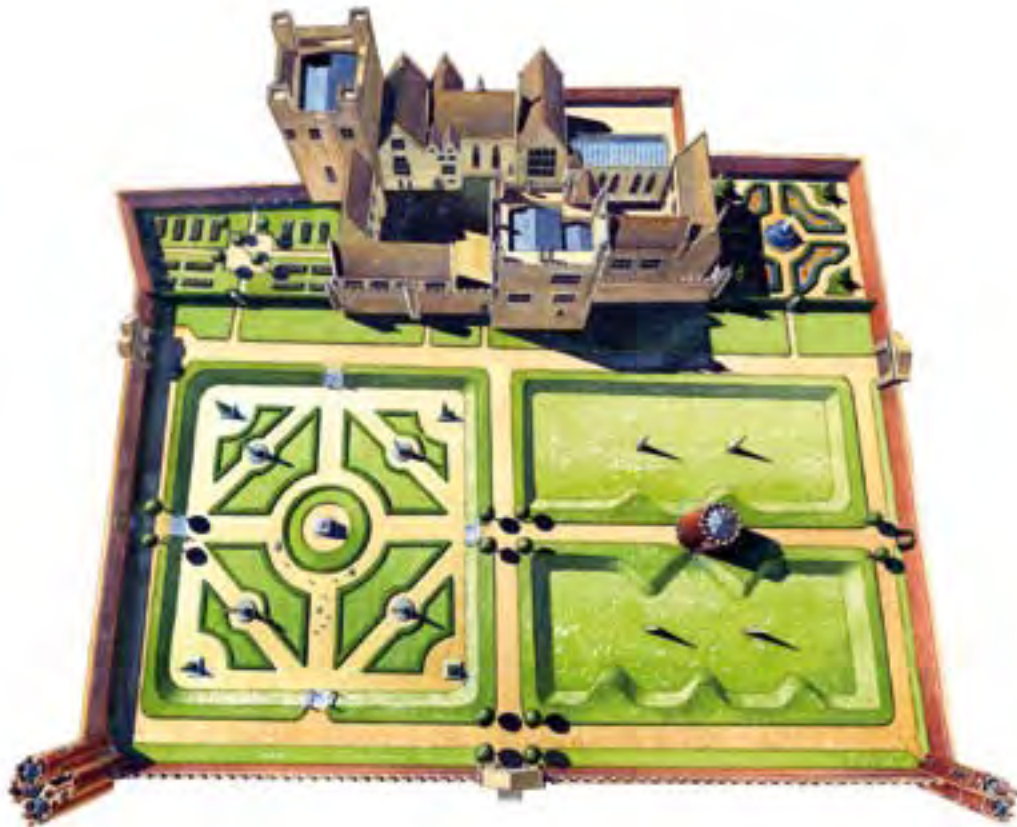
Figure 25: Reconstruction of the garden as it may have looked in the 1630s.

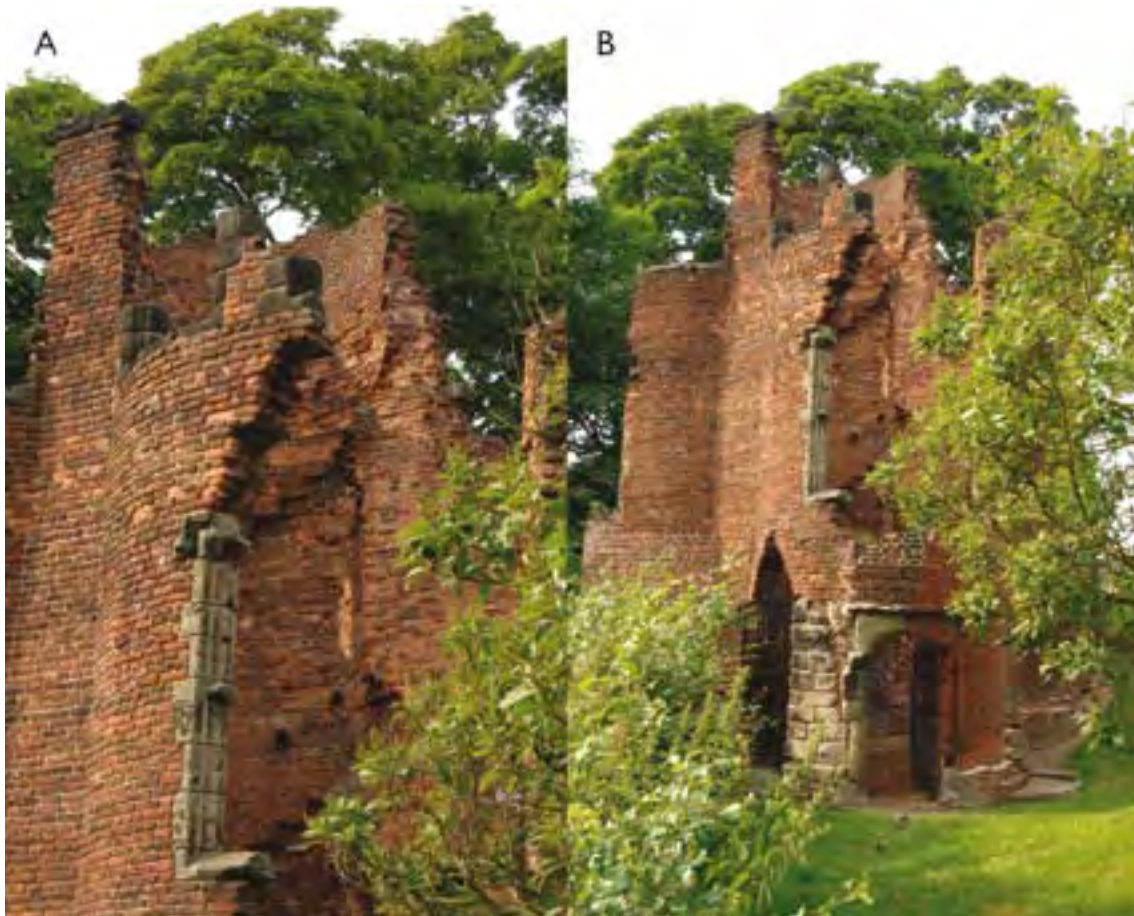
Figure 27: Western garden building. A - Window detail. B - Reconstructed south face.

A doorway into the wider garden is located in the centre of the southern lobe at basement level. The whole of this side of the building appears to have been rebuilt (Figure 27B) with major repairs occurring as late as 1970 (NMR AL0503 A8307/3). One side of the door has a stone surround similar to that on the other door, but it appears to have been reset and an arch head used as the sill. A large portion of brickwork on the eastern side of the door has been rebuilt to the wrong line, ignoring the plinth that is clearly visible. Above the door are the remains of a large curving window which had at least one transom. On the next level up are fragments of a row of three windows which have stubs of mullions and transoms, each probably having four lights (Figure 27A). To the west of the doorway a patch of stone ashlar is visible, again probably reset, though a photograph published in 1913 seems to suggest this patching was more extensive (Fosbrooke 1913, Plate 8).

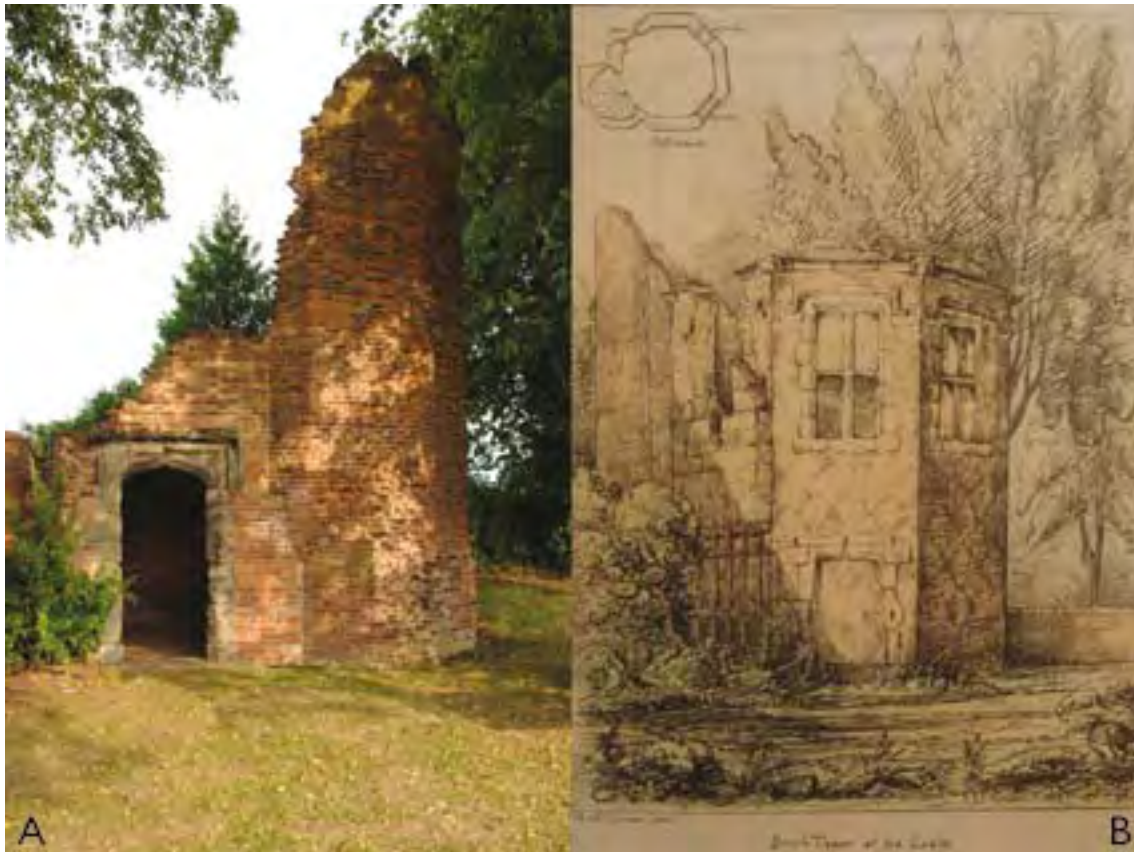
Figure 28: Eastern garden building. A – North-west elevation. B - 1855 sketch of eastern elevation by MAE Vavasour (Reproduced with the kind permission of Ashby Museum.)

compartments to the east of the castle. Though on the Vavasour plan it has been noted as a window, the sketch shows what appears to be a small door with squared-headed hood moulding at the upper terrace level, now Mount Walk. This agrees with an apparently more realistic floor plan shown by Fosbrooke (1913, drawing 8) and indicates the building bridged a change in level, as does its western counterpart. It is worth noting that Vavasour appears to show diaper work (similar to that at nearby Bradgate House) on the east elevation, though no sign of this pattern is visible on the faces of the building that still stand. It is possible that the pattern on the sketch in fact represents the iron tie rods which 'for many years held together' the building (Fosbrooke 1913, 42). Both the Vavasour sketch (Figure 28B) and the Fosbrooke drawing (1913, drawing 8) appear to show a chimney on the southern elevation. This may have been a later addition as the remains of hood moulding for a window, perhaps blind, can be seen on the wall above.

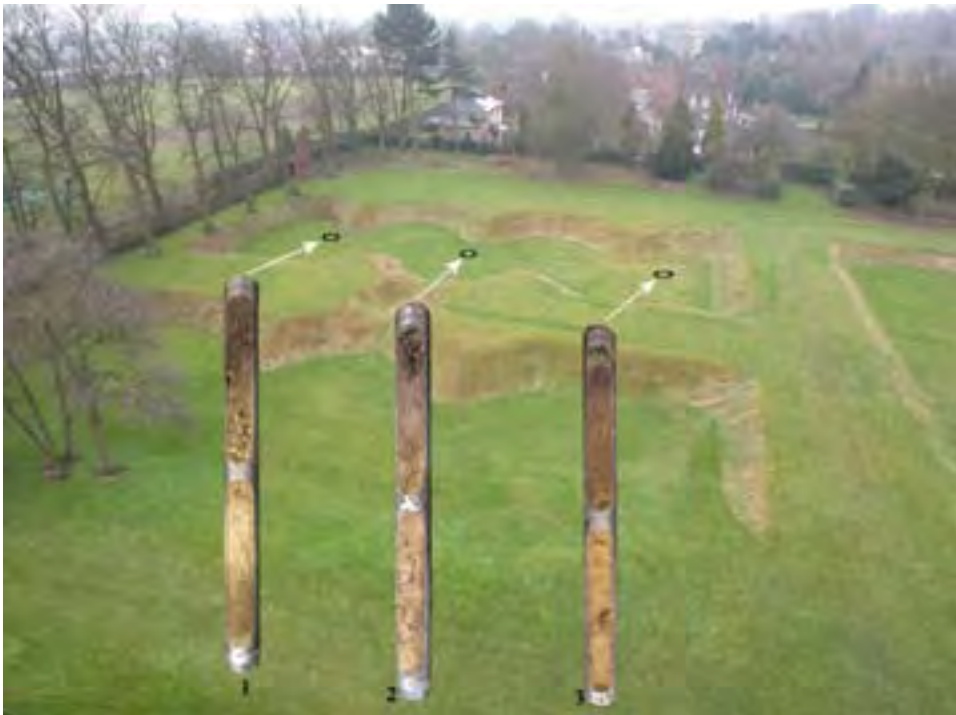
Figure 5. Cores from Holes 1 – 3 showing their landscape positions Detailed views of these cores can be found on Figures 2, 3 and 4.

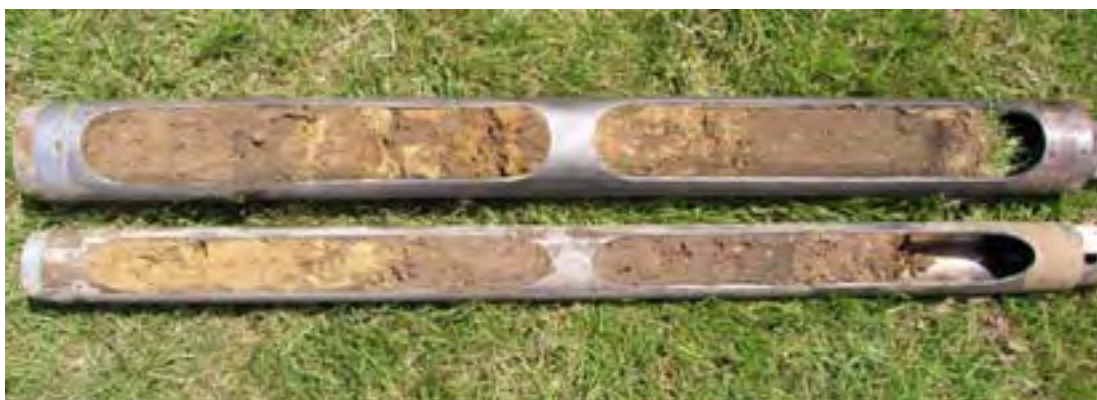
Figure 6. 2 m core from Hole 4

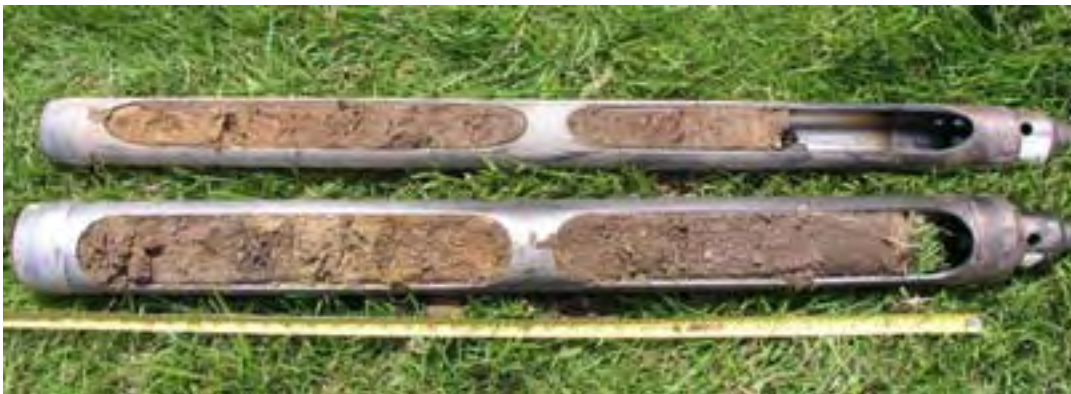
Figure 7. 2m core from Hole 5

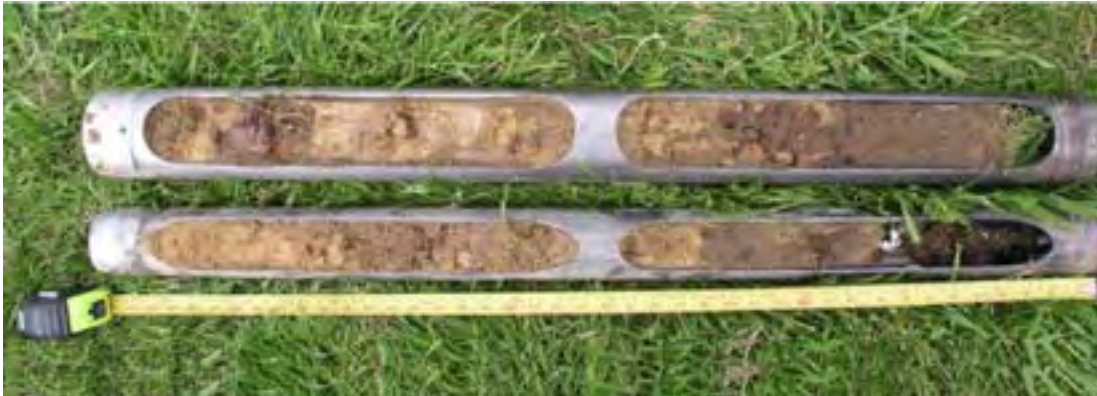
Figure 8. 2 m core from Hole 6

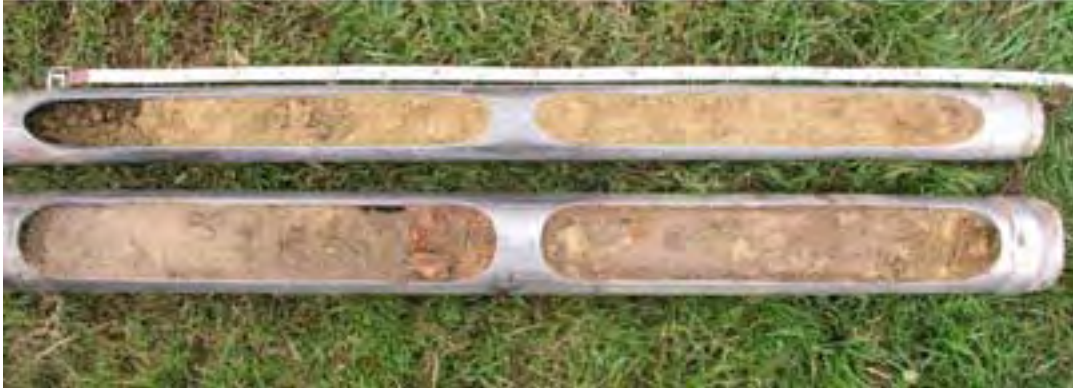
Figure 10. Two metres of Hole 8.

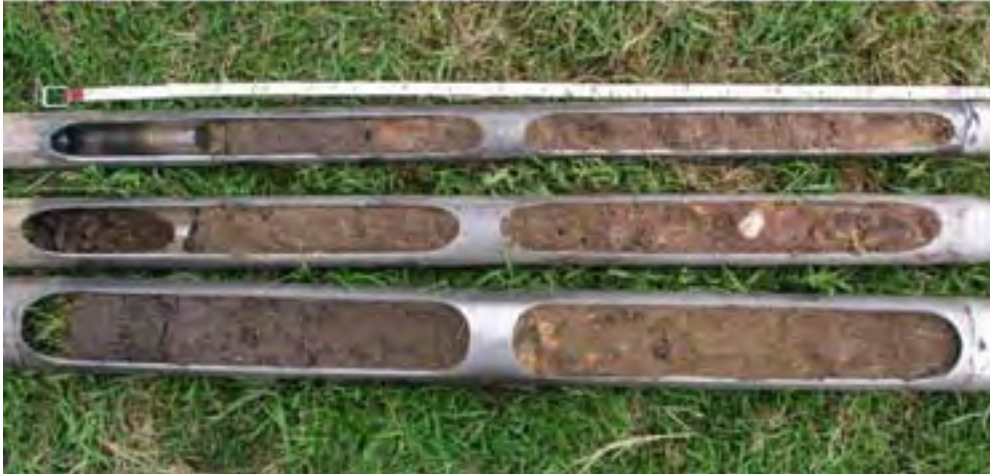
Figure 12. Three metres of Hole 12.

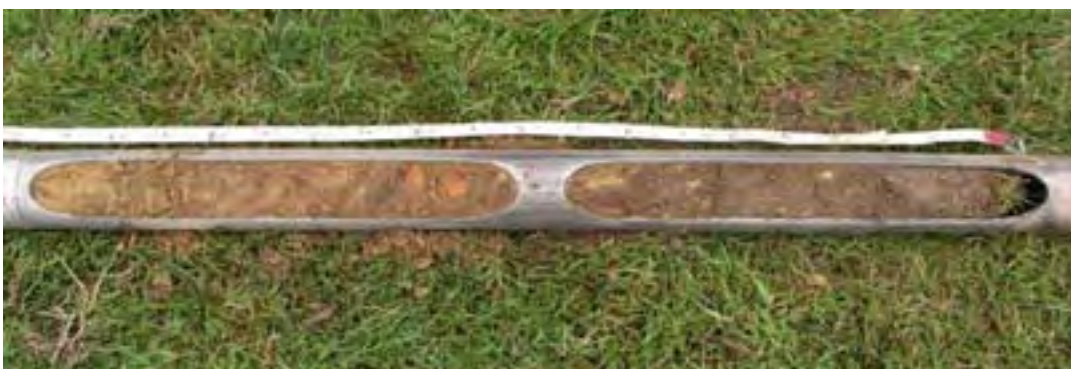
Figure 14. One metre of Hole 11.

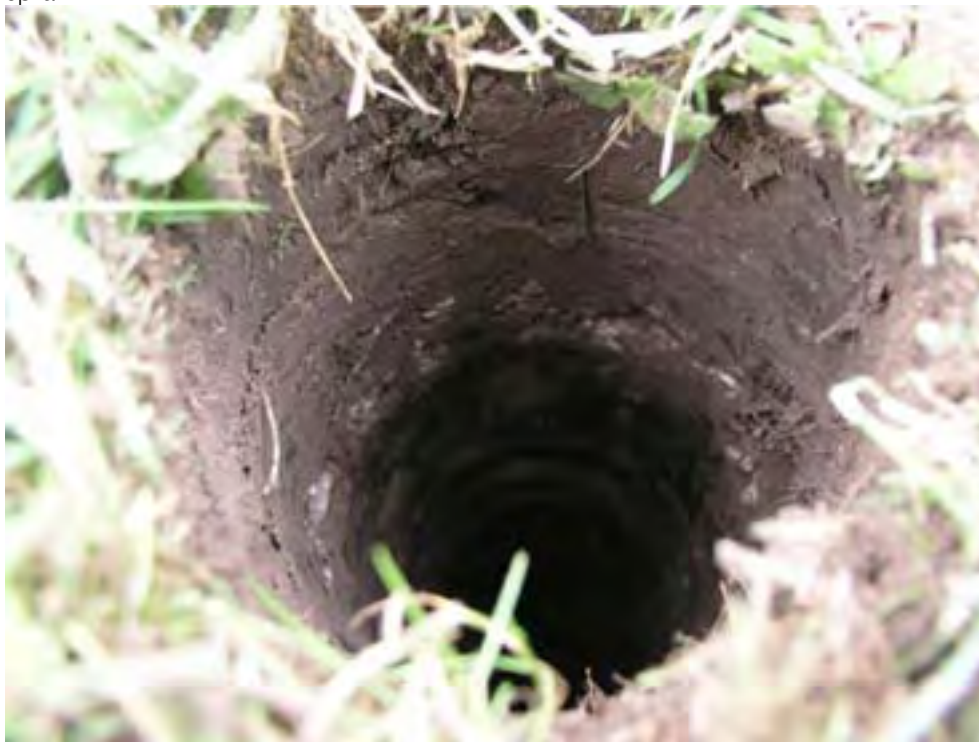
*Figure 15. View down Hole 10 after extraction of the core showing limestone chippings at 15 – 20 cm depth.*

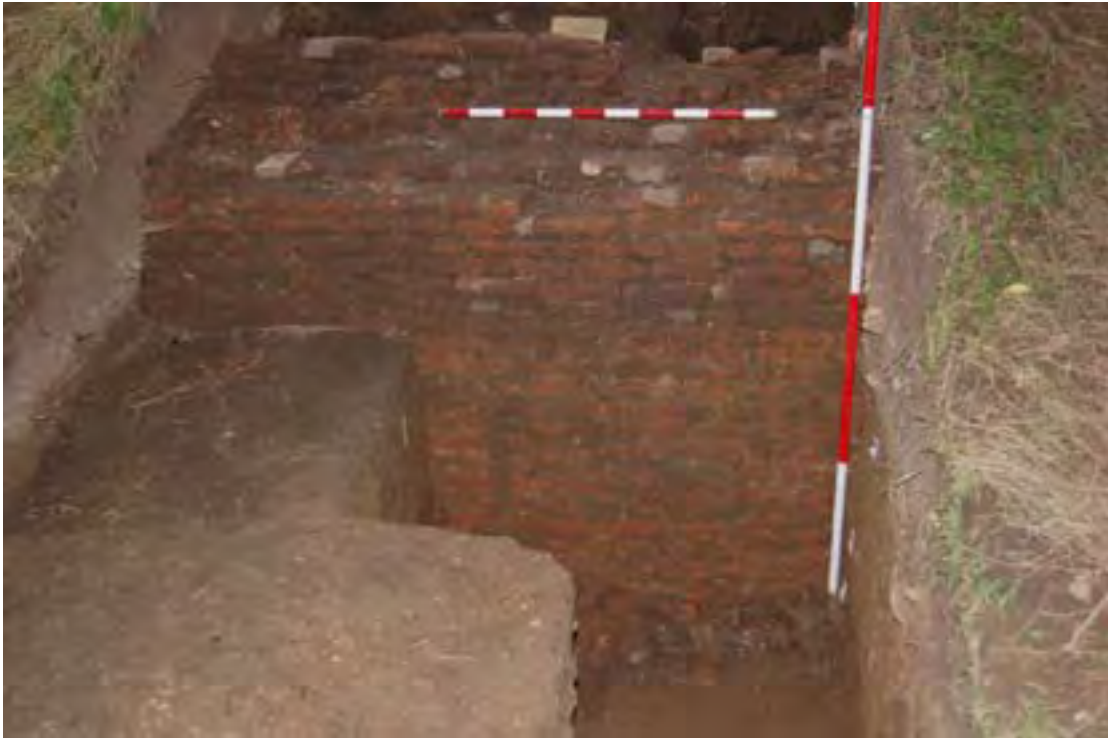
*Plate 1 View of the Phase 3 wall in Trench 1 (southern end), looking north (2m and 1m scales)*

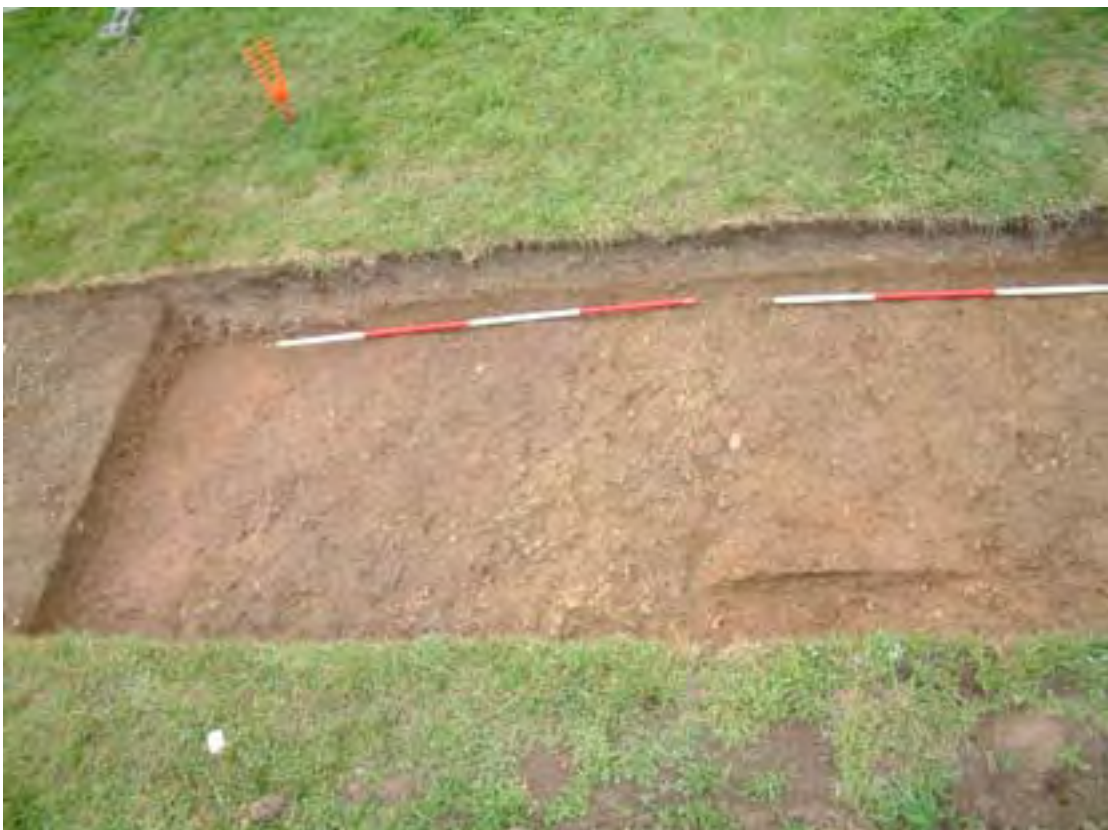
*Plate 2 View of the Phase 3 coloured sandstone fragments in Trench 1 (northern end), looking north (2 x 2m scales)*

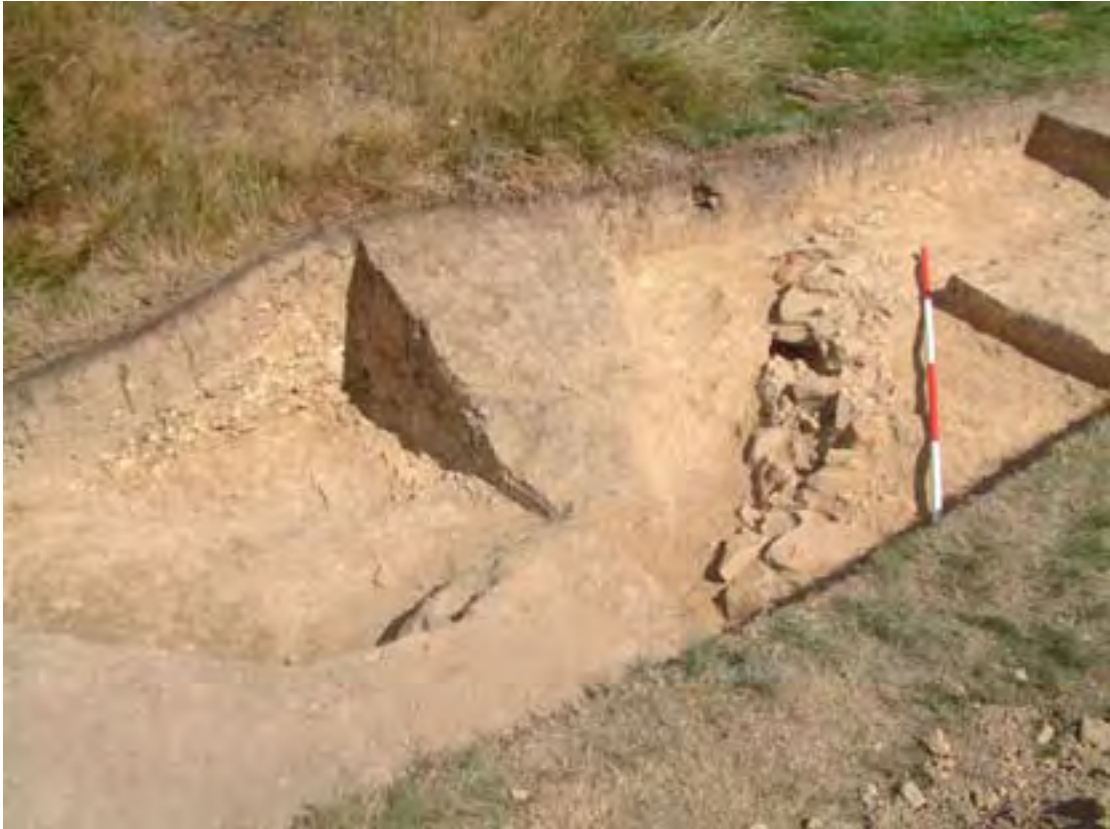
Plate 3 View of the Phase 3 drain in Trench 2, looking north (2m scale)

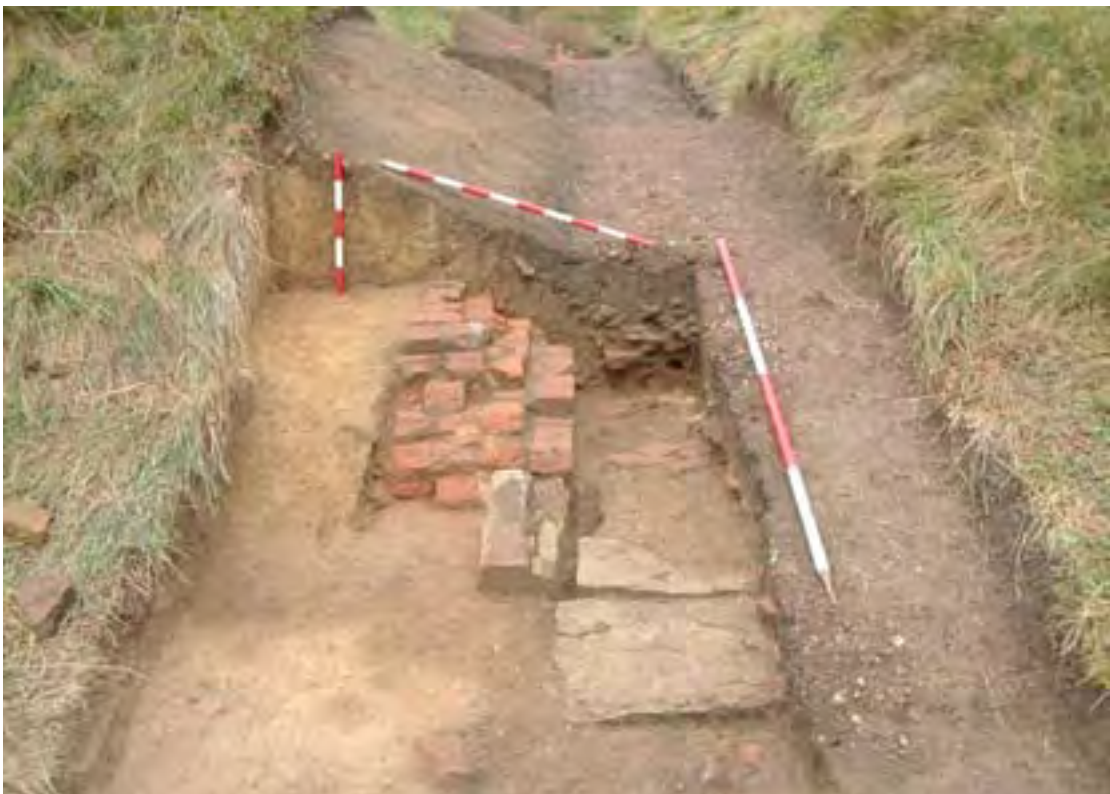
Plate 4 View of the Phase 3 building porch in Trench 2, looking north (2m, 1m and 0.5m scales)

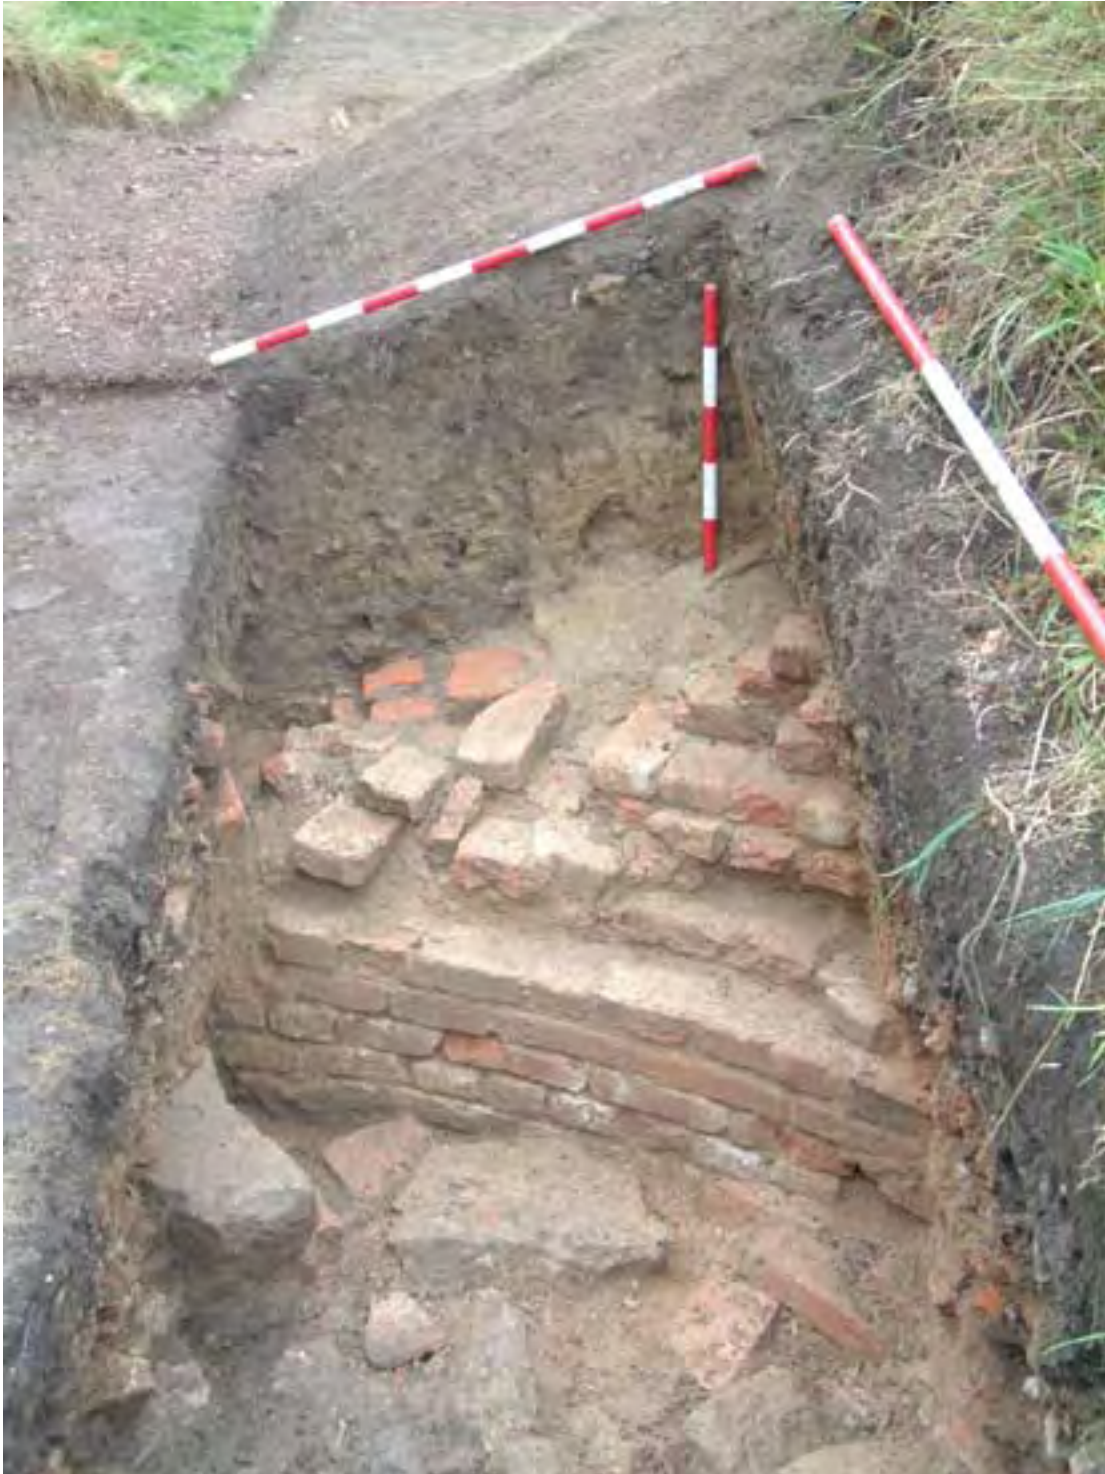
Plate 5 View of the Phase 3 garden building in Trench 2, looking south (2m, 1m and 0.5m scales)
