# SHURLAND HALL GATEHOUSE, EASTCHURCH, ISLE OF SHEPPEY, KENT TREE-RING ANALYSIS OF TIMBERS

SCIENTIFIC DATING REPORT

Research Department Report Series 58-2008

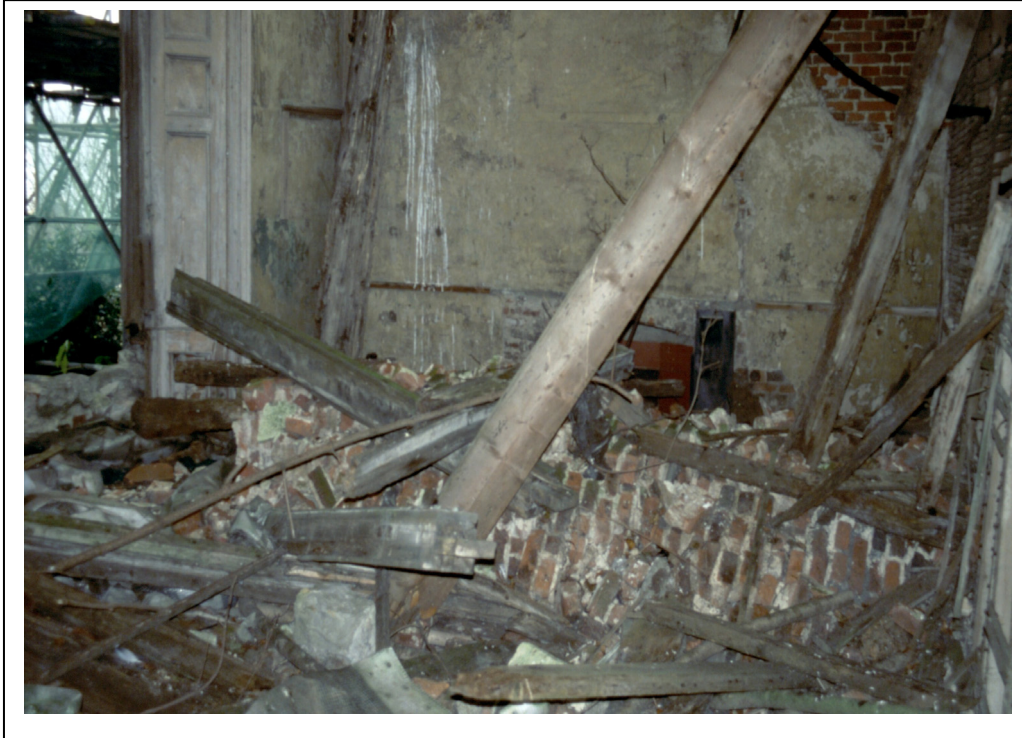
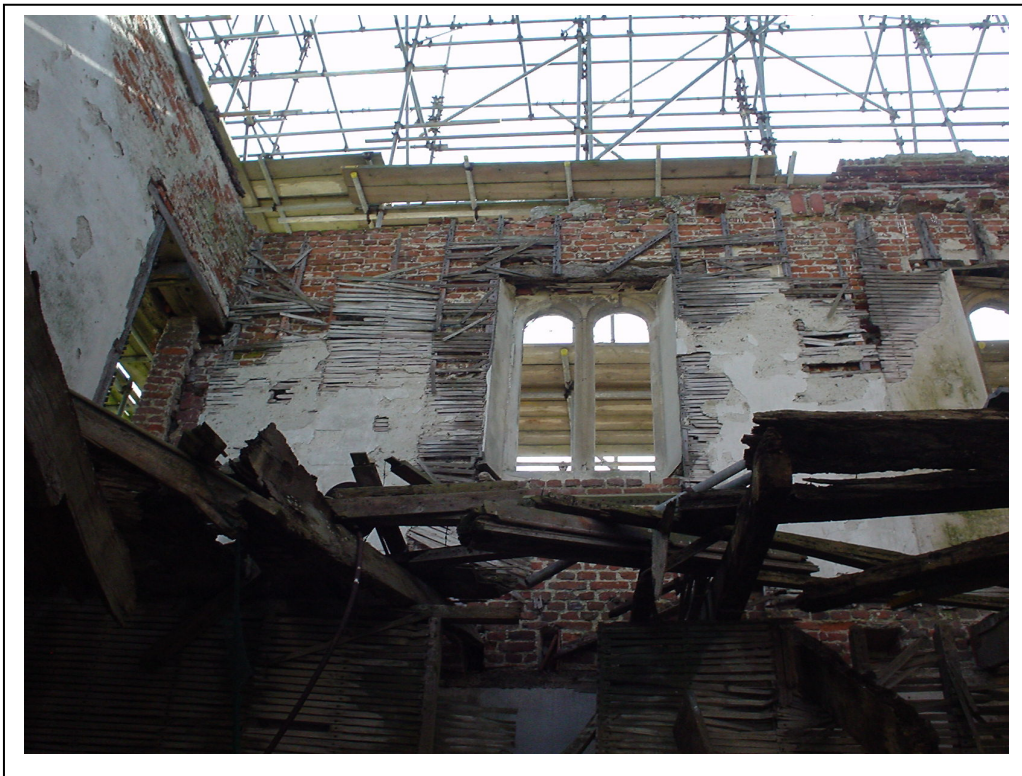
*Figure 4a/b: Photographs to show derelict and dangerous nature of the building before room clearance and stabilisation (photos by Peter Rumley consulting archaeologist)*

Given the extensive nature of the conservation and repair work being undertaken here, and particularly the decayed and unstable nature of the timbers (Fig 4a/b), the majority of these beams, particularly the bridging beams and common joists, had been removed from this structure and stored *ex-situ* before sampling was undertaken (Fig 5). In most instances, as with the bridging beams for example, the precise location of these timbers was recorded prior to removal. In some cases, however, as with the common joists, only the general original location was noted. Only door and window lintels remained undisturbed and *in-situ*. The other parts of Shurland Hall are now represented by partial wall remains and footing, and there are no timbers to these areas.

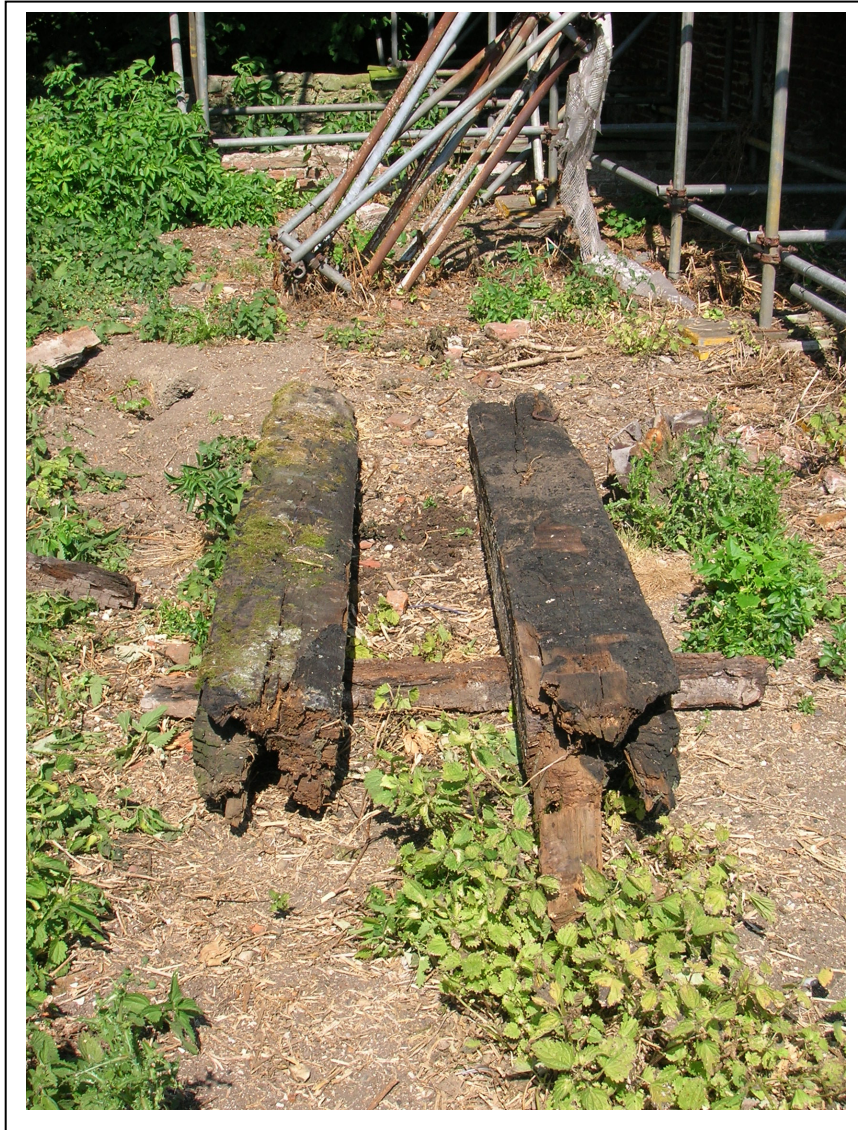
*Figure 5: Photograph to show two of the removed bridging beams*

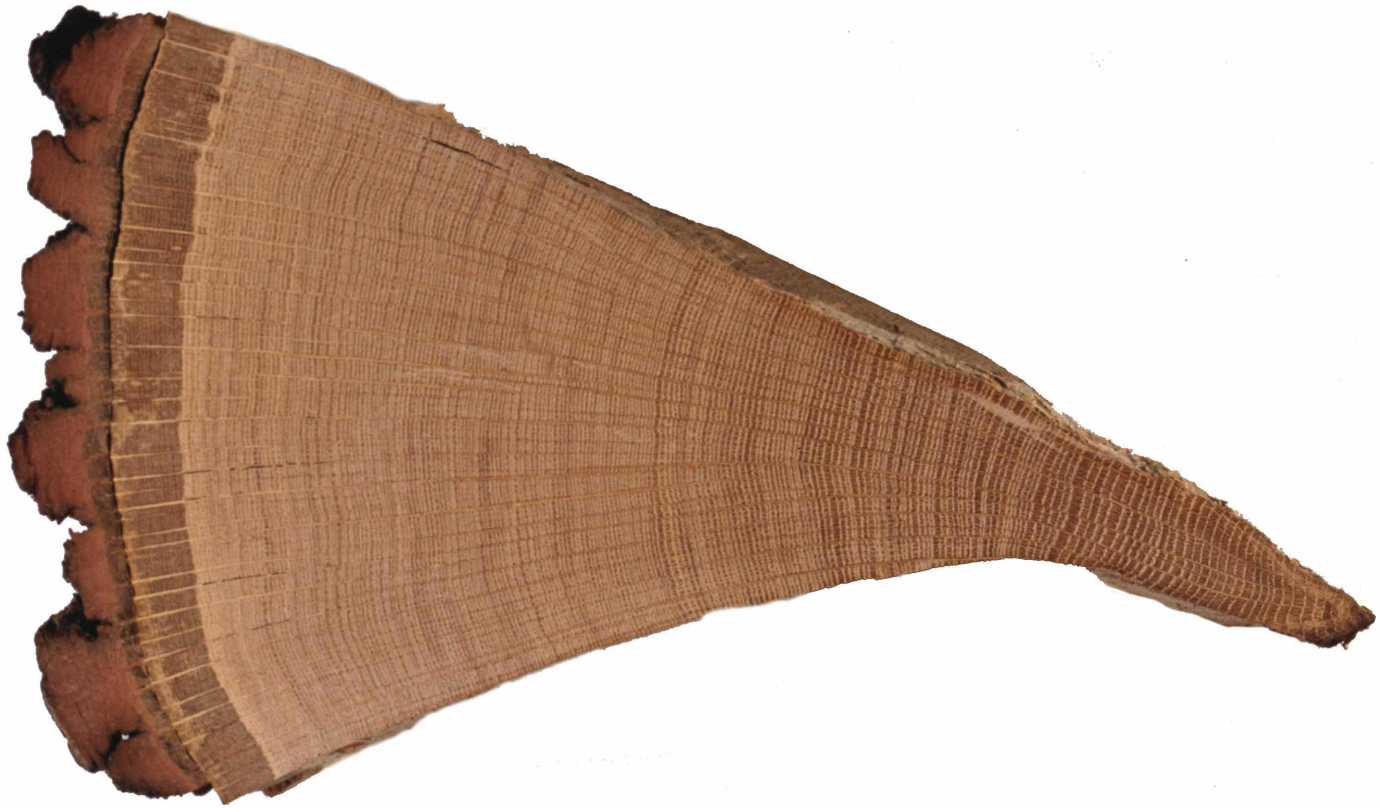
*Figure A1: A wedge of oak from a tree felled in 1976. It shows the annual growth rings, one for each year from the innermost ring to the last ring on the outside just inside the bark. The year of each ring can be determined by counting back from the outside ring, which grew in 1976*

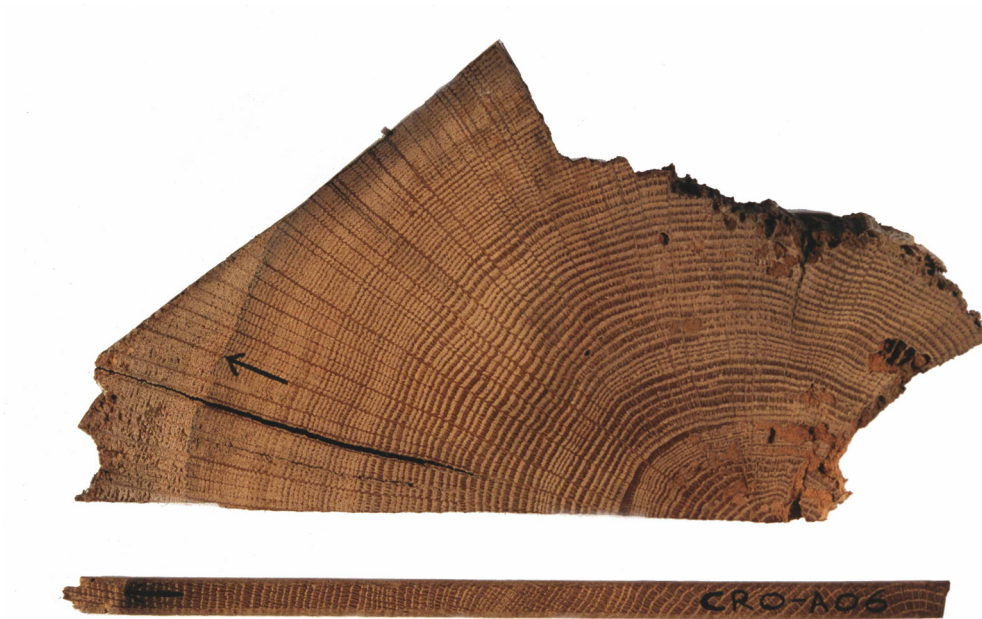
*Figure A2: Cross-section of a rafter, showing sapwood rings in the left-hand corner, the arrow points to the heartwood/sapwood boundary (H/S); and a core with sapwood; again the arrow is pointing to the H/S. The core is about the size of a pencil*

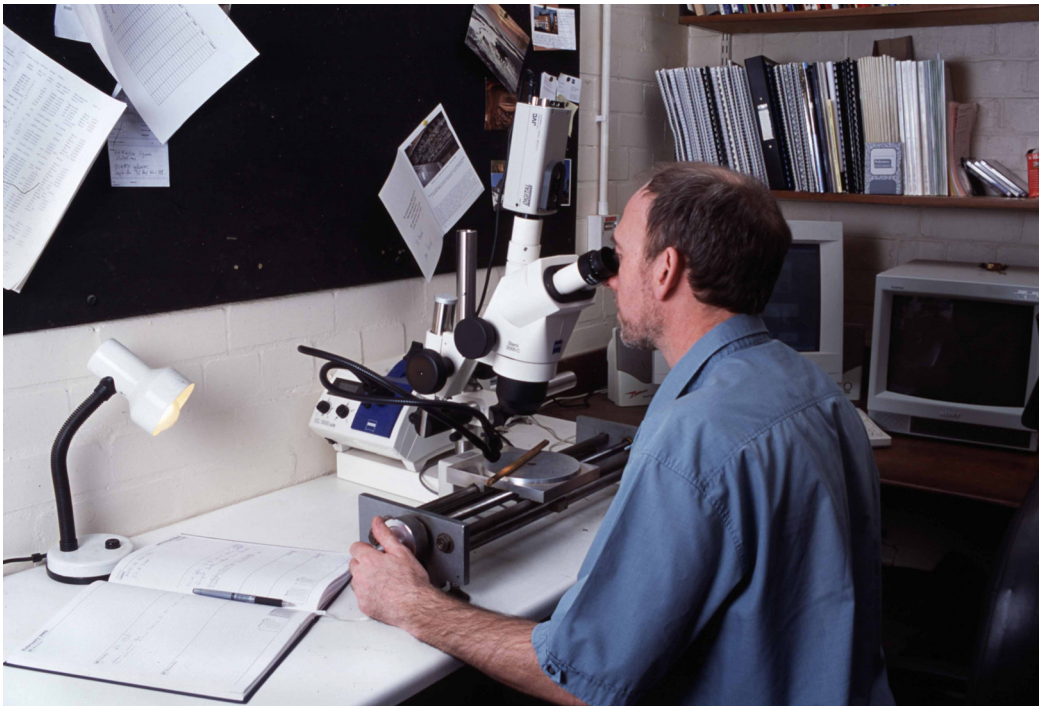
*Figure A3: Measuring ring widths under a microscope. The microscope is fixed while the sample is on a moving platform. The total sequence of widths is measured twice to ensure that an error has not been made. This type of apparatus is needed to process a large number of samples on a regular basis*

**2. Measuring Ring Widths.** Each core is sanded down with a belt sander using medium-grit paper and then finished by hand with flourgrade-grit paper. The rings are then clearly visible and differentiated from each other with a result very much like that shown in Figure A2. The core is then mounted on a movable table below a microscope and the ring-widths measured individually from the innermost ring to the outermost. The widths are automatically recorded in a computer file as they are measured (see Fig A3).

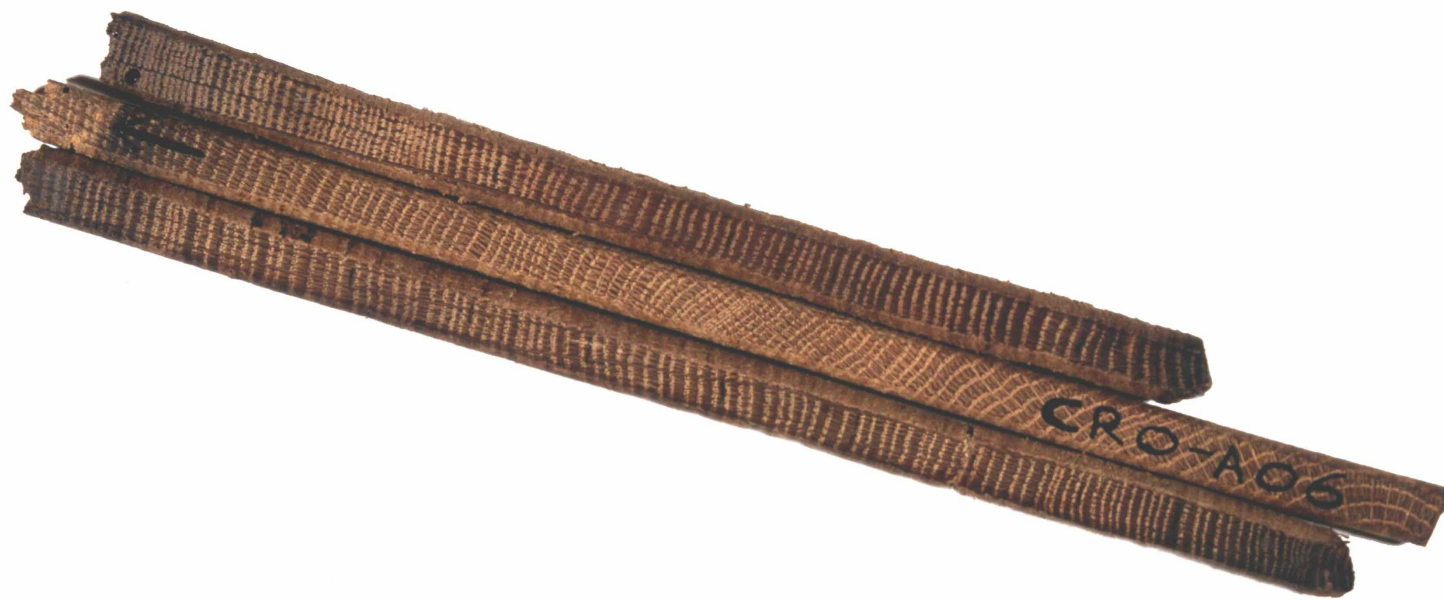
*Figure A4: Three cores from timbers in a building. They come from trees growing at the same time. Notice that, although the sequences of widths look similar, they are not identical. This is typical*
