# HADLEIGH CASTLE, ESSEX EARTHWORK ANALYSIS

## SURVEY REPORT

**HADLEIGH CASTLE  
HADLEIGH  
ESSEX**

**EARTHWORK ANALYSIS: SURVEY REPORT**

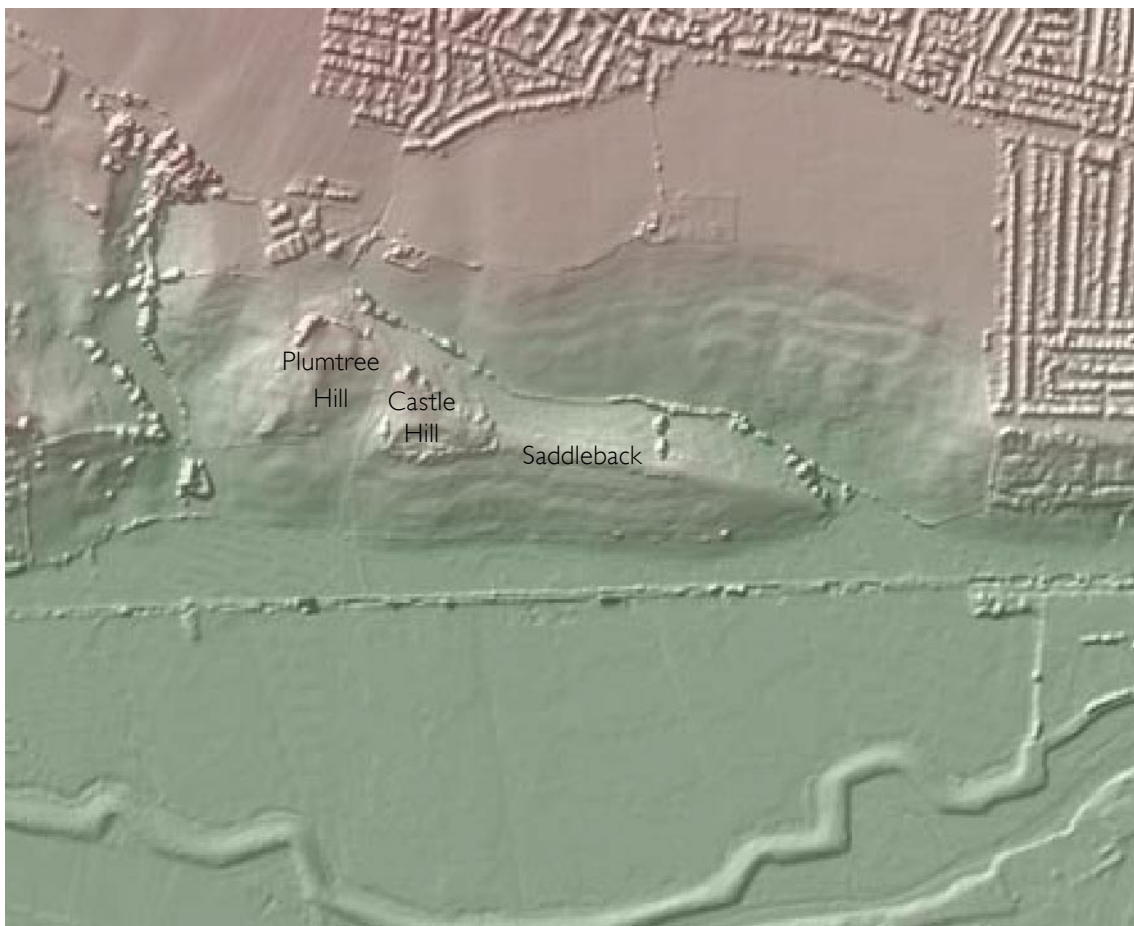
Figure 2 – Topography of the Hadleigh Castle area (based upon height data licensed to English Heritage for PGA, through Next Perspectives™.)

area (see front cover foreground, and Figure 2). The south curtain wall has collapsed and landslips displaced the north-east tower in the 1950s. Erosion and slippage continue today.

The castle is built on geologically unstable London clay (Hutchinson & Gostelow 1976). This clay appears to be composed of alternating firm, stable strata and soft, unstable strata, which have resulted in bands of slumping easily visible on open ground in the

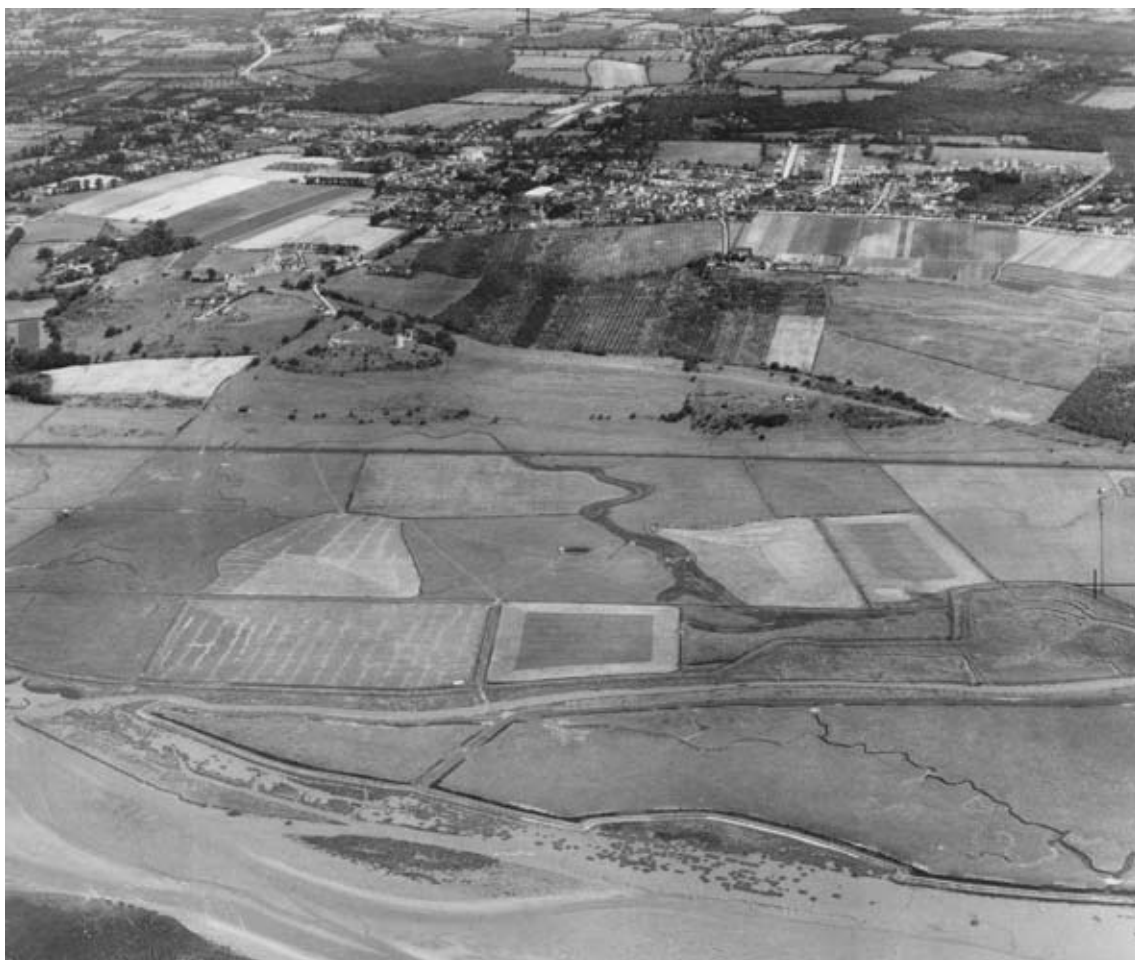
*Figure 3 – Aerial photograph of Hadleigh Castle from the south (English Heritage (NMR) RAF Photography, MSO 31007 PO:2534 21 JULY 1940)*

The castle sits upon an east/west clay spur defined to the north by a shallow valley (see Figures 2 and 3). To the north-west the spur is divided from the relatively discrete, and slightly higher, Plumtree Hill, by a small saddle and open valley running away to the south. This hill is in turn connected on its north side to the main clay plateau of the Rayleigh Hills and the main modern access route to the castle runs from the saddle between the castle and the hill, around the north-east side of Plumtree Hill, and north onto the plateau towards Hadleigh village. To the east the spur initially drops down from the castle and then runs away slightly south of east as a uniform, broad, flat-topped ridge, known locally as Saddleback, for almost 500m before dropping to a well defined terminal. To the south the land drops rapidly to level alluvium which, in the medieval period, would have been marshland separating it from the Thames Estuary, though it is clear that tidal creeks ran to the base of the spur until well into the 20th century (visible on Figure 3).

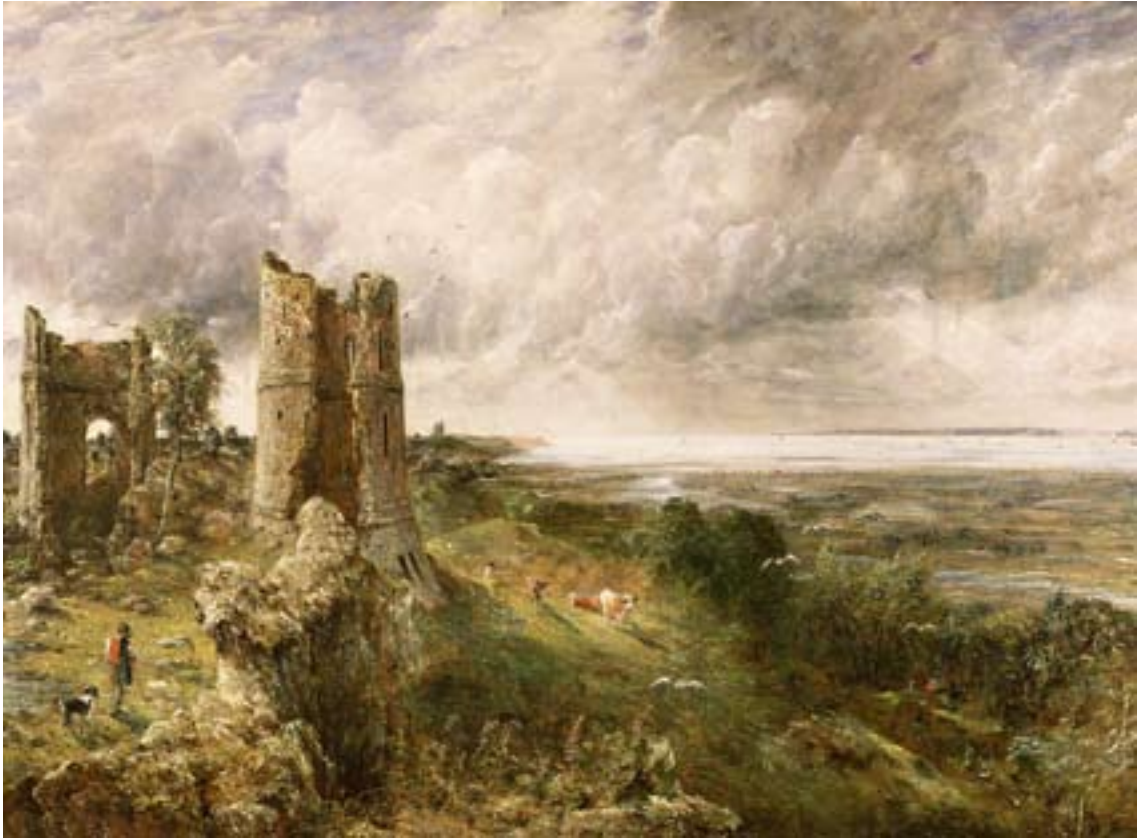
Figure 10 – John Constable's painting of Hadleigh Castle, 1828/9  
 (Yale Center for British Art, Paul Mellon Collection, USA/The Bridgeman Art Library)

The levelled bailey, retained by the southern curtain wall, survived intact until well into the 19th century. Constable's painting (Figure 10) and sketches based upon a visit made in 1814, show this, and King's commentary on his 1862 plan and report on his son's excavations of 1863 states that the external level adjacent to the South Tower was 12 feet below the bailey (King 1863, 86; King 1889, 72). It is not known exactly when the south curtain failed but it must have been after 1863. The first and second edition Ordnance Survey maps (1876 and 1898) show the apartments along the west end of the southern curtain wall as intact which the third and fourth editions do not. These two later editions (1923 and 1938) also show the line of the curtain wall in this area some way to the south of the former line suggesting that the first significant collapse, along this part of the south curtain wall at least, occurred between 1898 and 1923 (the collapsed area is shaded in green on Figure 22). The RCHME survey of 1923 shows the line of a collapse some way to the south of the current line and records that 'a landslide has carried practically the whole of the S. side of the bailey down the hill for a distance of about 40ft.' (RCHME 1923 64, 65). Several photographs also show the slip which appears to be fresh and still in progress (ibid, plates 64-5). A low level aerial photograph (CPE/ UK/2226 5029 15 August 1947) shows the southern curtain wall as considerably decayed

It is clear that there was a terraced area on the south side of the castle. Amidst the jumble of slumped material here it is hard to determine any archaeologically significant features. At either end of this area though, there are two quite steep scarps running away from the southern curtain wall to the south-west and south-east (A on Figure 25 - shown in grey). These have both slumped considerably (shown as a darker grey) and it is likely that they were originally steeper and better defined. They appear to mark a distinct change in the nature of the topography; outside these scarps the slopes are moderate with relatively minor areas of creep visible and appear to be largely natural (though this is less clearly so in the vicinity of the south-east tower), within them lies the area of confusion created by the collapse of the southern curtain. As far as it is possible to determine, the earlier ground surface appears to have been fairly level in places and it seems highly likely that there was a terrace, or more likely several terraced areas, here. The steep scarps at each end and the contrast with the natural slopes beyond, strongly suggest that the terrace was deliberately constructed. This topography was apparently still visible in the early 19th century; Constable's finished painting of Hadleigh Castle, based on a visit he made in 1814, shows the eastern scarp dropping down to a level area in the foreground (Figure 10).

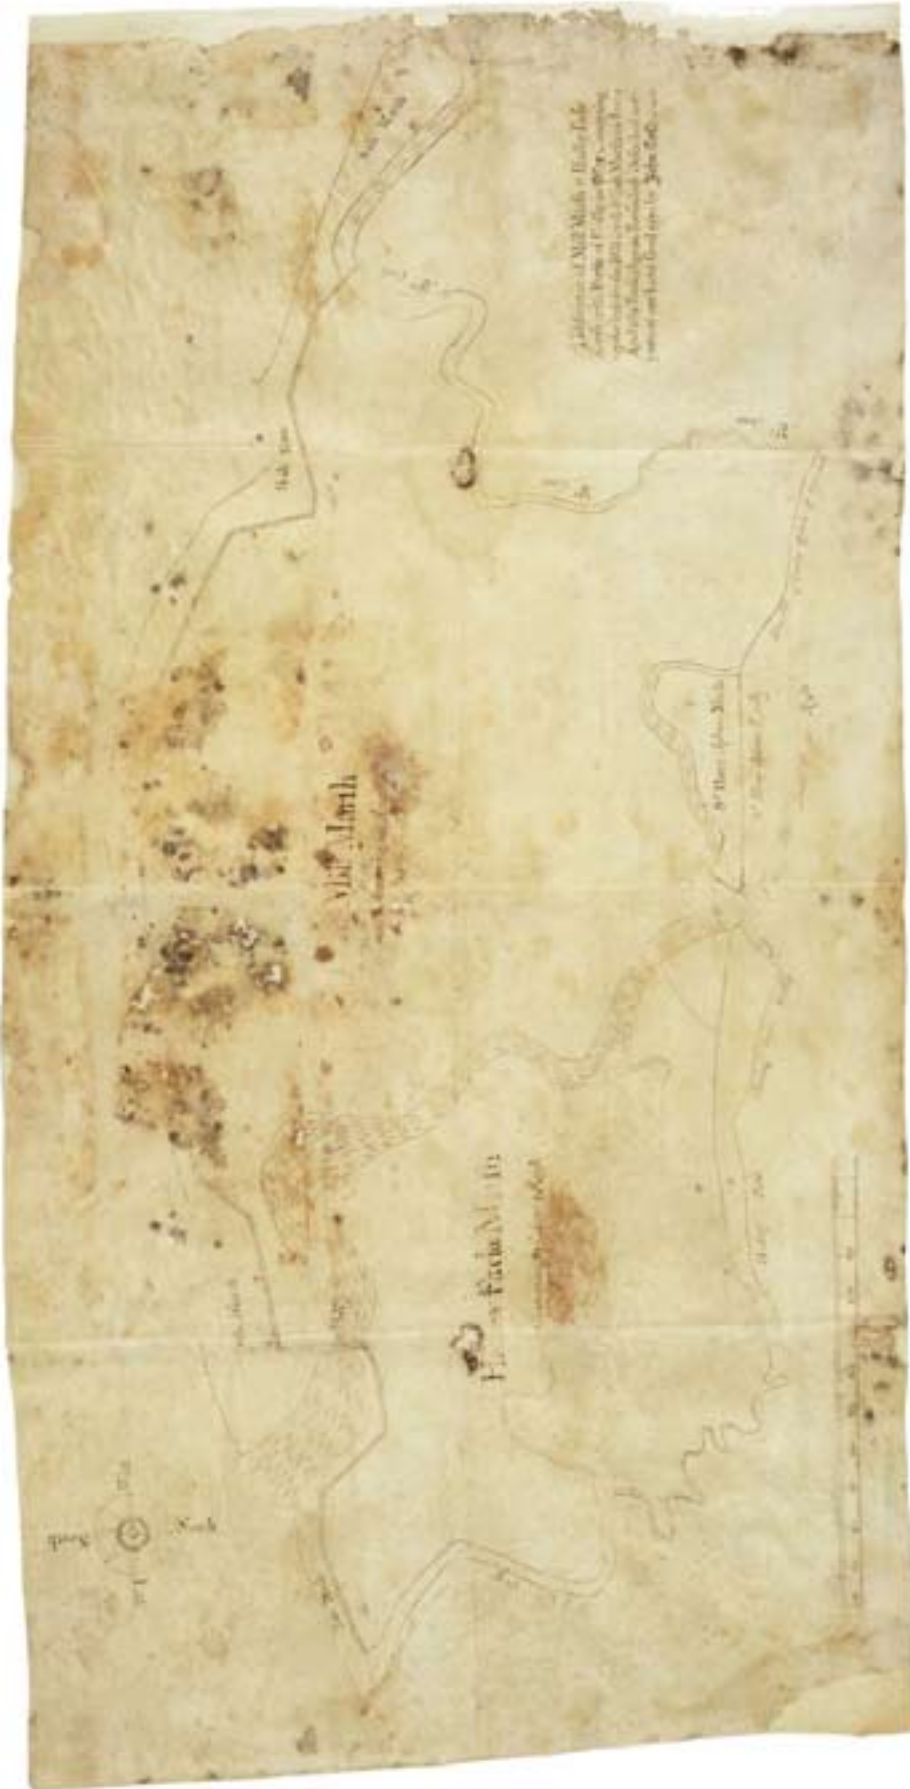
Figure 12 – Sketch map of the marshes below Hadleigh Castle, 1670. North is to the right of the page (CRO, Huntingdonshire Archives, M16/54, © Cambridgeshire County Council)

The castle mill was adjacent to a wharf (below) and so both must have been by a navigable watercourse. The name 'Mill Fleet' was recorded for a channel on the first edition 6" OS map (1876) indicating the location of the mill, but by far the best evidence is the map from 1670, which depicts Mill Marshe and Hadley Parke Marsh (Figure 12). This shows that there was once a wide, likely navigable watercourse, called 'Mill Creake' which flowed right to the bottom of the castle hill, and also depicts the site of the mill. By 1876, this watercourse had been much reduced in size and the marshes were already largely drained (OS 1876). The site of the water-mill was apparently still marked by a slight elevation in the ground upon the marshes below the Castle in the 19th century (King 1863, 90), and fragments of building materials and a large piece of mill-stone were described as being seen in this location (ibid).

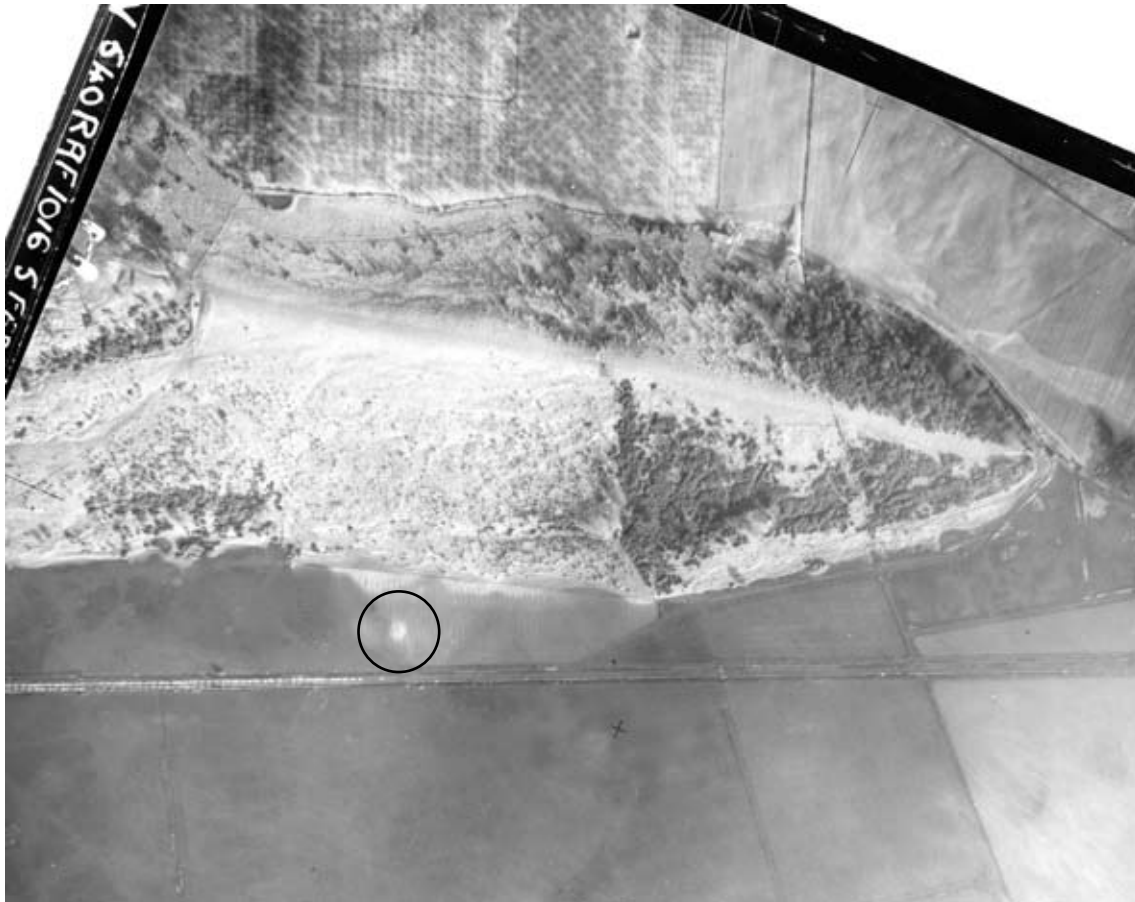
Figure 13 – Aerial photograph showing possible site of mill as pale raised area (circled)  
(V540RAF1016 5 February 1953 0037)

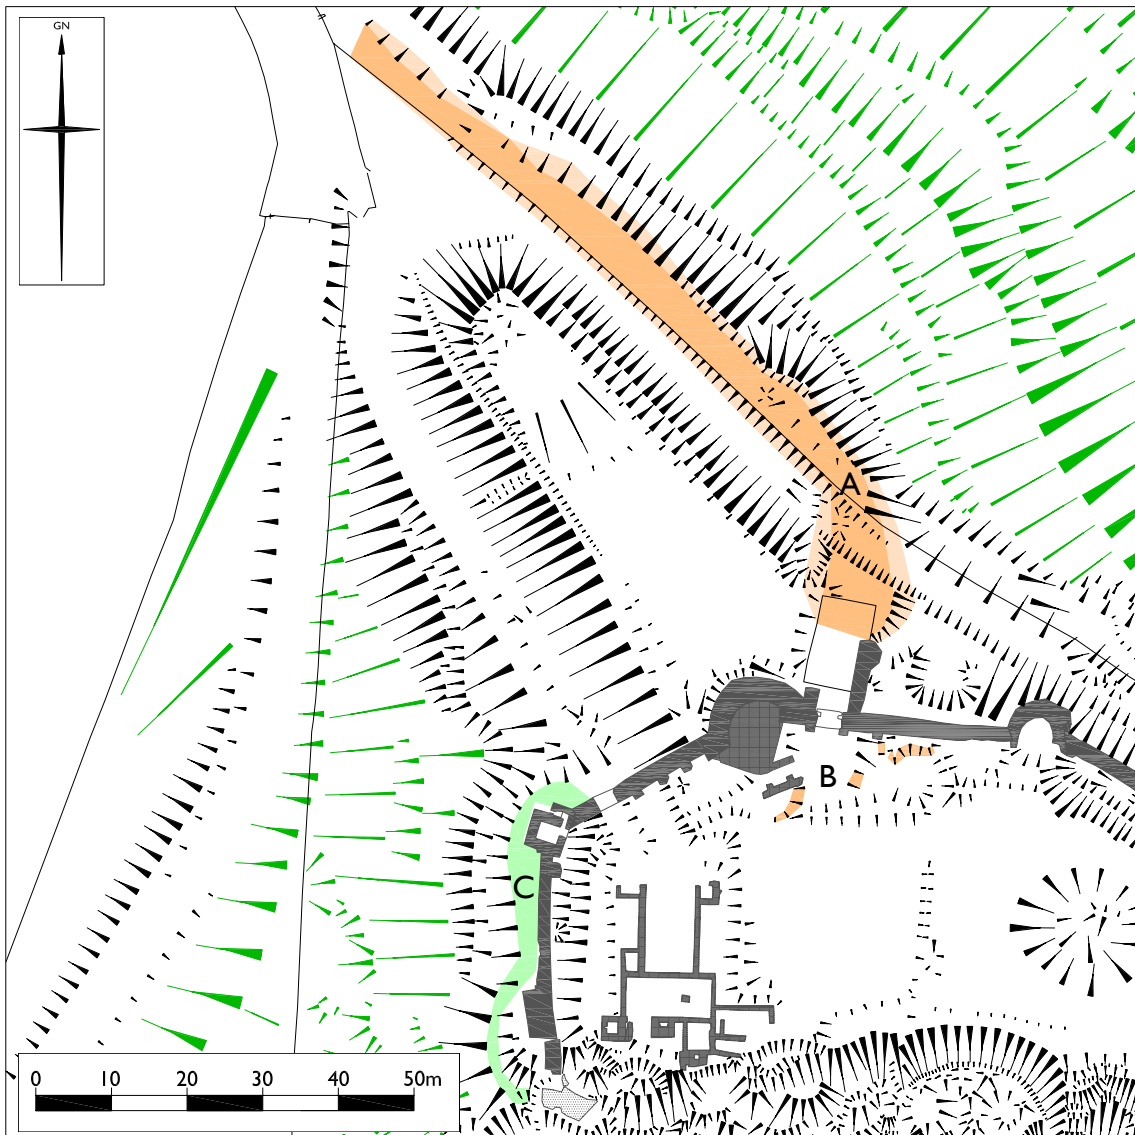
One of the last works to be undertaken was the construction of the new barbican on the north side of the castle (see 'Castle buildings' above). This was approached by a causeway from the north-west which turned sharply south and rose more steeply immediately in front of the barbican, presumably in order to hamper any direct attack on the gate (A on Figure 19 - shown in orange). This turn has, however, been somewhat eroded by the path running along the north side of the fence here and immediately in front of the barbican the causeway has been cut through, apparently relatively recently, presumably to allow easier access along the south side of the fence. The causeway is

Figure 19 – Period 4 earthworks, west and north-west of the bailey (Extract from Figure 27. Letters refer to text, colour coding explained therein) © Crown Copyright and database right 2009. All rights reserved. Ordnance Survey Licence number 100019088

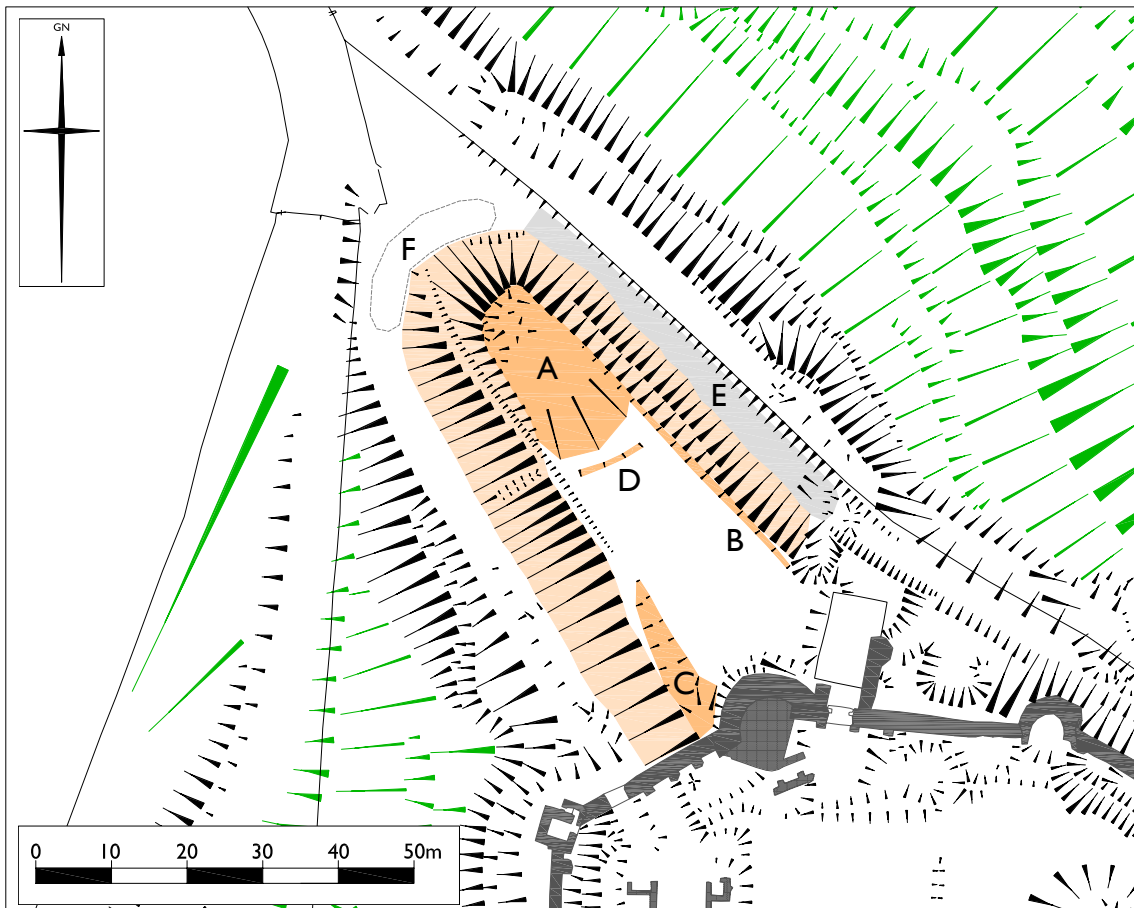
The large spur of land running away from the castle to the north-west must predate the castle as the curtain wall can be seen to rise up over it and the highest part of the bailey is in this area. It is most likely to be natural in origin but with its broad flat top and steep, relatively uniform sides it has clearly been sculpted into its present shape (shown as pale orange on Figure 20). When this occurred or if it was all of one period is uncertain. On its top there is some modern erosion around the base of the High Tower and in the area of the barbican, and at the north end some amorphous hollows and mounds are probably the remains of tree throws. Between these there are some earthworks that hint at possible structures (A on Figure 20 - shown in orange). The end of the spur appeared to have been built up slightly and along the top of the main north-east facing scarp was a second faint scarp set about 0.5m back from the edge which suggests a wall line here (B). A second wall line might be represented by the low bank seen at the south end of the spur running parallel to the south-west facing scarp above the current entrance to the castle (C). In the central area there were some other very faint features but these did not form a coherent pattern, apart from one scarp which ran across the spur about half way along its length (D). Taken together these suggest that the top of the spur may have had an outwork of some form on it but the slight earthworks suggest that if this was the case then it was either a short-lived structure, or cheaply built, or

Figure 20 – Period 5 earthworks, north-west of the bailey (Extract from Figure 27. Letters refer to text, colour coding explained therein) © Crown Copyright and database right 2009. All rights reserved. Ordnance Survey Licence number 100019088

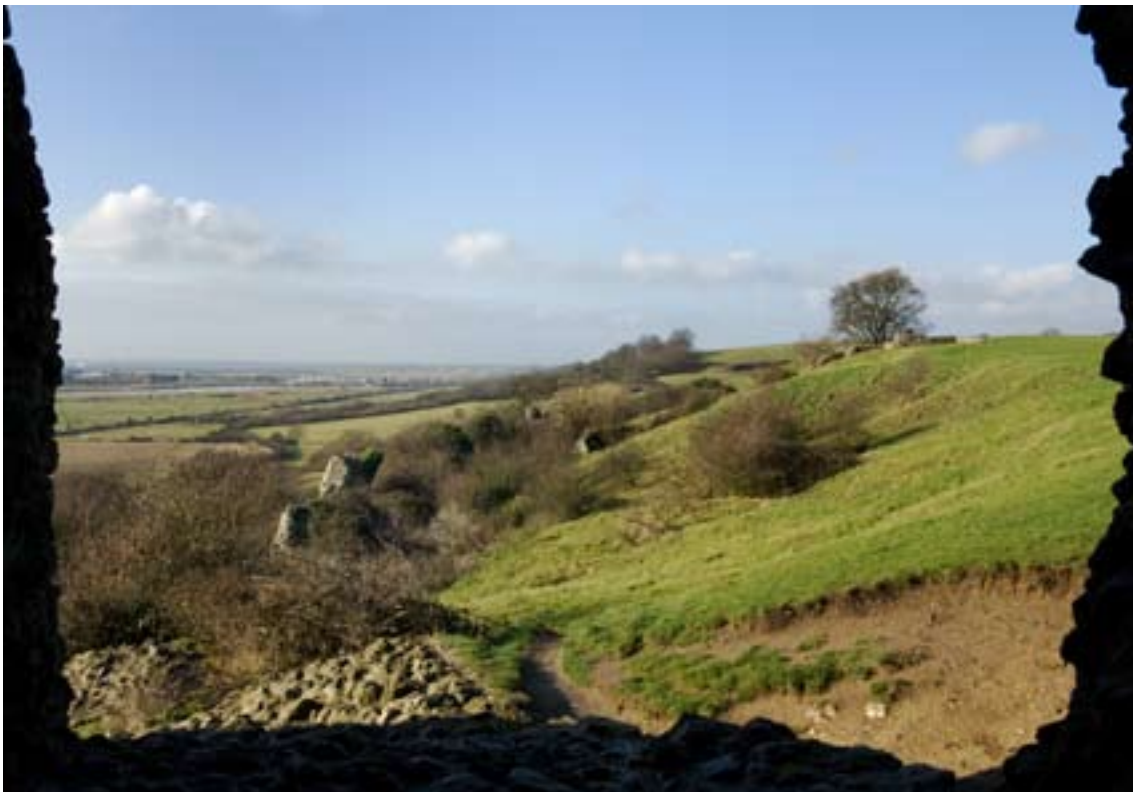
Figure 21 – Slumping on the south side of the bailey, from within the south east tower  
(© EH - DP068090, photographer Patricia Payne)

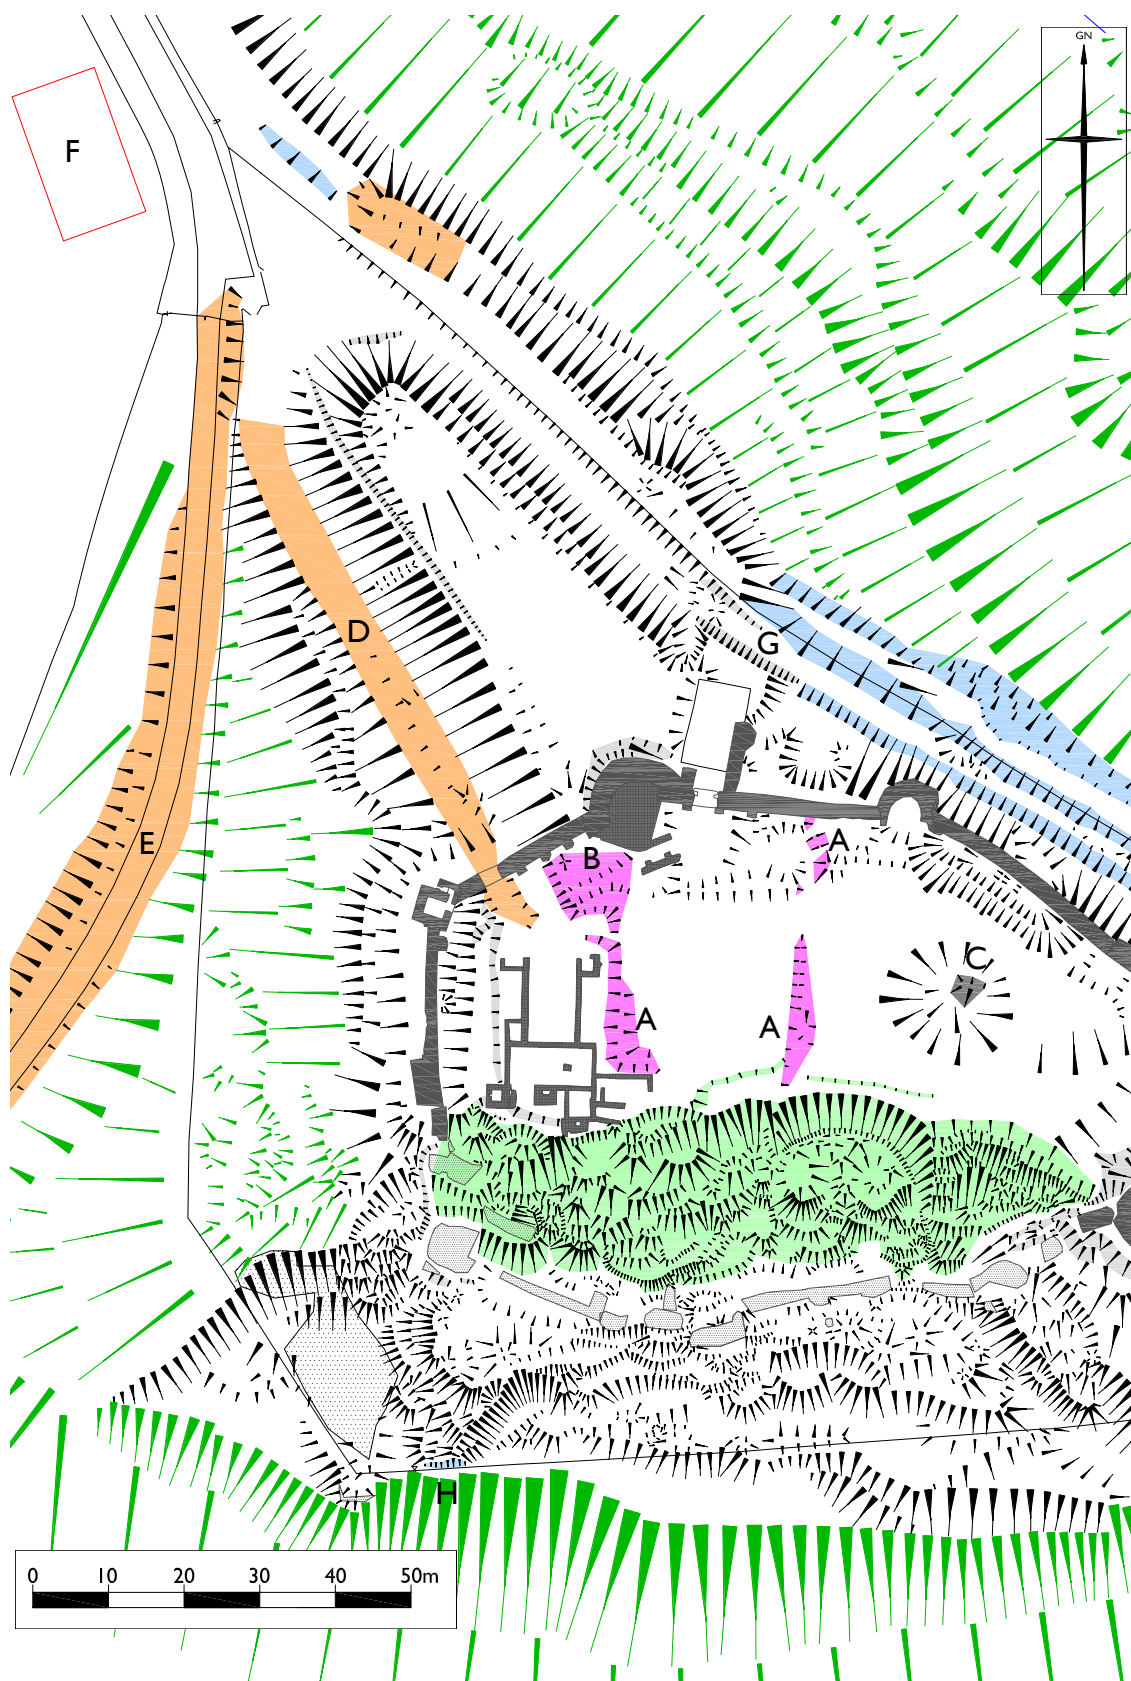
Figure 22 – Recent features (Extract from Figure 27. Letters refer to text, colour coding explained therein) © Crown Copyright and database right 2009. All rights reserved. Ordnance Survey Licence number 100019088

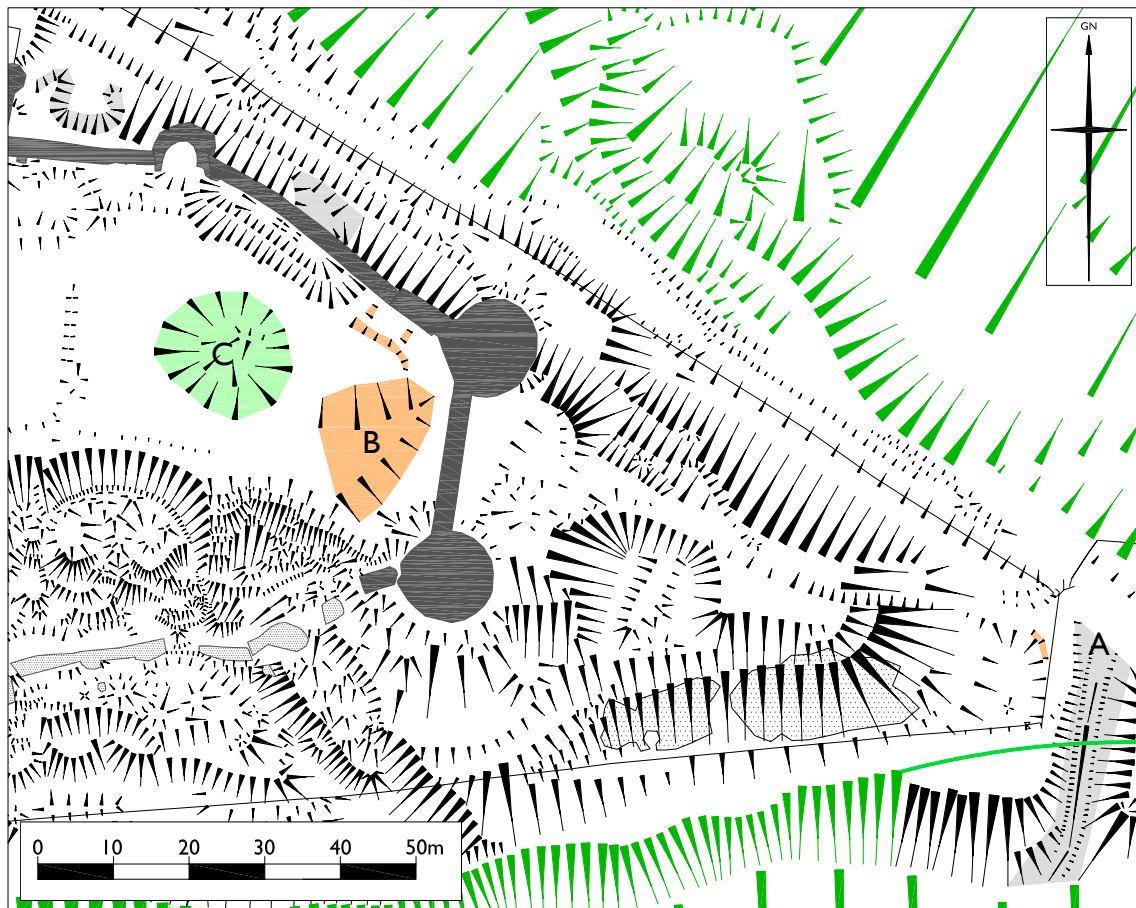
One feature of note is a single mass of masonry, measuring at least 4m by 4m, partly buried just outside the south-west corner of the fenced castle enclosure, about 35m

Figure 24 – Undated features (Extract from Figure 27. Letters refer to text, colour coding explained therein) © Crown Copyright and database right 2009. All rights reserved. Ordnance Survey Licence number 100019088
