ST MARY'S, FELTWELL, NORFOLK TREE-RING ANALYSIS OF TIMBERS

SCIENTIFIC DATING REPORT

Alison Arnold and Robert Howard

NGR: TL 715 907

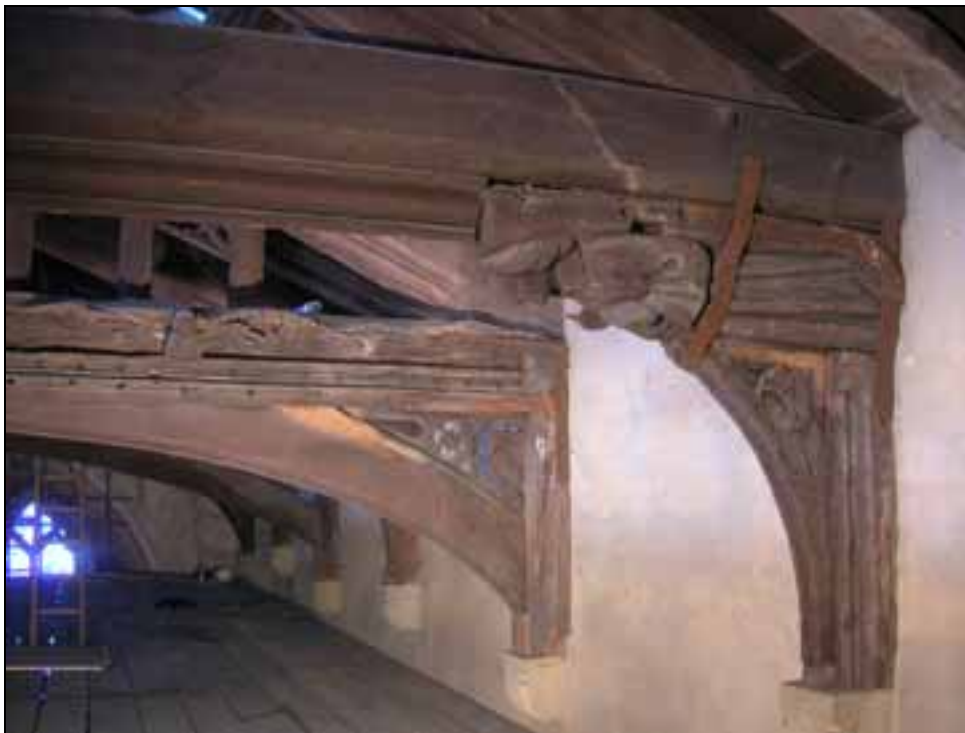
Figure 5: Nave roof; intermediary truss 6

This is of 11 trusses; major and intermediary ones with roll-moulded tiebeams on arched braces and wall posts to corbels. The corbels to the north are thought to be nineteenth-century, and those to the south, fifteenth-century angel figures. The major trusses have pierced spandrels and queen-post struts to moulded principals (Fig 4). The tiebeams of the intermediate trusses are supported on shorter arched braces with the figure of an angel on each side (Fig 5). There is one set of moulded butt purlins to each side and a ridge piece. This roof was thought to date to the fifteenth century (www.imagesofengland.org.uk).

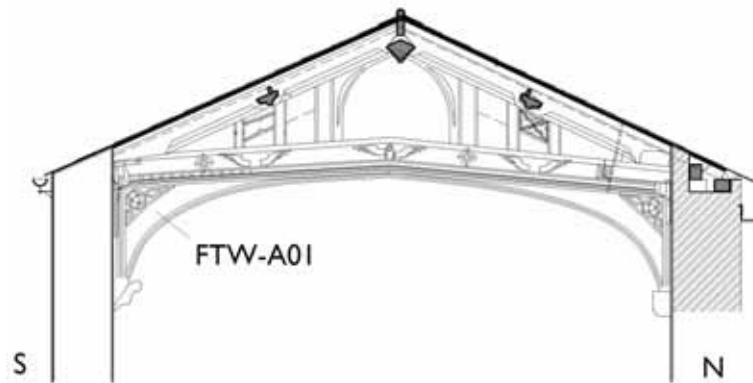
Figure 7: East elevation of principal truss 1 (based on truss 11), showing the location of sample FTW-A01 (Freeland Rees Roberts Architects)

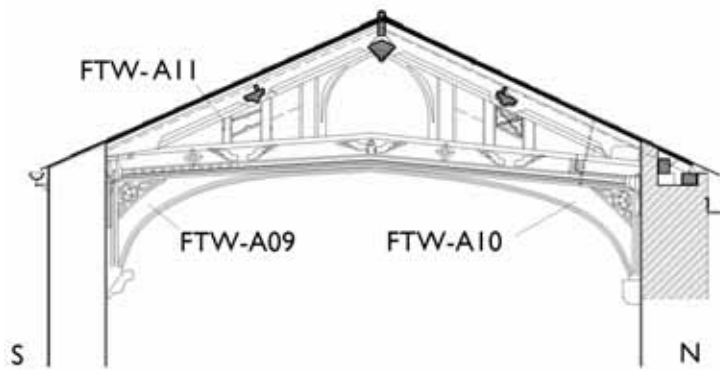
Figure 11: East elevation of principal truss 5 (based on truss 11), showing the location of samples FTW-A09–11 (Freeland Rees Roberts Architects)

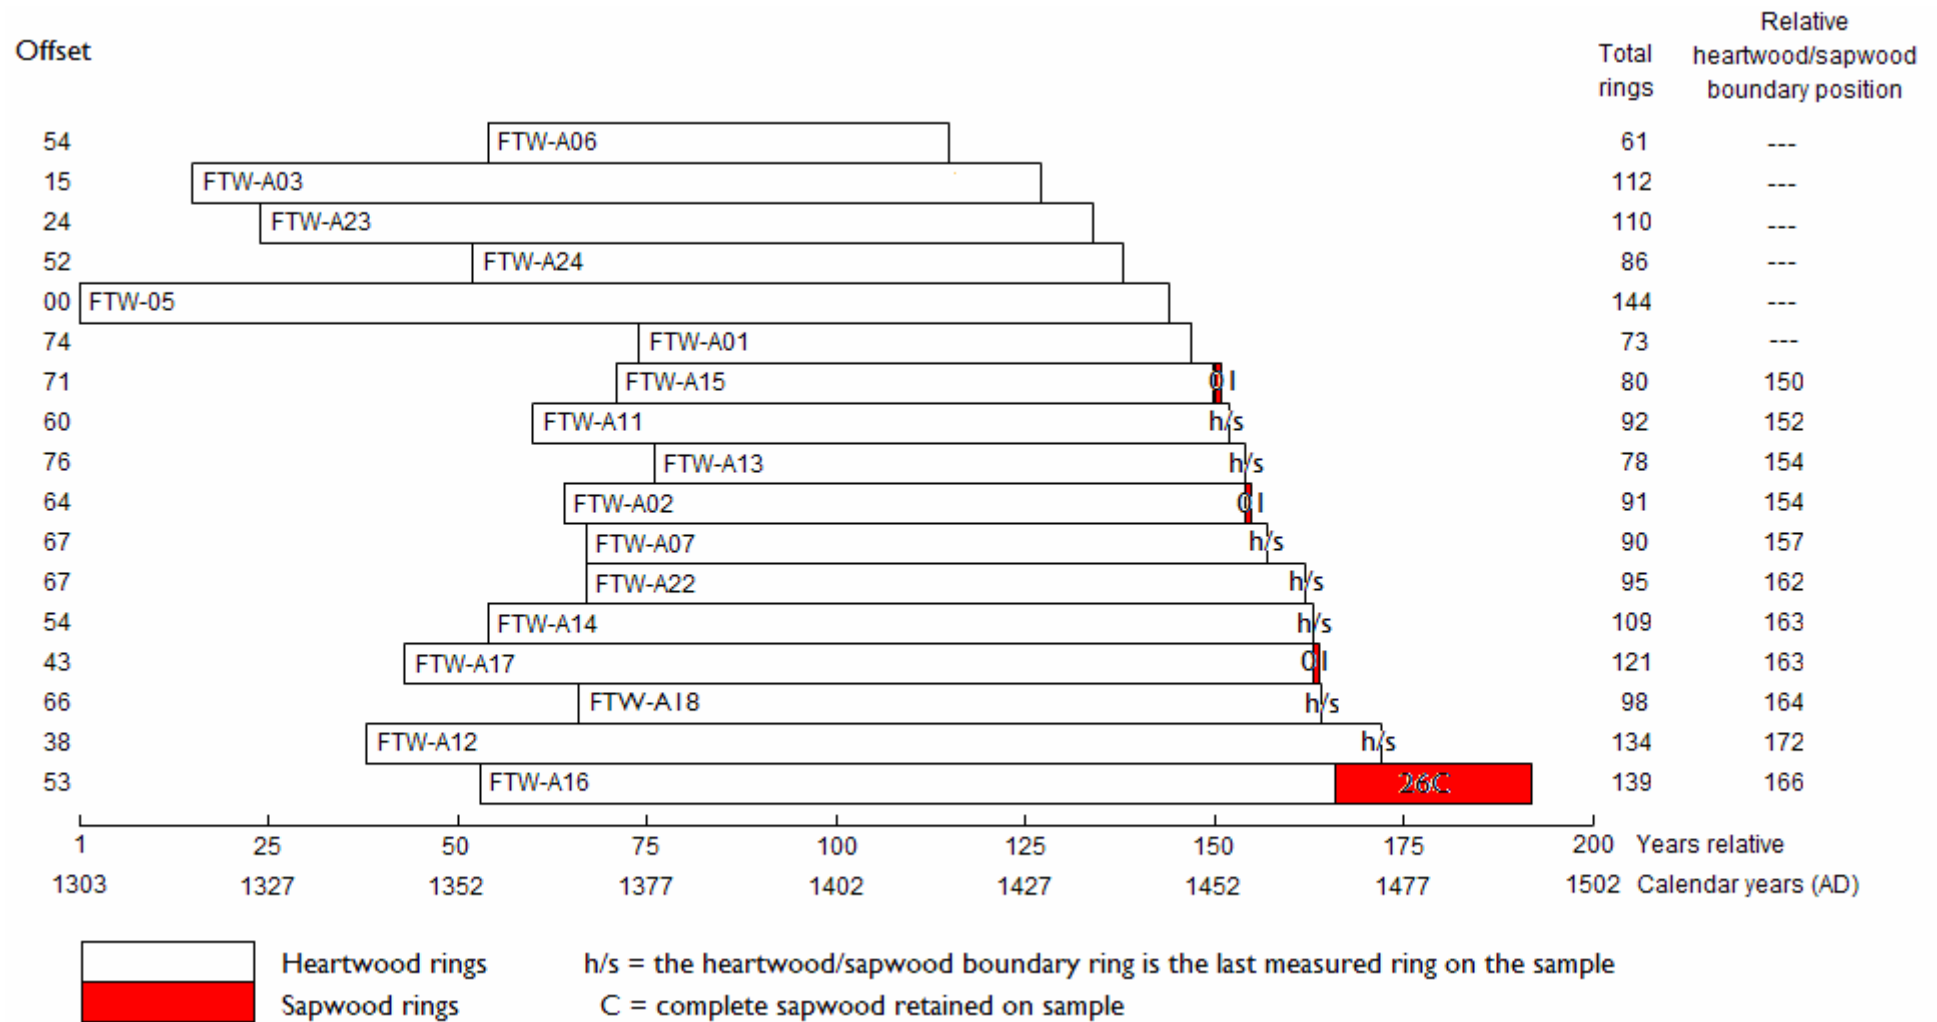
Figure 17: Bar diagram of samples in site sequence FTWASQ01

Firstly, 17 samples matched each other and were combined at the relevant offset positions to form FTWASQ01, a site sequence of 192 rings (Fig 17). This site sequence was compared against a series of relevant reference chronologies for oak, where it was found to match consistently and securely at a first-ring date of AD 1303 and a last-measured ring date of AD 1494.

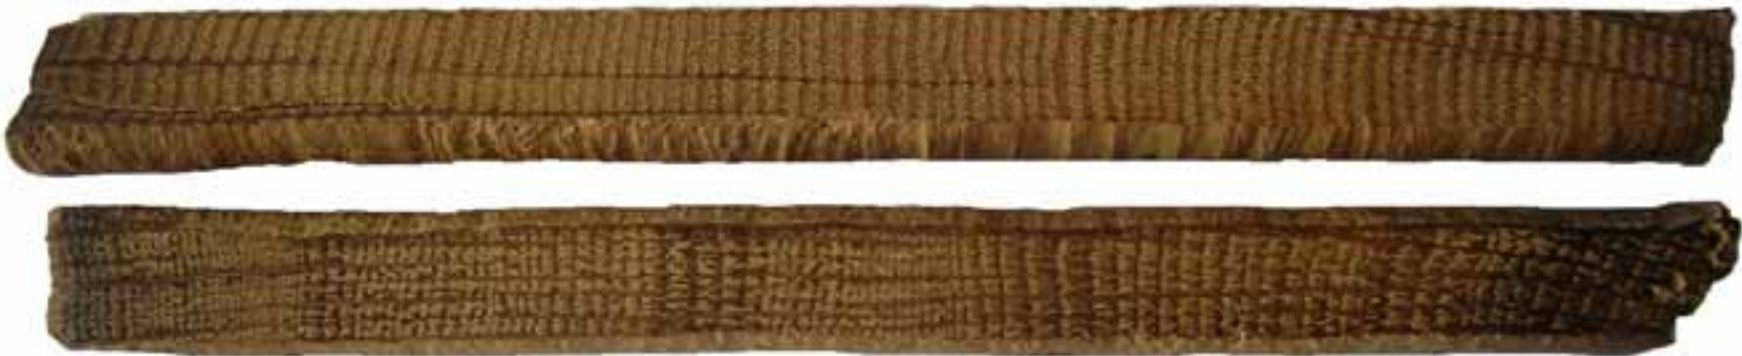
Figure 19: Superficially the samples fell into two groups, the first (upper sample) where the growth rings appeared to be more regular and generally evenly spaced and the second (lower sample) where they were more varied

Once on site, an initial examination of the timbers was undertaken. At this stage there appeared to be a marked difference in the growth pattern of the timbers used within the construction of the roof, with the timbers falling into two distinct groups. After discussion with the Scientific Dating Section at English Heritage, it was decided to sample each group of timbers as if they were a separate phase. It was hoped that this course of action would give a greater chance for success if there did prove to be a difference in date and/or origin.

The potential differences in timber date and/or source suggested by the surface examination did not materialise upon analysis. Despite the superficial differences in growth patterns exhibited by the samples (Fig 19), the analysis points towards a coherent group of timbers being utilised in the construction of the roof. The intra-site matching of samples is good, with a number of samples grouping at values in excess of $t=7$ and the possibility of at least one same tree match at $t=15.8$ between two stud posts from truss 11 (FTW-A23 and FTW-A24). It would appear that the difference in appearance is simply a characteristic of these trees.

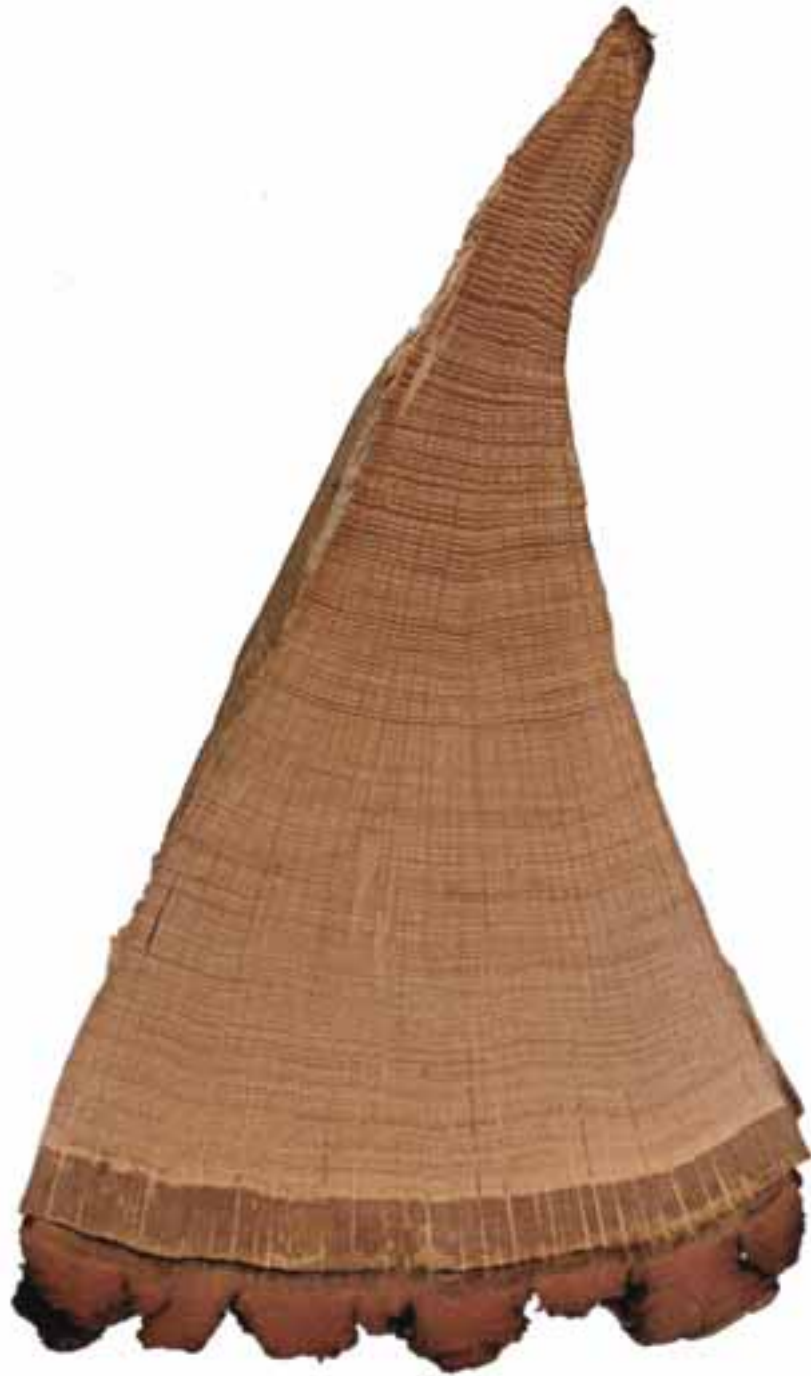
Figure A1: A wedge of oak from a tree felled in 1976. It shows the annual growth rings, one for each year from the innermost ring to the last ring on the outside just inside the bark. The year of each ring can be determined by counting back from the outside ring, which grew in 1976

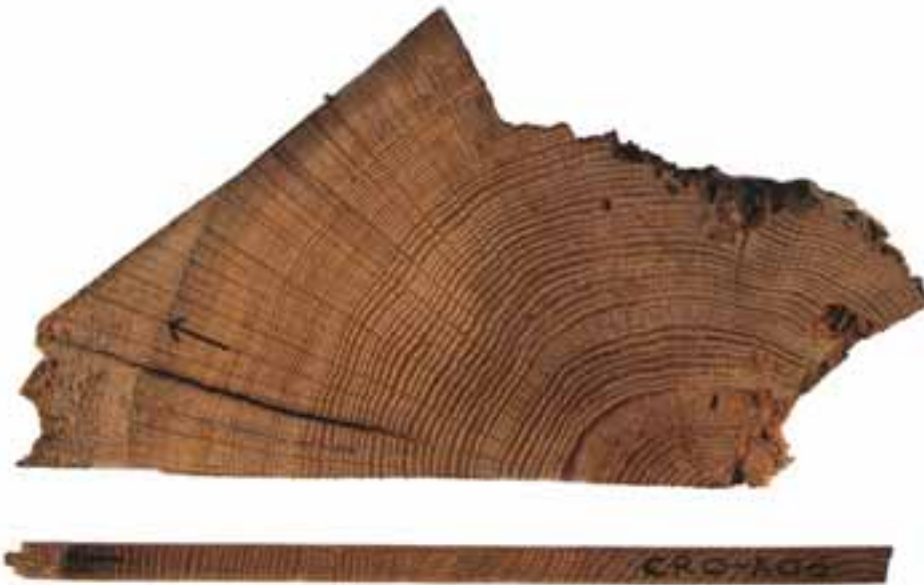
Figure A2: Cross-section of a rafter, showing sapwood rings in the left-hand corner, the arrow points to the heartwood/sapwood boundary (H/S); and a core with sapwood; again the arrow is pointing to the H/S. The core is about the size of a pencil

Quite often some, though not all, of the original outer rings are missing on a timber. The outer rings on an oak, called sapwood rings, are usually lighter than the inner rings, the heartwood, and so are relatively easy to identify. For example, sapwood can be seen in the corner of the rafter and at the outer end of the core in Figure A2, both indicated by arrows. More importantly for dendrochronology, the sapwood is relatively soft and so liable to insect attack and wear and tear. The builder, therefore, may remove some of the sapwood for precisely these reasons. Nevertheless, if at least some of the sapwood rings are left on a sample, we will know that not too many rings have been lost since felling so that the date of the last ring on the sample is only a few years before the date of the original last ring on the tree, and so to the date of felling.

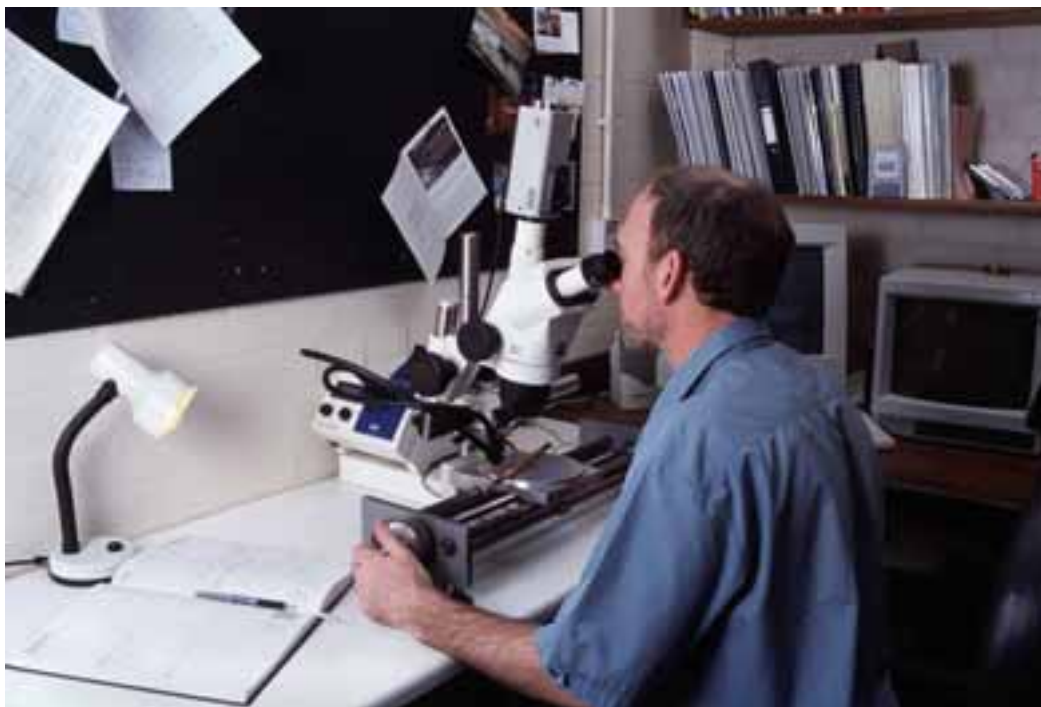
Figure A3: Measuring ring widths under a microscope. The microscope is fixed while the sample is on a moving platform. The total sequence of widths is measured twice to ensure that an error has not been made. This type of apparatus is needed to process a large number of samples on a regular basis

2. Measuring Ring Widths. Each core is sanded down with a belt sander using medium-grit paper and then finished by hand with flourgrade-grit paper. The rings are then clearly visible and differentiated from each other with a result very much like that shown in Figure A2. The core is then mounted on a movable table below a microscope and the ring-widths measured individually from the innermost ring to the outermost. The widths are automatically recorded in a computer file as they are measured (see Fig A3).

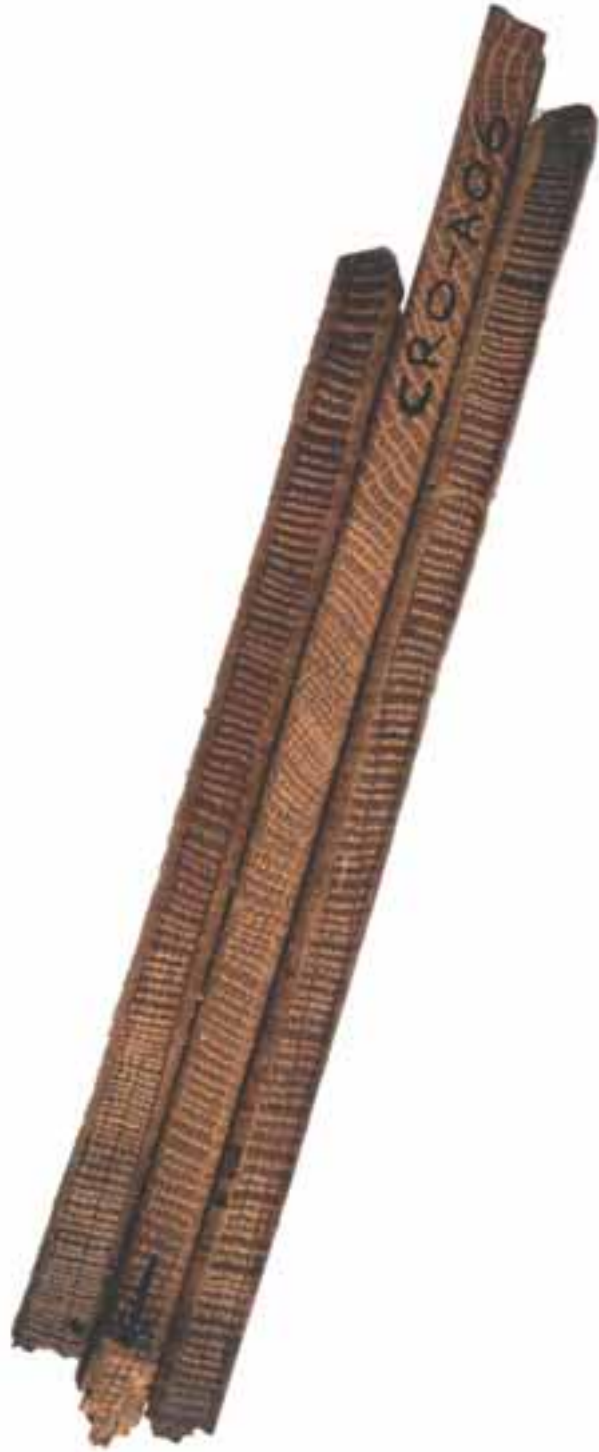
Figure A4: Three cores from timbers in a building. They come from trees growing at the same time. Notice that, although the sequences of widths look similar, they are not identical. This is typical
