# THE CHANTRY, CHANTRY PLACE, MORPETH, NORTHUMBERLAND TREE-RING ANALYSIS OF TIMBERS

SCIENTIFIC DATING REPORT

Alison Arnold and Robert Howard

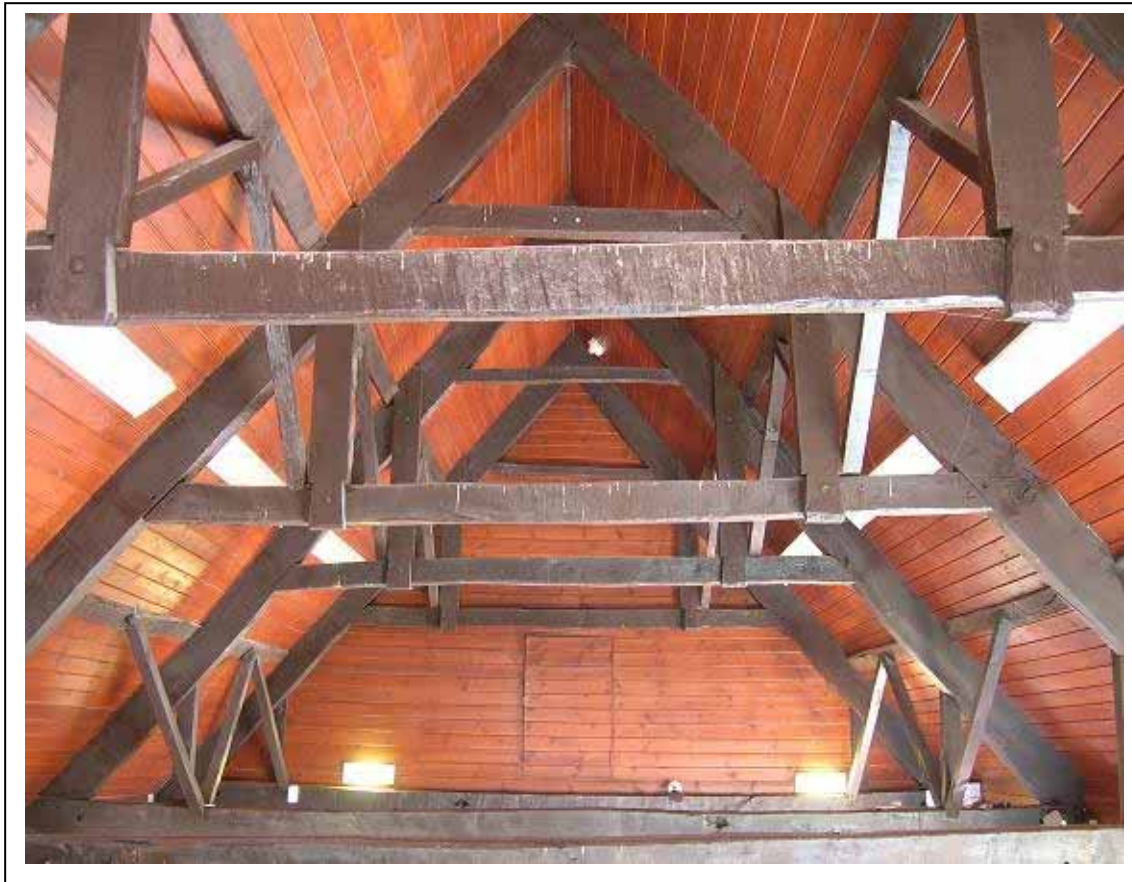
*Figure 4: View of the Chantry roof looking west to east*

Unusually, there are vertical 'hanging ties', or struts, between the lower collars and the principal rafters (Fig 4), and although the lower ends of these verticals are given dove-tailed tenons, the dovetails are not set into corresponding mortices in the tiebeams. Instead, these timbers are fixed, by large-headed bolts with nuts and small flanges, face-on to the tiebeams. The top ends of the verticals are also face-bolted to the principal rafters. The majority of these timbers are of oak, but there appear to be no assembly marks on them.

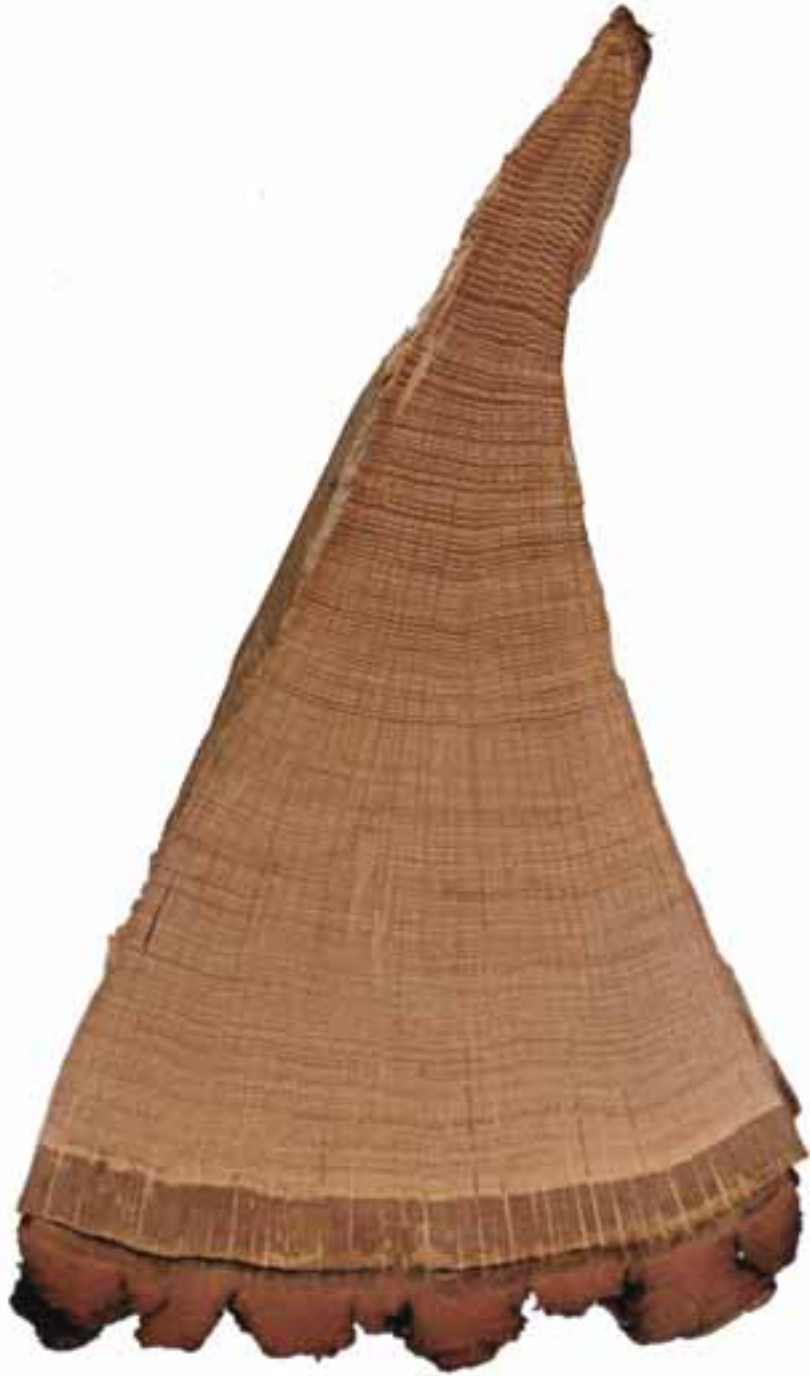
*Figure A1: A wedge of oak from a tree felled in 1976. It shows the annual growth rings, one for each year from the innermost ring to the last ring on the outside just inside the bark. The year of each ring can be determined by counting back from the outside ring, which grew in 1976*

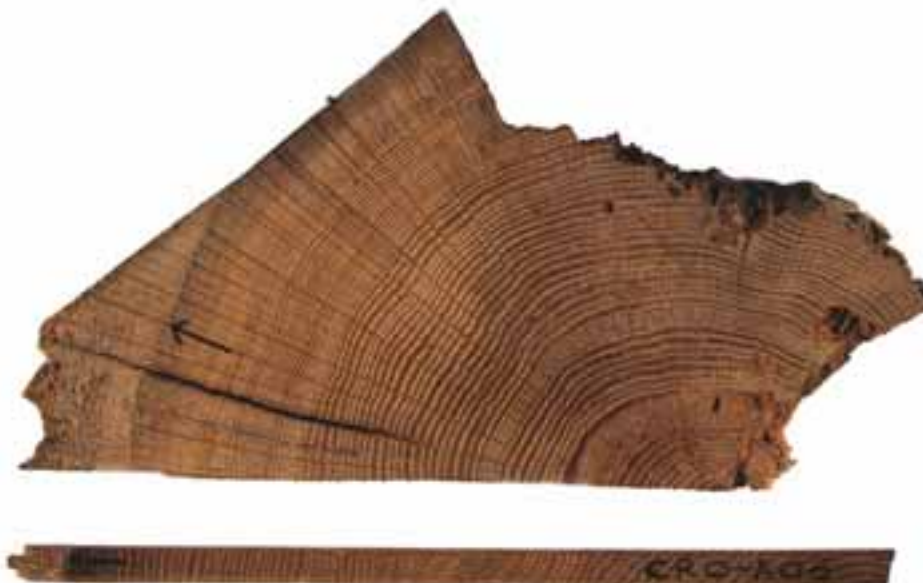
*Figure A2: Cross-section of a rafter, showing sapwood rings in the left-hand corner, the arrow points to the heartwood/sapwood boundary (H/S); and a core with sapwood; again the arrow is pointing to the H/S. The core is about the size of a pencil*

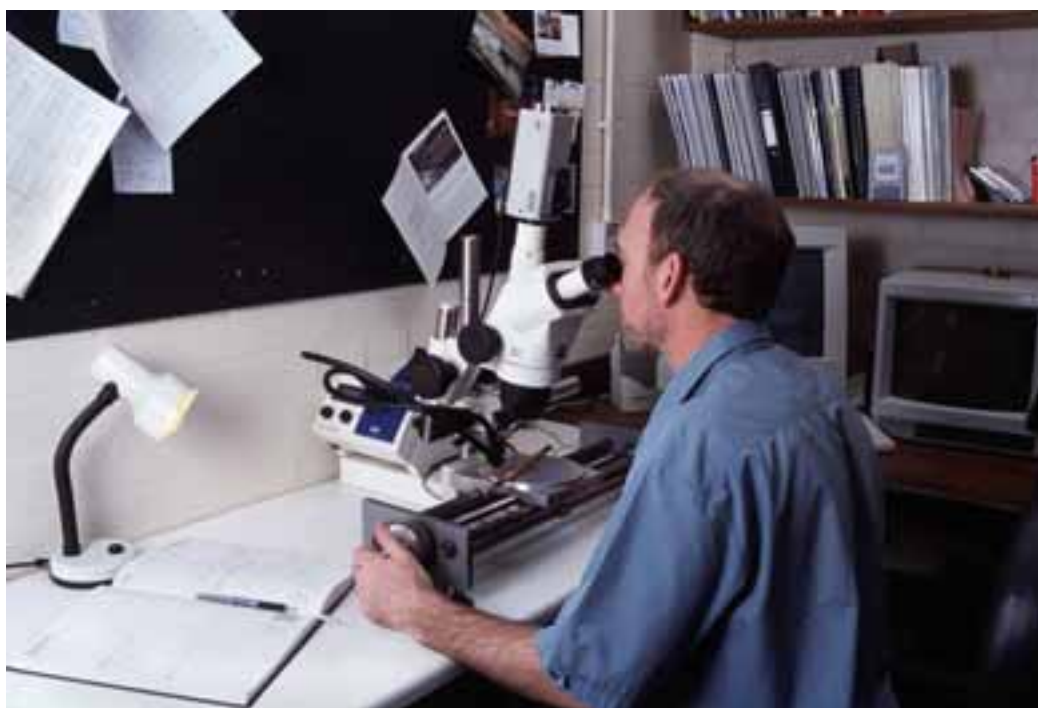
*Figure A3: Measuring ring widths under a microscope. The microscope is fixed while the sample is on a moving platform. The total sequence of widths is measured twice to ensure that an error has not been made. This type of apparatus is needed to process a large number of samples on a regular basis*

**2. Measuring Ring Widths.** Each core is sanded down with a belt sander using medium-grit paper and then finished by hand with flourgrade-grit paper. The rings are then clearly visible and differentiated from each other with a result very much like that shown in Figure A2. The core is then mounted on a movable table below a microscope and the ring-widths measured individually from the innermost ring to the outermost. The widths are automatically recorded in a computer file as they are measured (see Fig A3).

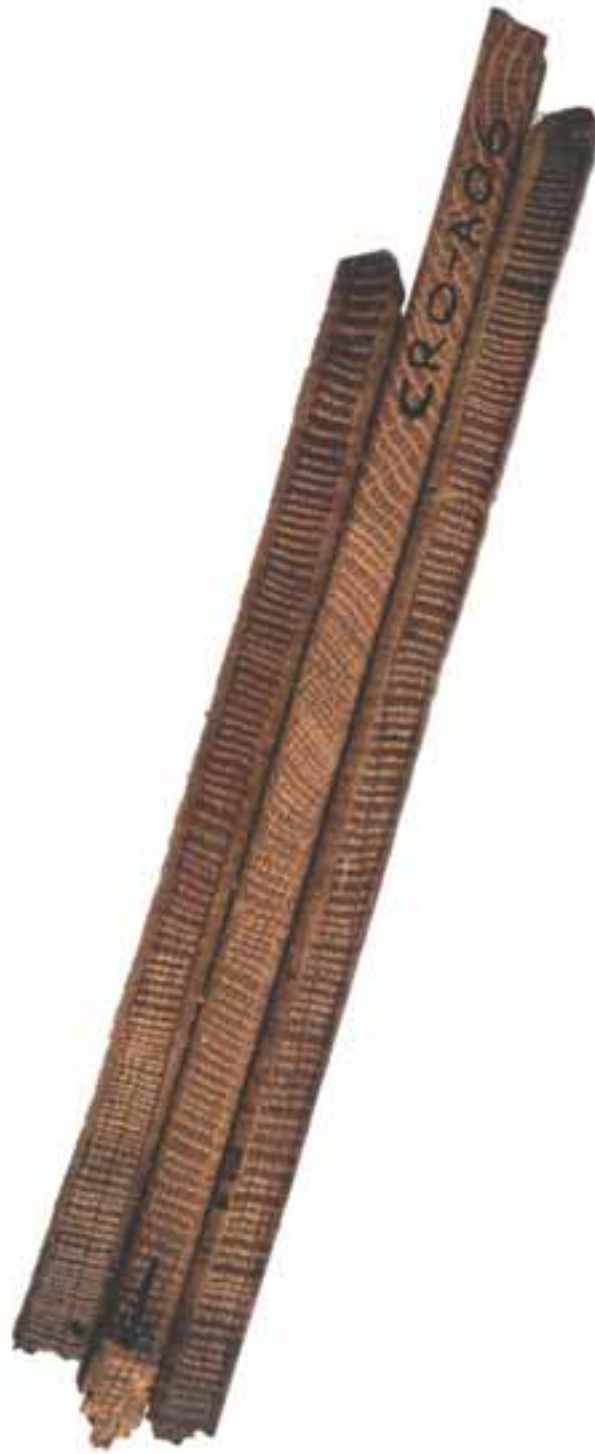
*Figure A4: Three cores from timbers in a building. They come from trees growing at the same time. Notice that, although the sequences of widths look similar, they are not identical. This is typical*
