# ALL SAINTS' CHURCH, SANCTON, NEAR MARKET WEIGHTON, EAST YORKSHIRE TREE-RING ANALYSIS OF TIMBERS FROM THE BELFRY FLOOR AND BELLFRAME

SCIENTIFIC DATING REPORT

NGR: SE 899 392

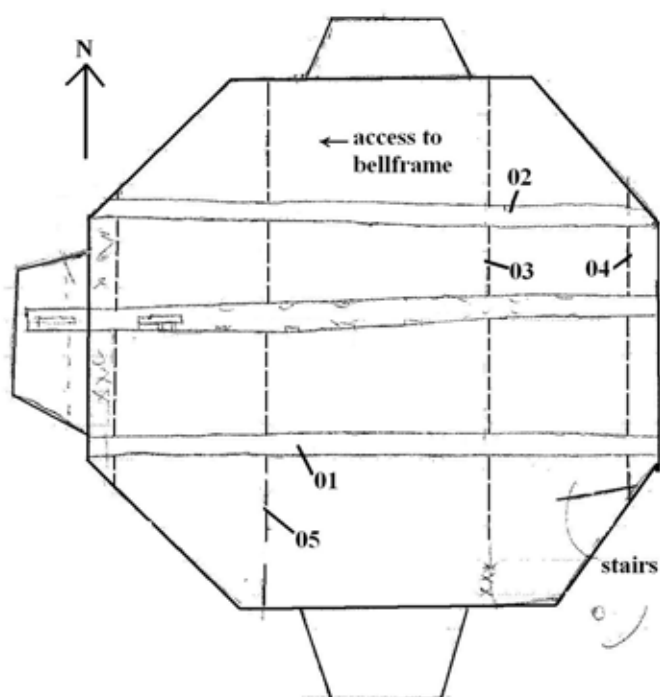
Figure 3. Sketch plan of the tower showing the locations of the three support beams and the four north-south beams supported by them, with the approximate locations of samples taken for dendrochronology added.

Details of the samples taken are given in Table 1, and their approximate locations are illustrated in Figures 3–9. Six samples were found to have too few rings to be considered for further analysis. Of the eight measured samples, six were cross-matched, as is shown in Table 2, and were combined to produce a site master chronology of 100 years, SANCTON. Samples snc03 and snc08 are seen to match very well ( $t = 10.7$ ) and might be considered to have come from the same tree. However, as they were from the two different structures under investigation, the floor and the bellframe, and there was no other evidence, such as matching grain and knot patterns, for them having come from the same tree, their series were not first combined into a single-tree sequence before making the site chronology. The 100-year-long site chronology, formed by combining the six matched individual series, SANCTON, was dated to the period AD 1620–1719, some of the strongest matches being shown in Table 3. The relative positions of overlap of the samples is shown, along with their actual or interpreted likely felling dates/date ranges, in Figure 10.

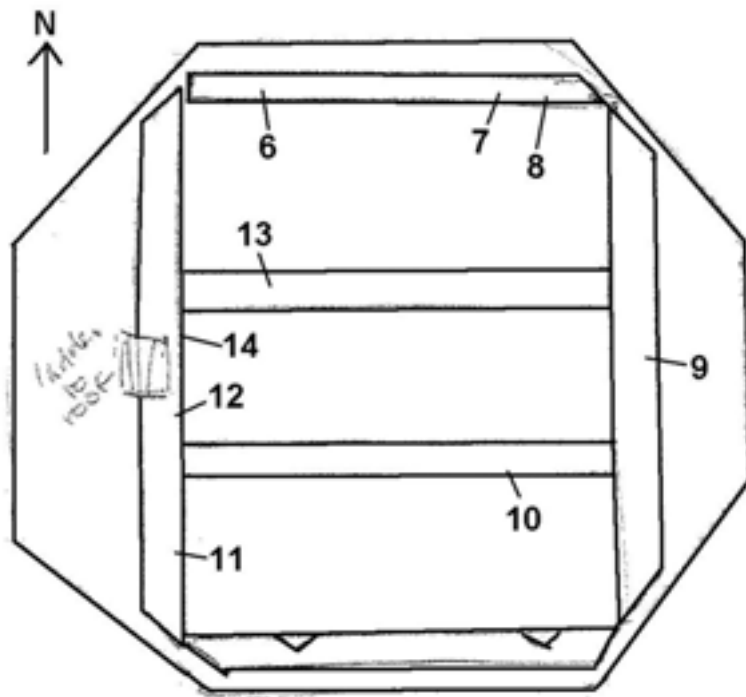
Figure 4. Sketch plan of the bellframe showing the approximate positions of the samples taken, and detailed in subsequent figures

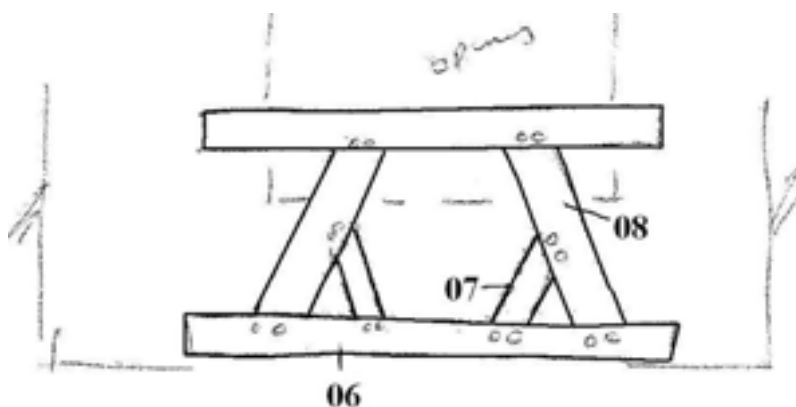
Figure 5. Sketch of the northern east-west frame, looking north, showing the timbers sampled for dendrochronology

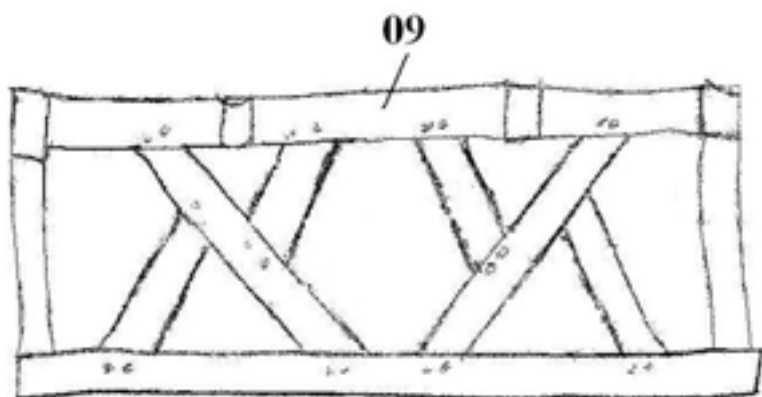
Figure 6. Sketch of the eastern north-south frame, looking east, showing the timber sampled for dendrochronology

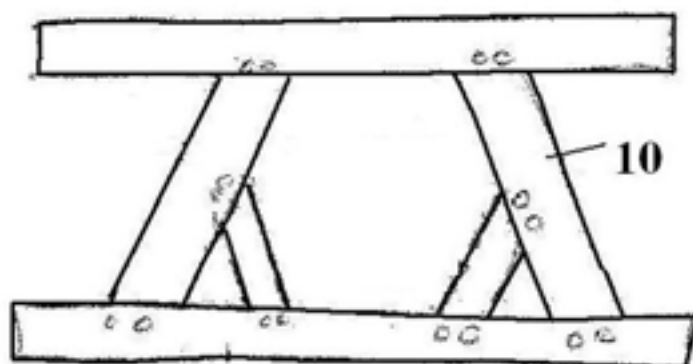
Figure 7. Sketch of the third east-west frame from the north end, looking north, showing the timber sampled for dendrochronology

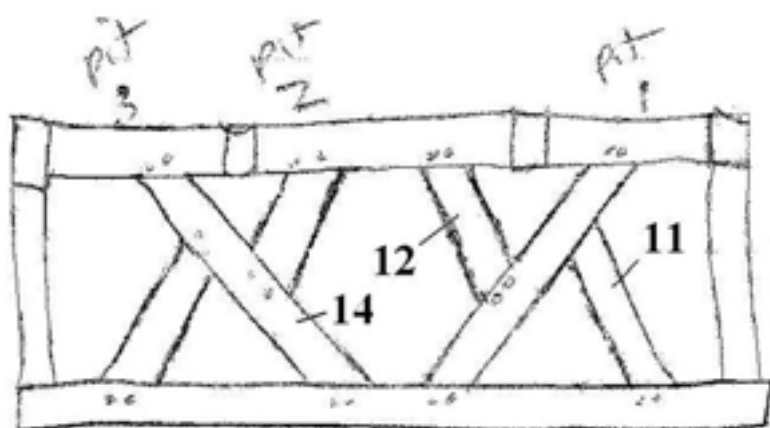
Figure 8. Sketch of the western north-south frame, looking east, showing the timbers sampled for dendrochronology

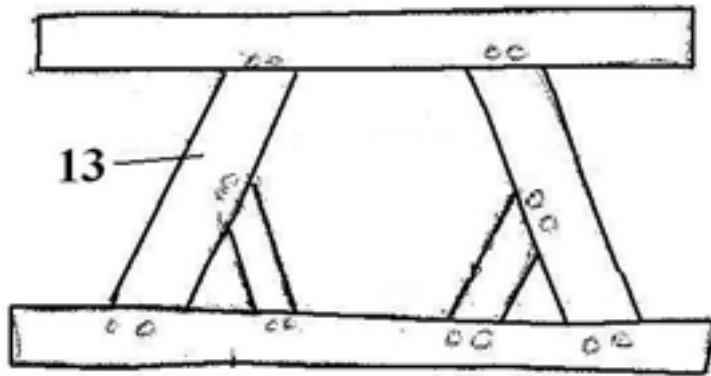
Figure 9. Sketch of the second east-west frame from the north end, looking north, showing the timber sampled for dendrochronology

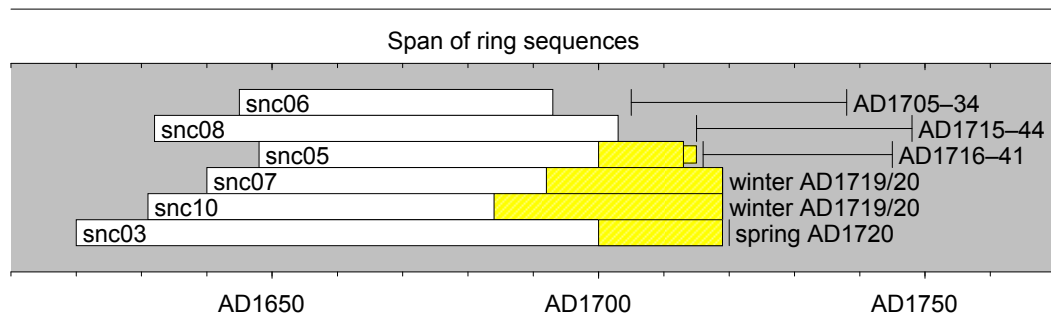
Figure 10. Bar diagram showing the relative positions of overlap of the dated samples, along with their actual or interpreted felling dates/date ranges
