# THE FORMER DRILL HALL, YORK ROAD, GREAT YARMOUTH SURVEY AND ANALYSIS

## HISTORIC BUILDING REPORT

**The Former Drill Hall  
York Road  
Great Yarmouth, Norfolk  
Historic Building Report**

NGR: TG 52710722

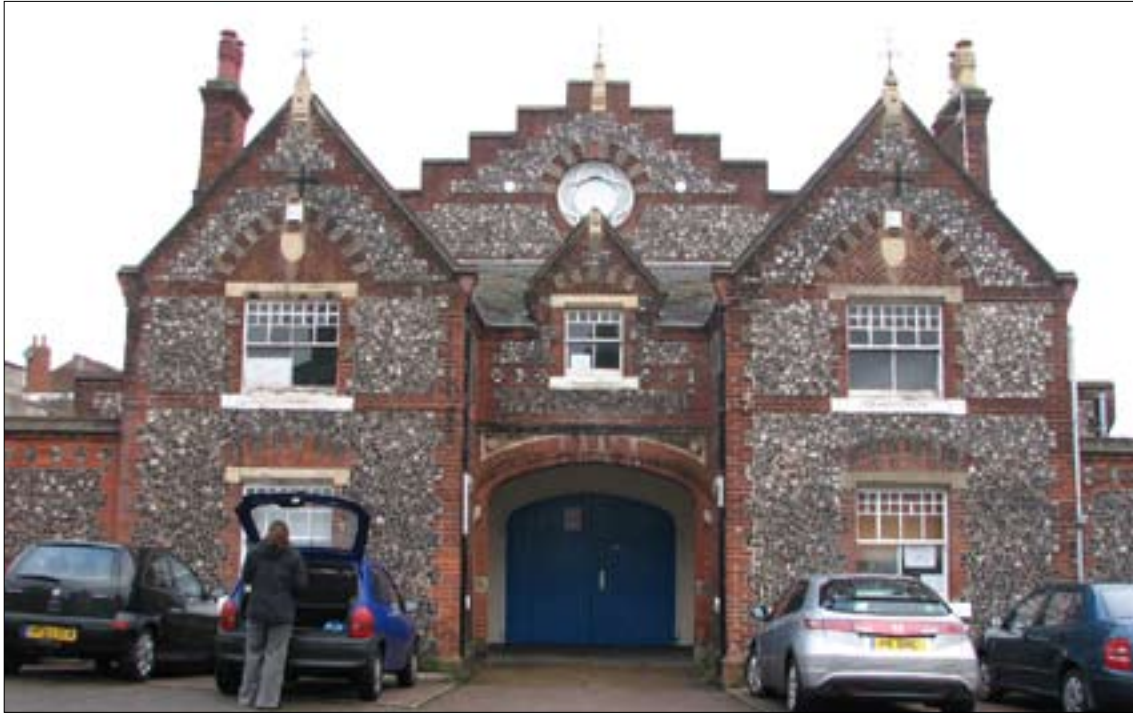
The residential front block is symmetrical in appearance and formed from two two-storeyed gabled bays connected by a central linking bay at the first-floor level, flanked by single storeyed bays (Fig. 2). The capping stones of the end bays conceal flat roofs which creates the appearance of walled yards rather than solid structures. The central bay forms a porch below, accessed by a four centred open arch (once containing gates) and providing access to the hall behind. The crow-stepped gable wall of the hall rises behind this central bay with an oculus clearly visible above the gabled dormer – forming the central focus of this façade.

The building is highly decorated with a polychromatic Gothic Revival style formed by the facing of uncoursed knapped flint with dressings of red brick, yellow brick and some ashlar. The red brick is used for quoins, window and door surrounds, chimney stacks, horizontal bands at first-floor and eaves level, and to edge the steps of the gable. The

Figure 2. Southern facade of the drill hall.

porch arch is formed from moulded red brick with the addition of moulded stone spandrels. Stone is also used for the ashlar window sills and lintels although some have been replaced in concrete due to weathering. The windows themselves largely contain attractive Edwardian glazing with two lights to the lower sash and a more detailed upper sash containing a number of smaller lights. Several single light windows (Fig. 3) retain the original Gothic glazing with cusped heads and pierced spandrels. This original glazing is shown in the 1868 engraving of the property (Fig. 4) and had been replaced by the time that the time a photograph (Fig. 5) was taken in c.1911. The principal windows have very decorative heads with polychrome segmental and pointed brick relieving arches. The pointed arches contain herringbone brick infilled tympana with plain stone shields whilst the segmental arches are filled with radiating brickwork. The gables are surmounted by ornamental stone finials with decorative wrought iron terminals. The pitched roofs are covered in slate.

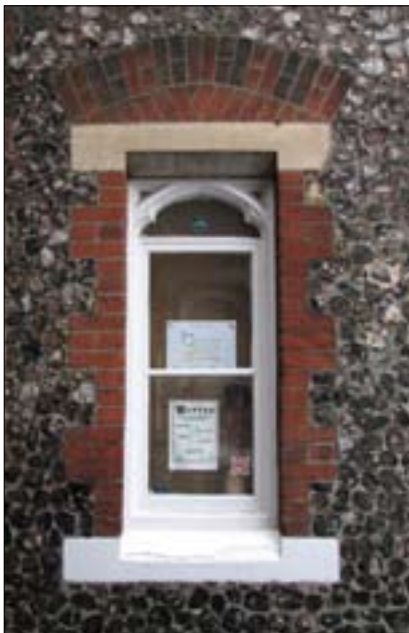
Figure 3. The original glazing style.

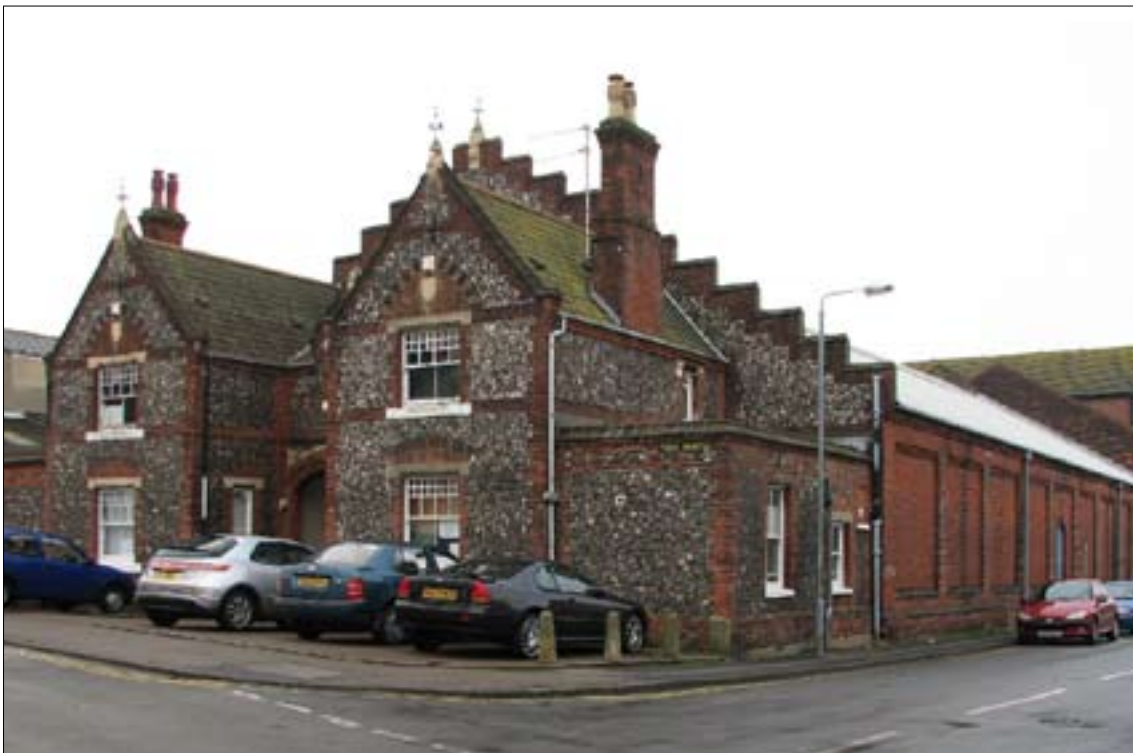
The stepped southern gable wall of the hall forms the rear of the front block and accordingly is constructed from matching red brick and flint. The apex of the gable is topped with a finial to match those on the front gables, whilst the circular window containing quatrefoil glazing has a polychrome brick surround to its upper half and a plain red brick surround to its lower half, continuing to either side as a band. The main structure (Fig. 6) is 10 bays long, constructed from red brick in Flemish bond on a brick plinth with no windows or doors along the west wall and a single doorway in the fifth bay from the south along the east wall. The hall is lit from above by a skylight running the length of the hall along the apex of the roof. Whilst this is not an original feature it replaced an earlier version which, as may be seen in Fig. 4, was originally in the form of a ridge lantern.

Figure 6. Front block with the drill hall behind.

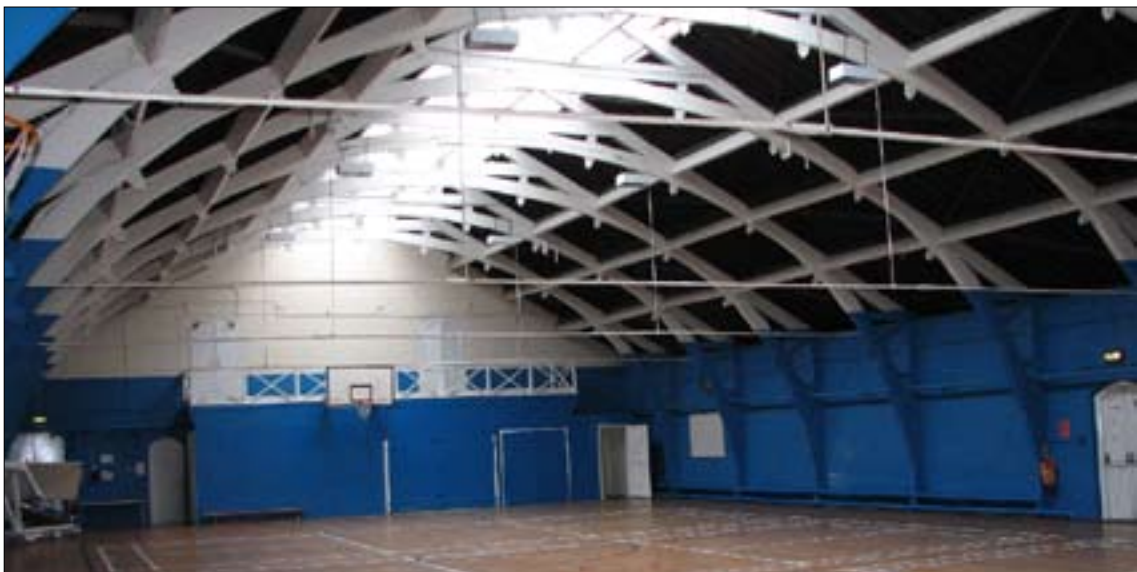
The roof is supported on composite or laminated timber curved braces set within a simple frame with small king posts with diagonal braces rising from the collar to support the modern ridge beam (Fig. 7). The lightweight metal tie beams and the timber arrow-shaped finials projecting from the trusses increase the visual impact of the roof itself which arches in a single span across the entire width of the hall – a distance of some 65 ft. *The Illustrated London News* reported that 'the ribs, principals and purlins are stained of a brown colour relieved with borders of ivory white and with gilding, so as to bring out the constructive features'.<sup>8</sup>

The wooden floor appears to be original and is laid on top of concrete so as to minimise the noise from drill marches. At first-floor level along the south wall are the remains of six timber supports for a viewing gallery (no longer extant) with a blocked two-centred arch headed doorway on the first floor to the west side. As galleries were generally used by the public it would appear that the eastern part of the front block allowed access to this gallery and was not, therefore, part of the private accommodation. A matching gallery existed at the north end of the hall (although this has been replaced) and was accessed via a pair of doors at first-floor level. A two-centred arch headed doorway is found to either side of this end wall, matching those seen elsewhere, whilst two further doorways are found nearer the centre of the wall. Central heating in the form of substantial hot water pipes, heated by a boiler in the rear block, runs around the room at floor and head height and, if not an original feature, is certainly not much later than 1867.

Figure 7. Interior of the drill hall looking north.

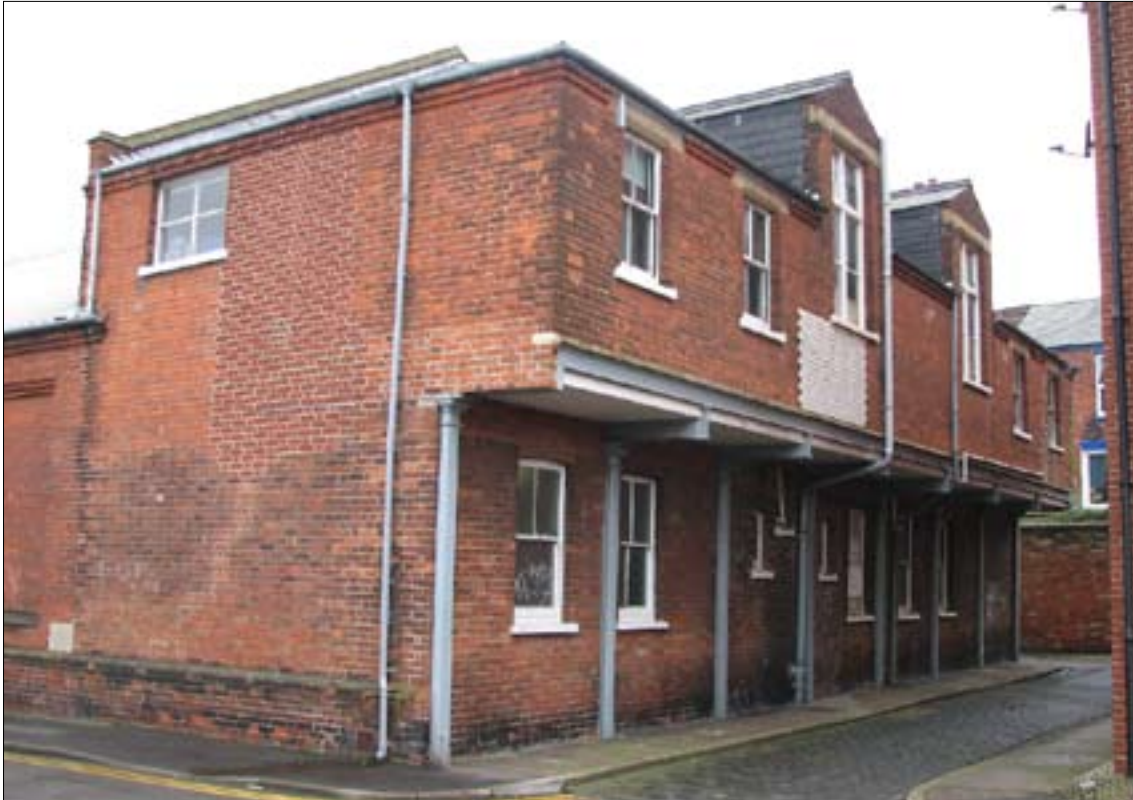
The block to the rear of the hall (Fig. 8) is constructed from red brick and was built in a number of phases, as evidenced by the various building breaks and changes in the character of the brickwork. The arrangement of the doorways leading from the hall, and the presence of the gallery above, suggests that there was always a building to the centre rear of the hall which contained a staircase allowing access to the gallery

Figure 8. The rear block.

above. However, the fact that the outermost doorways contain heavy external doors suggests that they opened onto a yard or open area (similar to the arrangement seen to the front of the building) rather than into another building. Fig. 4 shows the rear gable of the hall as originally being stepped, matching that at the front, making a similar arrangement which incorporated matching yards to the rear yet more plausible. It would appear that this central block was replaced with one which ran the width of the hall, and that the upper storey was replaced at a later date with the present structure which projects considerably beyond the ground floor and is supported by steel girders which run through the building and into the hall beyond, supporting the replacement gallery. Externally, the ground-floor windows to the east are in their original position whilst those in the centre and to the right appear to be original windows reset into new positions, as evidenced by the lack of quarter-batts. A patch of white glazed tiling at first-floor level, of a type commonly seen in light wells etc, is as yet unexplained.

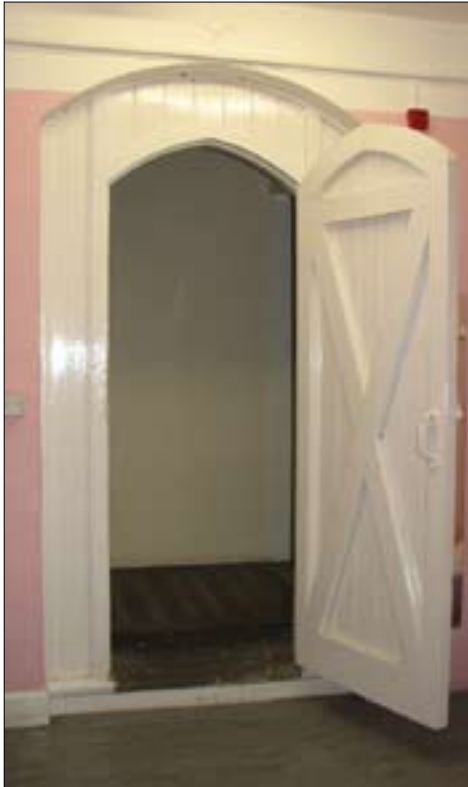
Internally, the doorway to the far west of the hall provides access to the staircase to the first floor – a doorway on the west side of the rear block allows direct access to this staircase from outside. The next doorway from the hall opens into an office with early reeded glass in the windows; these are barred – suggesting that this office or store was intended to be secure. This room was never plastered, although the salient framing around the windows suggests that it was originally intended to be. The far west room, the boiler room, is accessed through this office. The boiler is not original but the function of the room seems original and there is only one, small, window in the west wall. The second room from the east, now lavatories, appears to have been offices although few features remain – the door here (Fig. 9) is an external one which has been

*Figure 9. External door reset in an internal doorway.*

removed from its original location and re-set. The doorway to the far east of the hall provides access to a room with a number of decorative details such as an alcove, skirting and a blocked fireplace. The width of the threshold into this room, and the drop in the floor level, clearly demonstrates that this part of the rear block is a later addition.
