WELCH ROAD, SOUTHSEA, PORTSMOUTH

AN INVESTIGATION OF SOME WINDOW GLASS

TECHNOLOGY REPORT

David Dungworth

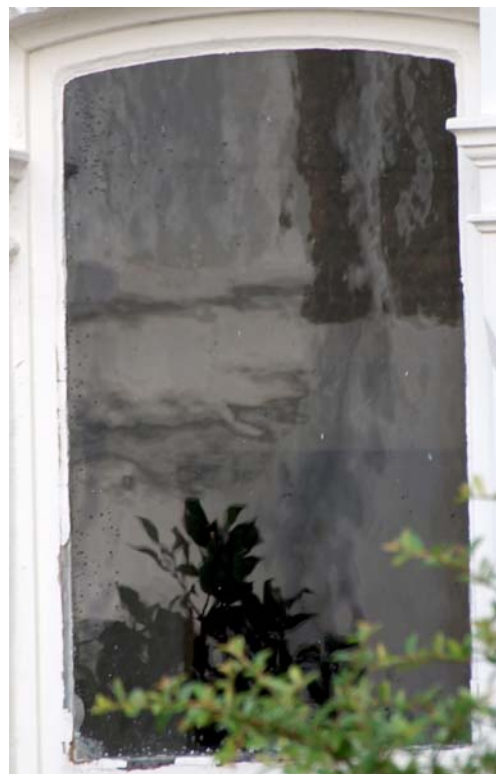
Figure 2. A typical window from Welch Road with a characteristic surface texture indicating that it was manufactured before the development of the float glass process in 1960

The east side of Welch Road was built in two sections in 1894 and 1895 (Figure 1) and window glass from these houses has the potential to provide information on the composition of window glass used in Britain in the last decade of the 19th century. Over the past few years every opportunity to sample glass has been taken and samples have been obtained from four houses. In three cases window glass was collected during the installation of double glazing, while in the remaining case sampling was undertaken during repairs (in this case the glass was returned to its original position after sampling). Most of the glass sampled for analysis has a slightly wavy surface (Figure 2) and occasionally bubbles, however, the surface textures were not sufficiently distinctive to allow immediate identification of the forming technique.

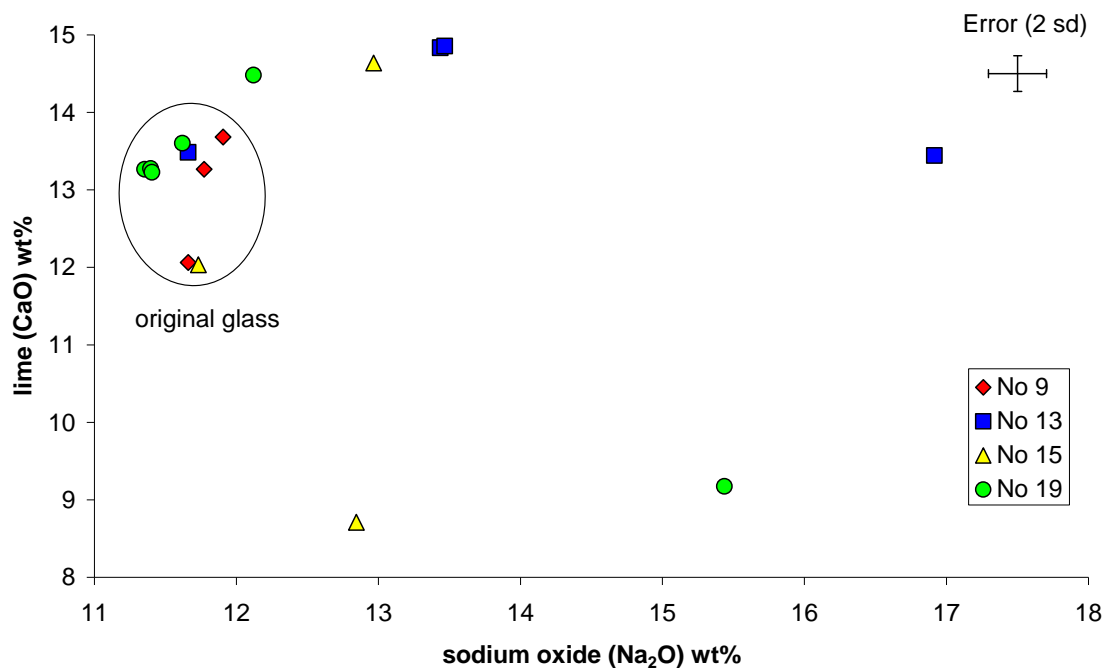
Figure 3. Plot of sodium oxide and lime content of the Welch Road window glass. The ellipse indicates those samples which share similar compositions and are likely to be original

All of the Welch Road glass is rich in sodium, calcium (Figure 3) and silicon with low concentrations of other elements. These glasses have chemical compositions which indicate that they were made with relatively pure raw materials. Two samples (#15.3 and #19.2) have low lime content compared to the other samples and high concentrations of magnesia indicating that they were probably manufactured after 1930. Sample 13.2 has a high manganese content, however, this was the only example of analysed glass which was not colourless. The manganese may have helped to provide this glass with its amber colour. Figure 4 shows the concentrations of two minor oxides in the glass (alumina and potassium oxide). This illustrates that nine fragments (including at least one fragment from each of the four houses) have chemical compositions which are almost identical (the variations in chemical composition between these samples is rarely greater than the analytical precision, as shown by the error bars).

The sixteen samples of Welch Road window glass analysed include nine fragments with virtually identical compositions which probably represent the glass that was originally installed in these houses when they were built in 1894 and 1895. The remaining seven samples have rather varied compositions and some of these are likely to represent piecemeal replacement of windows in the decades which followed. Three of the samples from No 13 Welch Road were from a decorative window (one amber and two acid-etched) and may be original but obtained from a different source. Sample #15.1 has a low magnesium content and probably represents replacement before 1930. Samples #15.3 and #19.2 have a high magnesium content and probably represent replacement after 1930.
