# HIGHLAND HOUSE, 117 LIDIARD GARDENS, PORTSMOUTH CHEMICAL ANALYSIS OF WINDOW GLASS

**TECHNOLOGY REPORT**

David Dungworth and Roger Wilkes

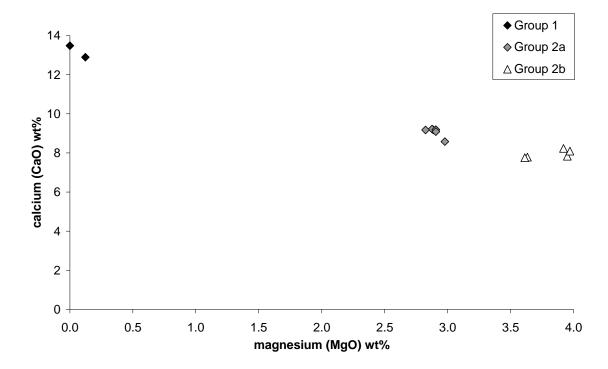
Figure 1. Plot of magnesium and calcium content of the Highland House window glass

The variations in chemical composition suggest three major groups: the first with negligible magnesium (<0.2wt% MgO) and the second with 2.8–4.0wt% MgO (Figure I). Magnesia was deliberately added to window glass from the late 1920s onwards in order to overcome problems of devitrification during forming (Turner 1926; Cable 2004). It is likely that the glass in Group I windows was produced before 1930 and that Groups 2 and 3 were produced after 1930.

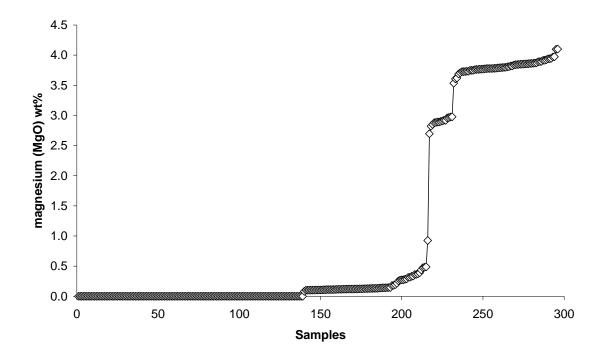
Figure 2. Magnesium concentration of 296 samples of 19th- and 20th-century soda-lime glass in rank order (data from this report; Dungworth 2009; 2010a; 2010b; Dungworth and Loaring 2009; Dungworth and Wilkes 2010)

The Highland House glass with significant levels of magnesium has been divided into two sub-groups (2a and 2b). These sub-groups recur in other samples of analysed post-1930 window glass which contain >2wt% MgO (Figure 2). The first group (cf Highland House Group 2a) contains 2.7–3.0wt% MgO while the second group (cf Highland House Group 2b) contains 3.5–4.1wt% MgO). A review of published analyses of 20th-century window glass by Smrcek (2005) suggests that relatively small proportions of magnesia were used by British glassmakers between 1930 and 1960, but that higher proportions of magnesia were employed after the development of the float process at the end of the 1950s.

The available data suggests, therefore, that it may be possible to distinguish between British window glass manufactured between 1930 and 1960 and glass manufactured since 1960 on the basis of the magnesium content.
