# BESSIE SURTEES HOUSE, SANDHILL, NEWCASTLE UPON TYNE DENDROCHRONOLOGICAL ANALYSIS OF OAK TIMBERS

SCIENTIFIC DATING REPORT

**DENDROCHRONOLOGICAL ANALYSIS OF OAK TIMBERS**

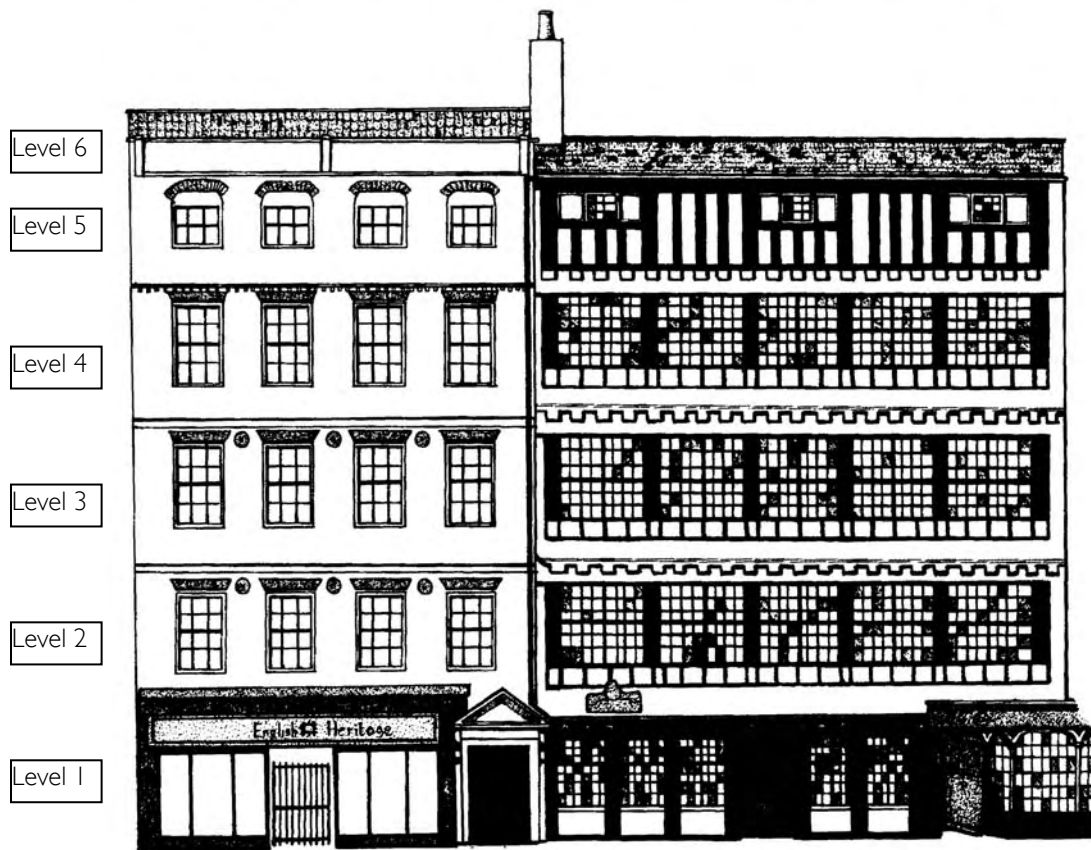
*Figure 3. Street frontage of Bessie Surtees House showing the contrasting frontages of Milbank House and Surtees House and also showing Levels 1–6 following the convention of Heslop et al (1994). Based on a figure from English Heritage leaflet 'Bessie Surtees House, Information for Teachers', English Heritage 2000*

This five-storey building is a bay wider than Milbank House (Fig 3). The timber-framed structure is jettied at every level (Fig 11), and is one floor lower than Milbank House. The attic had a secondary remodelling to form the garret on the front elevation. The building only came into the same ownership as Milbank House from 1931, so it might be expected to have different construction events, though these are likely to be within a general chronological framework of the same economic and social pressures to extend and aggrandise.

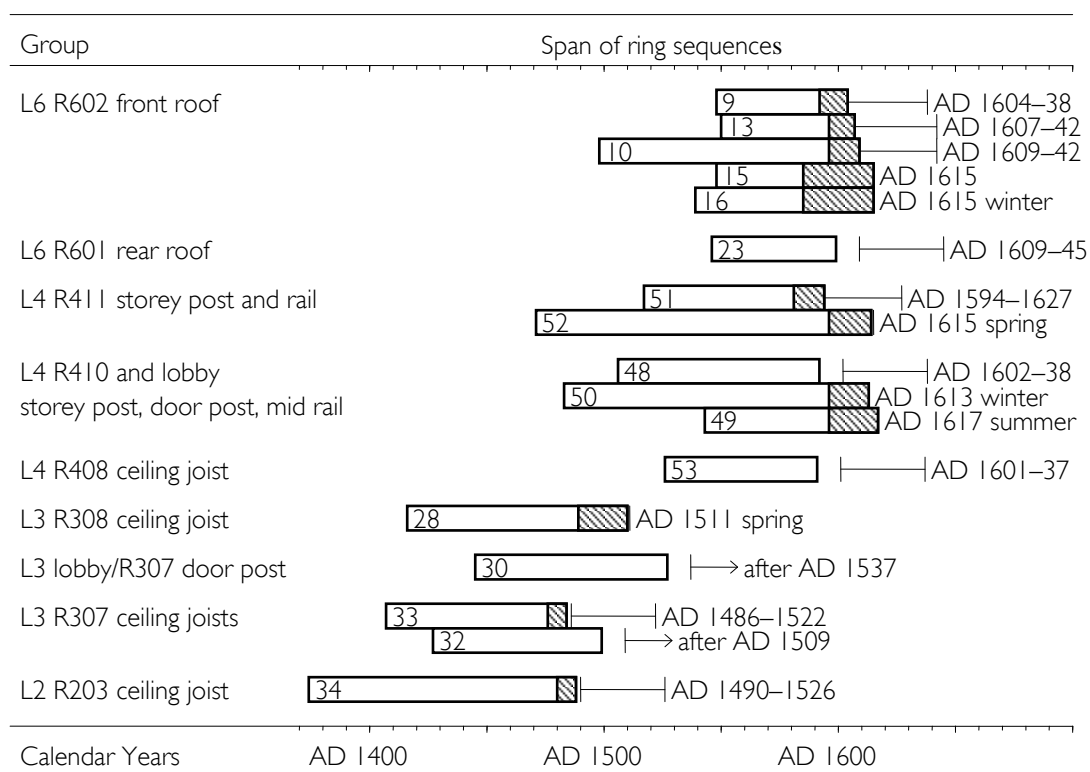
**Figure 12. Bar diagram showing the absolute dating positions of the 17 dated tree-ring sequences for samples from Milbank House, Bessie Surtees House. The interpreted felling dates are also shown for each sample**

KEY L1-L6 building levels, eg R203, R602 room numbers, following Heslop *et al* (1994), see also Figures 4-9. Horizontal scale the same as for Figures 13 and 14. White bars are oak heartwood, hatched bars are sapwood

from these, named Bessie 2, which matches with reference data (Table 14) at AD 1471 to AD 1650 inclusive. A summary of the results for the component samples of these chronologies are provided in Tables 1–3 and Figures 12–14.

The 32 samples obtained from timbers within Milbank House yielded 17 datable tree-ring sequences. These fall into two clusters of dates: five samples are broadly early sixteenth-century, and were derived from levels 2 and 3, and 12 samples are broadly early seventeenth-century, and were derived from levels 4 and 6 (Fig 12).

The tree-ring analysis dates the rings present in the cores. The correct interpretation of those dates relies upon the characteristics of the final rings in them. Bark-edge survived on one of these timbers, some sapwood on another two, and no sapwood was present on the remaining two. Making allowances for minimum and maximum likely amounts of missing sapwood provides individual felling dates, or felling date ranges, or *terminus post quem* dates for each of the datable timbers. Figure 12 and Table 1 includes the felling date or interpreted felling date ranges for each of the datable samples.

The correct interpretation of these results relies upon the characteristics of the final rings in the samples. Bark-edge survived on five of these timbers, some sapwood on another four, and the onset of sapwood was present on the remaining three. Making allowances for minimum and maximum likely amounts of missing sapwood provides individual felling dates, or felling date ranges, for each of the datable timbers. Figure 12 and Table 1 includes the felling date or interpreted felling date ranges for each of the datable samples.
