BREMHILL COURT BREMHILL, WILTSHIRE TREE-RING ANALYSIS OF TIMBERS

SCIENTIFIC DATING REPORT

NGR: ST980730

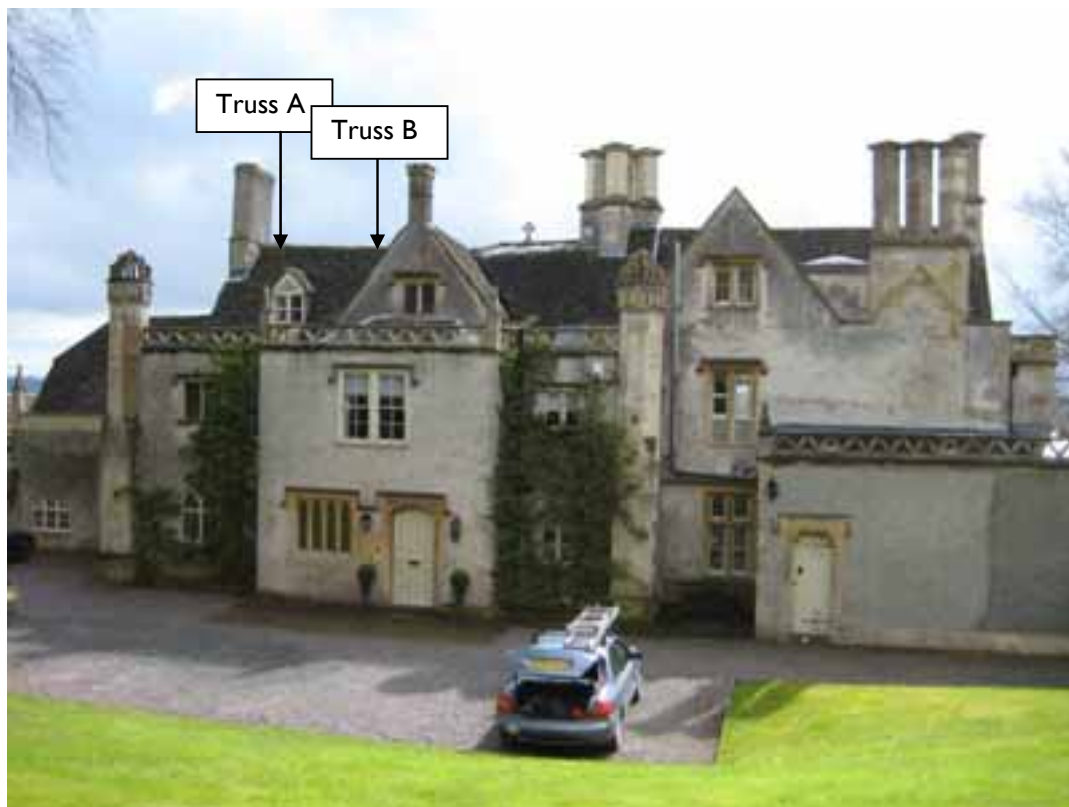
Figure 3: The north elevation of Bremhill Court showing truss locations viewed looking south-east

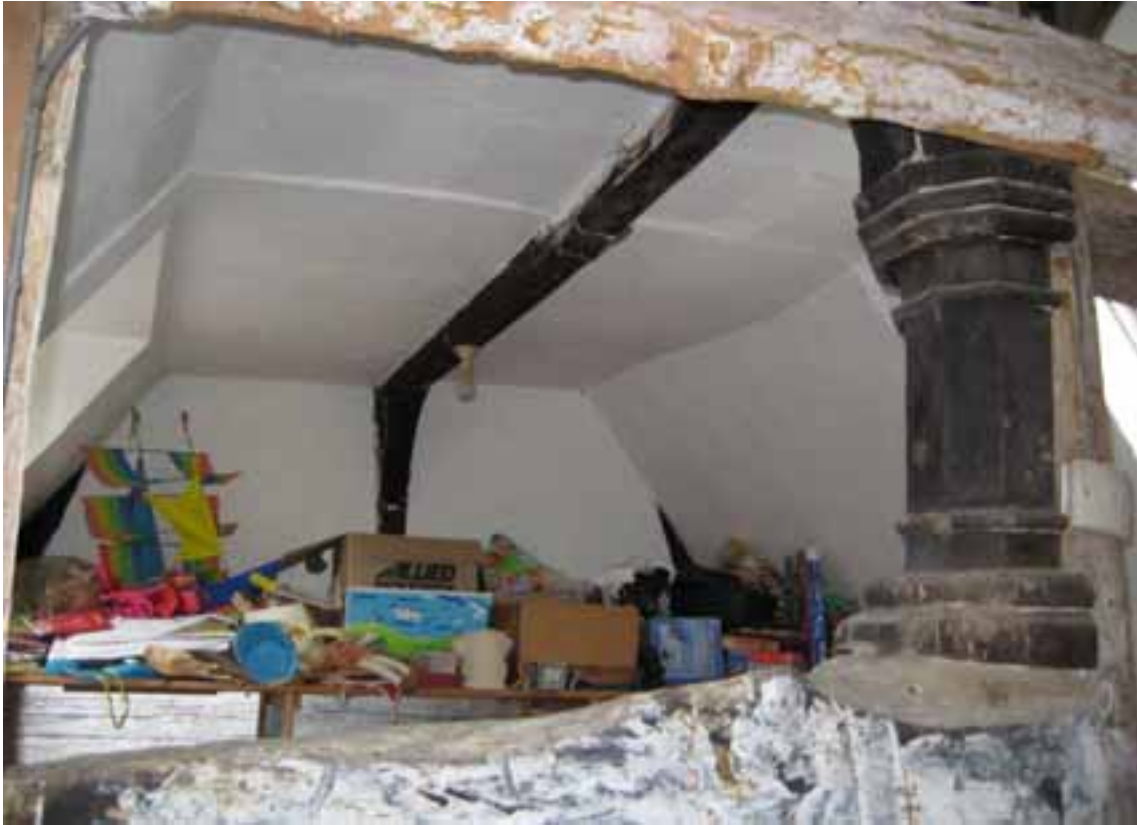
Figure 5: Crown post of Truss B with Truss A in the background, viewed looking south-east

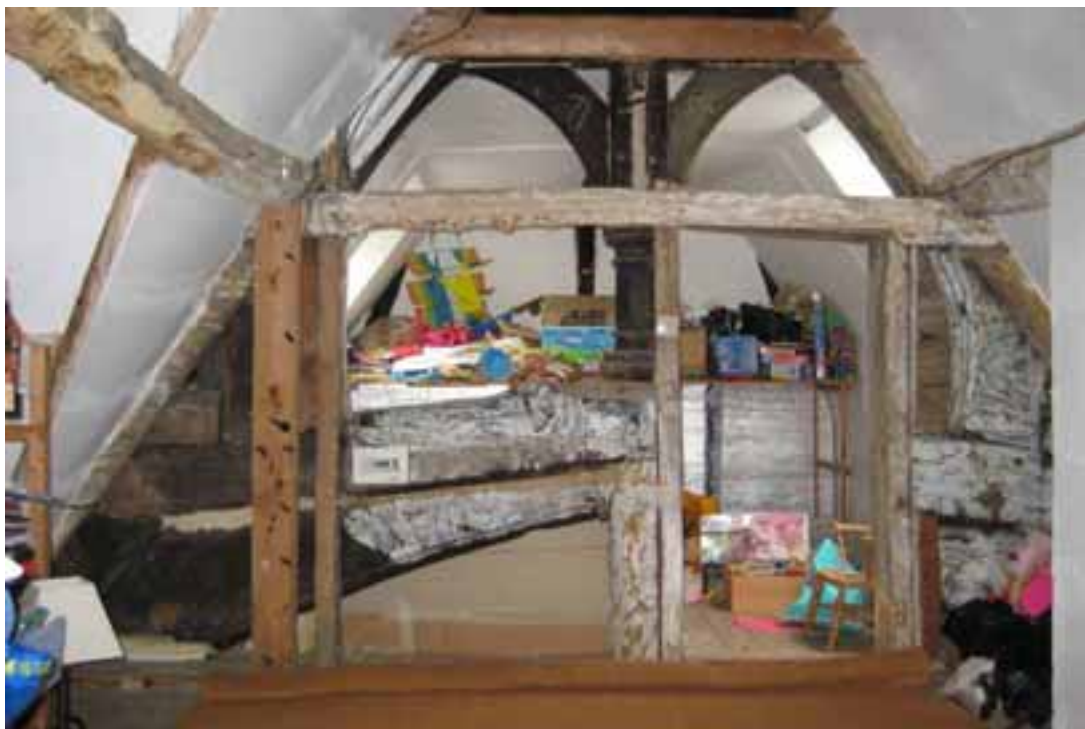
Figure 6: Truss B viewed looking east

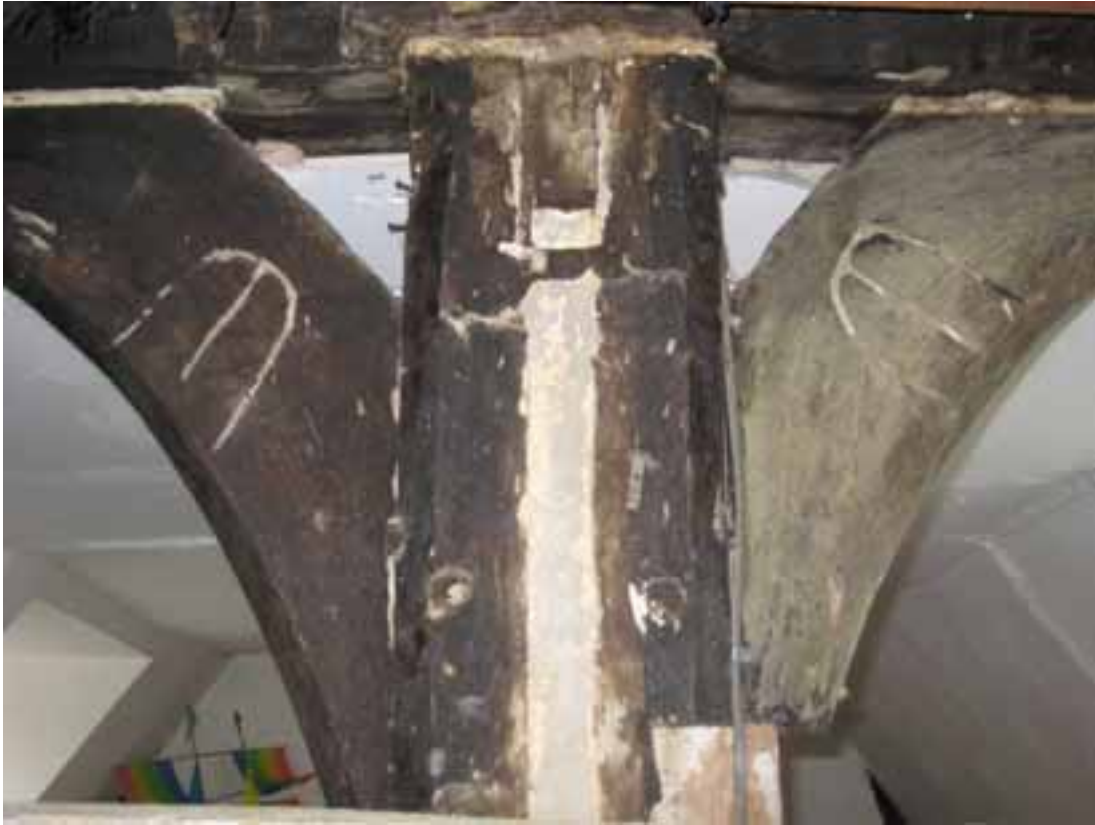
Figure 7: Detail of the Arabic assembly marks on the west face of the upward braces from the Truss B crown post to the upper crucks viewed looking east

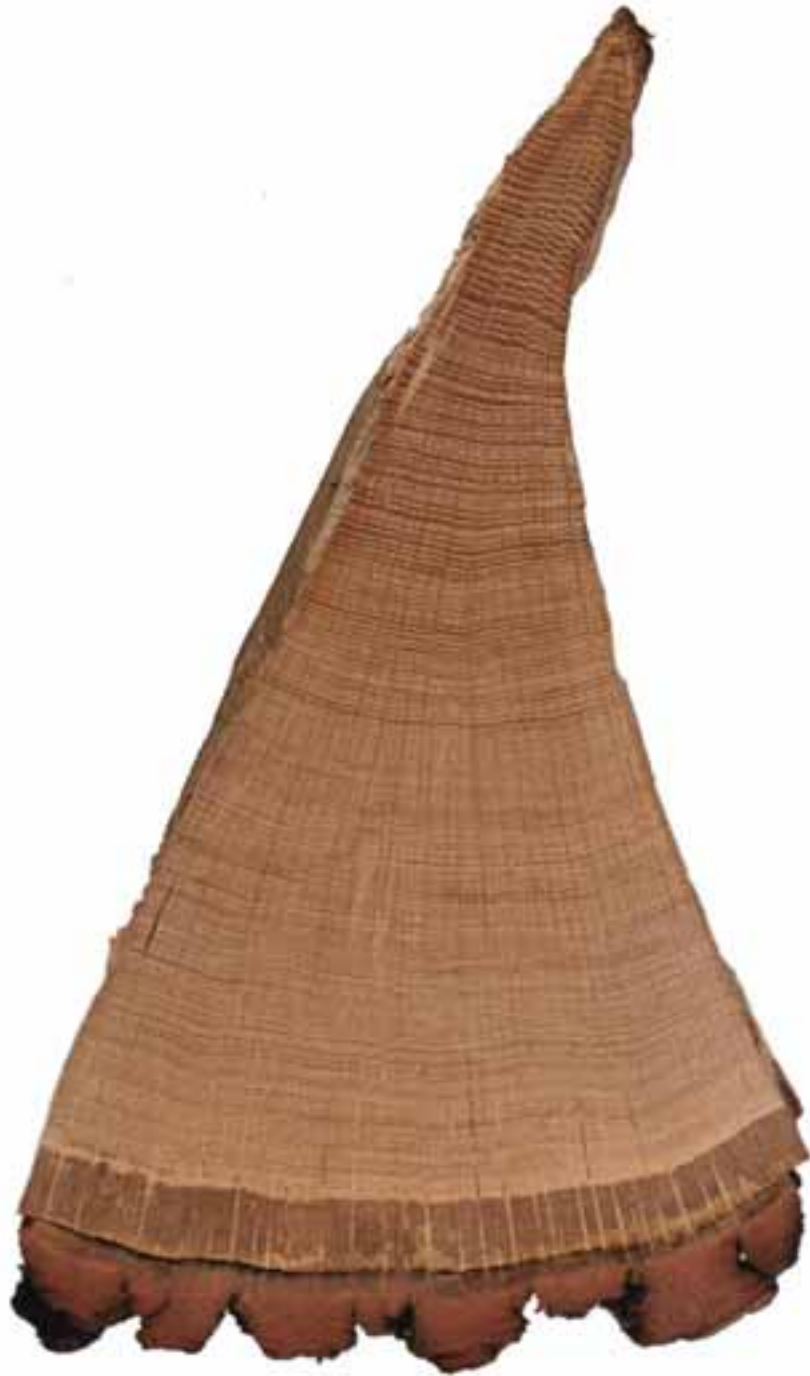
Figure A1: A wedge of oak from a tree felled in 1976. It shows the annual growth rings, one for each year from the innermost ring to the last ring on the outside just inside the bark. The year of each ring can be determined by counting back from the outside ring, which grew in 1976

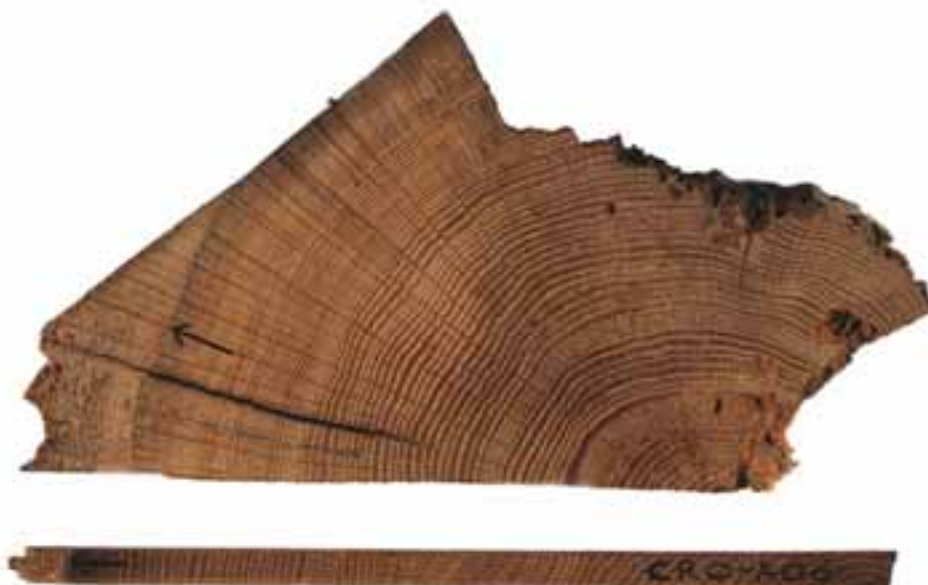
Figure A2: Cross-section of a rafter, showing sapwood rings in the left-hand corner, the arrow points to the heartwood/sapwood boundary (H/S); and a core with sapwood; again the arrow is pointing to the H/S. The core is about the size of a pencil

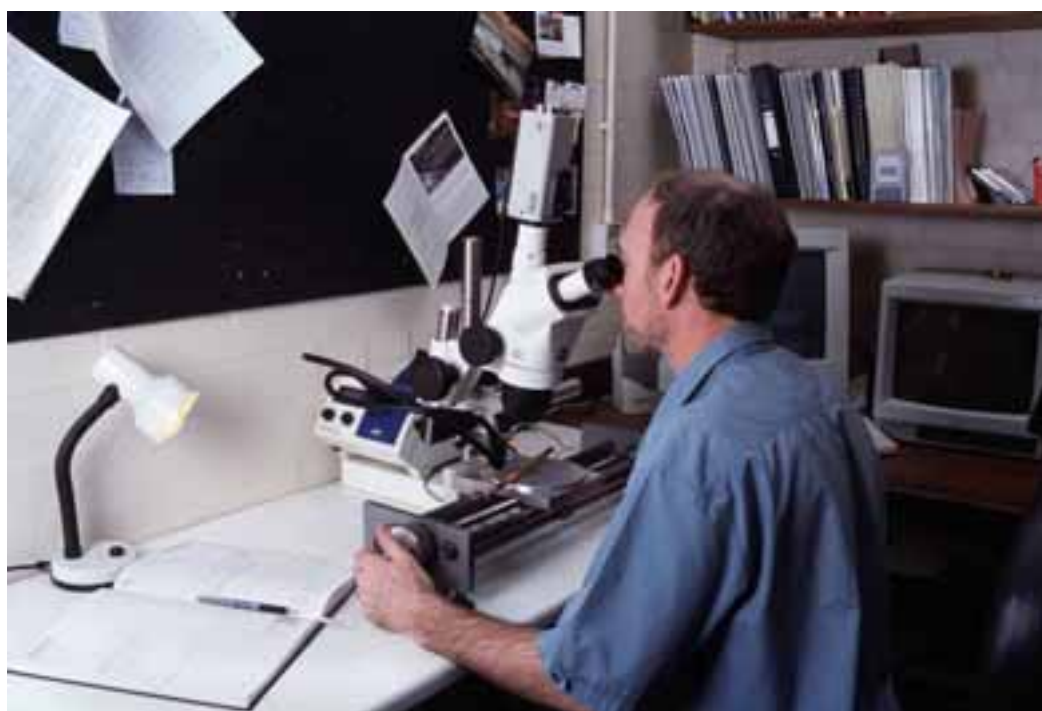
Figure A3: Measuring ring widths under a microscope. The microscope is fixed while the sample is on a moving platform. The total sequence of widths is measured twice to ensure that an error has not been made. This type of apparatus is needed to process a large number of samples on a regular basis

2. Measuring Ring Widths. Each core is sanded down with a belt sander using medium-grit paper and then finished by hand with flourgrade-grit paper. The rings are then clearly visible and differentiated from each other with a result very much like that shown in Figure A2. The core is then mounted on a movable table below a microscope and the ring-widths measured individually from the innermost ring to the outermost. The widths are automatically recorded in a computer file as they are measured (see Fig A3).

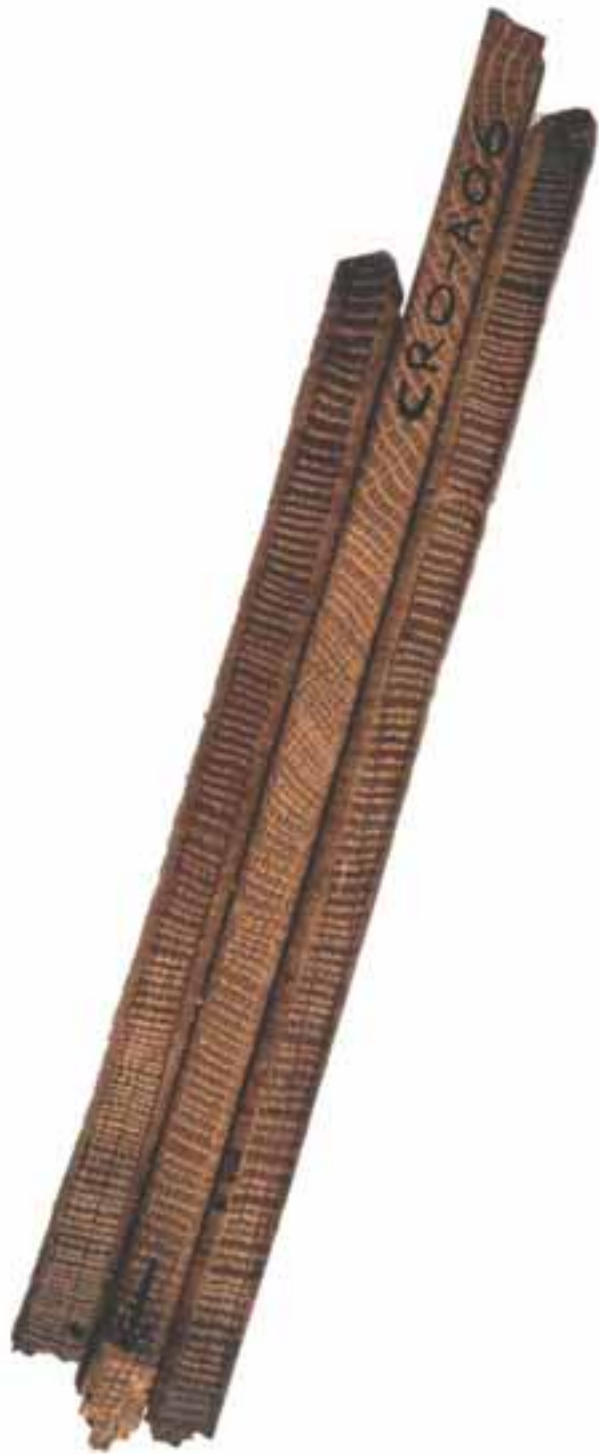
Figure A4: Three cores from timbers in a building. They come from trees growing at the same time. Notice that, although the sequences of widths look similar, they are not identical. This is typical
