# THORNTON ABBEY, NORTH LINCOLNSHIRE

## HISTORICAL, ARCHAEOLOGICAL AND ARCHITECTURAL INVESTIGATIONS

Al Oswald, John Goodall, Andrew Payne and Tara-Jane Sutcliffe

Between 2007 and 2009, English Heritage carried out historical, archaeological and architectural research at Thornton Abbey, a major Augustinian house in Lincolnshire. The findings of geophysical surveys undertaken by English Heritage in 1995 were also taken into account. New documentary research highlighted information previously overlooked in Thornton's 16th-century *Chronicle* and produced a more thorough account of the site's later use. The effects of post-medieval activity were clarified by detailed survey of the complex earthworks lying between the claustral buildings and the surviving gatehouse. These include garden landscaping – apparently unfinished – associated with a short-lived stately home, built about 1607 for Sir Vincent Skinner, and various scars left by 19th- and 20th-century archaeological excavations. Evidence for the medieval constructional sequence was also identified. The 1995 geophysical surveys complemented the earthwork survey and detected a number of monastic buildings and boundaries not recogn

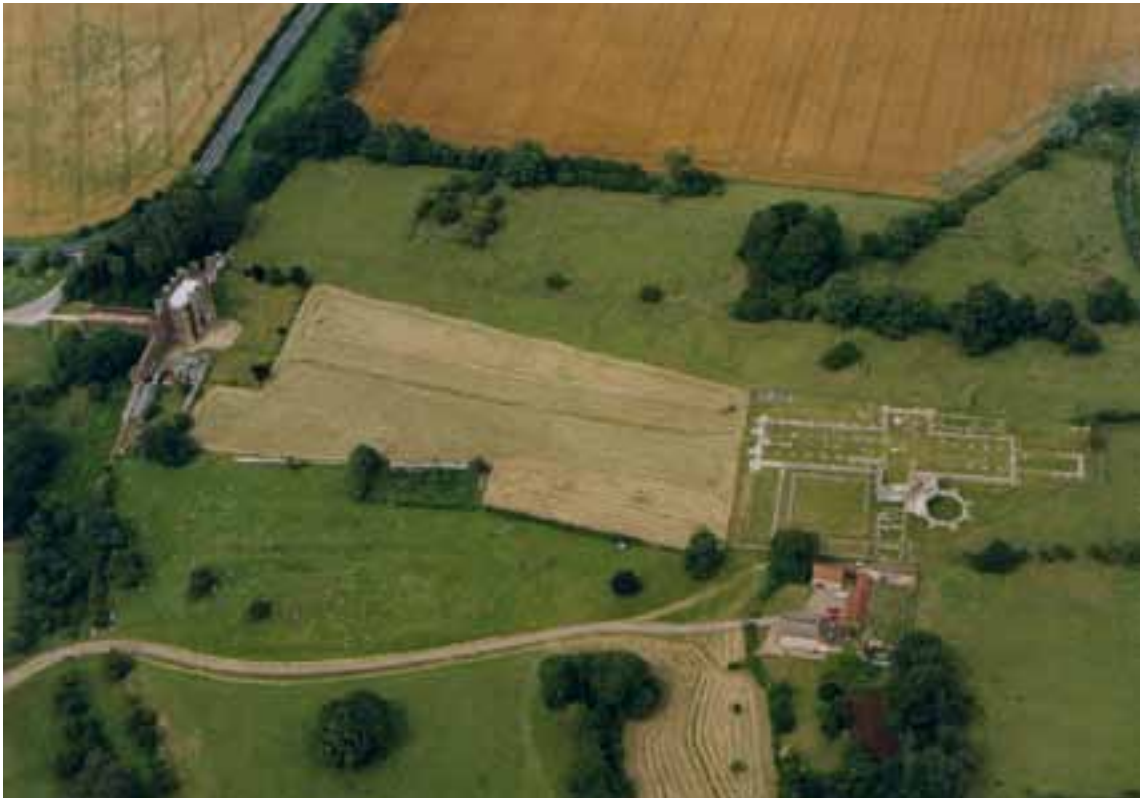
*Figure 2. Oblique aerial photograph of the core of the monastic complex taken 19 July 1999, looking north, showing Abbot's Lodge Farm towards the bottom right corner and the late 14th-century gatehouse towards the left-hand side. The earthworks in the pasture between the gatehouse and the ruins of the claustral buildings, including most of those surveyed in 2007, are obscured by cut hay. The land parcel called North Bail in the Thornton Chronicle corresponds to the field containing a ripe cereal crop, at the top of the frame. English Heritage NMR index number TAI118/38, accession number 17295-09.*

The abbey's entire precinct, together with College Bridge, a medieval stone bridge which lies just outside the precinct to the north, and an elaborate complex of medieval fishponds located immediately to the south, are designated a scheduled ancient monument (RSM number 13377), while the gatehouse and the ruins (and excavated foundations) of the claustral buildings have been in state guardianship since 1938. The core of the site remains under pasture, allowing extensive and complex earthworks to survive here, particularly between the gatehouse and the remains of the claustral buildings (Figure 2).

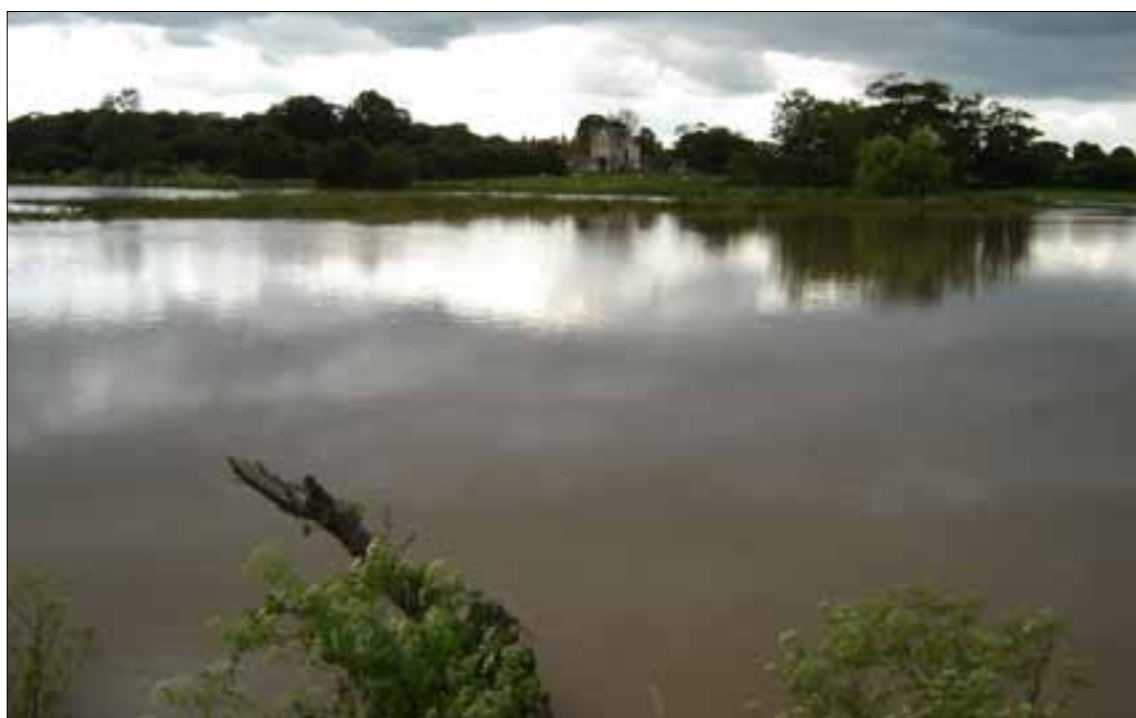
*Figure 19. The chapter house, seen from the north-east across the flooded Skitter Beck on 26 June 2007. The floodwaters were held back by the substantial earthen bank south-east of College Bridge, which carries the modern road across the valley and may once have acted as a dam as well as a causeway (see Figure 3). Photograph by Keith Miller.*

the required barrier was formed on the eastern side. The channel of the Skitter Beck is now deep and steep-sided, having clearly been subject to repeated recutting and cleaning, indeed to judge from the relationship of the current channel to the footings of College Bridge, the beck appears to have been deepened by about 1m. Much of its current depth may be the result of the canalisation undertaken shortly before 1867, since a section of the relict course depicted on the 1867 plan can still be identified as a much shallower channel, running northwards from the supposed mill headrace (u1). There is some evidence that this pre-canalisation course of the Skitter Beck was itself the product of an earlier diversion. Despite its sinuous course, which is at first sight suggestive of natural meandering, the watercourse hugs the valley edge up to 2m above the valley floor. Along the more predictable line in the centre of the valley, which is evident from the Lidar imagery (Figure 3), a stream flows spontaneously following heavy rain. This diversion to the edge of the valley must have happened during the medieval period, since the modified channel passes under College Bridge, which is a late medieval structure. It has been suggested that it dates to the 14th century (English Heritage 1992), but the basis for such precision seems insecure. However, it is questionable whether this watercourse alone would have provided an adequate perimeter as has previously been assumed (Coppack 1991, 37). South-east of College Bridge, the road passes across an embankment up to 2m high, which acts as a causeway across the lowest ground in the centre of the valley (see Figure 3). There is nothing to prove that this earthwork is not a later addition, but it seems to be designed to partner the bridge, and would therefore appear to be of medieval origin. During the floods in June 2007, it became apparent that this embankment could also have functioned as a dam to retain a broad but fairly

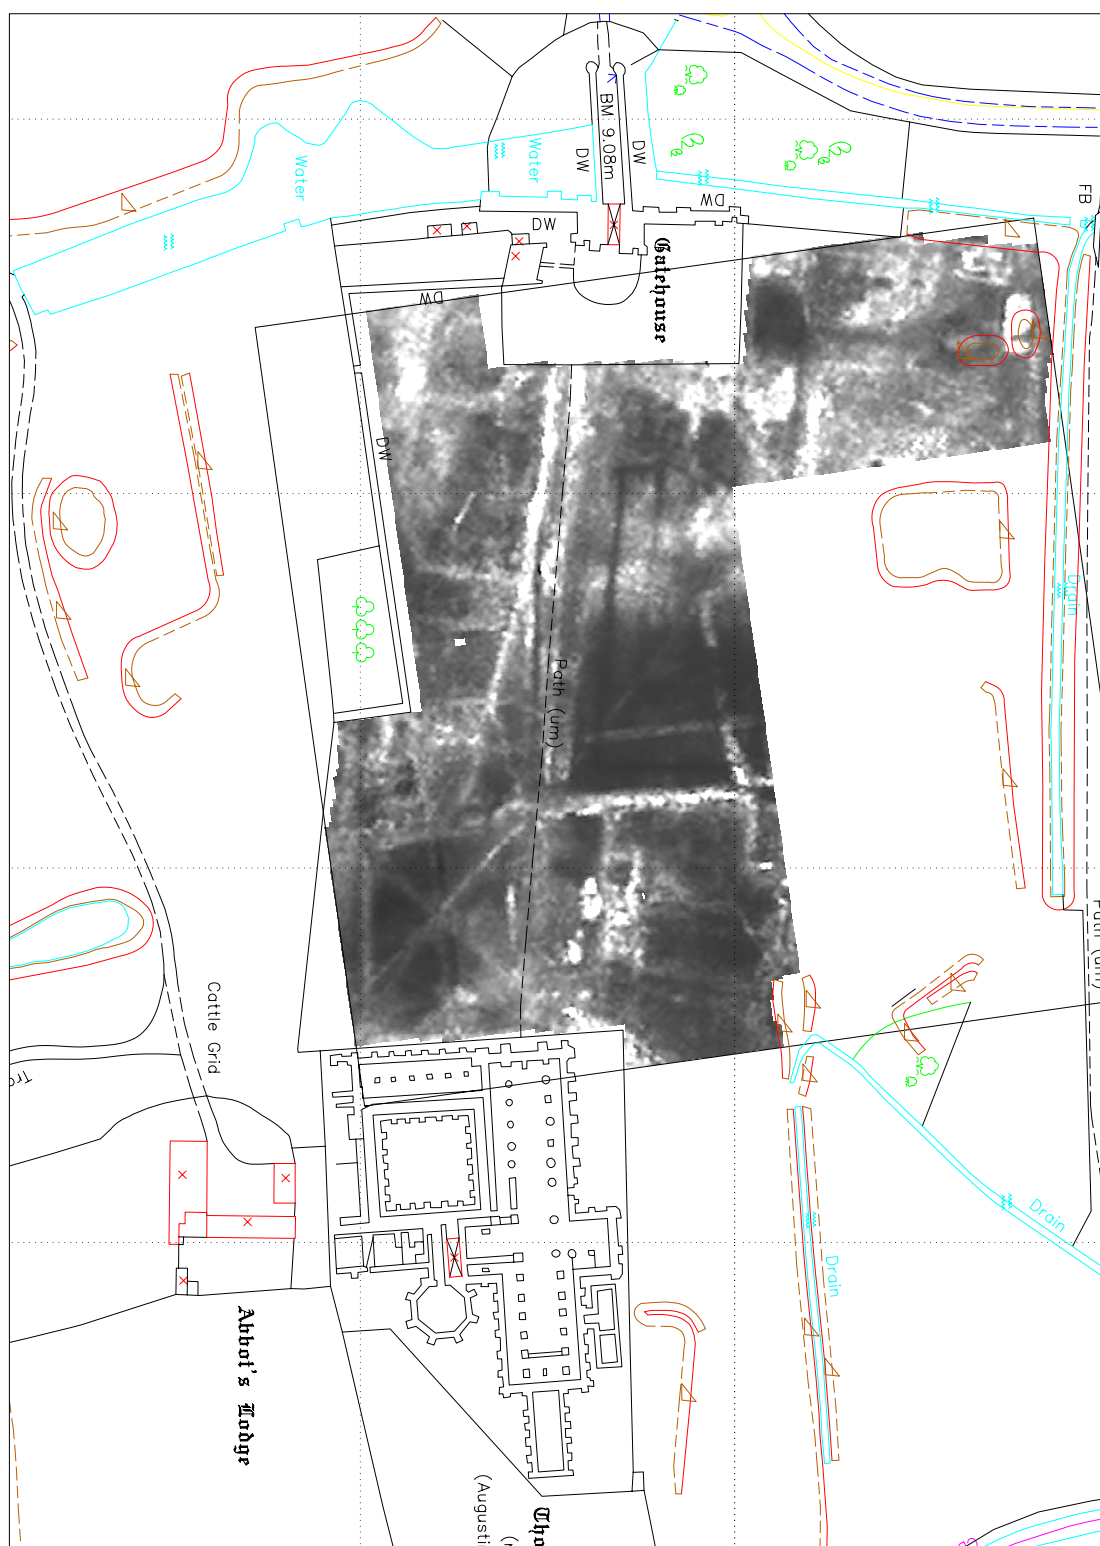
Figure 27. Earth resistance survey data, reduced from original plot at 1:1,250 scale.

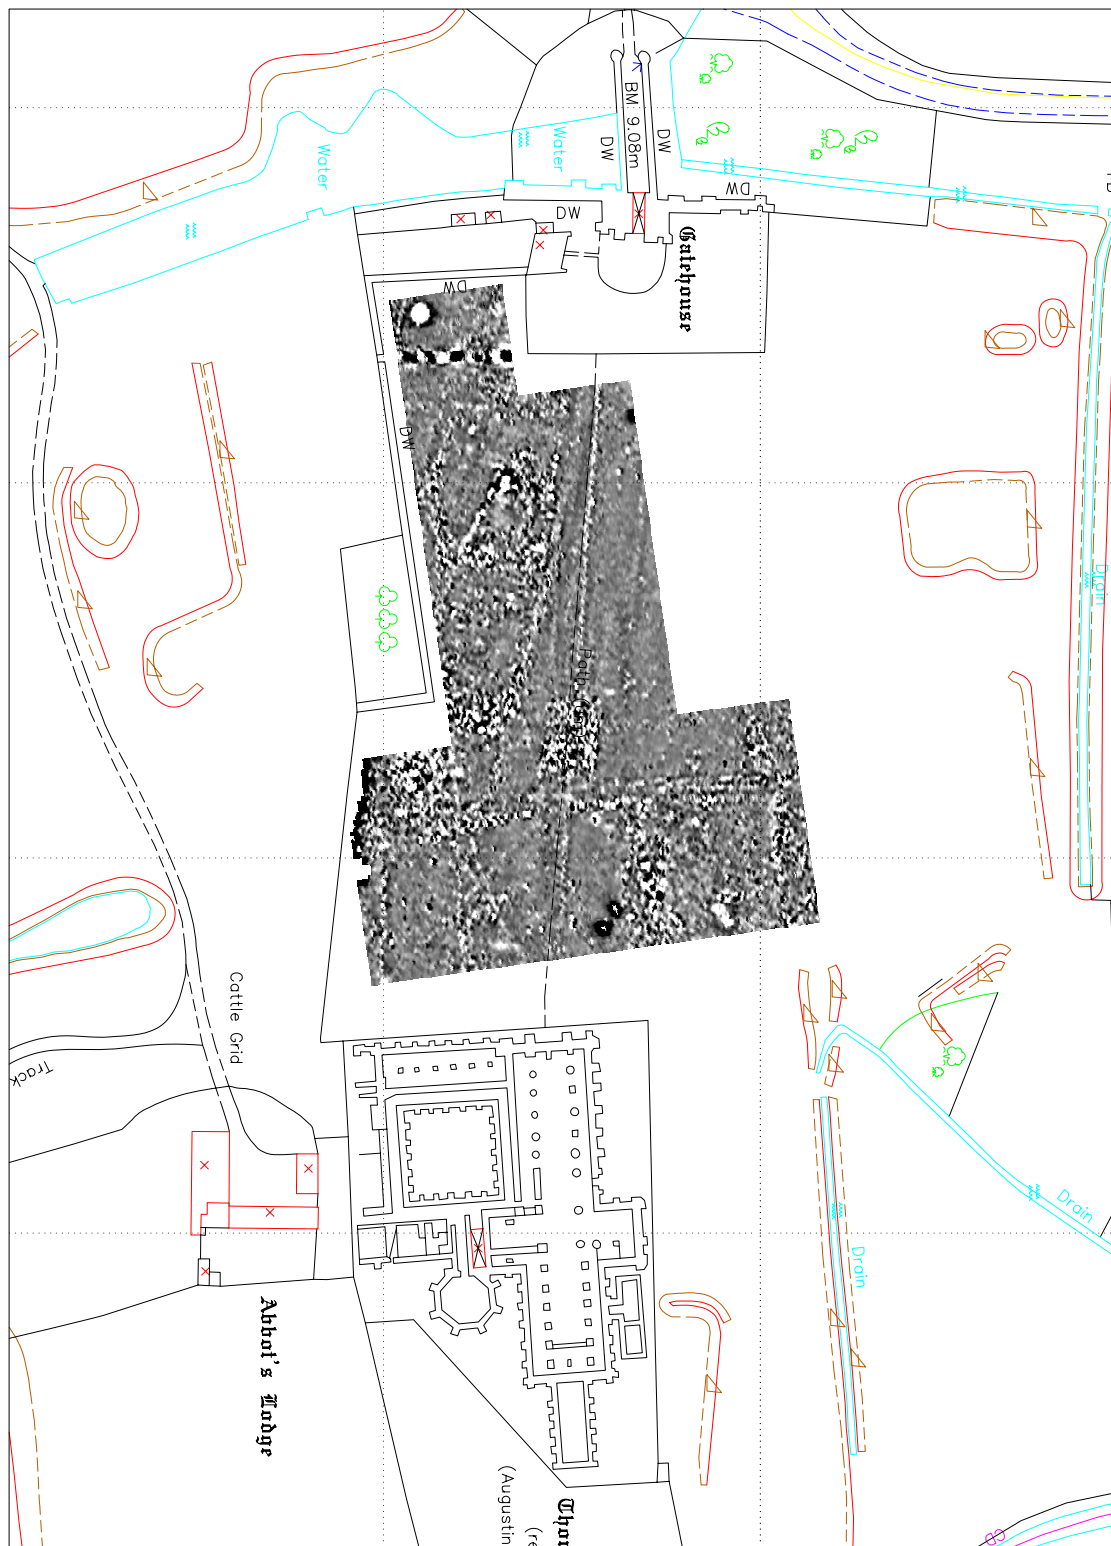
Figure 29. Magnetic survey data, reduced from original plot at 1:1,250 scale.

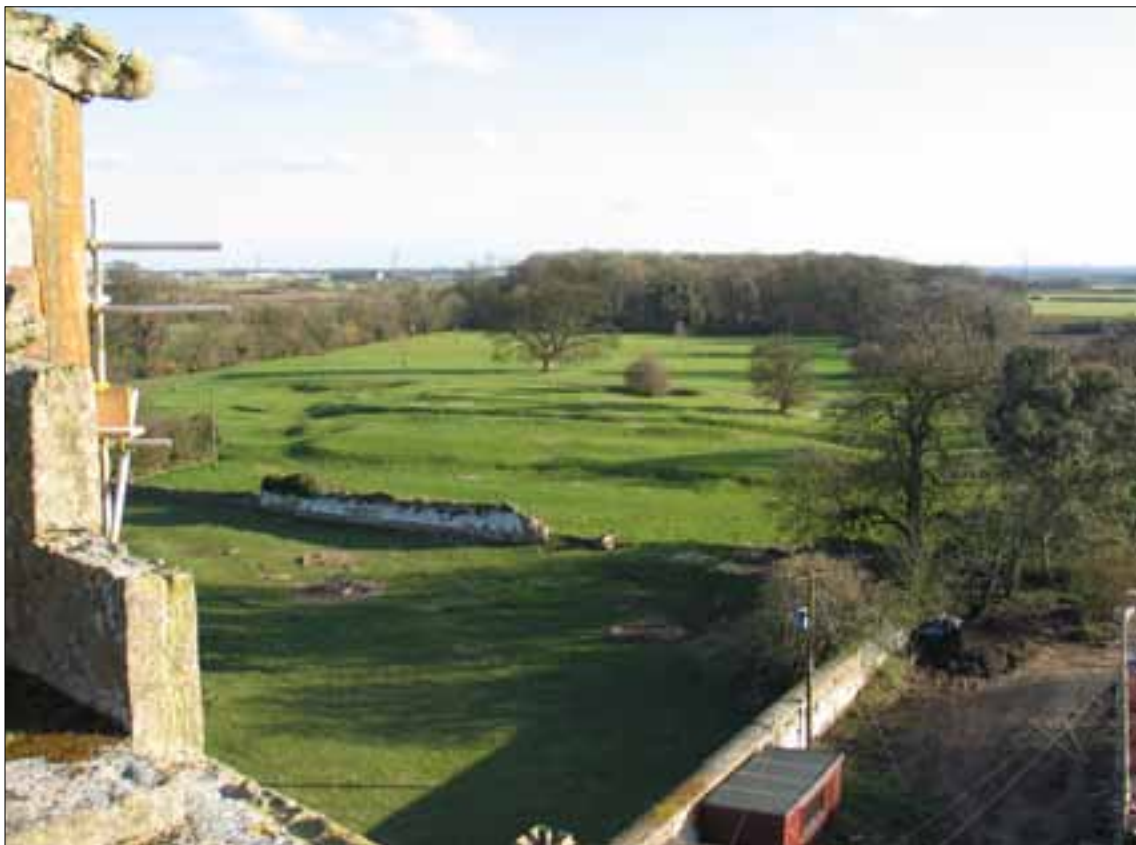
Figure 31. View of part of wall (**e**) and the earthworks beyond it (to its south), seen from the roof of the gatehouse.

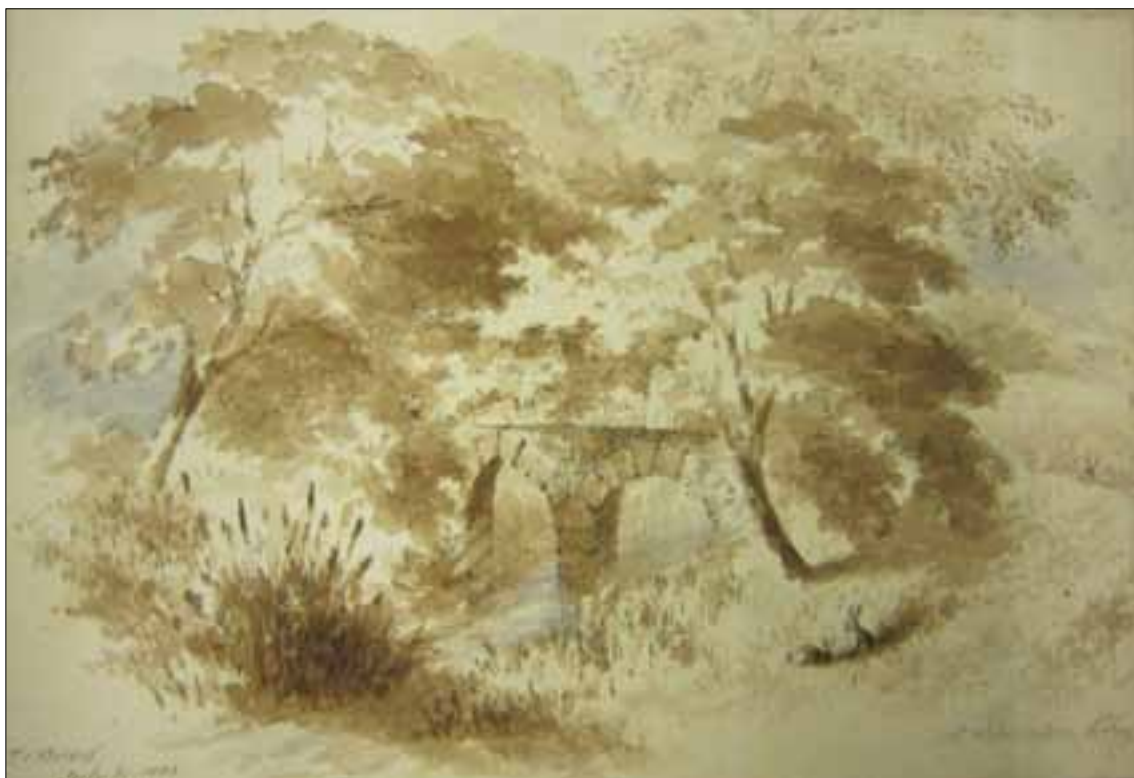
*Figure 32. Watercolour view of the west side of the fine, two-span, 14th-century bridge across water channel (**u1**), painted in July 1883 and pasted into the Yarborough scrap-book (Lincolnshire Archives YARB/11/2/4). Note that the standing water is today retained by material blocking the channel to the east, concealing two more courses of stonework and giving the bridge a rather squatter appearance than the painting shows that it once had. Reproduced by kind permission of Lincolnshire Archives.*

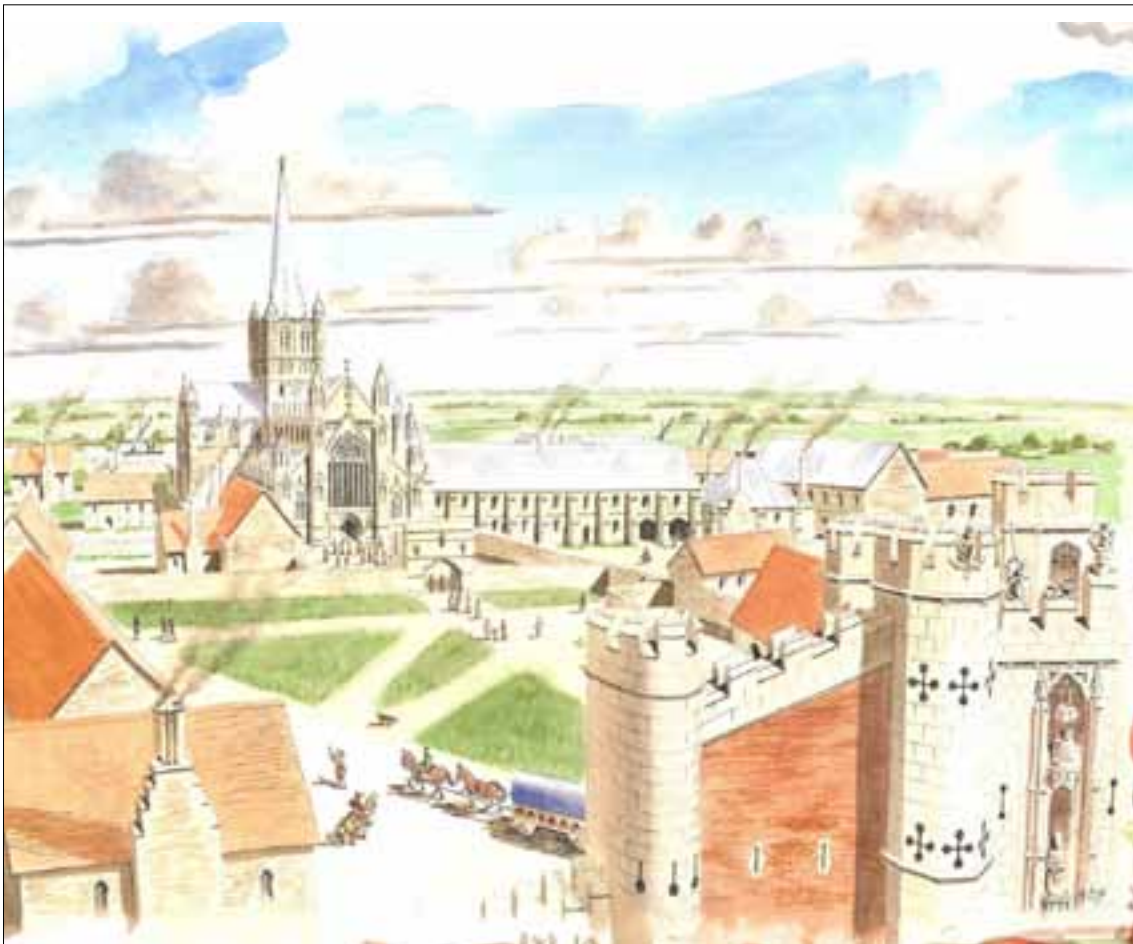
*Figure 37. Reconstruction of abbey at the end of the 14th century (by Gill Atherton). Note that the depiction of unrendered brick on the gatehouse is now known to be misleading.*
