RESEARCH REPORT SERIES no. 3-2011

KENWOOD HOUSE, UXBRIDGE, LONDON AN INVESTIGATION OF THE MUSIC ROOM WINDOW GLASS

TECHNOLOGY REPORT

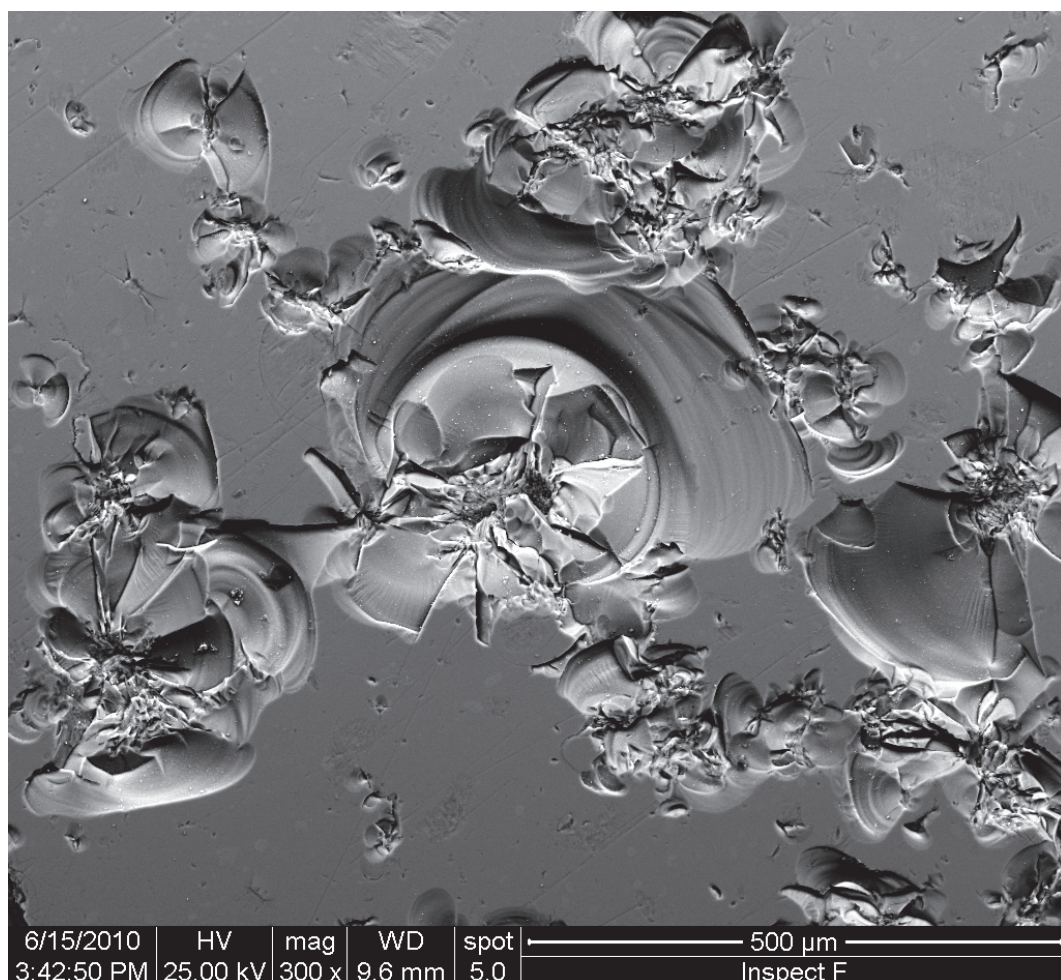
Figure 2. SEM image of the surface of the broken pane from the Music Room

The fragments of broken window submitted for analysis displayed a 'frosted' appearance on parts of one surface which consists of thousands of small impact fractures (Figure 2). The same surface was observed on several of the remaining panes at Kenwood and is believed to have been accidentally produced when the adjacent brickwork was cleaned (shot-blasting).

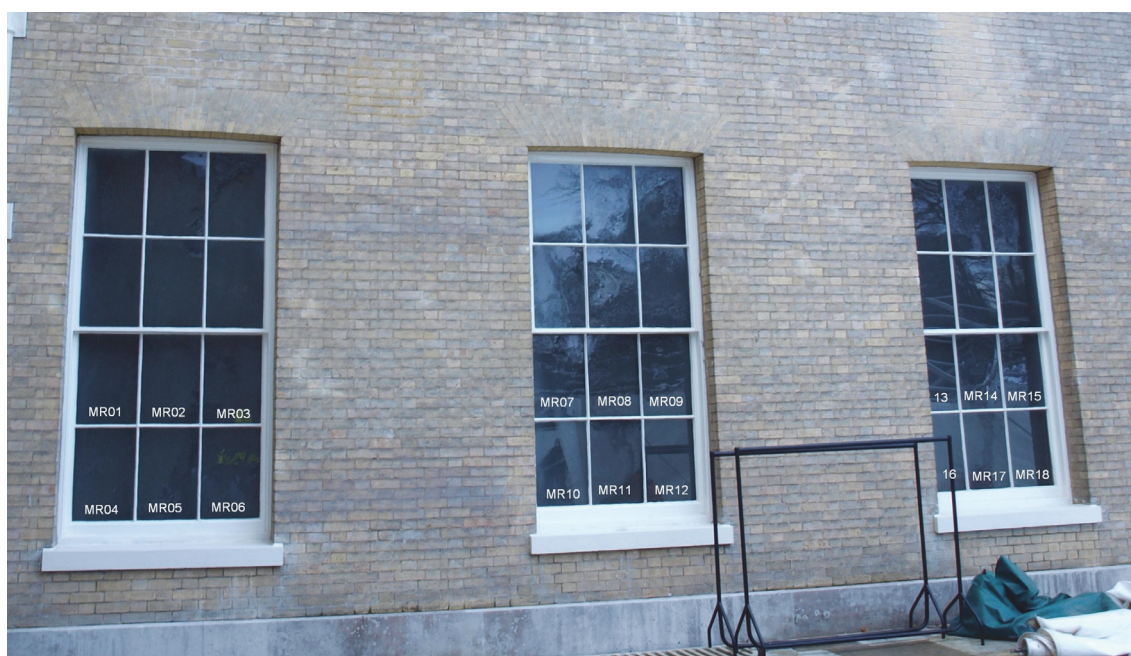
The pXRF analyses of the Kenwood windows included the lowest (and so most accessible) 18 panes from the three windows on the east side of the Music Room (Figure 3). All of the ground-floor windows on this side of the Music Room are 'blind' — behind the glass is a brick wall and the windows do not serve to admit light but merely to provide an architectural balance with the west wall of the Dining Room (whose windows are not blind). MR18 was the pane which was replaced in 2010 following the breakage. For comparison with the Music Room windows, 12 panes from two windows of the west wall of the Dining Room were also analysed using pXRF (Table 4).

Figure 3. East side of the Music Room showing the three windows analysed.

Thirteen of the analysed panes from the Music Room share similar compositions which are distinguished by high levels of potassium ($15.7\% \pm 0.8$) and are comparable with the fragments of the broken pane (Table 3). Such high levels of potassium are unusual in English historic window glass (Dungworth 2011). Medieval window glass did contain comparable levels of potassium but Kenwood was built long after manufacture of that glass type ceased. In addition, medieval glass usually contains much higher levels of a range of elements (manganese, iron, strontium, zirconium, etc) compared to this glass type. This glass type is comparable with window glass at Walmer Castle and is believed to have been imported from Bohemia or Germany (further discussion below). It is assumed that this glass type represents the original glazing for this room.
