8-9, 9A, AND THE LAW LIBRARY, THE CLOSE, EXETER, DEVON TREE-RING ANALYSIS OF TIMBERS

SCIENTIFIC DATING REPORT

NGR: SX 921 926

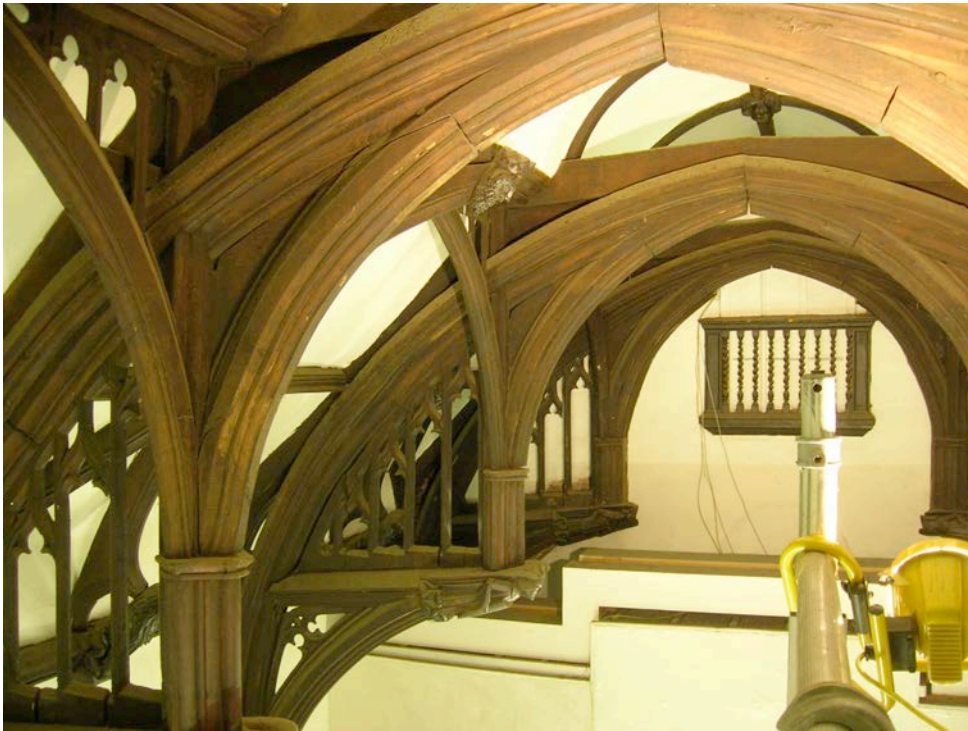
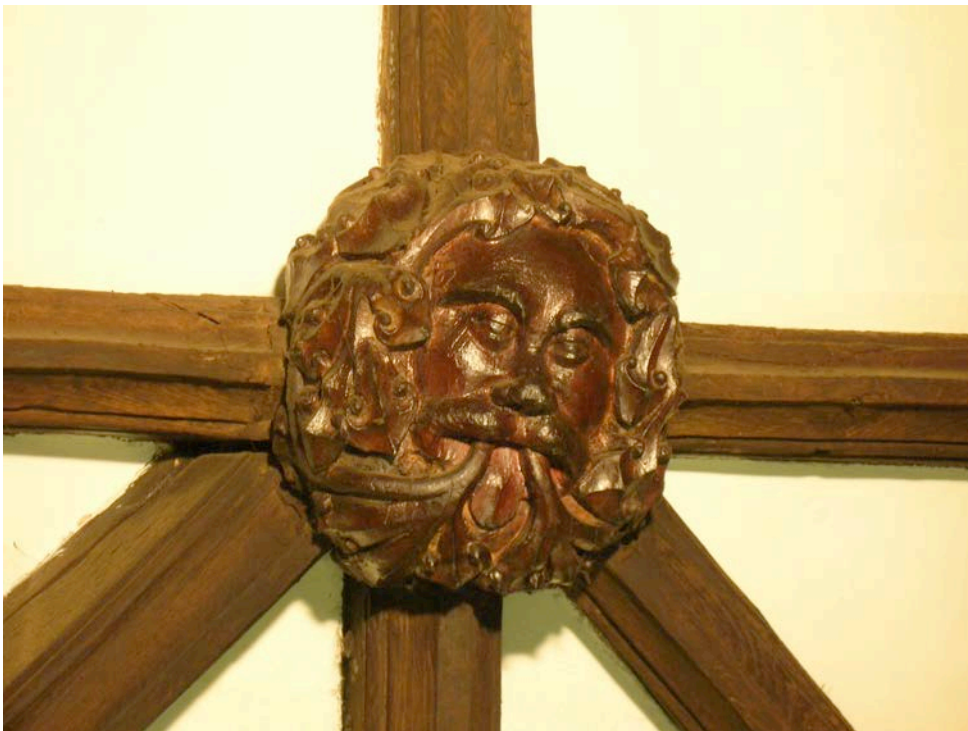
Figure 6a (top): View of Law Library roof

Figure 6b (bottom): View of a boss hiding the junction of timbers

The rear west range, the Law Library, contains a three-bay open hall formed by four single hammer beam roof trusses of a design similar to that of Westminster Hall. Between the main trusses there are intermediate frames. The hammer-beams, arch-braces, coved rafters, and purlins, along with many other elements, are all highly moulded and carved, as is the open-work tracery in-fill. The ends of the hammer beams are decorated with angels, whilst ornately carved bosses hide the joints between timbers (Fig 6a/b). The roof is thus exceptionally decorative, even by the standards of the Exeter group, of which other examples include The Archdeacon's House, The Guildhall, and The Deanery (Howard *et al* 1999a, 1999b, 2000). The Law Library is believed to date to c AD 1450-AD 1550, but a date as early as c AD 1390 has also been suggested.

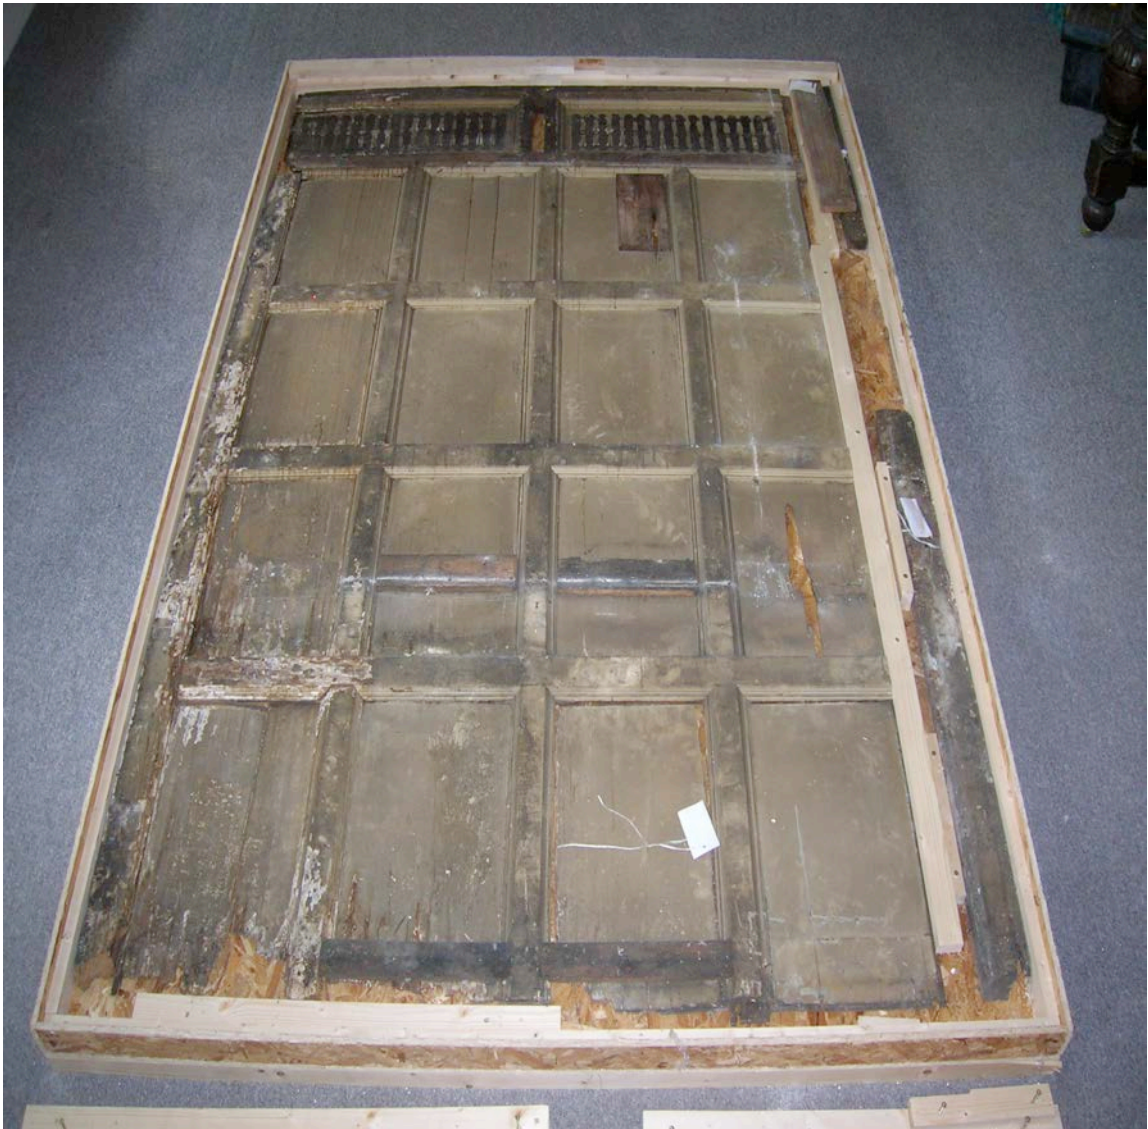
Figure 8: View of the panels from 8-9 The Close

Sampling and analysis by tree-ring dating of timbers from the three constituent parts of this building complex, 8-9 The Close, 9a The Close, and the Law Library, were commissioned by English Heritage. Apart from the roof timbers of each part, this programme of analysis was to include a series of joists to the ground-floor ceiling of the front range, both those always exposed in the external west passageway and those exposed by the lifting of a small number of first-floor floorboards during internal renovation works. The sampling and analysis of a small section of wall panelling temporarily removed from the front range during repairs was also requested (Fig 8).

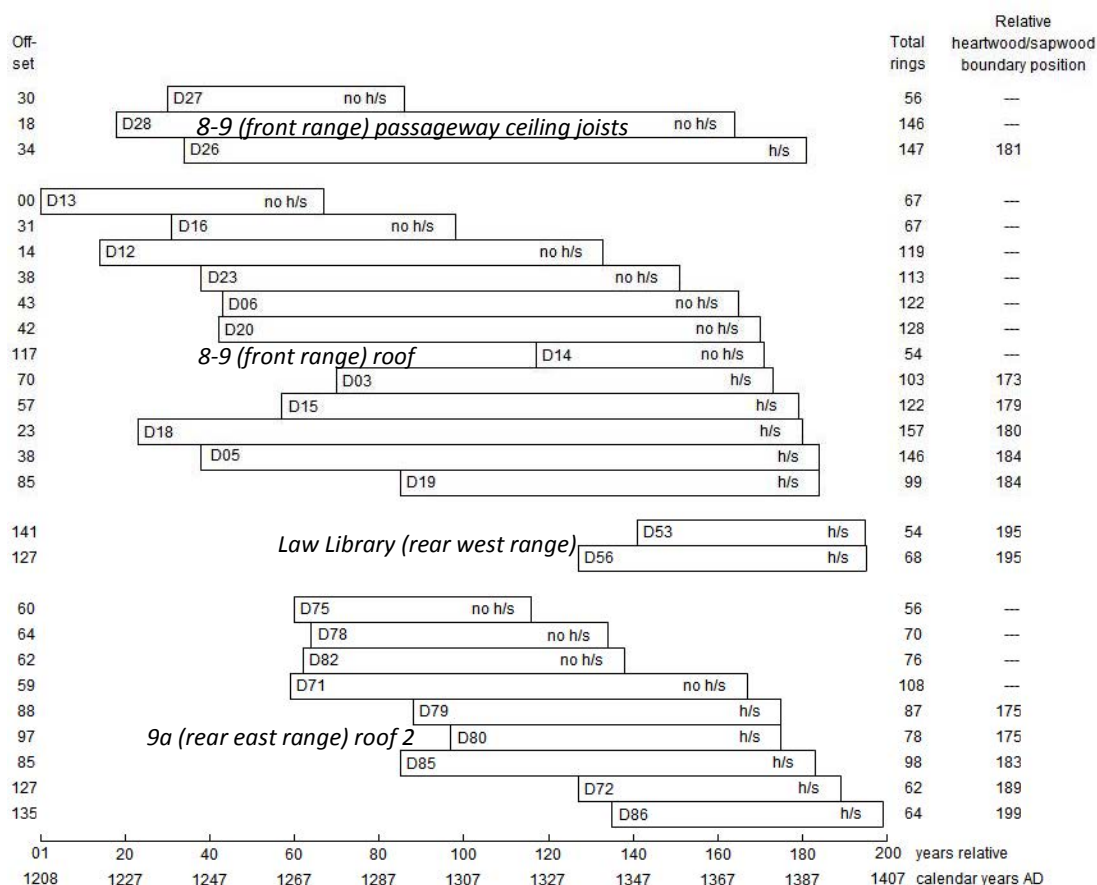
Empty bars = heartwood rings

h/s = the last ring on the sample is at the heartwood/sapwood boundary, only the sapwood rings are missing. NB: Samples D75 & D79 are from the same timber)

Figure 12: Bar diagram of the samples in site chronology EXTDSQ01 sorted by sample location in last measured ring date order

As may be seen from Table 1 and the bar diagram, Figure 12, where the cross-matching samples of dated site chronology EXTDSQ01 are shown sorted by sample location and in last measured ring date order, the overall position of the heartwood/sapwood boundary varies by some 26 years. The earliest sapwood boundary is a relative position 173 (AD 1380), on sample EXT-D03, with the latest boundary being at relative position 199 (AD 1406) on sample EXT-D86. This variation is possibly slightly wider than might be expected in a group of timbers were they all cut at the same time as each other in a single episode of felling, but might be explicable in timbers felled over a period of time. In respect of this possibility, it may be of interest to note that if the samples are examined by area group, a slight difference in felling date range may be detected. Although this dating would support the relative sequence of building construction as intimated by the structural evidence, because the date ranges have a significant overlap, this does not necessarily indicate that the two parts of the building are definitely of different construction dates.

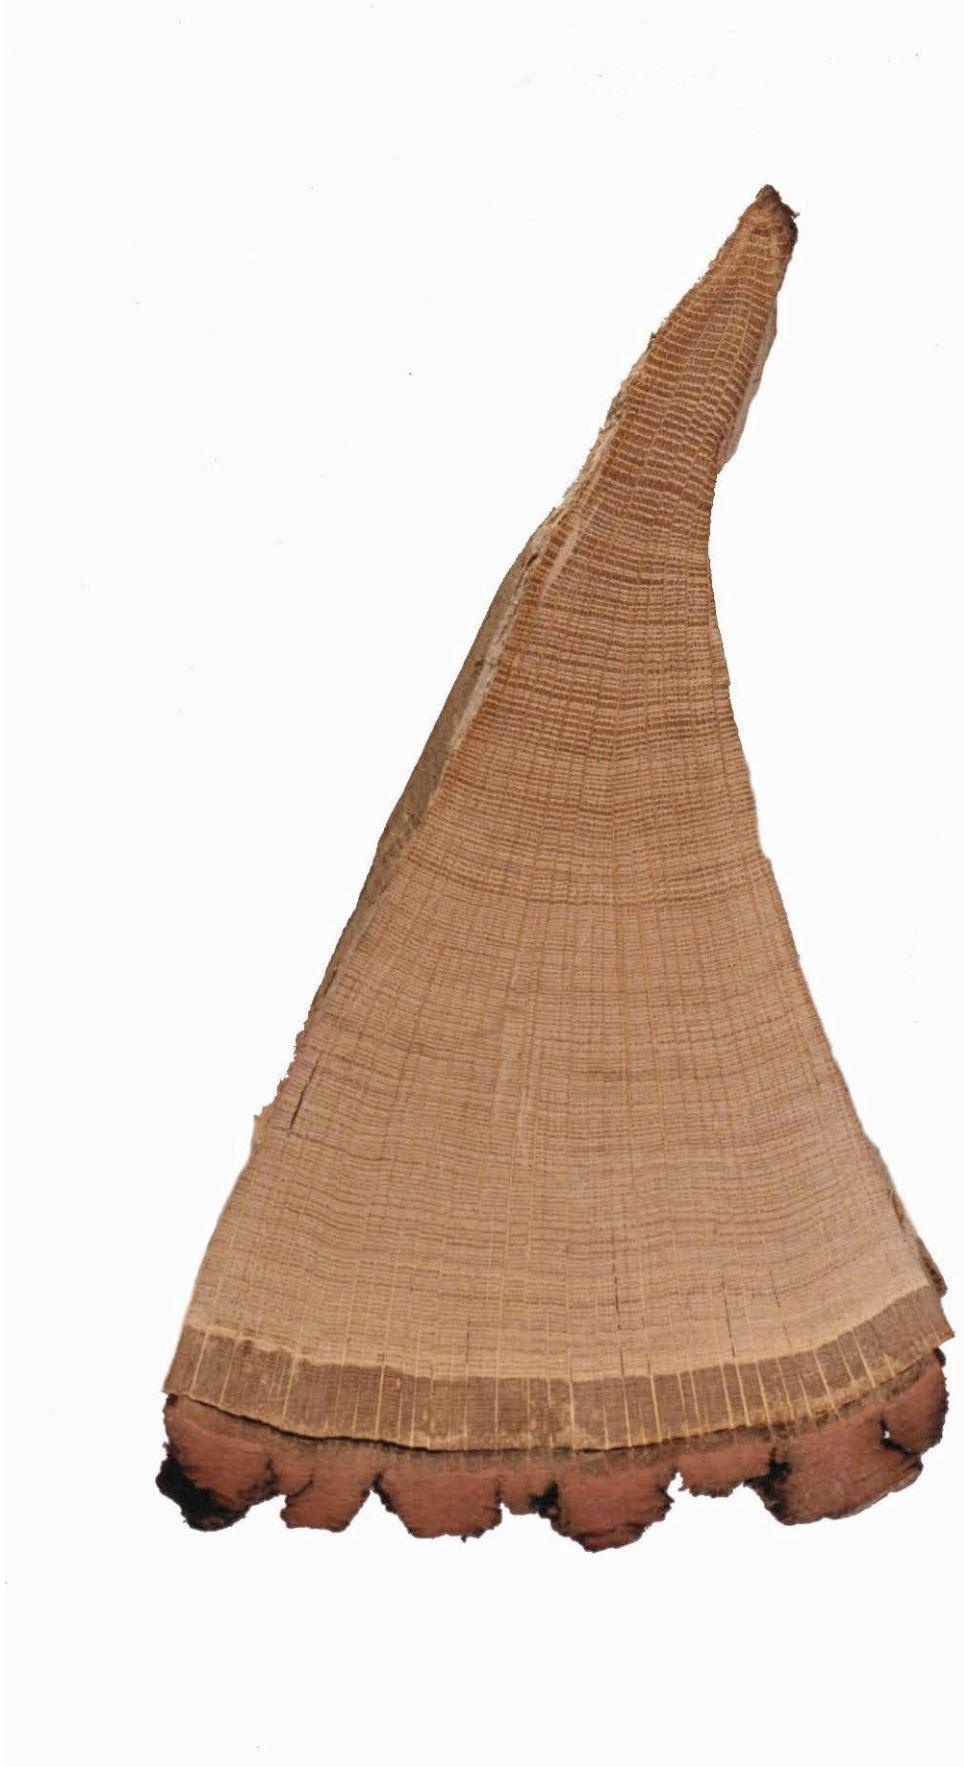
Figure A1: A wedge of oak from a tree felled in 1976. It shows the annual growth rings, one for each year from the innermost ring to the last ring on the outside just inside the bark. The year of each ring can be determined by counting back from the outside ring, which grew in 1976

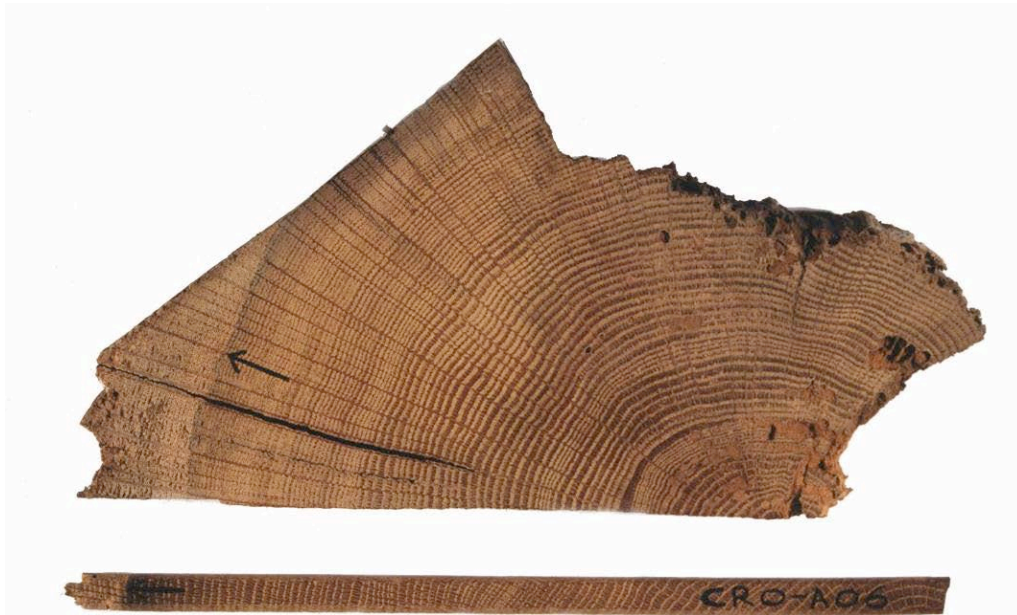
Figure A2: Cross-section of a rafter, showing sapwood rings in the left-hand corner, the arrow points to the heartwood/sapwood boundary (H/S); and a core with sapwood; again the arrow is pointing to the H/S. The core is about the size of a pencil

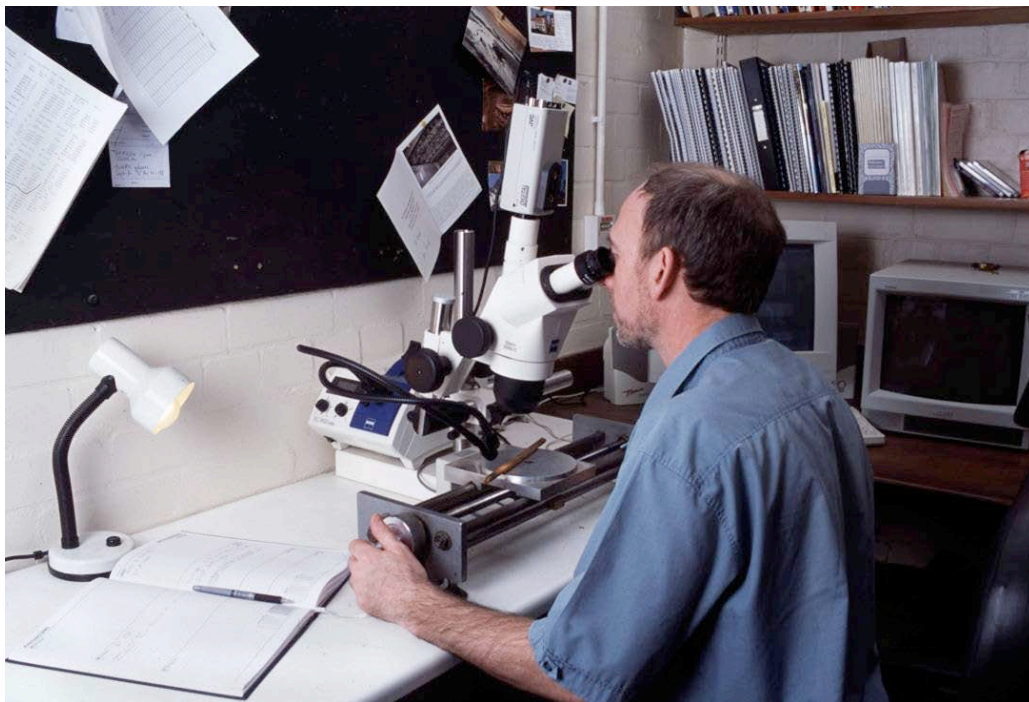
Figure A3: Measuring ring widths under a microscope. The microscope is fixed while the sample is on a moving platform. The total sequence of widths is measured twice to ensure that an error has not been made. This type of apparatus is needed to process a large number of samples on a regular basis

2. Measuring Ring Widths. Each core is sanded down with a belt sander using medium-grit paper and then finished by hand with flourgrade-grit paper. The rings are then clearly visible and differentiated from each other with a result very much like that shown in Figure A2. The core is then mounted on a movable table below a microscope and the ring-widths measured individually from the innermost ring to the outermost. The widths are automatically recorded in a computer file as they are measured (see Fig A3).

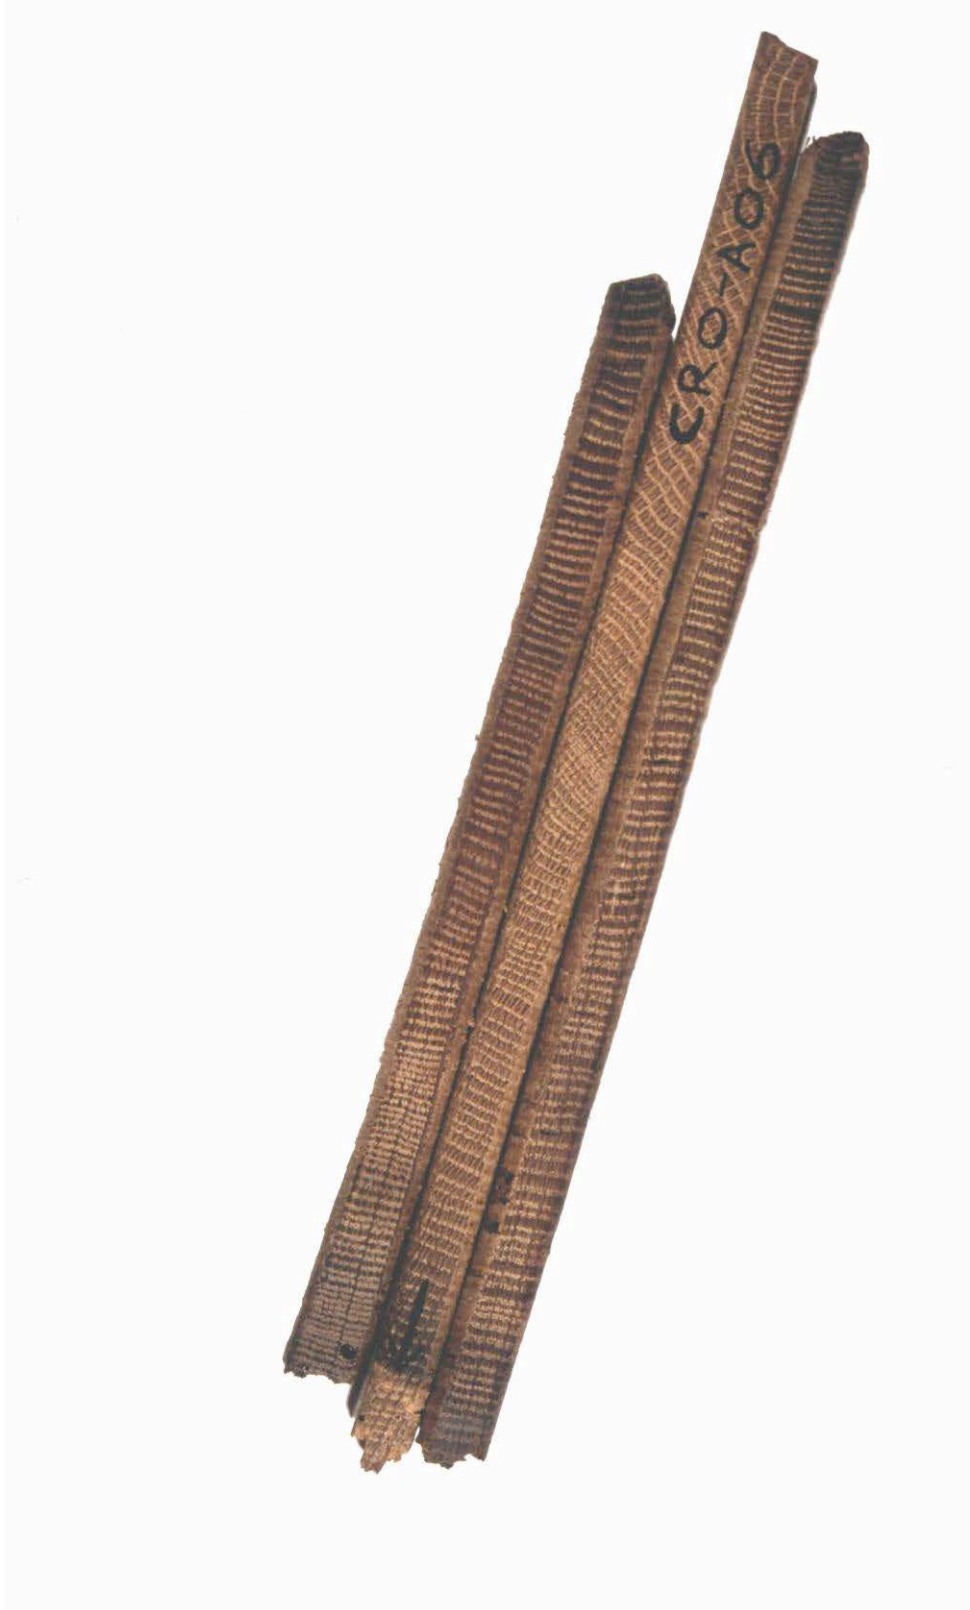
Figure A4: Three cores from timbers in a building. They come from trees growing at the same time. Notice that, although the sequences of widths look similar, they are not identical. This is typical
