KITCHENER'S CAMPS AT SEAFORD A FIRST WORLD WAR LANDSCAPE ON AERIAL PHOTOGRAPHS

ARCHAEOLOGICAL REPORT

Robert Skinner

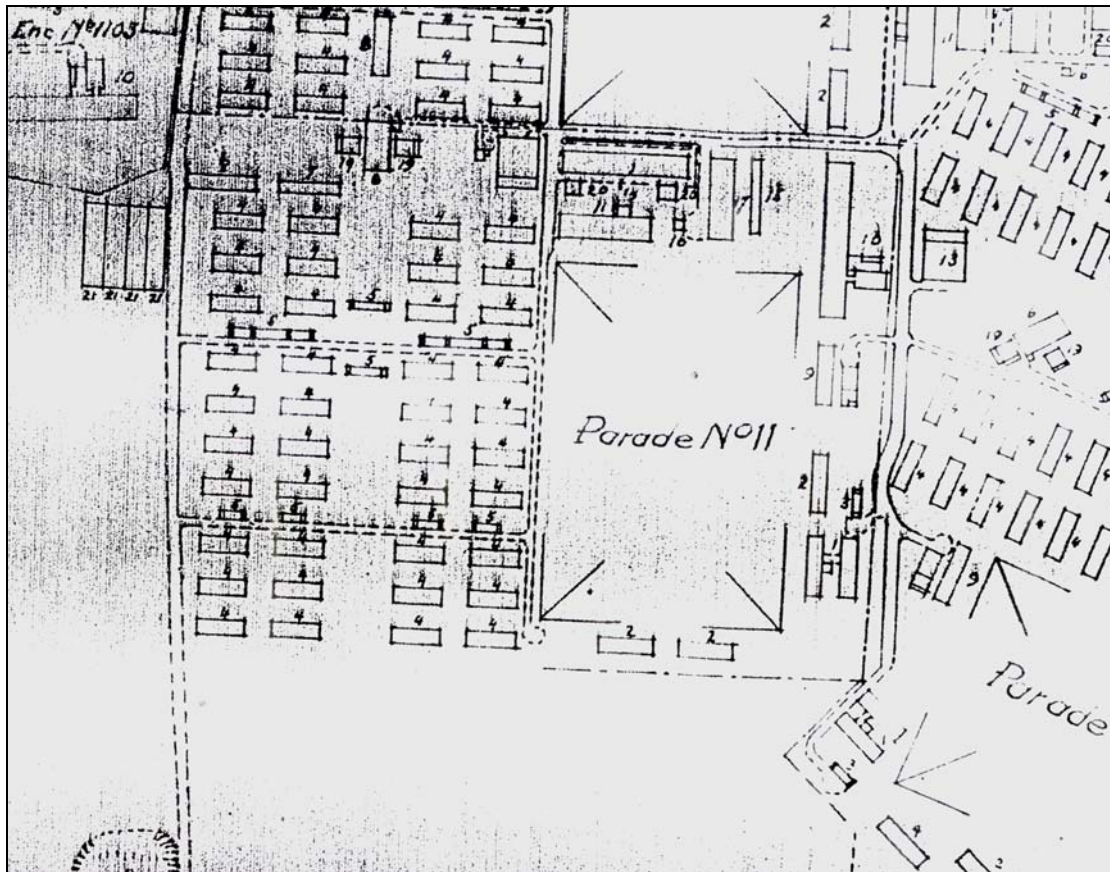
Fig 7: A typical battalion unit at South Camp. The barracks, and washing and cooking amenities are to the west of the parade ground, the HQ buildings are located to the south and east, and the storage and transport facilities such as stables are to the north. Canadian National Archives Reference: Q4-54887, Series E-17, Vol 21, File '21' (21-27) 1916-C 'Plans de camps' Crown Copyright, The National Archives, UK.

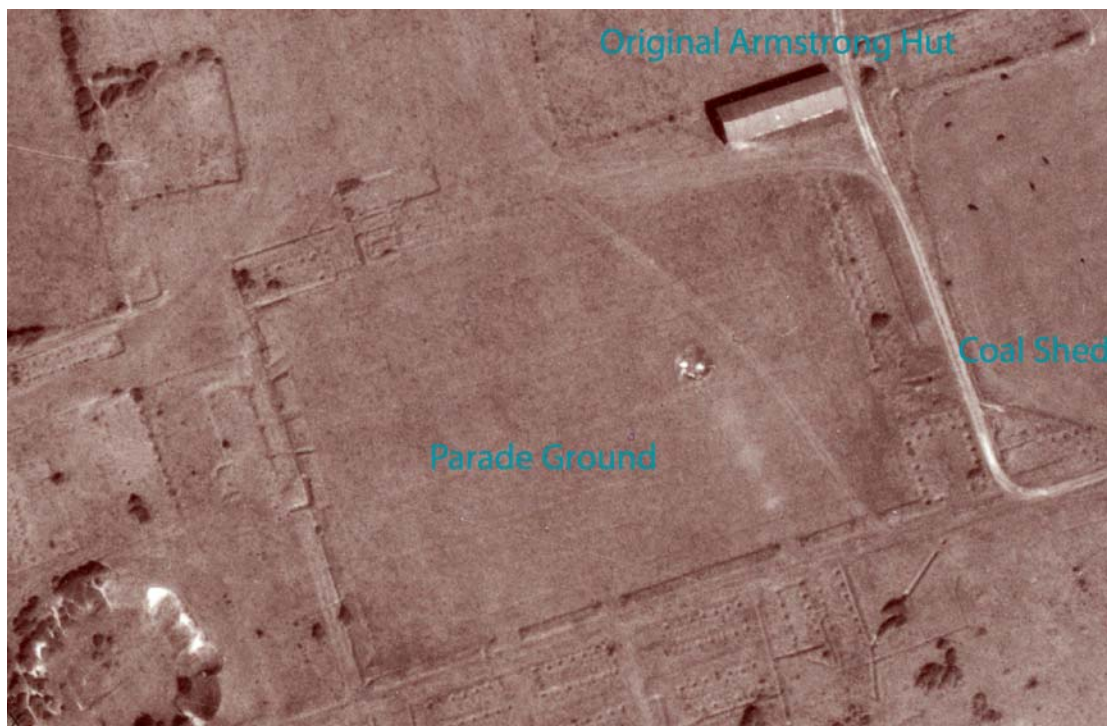
Fig 8: 1951 Aerial photograph showing the buildings beside a parade ground. NMR RAF/58/613 4237 05-APR-1951 English Heritage (NMR) RAF Photography.

Figure 8 shows one of a few Armstrong Huts surviving in 1951, possibly maintained as an agricultural building. Building foundations can be seen including the holes for the supporting piers. The foundations of a coal shed can be identified at the bottom right of the parade ground. The shed appears to have posts for a walls and roof but with a central open space and a wide entrance onto a camp road presumably for vehicle access.

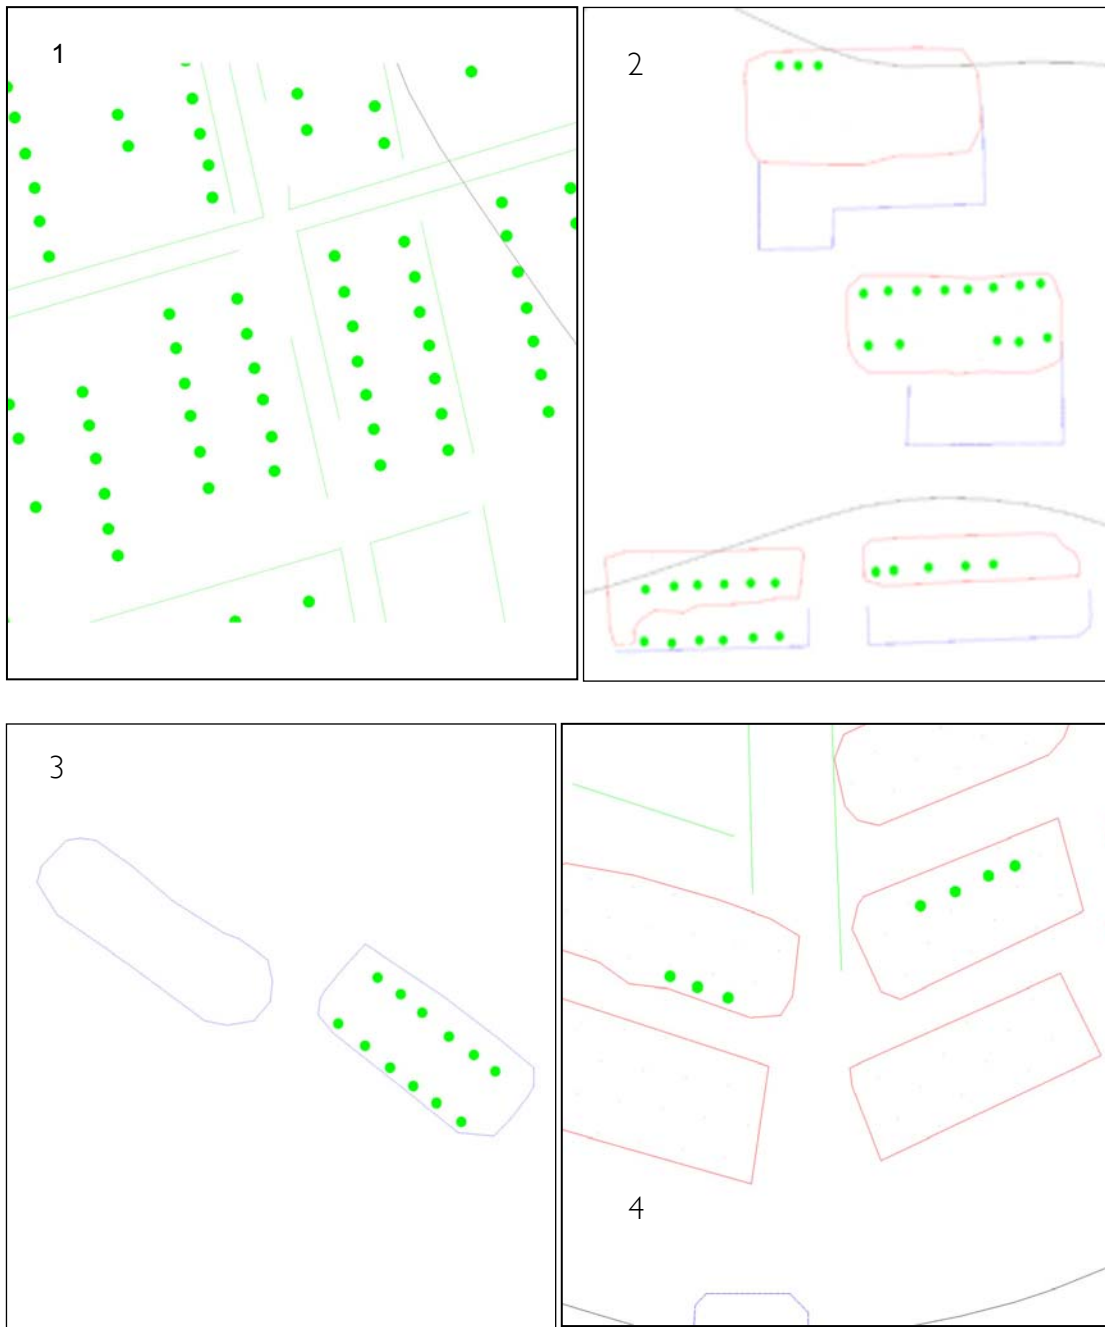
Fig 10: Different styles of building foundation as shown on the aerial photograph mapping.

Figure 10 shows the various layouts of the buildings. Figure 10.1 shows barrack huts constructed on a level surface with drainage ditches. Figure 10.2 shows barrack huts cut into the slope of the hillside with a raised earthwork to create a level platform. Figure 10.3 shows barrack huts constructed within a cut area. Figure 10.4 shows: barrack huts constructed on a raised earthwork platform in a herringbone pattern that follows the contours of the slope. The huts are all approximately 20m long.

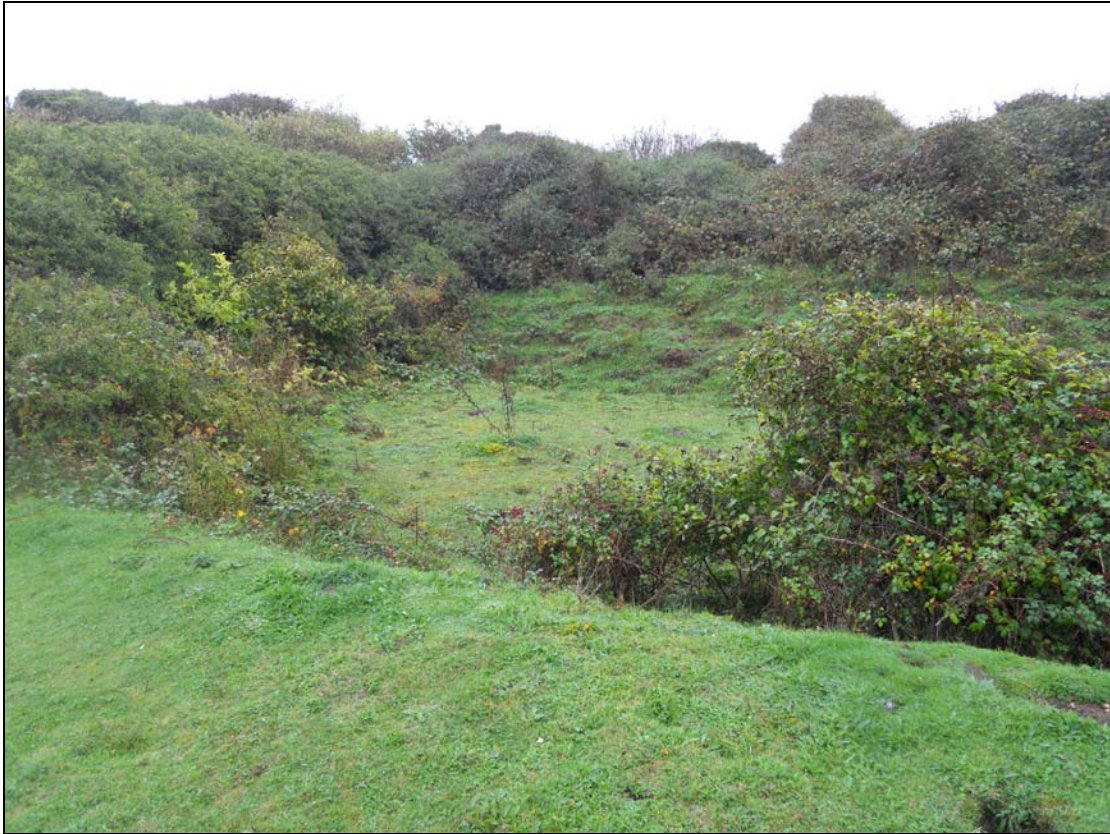
Fig 11: The deep building cut for the drying room associated with the battalion unit based around parade ground 10. Author's photograph.

The cut for a drying room is preserved in scrubland to the east of Seaford Head Golf Course (Fig 11). It is likely that this was designed to improve air circulation through the building.

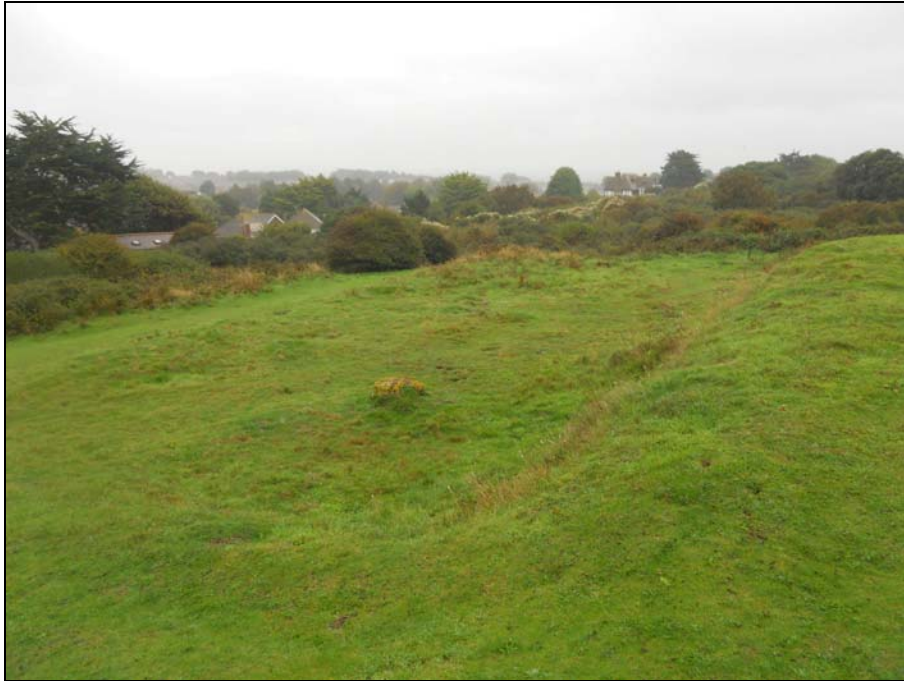
Fig 12: Image showing an extant hut platform with brick pier. Author's Photograph.

Schofield describes the standard design and materials used for the Armstrong hutments. Brick piers were initially used but were replaced by woodpiles, as bricks became scarce (Schofield, 2006, 5). A hut platform still visible at Seaford has a brick pier in situ (Fig 12). However, it is possible that other camp buildings used wood. Schofield describes the standard hut building material as red fir scantlings (ibid). This material was likely to have been used at Seaford as the huts depicted in the postcards are mostly of a light wood, which in colour images has a reddish tint (E.g. in Figs 13 & 18). Figure 13 shows some of the huts under construction with piles of planks and huts with no windows, the dark roofs are likely to be tar covered. Several huts survived post war many being sold off and used as private dwellings, this process is described in a later section of this report.

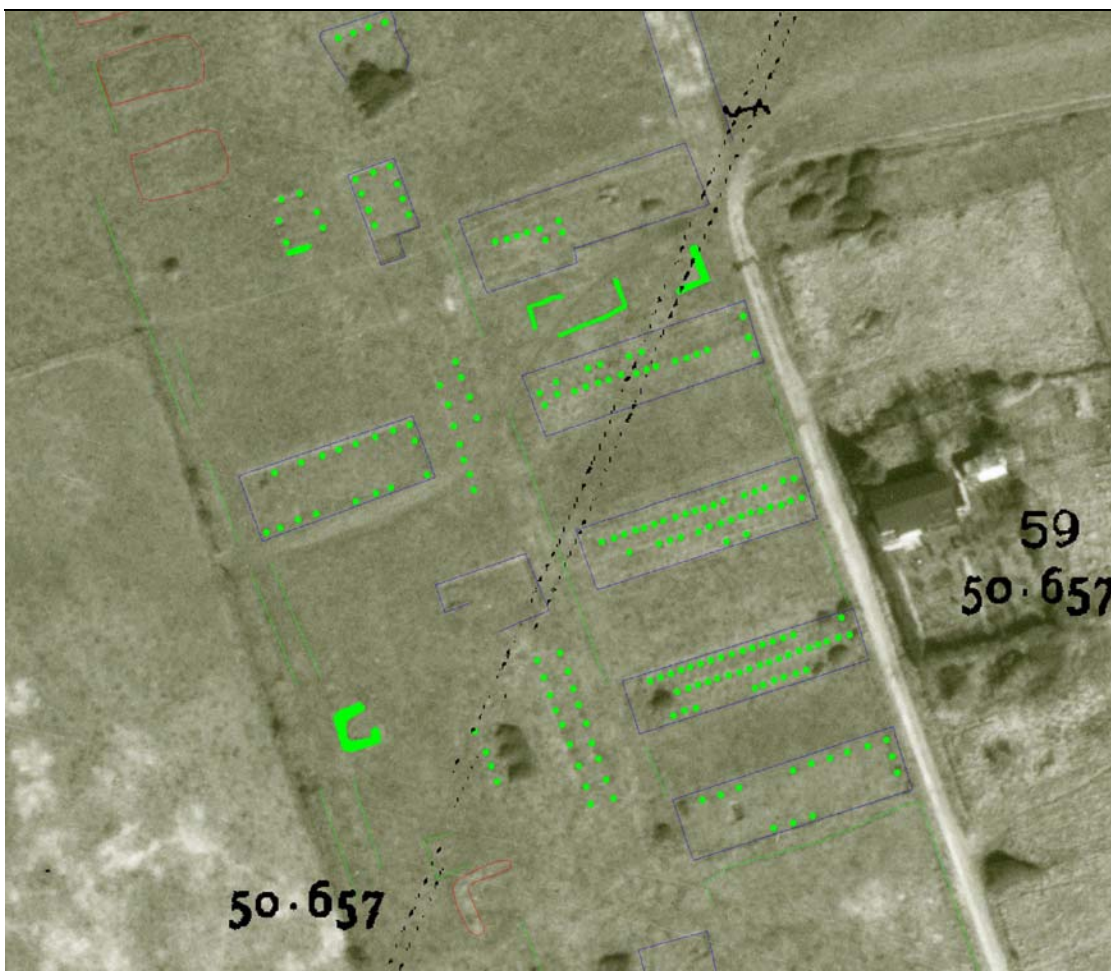
Fig 14: Image showing a 1951 aerial photograph overlaid with the mapping depicting the unusual northwestern part of North Camp. NMR RAF_58_613 4235 5-APR-1951. English Heritage (NMR) RAF Photography.

The area illustrated in Figure 14 presents more of a challenge to interpretation. The building's foundations seen here deviate from the pattern in the rest of the camp. The area contains a row of five large rectangular buildings, supported on many posts. The buildings share the dimensions of the large standardised storage buildings (e.g. vehicle stores, stables) from elsewhere in the camps at approximately 120' x 30' (37 x 9 meters). It is unusual in that these large buildings are clustered together in a pattern that has no comparison in South Camp where, according to the plan, each battalion would have a couple of large buildings for specific purposes. As it is unique, it is possible that this area had a specific function at a divisional level. There is evidence of a detachment of Canadian Engineers, a motorised machine gun depot and a recycling depot at the camp (Luke Barber pers. comm.) all of which have undisclosed locations. This northwest area of North Camp is a strong candidate for the location of this distinctive activity or may have been the location of the divisional HQ (See Figs 6 & 14).

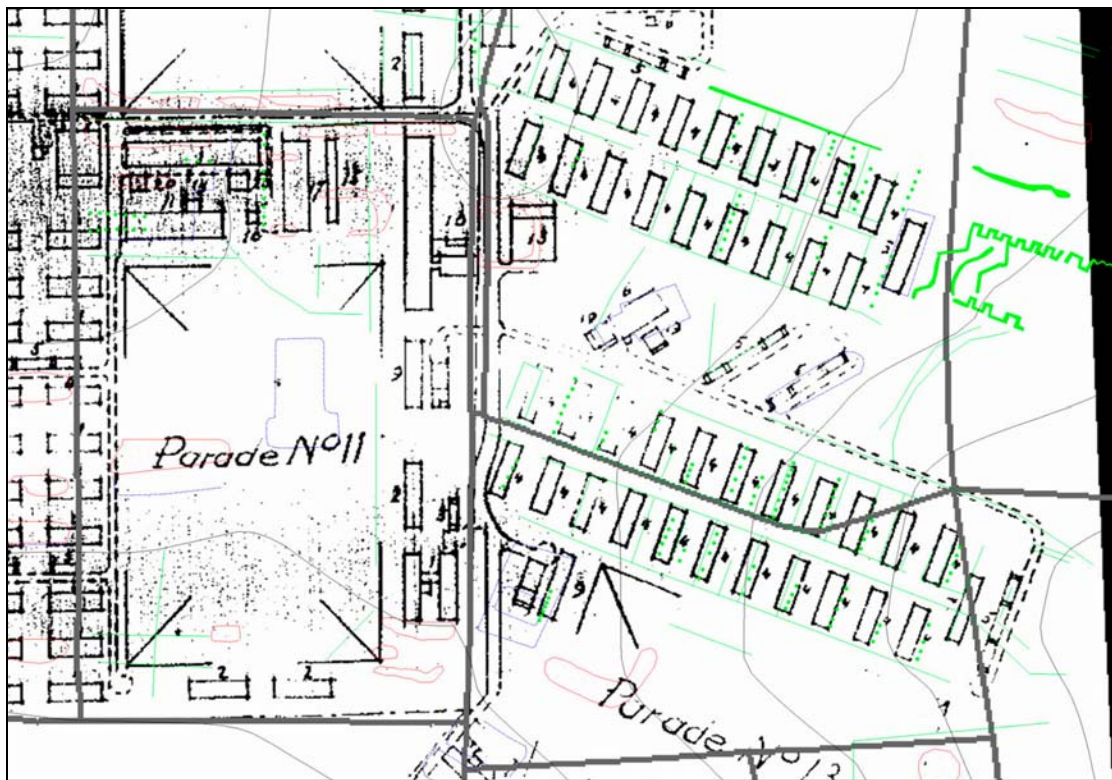
Fig 15: Diagram comparing part of the 1916 plan with the mapping for the east end of South Camp. Note the hut foundations located on parade ground 11 and the L-shaped earthwork on parade ground 13 (bottom right). Canadian National Archives Reference: Q4-54887, Series E-17, Vol 21, File '21' (21-27) 1916-C 'Plans de camps' Crown Copyright, The National Archives, UK.

Another area of the camp with aerial photographic evidence for variation from the original design is the far eastern end of South Camp. The area appears to have witnessed physical changes that deviated from the 1916 plan. On the aerial photographs several hut bases appear in the area defined as Parade 11 as does an earthwork feature on the edge of Parade 13 (Fig 15). Rows of possible hut foundations, or training features, extend to the northeast. These are not depicted on the 1916 plan and their function is unknown. It is possible that as the war progressed more accommodation was needed and parade grounds became less important. It is possible that parade and ceremony become secondary to the other functions of the camp as reinforcements were being rushed through their training in the face of mounting casualties.

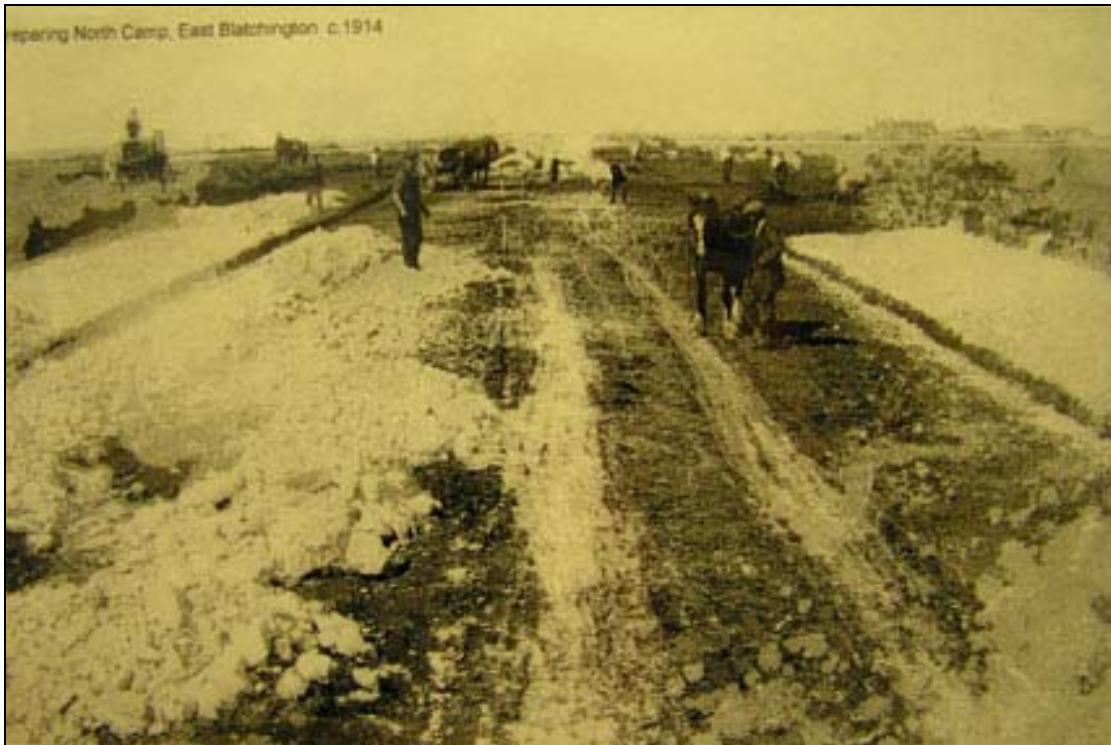
Fig 16: Postcard showing the laying down of a chalk road surface. Reproduced by courtesy of Luke Barber.

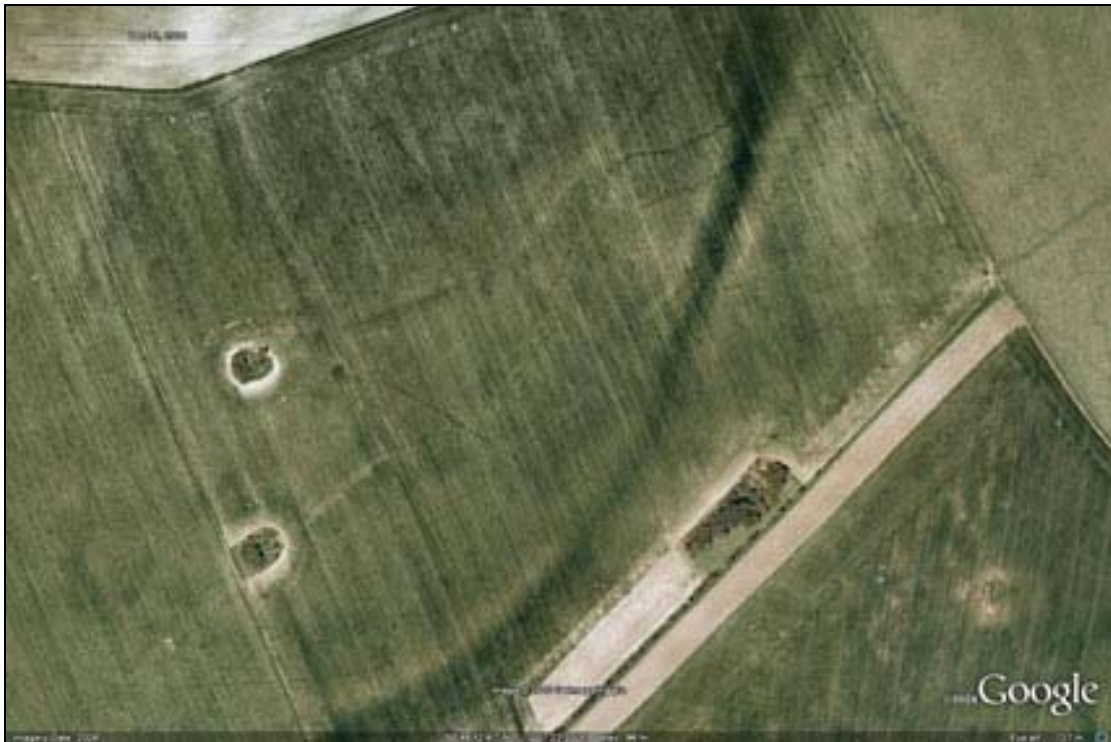
Fig 21: Aerial photograph showing practice trenches visible as cropmarks on the downs 2km to the north of Seaford North Camp. © 2009 Google, Image © 2011 Getmapping plc.

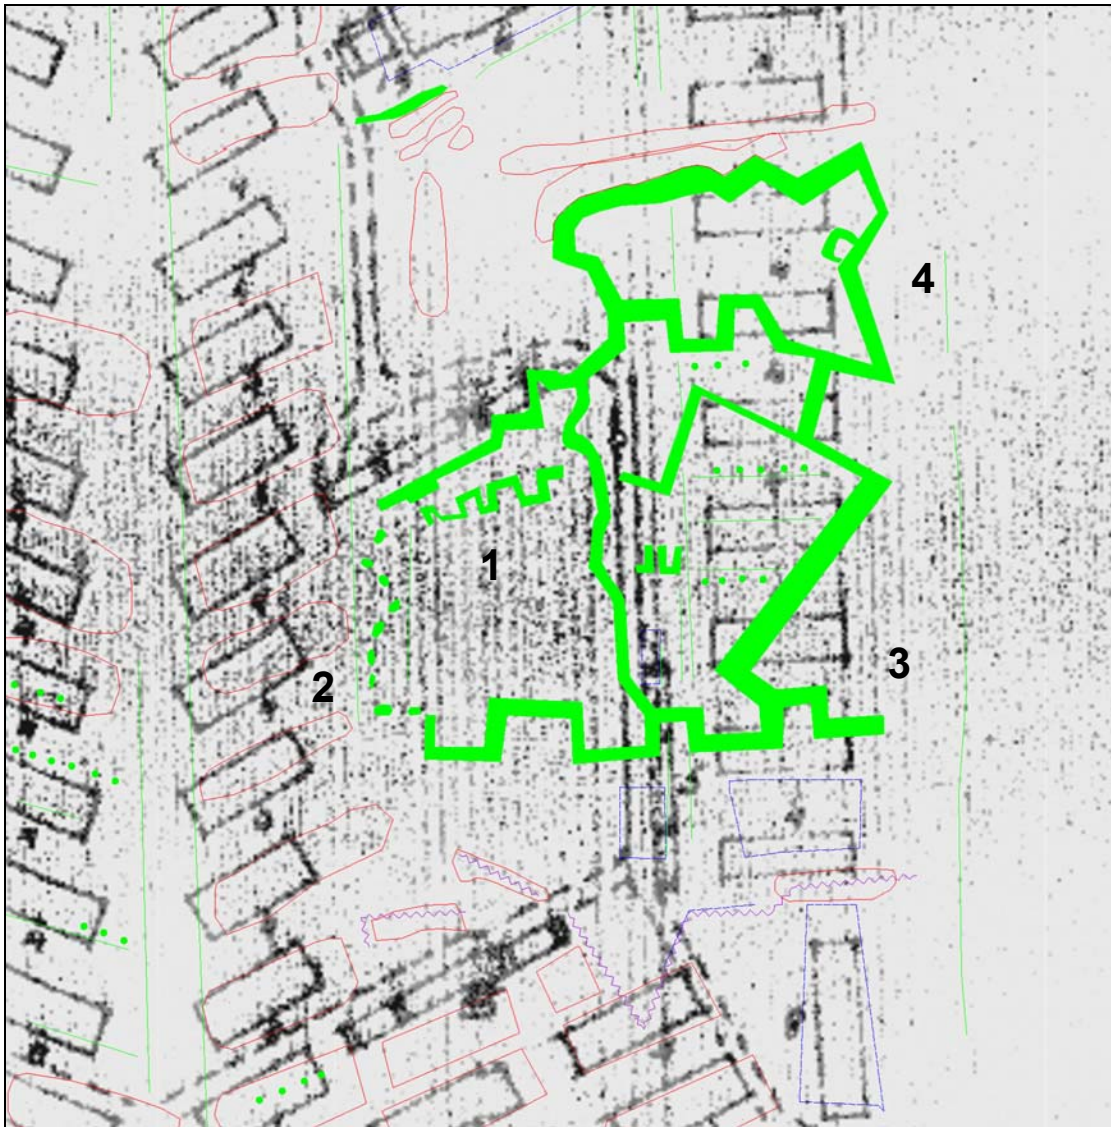
Fig 22: The trench works seen on aerial photographs on the south side of the camp overlaid onto the 1916 plan of South Camp (Canadian National Archives Reference: Q4-54887, Series E-17, Vol 21, File '21' (21-27) 1916-C 'Plans de camps' Crown Copyright, The National Archives, UK).

The trenching, which may be of a First World War date (Fig 22 area 1), could be a model demonstration trench. There is, however, a problem with this interpretation as a post card image dated January 1915 clearly shows the open area from a vantage point on the slopes of Seaford Head and it contains no sign of a trench. This does not rule out the notion that the trench could have been dug later during the conflict just that it was not a part of the initial camp construction. Alternatively, the earliest phase of trenching may date from between the wars; newspaper reports show that military training activity continued in the area (see below, page 34). Further unravelling of the sequence of trenches at Seaford South Camp could be achieved by analytical field survey and targeted excavation.

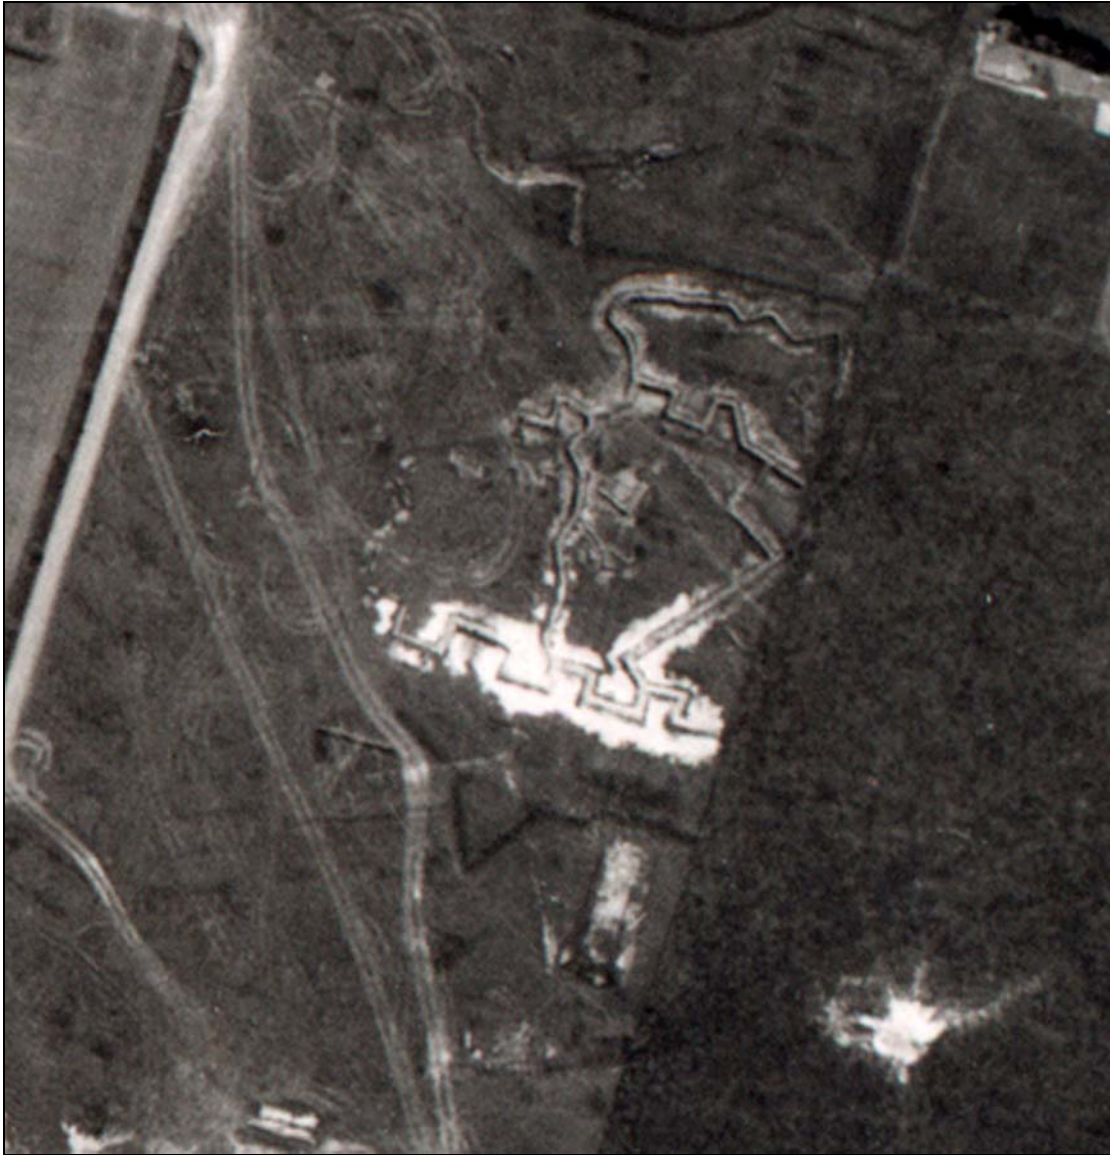
Fig 23: Aerial photograph from 1942 showing the trenches looking freshly dug out of the chalk. Note the vehicle tracks and the V-shaped arrangement of barbed wire (lower centre of photo) all suggestive of Second World War military activity at the trenches. NMR RAF/HLA/538 6 11 08-MAY-1942 English Heritage (NMR) RAF Photography).

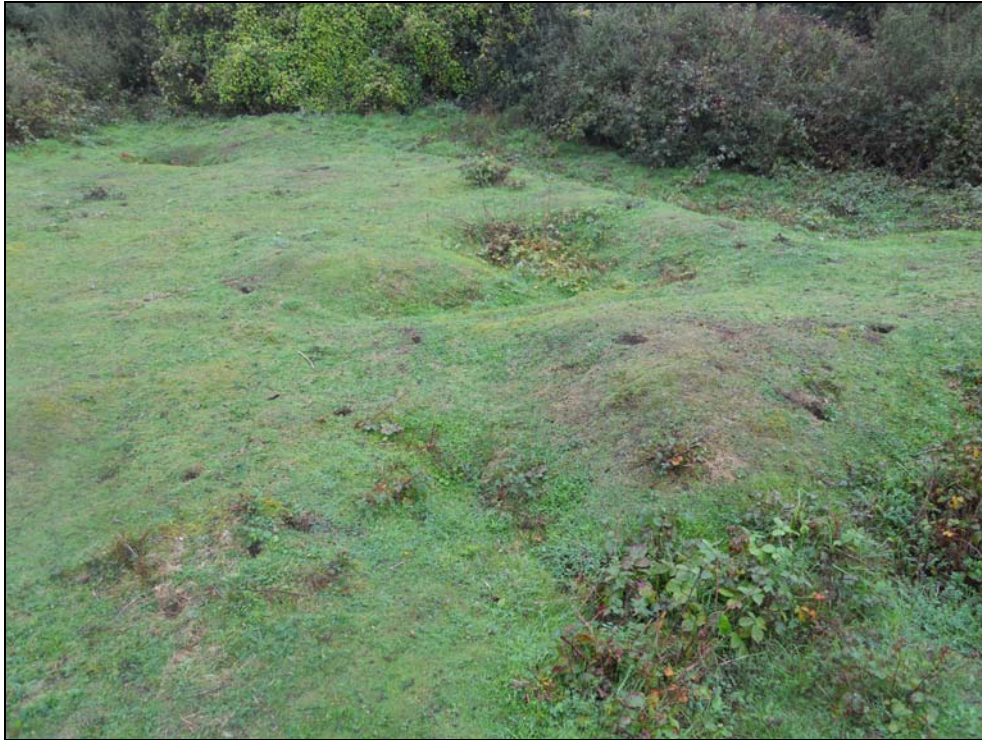
Fig 24: Extant trenches. These partially filled in features are probably from the earliest phase of activity (see Fig 22 1). Author's photograph.

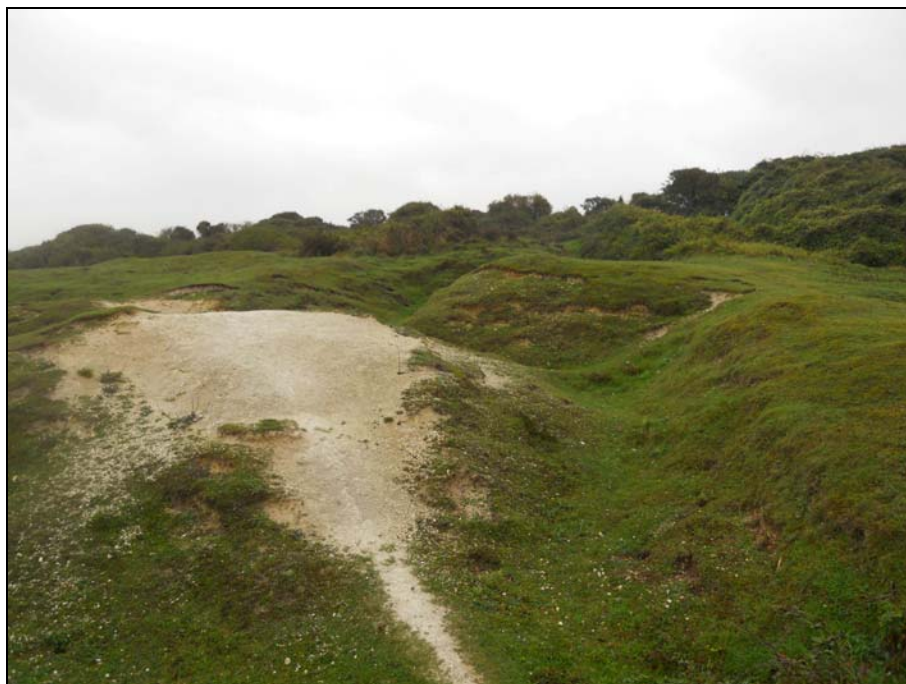
Fig 25: *The larger, probably later, trenches. Note the damage from motorbikes.* Author's photograph.

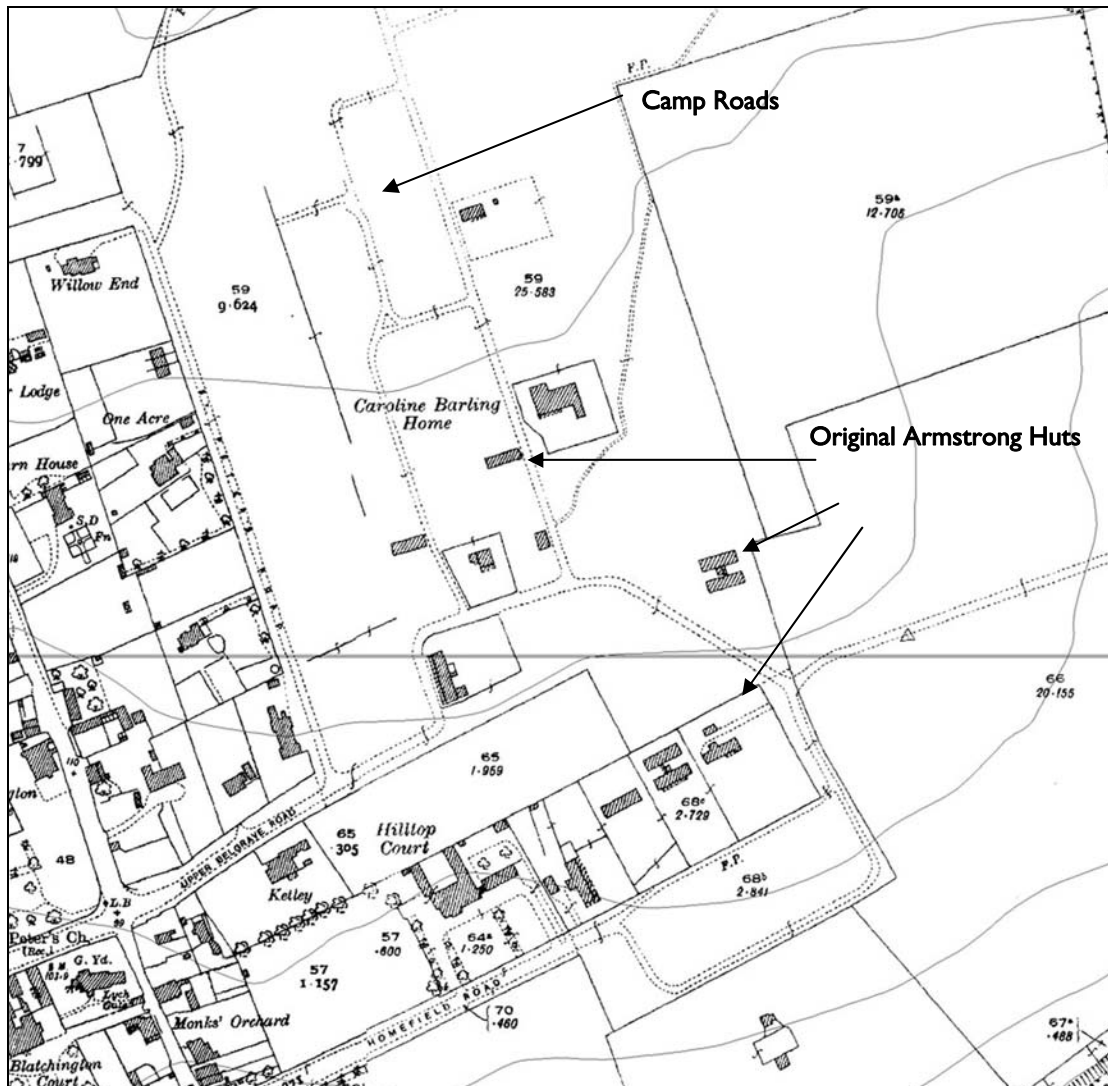
Fig 26: The 1927 1:10,560 Ordnance Survey map shows part of the road layout of North Camp preserved in East Blatchington. Original Armstrong Huts have been reused as dwellings and as the Caroline Barling Home (© and database right Crown Copyright and Landmark Information Group Ltd (All rights reserved 2010). Licence numbers 000394 and TP0024).

In the same manner in which local field boundaries and roads became part of the camps some of the camp roads were incorporated into the future layout of the new housing estates. Roads were hard to remove and useful assets in their own right therefore it was quite common for the roadways of military camps to be preserved in town layouts (Foot, 2005, 9). For example, North Way follows a North Camp route as does the appropriately named North Camp Lane and Northfield Drive. South Camp's layout was partially preserved in Chyngton Road, Fairways Road and Rodmel Road.

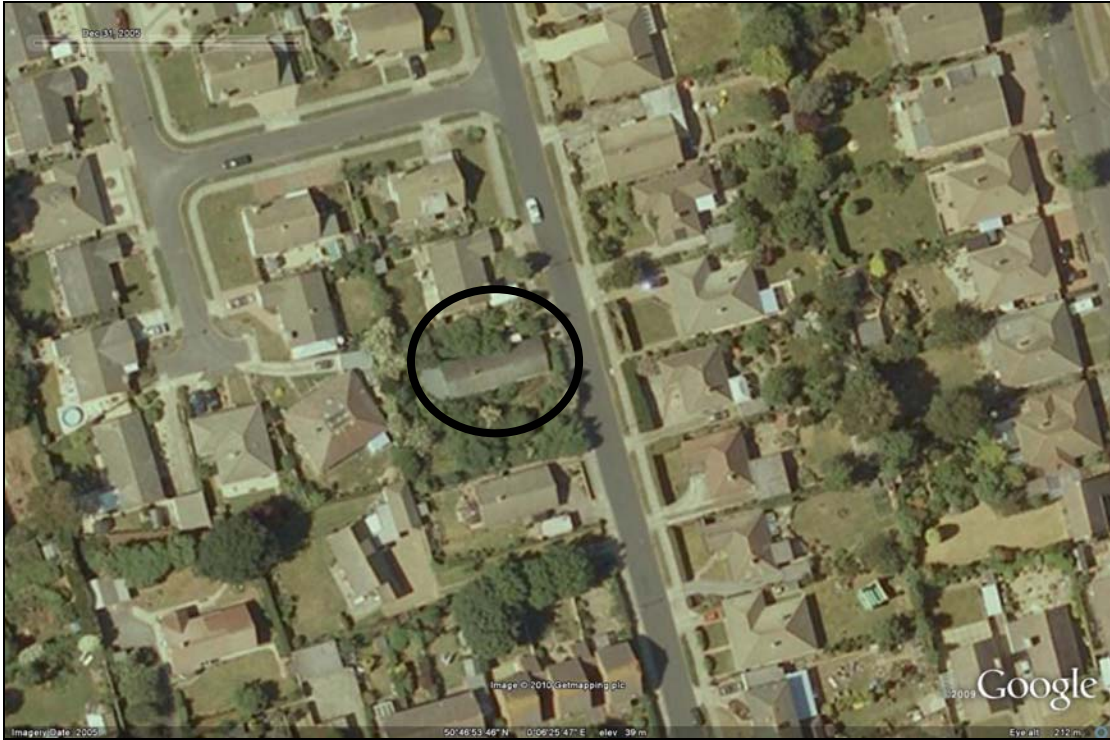
Fig 27: A 2005 aerial photograph showing the last surviving hut, now demolished, of North Camp. © 2009 Google, Image © 2011 Getmapping plc.

The addition of gardens also suggests that some of the huts were sold as private dwellings creating a sparsely occupied district of homes amidst the remains of North Camp. This area was developed in the 1960s but one such dwelling survived on North Way up until at least 2005 where it is visible on Google Earth (Fig 26). Unfortunately, the hut was demolished between 2005 and 2009, replaced by a modern suburban building.
