# CHURCH OF ALL SAINTS, EDINGTHORPE, NORFOLK TREE-RING ANALYSIS OF NAVE ROOF TIMBERS

## SCIENTIFIC DATING REPORT

**CHURCH OF ALL SAINTS,  
EDINGTHORPE,  
NORFOLK**

**TREE-RING ANALYSIS OF NAVE ROOF TIMBERS**

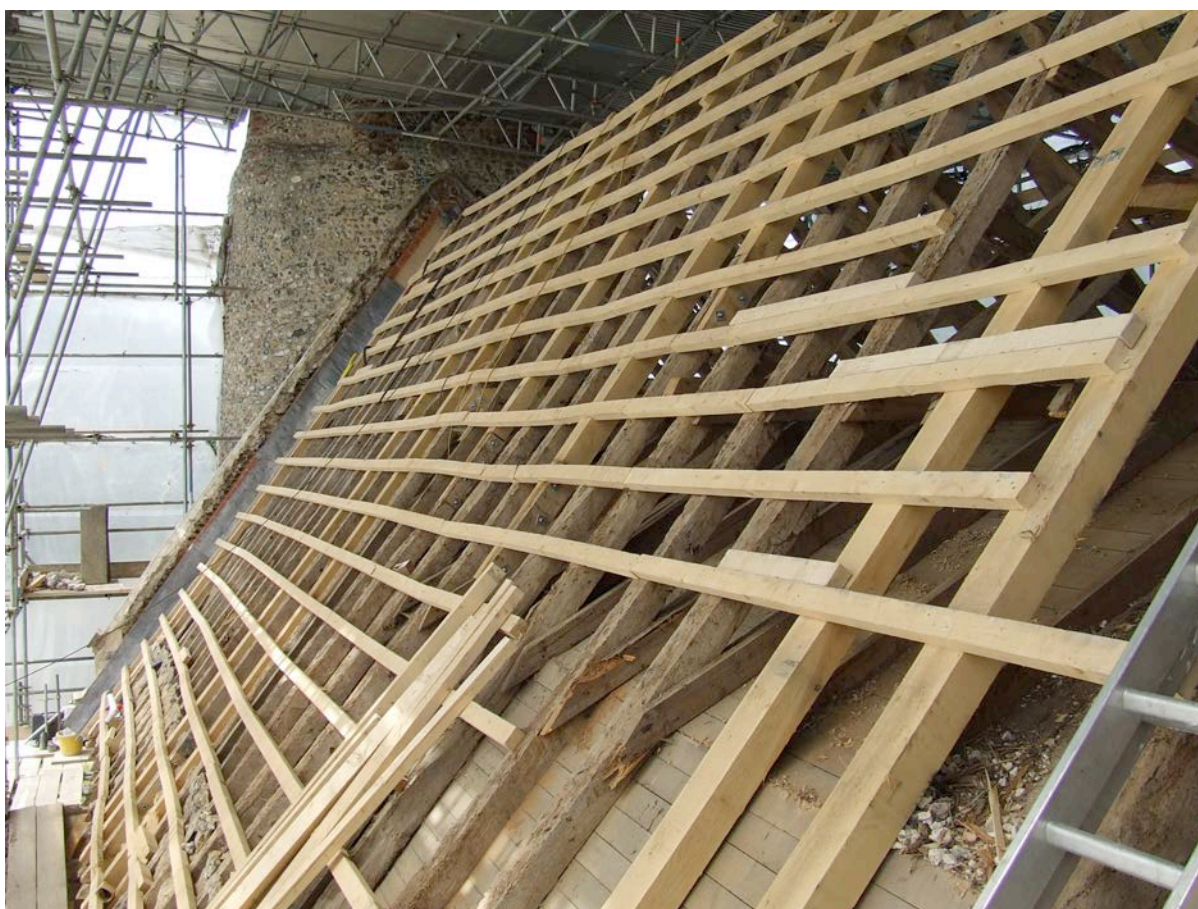
*Figure 3. Photograph of the south side of the nave roof at the time of sampling, showing the small scantling of the rafters and braces*

Basic information about the samples taken is presented in Table 1. Five cores were taken from the most promising looking rafters on the north side of the nave roof. Only one of these contained sufficient numbers of rings to make further analysis justified, and subsequent assessment of timbers on the south side suggested that none of these were likely to be any better, and coring was halted. Six cross-sectional slices were taken from timbers stacked in the working area in the churchyard. One of these when cleaned up was also found to have too few rings for useful analysis. The remaining five slices were all measured. Cross-matching was only found between two series, edgS01 and edgS04 ( $t = 4.4$  with 115 years of overlap). These two series were combined to produce a new sequence, edgS41m. Neither this, nor any of the other measured series gave consistent acceptable matches when compared with the dated reference material, and all the timbers therefore remain undated.
