# ARTHUR'S HALL, DOVER CASTLE, KENT ANALYSIS OF THE BUILDING

## HISTORIC BUILDINGS REPORT

**ANALYSIS OF THE BUILDING**

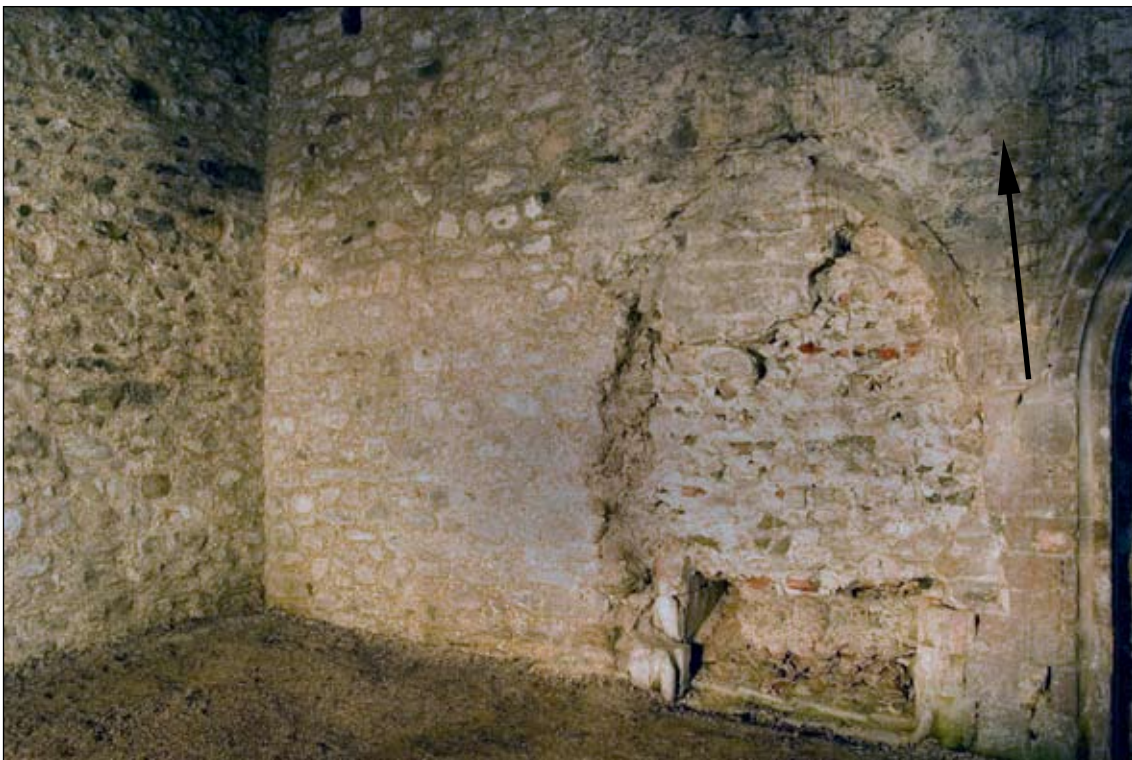
Figure 3. Line of voussoirs and stonework patch above service doorways

The south-east wall of Arthur's Hall, which contains three service doors from the 1238-40 campaign, retains some evidence of an earlier arch. (Fig. 3) In the wall above and between the left service door and the central one, there are seven voussoirs of a plain arch, probably from around the outside of a narrower opening. The presence of this feature suggests that a significant part, if not all, of the south-east wall predates 1240. Further support for this assertion is provided by the area of stone work above the central of the three arches. The rubble in this area has been disturbed, apparently when the arch of the service door was inserted.

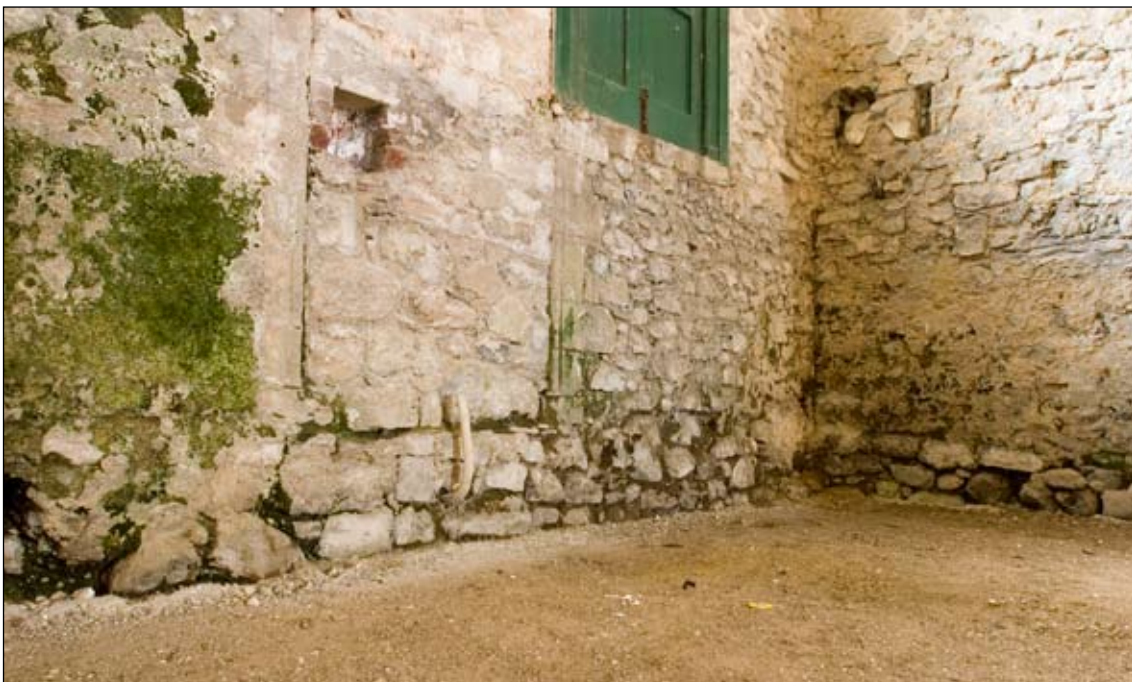
Figure 4. Line of stonework beneath 13th-century doorway where dais was located

There is clear evidence of a dais in the fabric of Arthur's Hall. There appears to be a slight thickening of the wall at the level below the blocked door in the north end of the south-west wall of the hall. (Fig. 4) This setback exists from a short distance to the south-east of the blocked door opening and continues to the north-west wall of the hall and along this end wall up to the inserted fireplace. Less evidence exists at the other side of the upper end of the hall. There is no obvious projection as this wall, part of the Inner Bailey defences, predated the construction of the hall. However, there may be stones aligned from north-east to south-west that may represent the front of the dais. The base of the door in the south-west wall and the level of the setback suggest that the dais was 0.48m high above the current floor level, therefore approximately 0.6m above the likely 13th-century floor level.

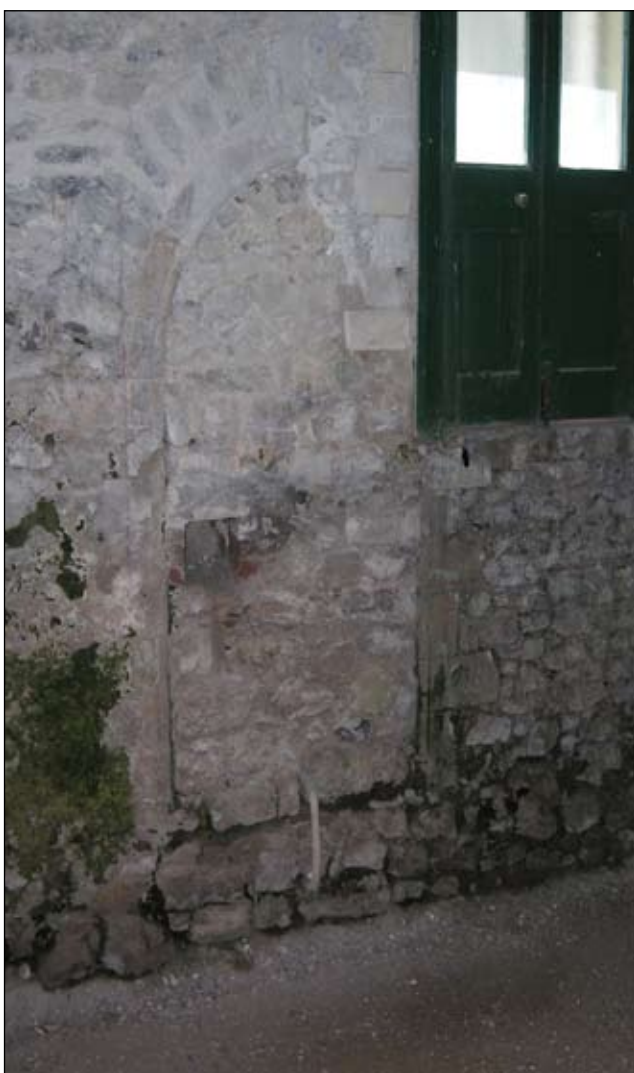
Figure 5. Blocked doorway at upper end of hall

Part of the evidence for the dais is supplied by the blocked doorway in the south-west wall of Arthur's Hall. This arch is roll-moulded around the inside face and its overall height is 2.3m: 0.10m higher than the central service door. (Fig. 5) While its position 0.48m above the current floor level proves the existence of a dais, its position, opening on to the front of the dais is unusual. (Fig. 6) In conventional halls, the communication with buildings attached to the upper end would usually be through the end wall, or in the corners of the side walls, or by the cross passage. Excavations in the 1960s revealed the stub end of a medieval wall projecting from the south-west wall of the hall, just beyond where the door on to the dais existed.<sup>25</sup> There is no evidence of this wall above ground today, so any assessment must be speculative. However, it could be a remnant of a pentice or passage running from the hall north-westwards to the adjacent chamber. On 29 August 1240 a reference was made to a passage from the 'King's new hall of the castle to his chamber', and this seems to match the location of this proposed passage. An excavation in 2008 revealed that a part of this wall may have projected into the interior of Arthur's Hall.

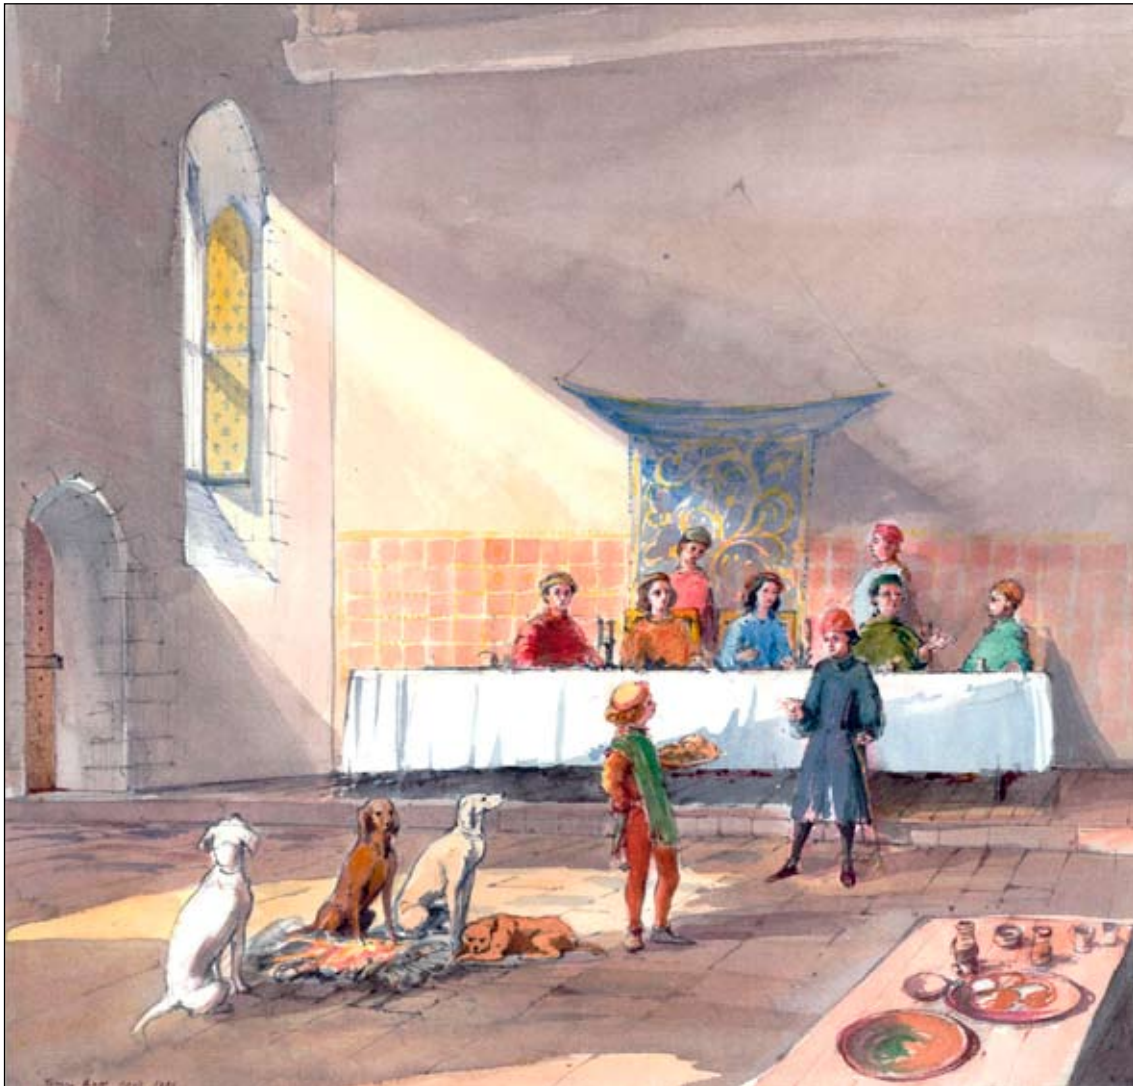
Figure 6. Artist's impression of the upper end of the hall

windows. The remains of the south-west wall, uninterrupted at its base, would not contradict the existence of such windows. The most likely form of the window would be a plate tracery design of two trefoiled-headed lights with an oculus or quatrefoil above. An illustration of the upper end of the hall shows a window lighting the dais, in the position of the current door. (Fig. 6) There is no archaeological evidence to support this.

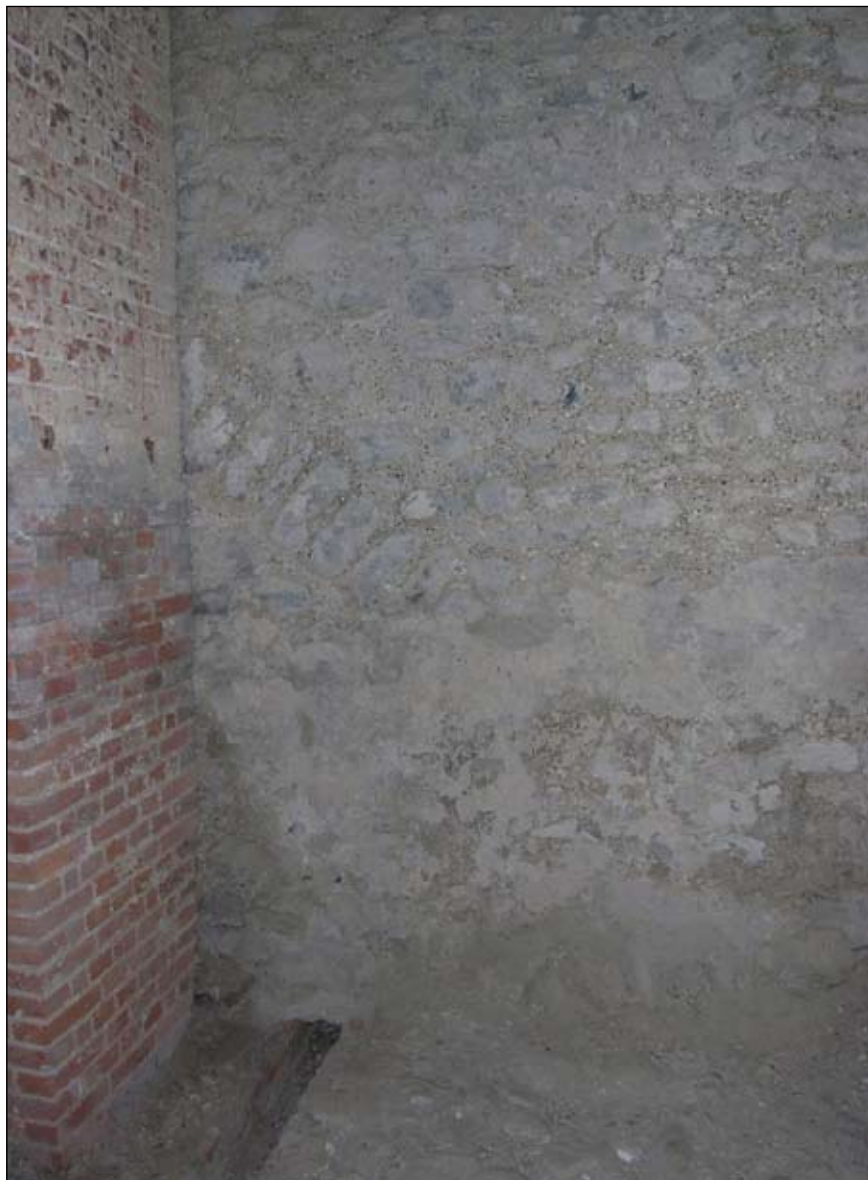
*Figure 7. Line of voussoirs at upper end of hall*

Regarding heating, an open fire towards the upper end of the hall is the most common arrangement in the first half of the 13th century. There is no evidence of any fireplace in the early fabric, but in the north-eastern part of the north-west wall there is some evidence of what might have been a low wide arch. Seven crude voussoirs arranged

diagonally appear to the right of the inserted fireplace. (Fig. 7) However, these stones are in a straight line, rather than being curved and the opening would have been very wide. An alternative explanation is that these stones relate to a later flue arrangement going into the inserted fireplace.

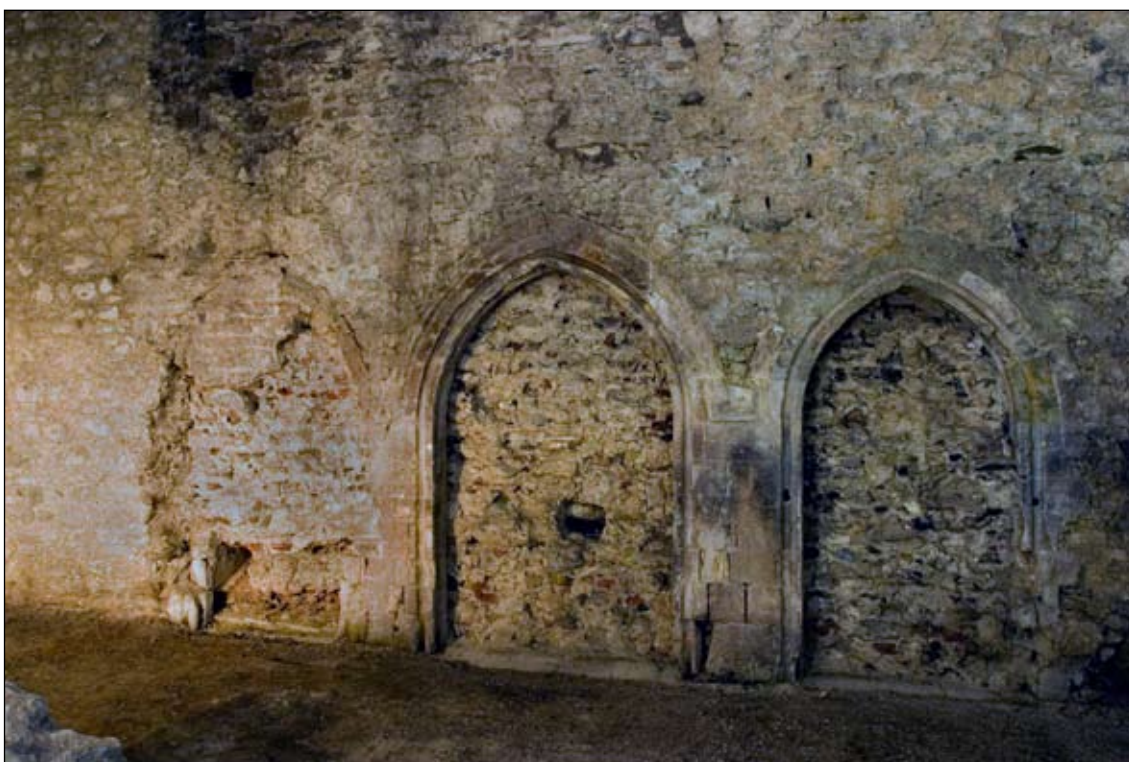
*Figure 8. Service doorways at lower end of hall*

The south-east wall of Arthur's Hall retains three arches that once opened from the hall to the services (that were located on the site of the current building containing the former AV room & education room). The tall, central arch is 1.59m wide and 2.2m high, and is flanked by two doorways 1.03m wide and 2m high. (Fig. 8) The left jamb of the left doorway has largely disappeared, but sufficient survives to establish this door's width. The three doorways are likely to correspond with the buttery, pantry and a central, wider passage providing access to a kitchen. Butteries and pantries did not have to be particularly large and the area of the AV building beyond the south-east wall of Arthur's Hall would have been more than adequate.

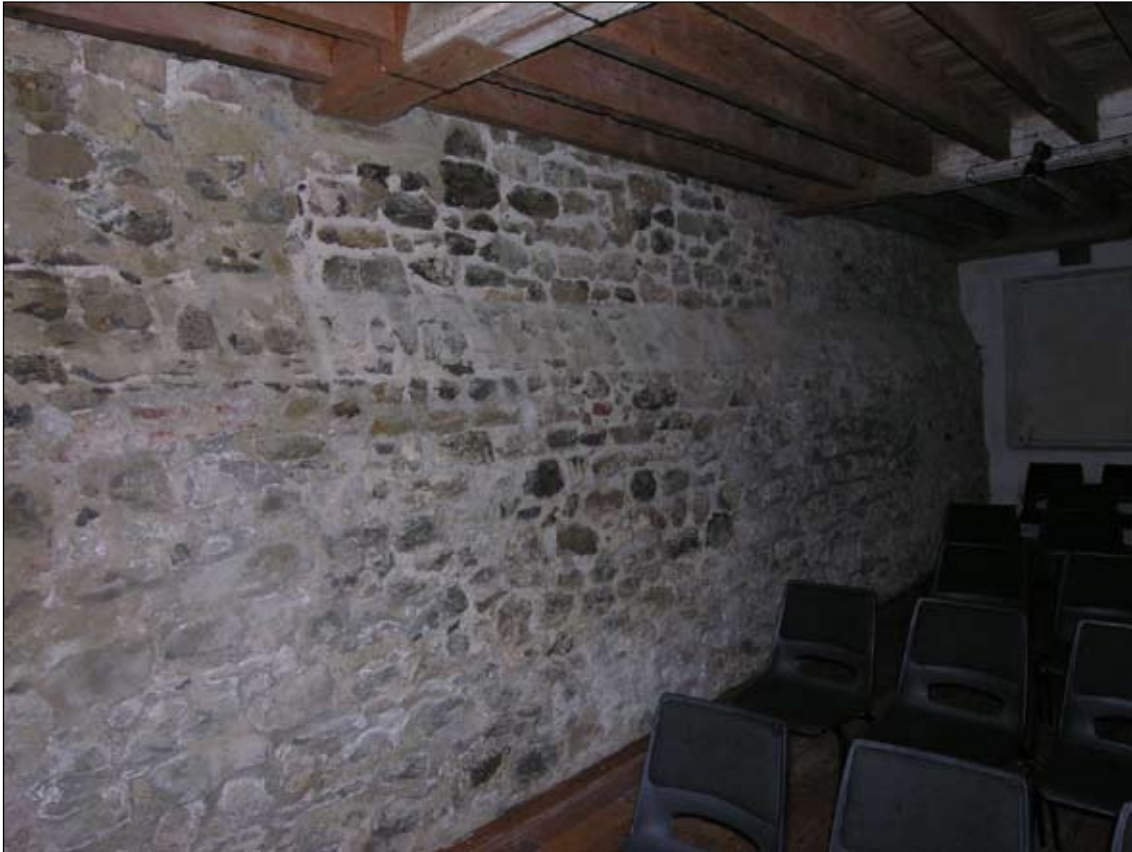
*Figure 9. Battered wall on inside of AV room (former external face of kitchen wall)*

of batter found on walls that were meant to be external. (Fig. 9) However, this supposed 'batter' is actually a rectangular setback that has had an angled face created to smooth the transition from one wall thickness to the thinner one above. Does this indicate that the lower, thicker wall predates the slightly thinner, upper part?

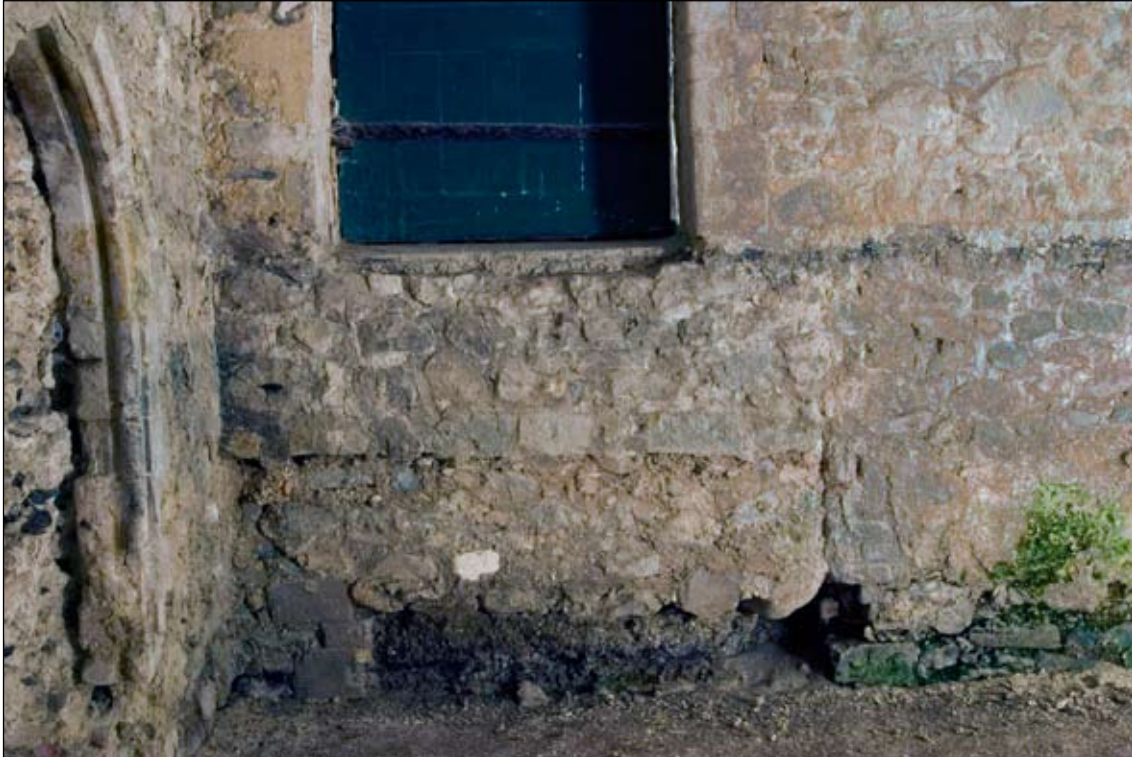
Figure 10. Joints marking site of 13th-century doorway

In the south-eastern end of the south-west wall there are the remains of a door at 13th-century floor level, immediately below the later, higher door. (Fig. 10) There is a straight joint 0.92m high located 2.12m from the south-west corner of the hall. This crude

caesura seems to mark where the jamb of a door has been removed. Closer to the corner there are three haphazardly-arranged dressed stones, perhaps providing a hint of where the other jamb was located. A shaped medieval stone has been set into this infilling. In the front wall of the former AV building there is a 13th century moulded arch set on 18th-century jambs, entering the area of the porch in front of Arthur's Hall. Could this be the reset arch of the main door into the hall?

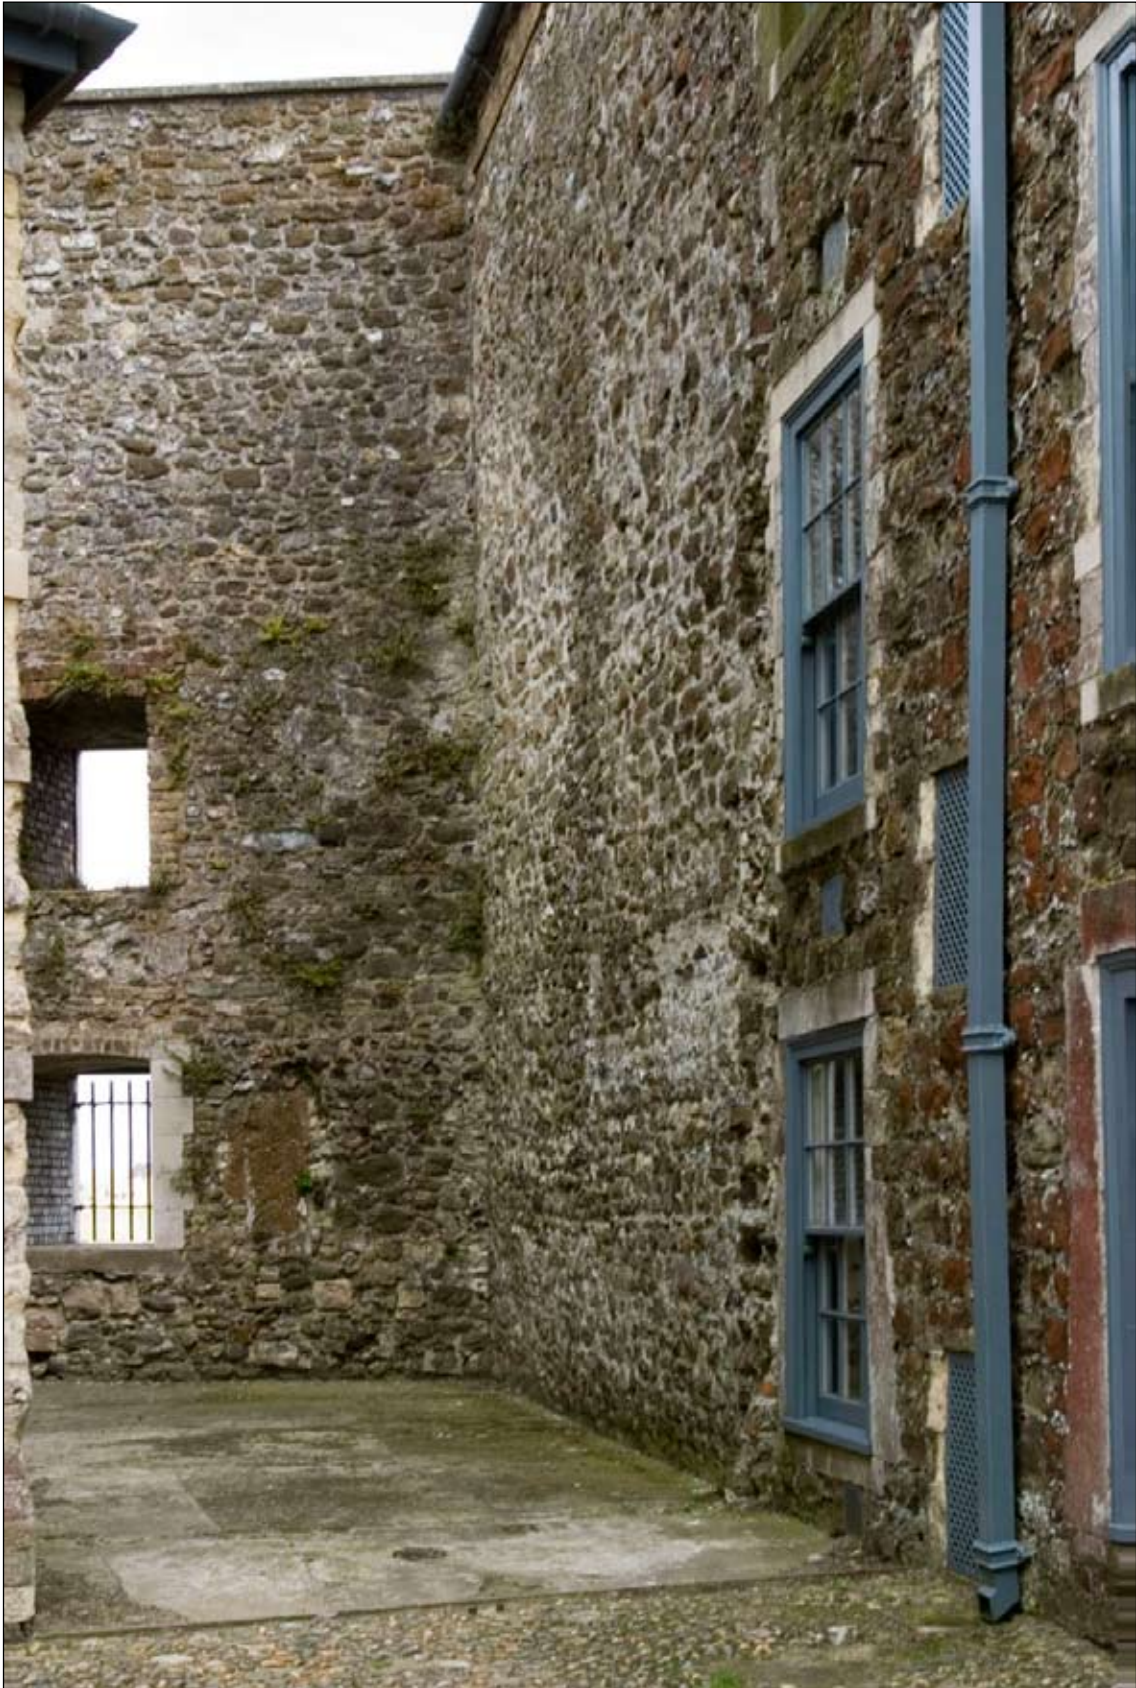
*Figure 11. Site of former building interior (to left of sash windows)*

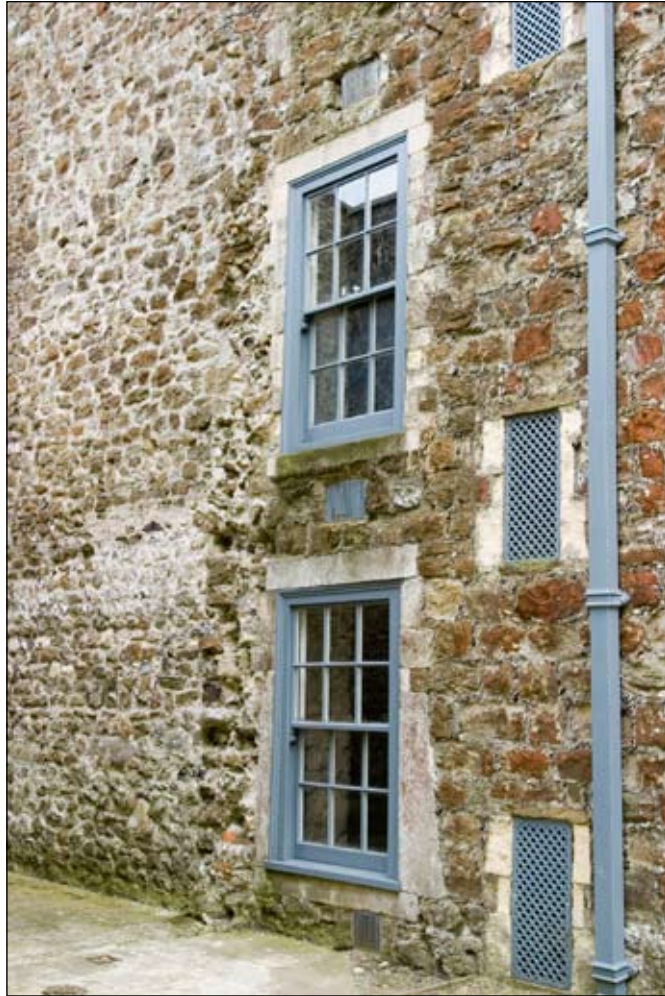
*Figure 12. Vertical scar of former front wall of building, in south east corner of Inner Bailey*

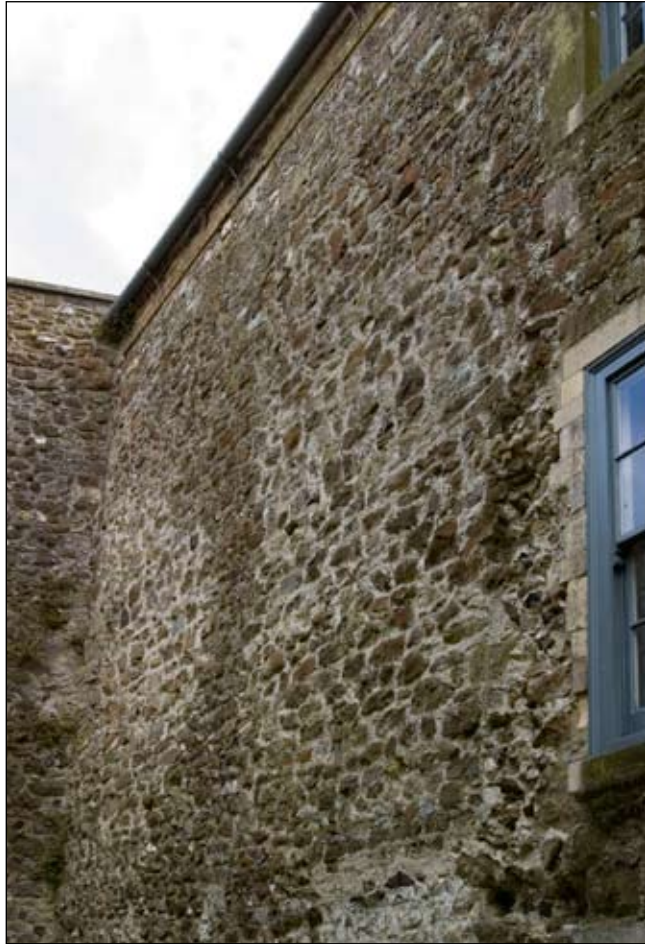
*Figure 13. Outlines of roof line and former central division in upper storey*

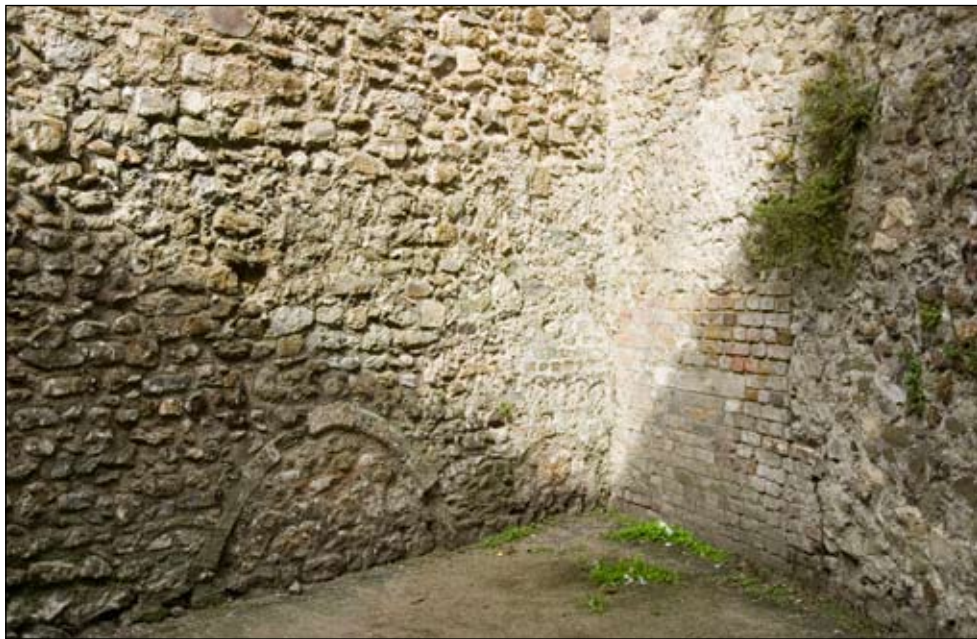
*Figure 14. Blocked arches in corner of possible 'kitchen' at 13th-century floor level*

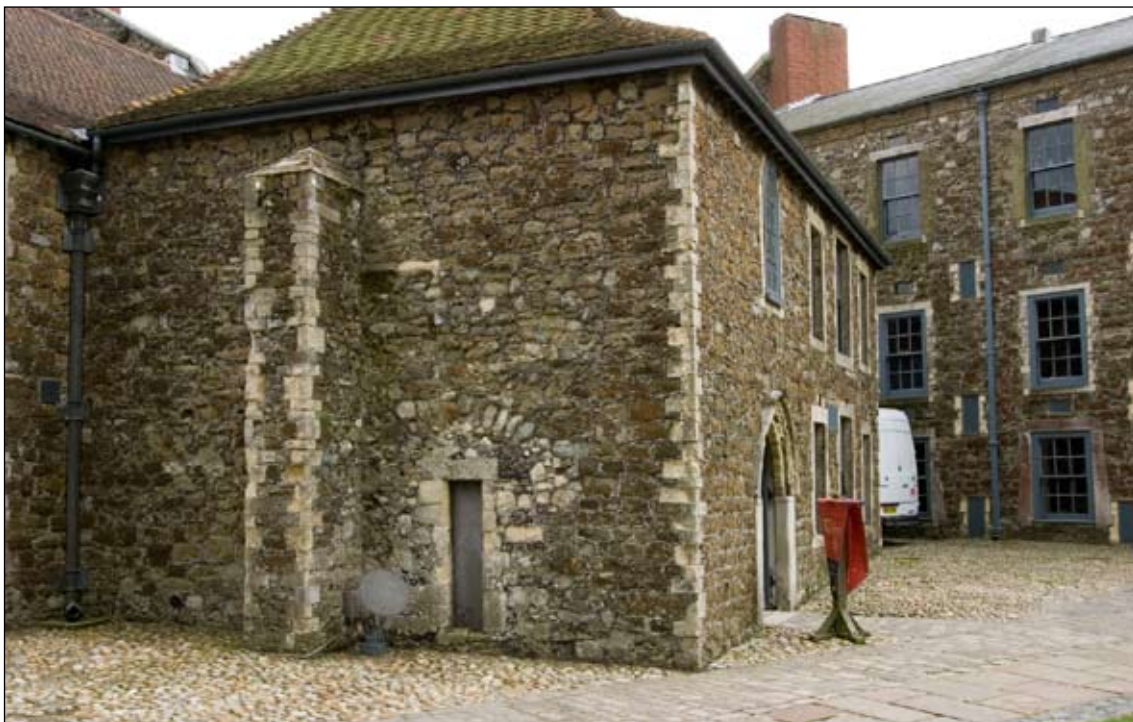
*Figure 15. North-west wall of AV Building showing 'buttress' and remains of blocked arch into porch set in medieval walling with more regular, 18th-century fabric above*

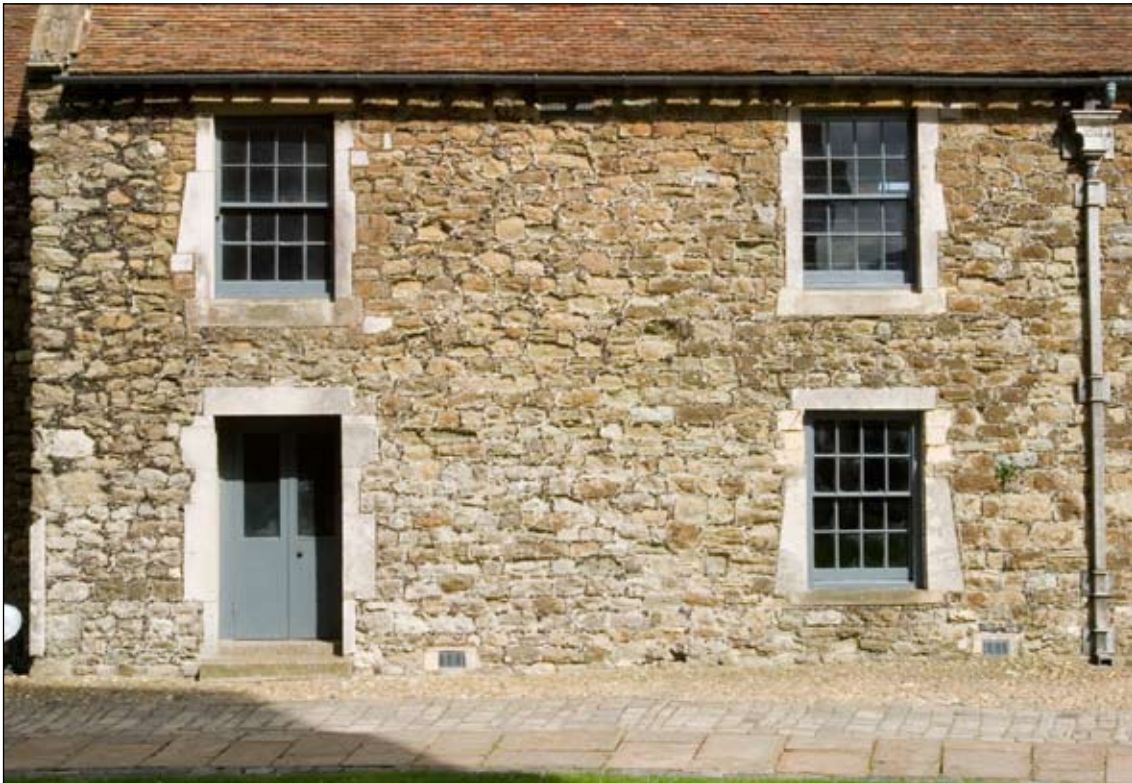
*Figure 16. Joint between regular 18th-century fabric and medieval rubble, to left of right-hand sashes*

This wall contains two clear phases and there is evidence of a similar break in the south-west wall of Arthur's Hall. Most of the wall is built in regular coursed stonework with galleting, but at the north-west end of the wall, between the two westernmost sets of sash windows, there is a change in the stonework to more irregular rubble with galleting. (Fig. 16) This type of stonework continues around on to the north-west gable wall of the Arthur's Hall. The location of the patch of apparently earlier fabric on the exterior accords with the evidence of the early stonework on the interior. The door on to the dais is important as it indicates where 13th century fabric survives in the south-west wall of the hall. (Fig. 17) However, to the south-east (left) of this arch there is a slight, but significant change in wall thickness. There is a setback in the wall 1.3m above the 13th century floor level. Above this position the upper part of the wall is set back by approximately 0.05m. This set back runs from just beyond the 13th century door, approximately 4m from the north-west wall, to around 14.4m along the inside of the south-west wall. Thereafter the setback ends, but the lower parts of the wall still seem to date from the 13th century.

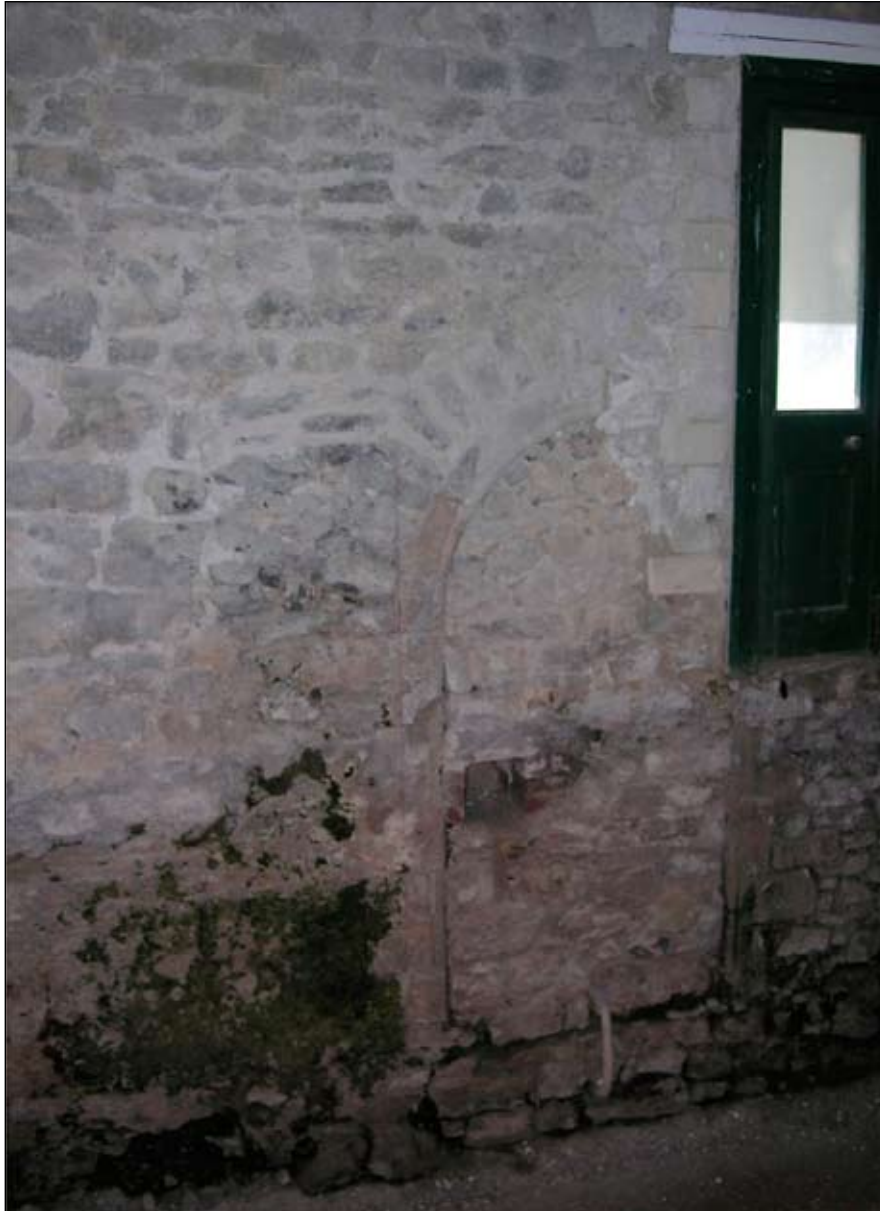
*Figure 17. 13th-century fabric around door on to dias*

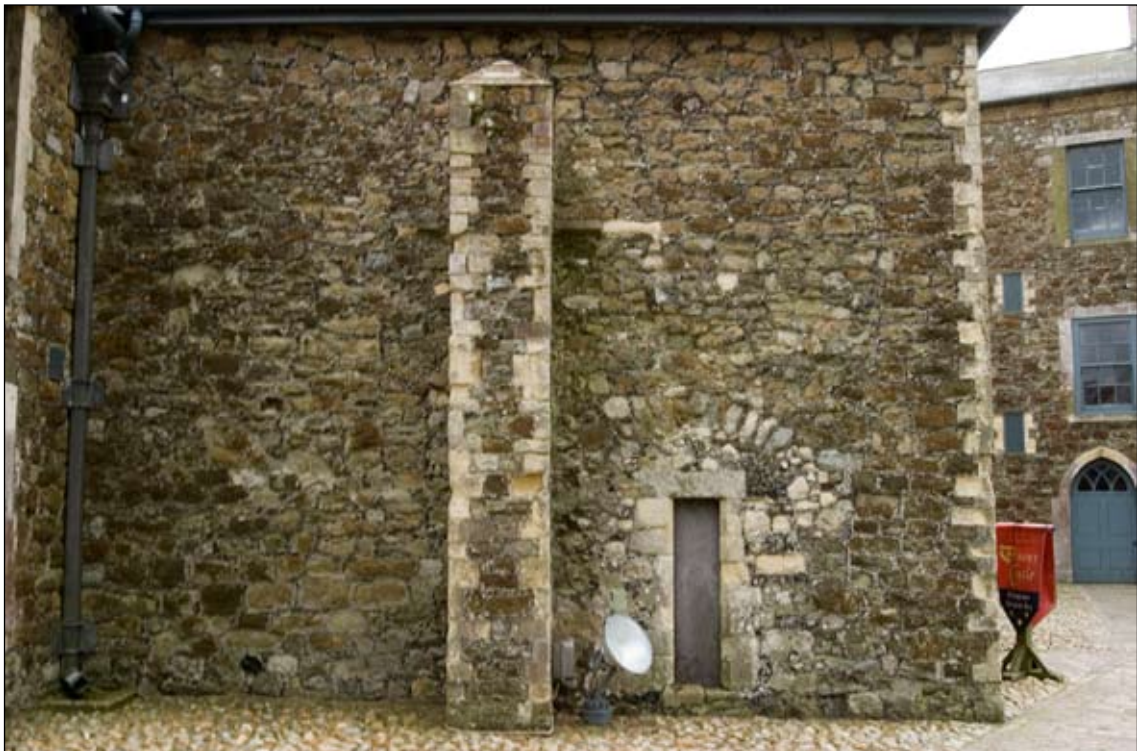
Figure 20. North-west wall of AV Building showing 'buttress' and remains of blocked arch between pentice and 'porch', now incorporated into the building

wall into the large porch, before entering Arthur's Hall at the raised level. The level and the form of the arch suggest a late medieval date. Was it one of the measures taken by Edward IV while revamping the Great Tower? It seems clear from the reference to 'Caves' in the 1620s that the floor had already been raised by the 17th century.

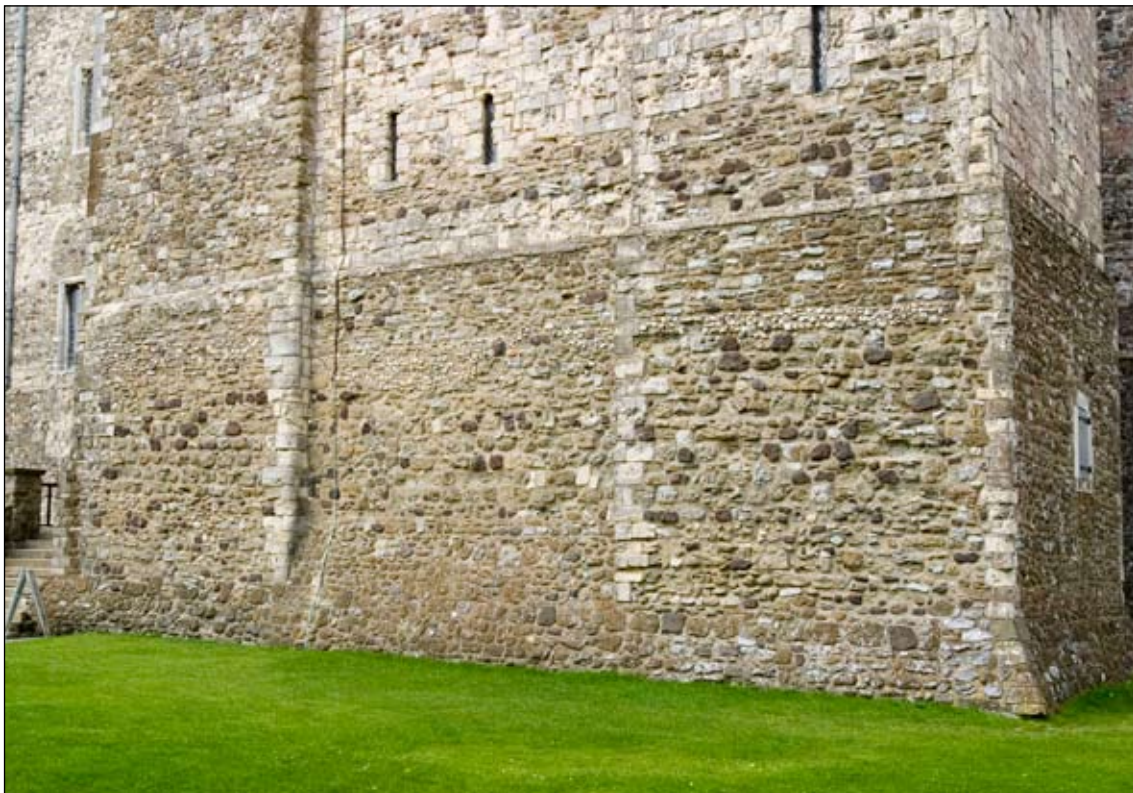
*Figure 21. Line of flints along face of Forebuilding of Great Tower*

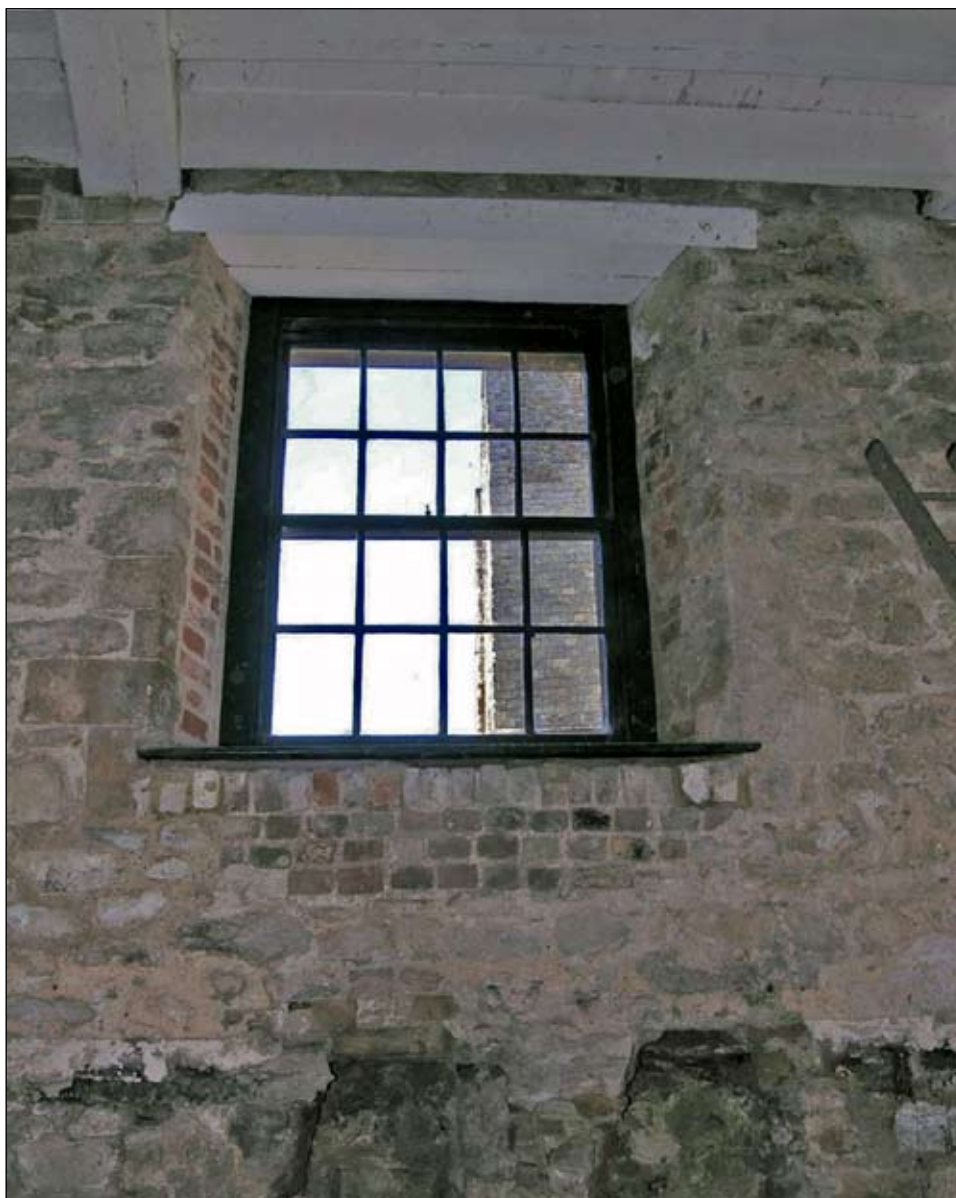
*Figure 22. Sash window in Arthur's Hall showing surrounding patching where the window was inserted into a pre-existing wall*

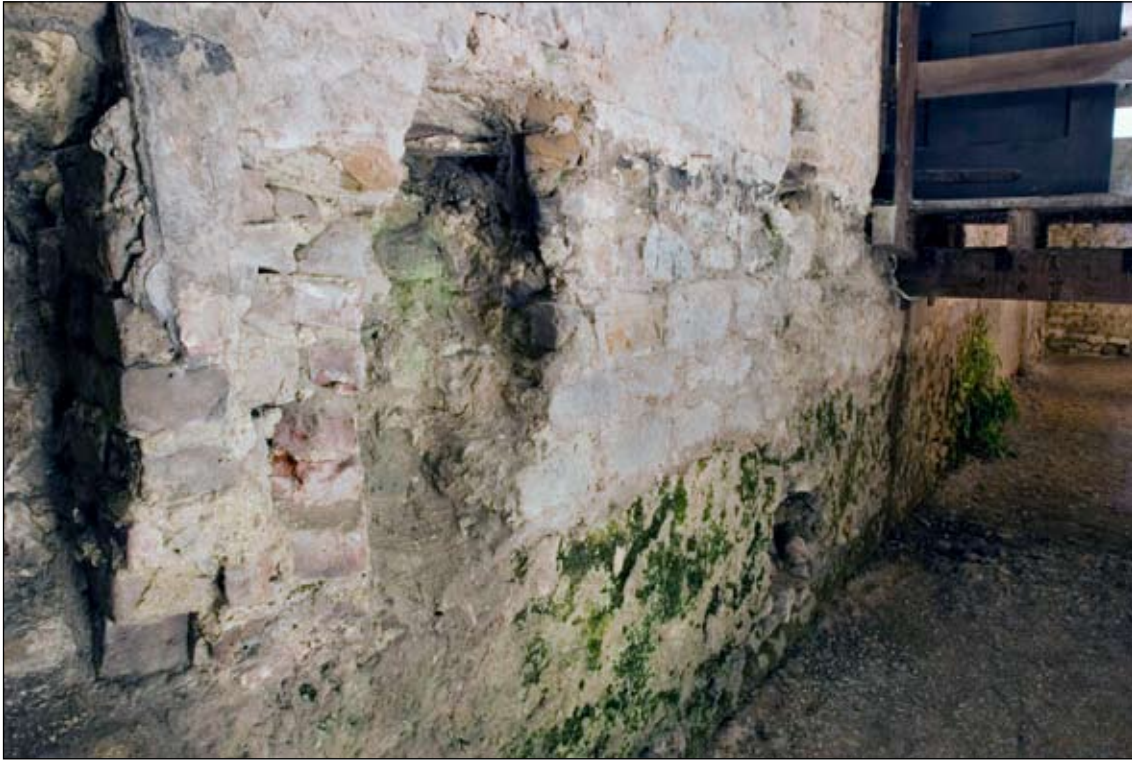
*Figure 23. Layers of fabric from different phases, in the south-west wall of Arthur's Hall. Some 13th-century fabric at base (green), with three courses of possible 15th-century stonework above*

The top section of the main façade predates the mid-18th century, while the bottom part belongs to the 13th century and there are traces of another phase of construction in the south-west wall, sandwiched between. (Fig. 23) This is most obvious to the left (south-east) of the current door, just below the modern walkway. A short stretch of wall, three courses high, is slightly thicker than the later walling above. Is this the only trace that has survived of Edward IV's work on the buildings?

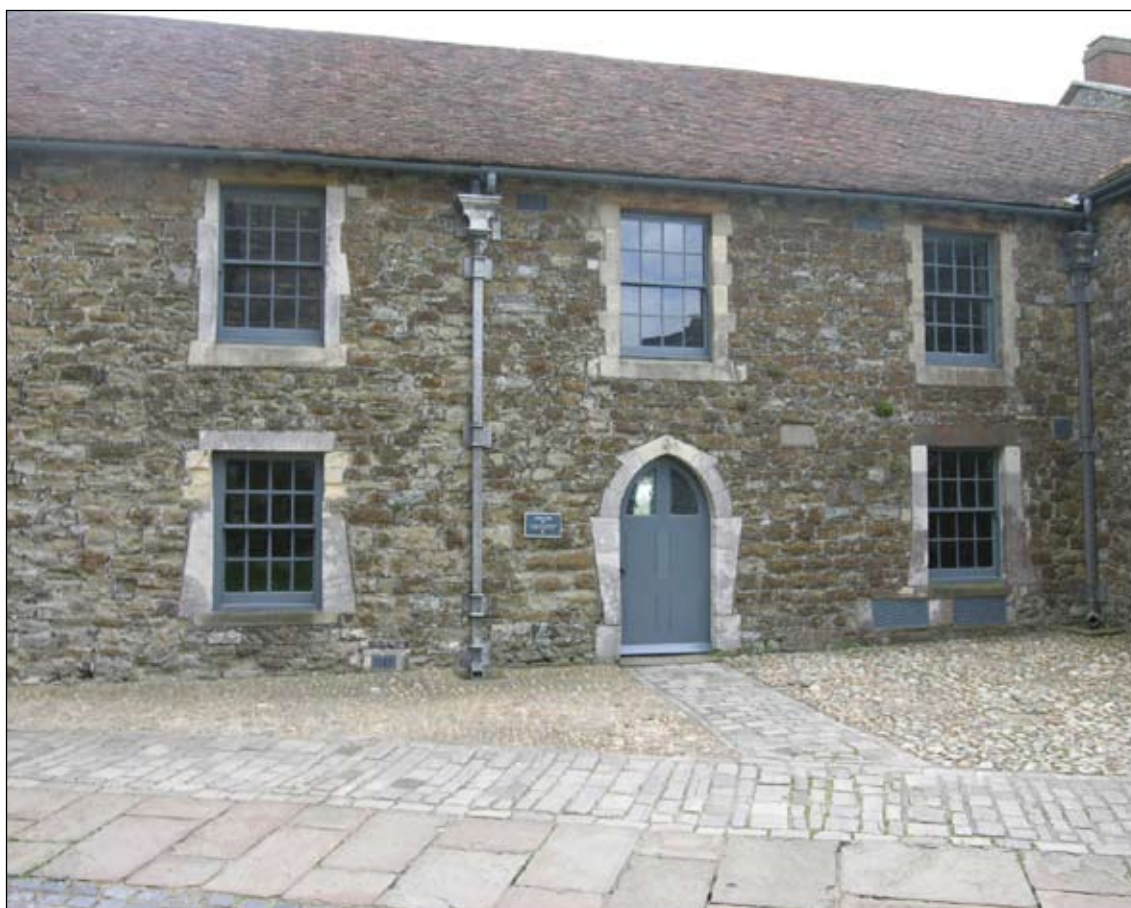
*Figure 24. External face of south-west wall of Arthur's Hall. Coursed fabric to right, rubble to left*

In the mid-18th century a series of barracks buildings for officers and ordinary soldiers were created around the inside of the Inner Bailey, through a mixture of new building and adapting existing buildings. Statham writing at the end of the 19th century concluded, erroneously, that 'These buildings were converted into barracks in 1745, and the alterations then made were so extensive as to amount to an entirely new construction.'<sup>30</sup> To cover the haphazard assortment of structures, a uniform external finish was employed in which the joints in the fabric were treated with galetting. Where the external face of a wall was new, usually coursed stone was employed, but where older fabric was being employed without being refaced, the existing rubble was tidied up. The south-west façade of Arthur's Hall exemplifies this twin-track approach, with the north-western end having rubble while the refaced section of the wall was coursed. (Fig. 24)

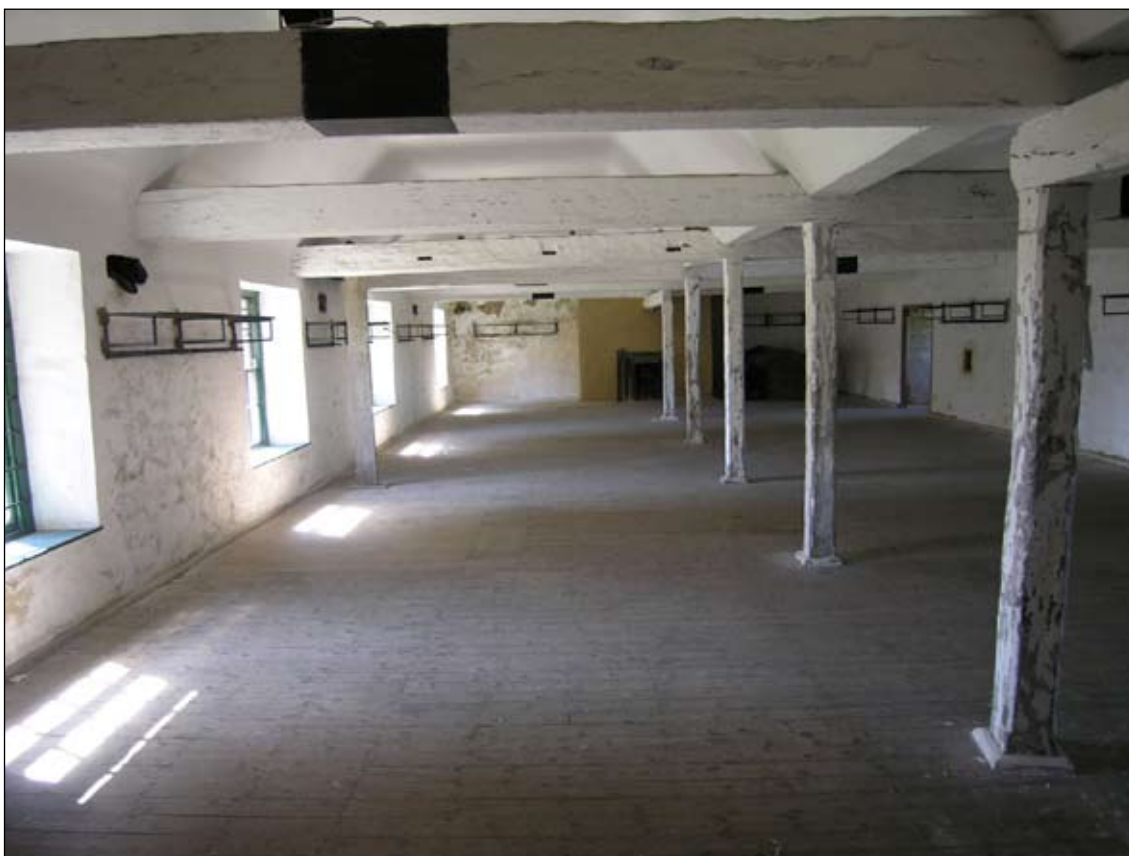
*Figure 25. Upper barracks floor of Arthur's Hall*

A major change to Arthur's Hall in the 18th century was the insertion of a floor to create two stories. The present roof structure consists of two pitched roofs with a central valley. (Fig. 25) The valley is carried on a line of central posts. The roof form is not visible from inside the upper storey. However, inside the upper storey of the AV room the roof

has kingposts with expanded bases and is wholly of pegged construction, suggesting it could date from the conversion into barracks. More discussion of the conversion into barracks is contained in the report on the development of the Inner Bailey.<sup>31</sup>
