# STONEHENGE WORLD HERITAGE SITE LANDSCAPE PROJECT STONEHENGE, AMESBURY, WILTSHIRE ARCHITECTURAL ASSESSMENT

**STONEHENGE WORLD HERITAGE SITE LANDSCAPE  
PROJECT  
STONEHENGE, AMESBURY, WILTSHIRE  
ARCHITECTURAL ASSESSMENT**

NGR: SU 1224 4219

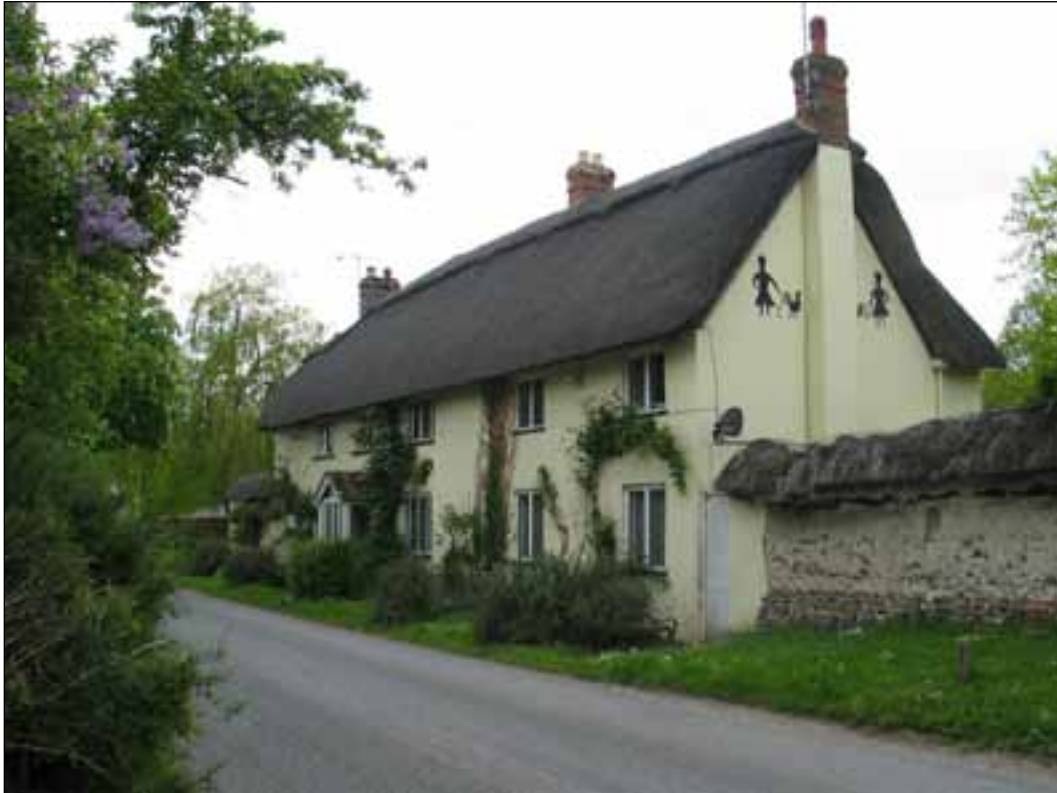
Figure 6. The house now known as *Fighting Cocks*, the earliest parts of which may represent a farmhouse of the 17th century.

century origins, albeit of less ambitious status (Figure 16). It was timber framed, with post and truss construction, possibly with brick used in the gables. It appears to have originally had a three-room plan, comprising a room at either end heated by gable-end chimney stacks and a central unheated service room. At first-floor level the house had a further three rooms, possibly with additional accommodation in the attic storey. Some vertical posts are still visible within the building, although the majority of the wall framing has been concealed by later brickwork added to the rear (west) elevation, and by the later wing added to the east. The roof indicates a three-bay plan, with box-framed partitions still surviving under the trusses and with two tiers of clasped purlins with straight wind braces. 17<sup>th</sup> century houses may be represented by the earliest phases of the farmhouses at Normanton and 'Fighting Cocks' in West Amesbury. The first phase of the Normanton building also appears to have been timber-framed. This phase is now so vestigial that it is difficult to assess its exact form, and the evidence for the timber-framed nature of the earliest phase is apparently only the narrowness of the southern wall of this range where it abuts a later block, as at Countess. Internally no timber-framed elements appear to have been observed by the Royal Commission in their late 1970s survey. The plan form is discernable but as a single-pile three-room plan similar to that at Countess Farm, with an additional bay added to the east soon after the initial construction, but after the encasing of the range in rubble-stone. Fighting Cocks is now rendered and has not been examined internally so the construction material is not readily discernable although a low flint and brick plinth is visible below the render and the render itself could suggest that the building is of timber or cob (see Figure 6).

Fighting Cocks is a house of one and half storeys, rendered, with a brick and flint plinth and a thatched roof (see Figure 6). The earliest parts of the house may be 17<sup>th</sup> century. Straight joints and changes in material in the plinth suggest that originally this formed a small single-pile two-bay house, symmetrically arranged with a central doorway. Extensions to both ends and the rear have taken place over a considerable period, with the first (to the south) of possible 18<sup>th</sup> or early 19<sup>th</sup> century date. An extensive 20<sup>th</sup>-century phase of re-fenestration, coupled with the rendered walls, makes the house difficult to read from external observations. On the west elevation are painted figures with cockerels, these are clearly modern but may indicate the former location of similar figures which were noted earlier in the 20<sup>th</sup> century, and which were mentioned to the Wiltshire Buildings Record surveyor when he visited in 1969.

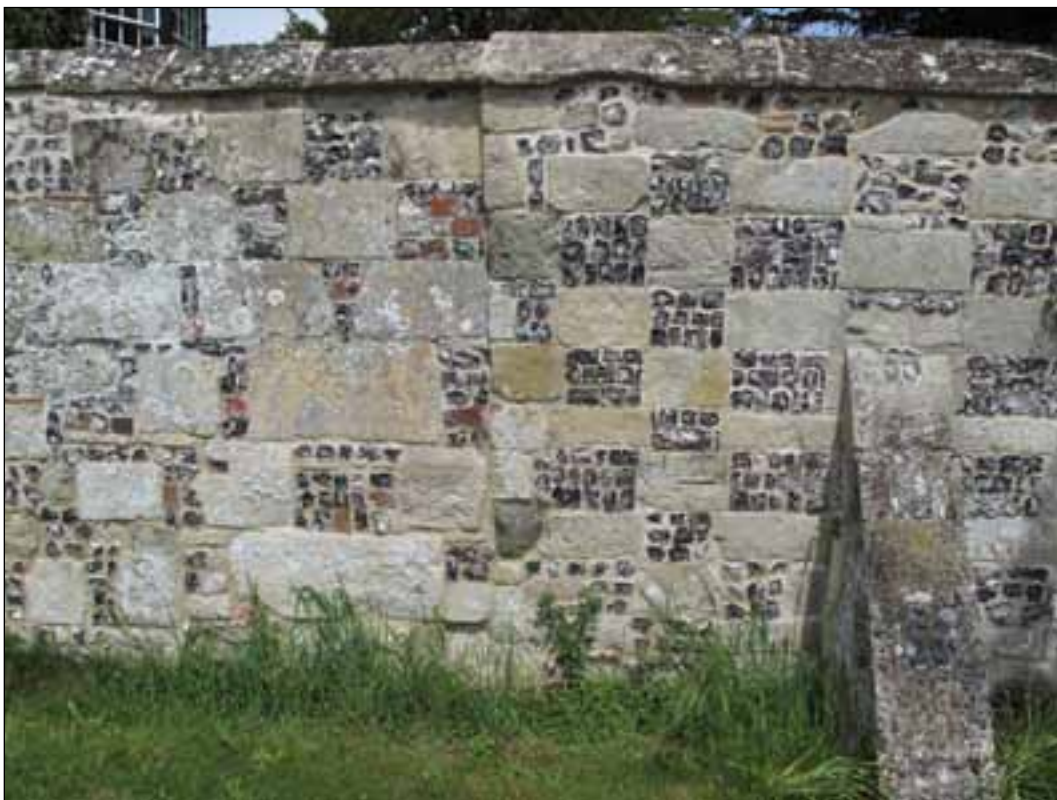
Figure 7. Surviving early flint and limestone chequer work in the garden wall of West Amesbury House

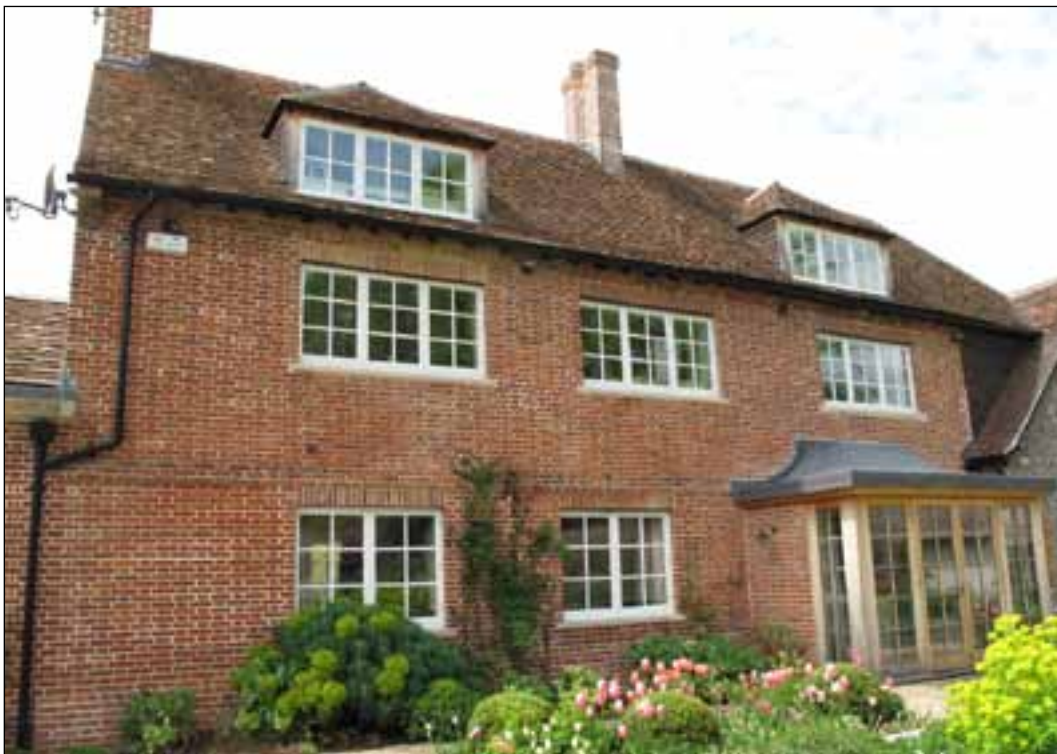
*Figure 8. Moor Hatches, a substantial farmhouse of the early 18th century, possibly attached to an earlier house.*

Large 18<sup>th</sup> century brick farmhouse, two and half storeys running at right angles to the road (north to south), with a low one and a half storey brick and flint range running along the roadside. The VCH believe that Moor Hatches is the 'new farmhouse' mentioned in a document of 1728. Farmhouse has been altered considerably in the 20<sup>th</sup> century, but retains a number of 18<sup>th</sup> century details including plinth, brick band above ground-floor window level, 'dog-tooth' decoration under the eaves and a central chimney stack (see Figure 8). A lower stone range, standing between the main range and the road, includes a canted timber-framed two-storey bay window towards the eastern end of the north elevation. This heavily-altered series of low ranges fronting the road may conceivably represent the remnants of a smaller house of late 17<sup>th</sup> century date. See Figure 8.

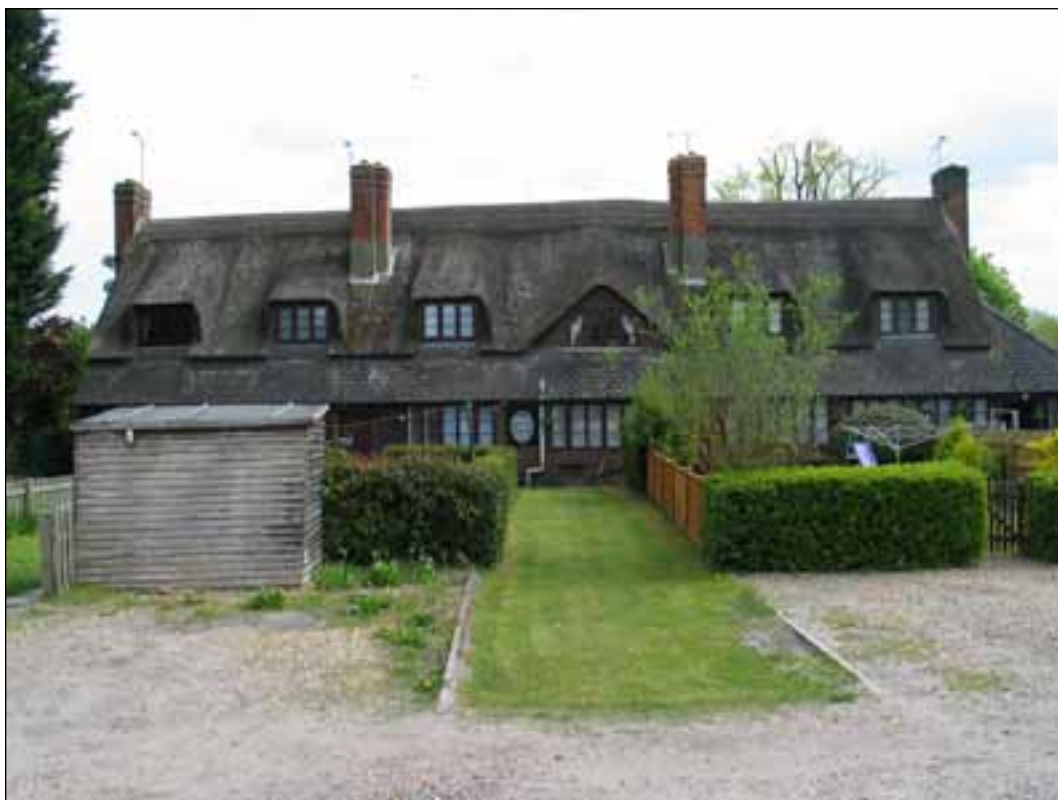
*Figure 12. Barn's End in West Amesbury. A late 18th century aisled barn converted into a terrace of cottages in 1938.*

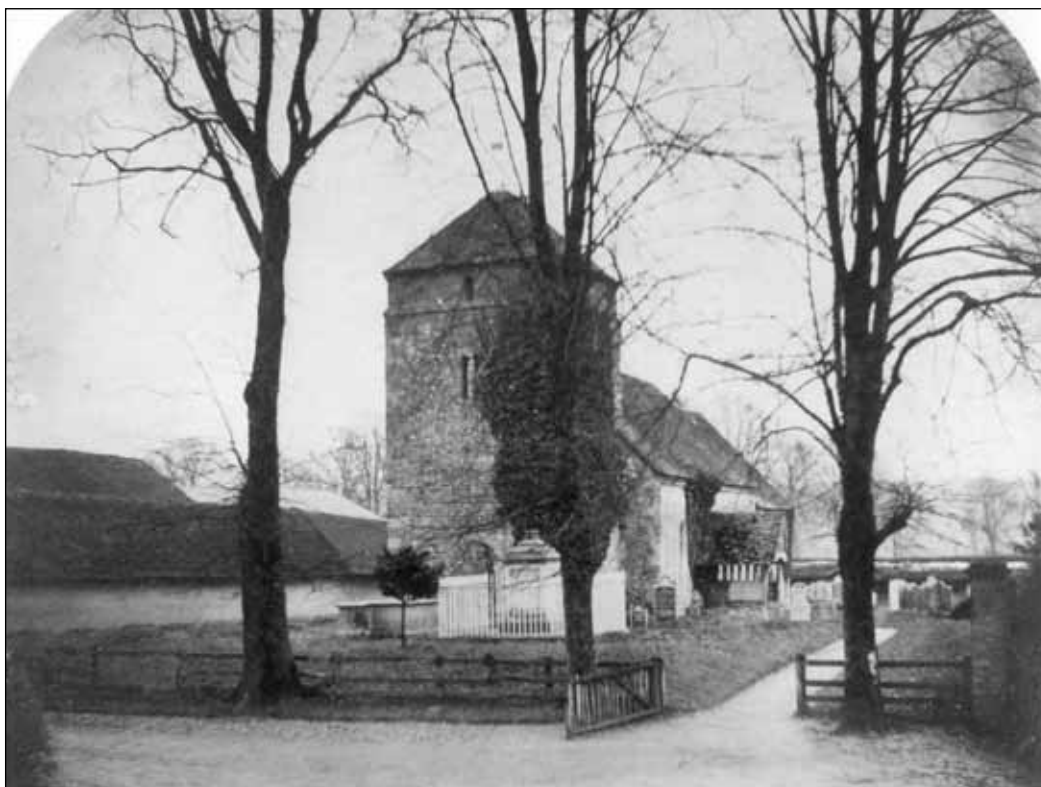
Figure 13. Wilsford Church in 1857, prior to the rebuilding of the nave. Note the farm buildings of Wilsford Farm to the left (Reproduced courtesy of Salisbury and South Wiltshire Museum)

Of the form of the individual houses within the settlements there is little surviving evidence. The only medieval building fabric to survive within the World Heritage Site in a non-domestic building is the tower of Wilsford Church, which is 12<sup>th</sup> century. This is of knapped flint with stone dressings. A photograph of the church taken before the demolition of the original nave (circa 1857), indicates that it was built of the same materials, although partially rendered by the 19<sup>th</sup> century (Figure 13). Stylistically the form of the detailing on the tower has been linked to a number of churches in the area which date to the first part of the 12<sup>th</sup> century, with Wilsford probably late in that period, perhaps mid-12<sup>th</sup> century.<sup>57</sup> The two principal features of this date are the west doorway and the tower arch. The west doorway has single shafts to either side with scalloped capitals, with similar responds and slightly simpler capitals to the tower arch, with stud decoration to the imposts (Figure 14).

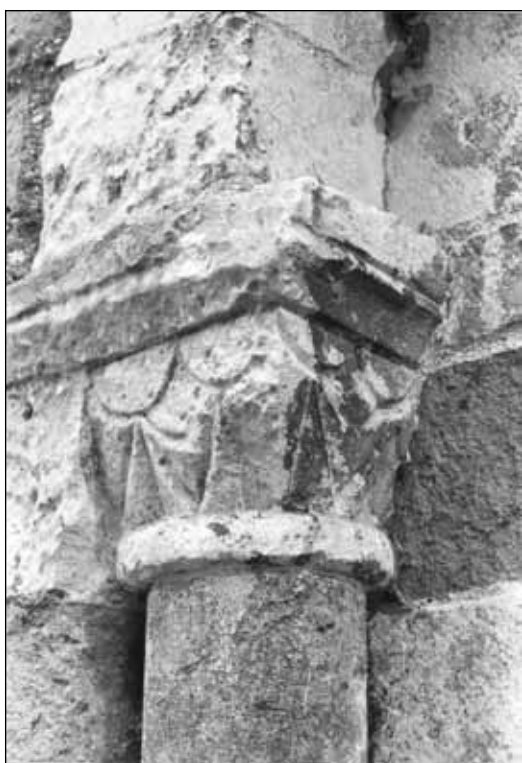
Figure 14. Detail of capital, in the west doorway of Wilsford Church (NMR 9C-23)

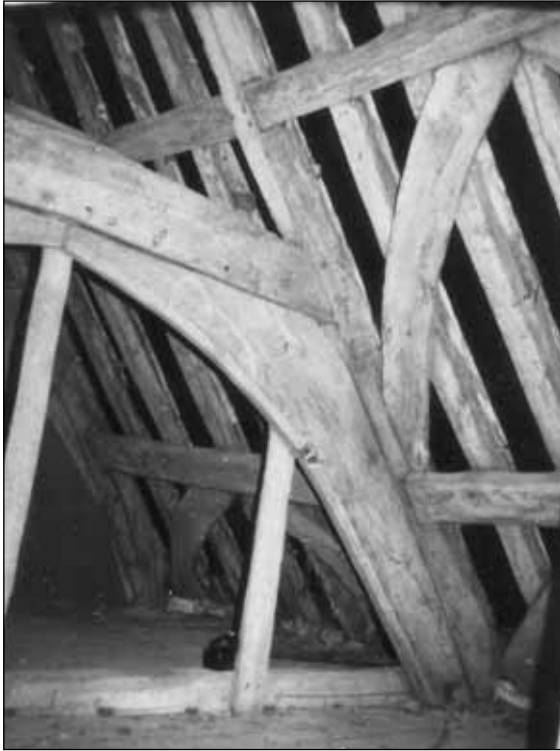
*Figure 15. West Amesbury House medieval roof structure photographed in 1979 (NMR RCHME field photo, file BF50119)*

The only domestic building which retains an identifiable medieval phase is West Amesbury House, the earliest parts of which date to the late 15<sup>th</sup>, or possibly early 16<sup>th</sup>, century. The building was constructed to the north of the main

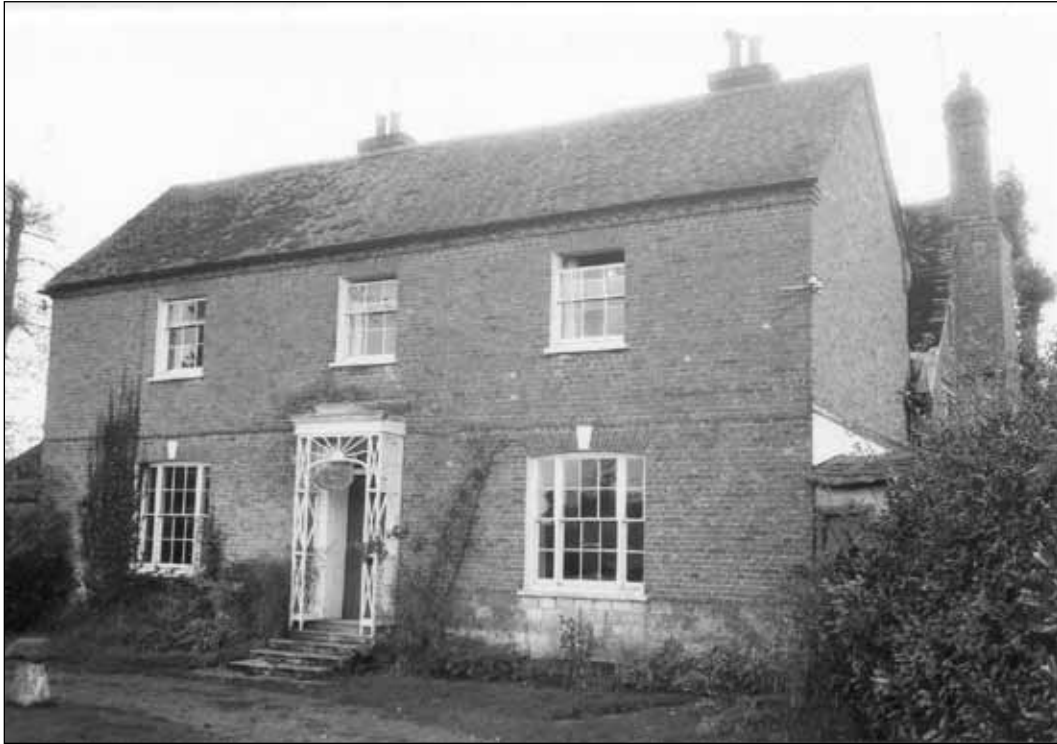
Figure 16. The west front of Countess House, with the earlier house now forming the rear portion of the building (NMR RCHME field photo, file BF50098).

Countess farmhouse is a double-pile house, of which the rear block is a timber-framed building possibly dating from the 16<sup>th</sup> century. The front block (east) was added circa 1800 and is built of brick, with some flint panels. It is two-storeyed with a tile roof (see Figure 16). The earlier timber-framed building is now faced in brick, with gable walls of brick and flint. Internally this appears to have comprised a central unheated service room with a heated room to either end. The later front range is of brick resting on a sarsen plinth, and is symmetrically arranged with a central entrance flanked by the principal rooms.

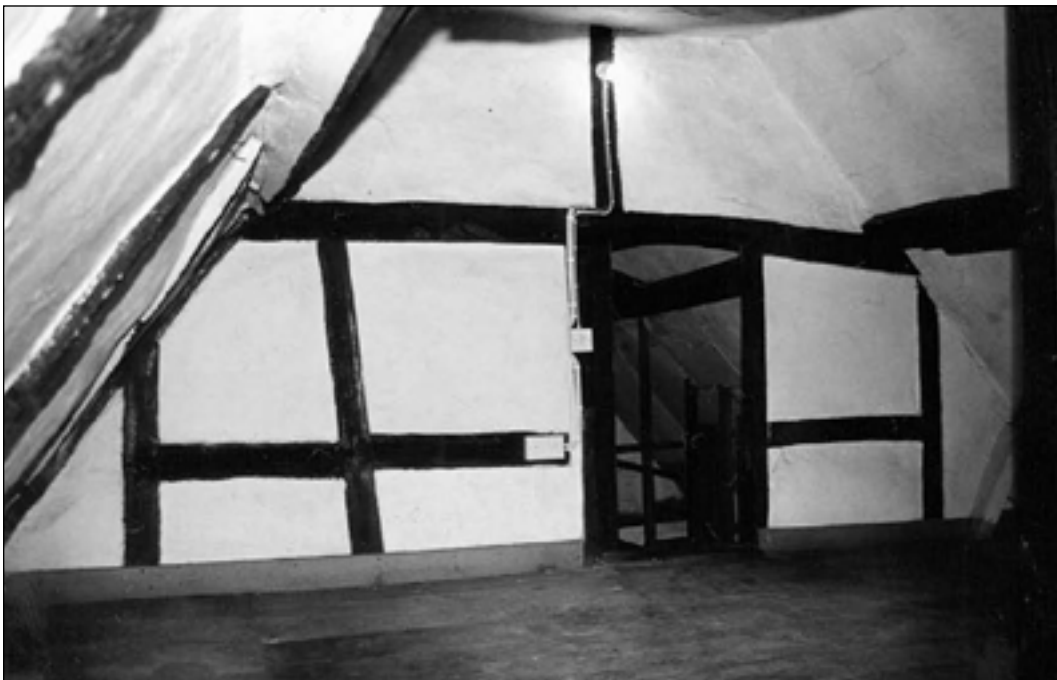
Figure 17. The attic storey of the earlier wing of Countess Farmhouse, showing the box framing of the internal partitions. Such framing may have also formed the original external walling for the house (Reproduced courtesy of the Wiltshire Buildings Record).

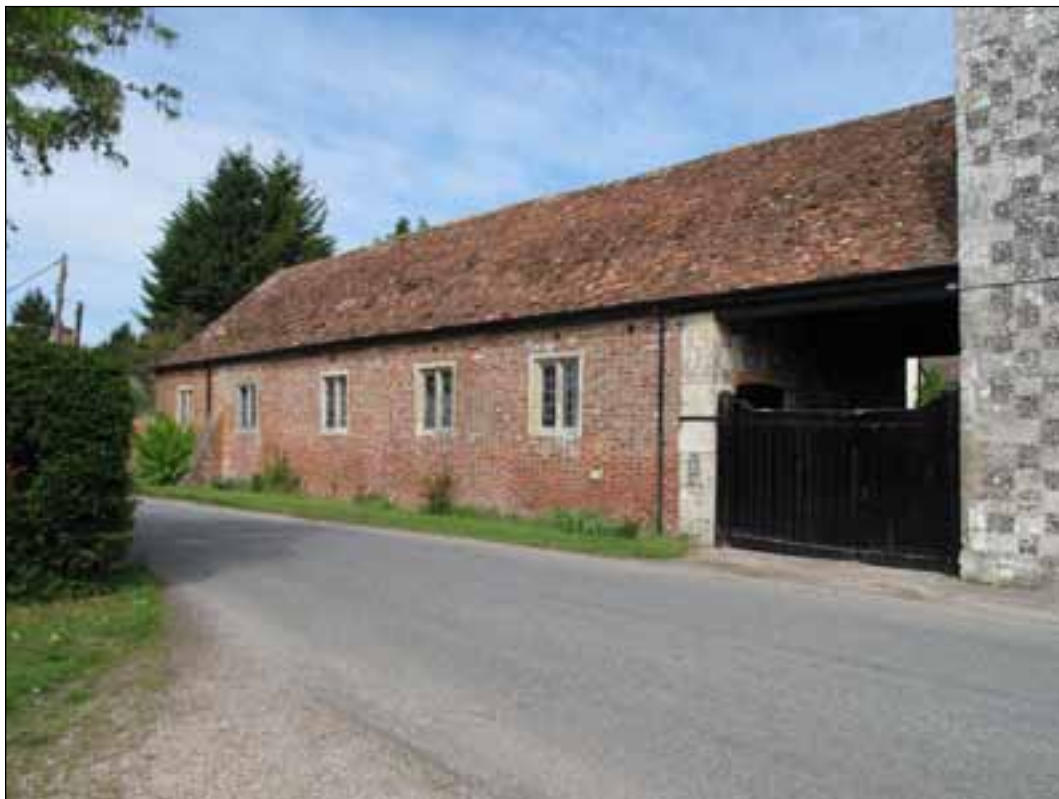
*Figure 18. The stable block of West Amesbury House, with an earlier chequer work gable wall incorporated.*

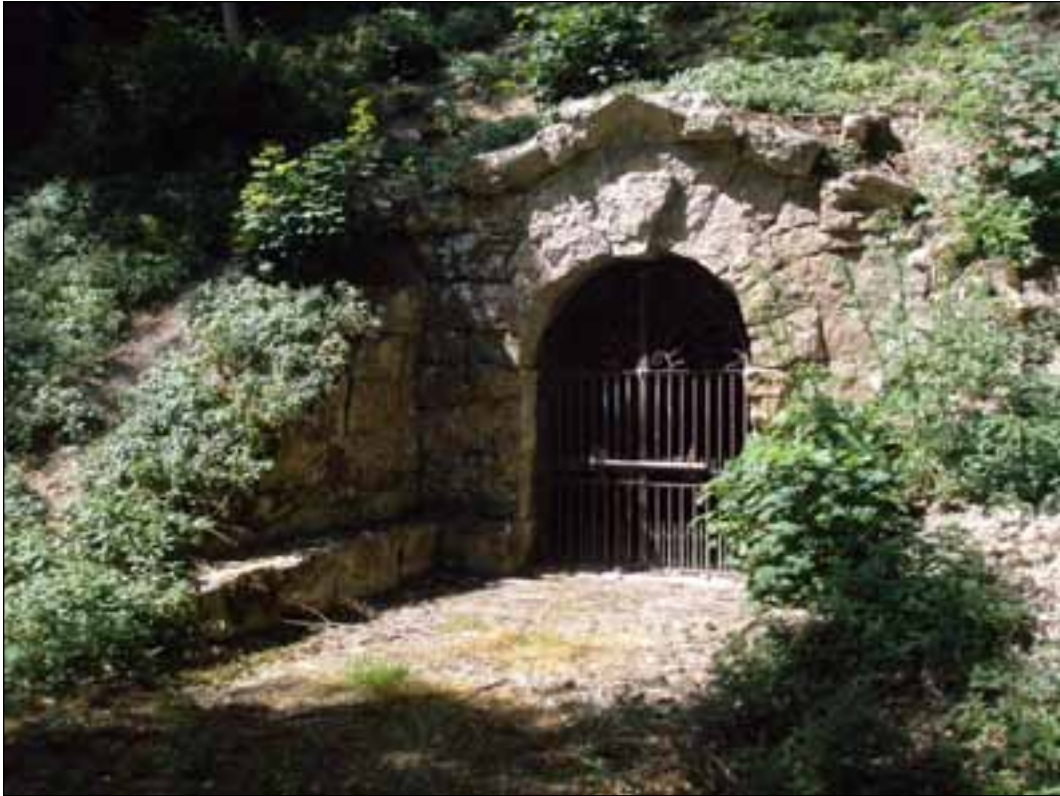
*Figure 19. The entrance to Gay's Cave, in the grounds of Amesbury Abbey*

On the side of the Vespasian's Camp a grotto was constructed, now known as Gay's Cave, and built partially into the side of the hill, with a groin-vaulted chamber and classical detailing (Figure 19). The exterior stonework feigns the effect of classical detail emerging from the natural stonework through the use of rock-cut stone blocks. The design and workmanship is of high quality and the design has been attributed to Henry Flitcroft.<sup>66</sup> The land in front of the grotto was laid out in a formal garden called 'The Diamond' with symmetrical walkways, illustrated on Bridgeman's plan of the park in 1738.<sup>67</sup>

A small grotto built into the side of the hill, with a limestone façade including naturalistic rock-faced work, from which carved classical detailing breaks out, including a moulded triangular pediment (see Figure 19). The interior is lined with ashlar limestone, with two classical round-arched niches set into the sides and a large rounded apse to the rear. Possibly designed by Henry Flitcroft or William Chambers.

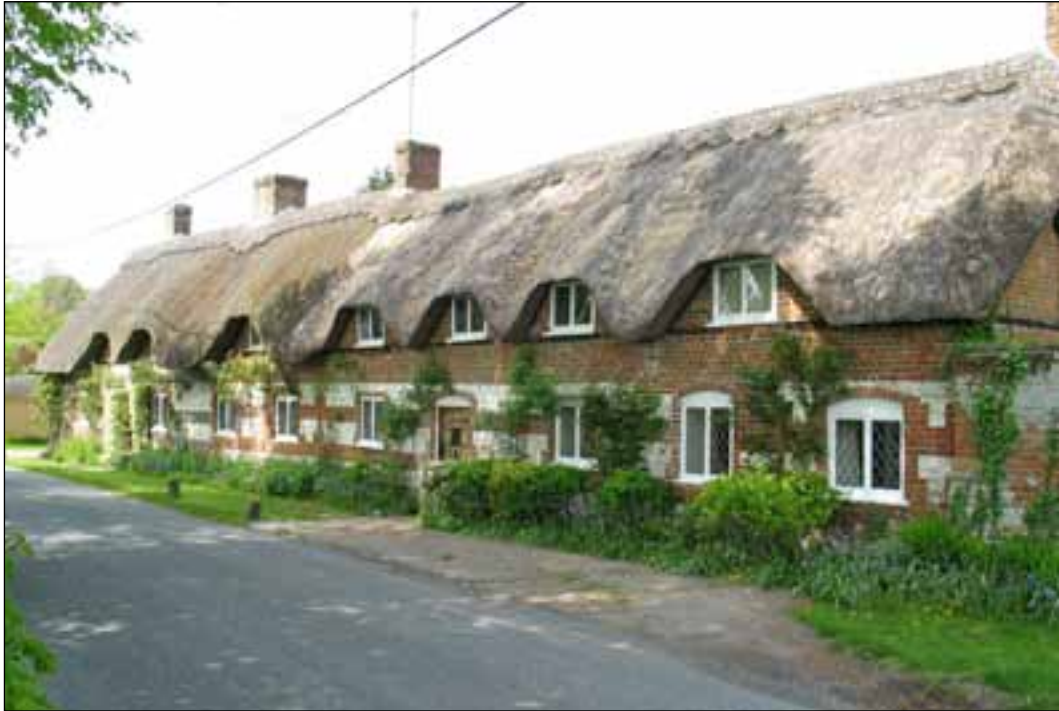
*Figure 22. Chalk Cottage and Merion Cottage, West Amesbury. 18th century workers' housing*

Formerly a row of five cottages, now converted into semi-detached houses. The row has a thatched roof, with irregular ridge heights, and thatch swept over an extensive array of dormers (see Figure 22). Originally single storey, with the original wall plate surviving (although partly reset) in the heightened, one-and-a-half storey building. Chalk, brick and flint walls, with evidence of substantial reworking associated with the conversion into two cottages, but also reflecting the piecemeal nature of construction, with a series of additions. The earliest phases must be at least early 18<sup>th</sup> century, as the row is included in the 18<sup>th</sup> century mapping of the village. It is possible that the central part of what is now Merion Cottage, with a central doorway flanked by symmetrical bays, may represent the earliest phase of construction of a slightly higher status dwelling (possibly a modest farmhouse), but with the addition of single-room cottages indicating accommodation for labourers.

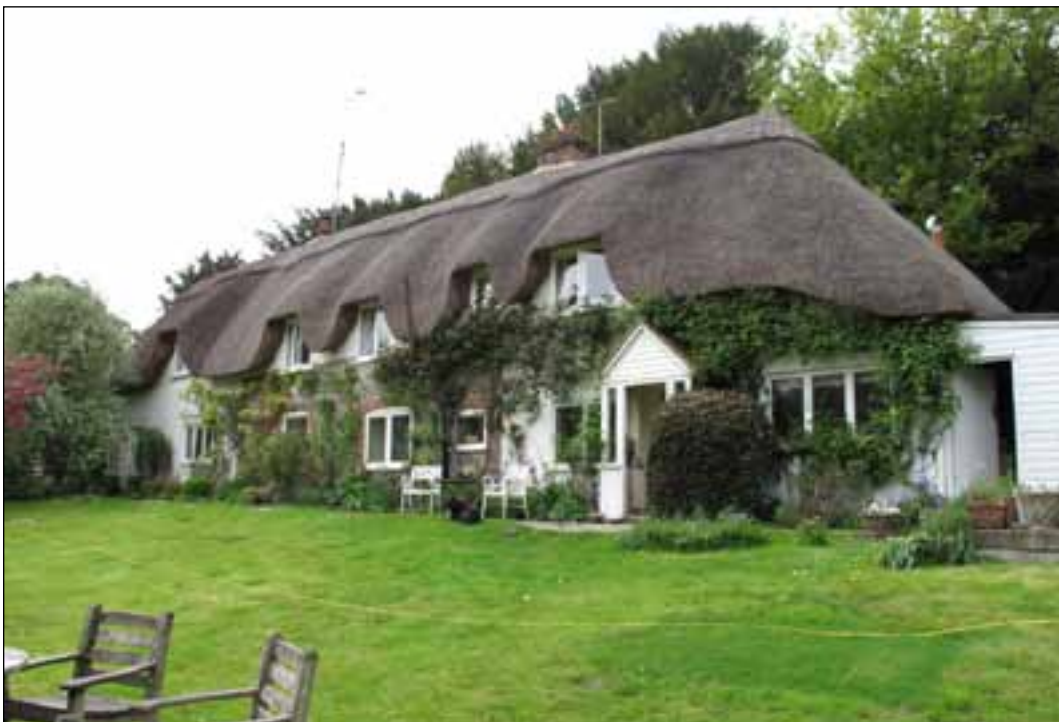
*Figure 23. The Old Post Office, Lake. 18th century terraced housing like that seen in West Amesbury, now converted into a single dwelling.*

Originally three cottages, The Old Post Office is, now a single house of brick and flint, partially rendered, and of one and a half storeys, with a hipped thatched roof (see Figure 23). Internally the evidence suggests that the earlier three units were constructed in separate phases, each with a single-room plan. The central section may be the earliest. This has waney-edged timbers of indeterminate date, with a large fireplace positioned centrally in the north wall. The southern section has a beams and roof timbers suggestive of a late 17<sup>th</sup> or early 18<sup>th</sup> century and the northern section has one beam of 18<sup>th</sup> century date. The 1773 map of Wiltshire shows a building approximately in this location, confirming at least an 18<sup>th</sup> century date for the cottage. It appears that the southern cottage acted as the Post Office in the late 19<sup>th</sup> and early 20<sup>th</sup> centuries.

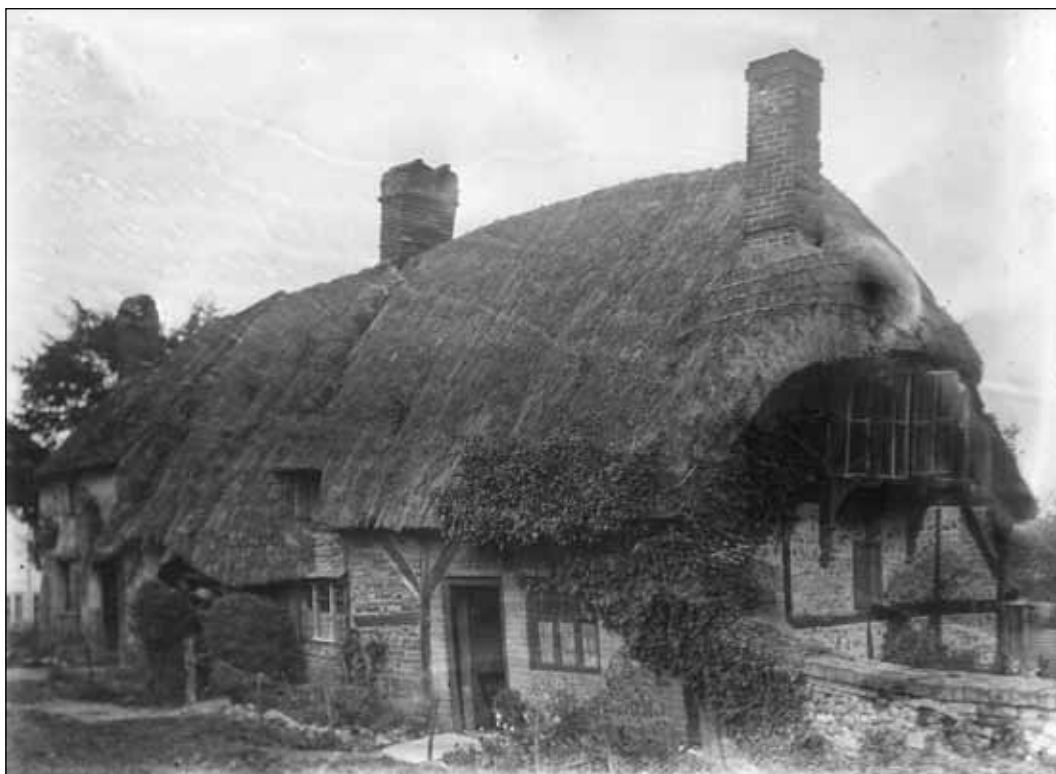
*Figure 24. The earlier cottage on the site of Diamond Cottages. Different phases of development created an irregular terrace.(NMR C.I B35/1272)*

different sections of the building represent a variety of dates. The central section may reflect the earliest, possibly 17<sup>th</sup> century fabric, with later, probably 18<sup>th</sup> century, additions to the north and south of this. The units vary in size, again reflecting the piecemeal nature of the construction, but all three appear to have originally provided single-room units. To the north of the Old Post Office, the house now known as Kingfisher Cottage also appears to have been constructed as two separate units, with the eastern part appearing later than the western. The larger western section appears to have originally been a two-room cottage with a central entrance, the form suggestive of an 18<sup>th</sup> century date. Again this is built of a mixture of materials, including brick, flint and cob with a thatched roof. In the West Amesbury and Lake examples the individual holdings would have provided accommodation for a family, perhaps those of a farm worker serving the estate. Other examples of lower-status housing are shown in photographic evidence. One of these is an additional cottage in Lake, which originally inhabited the site now occupied by Diamond Cottages (Figure 24). A late 19<sup>th</sup> century photograph shows a single-storey timber-framed building with brick infill panels which again appears to have provided more than one residential unit.

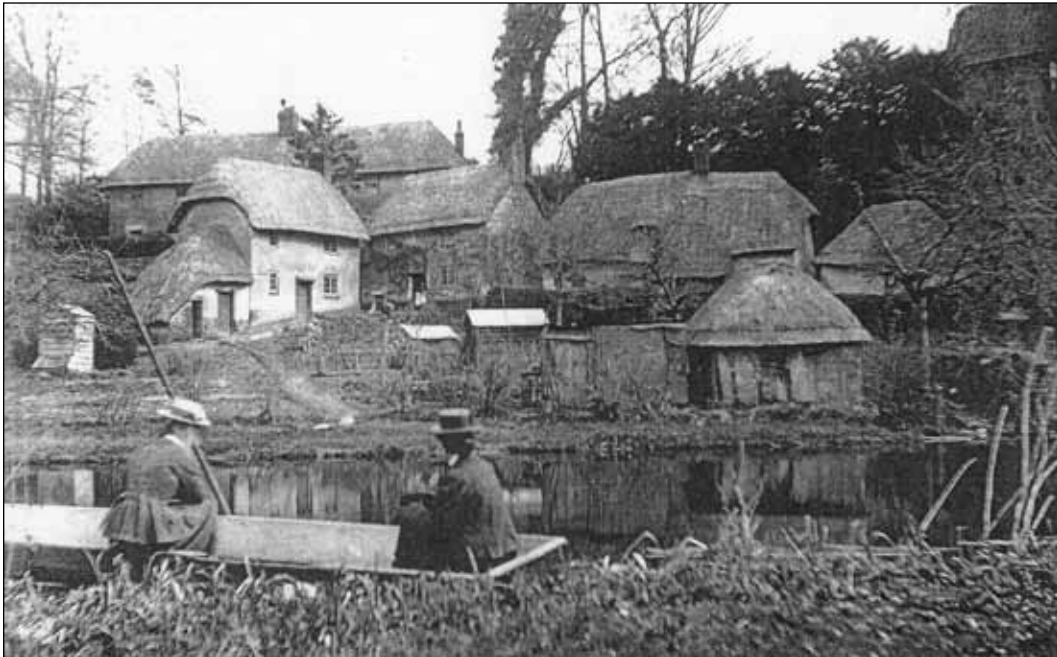
century photograph taken from the riverside shows these cottages still extant, with some additional 19<sup>th</sup> century housing uphill, further from the river and closer to the road (Figure 25). These earlier cottages were grouped on a rise immediately above the river and the photographic evidence indicates that they included one long single-storey cottage and two or three other detached cottages apparently of one and a half storeys with a symmetrical arrangement and a central front doorway, similar to the original form of Kingfisher Cottage surviving in Lake. All the buildings appear rendered so it is difficult to establish what they were built of, but all have thatched roofs. The grouping clearly indicates a piecemeal development, with no suggestion of a regular layout, borne out by its location on what could be considered marginal land, located between the river and the steep scarp on which the road runs. As with the humbler housing of this period identified within the main villages, these houses at Teazle may well have been built by farm workers or others connected with the estate. The location, scale, forms and standard of this housing suggests that it was not built by the estates. During this period, none of the estates appear to have taken responsibility for establishing recognisable estate-workers' housing, with the cottages suggesting an arbitrary development over a considerable period of time. The planned estate-workers' cottage was a development that came to the area later, in the 19<sup>th</sup> century.

*Figure 25. The hamlet of Teazle, part of Wilsford, viewed from the river in the early 20<sup>th</sup> century.*

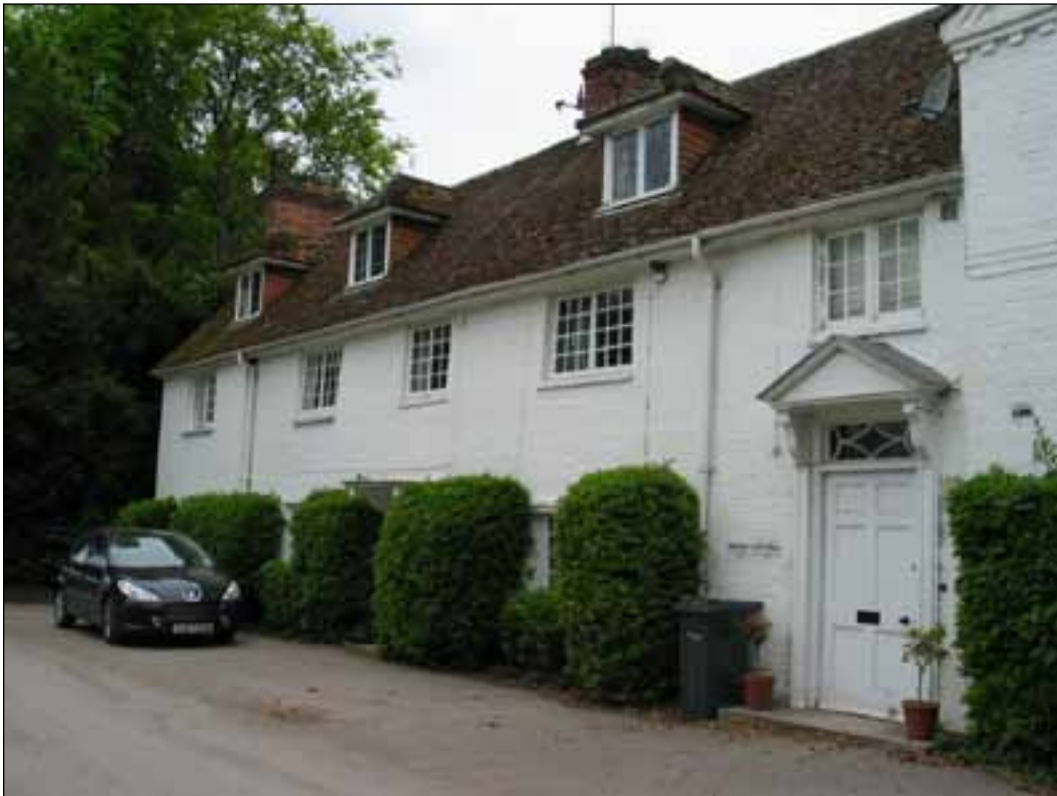
Figure 26. The possible 18th century lobby-entry house at Druid's Head, just outside the World Heritage Site.

Just to the southwest of the World Heritage Site, the earliest building at Druid's Head may also date to the late 18<sup>th</sup> century, with the appearance of a lobby-entry house of that date (Figure 26). In many ways it is atypical of the development patterns observed at the time, as an apparently domestic building in an isolated position rather than associated with an earlier settlement. It does not appear on Andrews and Drury's map of the area, but may have been built soon after, possibly in association with the phase of construction of the turnpike roads, as it sits adjacent to a major route.

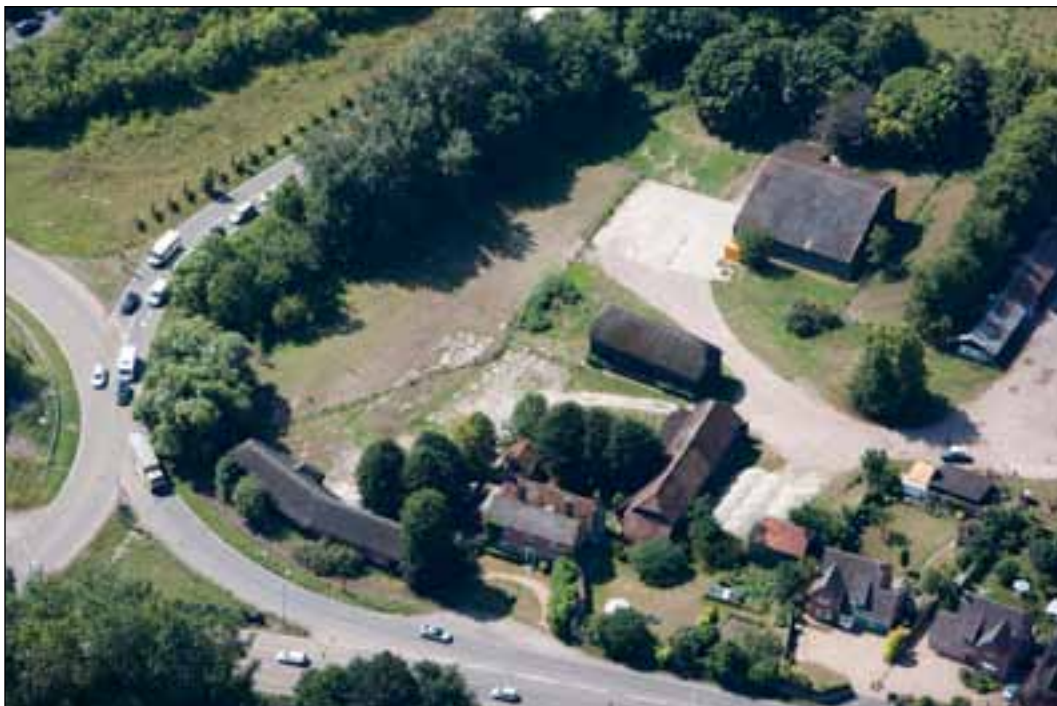
Figure 27. Aerial view of the farmstead at Countess Farm, showing the farmhouse fronting the road to the south with the farmbuildings to the side and rear (NMR 26708\_013).

Late 18<sup>th</sup> century farm buildings survive in all of the settlements examined. Most notable among these is the large complex at Countess Farm, dated by an inscription to 1772 (Figure 27). Initials included with the date indicate that they were built by John Osgood, who is known to have been a local carpenter based in Amesbury.<sup>72</sup> The four barns include a small three-bay granary building on a grid of four by three staddle stones and a larger five-bay staddle barn on a grid of four by nine staddle stones. Two further barns now known as the Great Barn and Little Barn, are both built on brick sleeper walls the small barn of five bays and the great barn of seven bays. All four have timber frames covered in weatherboard, and all originally appear to have had thatched roofs, although some of these have now been replaced with tile. All the timber-framed structures are of comparable design, with jowled wall posts from which straight braces rise to the wall plate and the tie-beams. Above the roofs are half-hipped with clasped-purlin trusses with queen struts rising from the tie-beams to the collars. The three larger barns have straight wind braces rising from the principal trusses to the purlins.

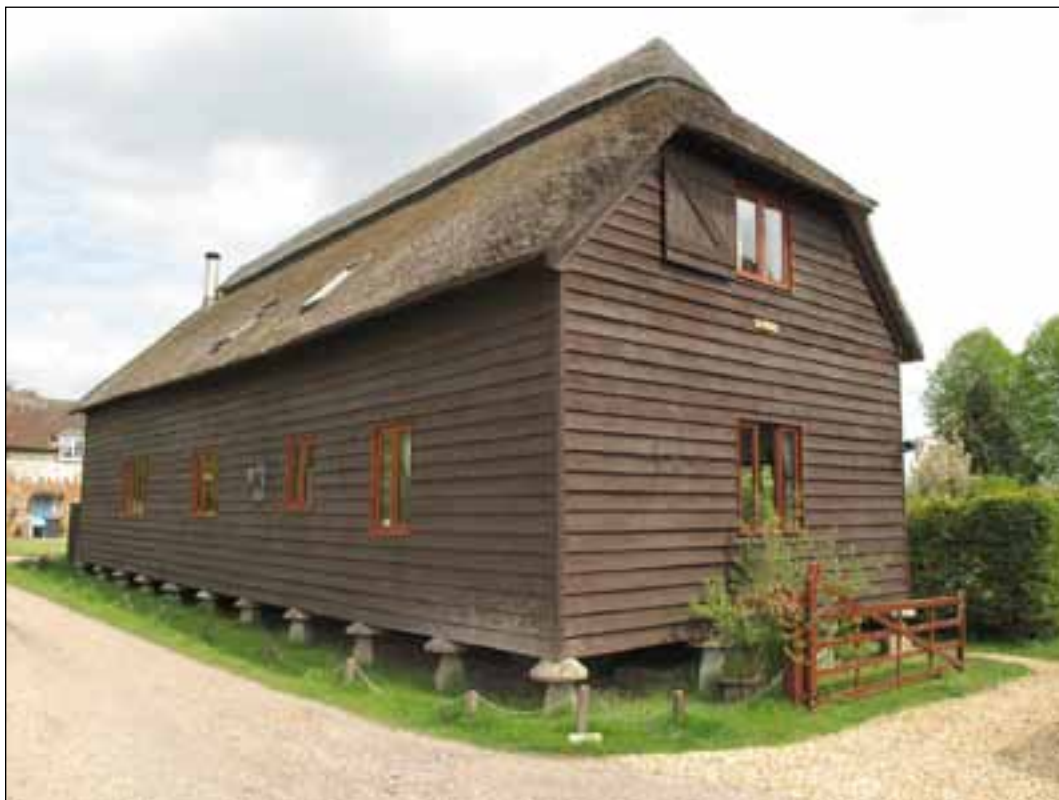
*Figure 28. West Barn, West Amesbury, late 18th century staddle stone barn now converted into a house.*

None of the other farmsteads have such a complete range of barns surviving, but two barns which are similar in form and construction survive in West Amesbury. 'West Barn' is raised on staddle stones and is timber framed, with weatherboarding and a thatched roof (Figure 28). It is dated to 1798, and although the basis for this attribution is not clear it certainly appears late 18<sup>th</sup> century. The interior of this was not examined. The other surviving barn in West Amesbury was converted into estate cottages in the 1930s, and is now called Barn's End (see Figure 12). It has been altered externally, with the insertion of doors and windows to create a terrace of small cottages, although it retains

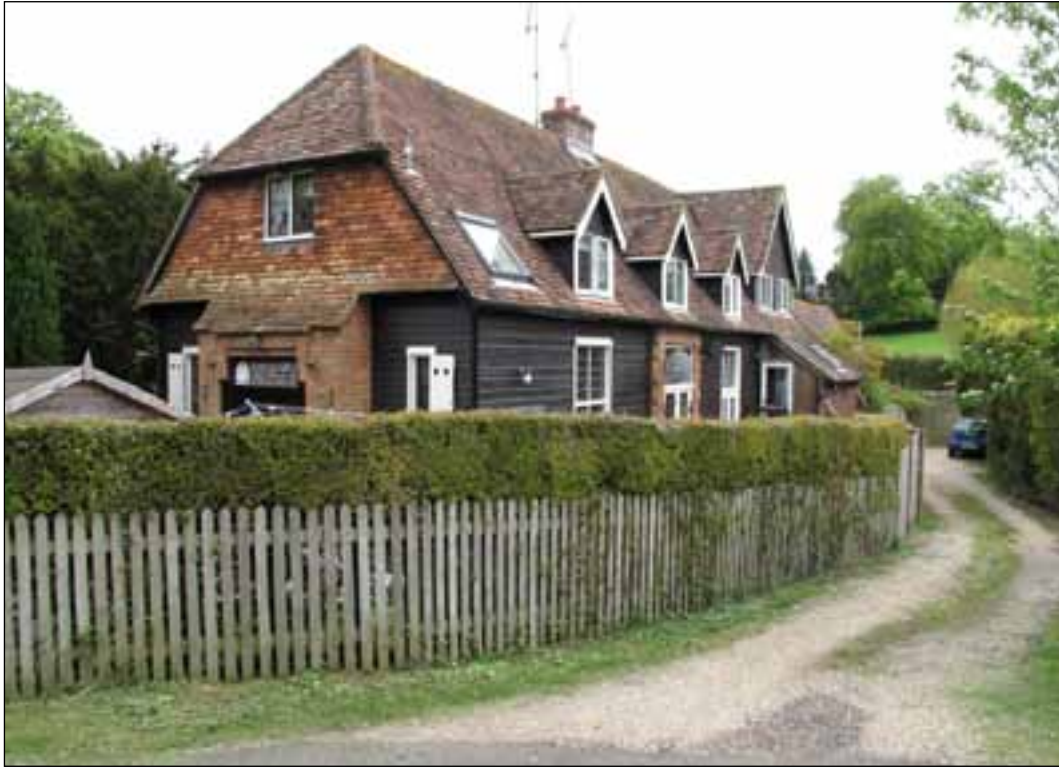
Lake has one surviving barn of a similar form to those seen at Countess and West Amesbury (Figure 29). This was converted to a village hall in the 1930s and is now in use as a house, but retains its weatherboard cladding and half-hipped roof structure, which strongly associates it with the agricultural trends seen in the other settlements. In Wilsford no large barns survive but there is a small granary building in the grounds of Wilsford Manor which is in a similar style, with a staddle-stone base and weatherboard exterior.

Figure 29. Former barn in Lake. Converted to a village hall in the 1930s and a house in the 1980s.

A converted barn, originally part of the farmyard associated with Lake Farm, and which formed part of a loose courtyard arrangement. The former barn has a weatherboard exterior with a half-hipped, tiled roof, with hung tiles in the half-gable ends. Regularly-spaced doorways on the north and south elevations suggest it was originally a threshing barn. These have brick surrounds, with a similar treatment given to an inserted doorway in the centre of the gable end. A plaque over the door at the east end records the conversion of the barn to a village hall in 1932. It was converted to domestic accommodation in the 1980s (see Figure 29).

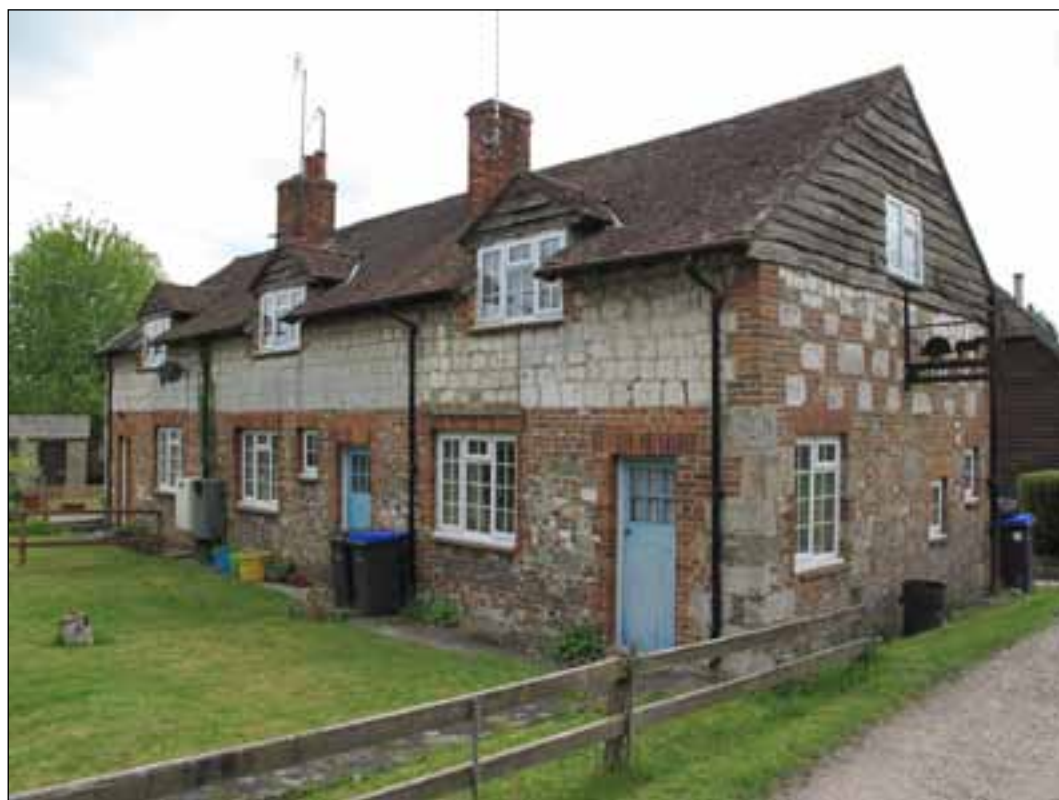
As well as this series of barns, other, smaller, farm buildings also survive. Notable among these is a building now converted into three small cottages and known as Carter's Row, in West Amesbury (Figure 30). The original walls are of brick and knapped flint, with occasional stone pieces including large quoins in roughly-squared blocks. It appears that this formed part of the farmstead associated with West Amesbury along with the larger barns of Barn End and West Barn, perhaps serving as a stable. Similar brick buildings

Figure 30. Carter's Row, West Amesbury. A converted farmbuilding from the large farm complex, possibly originally a stable.

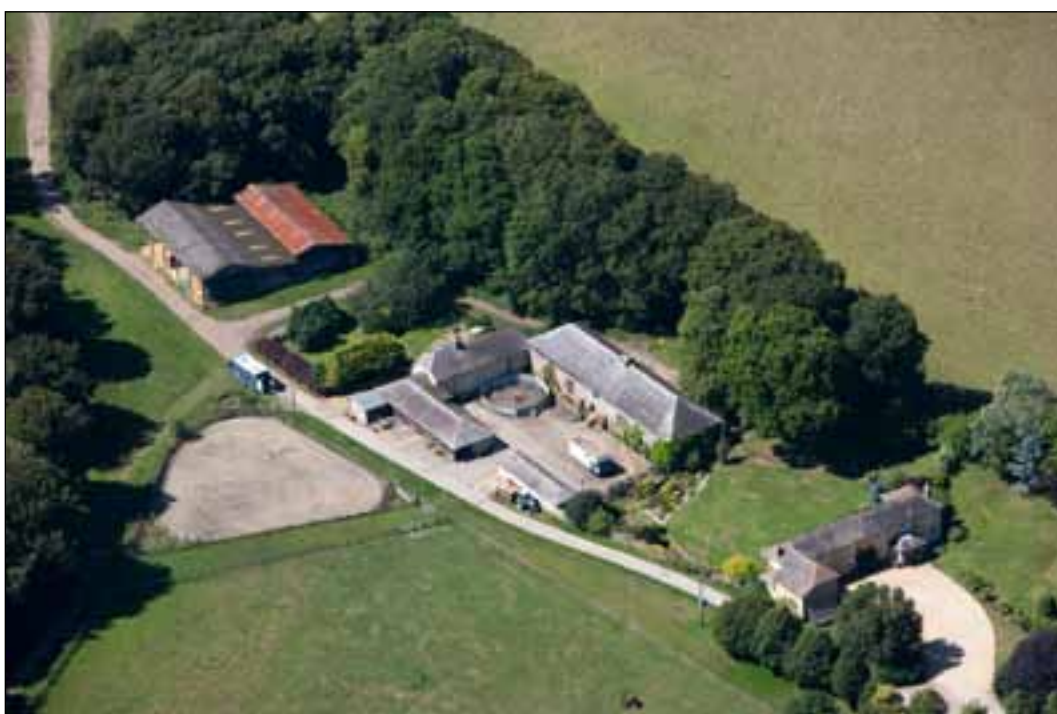
*Figure 33. Farm complex at Springbottom Farm, a late 19th century out-farm which became the principal farm for the Lake Estate (NMR 26713\_009).*

Associated with this shift was the conversion of the earlier workers' cottages provided on the out-farms into the principal farmhouses for the landholdings. This is seen at both Westfield Farm and Springbottom Farm where the semi-detached cottages were converted into single dwellings in the early 20<sup>th</sup> century. By the mid-20<sup>th</sup> century Springbottom Farm was the centre for the Lake Estate, as well as additional land which had previously formed parts of Normanton and West Amesbury Farms.

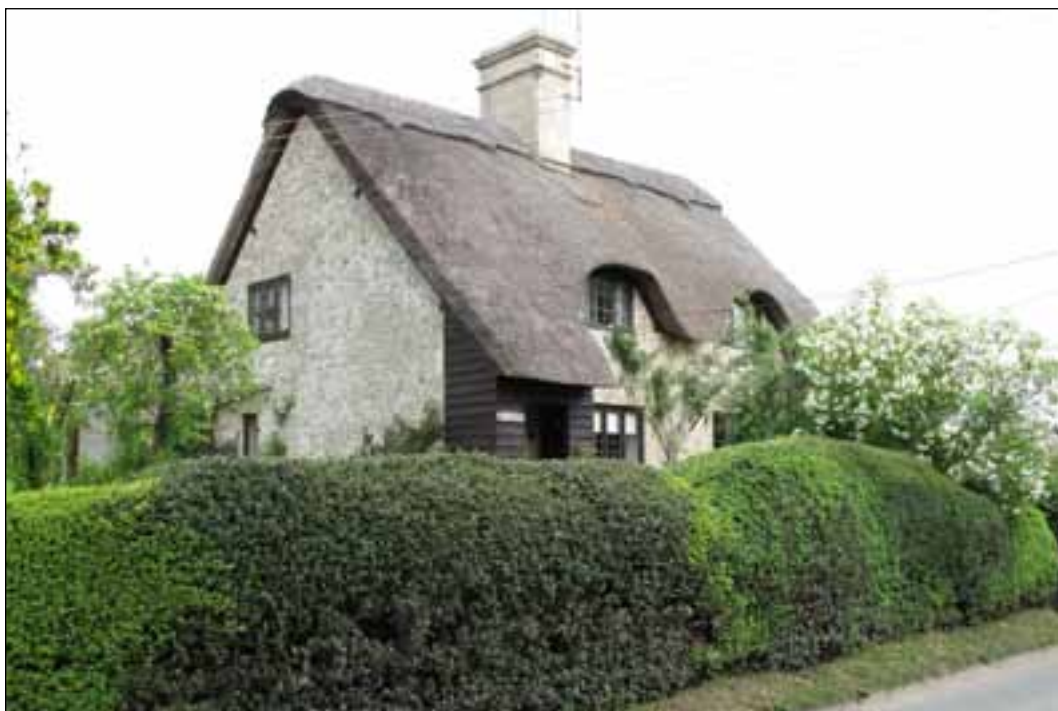
*Figure 34. Lilac Cottage and Wilsford Cottage, probably designed by Detmar Blow during his work on Wilsford Manor for the Tennant family.*

A pair of cottages in rubble stone and flint (see Figure 34). One and a half storeys with a gabled thatched roof, with upper storey lit through dormers in the thatch. Small timber porches symmetrically arranged in the outer bays of each cottage. Central stone panel has the inscription 'EPT 1906', indicating construction as an estate cottage by Edward Tennant, Lord Glenconner. To the rear are small paired outhouses in the same style as the main house, with a hipped, thatched roof.
