# STONEHENGE WORLD HERITAGE SITE LANDSCAPE PROJECT STONEHENGE, AMESBURY, WILTSHIRE ARCHITECTURAL ASSESSMENT

**STONEHENGE WORLD HERITAGE SITE LANDSCAPE  
PROJECT  
STONEHENGE, AMESBURY, WILTSHIRE  
ARCHITECTURAL ASSESSMENT**

NGR: SU 1224 4219

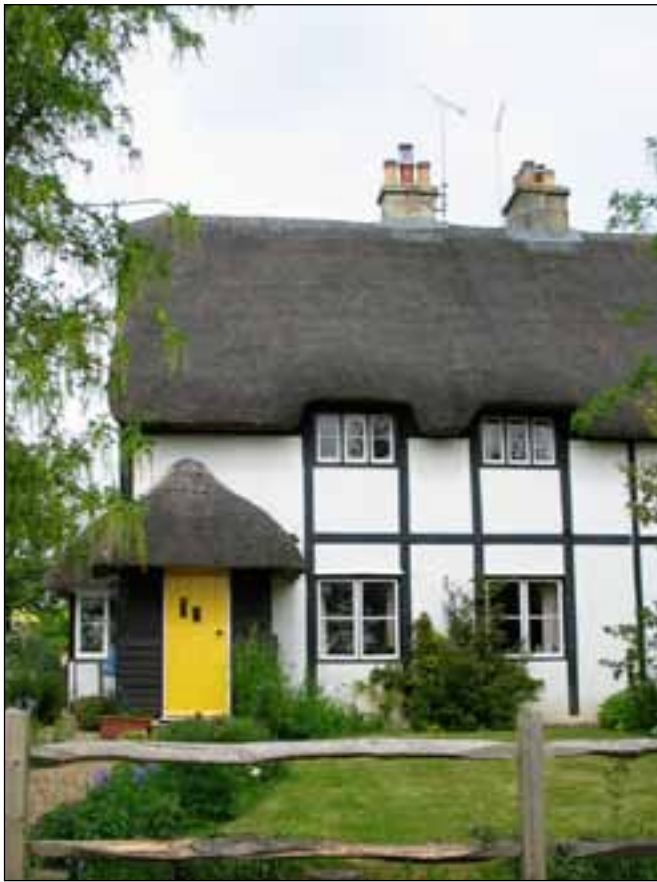
*Figure 36. A concrete cottage, with applied timber frame elements, as built on the Lake Estate by Joseph Lovibond in the early 20th century*

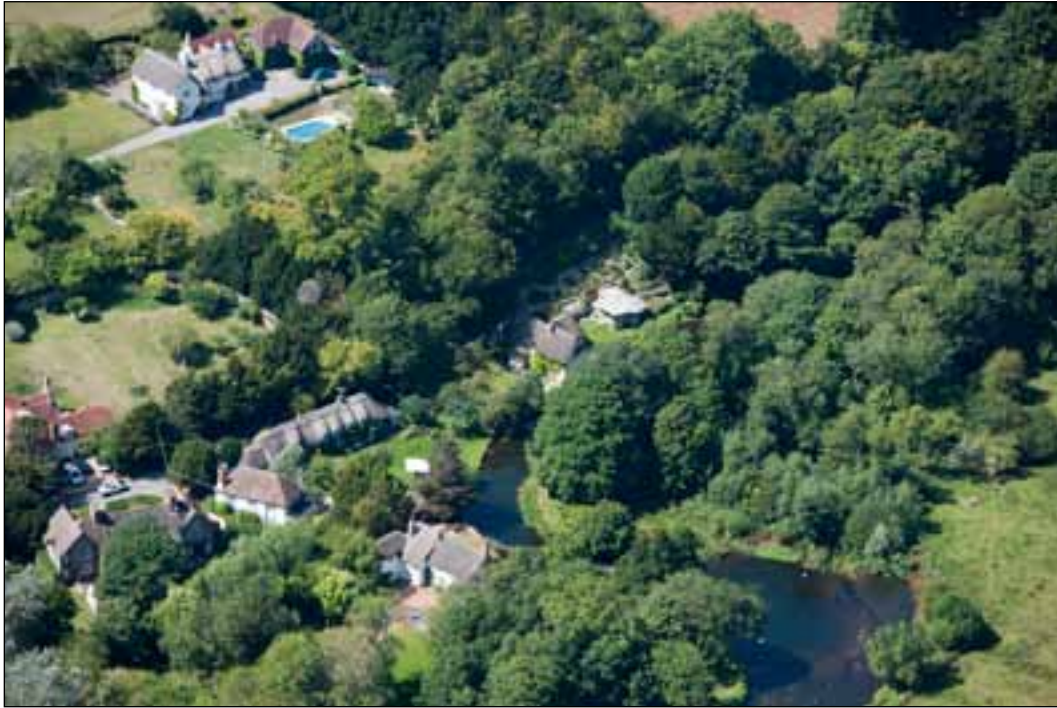
Lake Rising may have been the first of these to be constructed, certainly the form of the frame and concrete present an irregular appearance, possibly suggestive of an experimental phase, particularly in comparison to the other concrete structures which are more regularly arranged. The building must have been completed prior to 1910, when it was visited by a 17-year old Dorothy L Sayers, who wrote about the visit to her mother - 'we had been invited to tea by some dear little people who lived the simple life in a little house on the top of a hill, overlooking the most perfect scenery. The old grandfather, whose name is Mr Lovibond, is most awfully clever and a perfect old dear. He owns Lake House – a glorious old place, but has let it and built himself this sweet little house on the hill' (Figure 37).<sup>83</sup>

*Figure 37. Lake Rising in the top left hand corner, on the high ground above Lake and the River Avon. (NMR 26712\_016)*

A house of one and a half storeys and built using cast in-situ concrete, with a very irregularly-arranged timber frame, and a thatched roof (see Figure 37). Later wing added to the south. This building appears to have been built and lived in by Joseph Lovibond in the early 20<sup>th</sup> century, when he could no longer afford to live at Lake House. The irregular timber frame may suggest that this house was one of the earlier, more 'experimental' of his concrete buildings. Accounts suggest that Lovibond was living here, when the house was known as The Pleasance, at the time of the fire at Lake House, in 1912. It does not appear on the 2<sup>nd</sup> edition O.S. map of 1901, suggesting a construction date in the first decade of the 20<sup>th</sup> century.

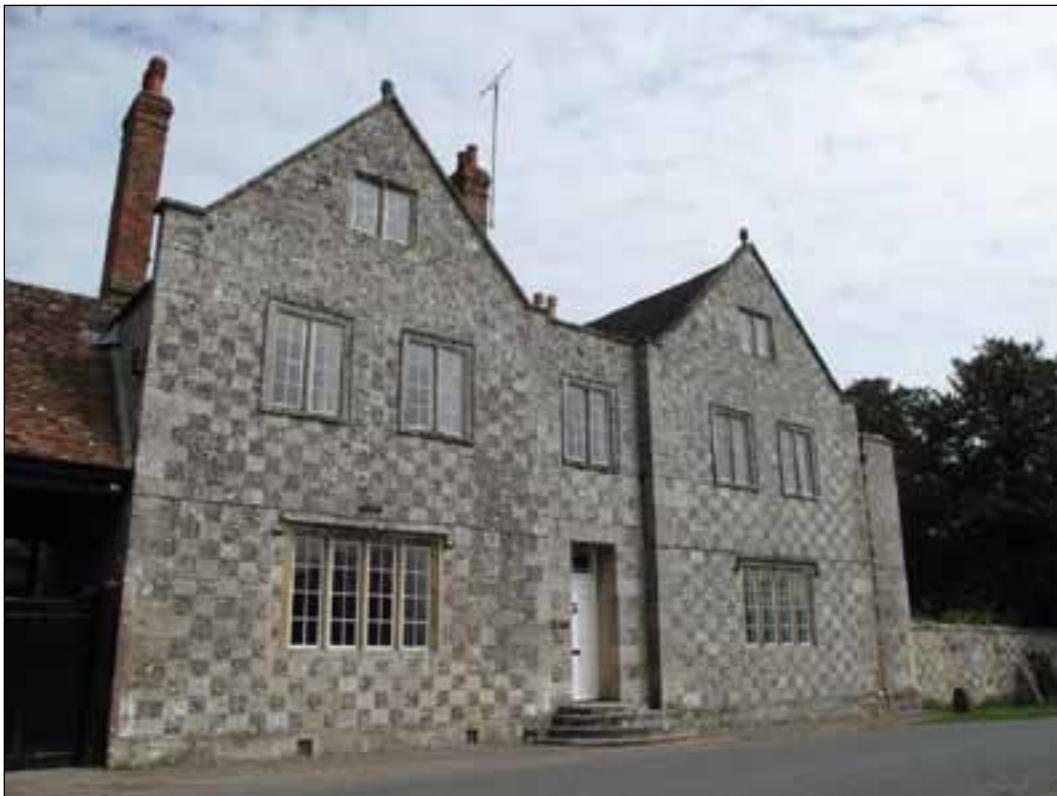
*Figure 38. West Amesbury House. Detmar Blow's alleged involvement may have included the refronting of the building.*

West Amesbury House, at this time part of the abbey's estate, was allegedly also worked on by Blow at this stage. A series of small extensions along the eastern side of the building have been attributed to him; however, the

cartographic evidence makes it clear that these were in fact in place prior to 1878, and cannot have been part of Blow's work for the estate. Indeed, it appears that he did not make any changes to the footprint of the building, as it appears consistent throughout the late 19<sup>th</sup> and early 20<sup>th</sup> century mapping. If Blow did work at the house it may have been on the facades or interiors, perhaps reconfiguring using a similar approach to that at Amesbury Abbey (Figure 38). Blow's involvement at West Amesbury House may reflect a change in status for the building, which had been used as a farmhouse since the 18<sup>th</sup> century. The shift in agricultural patterns during this period may have lead to a reinvestment in the house as a higher-status residence, and it was apparently leased by the Tennants during the construction of Wilsford Manor.<sup>85</sup> As at Wilsford there is some suggestion that Blow was also involved in the construction of other estate buildings, apparently responsible for Sandall's Farm (now Sandall's House) at the south end of West Amesbury in 1902.<sup>86</sup>

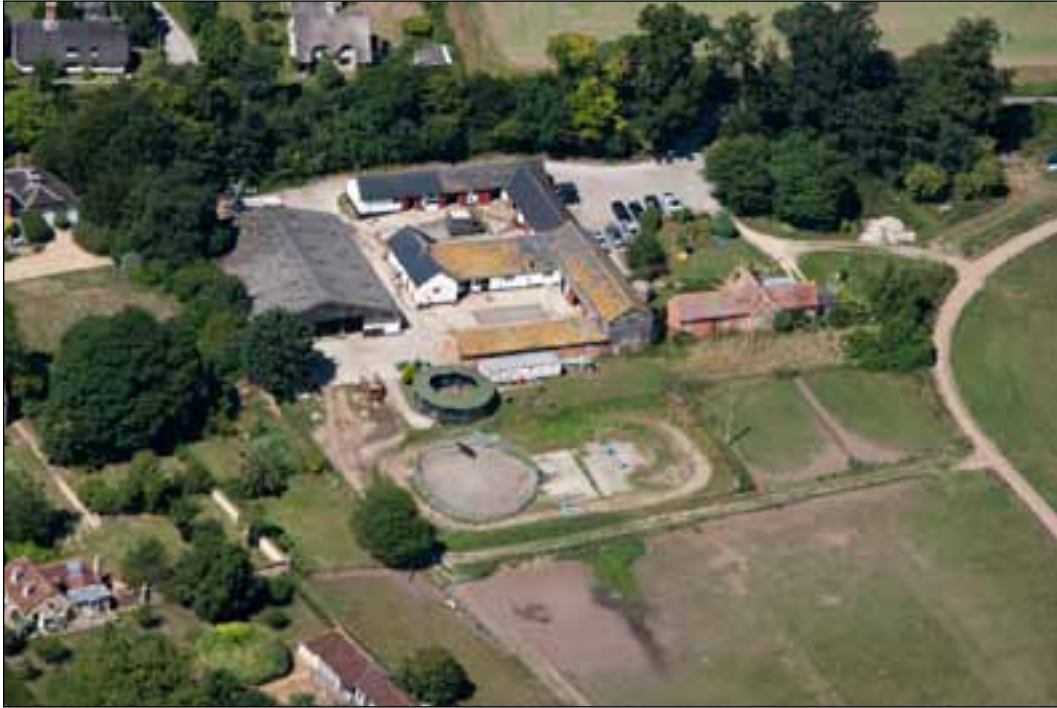
*Figure 39. The early 20th century E-shaped farmstead constructed in association with Wilsford Farm. This now forms racing stables. (NMR 26711\_022)*

The partial exception to this move to the downland is Wilsford where, although the original farmstead associated with Wilsford Farm was demolished in the first part of the 20<sup>th</sup> century, a new farm complex was constructed immediately north of the house still near the river meadow and within sight of the settlement (Figure 39). This was apparently constructed as a dairy, and thus the exception may be associated with the use of the river meadow for cattle, as opposed to the other farmsteads which were increasingly associated with the cultivation of the upland. The dairy complex, now a racing stables, comprised an E-shaped barn complex, with a large weatherboarded threshing barn provided in the northeastern corner. Immediately north of the barns a small detached building (now a house) was apparently originally used as an engine house, and suggests that the process undertaken in the dairy complex included substantial mechanisation.

The complex appears to have originated as a dairy, laid out between 1878 and 1901, and associated with Wilsford Farm (now the Red House). It replaced an earlier farmyard which was nearer to the house. The yard is now arranged in a E-shaped plan, with a larger weatherboarded barn to the north and a series of lower brick ranges running south (see Figure 39). At some stage in the 20<sup>th</sup> century, the Red House ceased to be Wilsford Farm, and the dairy was used as a self-contained unit. The structures were not closely examined.

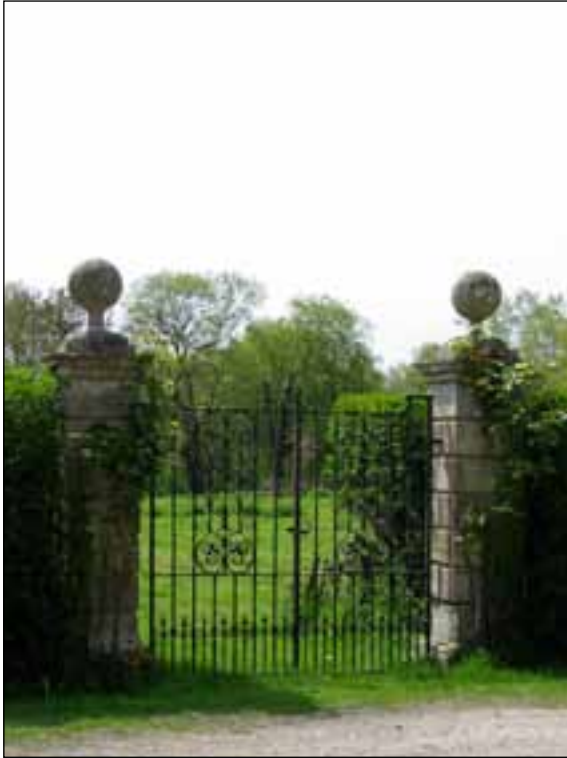
*Figure 40. The gate piers of West Amesbury House, now on the opposite side of the road but originally located in front of the house.*

Late 17<sup>th</sup> or early 18<sup>th</sup> century. There are rusticated stone columns (2.4m high), surmounted by ball finials, with wrought-iron gates. The RCHME interpretation of the house suggests they are contemporary with the construction of the north range, possibly

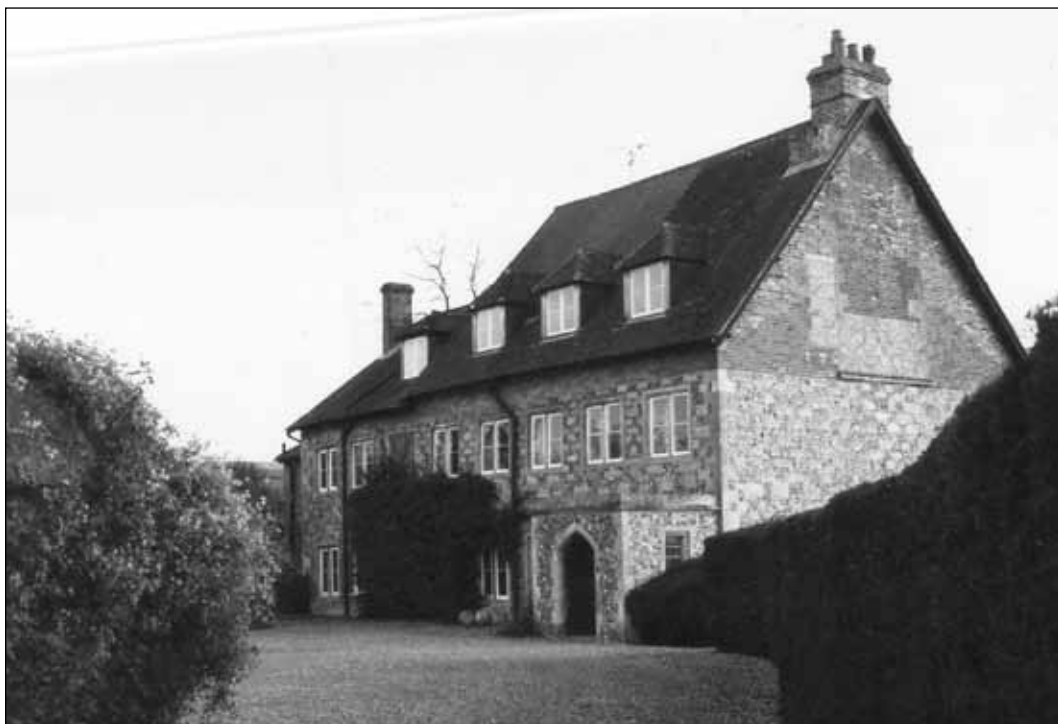
*Figure 41. North and west elevations of Normanton House, showing evidence of the earlier chimney arrangement in the gable (NMR RCHME field photo, fire BF50941).*

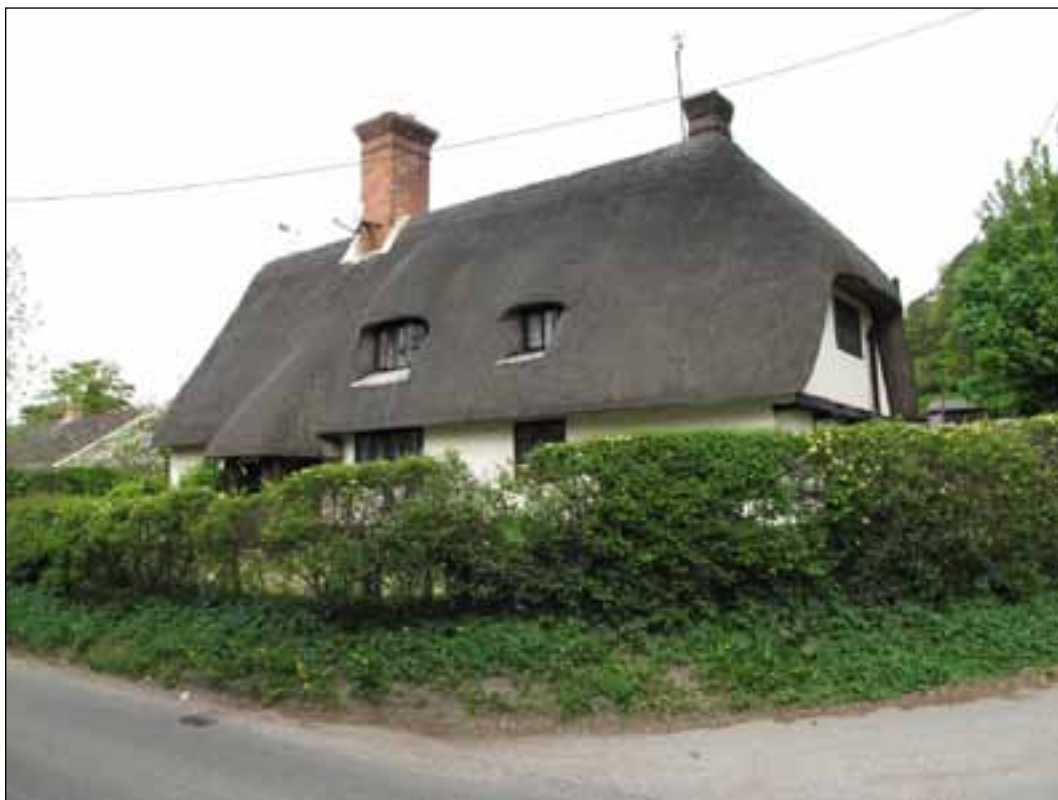
*Figure 42. Beechway, Wilsford, built c1905, possibly designed by Detmar Blow.*

A one-and-a-half-storey cottage with a half-hipped, thatched roof, with the upper storey lit by dormers in the thatch (Figure 42). The north elevation has a small overhanging jetty at first-floor level. The house is rendered, with the initials EPT and the date 1905 in pargeting on the north elevation, indicating construction as an estate cottage by Edward Tennant.

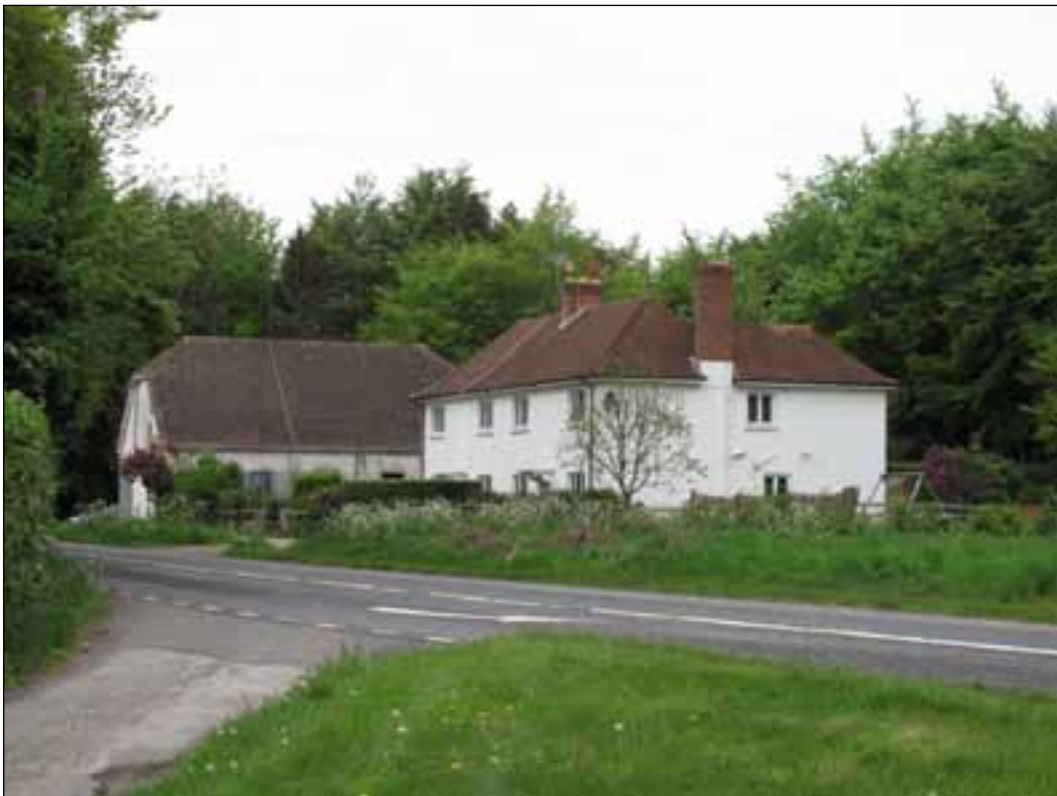
This group of building fall within the World Heritage Site, standing slightly northeast the Druid's Head, on the east side of the A350, and originally was associated with the early military use of the downland area. At the north end is a large concrete workshop or shed with a half-hipped tiled roof. South of this is a pair of semi-detached cottages, of two-storeys with a tiled gabled roof. The final component of the group is a large water tower with an associated pump house. None of these buildings are on the 1901 O.S. map. On the 3<sup>rd</sup> edition O.S. published in 1925 the northern building and the water tower are marked and the former is labelled engine house. The cottages appear on the 1939 O.S. map. By then, the northernmost building is no longer labelled engine house, possibly suggesting that it was no longer in use for its original purpose.

*Figure 45. Garage Cottages with the engine house beyond.*
