DOWNSIDE MILL, COBHAM, SURREY ANALYSIS OF THE METALWORKING REMAINS

TECHNOLOGY REPORT

Research Department Report Series 43-2011

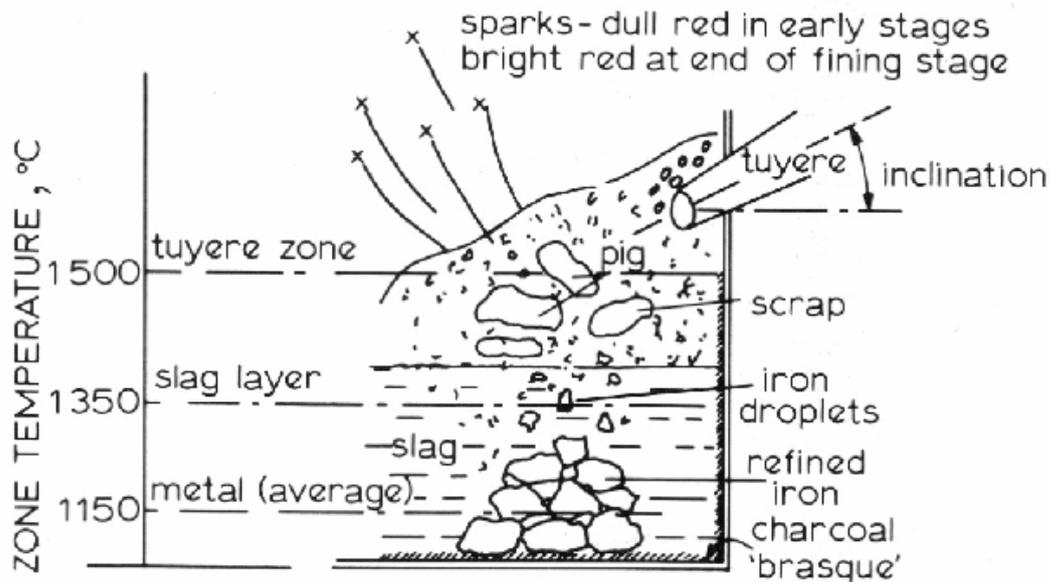
Figure 1. Diagram of the oxidation of cast iron in a finery furnace. Pig iron is melted and the droplets fall through an oxidising zone removing carbon before falling into the slag and solidifying (from Tylecote 1986, 219)

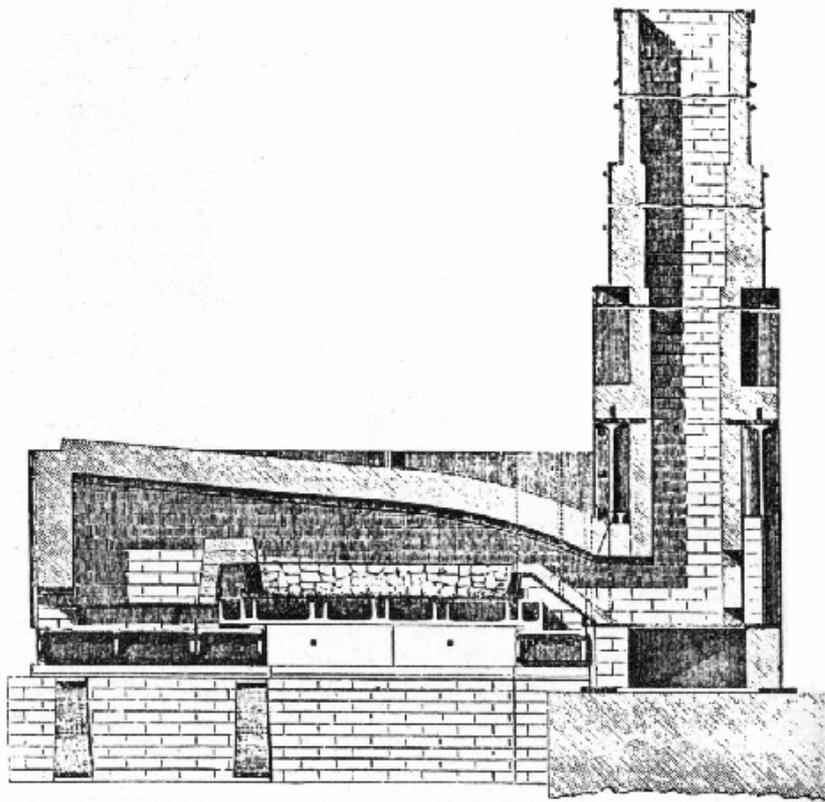
Figure 2: Reverberatory puddling furnace from Ebbw Vale from the mid 19th century (from Percy 1864, 648)

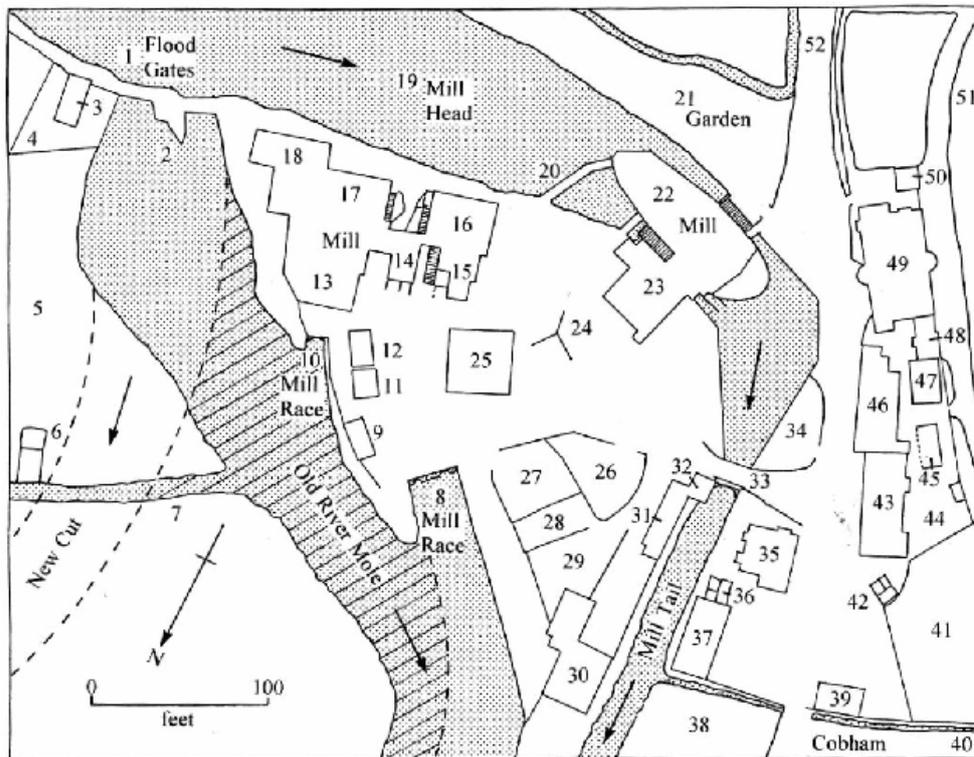
Figure 3: A redrawn and relabelled plan of Downside Mill from the original thought to have been made in 1798 (Crocker 2000).

1 = Floodgates; 2 = Flood Gate House; 3 = Standen's House; 4 = Garden; 5 = Dog Kennell Field; 6 = Dog Kennell; 7 = Flash Race; 8 = Forge & Tilt Race; 9 = Brick & Lime House; 10 = Cylinder Race; 11 = Helve House; 12 = Smoak House; 13 = Women's Shop; 14 = Cutting House; 15 = Break House; 16 = Tilt; 17 = Forge; 18 = Iron Foundry; 19 = Mill Head; 20 = Bridge; 21 = Mill Garden; 22 = Mill; 23 = Copper Foundry; 24 = Triangles; 25 = Coak House; 26 = Coak Penn; 27 = Charcoal Penn; 28 = Charcoal Penn; 29 = Coal Penn; 30 = Smith's Shop; 31 = Counting House & Assay House; 32 = Ware House; 33 = Bridge; 34 = Dung Yard; 35 = Gibb's House; 36 = Sty; 37 = New Stables & Coach House; 38 = March Meadow; 39 = Carpenter's Shop; 40 = Road to Cobham; 41 = Kitching Garden; 42 = Sty; 43 = Old Stables and Coach House; 44 = Botany Garden; 45 = Dairy; 46 = Laundry, Washhouse, Coal House & Stable; 47 = Cellars; 48 = Scullery and Pantry; 49 = Dwelling House; 50 = Cold Bath; 51 = Pleasure Ground; 52 = Road to Down Farm

A contemporary site plan believed to have been drawn in 1798 (Figure 3) indicates a range of metalworking activities took place at Downside Mill including the casting, fining, shaping and fabrication of copper alloy and iron. The main activities, being housed in the two largest buildings, were the copper foundry (23) and the iron foundry (18) and forge (17). The iron foundry would have been used for the melting of cast iron for casting objects. This would probably have been carried out either in a cupola furnace (using coke) or a reverberatory furnace fuelled with coal. The presence of the coke house (26) could suggest that the cast iron was melted in a cupola furnace. The copper foundry, likewise, was for the casting of copper alloy objects into moulds, most likely heated in a reverberatory furnace.

Additional metalworking apparatus include water-powered helve and tilt hammers (11; 16) for the smithing and shaping of the wrought iron produced in the forge. The mill (22) could be used for rolling the different metal bars into sheets and the cutting house (14) for removing uneven edges or for cutting the sheets or bars. A smith shop (30) is also present as would be expected of an industrial complex. Smithing on site would be needed to repair parts or tools. The cylinder race (10) possibly indicates the use of cylinders to pump air for the forge and foundry as opposed to bellows which were becoming obsolete.

Raby initially started working iron in the 'ovoid mill' at Downside (23 on Figure 3). The copper foundry was a later addition in that structure however a large chafery-type smithing hearth may still have been required at the site. The presence of copper and tin in some of the slag suggests that it was contaminated by copper foundry waste whilst the slag was hot and that the chafery-type hearth was located near to the copper foundry and perhaps used for copper working on occasion as well. An additional route for contamination may be the use of metalworking waste to construct the muffle on chafery hearths, as described by Morton and Wingrove (1970), which would exacerbate the mixing of different types of waste. With so few samples of this type in the assemblage however, this identification remains speculative.

A small amount of slag from copper alloy casting was found. Some frothy wüstite-rich slag, possibly from a large chafery-type smithing hearth, was also identified and in several instances this was mixed with waste from copper alloy casting, suggesting that some smithing activity took place near to the copper foundry in the 'ovoid mill' (23 in Figure 3).

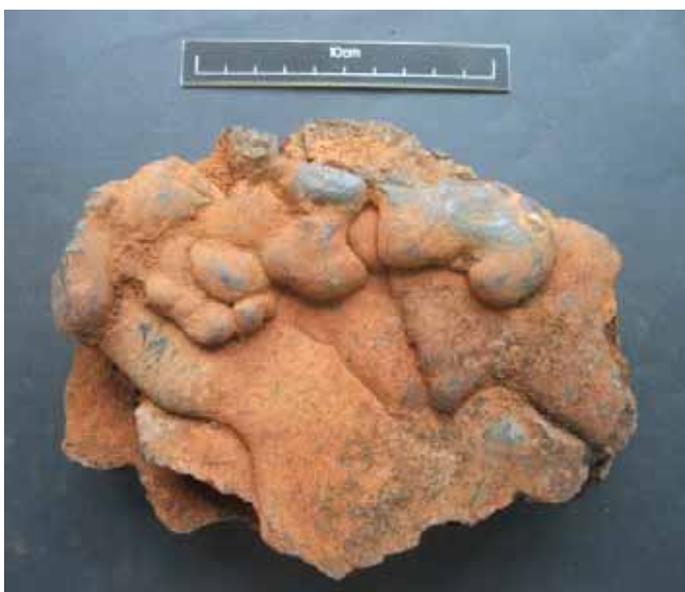
Figure 4: Top view of flowed fayalitic slag from dry puddling (#11)

The single most abundant material (~25kg) was **flowed fayalitic slag**. It had flow features but had not wetted the surface that it had run over. It tended to have a ropey upper surface (Figures 4 and 5) and an undulating base with impressions of the surface on which it solidified (Figure 6). This slag derives from the dry puddling iron conversion process, which is discussed later.

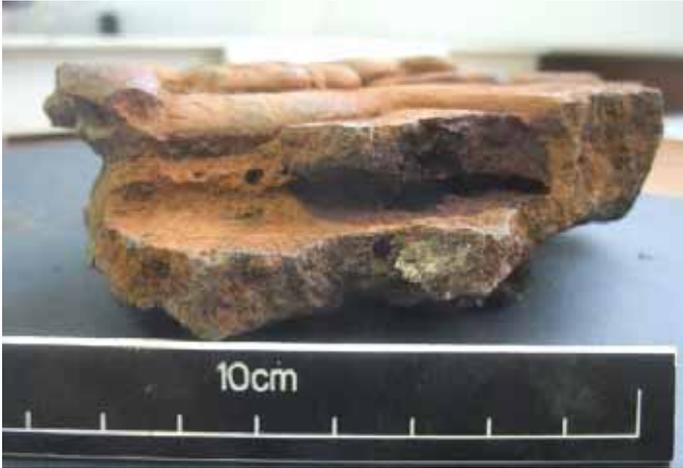
Figure 5: Side view of flowed fayalitic slag from dry puddling (#11)

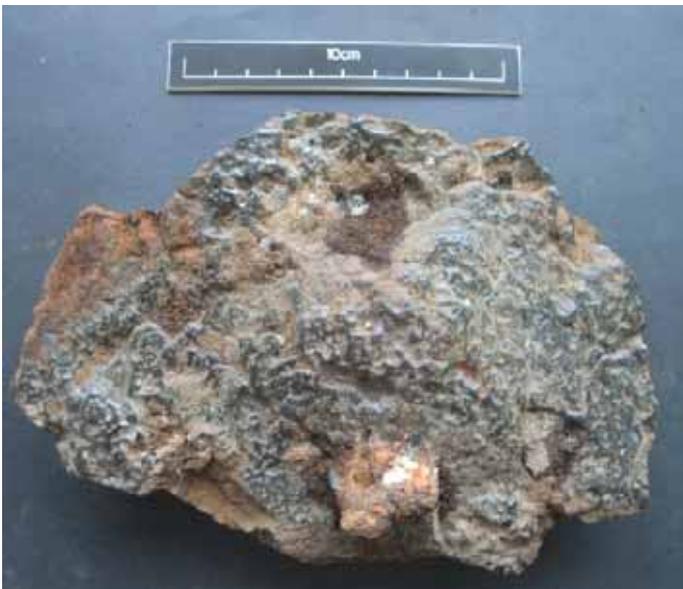
Figure 6: Underside view of flowed fayalitic slag from an iron conversion process (#11)

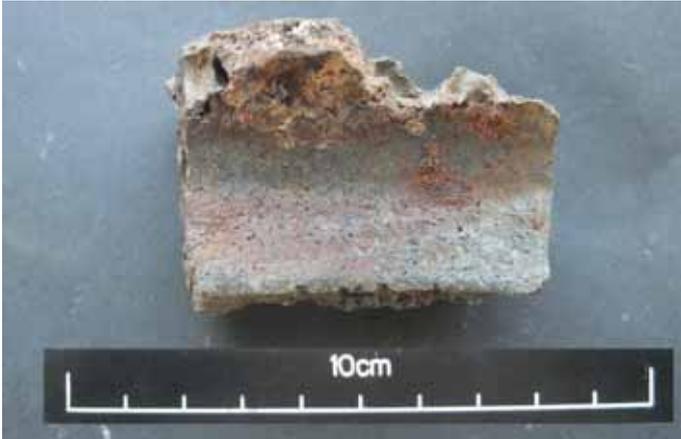
Figure 7: Plan view of sample #18, which probably derives from refining

Amongst this slag were some fragments that did not have typical flowed surfaces. These samples are thought to derive from the early or preparatory stages of puddling, the details of which are discussed later. These atypical samples were #18 (Figures 7 and 8), which had a flat base and side with a convex surface, and #50 (Figures 9 and 10), which was in the form of a dense pool of slag but without a flowed surface.

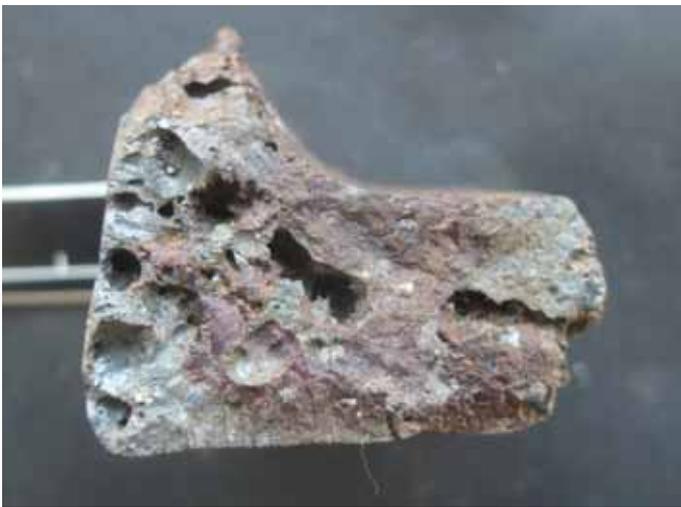
Figure 8: Side (bottom) view of sample #18, which probably derives from refining

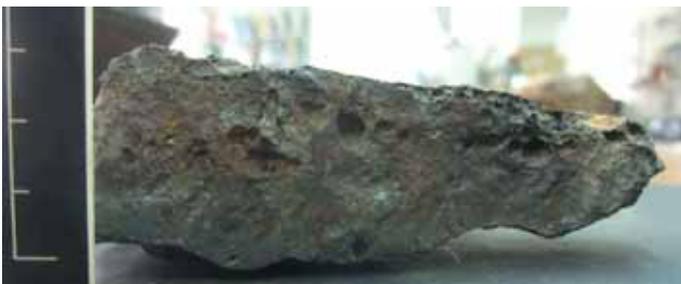
Figure 9: Side view of sample #50, which probably derives from refining

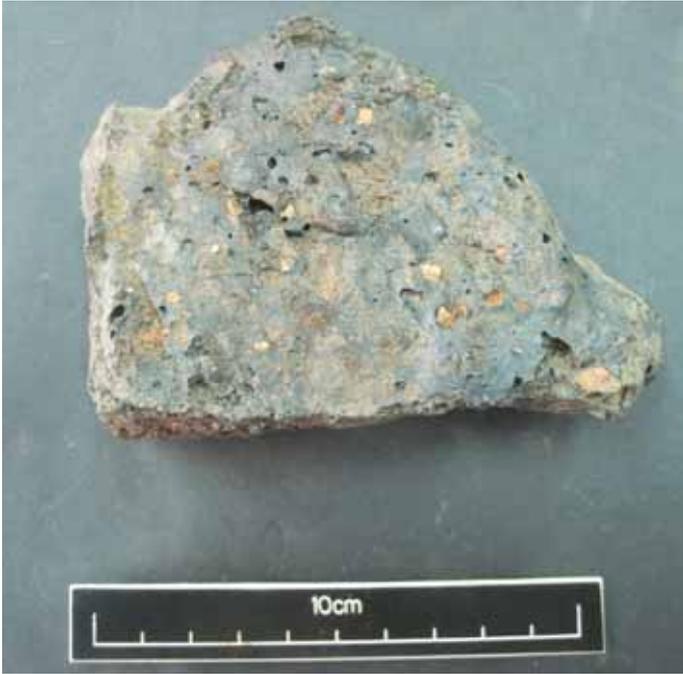
Figure 10: Plan view of sample #50, which probably derives from refining

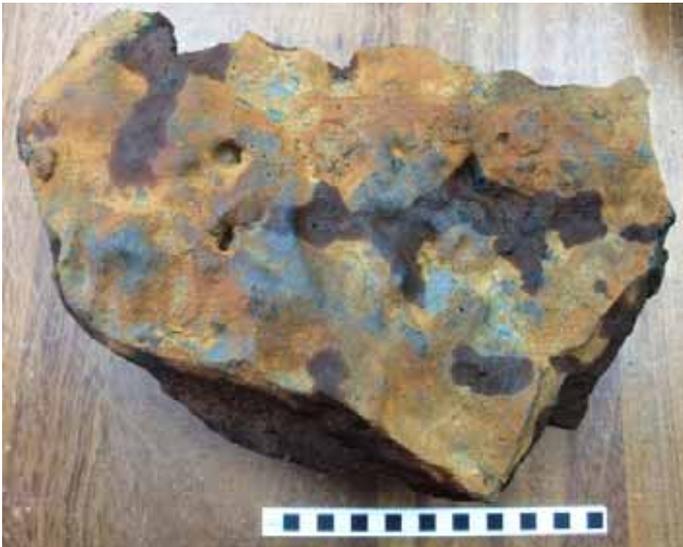
Figure 11: Upper surface of a large mass of puddling slag adhered to the hearth lining (sample #67)

Substantial quantities (~13kg) of **hearth lining** were identified. This largely comprised sandy ceramic bricks typically 50 by 100mm, fired to a grey or purple colour and sometimes permeated by fayalitic slag on the inside. The outer layers were orange and oxidised fired (Figures 11 and 12).

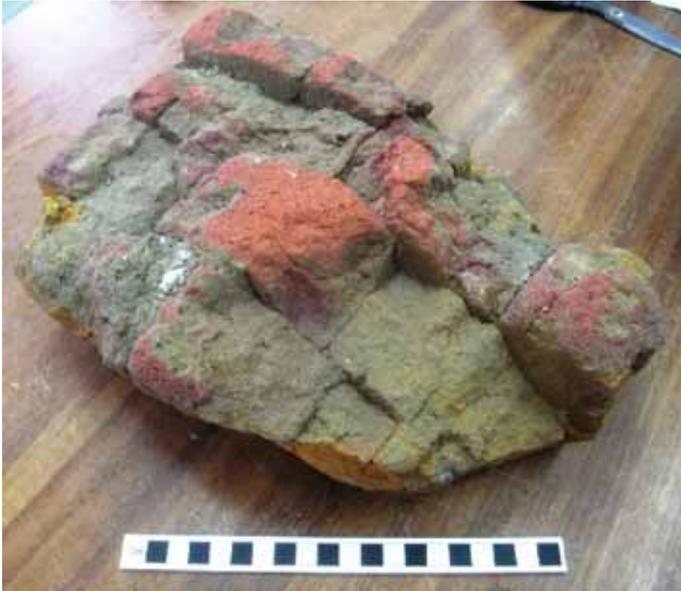
Figure 12: Lower surface of sample #67 showing that the hearth lining made up of small individual bricks (grading from orange oxidised-fired to purple then grey towards the inside surface of the hearth)

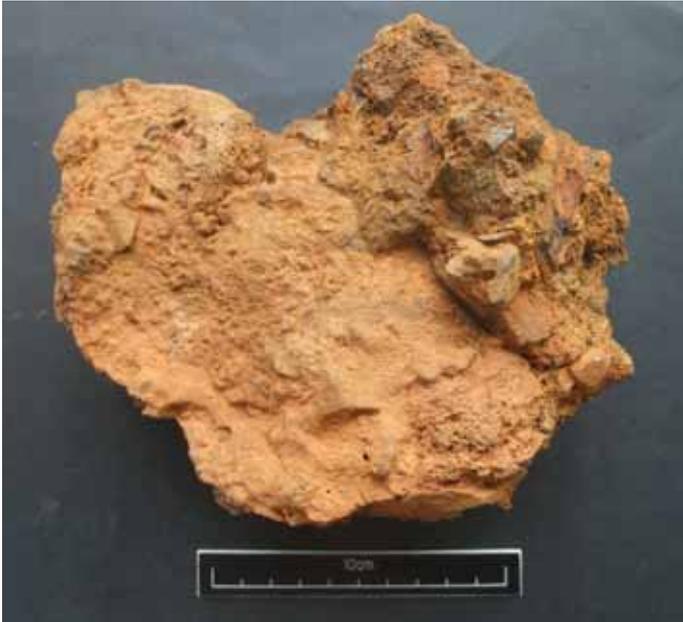
Figure 13: Plan view of sample #10, a large mass of dense fayalitic slag with adhering hammerscale and concretions.

A very small proportion of the fayalitic slag did not have flowed surfaces. This dense slag has probably derived from a foundry process and is discussed further later. The only substantial sample was #10, a 1.7kg lump lacking the distinctive flow patterns of the puddling slag. It had a rusty appearance, bowl-shape, fairly low porosity and was covered by concreted smithing waste including hammerscale (Figure 13).

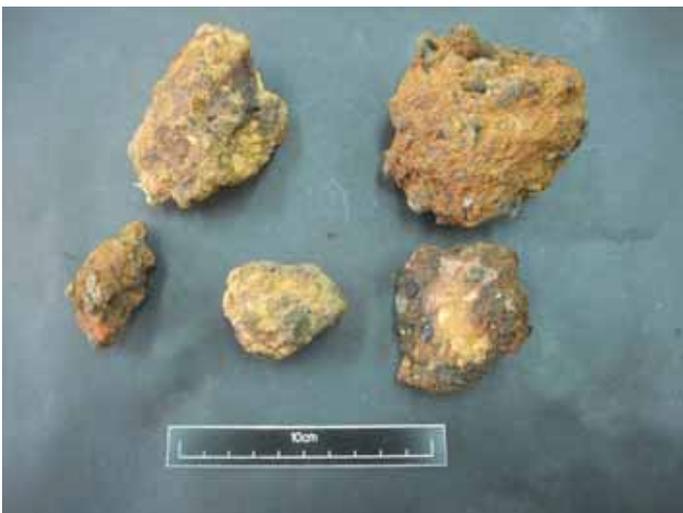
Figure 14: Iron concretions, including sample #66 (top right).

5.4kg of the material submitted for examination consisted of corroded iron metal often with a mixture of concreted material (Figure 14) including slag, sand, stone, charcoal, coke/coal and hammerscale, labelled **Fe and Fe conc** in Table 1. Hammerscale is a microslag formed during smithing and comprises small spheres and flakes, largely made up of iron oxides (Bayley *et al*/2001). Some of the metal fragments were pieces of objects.

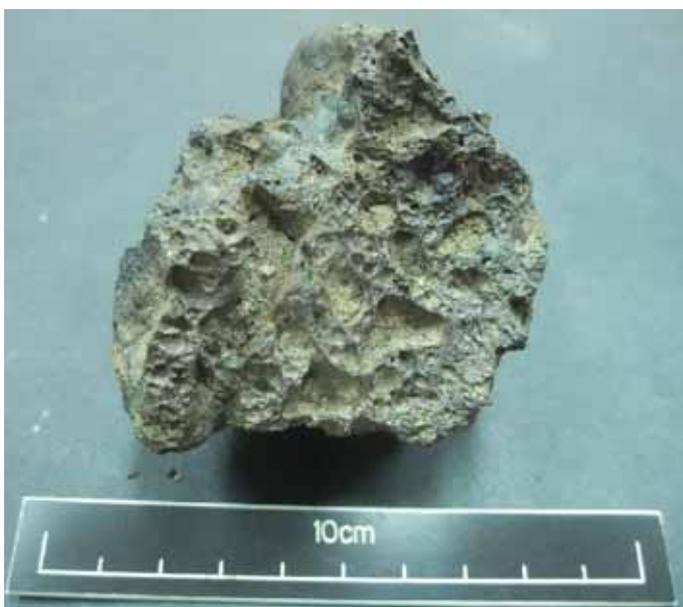
Figure 15: Bubbly fayalitic slag sample #43

1.5kg of **bubbly fayalitic slag** (Table 1) was recovered. This slag varied widely in appearance. Most of it was iron-rich, amorphous and bubbly with some evidence of flow on the surface (Figure 15). Some fragments were also heavily stained green due to copper corrosion products and had pieces of orange-fired ceramic incorporated (Figure 16). Several pieces of bubbly slag had adhering hammerscale and contained within them broken pieces of more dense fayalitic slag.

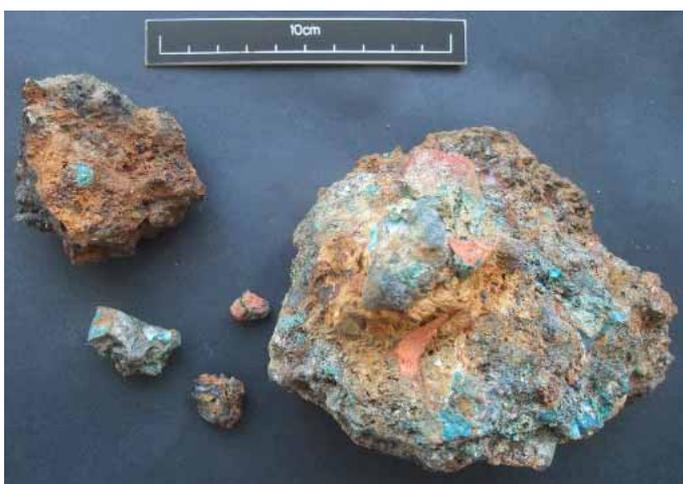
Figure 16: Bubbly fayalitic slag with green staining from copper corrosion products and adhering orange-fired fragments of ceramic (sample #6)

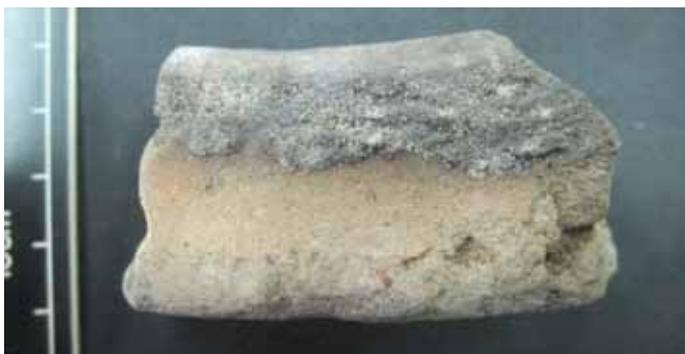
Figure 17: A plan view of a fragment of mould sample #47, with the internal surface to the top and external surface to the bottom and a raised ridge of residue along the rim.

A very small amount (~0.3kg) of heated sandy ceramic was recovered from three contexts. This material was fine-grained, with smooth, reduce-fired interior surfaces, and was tentatively identified as fragments of mould from metal casting. There were slight colour variations possibly indicating heating or heat damage to the surface. The top surfaces were completely flat but the outer surfaces were often missing. The only complete section was 30mm thick (Figure 17).

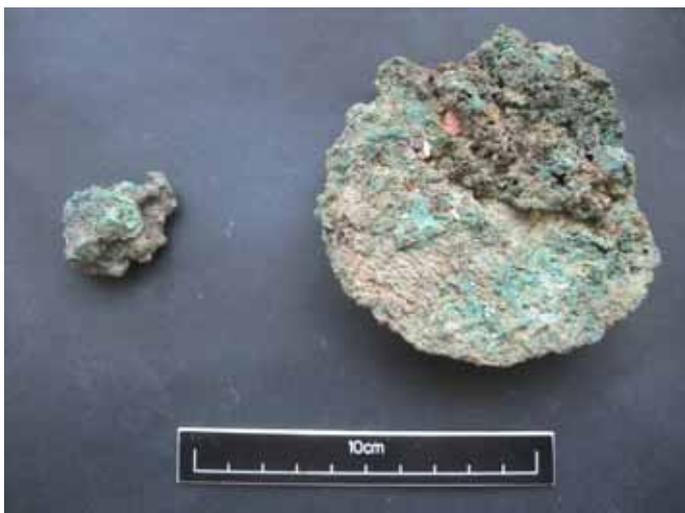
Figure 18: Copper alloy lump, left, and right, sample #5, a hemispherical mass of leaded bronze

The assemblage included several fragments of copper (Cu) alloy including pieces of finished artefacts and amorphous lumps. A hemisphere of metallic copper alloy was identified as the possible fill of a ladle (Figure 18).

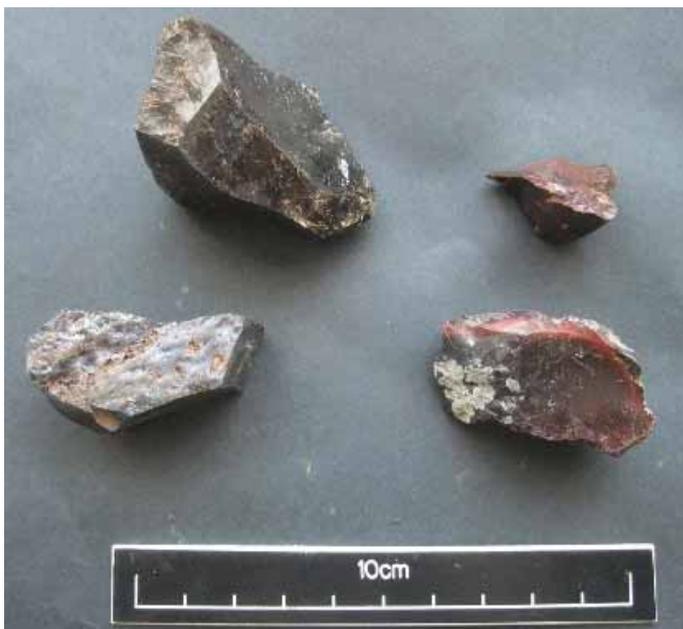
Figure 19: Glassy copper slag (sample #2 is top left)

150g of this material were recovered from context [1]. The analytical results, discussed later, suggest that this slag was probably produced in a copper foundry, using a reverberatory furnace for heating and casting copper alloys (Figure 19).

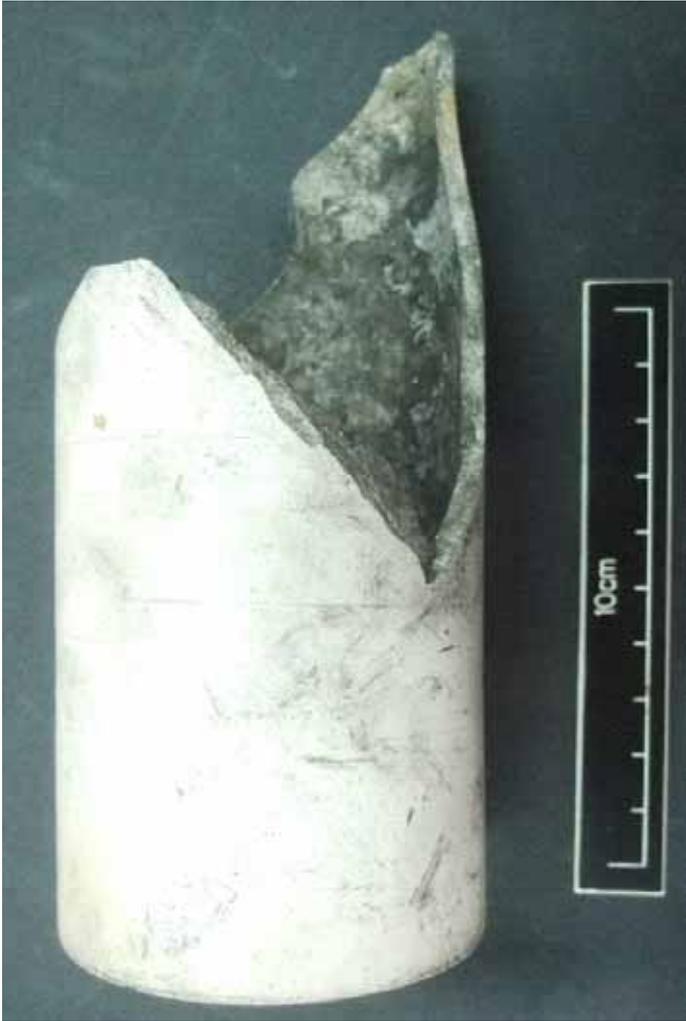
Figure 20: Ceramic vessel sample #52

Some of the material submitted for examination did not fit into the previously described categories (Table 1). This included fragments of one or more white ceramic vessels containing a dark grey charge (Figures 20, 21 and 22), as well as a dark grey rectangular plate (Figure 23). The best preserved ceramic vessel (Figure 20) is cylindrical, 62mm in diameter and surviving to a height of 150mm with thin walls (3mm) and a flat base. The fabric is fine-grained and refractory but there was no evidence of heating. A maker's stamp 'Bailey & Co London' near the base (Figure 21) indicates that it was made at the Fulham pottery between 1864 and 1888 (Green 1999, Figure 130k). The contents (Figure 22) comprised small fragments of a dark grey material exhibiting numerous lustrous fracture surfaces. Samples of the vessel, its contents and the rectangular plate (Figure 23) were taken for scientific analysis (Table 2).

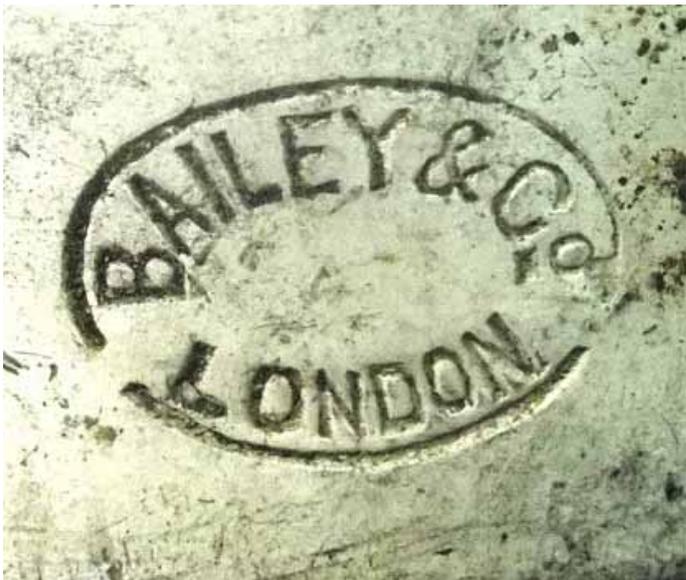
Figure 21: Close up of the stamp on sample #52

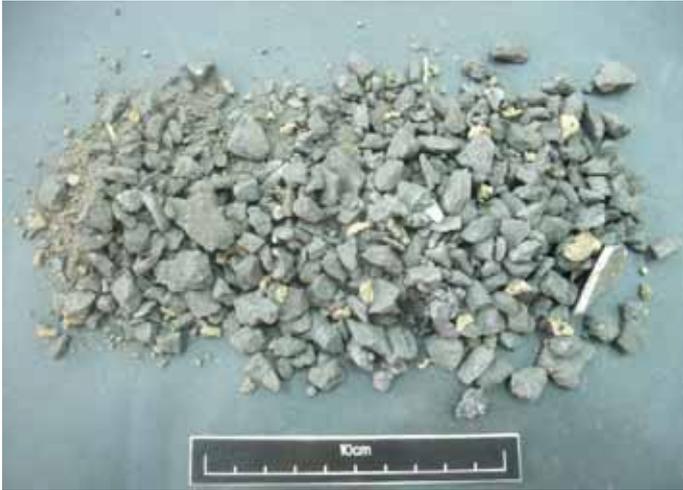
Figure 22: Contents of the ceramic vessel sample #52

The contents of the vessel (sample #52) are made up of two different materials. Both are dark grey with lustrous fracture surfaces but one is softer and has a lower density than the other. The soft, low density material was designated #52-1 and the harder, higher density material #52-2. The XRD spectrum for sample #52-1 produced three very broad peaks corresponding to the main peaks for plumbago/graphite (C): $2\theta = 26.5^\circ, 44.7^\circ$ and 54.5° . The severe XRD peak broadening is likely to result from stacking faults typical of materials like graphite (Dittrich and Wohlfahrt-Mehrens 2001). The SEM examination of sample #52-1 showed 'artichoke-like globular structures' (Jaszczak 1995) typical of lump graphite of hydrothermal origin (Figure 41). The SEM-EDS analysis of #52-1 identified carbon with only traces of other elements (iron, sulphur, silicon and oxygen).

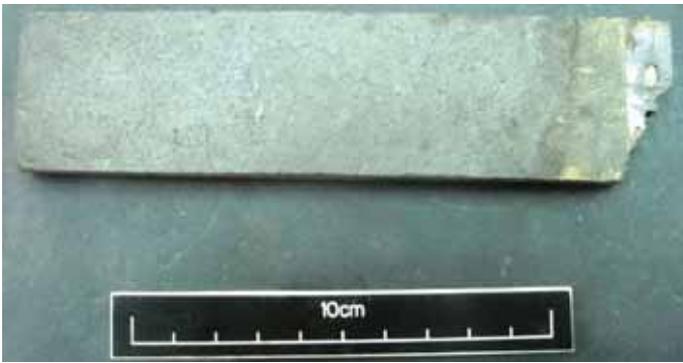
Figure 23: Rectangular artefact (#55)

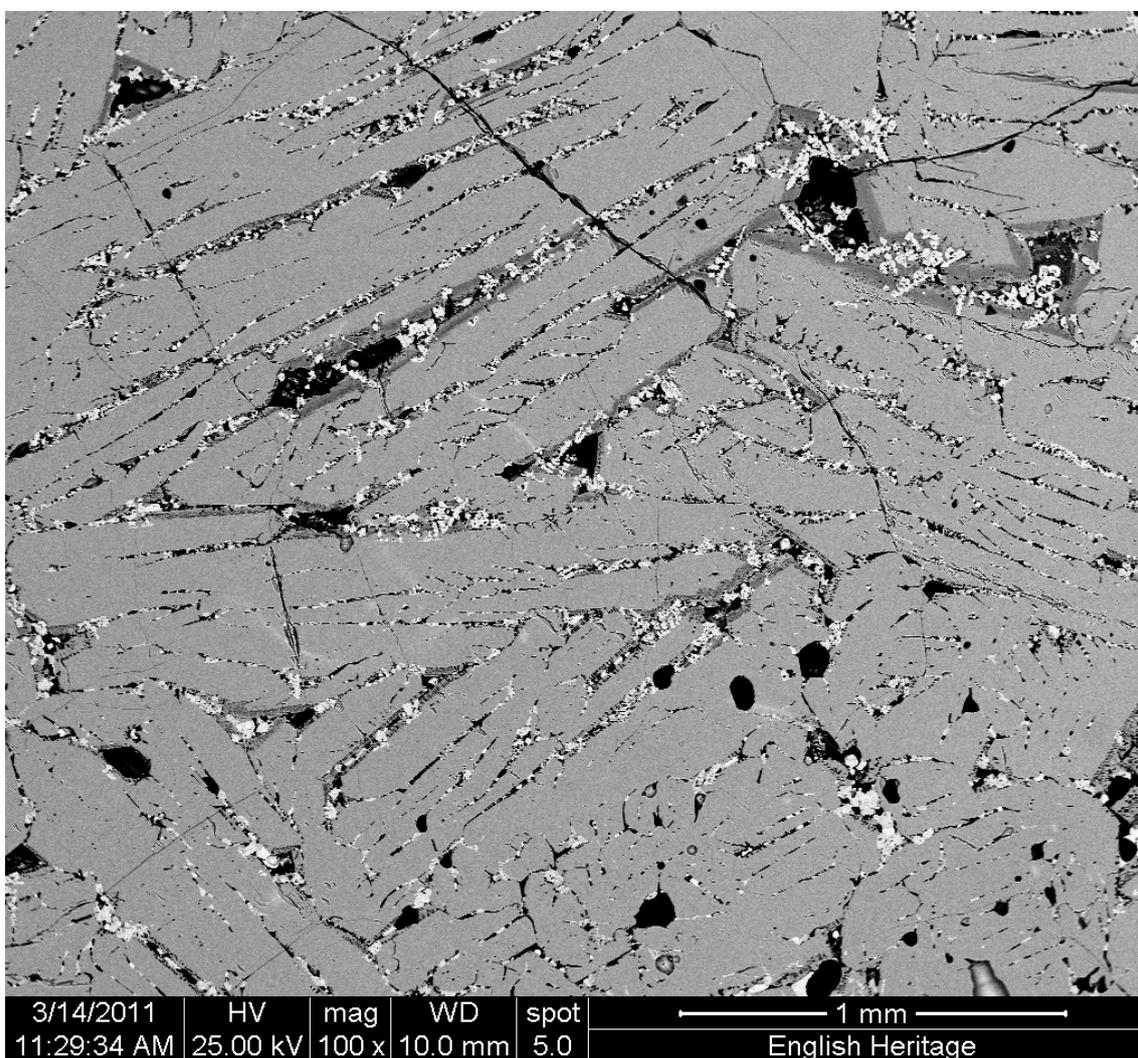
Figure 24: SEM image (back-scattered electron) of sample #11 dominated by large fayalite crystals (grey) with occasional dendrites of magnetite (white)

These flowed fayalitic slags made up the vast majority of the assemblage from Downside Mill. This slag (Figure 24) is dominated by fayalite, the margins of which often display finely dispersed inclusions of a silica phase (Figure 25). The very low concentrations of minor oxides, such as the alkalis, in these samples (Table 3) distinguish them from bloomery smelting slags (Paynter 2006; cf Killick and Gordon 1987). The presence of magnetite suggests an oxidising process such as iron conversion (Table 4). The low levels of sulphur and alumina in most of the samples are indicative of a reverberatory furnace. These slags are therefore likely to be waste from dry puddling and are very similar in terms of their composition and microstructure to slag from known puddling sites.

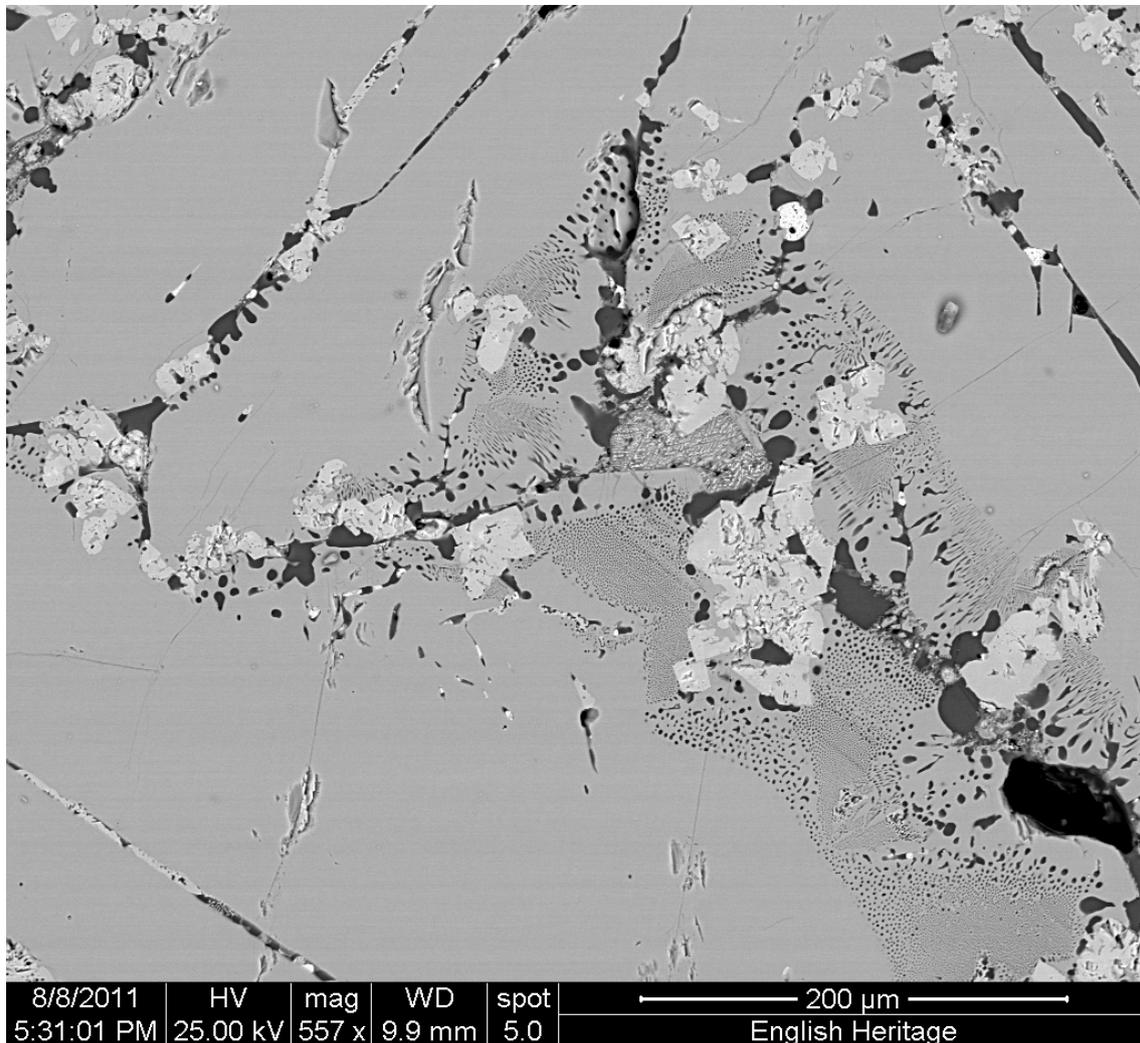
Figure 25: SEM image (back-scattered electron) of sample #11 at higher magnification, showing fayalite (grey), with fine silica phase (dark grey) in the fayalite towards the edges, in a matrix of magnetite (light grey and angular), iron sulphide (white spheres), leucite (dark grey) and glass (mid-grey)

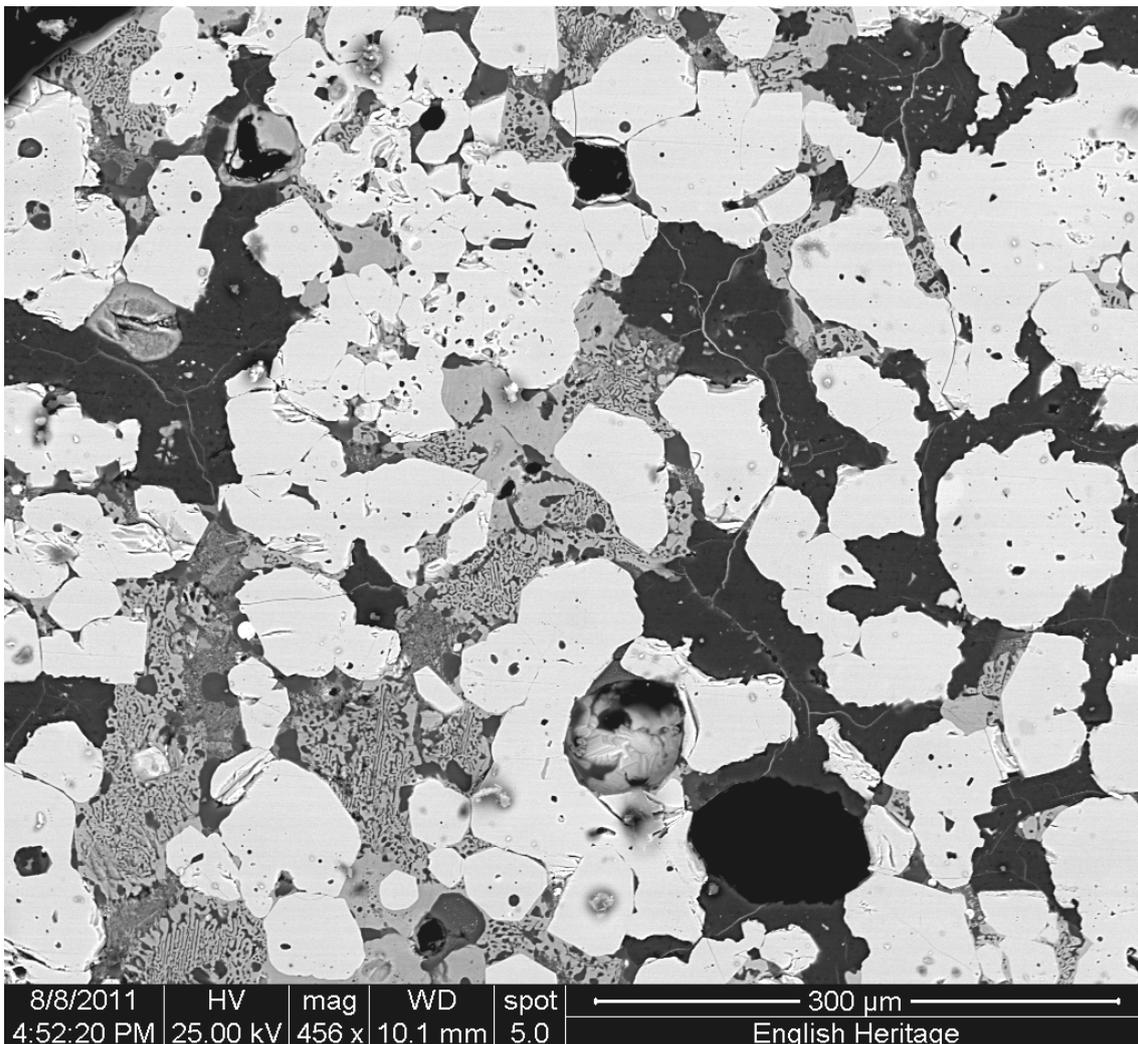
Figure 26: SEM image (back-scattered electron) of sample #21-1 showing magnetite (white), fayalite with inclusions of silicate phase (mid-grey with dark grey pattern), silica polymorphs, probably tridymite (dark grey), a matrix of eutectic glass and fayalite (mid-grey) and voids (black)

Sample #21-1 comprises slag adhering to one of the pieces of hearth lining (sample #21-2). The overall chemical composition of this sample is very similar to samples #11, #15 and #37 but the microstructure contains considerably more magnetite and silica polymorphs (Figure 26; Table 4), representing an earlier stage in the process of puddling slag formation. The quartz derives from the quartz-rich hearth lining, which is described further below. The size, shape and distribution of the silica polymorphs indicate that these have crystallised from a melt (Baldwin 1954). Photos-Jones *et al* (2008, 171–173) note the presence of both silica polymorphs and iron oxide in material from Monklands that was interpreted as ‘fettling’, that is the lining of a puddling furnace. Very similar microstructures are illustrated by Killick and Gordon for the 19th-century puddling slag from Roxbury (Killick and Gordon 1987).

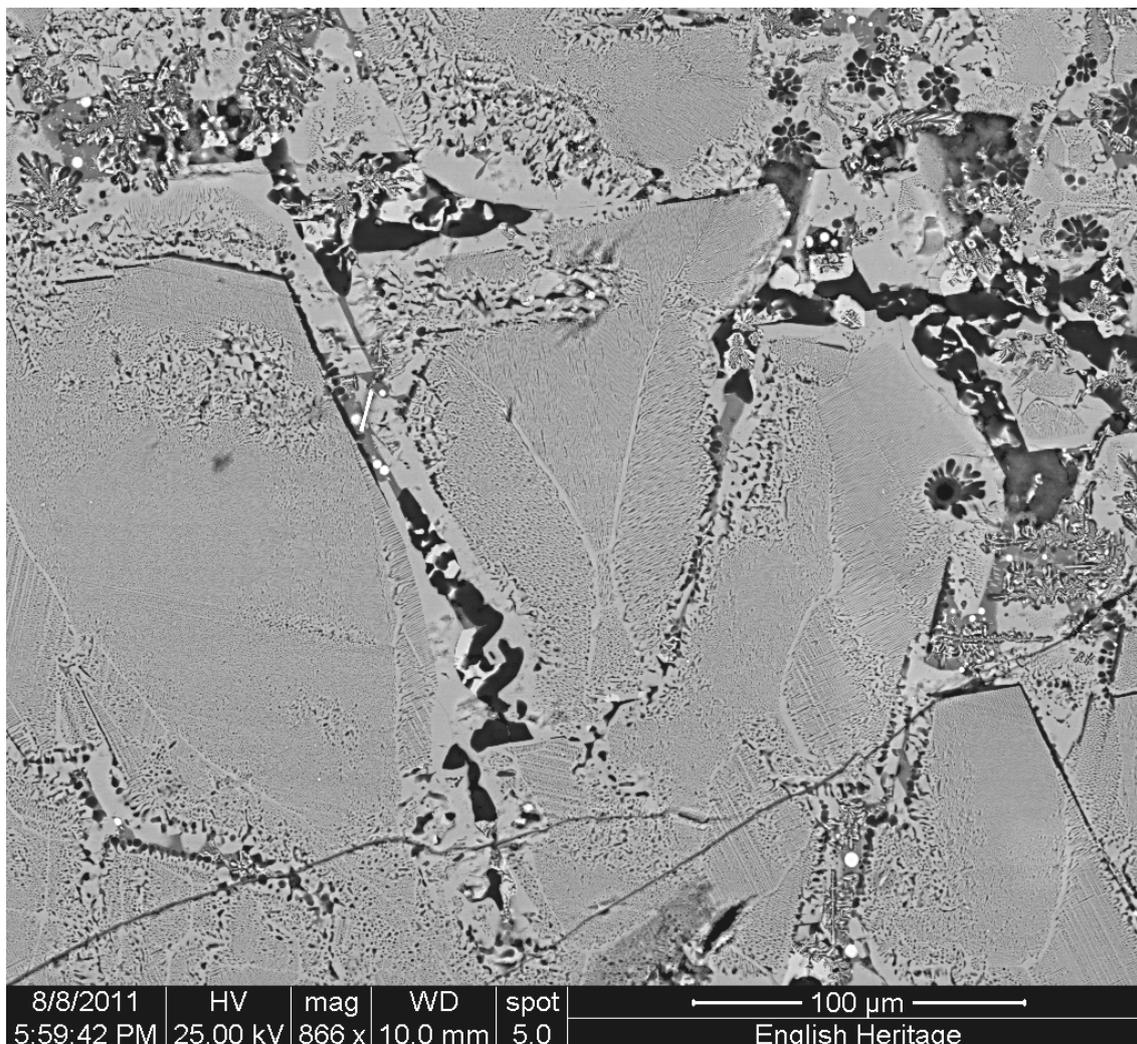
Figure 27: SEM image (back-scattered electron) of sample #18 showing fayalite containing inclusions of a silicate phase (mid-grey with dark grey patterning), magnetite (angular light grey crystals), iron sulphide (white spheres), silica polymorphs (black angular tridymite and possible spherulitic cristobalite) and a glass matrix

A small subset of samples had atypical shapes (samples #18 and 50) and slight compositional differences from the flowed fayalitic slag in that they contained higher levels of manganese and slightly elevated levels of phosphorus and sulphur (Table 5). Similar phases were present in these slags as to the puddling slags however (Figure 27, Table 6), suggesting that they were also waste from an oxidising process in a reverberatory furnace.

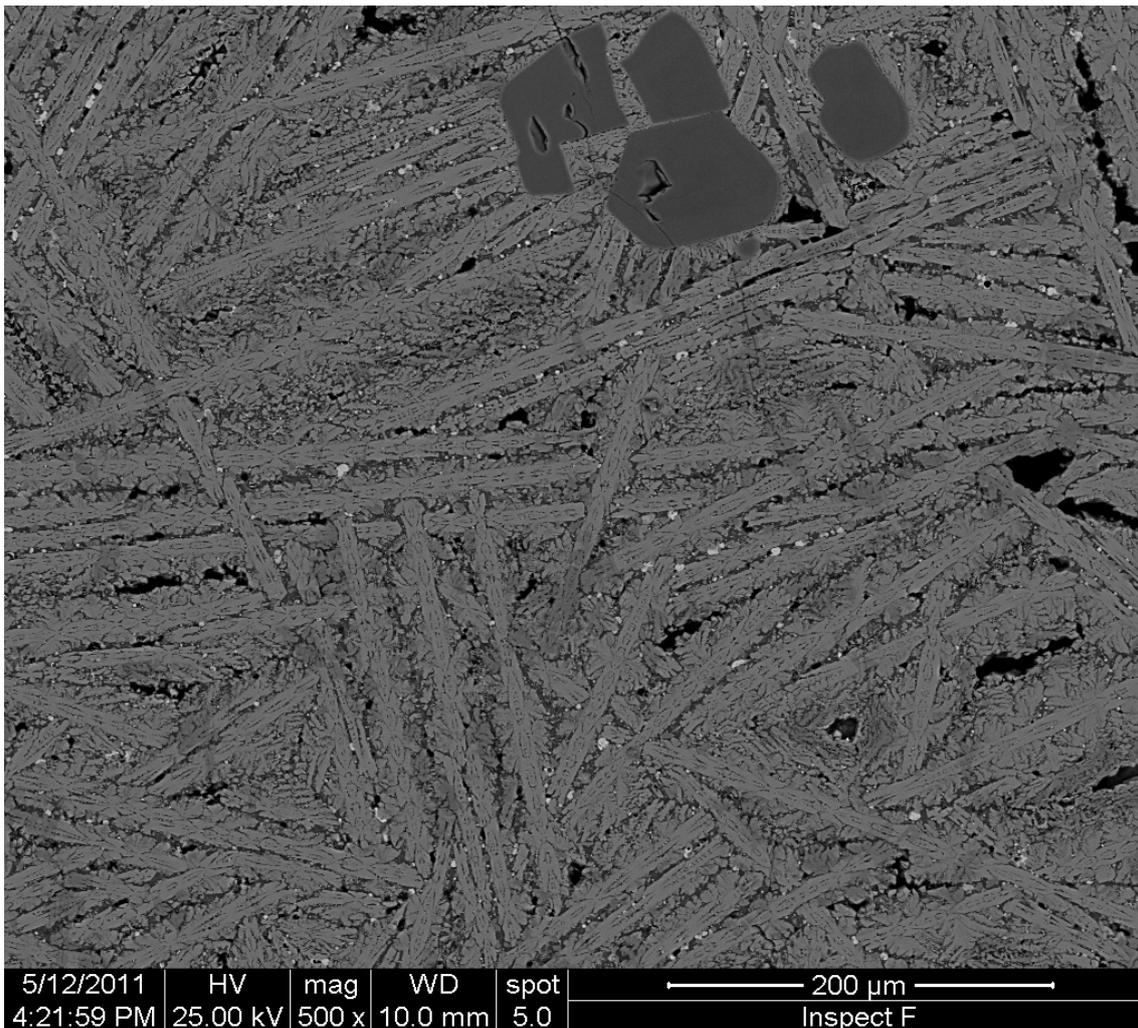
Figure 28: SEM image (back-scattered electron) of sample #43 showing fayalite laths and occasional spinels (top of image)

Dense fayalitic slag samples #10-1 and #43 are distinguished from the other slags by both their microstructures and chemical compositions. There is abundant fayalite but this tends to be present as long thin laths (Figure 28) indicating relatively fast cooling. Spinel and iron sulphide are also present due to the high alumina and sulphur contents respectively (Table 8).

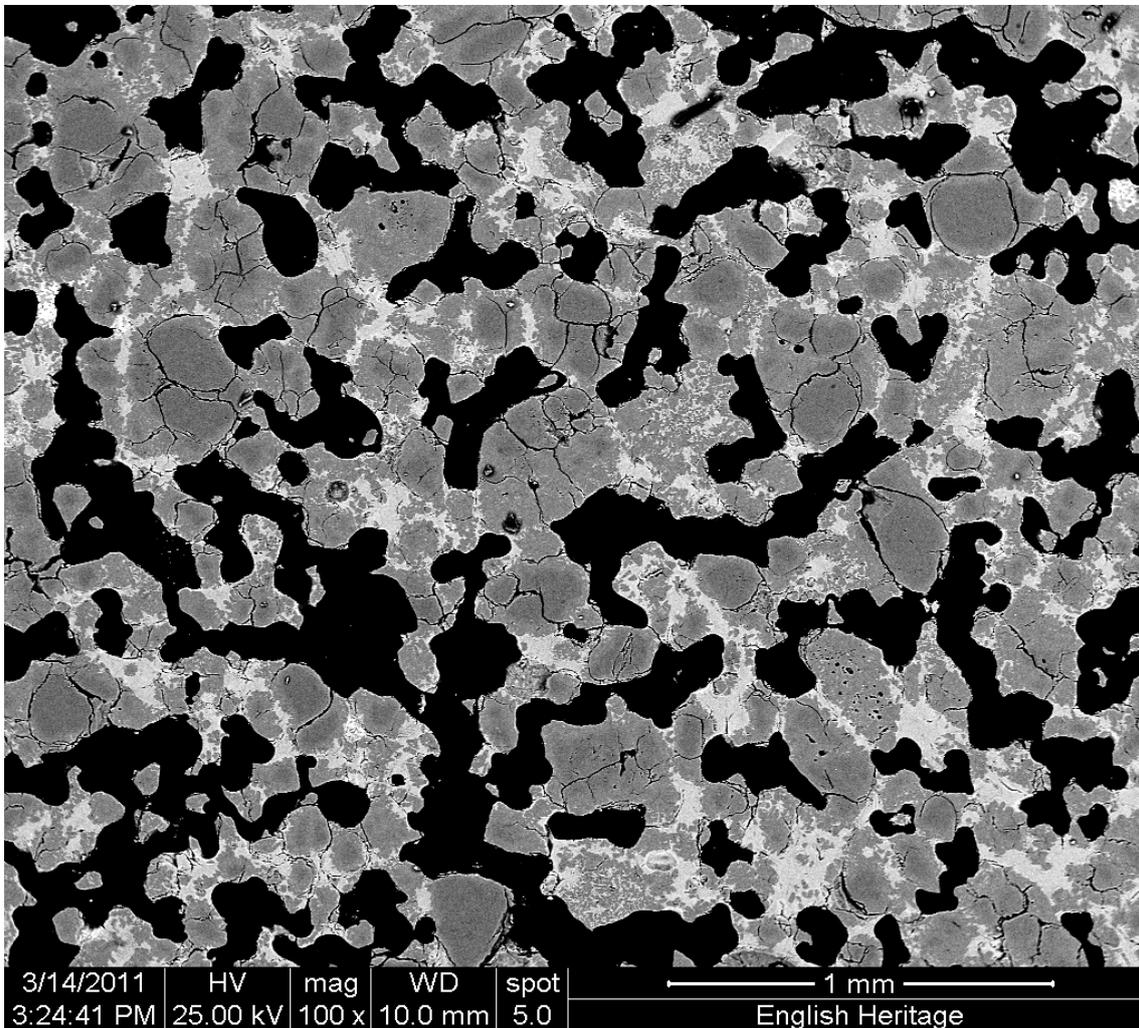
Figure 29: SEM image (back-scattered electron detector) of hearth lining (#27) showing dissolving quartz grains (grey, rounded and cracked grains) and silica polymorphs (small grey crystals) in a glassy matrix (light grey) with some porosity (black)

The puddling hearth was lined with a quartz-rich material. Two samples (#27 and #67) give some indication of the chemical composition of the ceramic as manufactured and contain 90wt% silica (Table 10). This material would be sufficiently refractory to withstand prolonged exposure to high temperatures. The hearth lining fragments had similar microstructures (Figure 29) consisting of abundant silica polymorphs (XRD analysis indicated the presence of quartz, tridymite and cristobalite) and a vitrified matrix. These microstructures have developed through the reaction of the lining with iron-rich slag and prolonged exposure to heat. The elevated concentrations of manganese in #70 and iron in #21-2 are due to the lining being permeated by slag. The range of phases present (in particular the silica polymorphs) suggests the furnace would have operated at temperatures in excess of 1300°C.

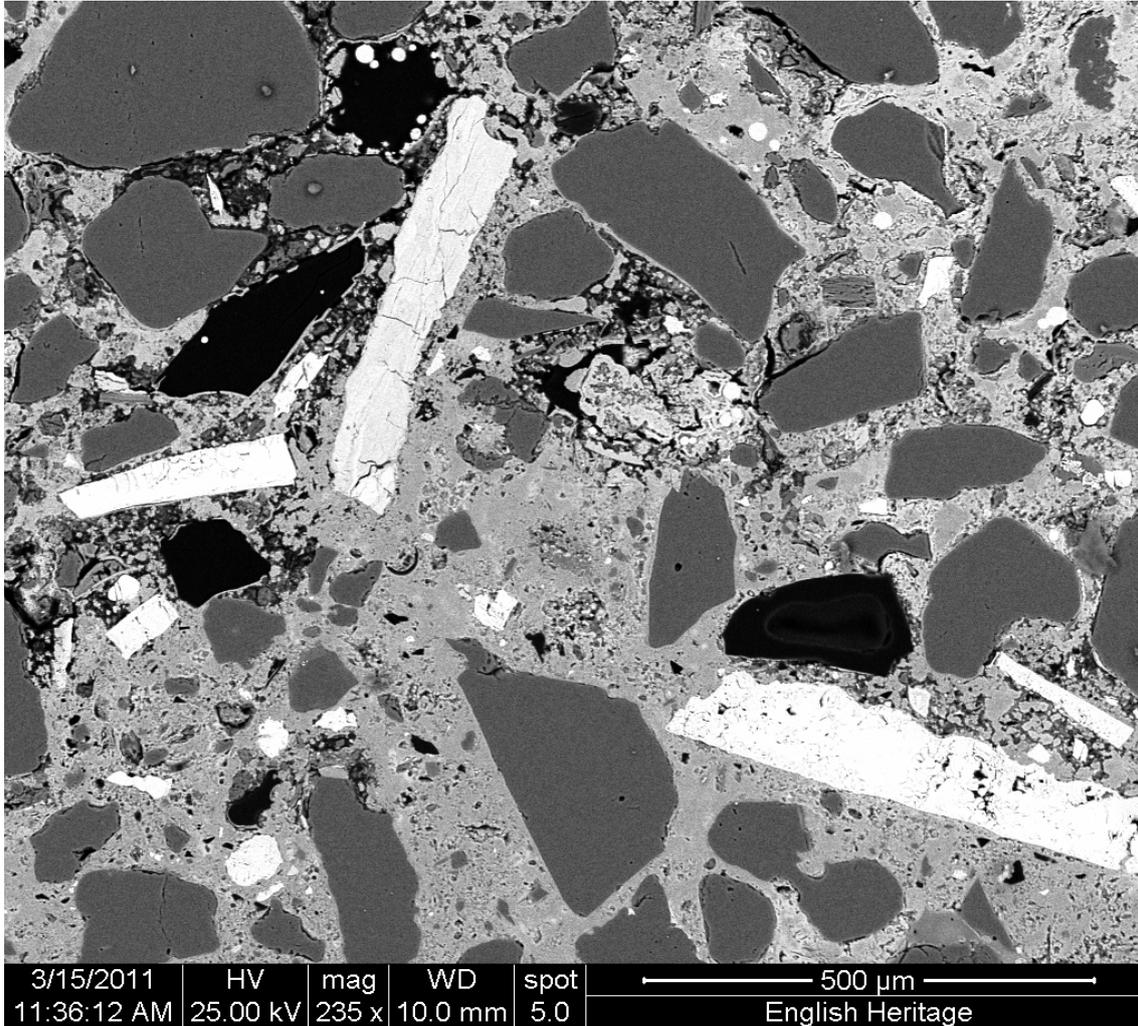
Figure 30: SEM image (back-scattered electron) of sample #66 showing iron oxide-rich hammerscale (white rectangular masses), quartz grains (dark grey and the black inclusions mineral fuel (black) in a light grey matrix made up of corrosion products.

phosphorus, sulphur and manganese (Table 11) in much of the hammerscale suggests that it was produced during foundry casting or puddling, for example as foundry spatter or as scale generated during the forging of the ball or bloom of iron produced in the puddling hearth. In sample #10, the scale is concreted around a mass of foundry slag, which supports this conclusion.
