DOWNSIDE MILL, COBHAM, SURREY ANALYSIS OF THE METALWORKING REMAINS

TECHNOLOGY REPORT

Research Department Report Series 43-2011

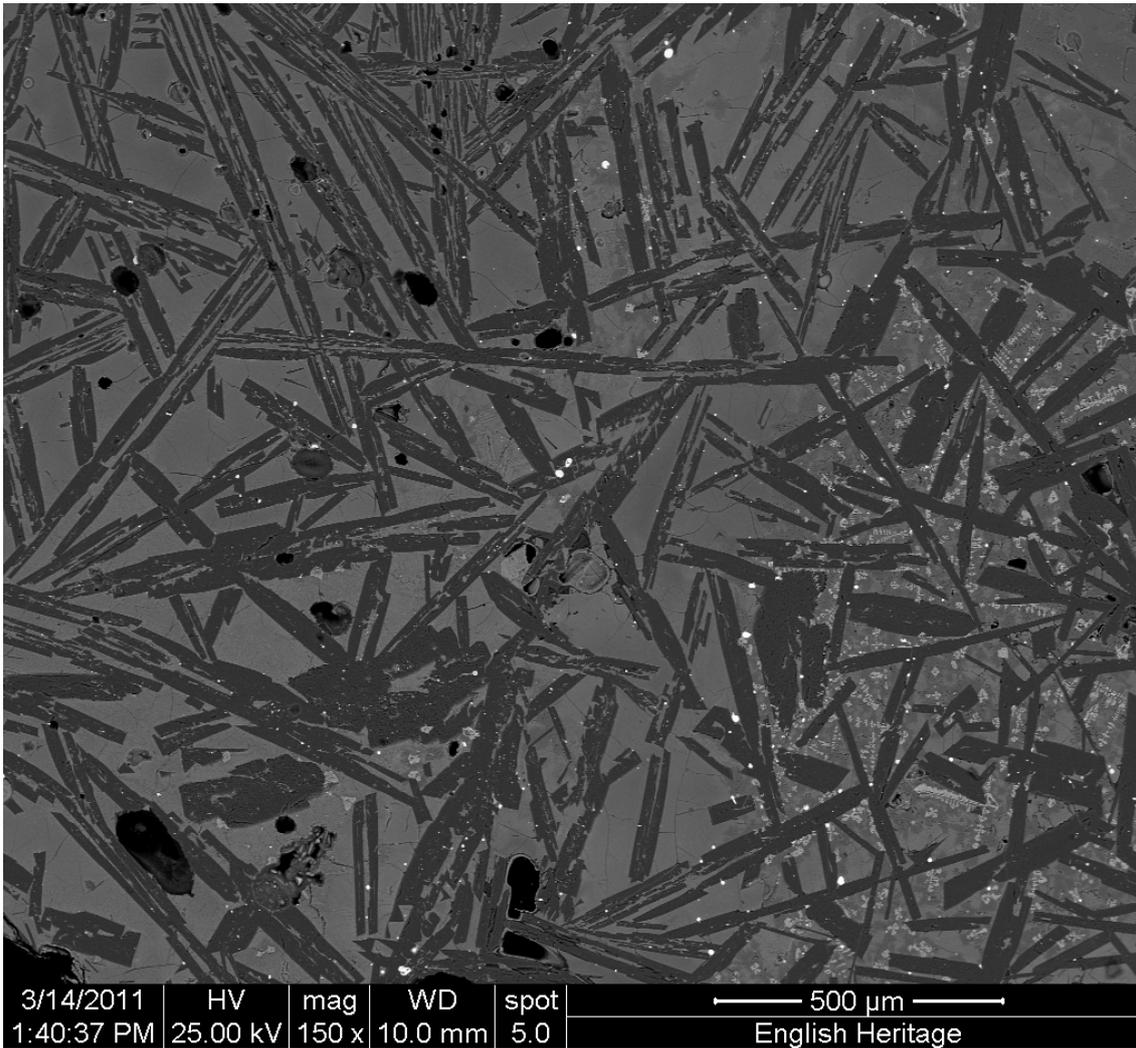
Figure 35: SEM image (back-scattered electron detector) of bubbly slag with green staining (#6)

The samples of bubbly slag were heterogeneous, often with pieces of ceramic or fragments of denser slag incorporated. Slag sample (#6) was green-stained indicating the presence of copper but also contained several fragments of denser slag. Analysis showed that these denser flows within sample #6 were dominated by laths of anorthite with occasional metallic copper droplets (Figure 35). The slag also contained a platy mineral fragment, probably derived from the use of mineral fuel. Some iron oxide scale was dissolving in the slag. Another region was made up of copper iron sulphide, which had been in contact with the slag whilst hot. The sample also included quartz-rich ceramic,

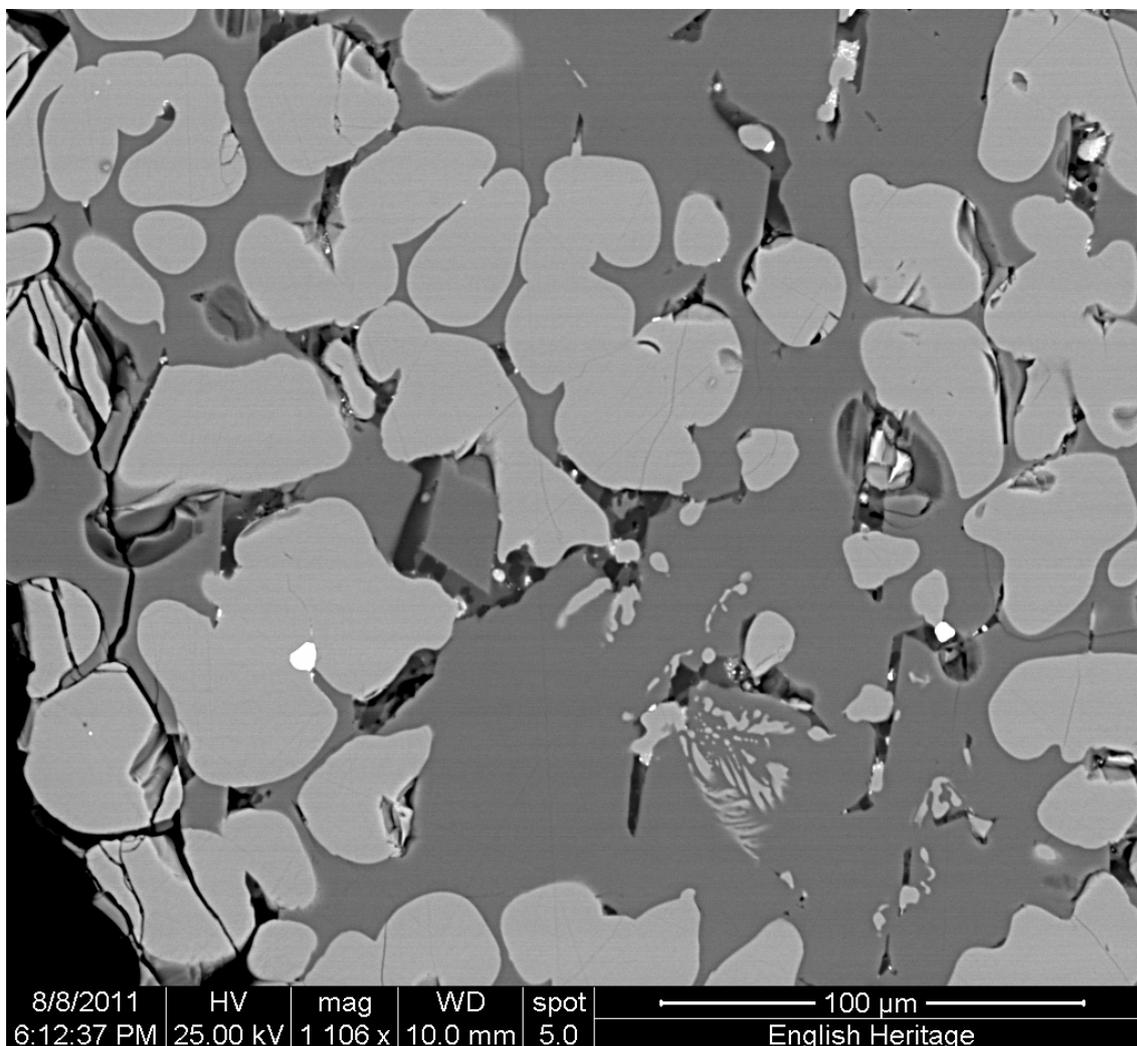
Figure 36: SEM image (back-scattered electron detector) of bubbly slag (#25) showing wüstite (light grey), fayalite (dark grey) and metallic tin / iron inclusions (white)

Sample #25 had no visible traces of copper alloy on its outside surfaces but examination at high magnifications revealed tiny metallic inclusions rich in tin and iron, with low levels of copper. These did not appear to be post-depositional contamination. The microstructure was again dominated by wüstite (Figure 36) with some fayalite.

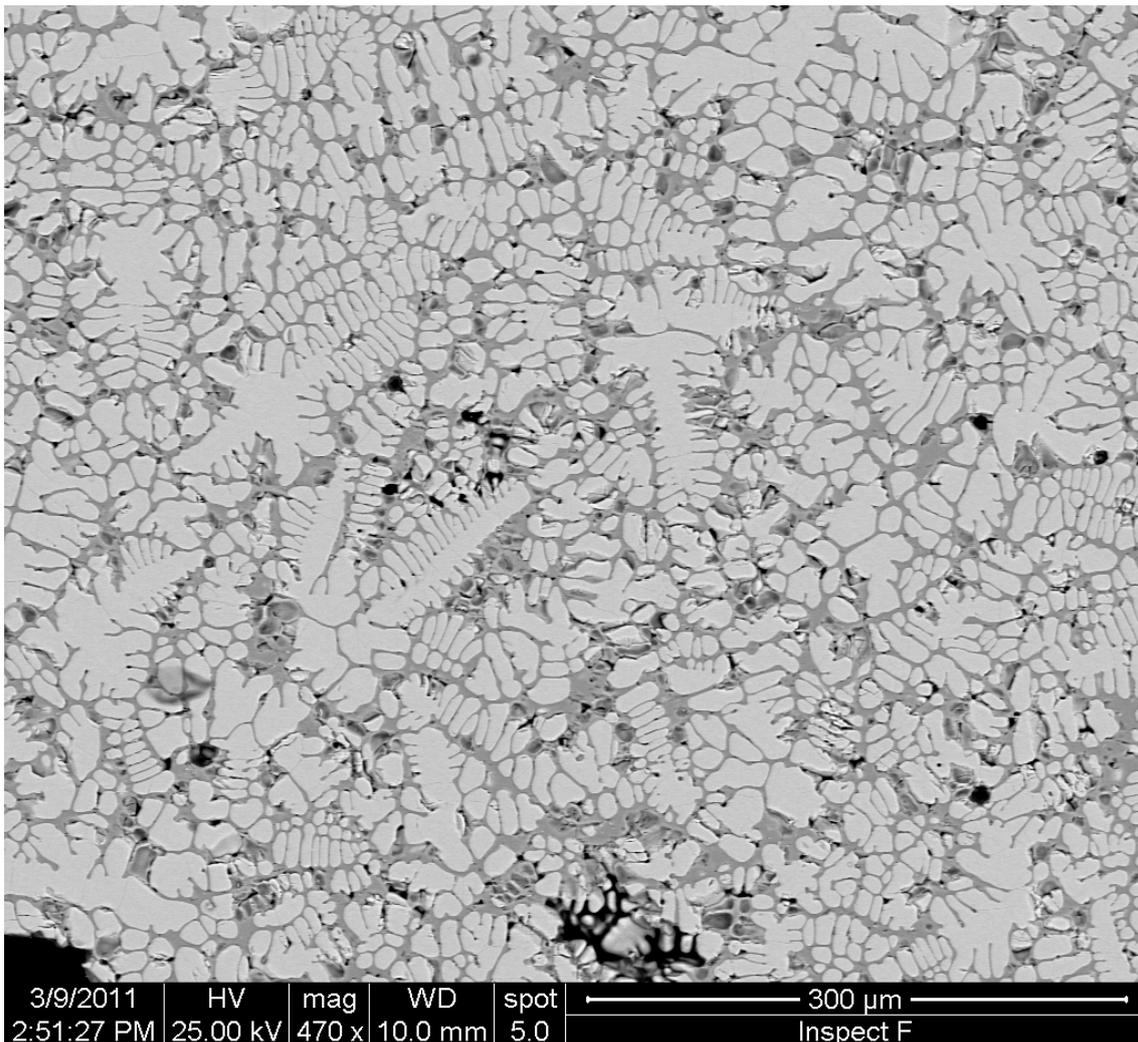
Figure 37: SEM image (back-scattered electron) of sample #8, showing a microstructure dominated by wüstite (light grey) with some fayalite (mid-grey)

The small runs of slag (sample #8) were also very iron-rich with a microstructure dominated by wüstite (Figure 37). These small runs are likely to be spatter from ironworking activity.

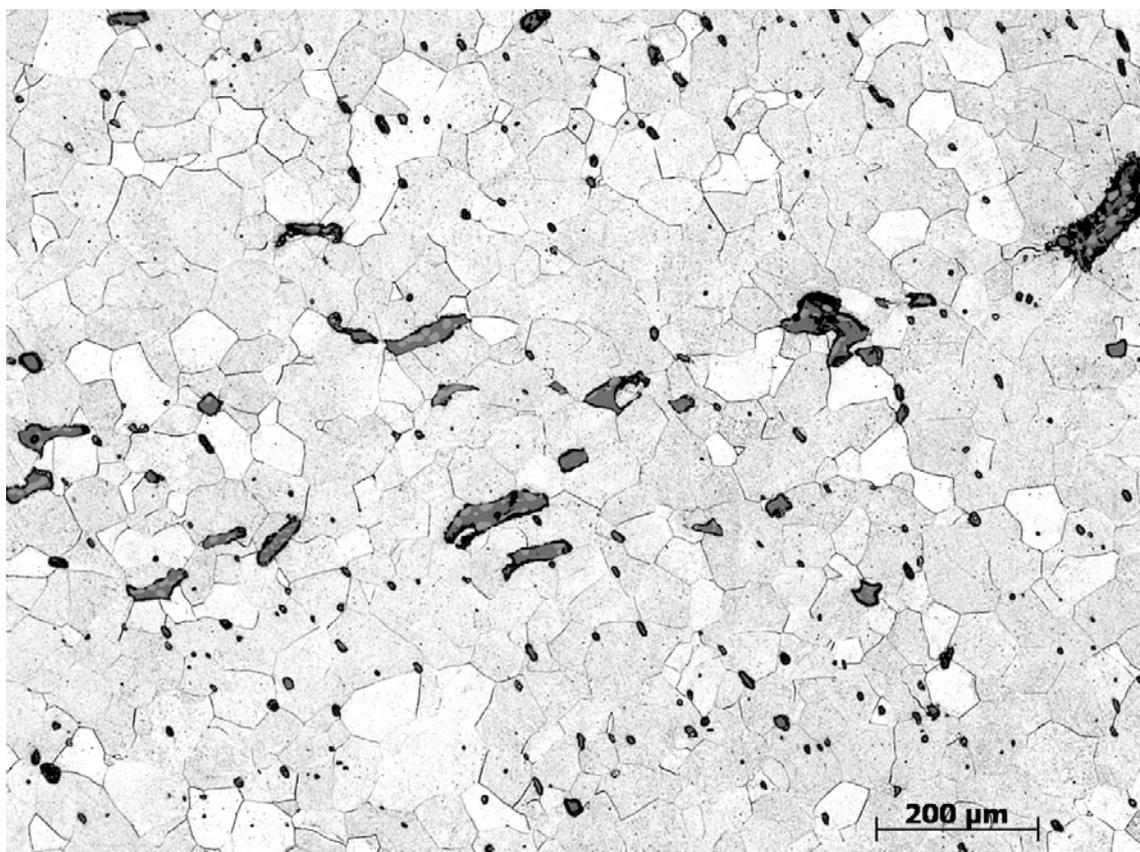
Figure 38: Optical microscope image of plain iron #68, showing grains of ferrite and slag inclusions

Three samples of iron were examined to determine their microstructure. One of these (#68) is a plain iron with little or no carbon but abundant slag inclusions (Figure 38). This microstructure is typical of wrought iron produced either in the finery/chafer furnace or a puddling furnace.

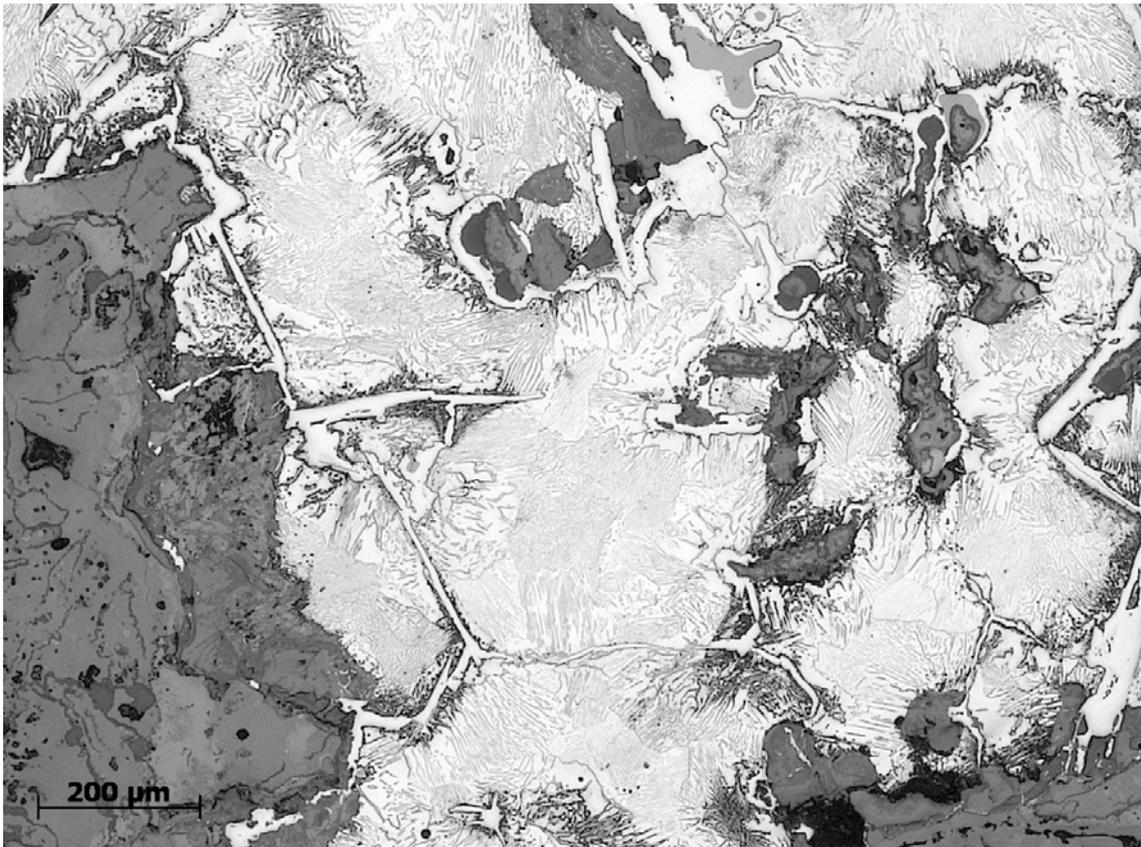
Figure 39: Optical microscope image of sample #14, showing pearlite, grain-boundary cementite and corrosion

The other two samples (#14 and #66) both have a microstructure which is dominated by pearlite with cementite (Figure 39). This microstructure is typical of hypereutectoid steels (ie those with more than 0.8% carbon) but overlaps with some low-carbon cast irons. The chemical analysis of these samples shows that one contains more silicon and manganese, and the other more sulphur, than would be usual for steels of the late 18th century or early 19th century (Table 12). The chemical composition is consistent with the samples being white cast iron; that is cast iron in which all of the carbon is present as cementite rather than pearlite. The presence of white (rather than grey) cast iron at Downside may indicate that the cast iron was routinely refined, that is melted to remove the silicon, prior to conversion to wrought iron in the finery.

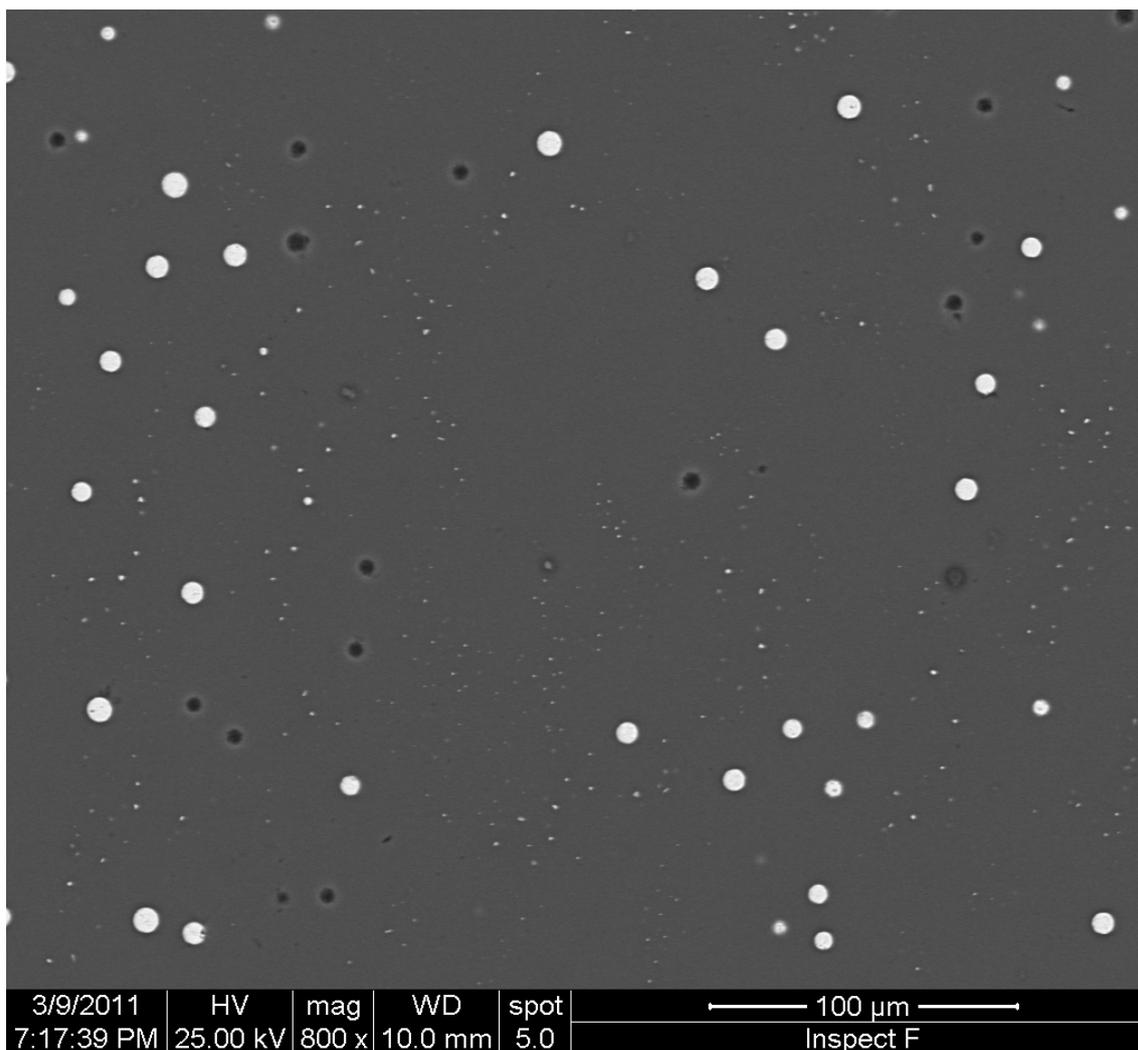
Figure 40: SEM image (back-scattered electron detector) of glassy copper slag (#2) showing the metal-rich droplets (white) in a glassy matrix (grey) with occasional voids (black)

The red glassy copper slag (#2) from Downside Mill is most likely to be foundry slag, from the melting and casting of copper alloys, such as bronze, in a reverberatory furnace. There was no clear archaeological or documentary evidence for copper smelting at Downside Mill. The copper slag comprised copper- and tin-rich droplets under 10 microns in size, in a glassy matrix (Figure 40, Table 14).

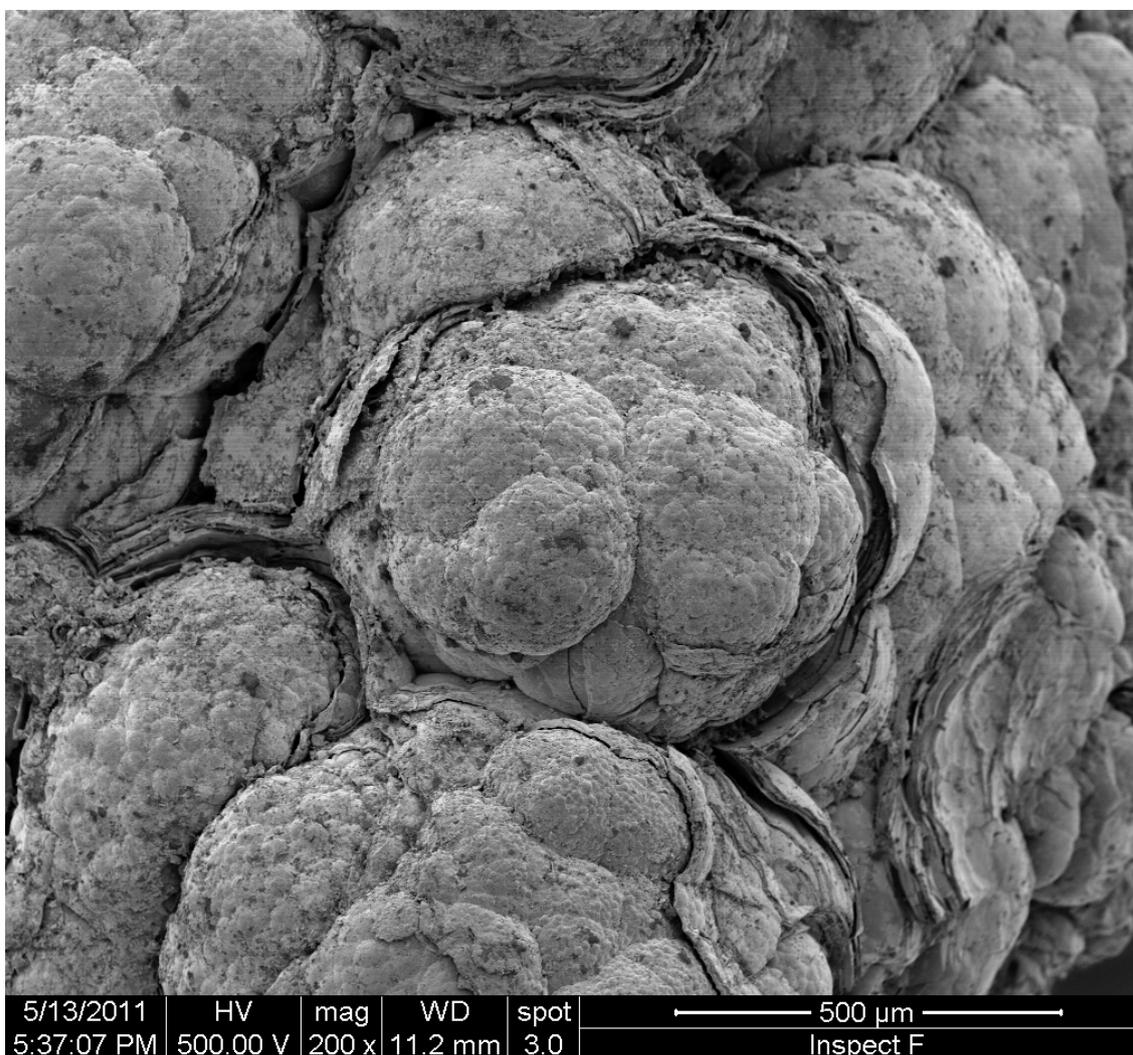
Figure 41: SEM image (secondary electron) of plumbago (sample #52-1)

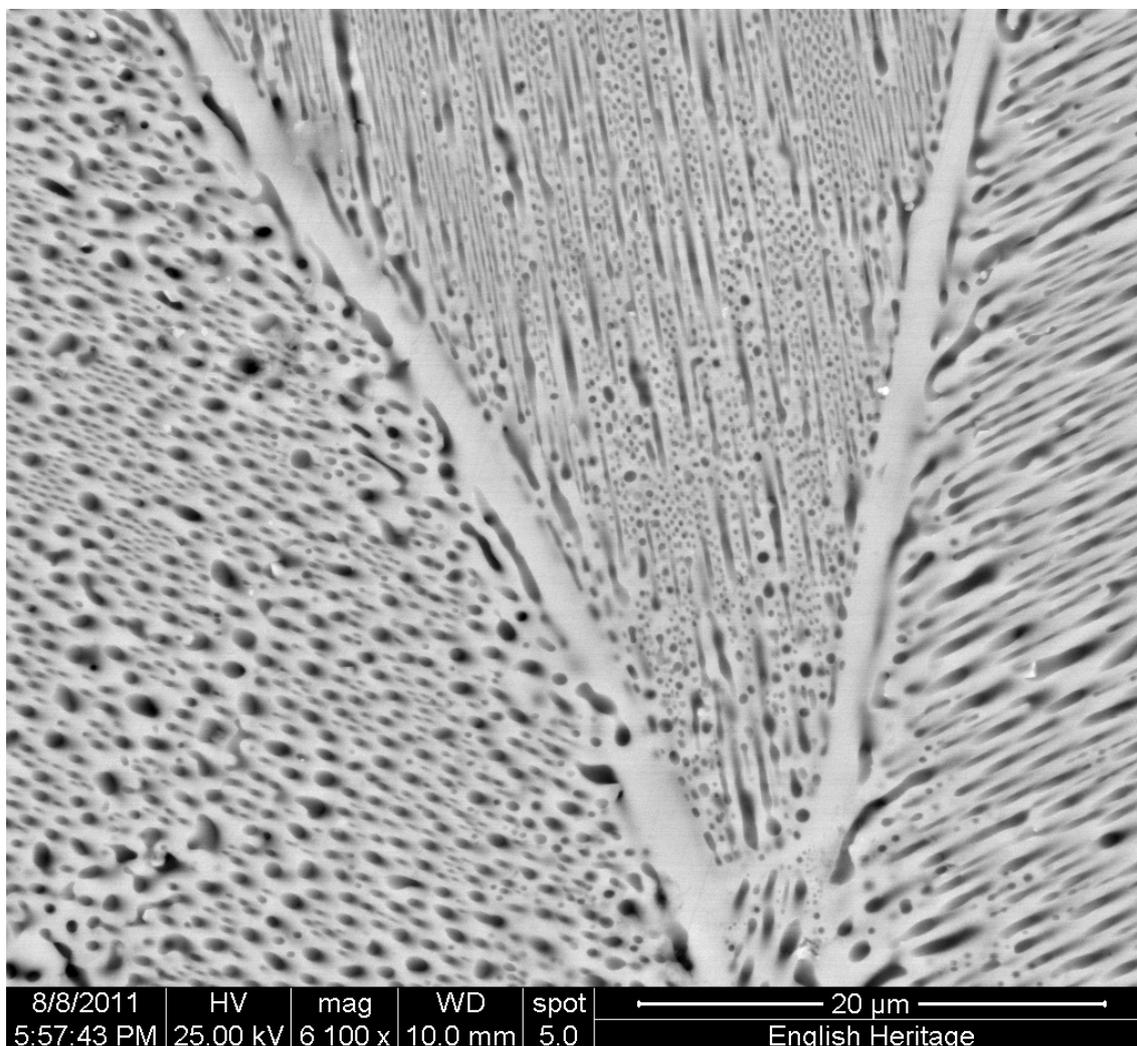
Figure 43: Back-scattered electron image showing the finely dispersed silicate phase (dark grey) dominated by potassium, aluminium and silicon oxides, in the fayalite (light grey) in sample #18

Many of the puddling slag samples had distinctive microstructures, where a finely dispersed silica-rich phase was present throughout the fayalite crystals or towards the edges of the crystals (Figure 43).

This microstructure was particularly common in samples that were richer in silica, for example samples from the interface between puddling slag and hearth lining (#21) or the samples interpreted as refining slags (#18 and #50) (Figure 43). Analysis of this phase was difficult, due to the small size of the features, but elevated levels of potassium, aluminium and silicon were noted relative to the fayalite, sometimes approaching the composition of leucite (KAlSi_2O_6) even though there are only low levels of potassium and aluminium oxides in these slags. Immiscible silicate liquids form over quite a large range of silica-rich compositions in the system $\text{FeO-SiO}_2\text{-Fe}_2\text{O}_3$, $\text{K}_2\text{O-FeO-SiO}_2\text{-Al}_2\text{O}_3$, etc. One explanation

for the microstructure observed in these slags is that two immiscible liquids formed at high temperatures. On cooling fayalite crystals precipitated from the liquid but tridymite did not and a silicate-rich phase persisted. The formation of immiscible silicate liquids would therefore result in the distinctive microstructures observed.

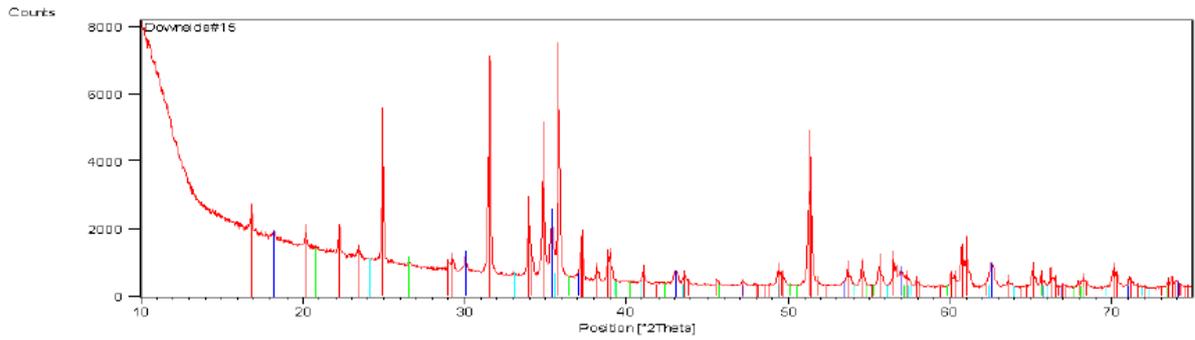
Figure 44: XRD analysis of slag from dry puddling (sample #15): red lines indicate fayalite, blue lines indicate magnetite, green lines indicate quartz and turquoise lines indicate haematite

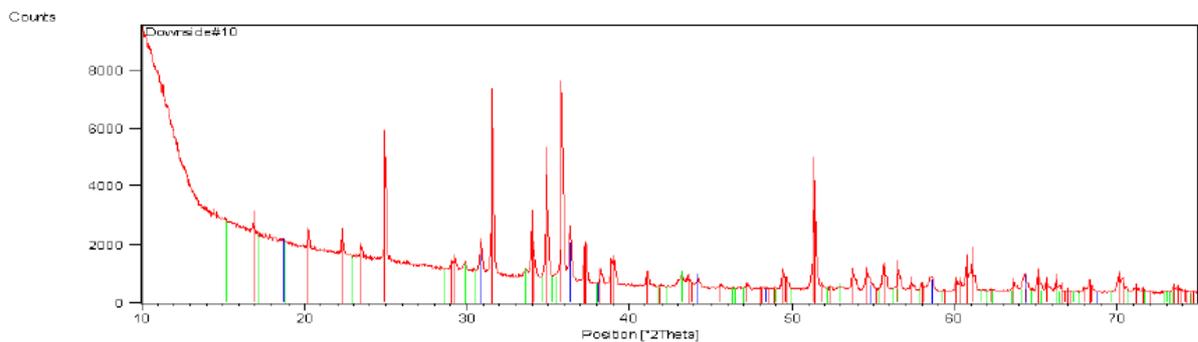
Figure 45: XRD pattern of slag probably from an iron foundry (sample #10); red lines indicate fayalite, green lines indicate iron sulphide and blue lines indicate spinel

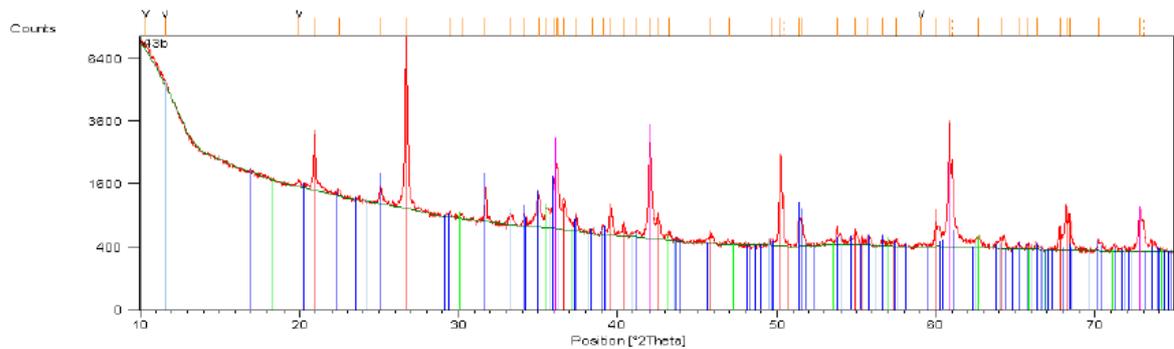
Figure 46: XRD analysis of slag probably from smelting (sample #43b); blue lines indicate fayalite, green lines indicate magnetite, pink lines indicate wustite, red lines indicate quartz and grey lines indicate haematite
