NORTON PRIORY, CHESHIRE AIR PHOTOGRAPH ASSESSMENT

Research Department Report Series 059-2011

SPECIAL PROJECT

SJ 5484 8302

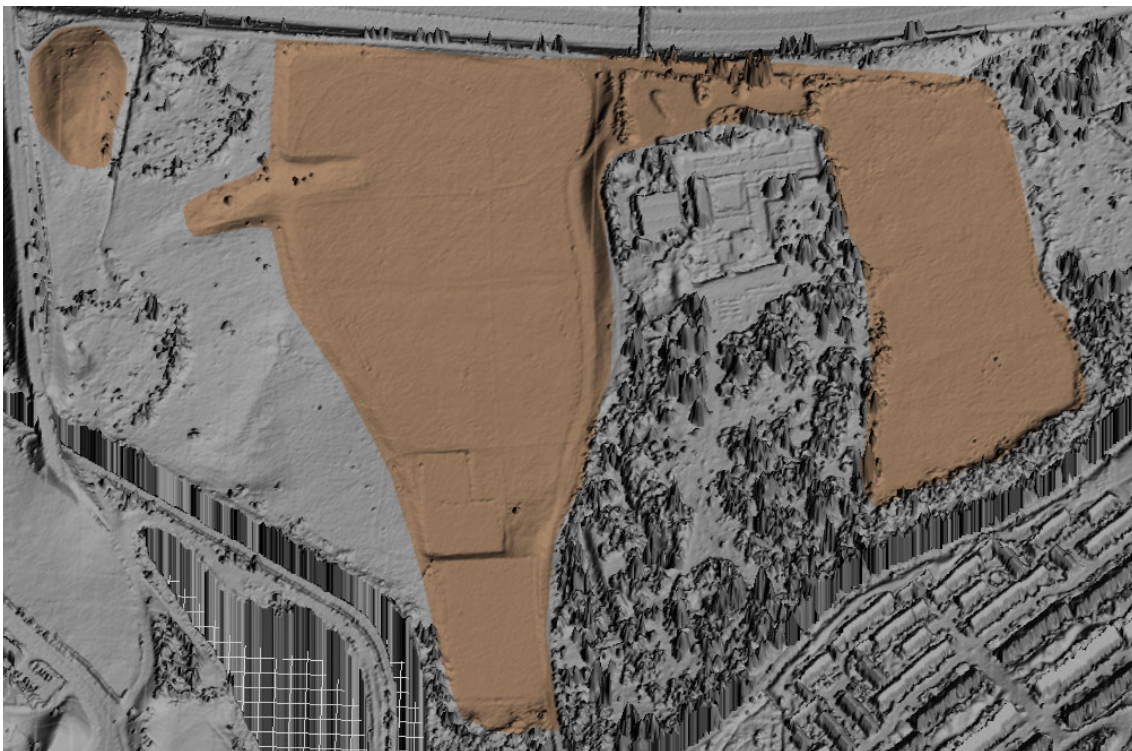
A digital surface model revealing the modern landscape surrounding Norton Priory, the highlighted areas have been landscaped, reducing the potential for archaeological survival. LIDAR SJ5482 Environment Agency DSM 16-MAR-2002 © Environment Agency copyright 2002. All rights reserved

A vast amount of landscaping has occurred in the vicinity of Norton Priory, mainly as a result of the construction of the Daresbury Expressway. Large amounts of spoil removed along the route of the road were heaped on the field immediately east of the priory (within the scheduled area). A vertical photograph taken in 1975, (NMR MAL/75002 0205 16-JAN-1975) shows the spoil being bulldozed to form a level surface suitable for playing fields. It is unclear from the available sources what damage this may have caused

to any underlying archaeological surfaces.

Further playing fields, situated to the immediate west of Norton Priory, are evident. Air photographs suggest that they were created later than 1968 but before 1975. In this instance, the surface was excavated to provide a level plane. Height data taken from the lidar suggest the playing field is at least 2 metres lower than the surrounding area. In these circumstances, the potential for survival of archaeological deposits is minimal.

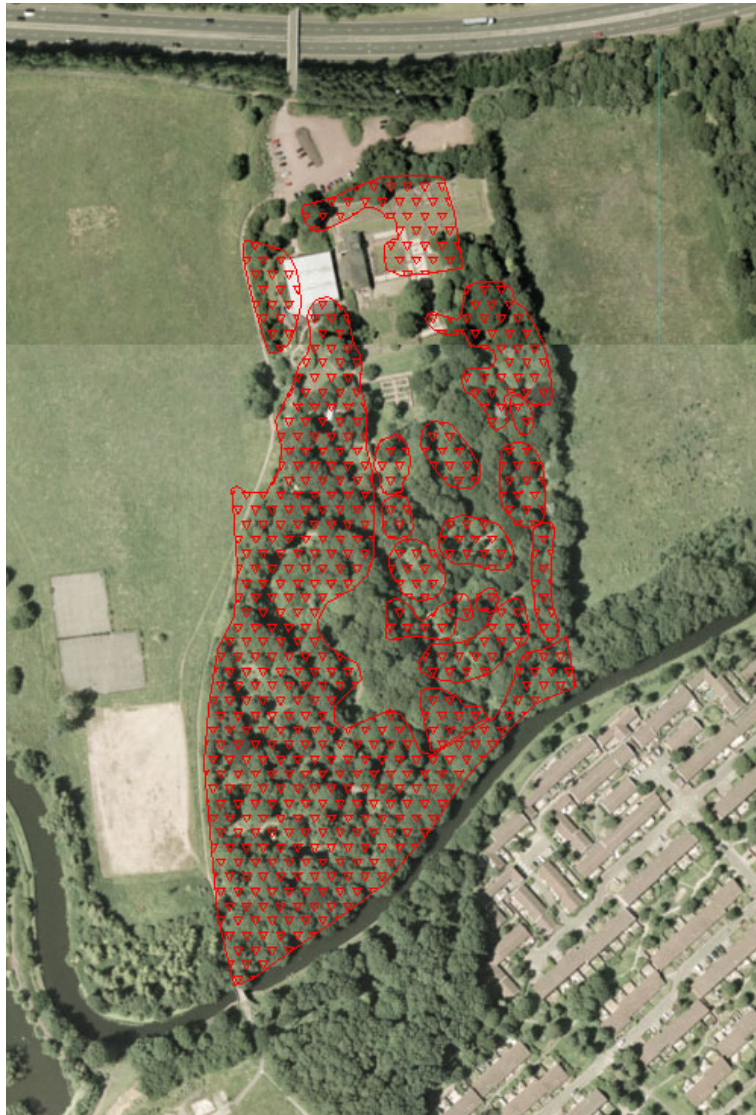
Orthophotography of Norton Priory taken in 2005 clearly shows extensive vegetation cover across the site. In contrast, the areas highlighted in red, depict tree cover visible on 1946 photography - a 21% increase over 59 years. Next Perspectives PGA Imagery NY5482 27-APR-2005. Aerial Photography: Licensed to English Heritage for PGA, through Next Perspectives™

Encroachment of vegetation within Norton Priory has been considerable over the time frame provided by the vertical photography - between 1946 and 2005. In the 1946 photography, vegetation appears to be either focussed around the perimeter of the priory, or located in a number of oval beds; covering a total area of approximately 4.5ha. By 2005 (the latest photography available for this study) vegetation cover had increased to 5.7 ha - the majority of southern section of the site. Obviously this is a crude observation some difference may result from the time of year of photography (February for the 1946 photography, April for the 2005 photography), but a 21% increase appears significant.
