# ENGLISH HERITAGE COASTAL ESTATE RISK ASSESSMENT

Abby Hunt

## RISK ASSESSMENT

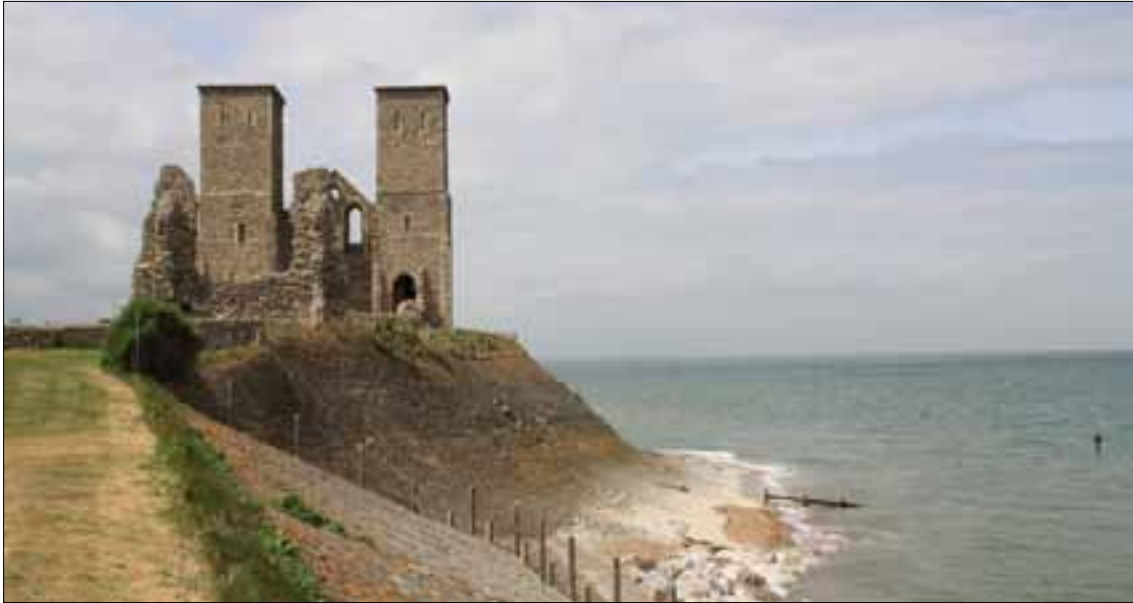
Coastal erosion has long been an issue at Reculver and attempts have been made for at least 200 years to try and stabilise the coastline. Documentary evidence suggests that the loss of the north wall of the Roman fort occurred around 1800: 'The walls on three sides are very visible, but the fourth, towards the north, has been very lately, nearly all of it, destroyed by the falling of the cliff down on the sea shore, where vast fragments of it lie' (Hasted 1800). Having purchased the towers at Reculver in 1809, in order to preserve them as navigation marks, Trinity House initially built groynes around the coast to prevent further erosion, supplementing this with a facing of ragstone blocks around the cliff in 1866. The coastal defences, which abut the northern side of the area in EH

Figure 11. View of Reculver from the east, showing the present defences at the foot of the Towers and illustrating the amount of coastline already lost here. Photograph by Abby Hunt.

- Monitoring of the coastal side of the site after severe stormy weather could potentially highlight any issues at an early stage and allow remedial works to be undertaken in order to stem any erosion before significant damage is done. This may be of further importance if land to the east of the site is allowed to retreat, thus potentially exposing the eastern side of the historic property to increased risk of erosion or flooding.

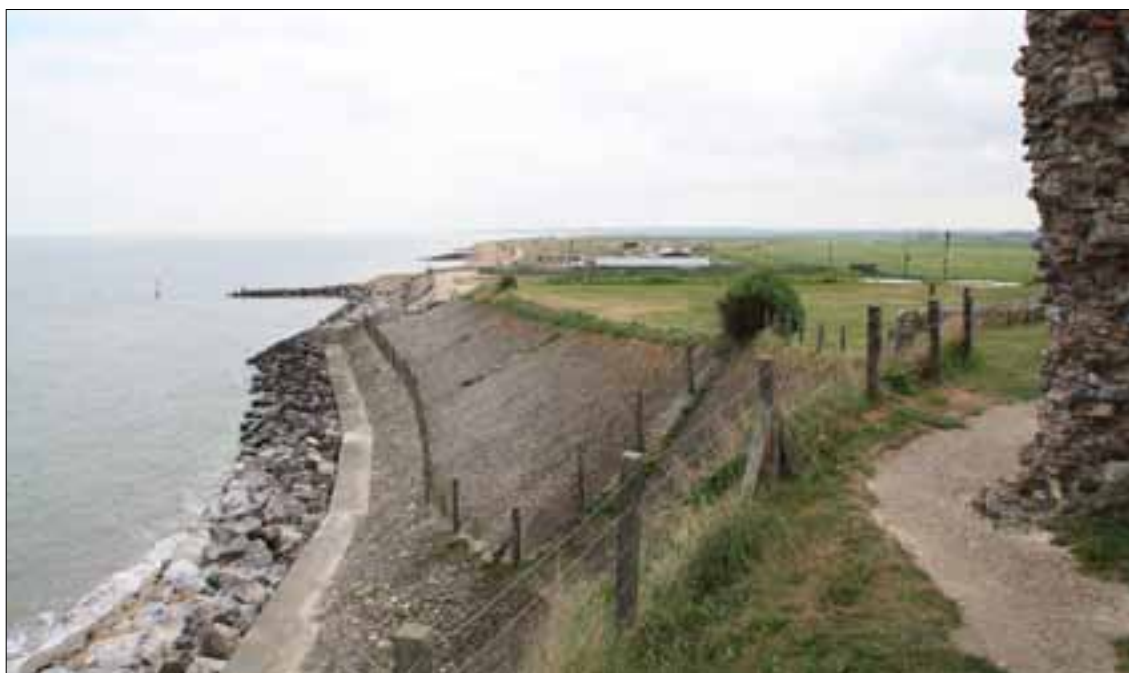
*Figure 13. View from the north-east corner of St Mary's Church at Reculver, looking east; the area in the distance is subject to a proposed 'Managed Realignment' policy. Photograph by Abby Hunt.*

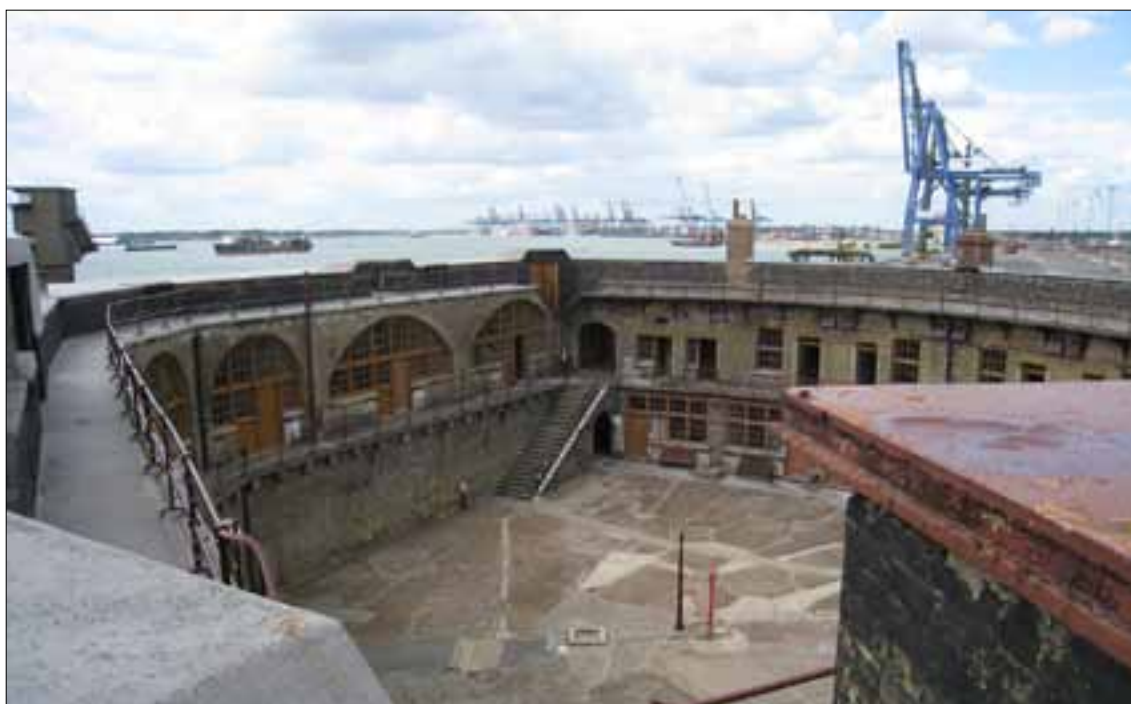
Figure 14. Landguard Fort with Felixstowe Container Port and the River Orwell in the distance. Photograph by Peter Murphy.

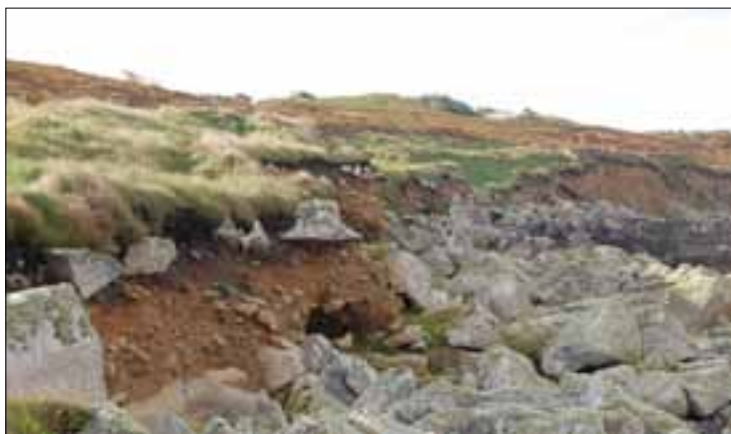
Figure 16. An example of active erosion of the low cliffs just below the breastwork to the south-west of King Charles' Battery. Photograph by Abby Hunt.

All around the headland, the effects of coastal erosion are visible (Figure 16). Storms battering the headland have caused undercutting of the cliffs and, in some cases, collapse. There are several places where this erosion will potentially have, or is already having, an impact on the part of the monument in the care of EH. During the course of the 2005 archaeological survey of the site, vulnerable areas of the monument were identified. Undercutting of the cliff was observed in the vicinity of King Charles' Battery, along the eastern side of the headland (between Upper Broom Platform and Morning Point Battery), between Morning Point Battery and Woolpack Point, around Colonel George Boscawen's Battery and south of Steval Battery (see Figure 17). A site visit for the purposes of this current study, in September 2010, confirmed that a number of the affected locations identified in 2005 are still actively eroding. Parts of the scheduled monument not in EH guardianship (the breastwork to the south-west of King Charles'

The geology of the western part of St Mary's is granite bedrock topped with a layer of stone and clay, often 1-3m in thick, which is known locally as 'ram'. The ram is unconsolidated and thus susceptible to wave action; erosion of the low cliffs often occurs in the form of undercutting, which creates substantial 'caves' at their toes, which will eventually cause the cliffs to collapse. On top of the ram is often a layer of black earth and peat, which can be 0.5-1m deep (visible in Figures 16 and 18).

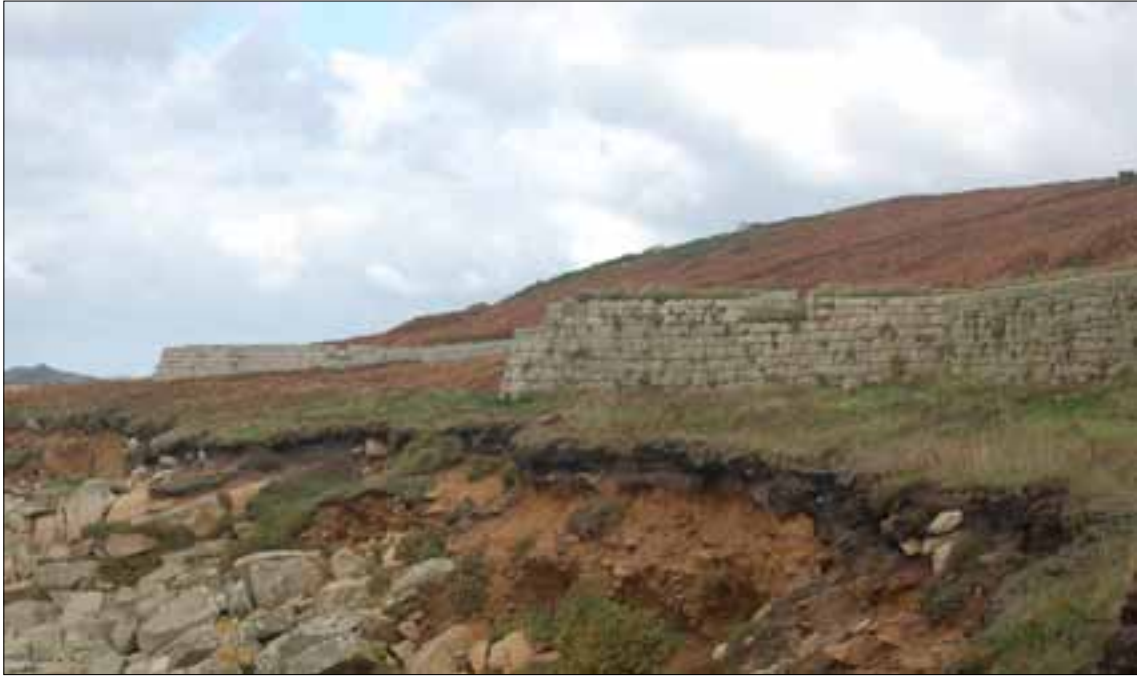
*Figure 18. Active erosion of the low cliff to the north-west of Woolpack Point. Photograph by Abby Hunt.*

Battery) were also observed to be under threat from cliff collapse during the 2010 field visit; erosion was recorded in additional locations to those observed during the 2005 survey, suggesting that it is a recent occurrence.

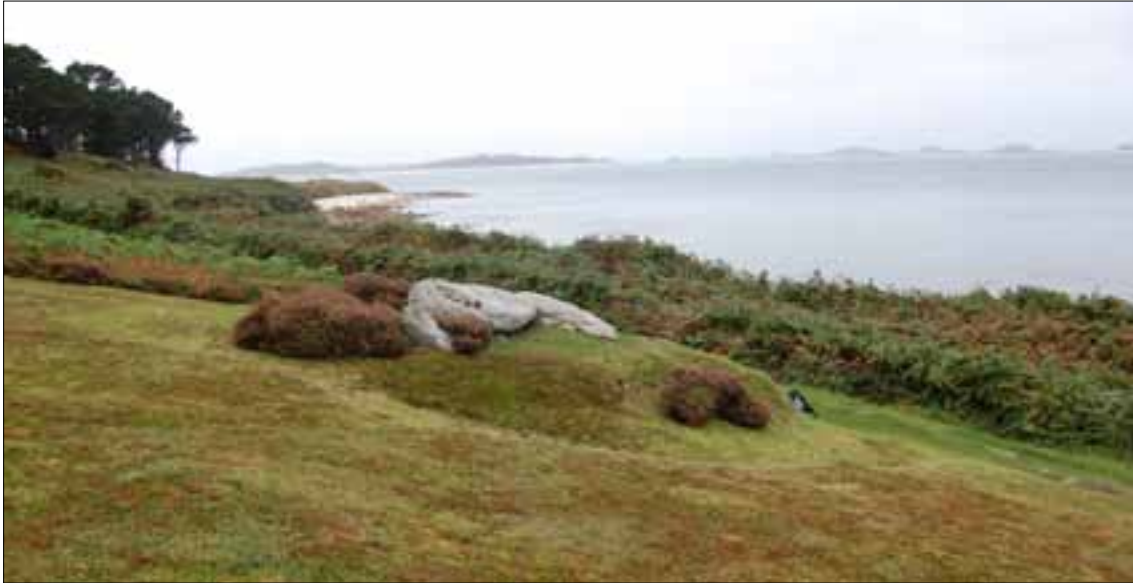
Figure 19. The lower entrance grave at Innisidgen. Photograph by Abby Hunt.

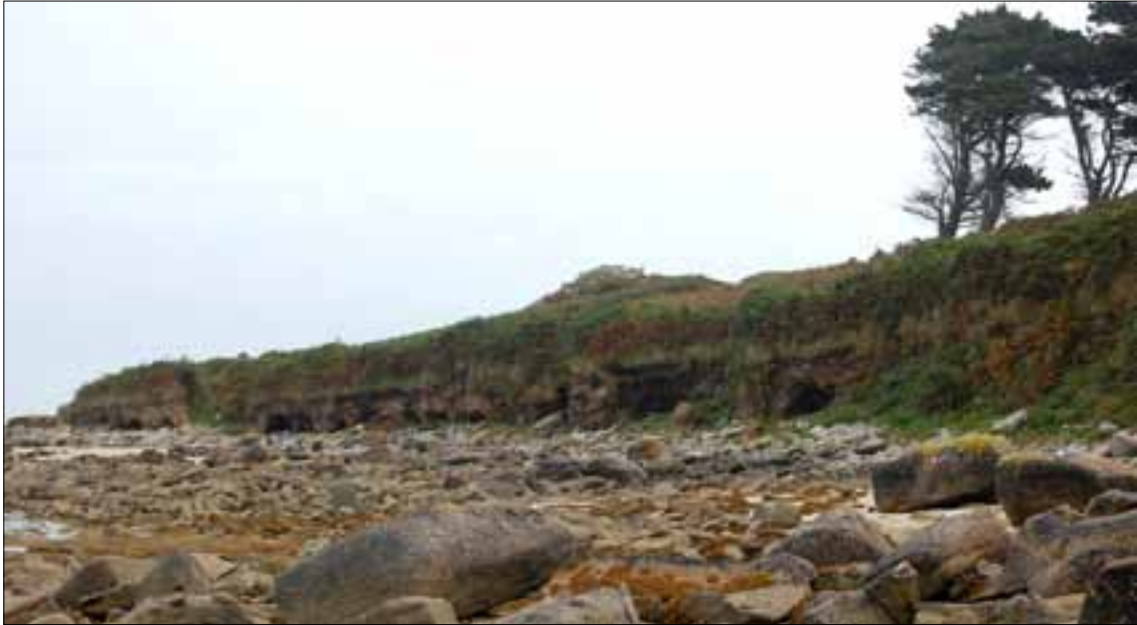
*Figure 20. The coastline below Innisidgen Burial Chambers. The low cliffs are being eroded, with wave action undercutting them and creating 'caves', visible along the foot of the cliff. Photograph by Abby Hunt.*

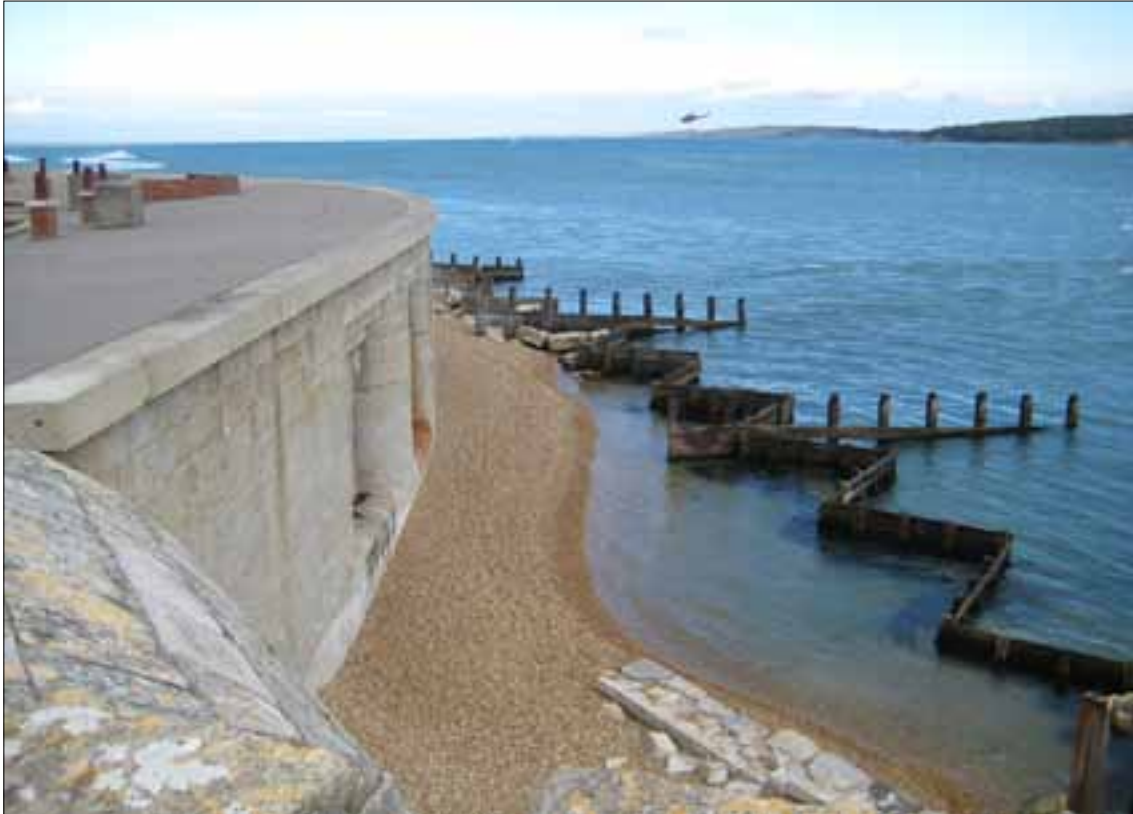
As it is located on a spit, a dynamic and mobile landform, Hurst Castle is at the mercy of potentially extreme environmental conditions. It has been noted by the Property Curator (National Collections, Curatorial Team) that the castle's caponier is regularly flooded. It was also noted that the shingle on the south and south-west side of the castle can be removed by the sea in rough weather, revealing the castle's foundations (R Porter, *pers comm*).

Figure 22. Groynes and sea defences to the south-east of Hurst Castle. Photograph by Abby Hunt.

- The Periodic Condition Survey and Report also identifies a number of issues relating to erosion of fabric due to sea/wave action and recommends that these are addressed as a matter of importance. In addition, monitoring of exposures of the foundations of the castle undertaken in the aftermath of extreme storm events, particularly when significant movement of shingle has occurred, would be a sensible measure to take.

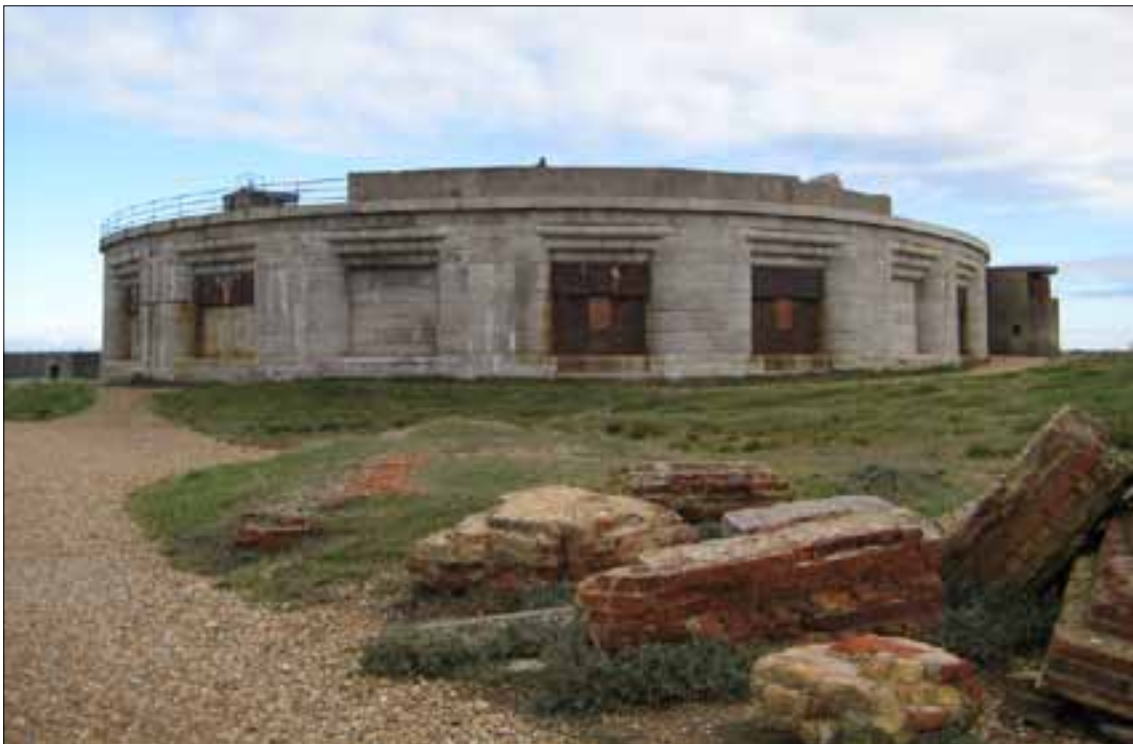
*Figure 23. The western end of the west wing of Hurst Castle with fragments of brick ruins in the foreground. Photograph by Abby Hunt.*

- The castle has been subject to numerous recording projects, primarily focussing on the structural elements, however the broader landscape context of the castle and any outlying features, such as earthwork defences, should also be subject to detailed recording. A search of the plans archive, to assess the extent of the pre-existing plans/surveys, would be necessary to ensure there was no duplication of work. The current Periodic Condition Survey and Report, commissioned by the EH Estates Programme Development Team, notes that there are brick ruins to the north-east and west of the castle on the beach which are susceptible to sea spray and erosion (see Figure 23); the survey's recommendation is to record and monitor these items (item no. 84 asset no. 255, Bailey Partnership 2010). A survey and analysis of the setting of the castle and features outside the structure itself would provide a baseline for future monitoring and would enhance the understanding of the site's setting and context.

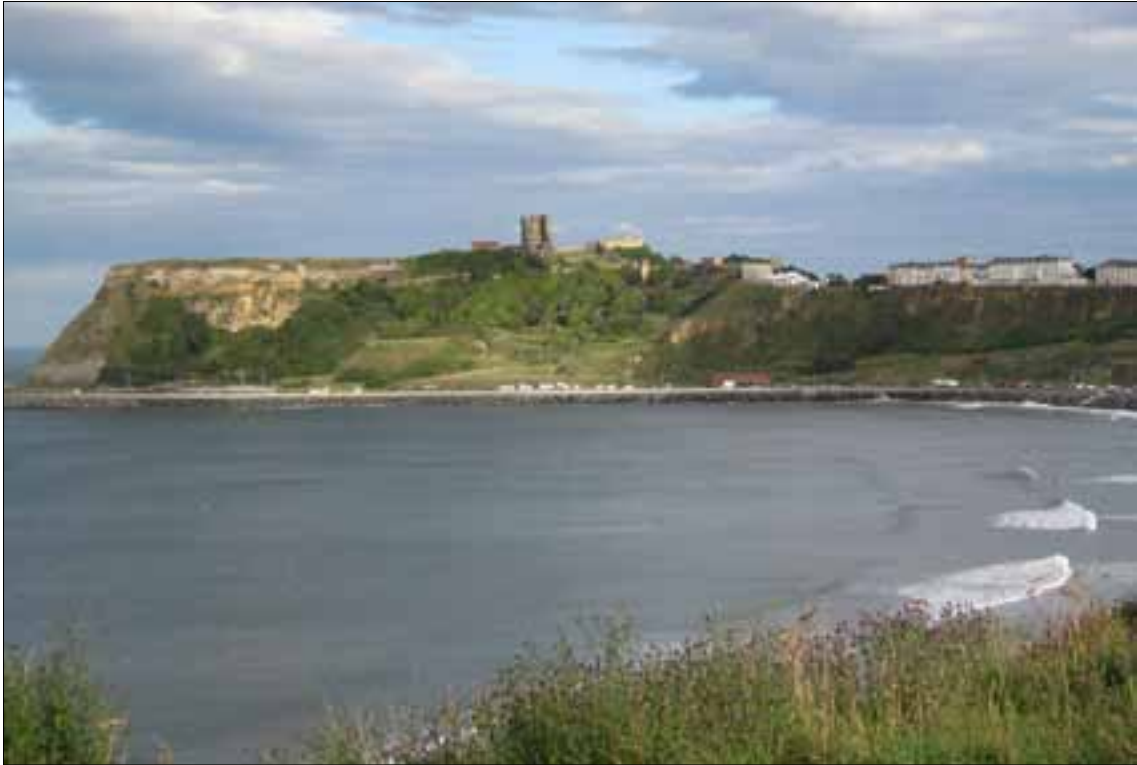
*Figure 24. Scarborough Castle viewed from the north-west across North Bay. The scars of former landslips can be seen along the cliff face below the castle. Photograph by Abby Hunt.*

- The cliff abseil survey photography should be assessed for archaeological potential or exposure of buried archaeological remains/deposits, as well as for maintenance purposes.
- Building fabric should be recorded, where possible, in case elements are lost due to cliff falls. The possibility of using remote methods, for example, reflectorless EDM, photogrammetry or kite aerial photography, should be investigated.
- Planned replacement of the cliff-top fence in the next 10-20 years (as recommended in the Periodic Condition Survey and Report) may necessitate archaeological

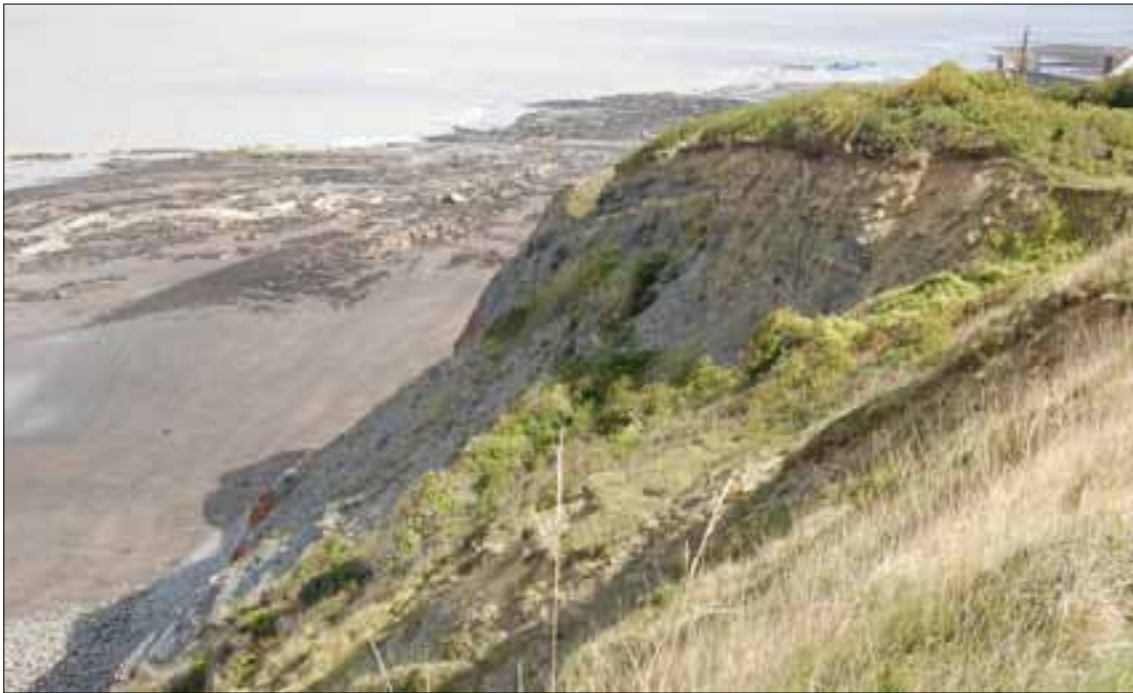
*Figure 26. The cliffs immediately to the east of Daw's Castle; recent slippage visible in the photograph illustrate the friable nature of the rock. Photograph by Abby Hunt.*

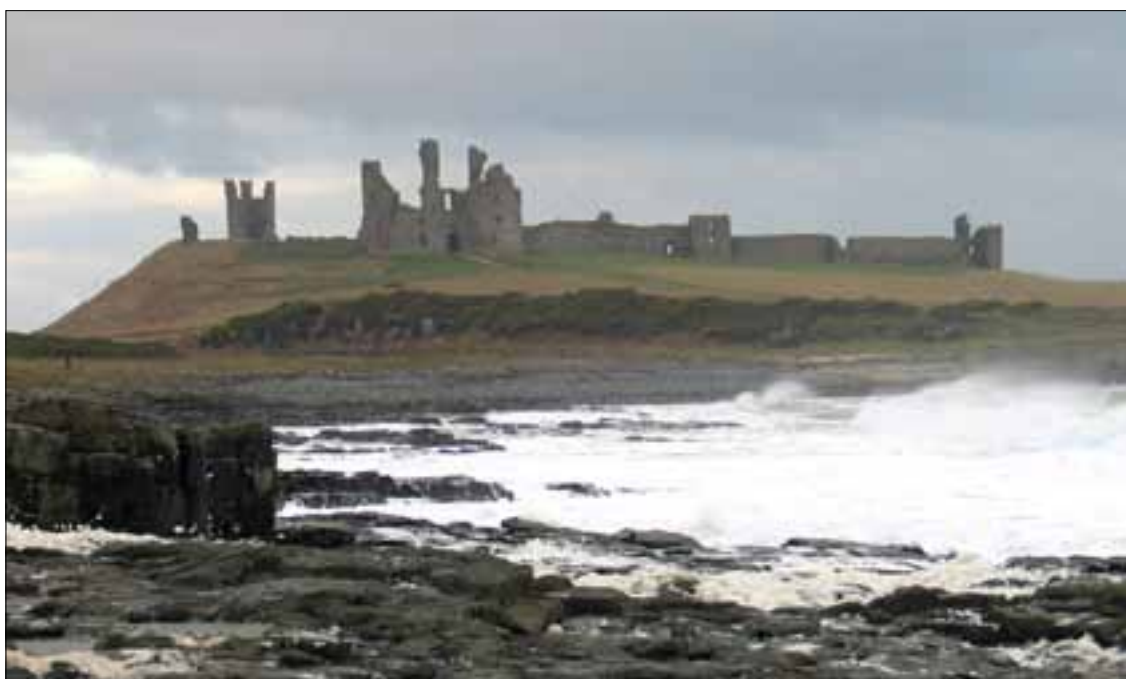
Figure 28. Dunstanburgh Castle from the south. Photograph by Al Oswald.

Dunstanburgh Castle, built in the 14th century, occupies a coastal headland approximately 2km to the north of the village of Craster. The rocky headland is at the northern point of the Great Whin Sill, a geological formation consisting of igneous quartz-dolerite black basalt. This hard rock formation is generally resistant to erosion, but there are defiles at points along the Sill, occasionally allowing water through the cliff-line; this is often witnessed to the west of the castle, beyond the boundary of the EH guardianship area. The area of the guardianship property includes c570m of coastal frontage and the SMP2 for Northumberland suggests a general figure of 2m of shoreline lost to coastal erosion over the next 100 years, with a potential sea level rise of 0.8m, although these are only indicative figures. However, digital data used to compile the SMP2 erosion risk mapping indicates that around the castle headland, erosion could be up to 12m in the next 100 years. In this scenario, much of the eastern curtain wall of the castle and the northern end of the western curtain wall would potentially be at risk of collapse.

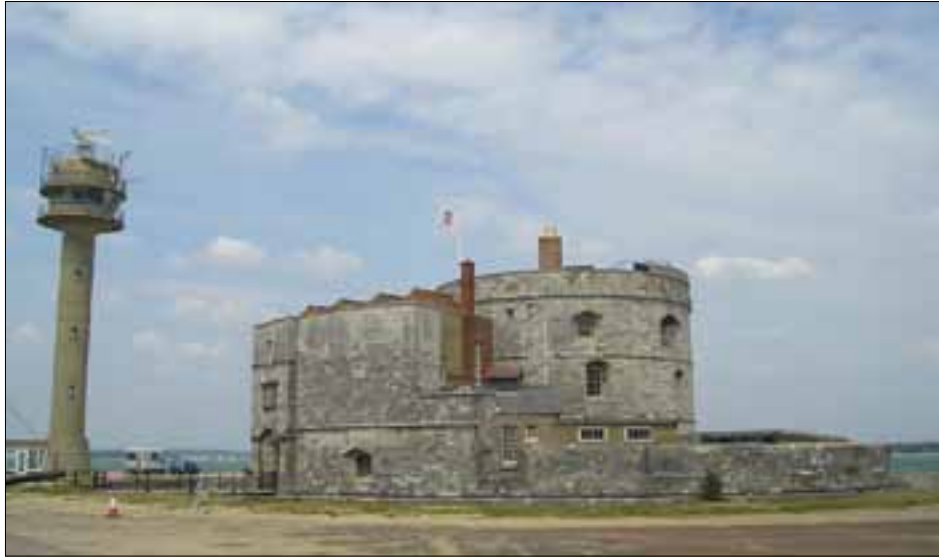
Calshot Castle is a Henrician artillery castle, built in 1539-40. It consists of a central tower surrounded by a concentric curtain wall and a moat. It was used for various military, defensive functions up until the Second World War, and thereafter as a sea plane base, until 1961. The castle is positioned at the end of a spit at the entrance to Southampton Water. EA flood zone data indicates that there is a risk of flooding at the site, both from flood zone 2 and 3 events, the latter indicating an annual probability of flooding from the sea of 0.5% or greater. The impact of flooding on the monument would clearly depend on the flood level reached, and it may be access to the site which is more at risk. The Periodic Condition Survey Report notes that pointing in the stone apron on the seaward side is being eroded by wave action; in the event of flooding this may be exacerbated and

Figure 30. Calshot Castle. Photograph by Peter Murphy.

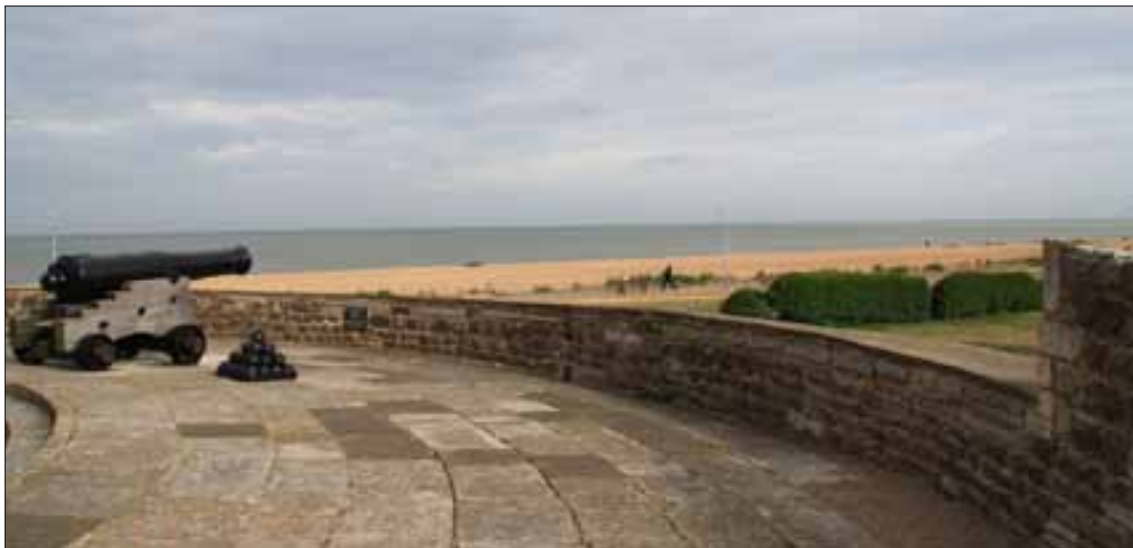
Figure 31. View from Deal Castle curtain wall to the south-east showing the proximity of the broad shingle beach. Photograph by Abby Hunt

nationwide, from this period, which also included Walmer Castle (see below). The castle itself consists of a central, circular keep with six semi-circular bastions at its base, surrounded by six larger, semi-circular bastions and a dry moat. The guardianship area also includes the Captain's Garden, situated to the west of the castle on the opposite side of the road. All of the guardianship area falls within the EA flood zones 2 and 3, the latter indicating an annual probability of tidal flooding of 0.5% or greater. The flood zone maps show that there are flood defences to the north-east of the castle, but these do not continue across the entire coastal frontage of the castle. Data contained in the SMP2 document for this area (Isle of Grain to South Foreland, Policy Unit 4b23, Sandown Castle to Oldstairs Bay) suggests that, with the present management regime, there will be a narrowing of the foreshore, but no significant coastal erosion that will have an impact on the area in the care of EH.

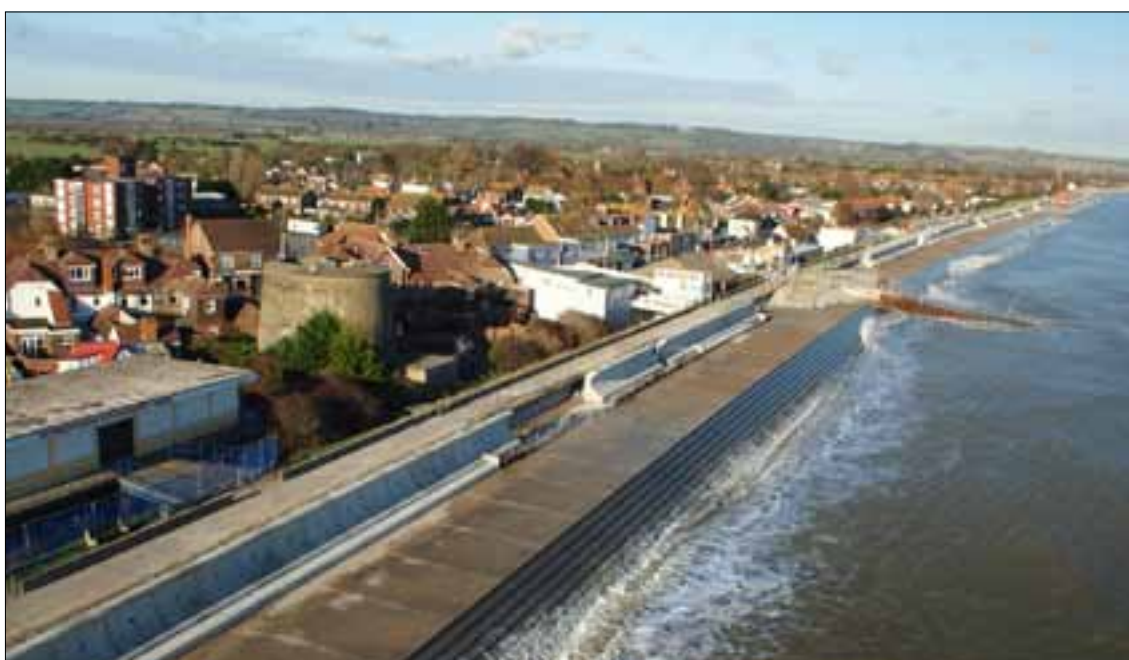
Dymchurch Martello Tower was one (no. 24) of a chain of 74 martello towers built along the Kent and Sussex coasts at the start of the 19th century, as a defence against the threat of invasion from France. By the 1870s the tower was obsolete in military terms, but was subsequently re-used as a coastguard station and lookout. The tower is approximately 35m from the Mean High Water level and is situated at less than 5m AOD. However, recent multi-million pound defensive works have included the construction of a 2.5km sea defence wall, which runs in front of Martello Tower no.24 (Figure 33). Assuming the effectiveness of the defences and their continued good maintenance and upkeep, flooding and/or erosion are unlikely to affect this site greatly.

Figure 33. Dymchurch Martello Tower (left of centre) with the construction of the new defensive works visible along the seafront; photograph taken from a kite-mounted camera. © English Heritage. Photograph by Bill Blake Heritage Documentation.

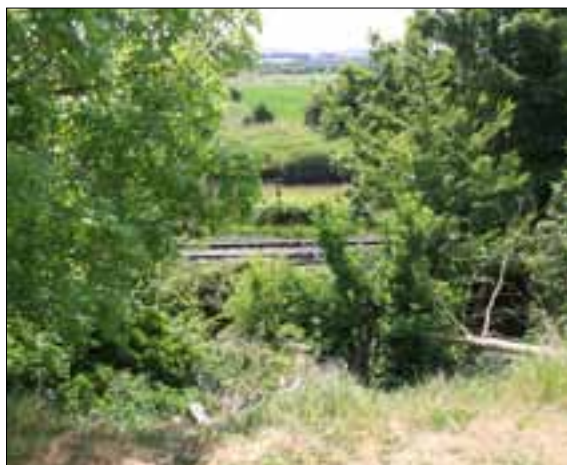
Figure 37. View from the east side of Richborough Roman fort, showing the adjacent railway line and River Stour. Photograph by Abby Hunt.

Saxon Shore fort, constructed c275AD; there was a Roman presence on the site into the 5th century. The east wall of the 3rd century fort no longer survives, having succumbed to erosion after the site had fallen out of use. The River Stour flows along the eastern side of the site and there is a railway line at the foot of the escarpment (Figure 37), which offers some degree of protection. The EA flood zone data indicates that there is minimal

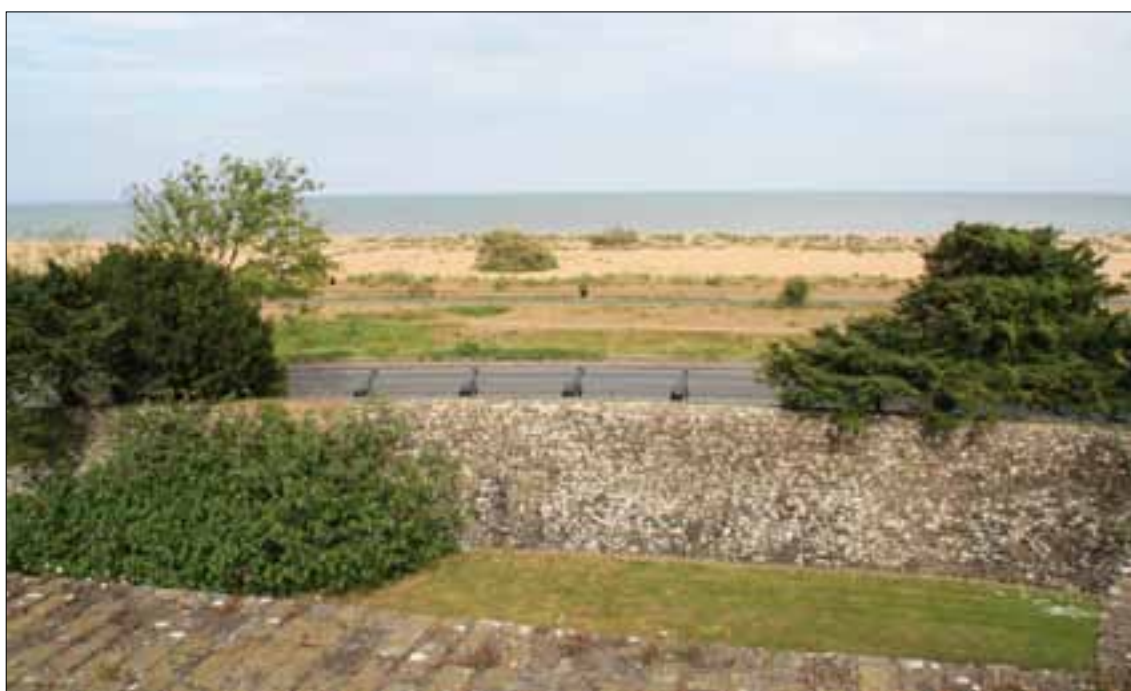
Figure 38. View from the curtain wall of Walmer Castle, looking east. The road adjacent to the castle can be seen in the middle of the photograph, with a footpath and broad shingle beach beyond it. Photograph by Abby Hunt.

Walmer Castle is a Henrician artillery fort, built in the late 1530s, consisting of a central circular keep within a curtain wall; the latter has four projecting bastions, giving the castle a quatrefoil plan. Since the early 18th century, the castle has been the home of the Lords Warden of the Cinque Ports, a ceremonial role which it still fulfils today. The area in the care of EH includes the castle and the surrounding gardens. The castle is situated to the east of a broad shingle beach (Figure 38), and stands approximately 200m away from the Mean High Water mark. There is also a road (Kingsdown Road) to the east of the castle, skirting the moat. The EA flood zone data indicates that the guardianship area is not at risk from flooding. Data contained in the SMP2 document for this area (Isle of Grain to South Foreland, Policy Unit 4b23, Sandown Castle to Oldstairs Bay) suggests that, with the present management regime, there will be a narrowing of the foreshore, but no significant coastal erosion that will have an impact on the area in EH care.

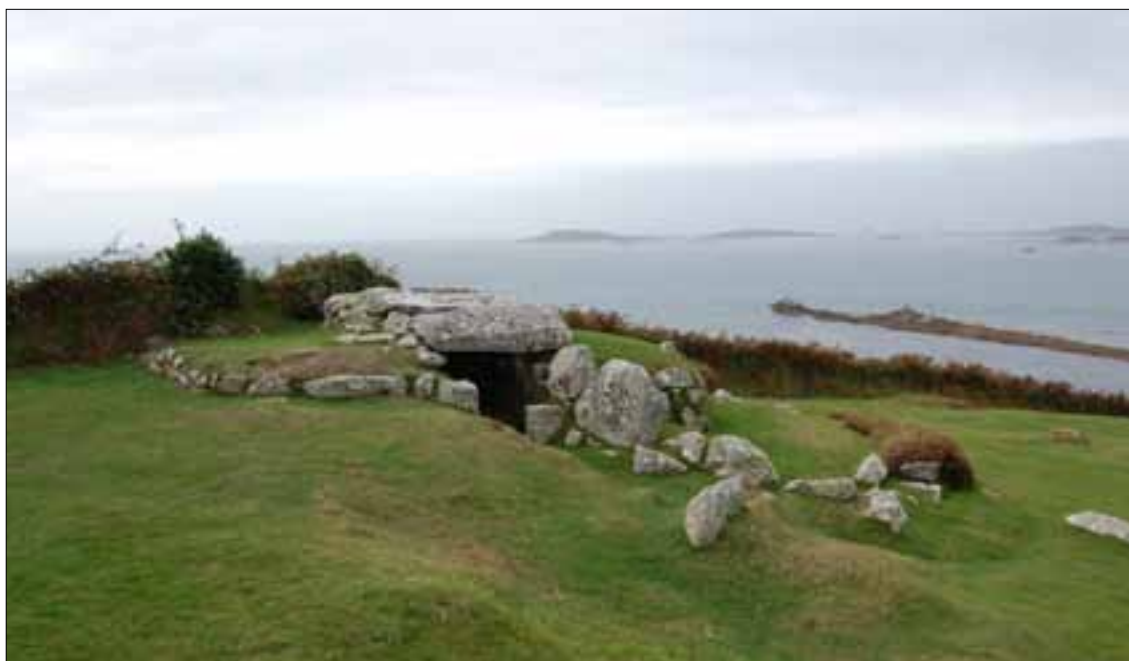
Figure 39. Bant's Carn Burial Chamber at the southern end of Halangy Down Ancient Village. Photograph by Abby Hunt

are presently subject to erosion. Coastal erosion data from the SMP2 suggests that there will be coastal recession in the order of 15m in the next 100 years, which would not represent a significant threat to the guardianship area, but would present continuing erosion issues for the broader scheduled monument.

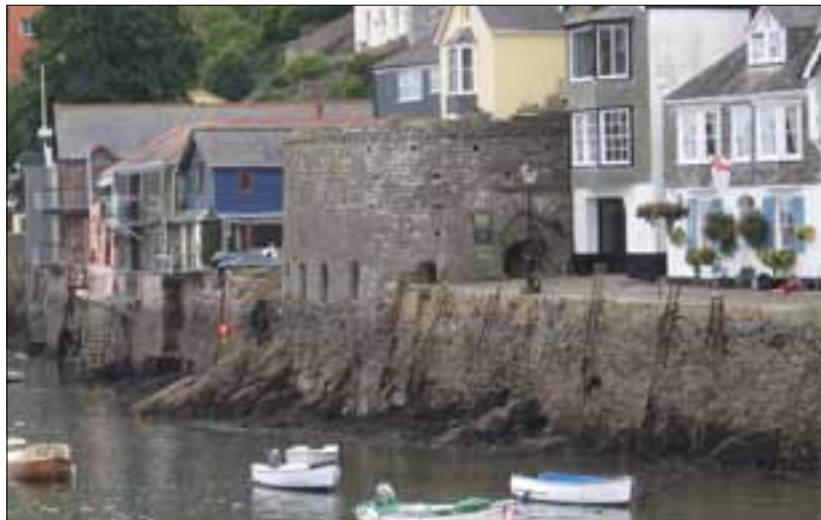
Figure 40. Bayard's Cove Fort, Dartmouth showing the apron wall on the estuary frontage. Photograph by Abby Hunt

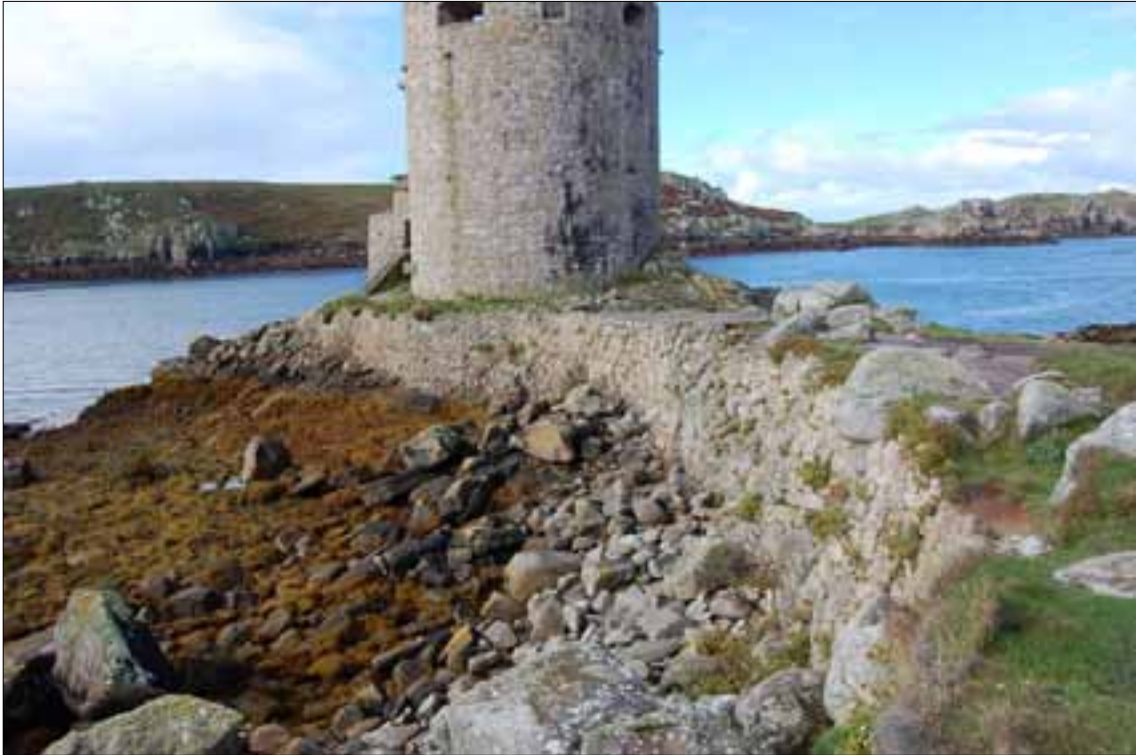
*Figure 41. Cromwell's Castle, Tresco, viewed from the east. Various repairs and revetment along the neck of land joining the castle to the island are visible. Photograph by Abby Hunt.*

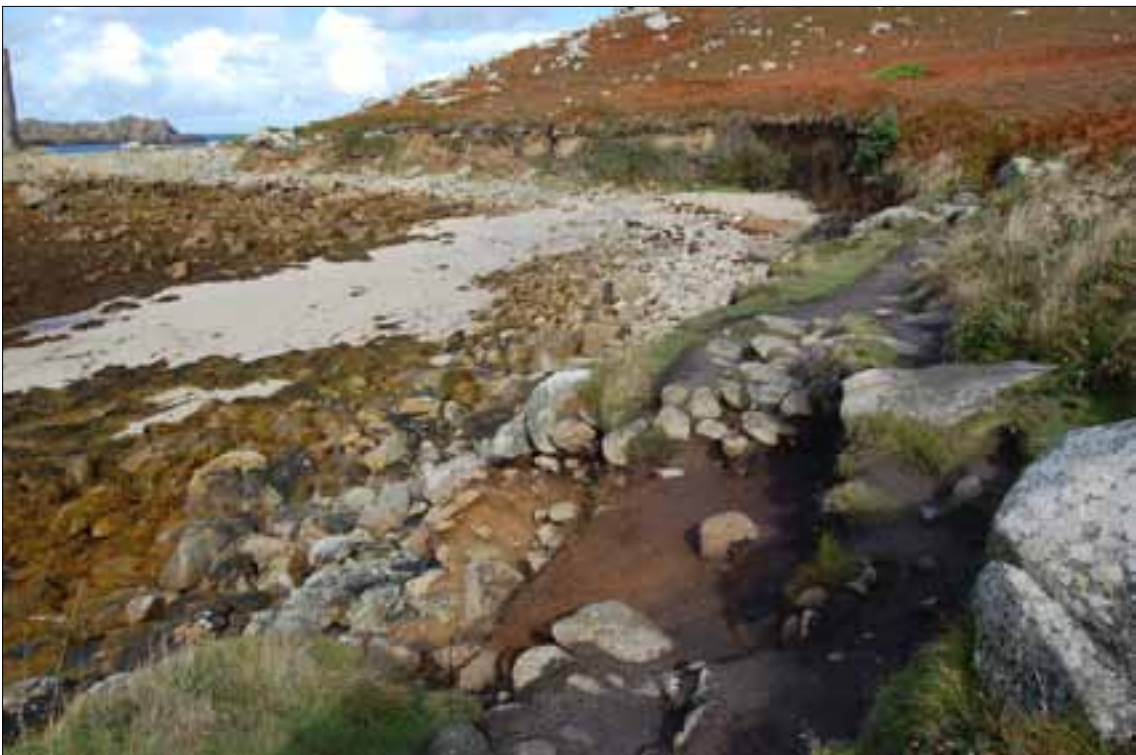
*Figure 42. Erosion of the access path leading to Cromwell's Castle. Further erosion, caused by the undercutting of the low, friable cliffs, can be seen towards the top of the photograph. Photograph by Abby Hunt.*

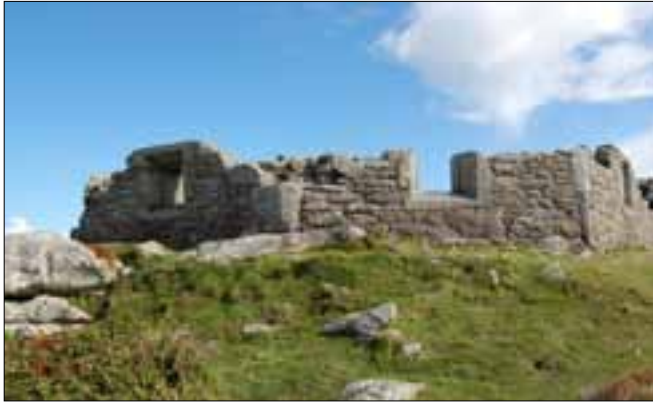
Figure 43. King Charles' Castle, Tresco. Photograph by Abby Hunt.

north-east of Cromwell's Castle, a later structure which replaced it. The castle is situated on high ground at approximately 42m AOD and is over 100m inland of the present coastline. This elevation and position means that the guardianship area is at no significant risk of flooding or coastal erosion. The only potential indirect threat to the site, which could impact on its management, is the erosion of the access path to the south (see Cromwell's Castle description above for further detail).

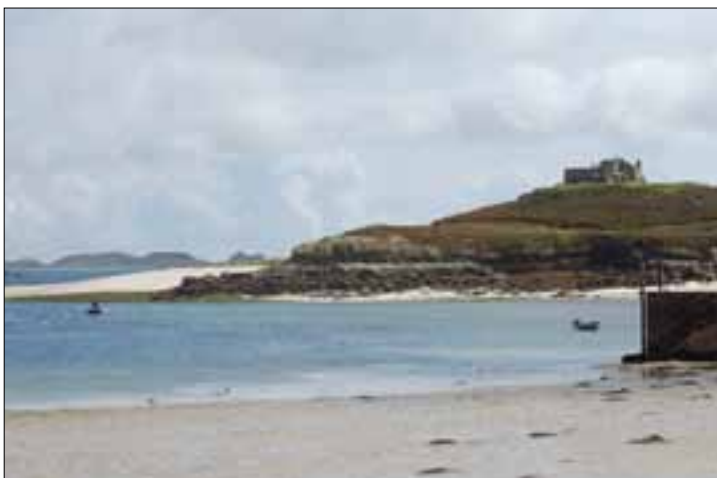
Figure 44. Old Blockhouse viewed from the north-west, across Old Grimsby Harbour. Photograph by Abby Hunt.

AOD, which means that it is not at risk of flooding. However, the potential coastal erosion at this location (as indicated by the SMP2 data) suggests that within 100 years, the coast could recede by up to 25m, leaving the edge of the EH guardianship area just 16m from the shoreline. This is not an immediate threat, but the general trend is one of coastal erosion, and this should be a consideration in the management/conservation

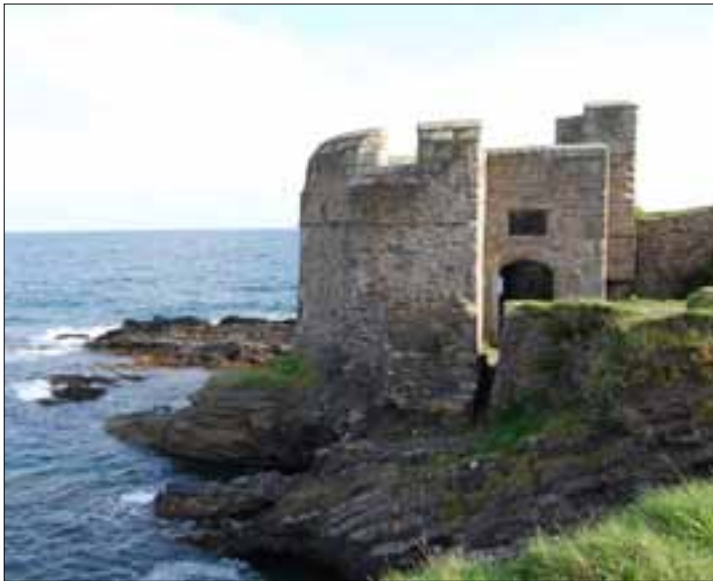
Figure 45. Little Dennis Blockhouse to the south-east of Pendennis Castle, viewed from the north. Photograph by Abby Hunt.

and coastal erosion. However, a small blockhouse, known as Little Dennis Blockhouse, also in the care of EH (List number 1270099, Grade I), is situated close to the shoreline (at 1.5-5m AOD) at the end of the peninsula to the south-east of the main castle. The blockhouse was built in the mid-16th century. Resistant geology means that there is little risk of coastal erosion to the majority of the area in the care of EH. However, EA flood zone data indicates that a small part of this area, around the base of Little Dennis Blockhouse, could be affected by tidal flooding

- Monitor the condition of the erosion and gully to the north of Little Dennis blockhouse. If the problem becomes more pronounced, assess whether this will impact on the structural integrity of the blockhouse and take appropriate action.

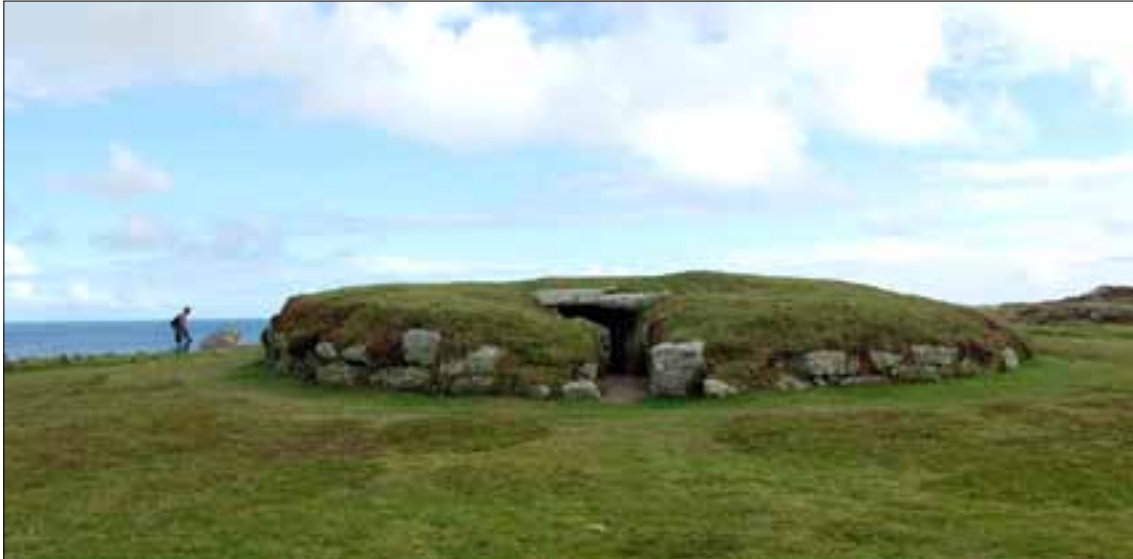
Figure 46. Porth Hellick Down entrance grave. Photograph by Abby Hunt.

AOD, which places it at negligible risk of flooding. The threat of coastal erosion to the monument is also minimal, as it lies over 150m inland from the current coastline and predictions suggest that only 1-2m will be lost from the coastline in this vicinity in the next 100 years.

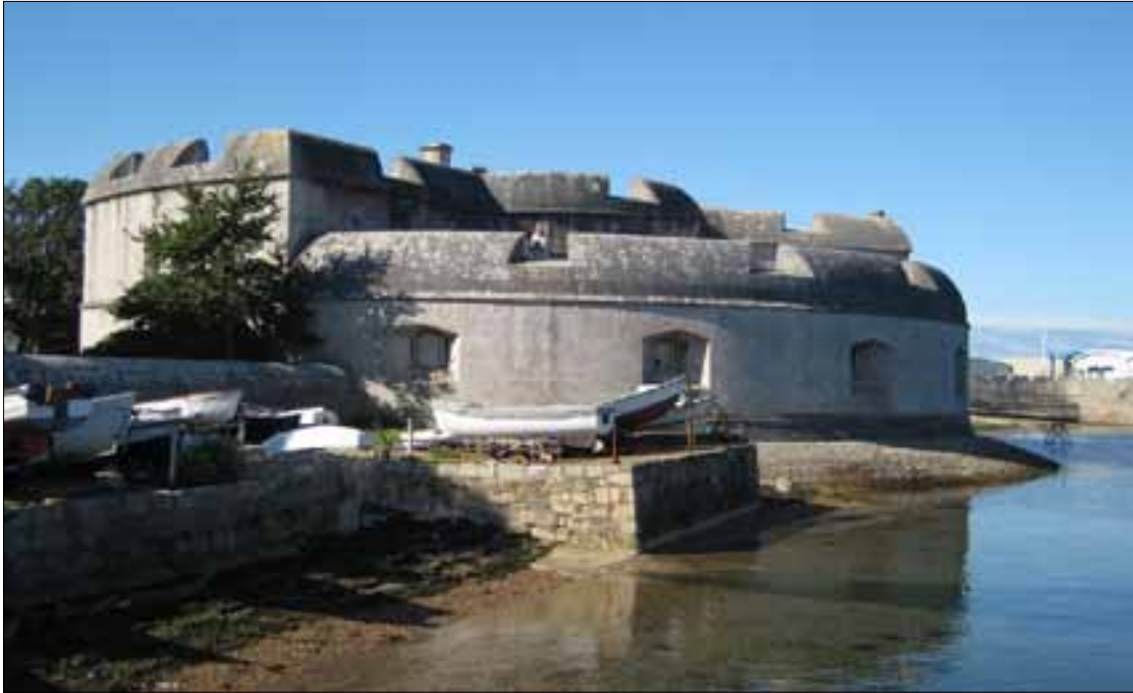
Portland Castle is located at the north of the Isle of Portland, a tied island joined to the mainland by Chesil Beach. The castle, one of Henry VIII's defensive fortifications, was built in the 1540s overlooking Portland Harbour and in a strategically important position in relation to the English Channel. It saw various periods of military activity through until the 20th century, including use as a seaplane station during the First World War. The construction of the castle is primarily Portland ashlar with a rubble apron below the outer defensive wall on the coast side, which offers a degree of protection from the sea; the apron was observed to be in relatively good condition during a site visit in September 2010. EA flood zone data indicates that there is a risk of inundation to over 50% guardianship area (the north-western part, including the keep and car park) from flood zone 2 tidal flooding. There is also a risk to a smaller area (the northern part of the car park and possibly the garden area to the south of the castle) from flood zone 3 tidal flooding, although this would potentially be minimised by the castle's defensive walls acting as flood defences. This section of the coast is presently well defended against erosion. However, the SMP2 (South Devon & Dorset Coastal Authorities Group, Durlston Head to Rame Head SMP2, Osprey Quay to Grove Point) indicates that to maintain current levels of protection into the long term, present defences may need to be upgraded.

Figure 47. The north-eastern side of Portland Castle. Photograph by Abby Hunt.
