# ENGLISH HERITAGE COASTAL ESTATE RISK ASSESSMENT

Abby Hunt

## RISK ASSESSMENT

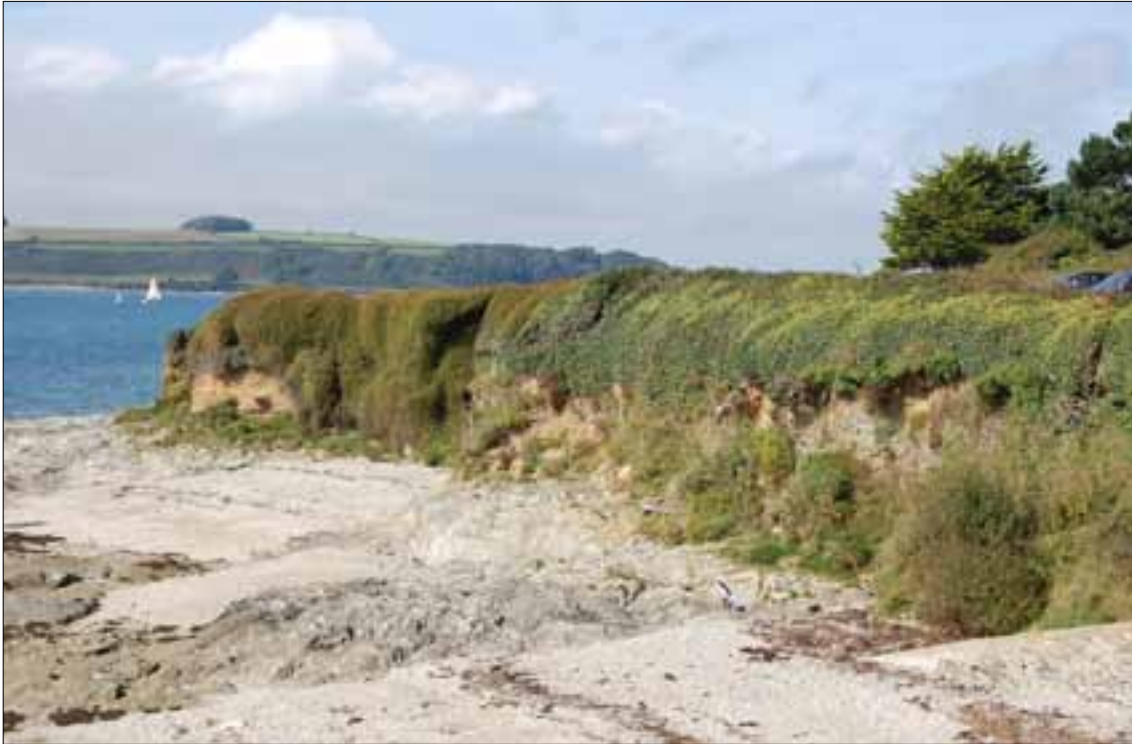
*Figure 48. The cliff at Castle Cove, below the overflow car park to the north-west of St Mawes Castle, showing signs of erosion. Photograph by Abby Hunt.*

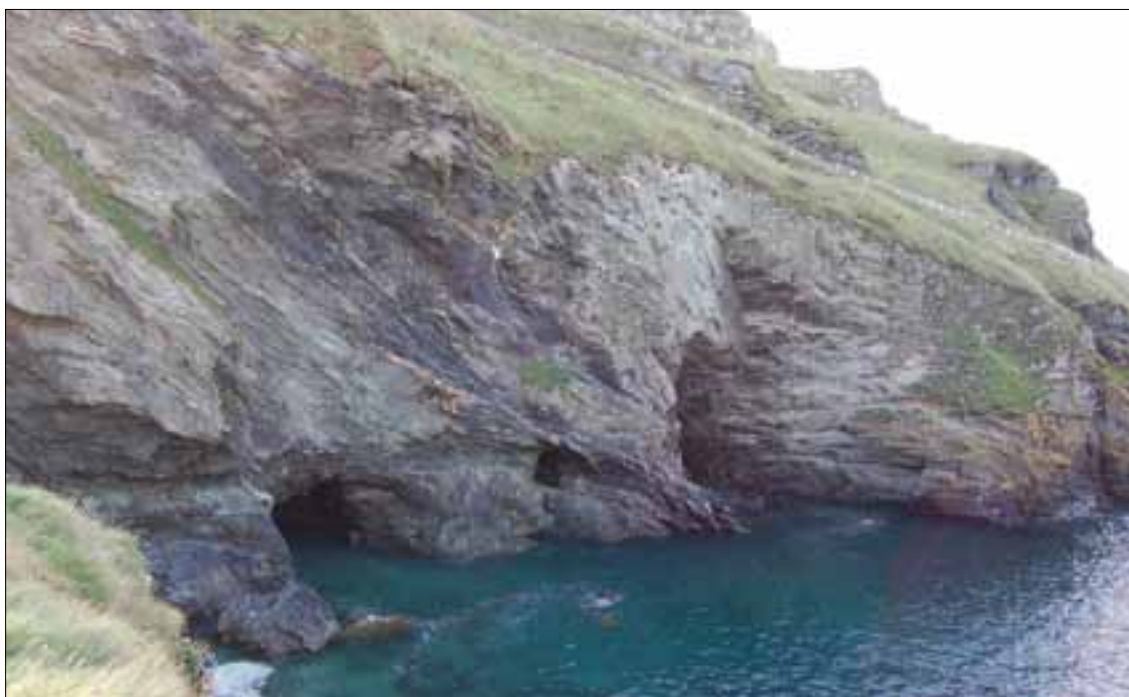
Figure 49. Merlin's Cave (the left-hand cave) at the foot of the cliff on the eastern side of Tintagel Island, where recent rock falls have occurred; there are a number of structural and archaeological remains on the cliff above. Photograph by Abby Hunt.

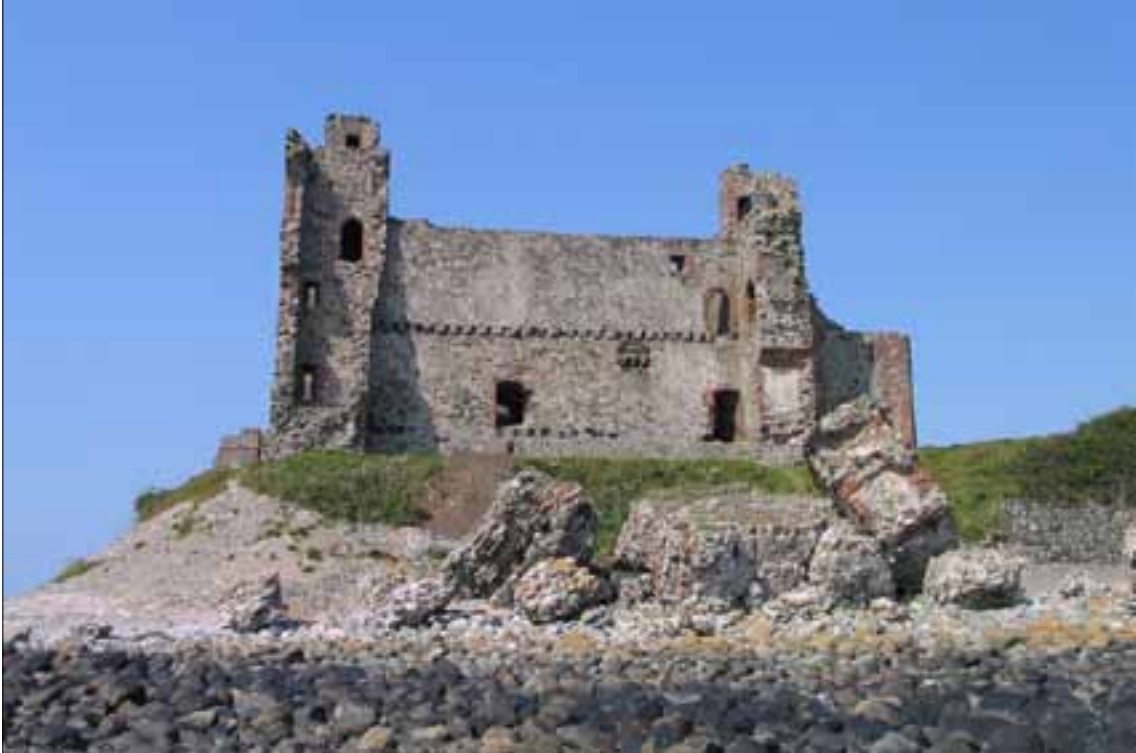
*Figure 50. The eastern elevation of Piel Castle. Large chunks of collapsed masonry can be seen on the beach in the foreground, a result of erosion in the 18th century. Photograph by Abby Hunt.*

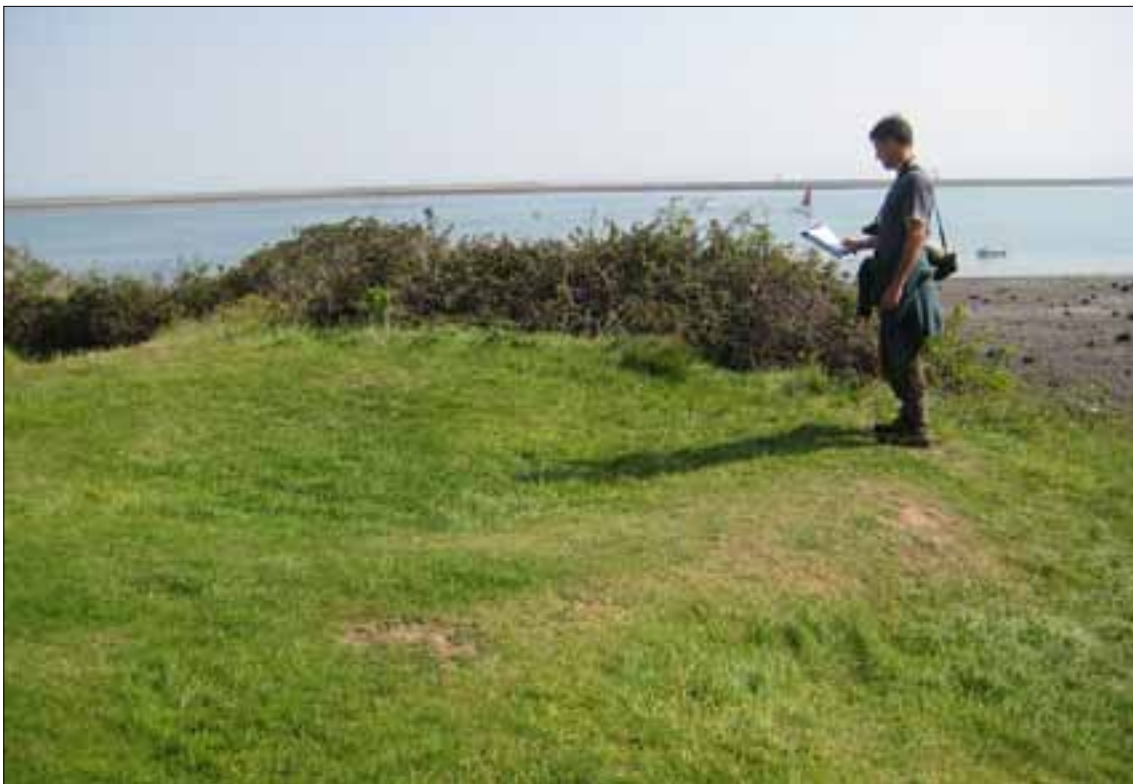
*Figure 51. Circular earthwork surviving to the north-east of the keep within the inner bailey. Photograph by Abby Hunt.*

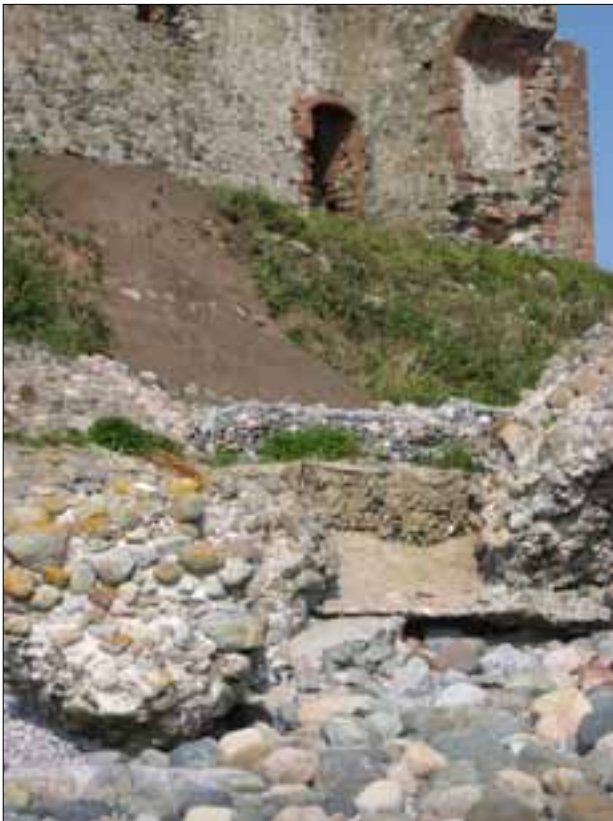
Figure 52. Erosion to the east of the keep.  
Photograph by Abby Hunt.
