RESEARCH REPORT SERIES no. 109-2011

THE JEWEL TOWER, ABINGDON STREET, WESTMINSTER, LONDON

TREE-RING ANALYSIS OF TIMBERS

SCIENTIFIC DATING REPORT

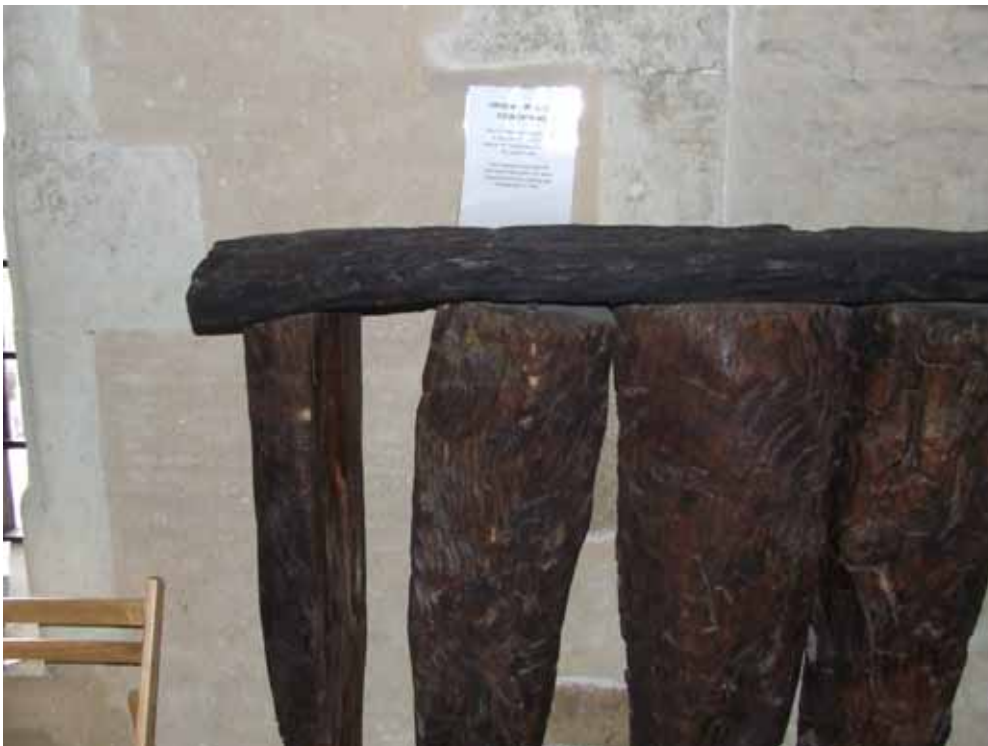
Figure 3: The elm piles and oak plate on display in the main chamber

On display in the main chamber are a series of elm piles and an oak plate which were thought to potentially represent part of the original foundations of the tower (Fig 3). A door leading to the second floor chamber is of eight lapped panels, cross-framed and heavily studded, hung from two strap hinges with the gudgeons set tightly in the stone jamb (Fig 4). Whilst the lock panel has been inserted, the door is otherwise thought to be an original fourteenth-century fitting.

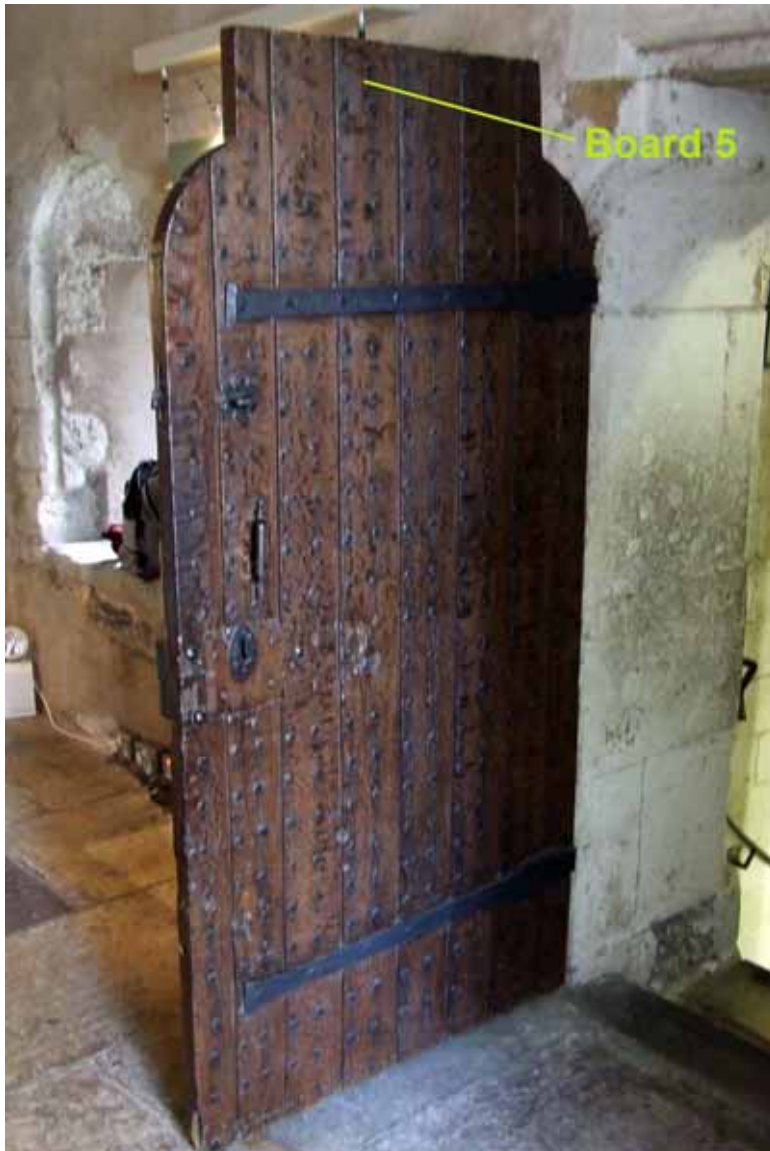
Figure 4: The door to the second floor chamber, indicating the position of the dated board

The outer boards of the door (Fig 4) were not investigated further because of the curved nature of their tops. This made cleaning, impression taking, and photographing very difficult, as well as distorting the ring width pattern. The exposed top cross-sectional surfaces of the central four boards were highly degraded but only minimal cleaning was undertaken as any greater intervention was deemed unacceptable. 'Fimo' impressions and photographs (eg Fig 6) were taken of these very slow-grown V-edged oak boards. The 'Fimo' impressions proved impossible to measure as the resolution from the minimally cleaned surface was very poor. The photographs were more useful on this occasion but were still problematic resulting in the attempted measurement of only partial sequences for each of the four central boards including two from board 5. The reliability of all but one of these sequences was considered questionable, thus only the raw data for jwlBD5i is presented in the Appendix.
