THE COACH HOUSE AND THE WEST STABLE, AUDLEY END HOUSE, SAFFRON WALDEN, ESSEX RECORDING AND FABRIC ANALYSIS

HISTORIC BUILDING REPORT

**THE COACH HOUSE AND THE WEST STABLE
AUDLEY END HOUSE,
SAFFRON WALDEN, ESSEX
RECORDING AND FABRIC ANALYSIS**

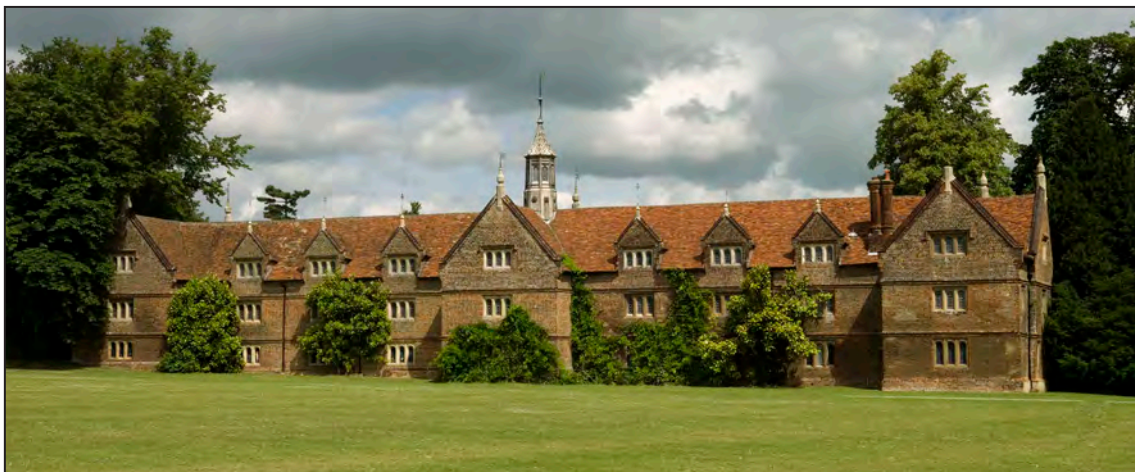
Figure 2. The south front of the Stables at Audley End House, March 2008.

The stable building (figs. 2 and 3), also known as the Great Stable, stands approximately 270 metres to the north-west of the present house, on the western side of the river Cam. Originally it stood within a walled courtyard to the north of the new entrance courtyard laid out c.1610; these walls were demolished in the mid-18th century. Today

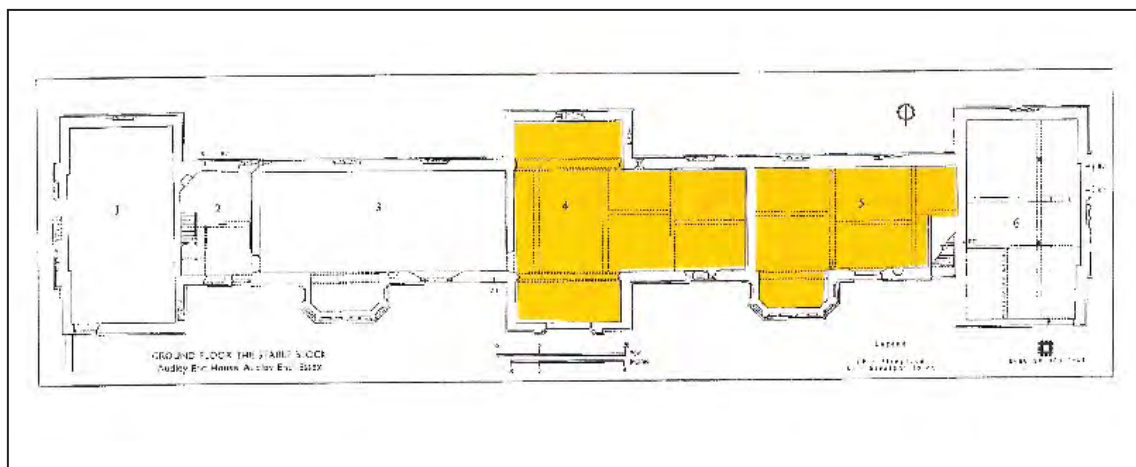
The partial removal of plaster took place in the central room of the Stable, known as the Coach House (fig. 4 - 4), and in the stable to the west, known as the West Stable (fig. 4 - 5). Both these rooms formed part of the two-storey open space which occupied the whole central section of the building between the east and west crosswings. It was created after the building was converted into a stable and coach house in the early years of the 17th century and was recorded in Winstanley's plan of c.1680 (fig. 5). This space was subdivided into four separate rooms sometime in the 18th century (fig. 4).

Figure 4. The ground plan of the Stables showing the rooms affected by the removal of plaster during March 2011. 4 - The Coach House, 5 - The West Stable
English Heritage - Pete Smith

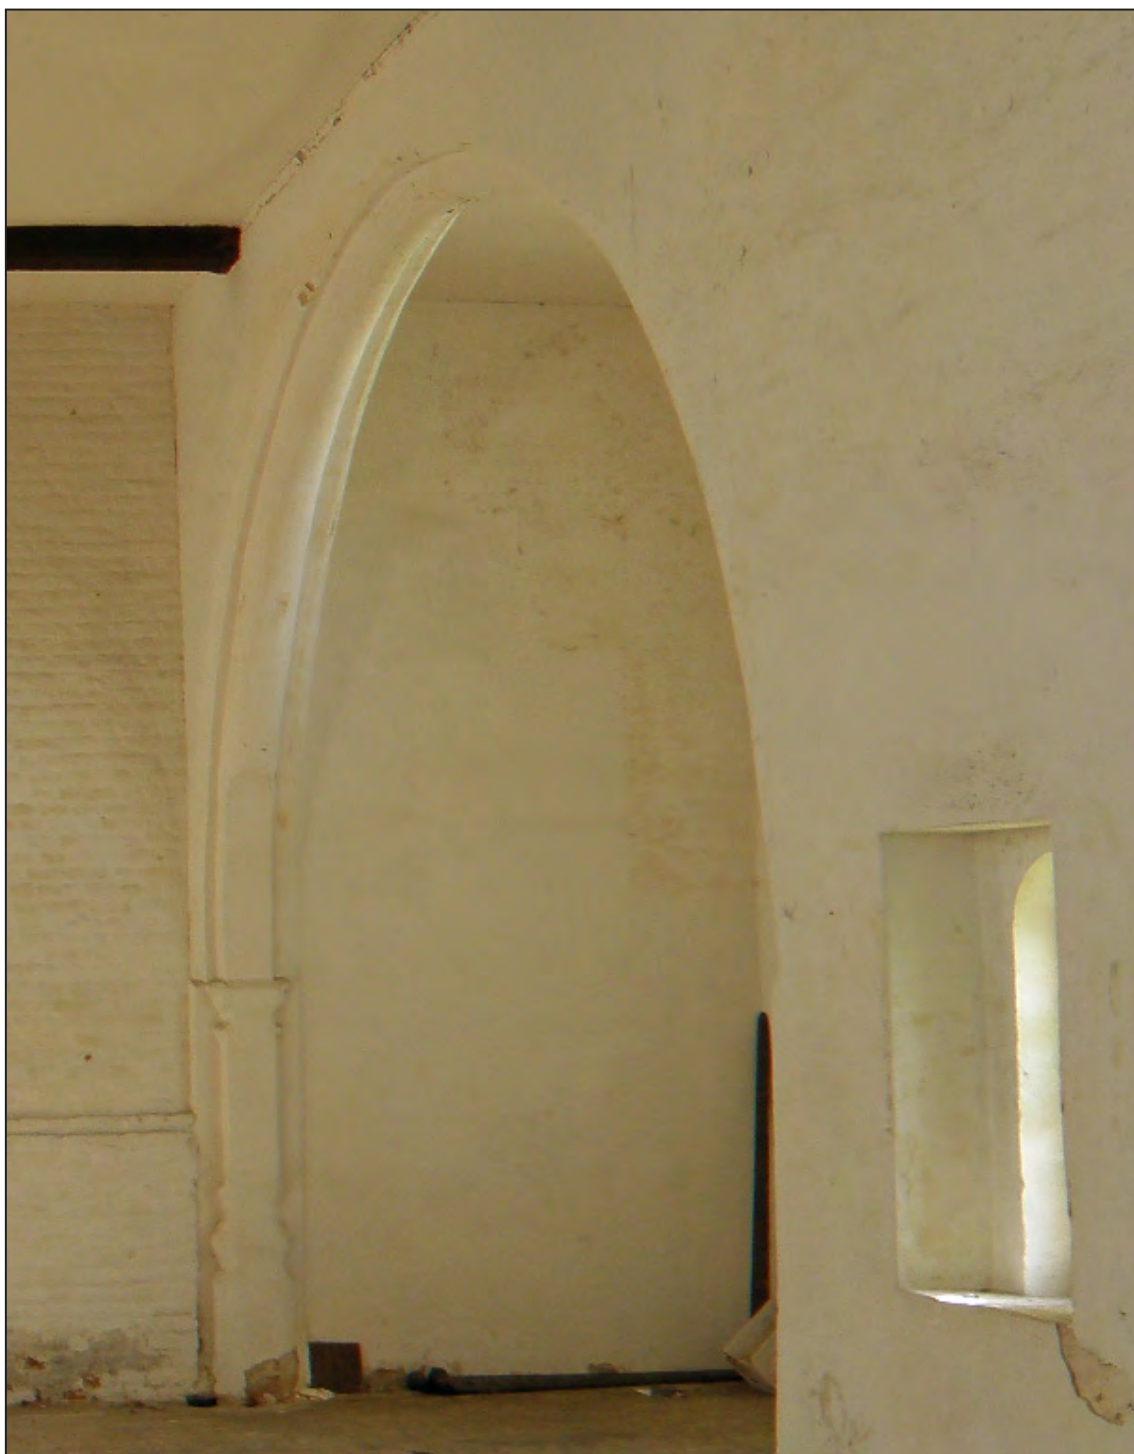
Figure 7. The south arch in the central crosswing and the porter's window (right) before the removal of the plaster, December 2009.
Pete Smith P1010027D.JPG

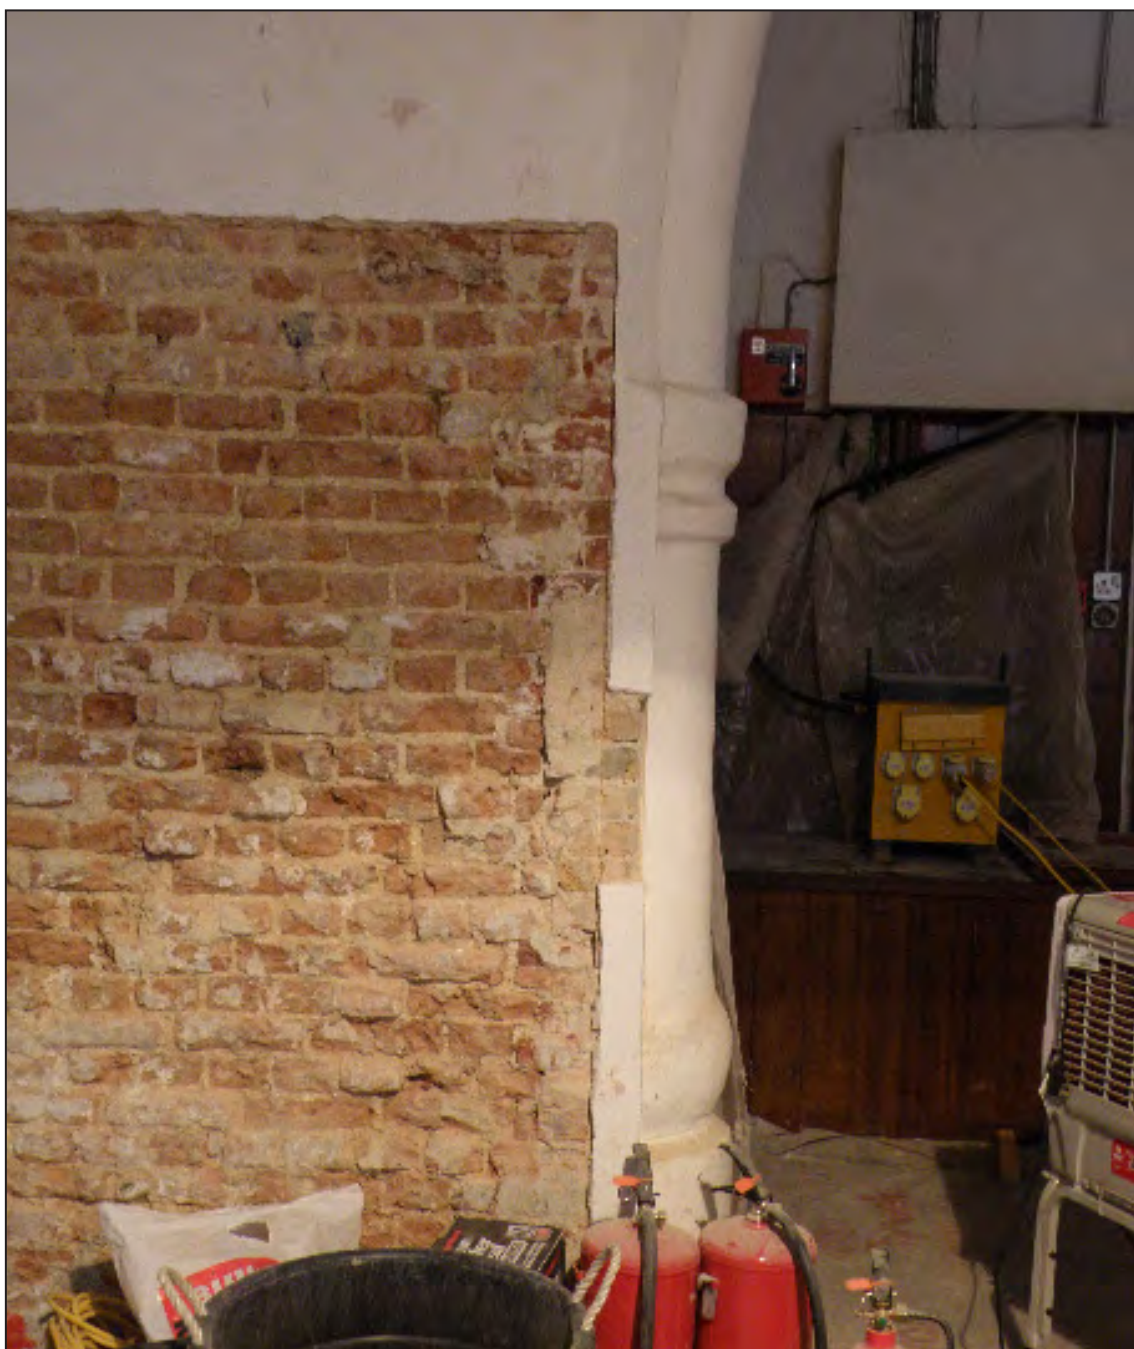
Figure 8. The wall to the west of the west respond to the north arch with the plaster removed.
Pete Smith PI010033.JPG

The plaster was removed from the wall to the west of the west respond of the north arch and from a small section of the respond itself (figs 6 A and 8). The removal of the plaster clearly revealed the difference in brick and mortar between the original walling and the brick structure of the respond. The later darker red brick of the brick work inserted to accommodate the respond with its lighter coloured mortar contrasts with the paler orange brick of the original walling (fig. 9). The later brick work has been patched into the original wall and the horizontal mortar joints do not always correspond.

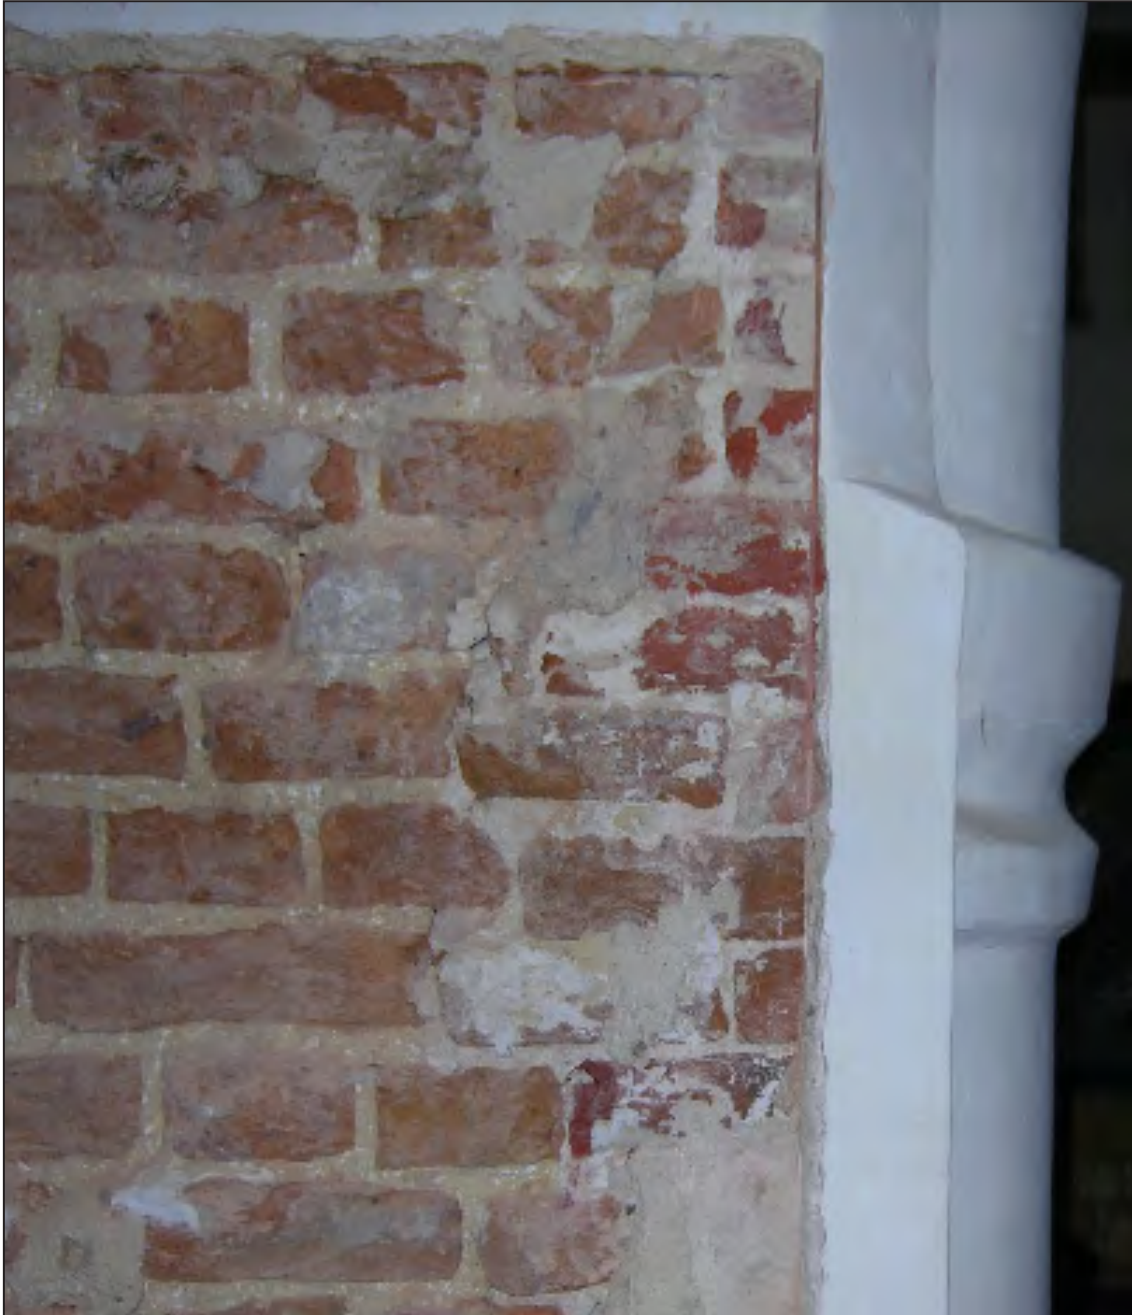
Figure 9. A detail of the exposed wall to the west of the west respond on the north arch showing the much darker red brick used to construct the respond to the arch and the original orange brick with cream mortar of the pre-existing wall.

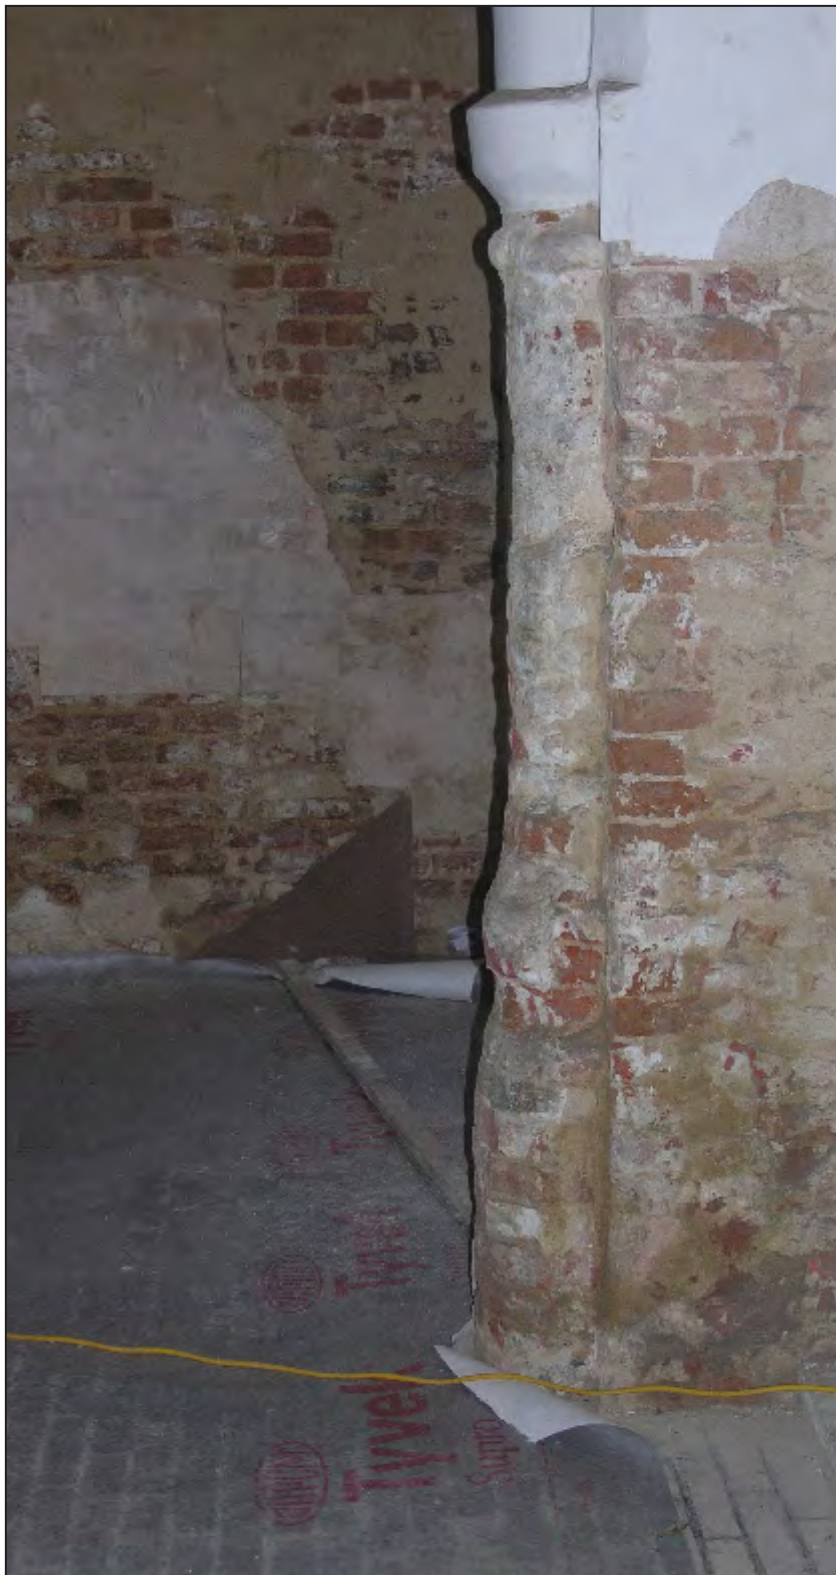
Most of the plaster was removed from the east respond of the north arch (figs 6 B and 10) and from the wall to the east. Though it was not possible to remove all the residual plaster from this respond some sections reveal it is constructed of the same dark red brick as the eastern respond.

Figure 10. The east respond to the north arch with the plaster removed.

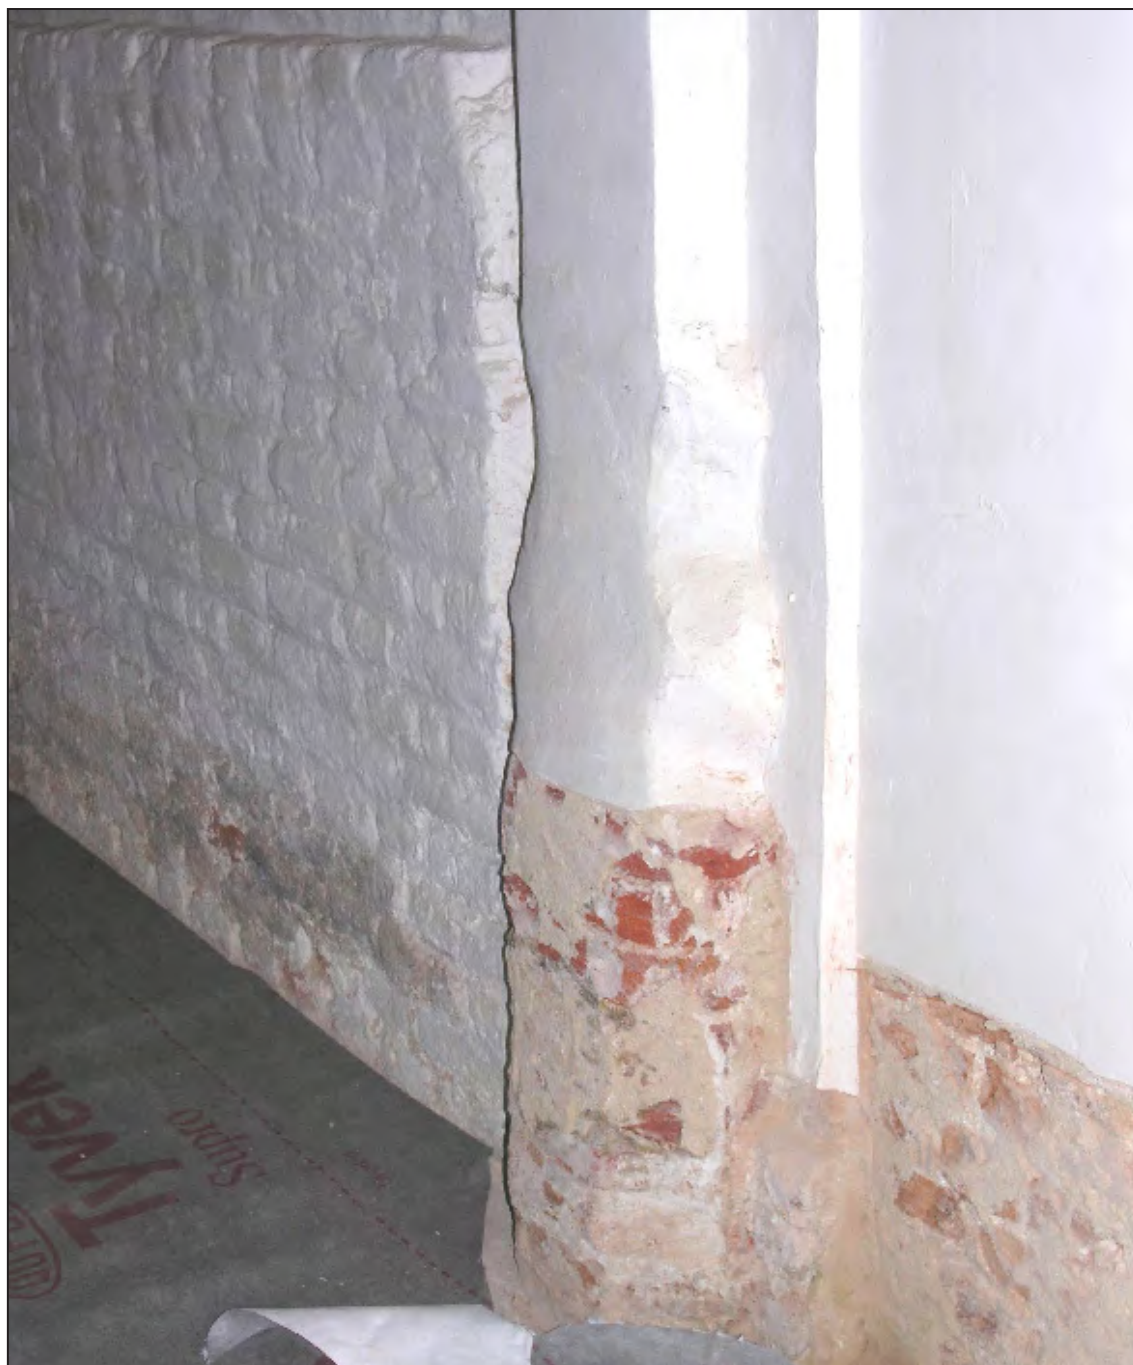
Figure 11. The base of the east respond to the south arch with the plaster removed.

Small sections of plaster were removed from the base of the east respond of the south arch and from the wall to the south (figs 6 C and 11). This clearly shows the distinct difference in colour between the original orange brick walling and the darker red brick of the inserted respond.

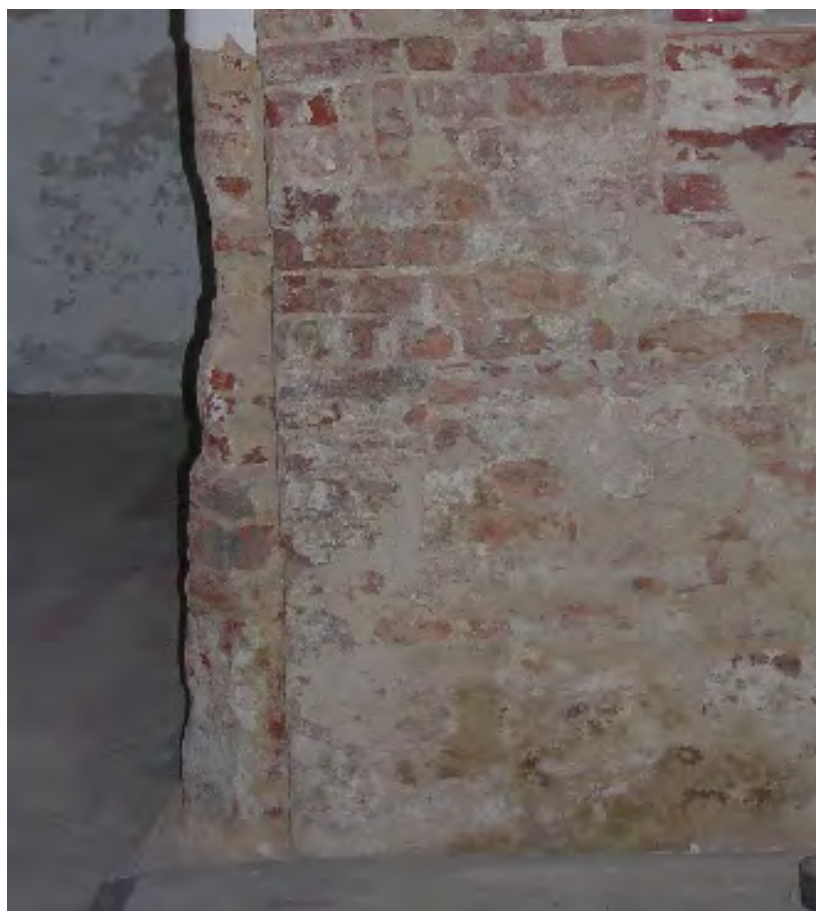
The plaster was removed from the lower half of the west respond of the south arch and from the adjacent walls (figs 6 D and 12). The removal of the plaster left a heavy residue of under plaster on the respond making it difficult to identify differences in the brickwork, but a number of bricks on the respond and on the wall, where the respond had been keyed into the existing wall, were clearly of a darker red brick which contrasted with the orange brick of the original walling.

Figure 12. The west respond of the south arch with the plaster removed.

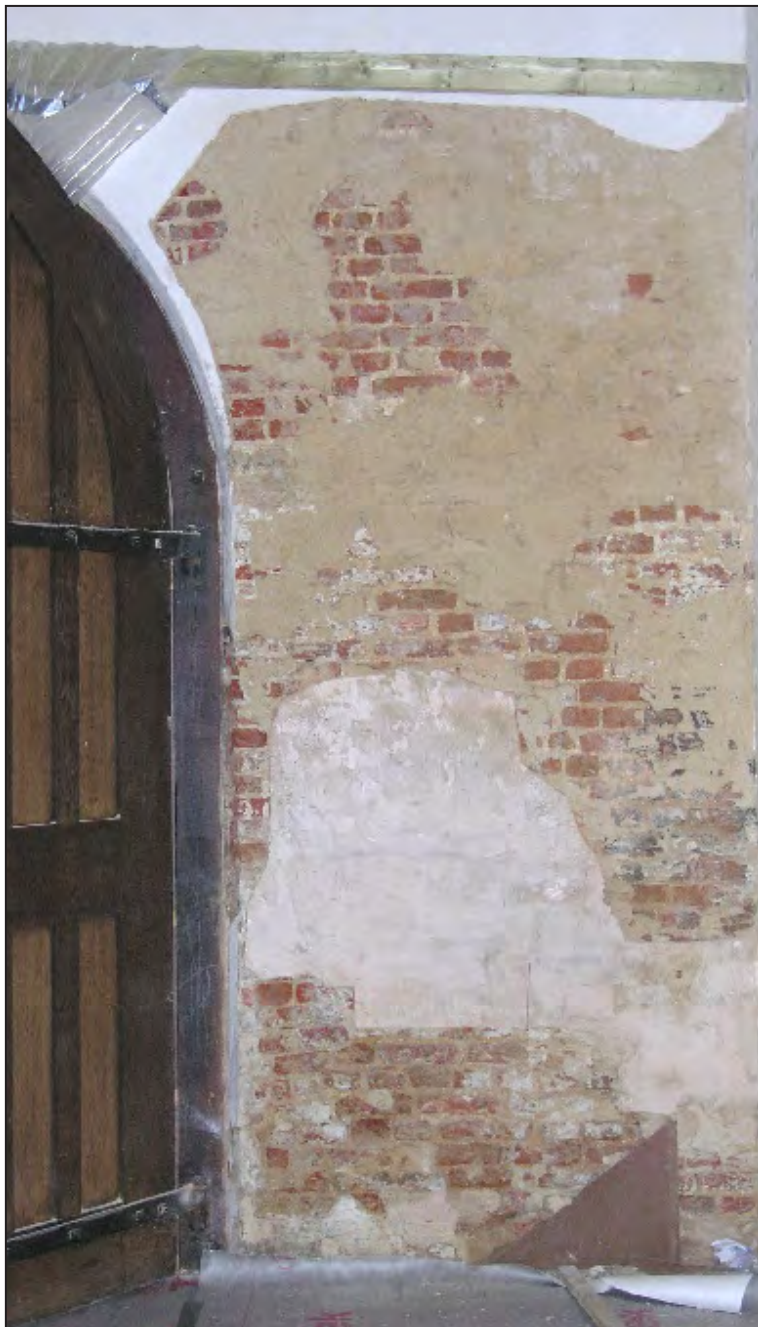
Irregular sections of plaster were removed from the wall immediately to the east of the central doorway on the north wall of the central crosswing (figs 6 E and 13). These included a section of the jamb of the central doorway which revealed that the same darker red brick, which has been noted on the responds (2.2b and c), was also used to construct the jamb of this inserted doorway (fig. 14). The difference in colour and form of the brickwork can be clearly seen on the exterior of the building where the paler and more irregularly shaped original brick (fig. 15 - left) contrasts strongly with the darker red brick of the inserted door surround (fig. 15 - right). There is less evidence of a difference in the colour of the mortars on the exterior due to weathering and to later re-pointing.

Figure 13. The north wall of the central crosswing, showing the partial removal of the plaster from the wall to the east of the central coach house doorway.

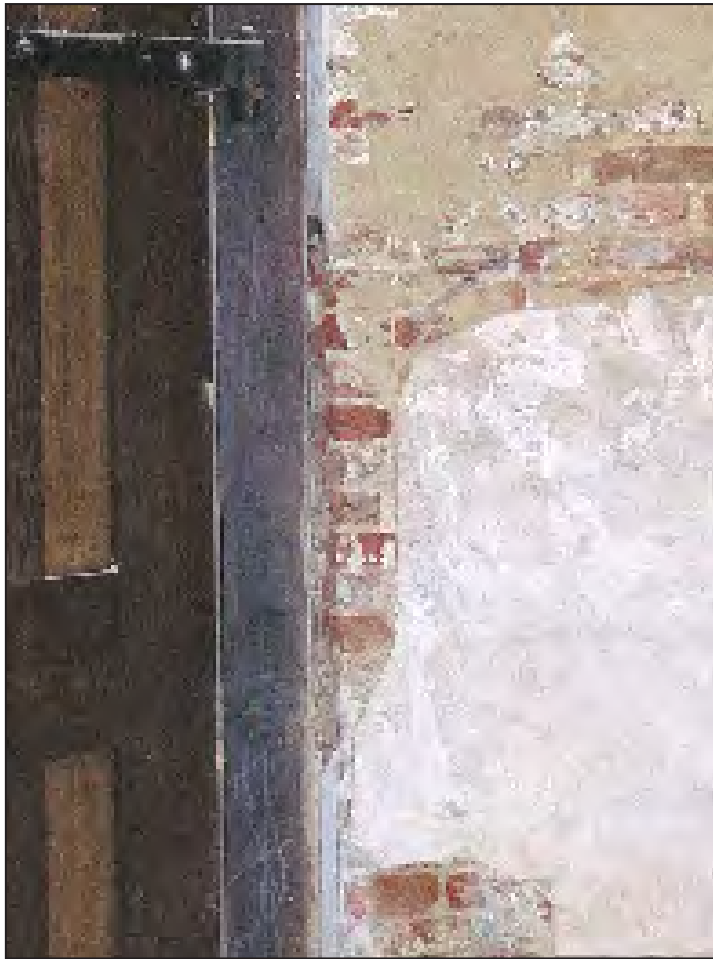
Figure 14. A detail of the jamb of the central doorway inserted into the north wall of the central crosswing with the plaster partially removed.

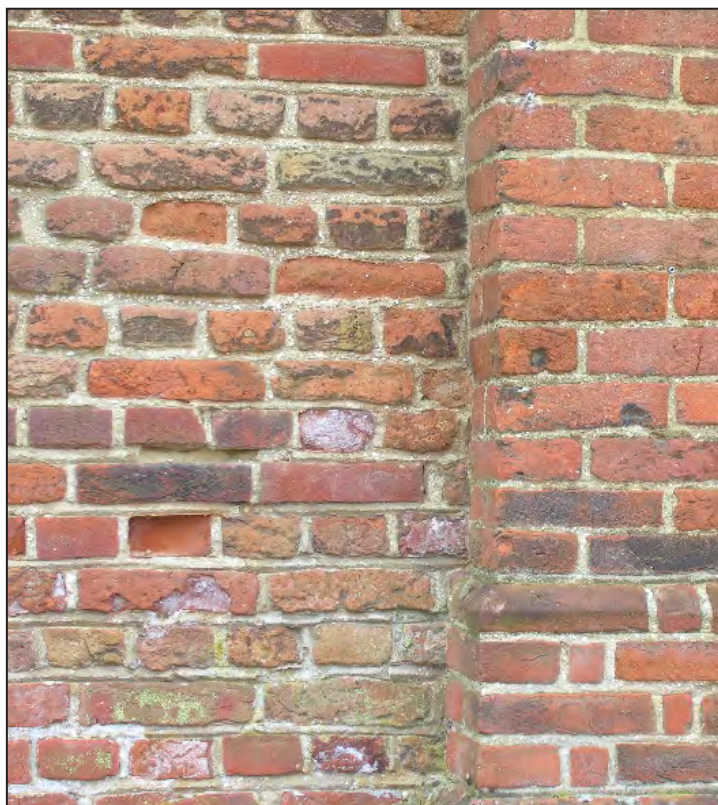
Figure 15. A detail of the exterior of the north wall of the central crosswing showing the clear difference in brick used for the original walling (left) and the darker red coloured bricks of the inserted central door surround (right).

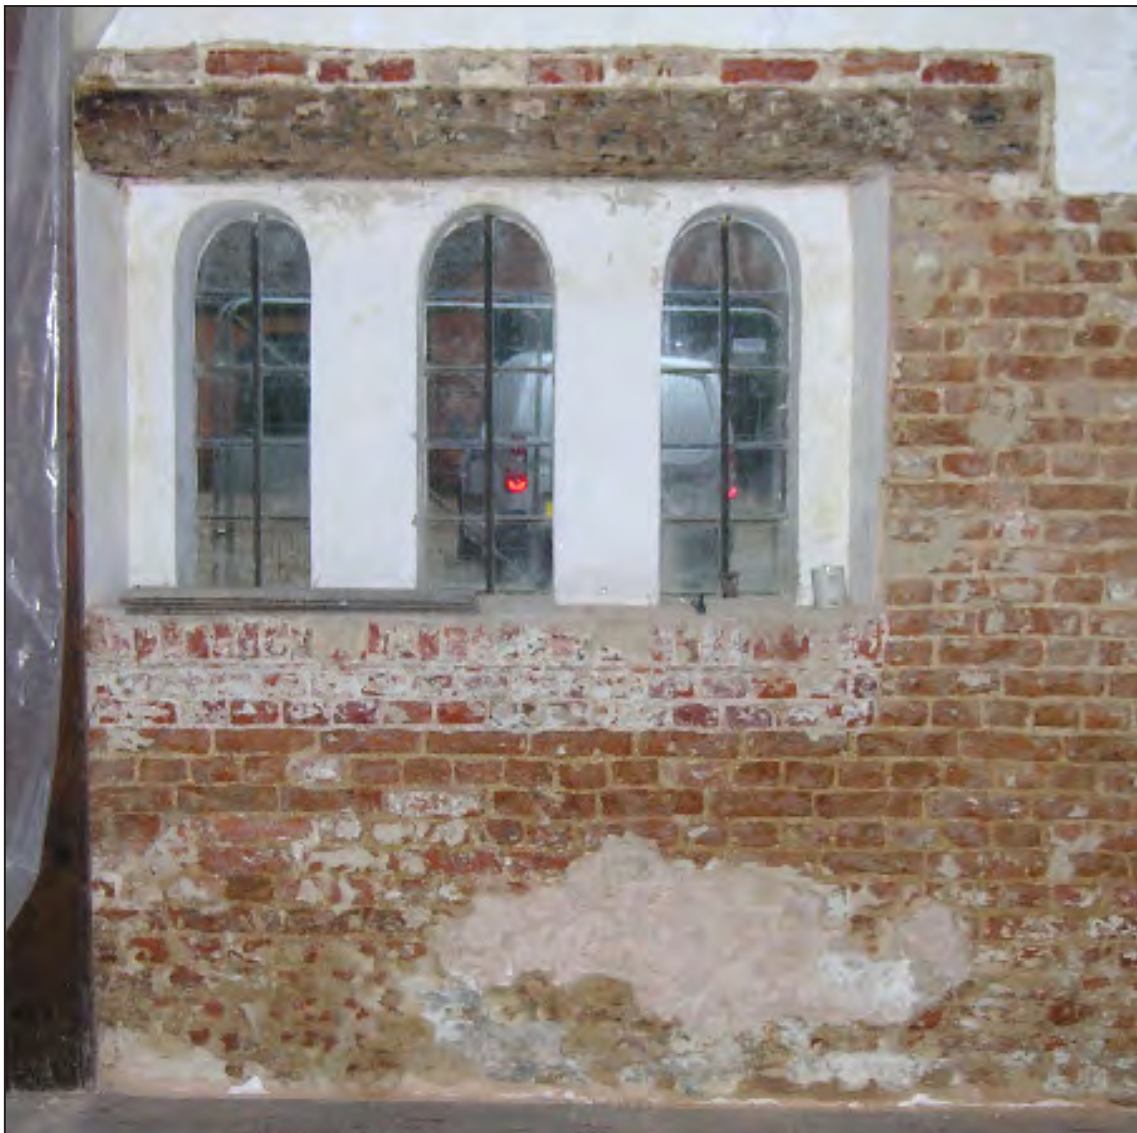
The plaster was removed from around and to the east of the ground floor three-light mullion window on the north wall and also from the timber lintel above this window (figs 6 F and 16). This revealed three rows of darker red bricks with white mortar forming the cill to this window. This infill consists of two rows of stretchers topped by a row of headers. This ground-floor window presumably had a deeply sloping cill originally and the darker red bricks are evidence of the heightening of this cill to form the flat cill which survives today. All the remaining original three-light mullion windows, which are not blocked internally, survive on the upper floor and some these windows have deeply sloping cills. The similarity in the colour of the dark red bricks and the white mortar to that found on the arch responds (2.2b and c) and central door jamb (2.2d) suggests that this window cill was heightened when the building was converted into a coach house and stable in the early 17th century.

Figure 16. The three-light mullion window on the north wall, showing the cill raised in darker red brick.
Pete Smith DSCN6716A.JPG

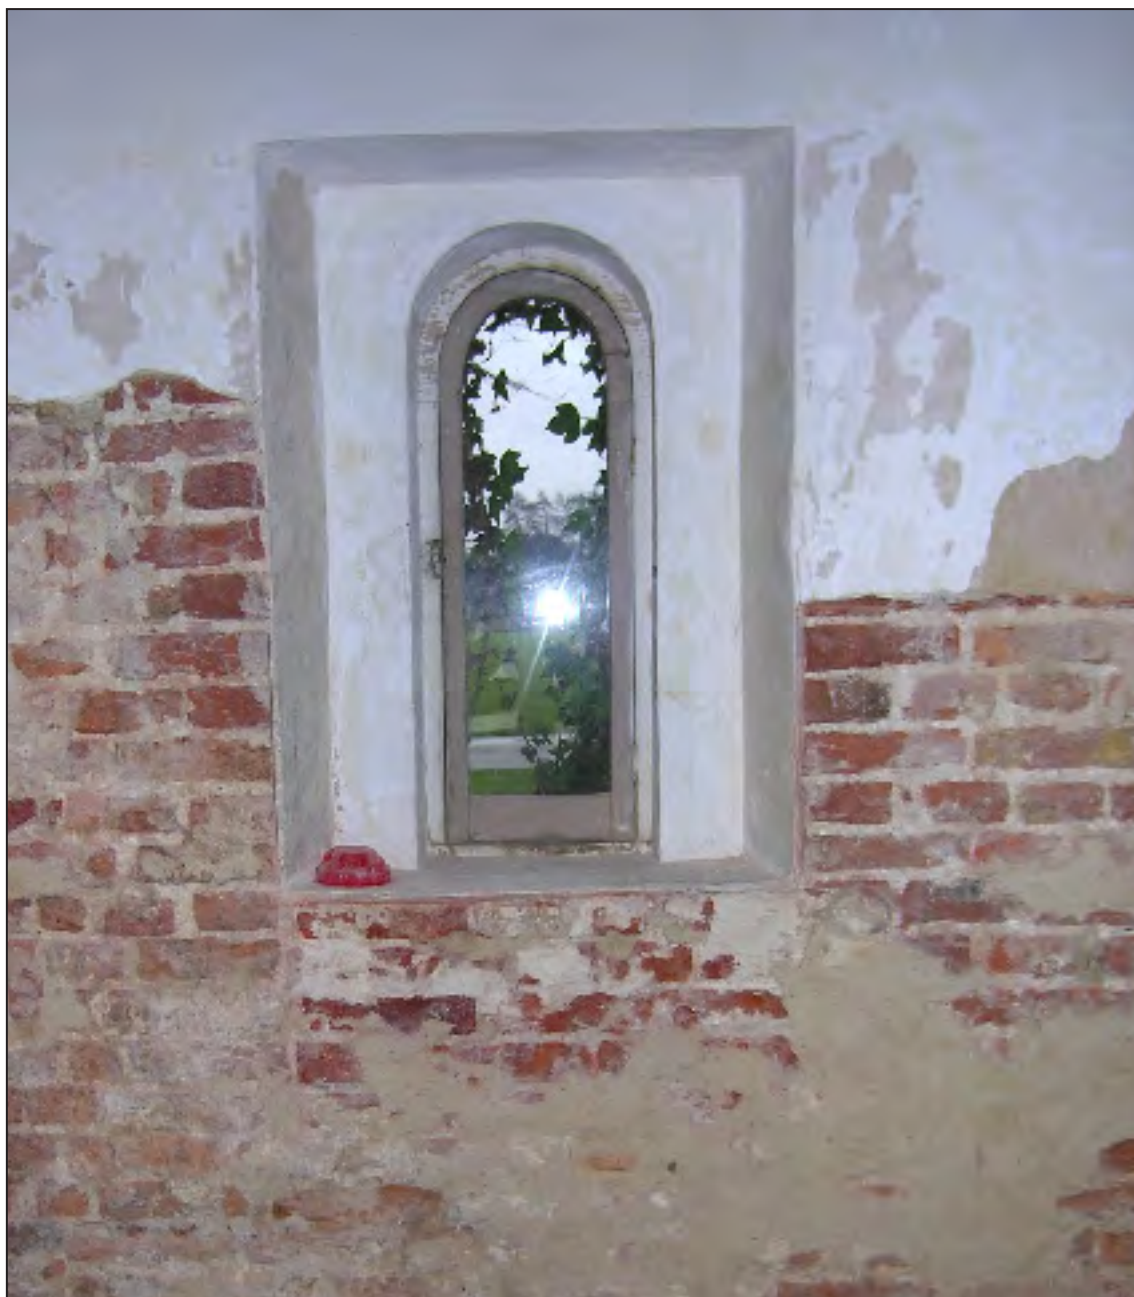
The plaster was removed from around the single-light window on the south wall (figs 6 G and 17); positioned just to the west of the central crosswing. This window looks out onto the now blocked doorway in the west wall of the central crosswing and it was probably originally intended as porter's window, allowing him a good view of anyone entering the building through this door. The removal of plaster revealed four rows of darker red bricks with pale mortar filling the original sloping cill, as on the north window (fig. 16).

Figure 17. The single-light porter's window on the south wall, showing the cill raised in darker red brick.
DSCN6714A.JPG

The top row of bricks is not a neat row of headers, as found on the north window (2.2e), suggesting that this window may well have been blocked completely and only opened up again at a later date. Winstanley does not show a window in this position on his engraved view of the south front c.1680, though this may well have been excluded by him to make the building appear more symmetrical.⁴ The similarity in the colour of the bricks and mortar to the other alterations revealed here (2.2b,c and d) suggests this window was also blocked when the building was converted into a coach house and stable.

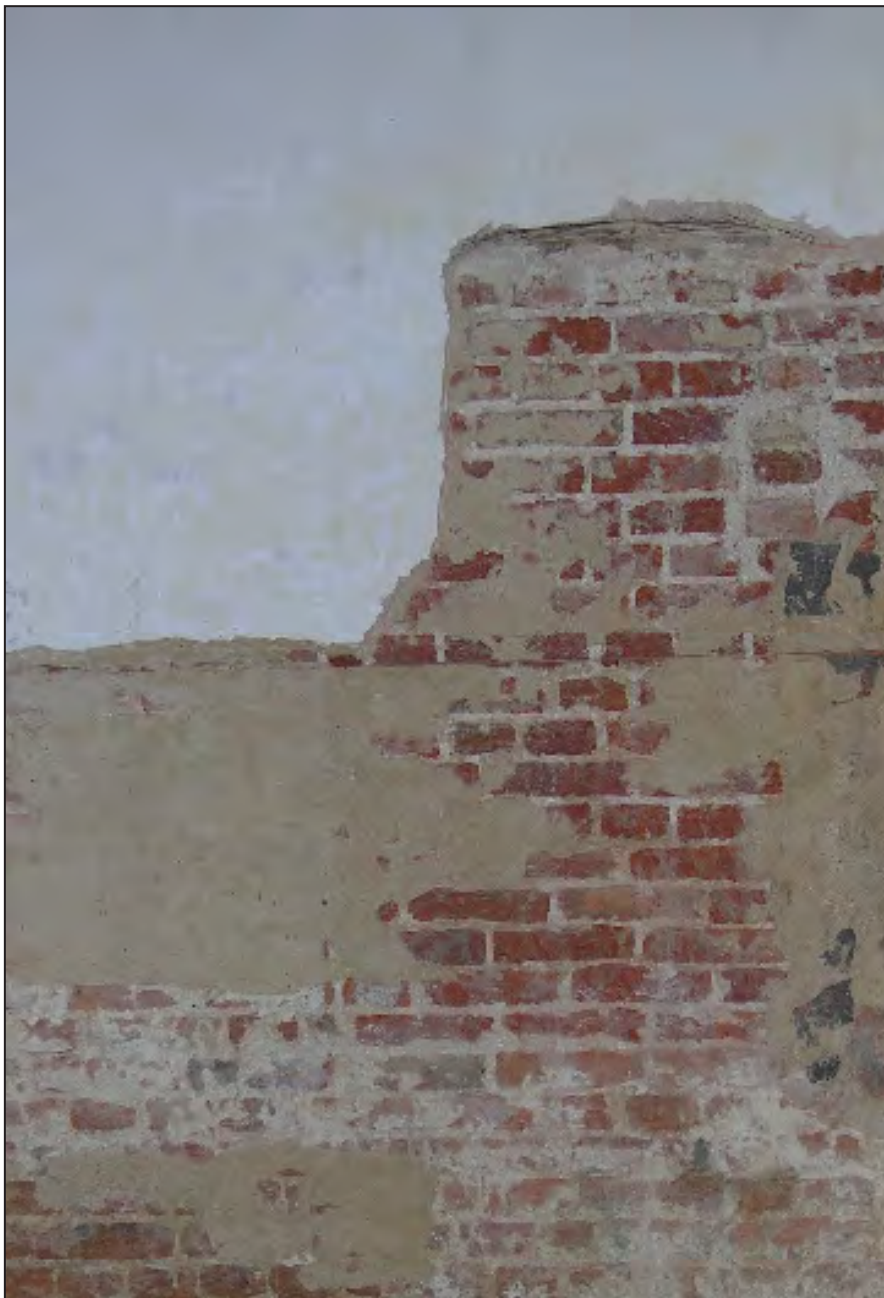
The plaster was removed from a large section of the south wall up to a height of approximately 1.2 metres, with a small section in the south-west corner where the plaster was removed to a height of approximately 1.5 metres (figs 6 H and 18). This higher section revealed a part of the timber lintel to the now blocked, ground floor, three-light mullion window which is still visible on the exterior (fig. 2). The removal of the plaster also revealed the slightly larger and darker red bricks used to block this window and its deep sloping cill (fig. 18). These bricks are laid in an irregular pattern, mostly rows of stretchers with the occasional row of headers, unlike the original walling which is usually laid in header and stretcher bond. The difference in colour of the mortar noted in the other instances of alteration found in this report (2.1b, c, d and e) is not as marked here.

Figure 18. The south wall of the coach house, showing the timber lintel and the inserted darker red brick blocking the former three-light window to the west of the central crosswing.

The removal of the plaster therefore confirms that the blind ground-floor windows (visible on the exterior – fig. 2) were originally constructed as fully functioning windows and that they were blocked internally when the building was converted into a coach house and stable. These windows were presumably blocked to allow the stalls for the horses to be constructed against the south wall. These ground-floor windows on the south front are shown as blocked on Winstanley's engraving of c.1680 (fig. 19). His plan does not show the stalls, but a report compiled by Sir Christopher Wren in 1695 refers to the 'Stalles' being in dire need of repair, suggesting that these stalls had been in existence for a good number of years by that time.⁵

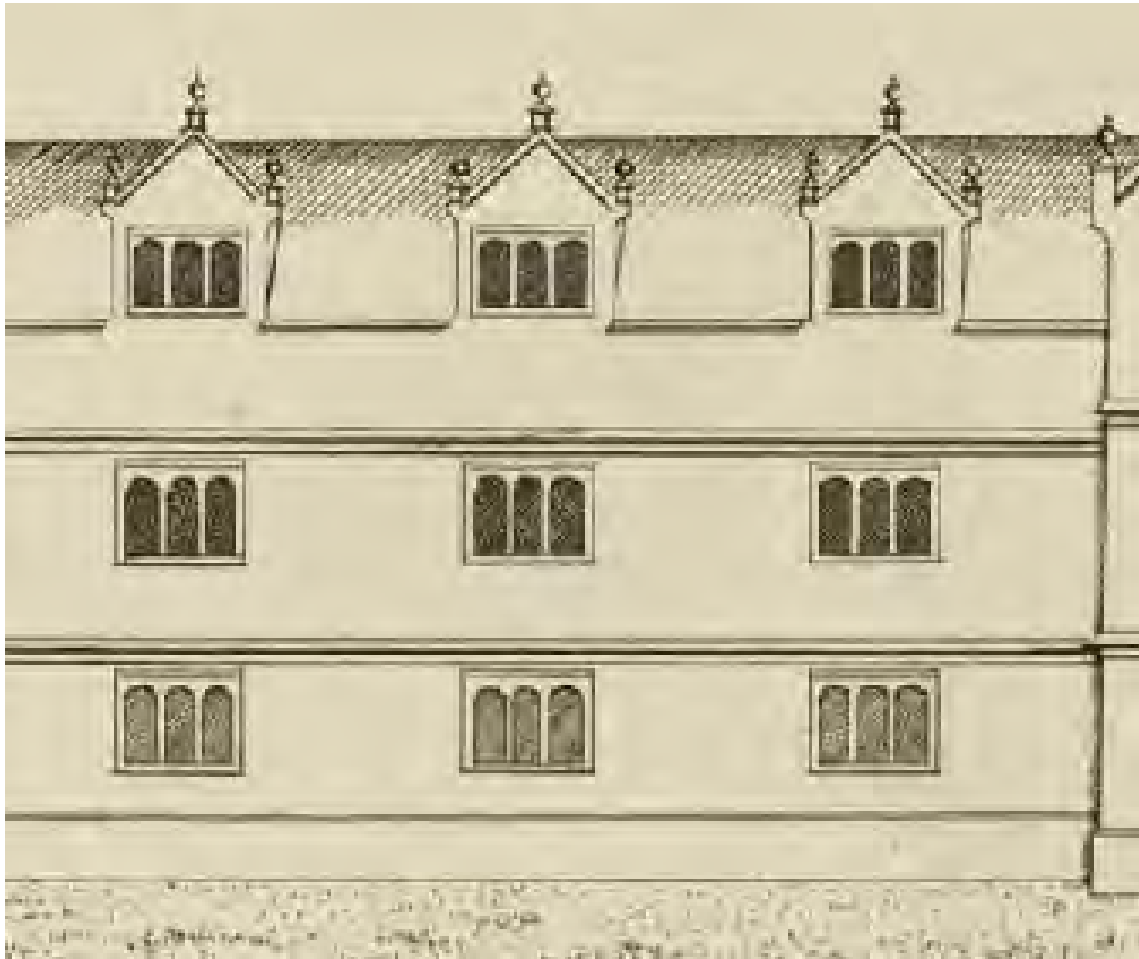
Figure 19. Henry Winstanley, c.1680. A detail of the south front showing the blind windows indicated by diagonal hatching on the ground floor, contrasting with the functioning upper windows shown with cross-hatching indicating diamond-lead casements.

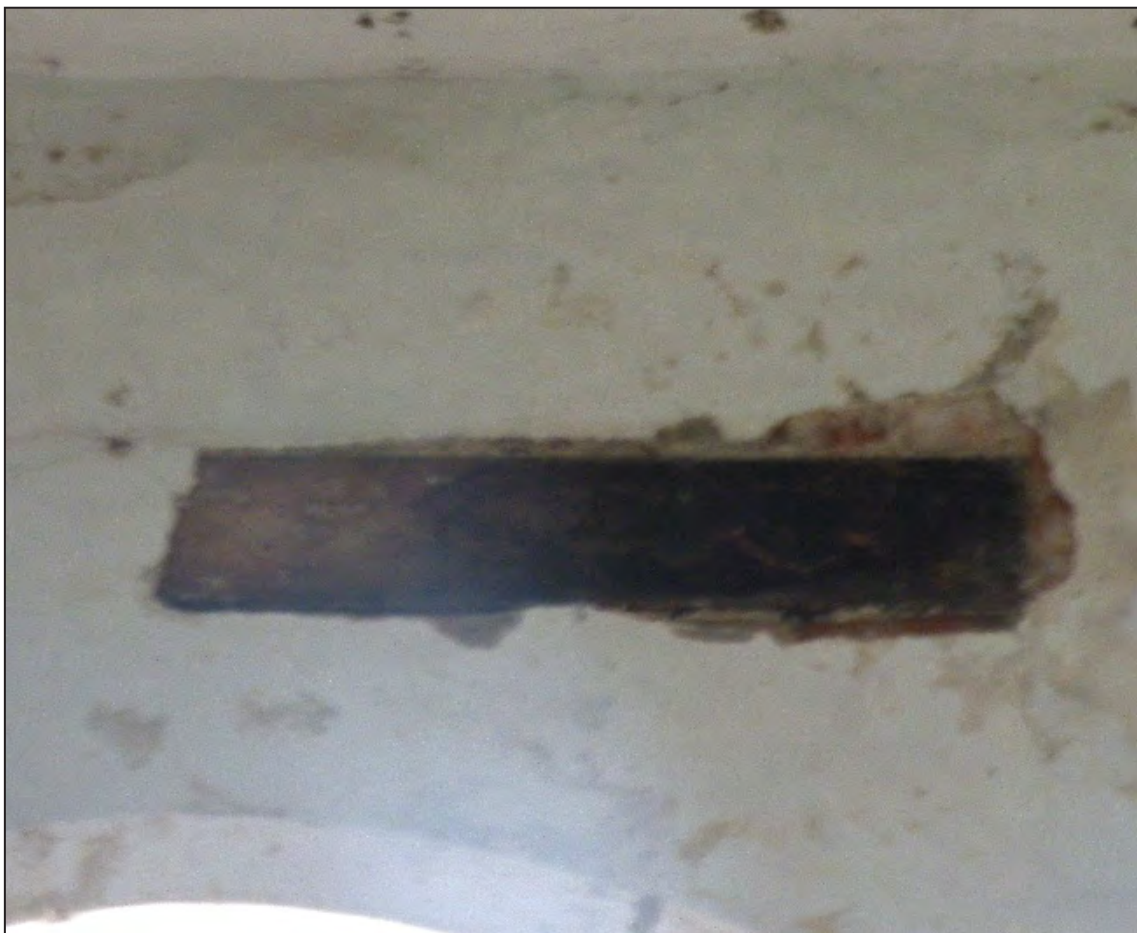
On the north wall, above the arch inserted to accommodate the western bay, a section of a timber lintel was revealed by the removal of the plaster (figs 6 I and 20). This piece of timber once formed part of the lintel to the original first-floor, three-light mullion window which existed here before the western bay was added to the north wall. It is one of the few surviving pieces of evidence which confirms that the north front originally had three-light mullion windows on the first floor, arranged in the same layout as those which survive on the south front.

Figure 20. The former lintel to the original three-light mullion window which existed at first-floor level before the bays were added when the building was converted into a stable.
Pete Smith P1010016A.JPG

The lintel uncovered over the arch of the western bay (2.3a) inserted into the north wall of the West Stable, is clear confirmation of the existence of a three-light window on the first floor prior to the construction of the bay. This, and the revealed central light of the ground floor window to the west (2.3b), confirms that the north front originally had three-light mullion windows arranged in an almost identical pattern to that which survives on the south front.

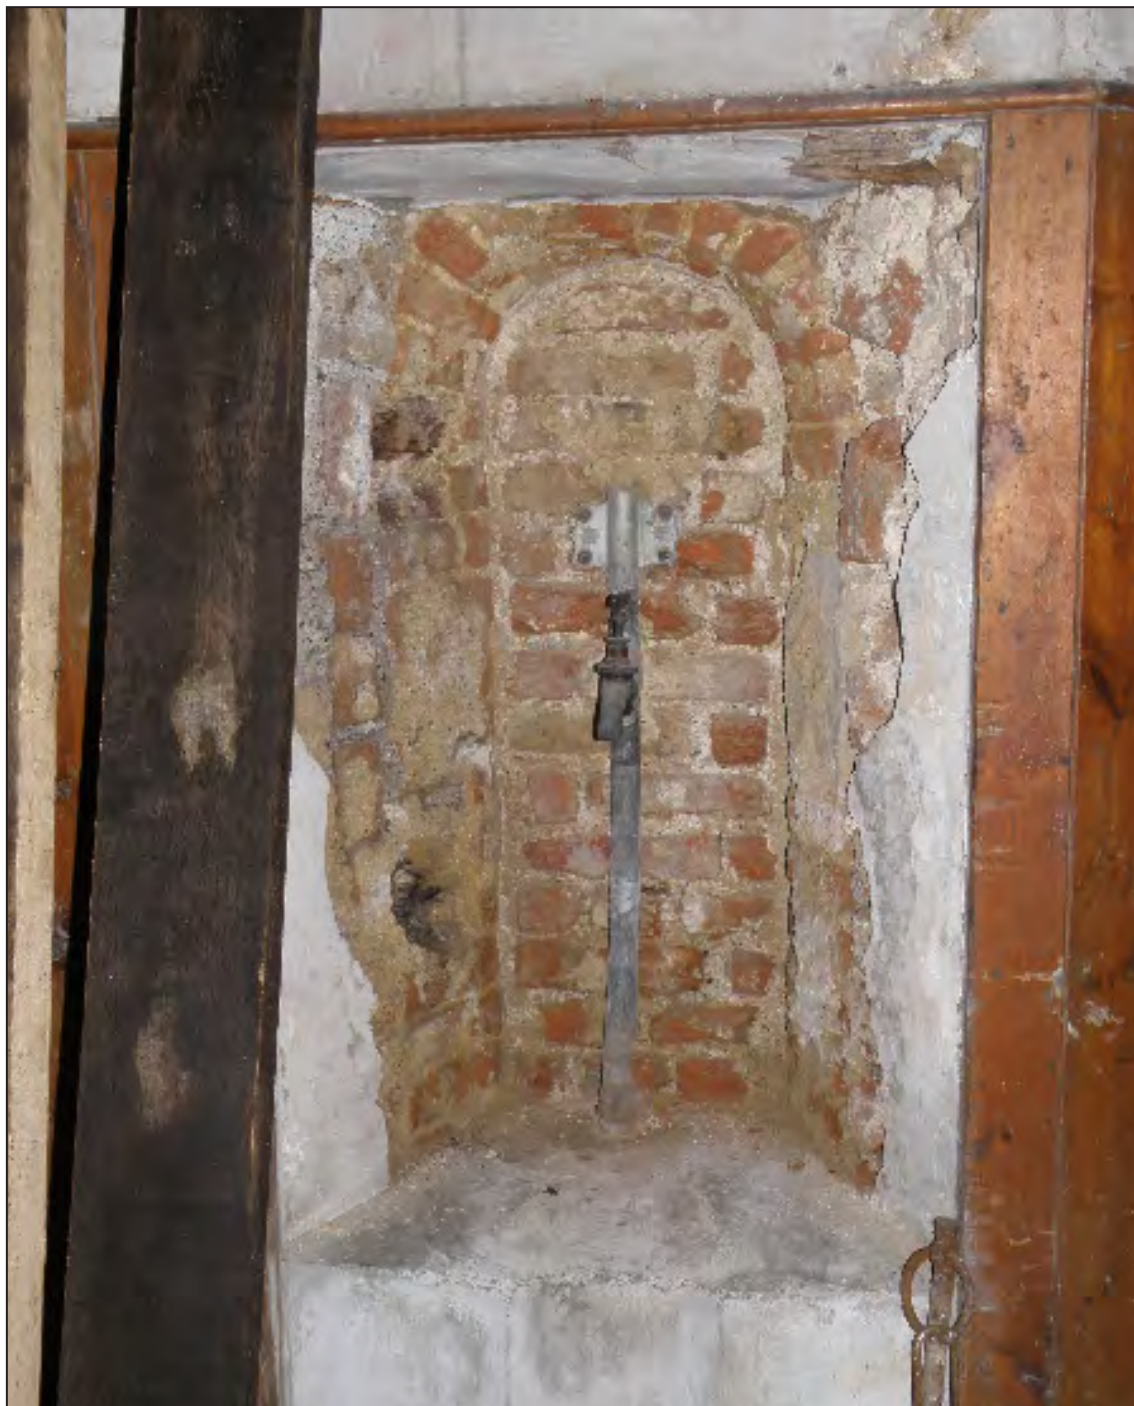
The plaster was removed from the small niche immediately west of the door into the West Stable which now contains a tap (figs 6 J and 2I). This revealed that this niche was originally the central light to the three-light mullion window which once existed on the ground floor between the western bay and the west crosswing. The coursing of the brick

Figure 2I. The niche on the south wall of the West Stable showing the blocked central light of the original three-light mullion window.

blocking the window does not run through into the coursing of the jambs. The removal of the plaster from the chamfered jambs revealed the former brick mullions and the rounded head of this central light. The later infill of the chamfered mullions to form the deeper jambs of the niche was clearly visible. The bricks used to infill this window were not the same darker red bricks used for the alterations to the Coach House. On the exterior the position of the niche, immediately to the right of the door, is in line vertically with the central light of the surviving first floor window (fig. 22). The blocking of the western section of this window can be seen on the exterior brickwork. This window is shown as a still functioning window with leaded lattice casements on the Winstanley engraving of c.1680 (figs 3 and 30 bottom right), and it was presumably blocked when the door was inserted to create an entrance to the searate West Stable in the 18th century.
