THE COACH HOUSE AND THE WEST STABLE, AUDLEY END HOUSE, SAFFRON WALDEN, ESSEX RECORDING AND FABRIC ANALYSIS

HISTORIC BUILDING REPORT

**THE COACH HOUSE AND THE WEST STABLE
AUDLEY END HOUSE,
SAFFRON WALDEN, ESSEX
RECORDING AND FABRIC ANALYSIS**

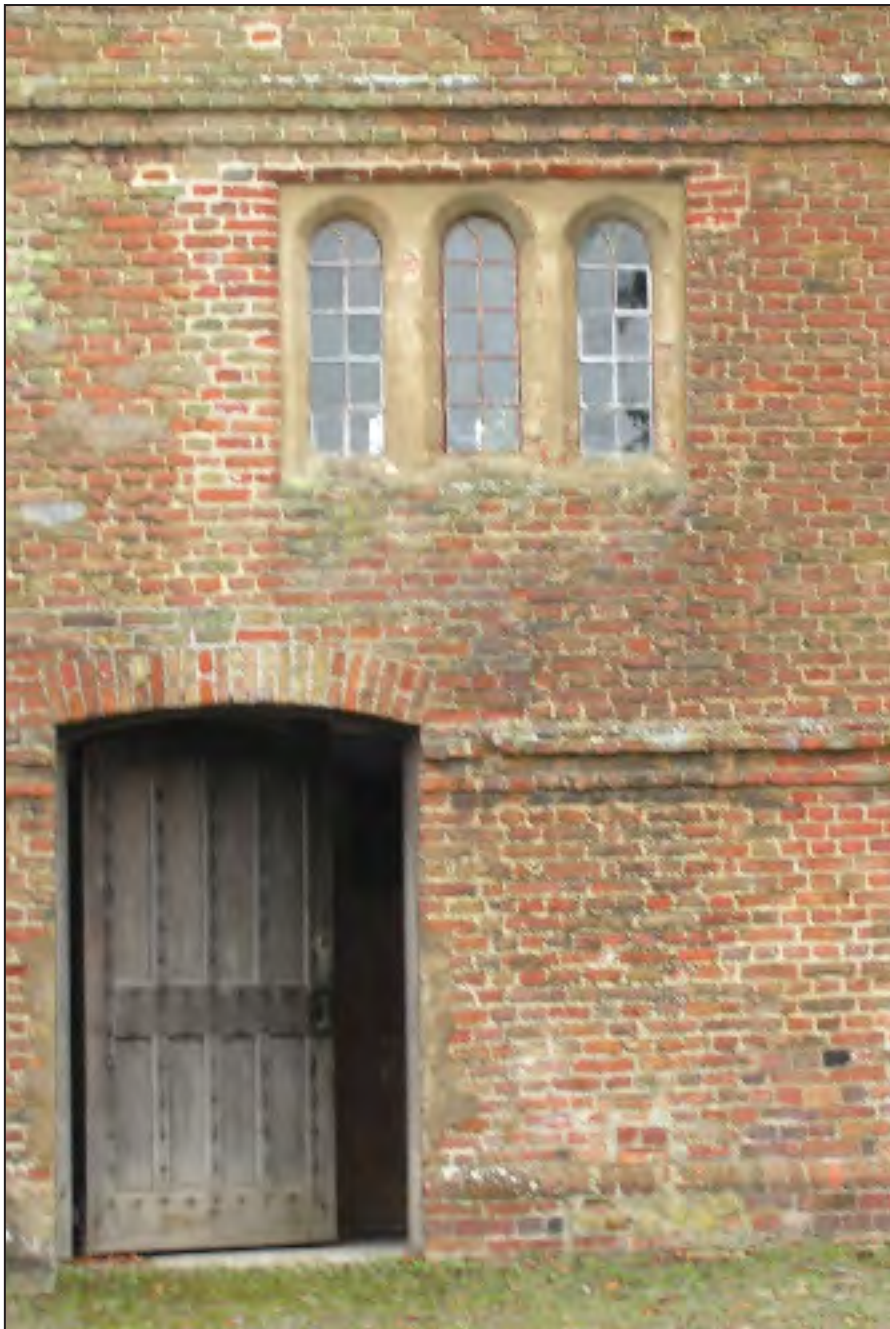
Figure 22. The north front showing the door to the West Stable and the surviving upper three-light window. The internal niche, which survives from original three-light ground floor window is sited immediately below the central light of the first floor window.

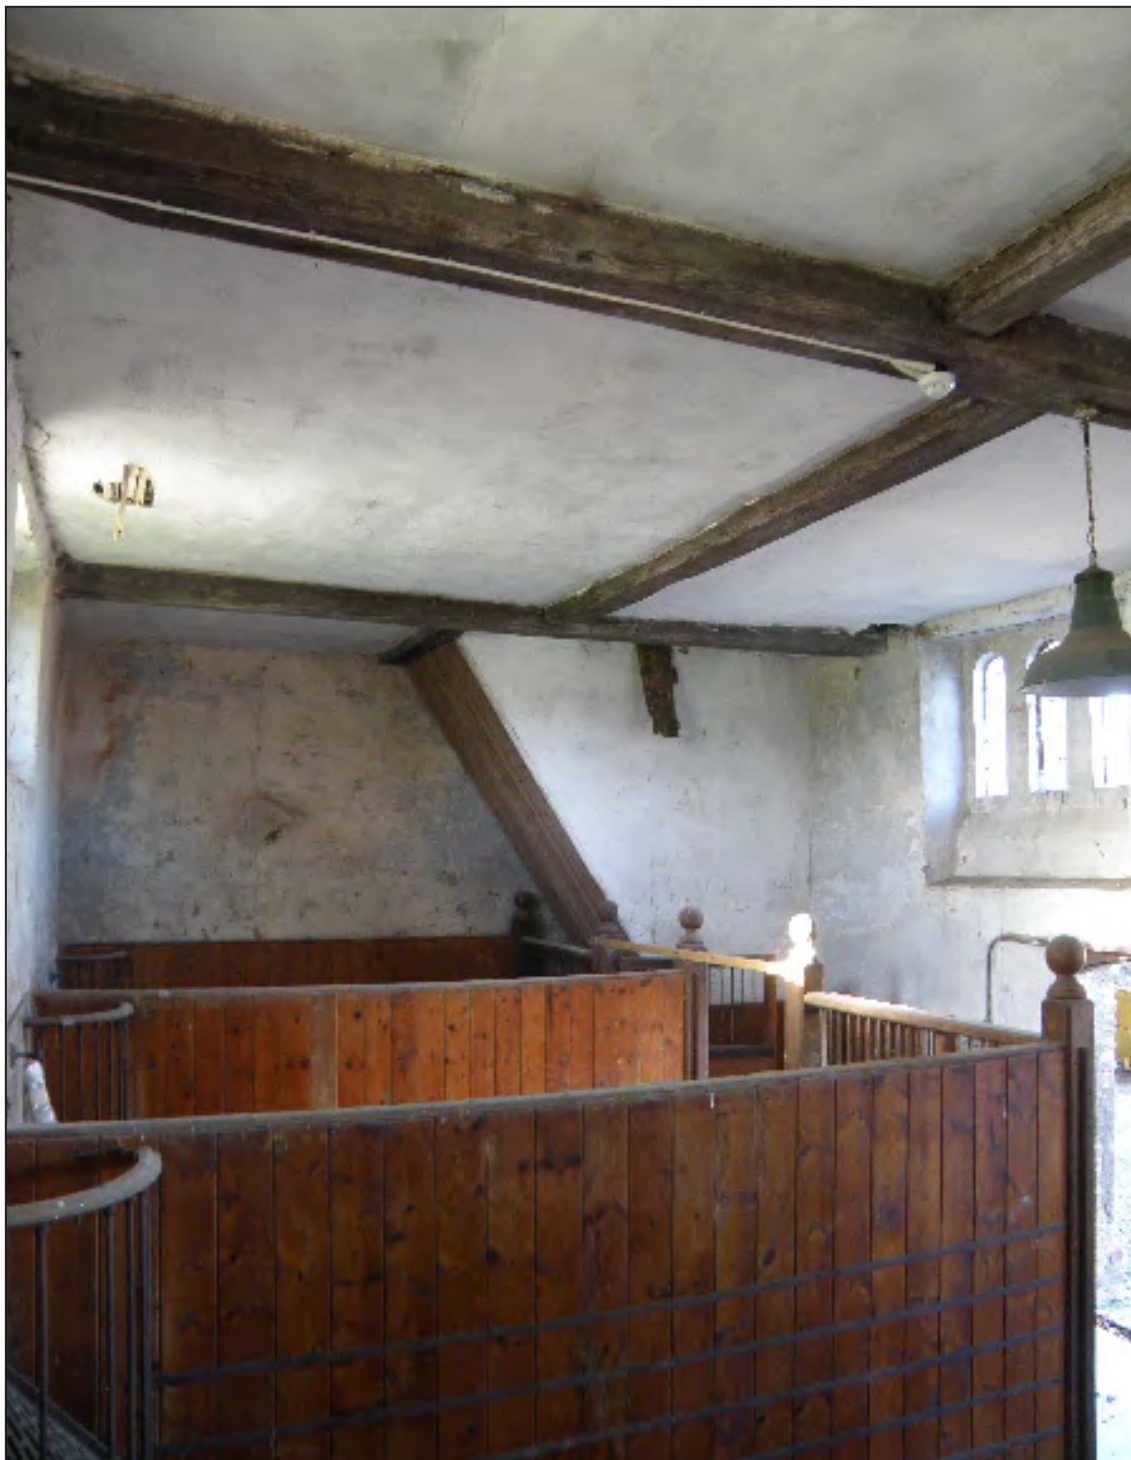
Paul Drury and I visited the Stables especially to examine what Paul had identified, on a previous visit, as a possible scar of a former doorway visible in the plaster high up on the west wall of the West Stable (fig. 23).

Figure 23. The interior of the West Stable looking west before the removal of the plaster, December 2009.
Pete Smith PI010026.JPG

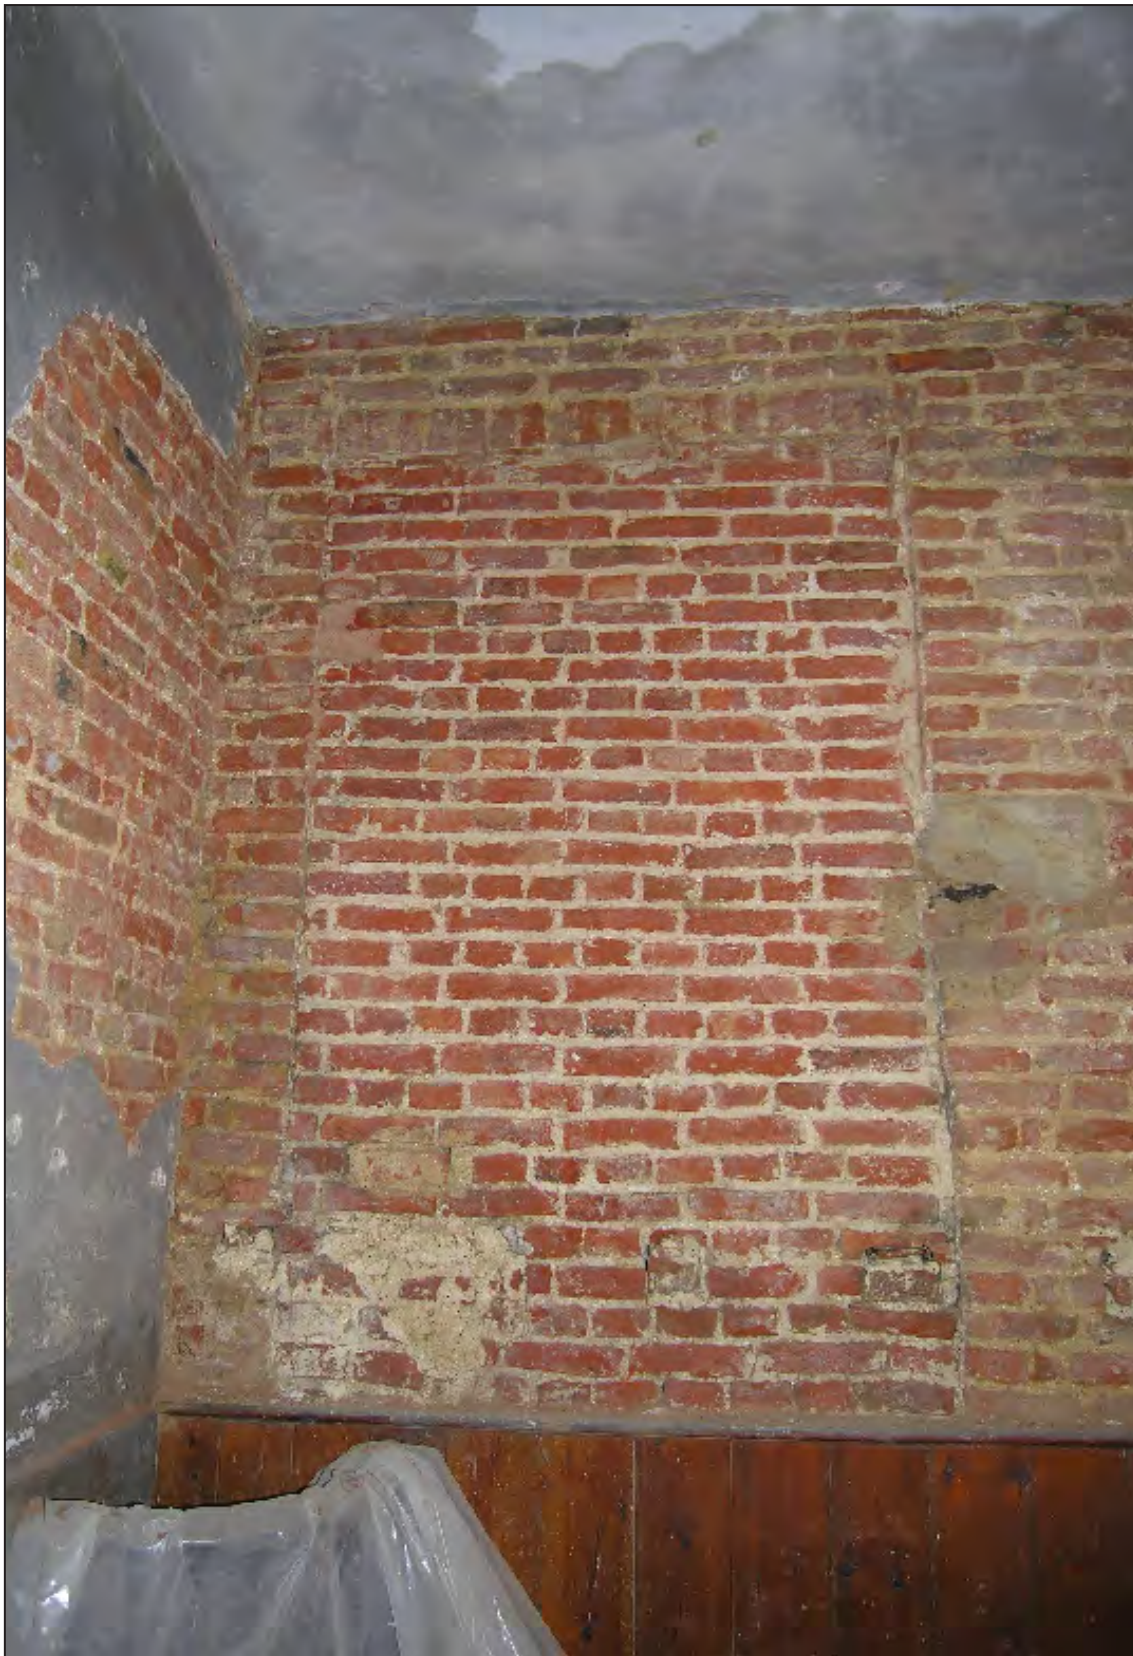
Figure 24. The southern section of the west wall of the West Stable after the plaster had been removed showing the south blocked doorway at first-floor level.
Pete Smith DSCN6730.JPG

The removal of all the plaster from the west wall of this stable revealed the clear outline of a former doorway above the vertical boarding (figs 6, K and 24). The infill bricks were a darker red in colour than the bricks of the original walling, and the mortar used was of much brighter whiter colour than the original mortar. The similarity of the colour of the bricks and mortar used here to those found in the alterations to the Coach House (2.2b, c, d and e) suggests that this work was carried out at the same time that the arches were inserted in the early 17th century. The infilled section is topped with a row of headers; it reaches to within three courses of the ceiling and continues downwards beneath the vertical boarding. This former doorway corresponds with another blocked doorway to the north, now hidden by the stair compartment, which extends across the northern section of the west wall (fig. 25). This other blocked doorway is partly visible from the stair, where the plaster has fallen from the wall and has not been renewed. Both these doorways appear to open into the west crosswing and they are clear evidence that this building was originally built with a floor at first-floor level.

More difficult to explain is why the scar of these doorways extend so far downwards below the level of the first floor. One explanation might be that the blocking included doors on the ground floor, as well as on the first floor, and that the intervening structures (the lintel of the lower doorways) was removed when these doorways were blocked.

The first-floor doorway revealed on the west wall of this stable (2.3c) is probably the most interesting feature to be uncovered as part of this repair work. It confirms that a first floor was built, or intended to be built, within the central section of this building prior to its being converted to a coach house and stable, and it proves that there was originally access through to the west crosswing at first-floor level, all of which was altered when the building was converted to a coach house and stable.

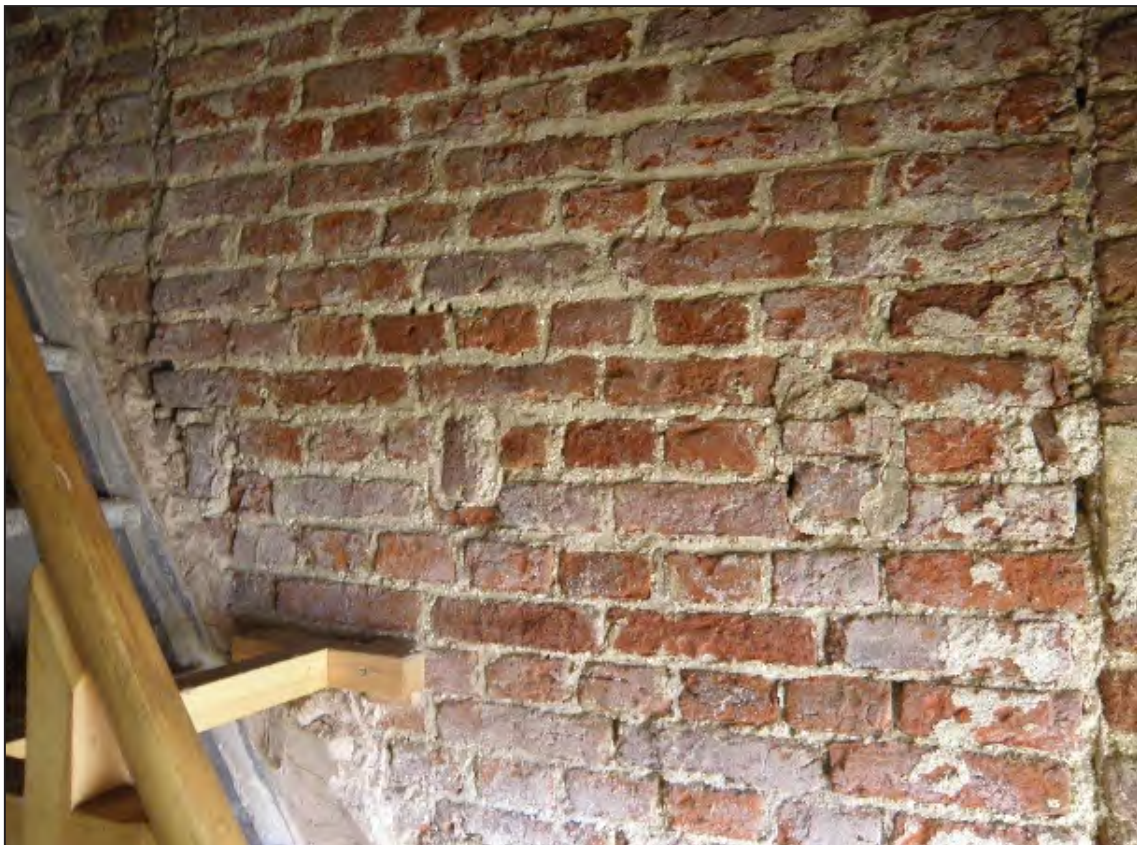
Figure 25. The northern section of the west wall, now within the stair compartment, showing the north blocked doorway at first-floor level. The blocked sockets for floor beams correspond in level with those found across the remainder of this wall. The plaster was not renewed as part of the repairs. Pete Smith PI010023.JPG

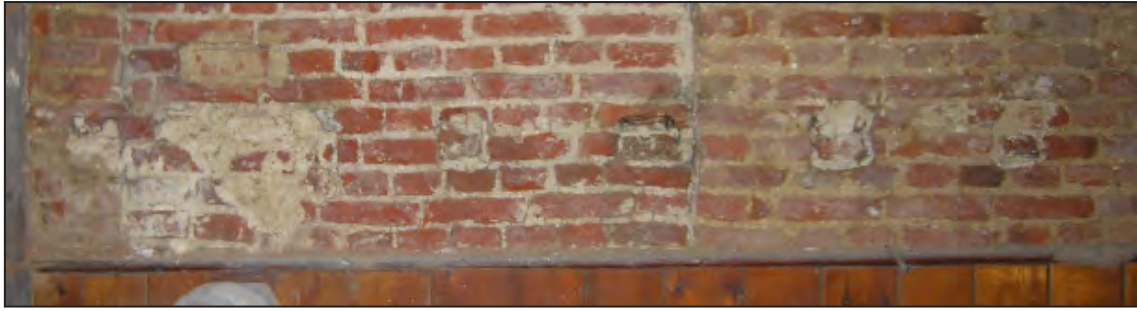
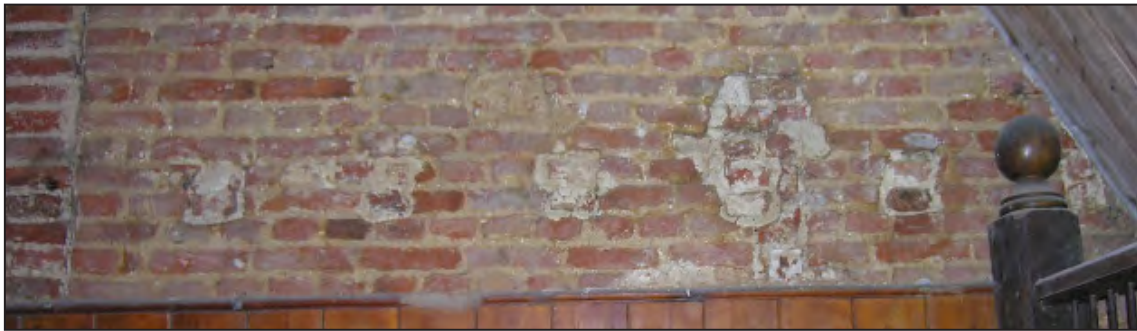
Figure 26. The northern section of west wall of the West Stable showing the blocked sockets for floor beams continuing across the north blocked doorway.
Pete Smith DSCN6733A.JPG

Figure 27. The southern section of west wall of the West Stable showing the blocked sockets for floor beams.
Pete Smith DSCN6735A.JPG

A series of blocked holes or sockets for floor beams was visible across the full width of the revealed west wall, three brick courses above the vertical boarding (figs 26 and 27). These correspond in level with the blocked sockets for floor beams across the northern section of this wall, now within the stair compartment (fig. 25). This indicates that a floor of some type, possibly a gallery or a landing, once existed across the full width of the west wall. These blocked sockets continue across both the blocked doorways showing that this floor was inserted after the doorways were blocked or possibly at the same time as this blocking. They do not appear to be evidence of the first floor which presumably existed within the original lodging range, rather they must be part of a floor inserted when the building was converted to a coach house and stable, between c. 1616 and c. 1680, or at some time after this date.

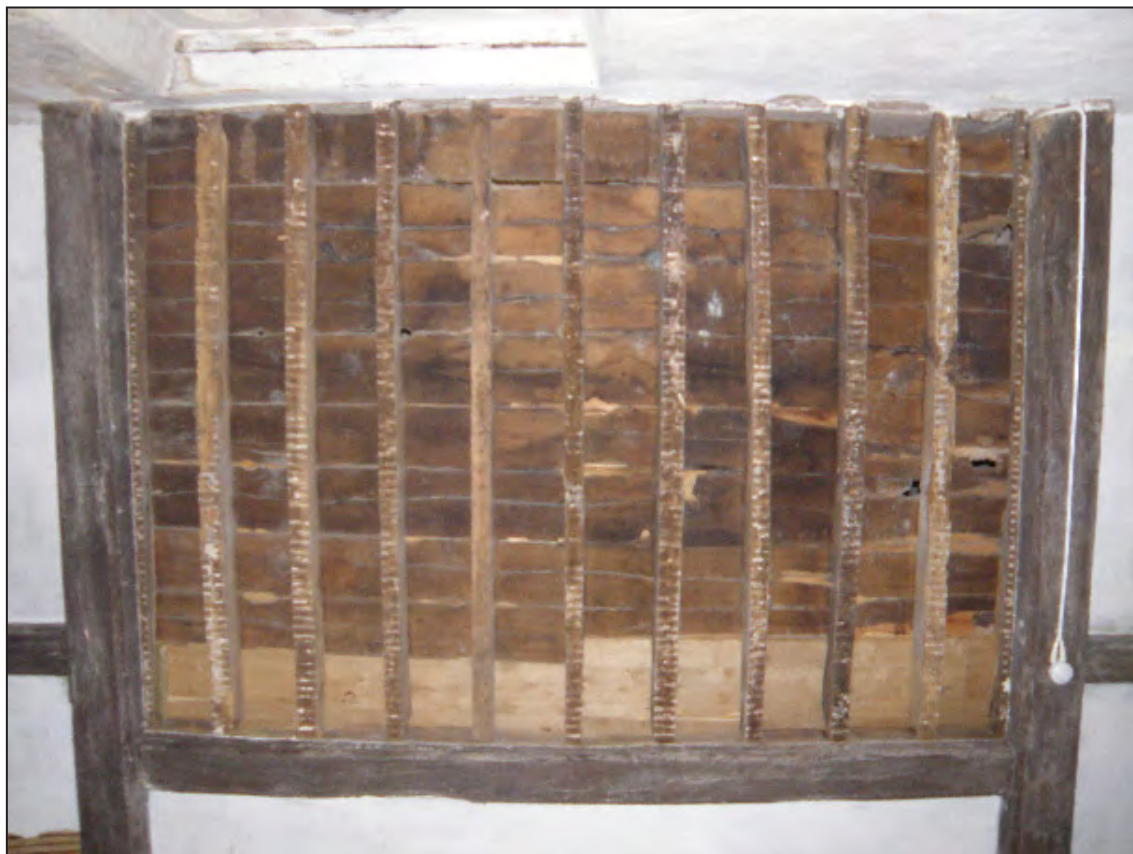
The lathes and the plaster were removed from the central section of the ceiling on the south side (figs 6 L and 28). This revealed the simple structure of eleven timber cross beams which support the attic floor boards and the plaster ceiling of this stable.

Figure 28. The central section of the ceiling on the south side of the West Stable.
Pete Smith PI010031D.JPG

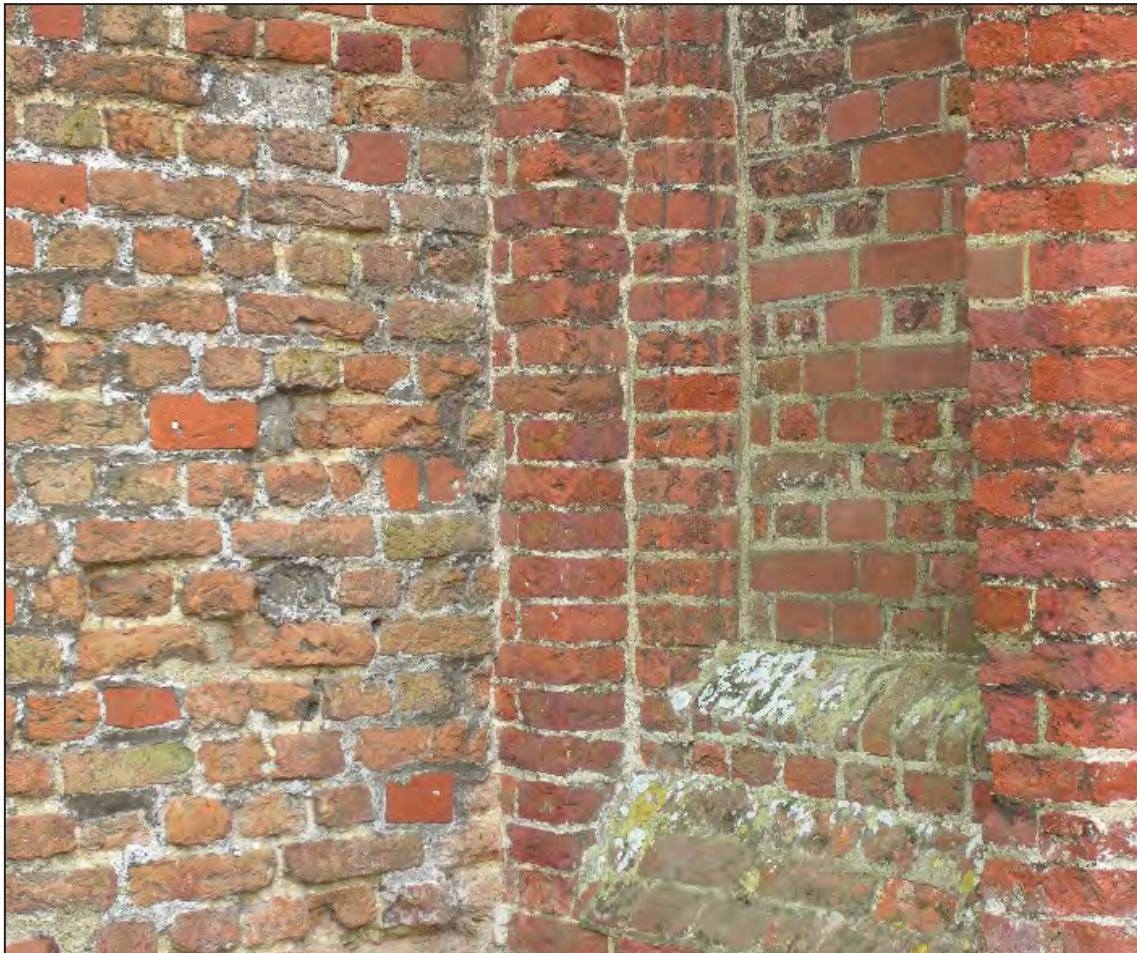
Figure 29. A detail of the north front showing the junction of the orange brick of the original walling (left) and the added western bay constructed of darker red brick (right). The brick coursing does not carry through.

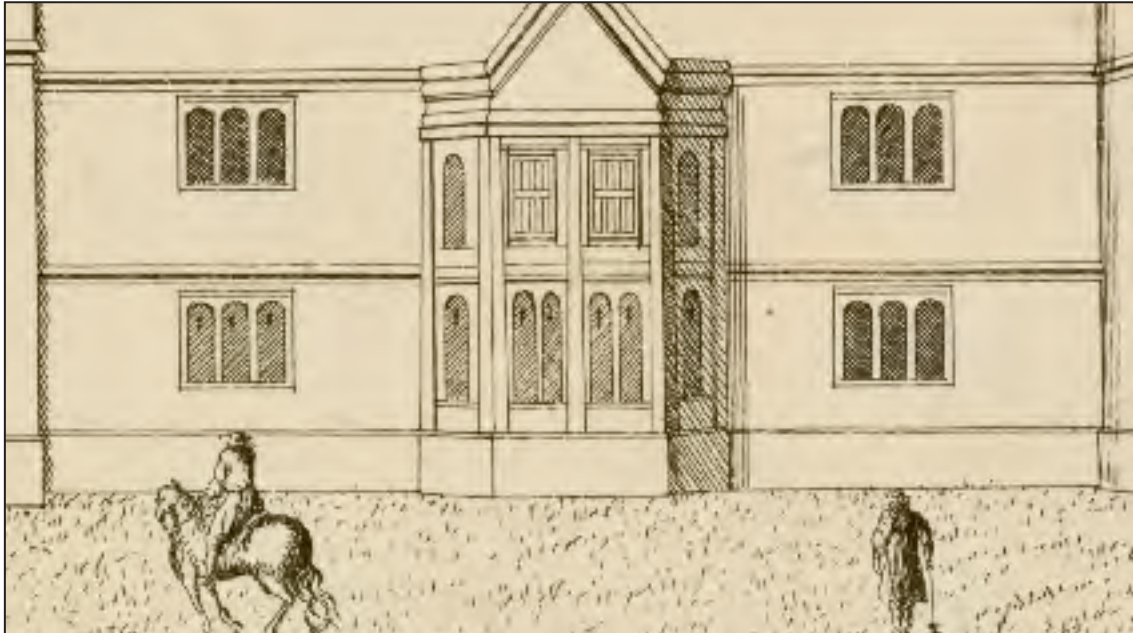
Figure 30. Henry Winstanley, c.1680. A detail of the north front showing the partially blocked window (bottom left) with its diagonal hatching and the small openings in its upper lights, probably indicating that it was boarded or shuttered. The unblocked windows (top left and right) are shown with cross-hatching indicating diamond-leaded casements.
