CHURCH OF ST MARY, WEST SOMERTON, NEAR GREAT YARMOUTH, NORFOLK TREE-RING ANALYSIS OF TIMBERS

SCIENTIFIC DATING REPORT

TREE-RING ANALYSIS OF TIMBERS

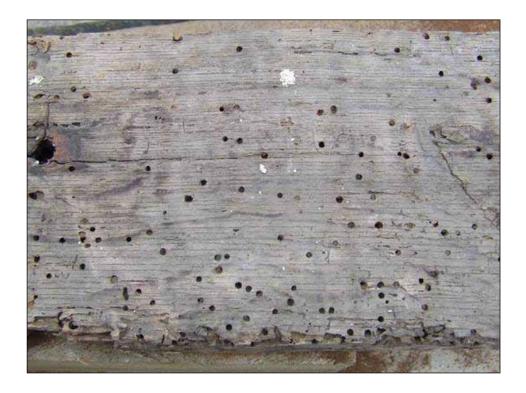
Figure 3: External view of a typical thatching spar, the grain showing a large number of rings, but also evidence of insect attack

The thatching spars looked sound from the outside (Fig 3). However, most were found on sampling to have suffered severe insect attack (Fig 4) and the samples disintegrated. Sampling was therefore much less extensive than had been initially envisaged. Only three spars provided sufficiently robust samples worthy of retention for measurement of their ring sequences. A fourth sample was taken from the *ex-situ* timber (Figs 5 and 6), thought to be associated with the original nave roof, that had been found in the void between the internal and external nave walls. Details of the four samples are shown in Table 1, whilst the raw ring-width data is given in the Appendix.

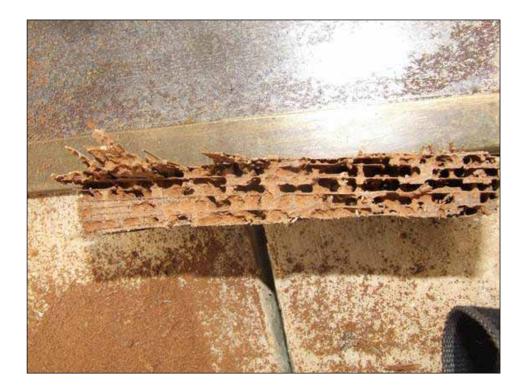
Figure 4: View of a section of a typical thatching spar showing the severe internal decay

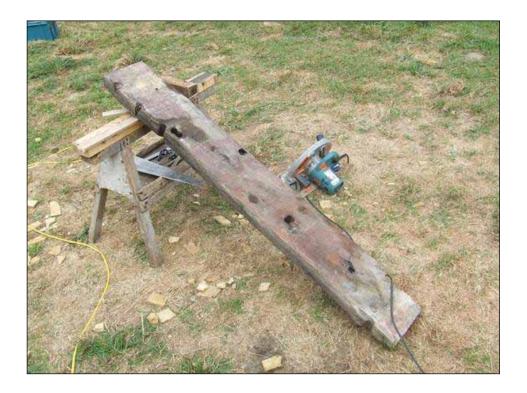
Figure 5: Ex-situ timber found between the internal and external nave walls

A number of thatching spars considered likely to contain sufficient numbers of rings for analysis had cross-sectional slices sawn from the ends where they overlapped the principal rafters. In addition, an *ex-situ* structural timber, thought to be potentially associated with the original nave roof, also had a thin section removed from one end.

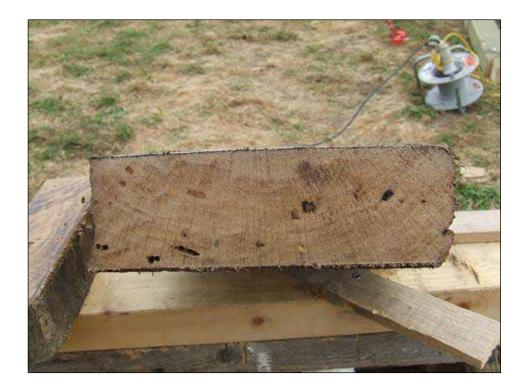
Figure 6: Cross-section of the ex-situ timber after the removal of a sample from one end
