# THE OLD MANOR HOUSE, ROSEBERY ROAD, MANNINGHAM, BRADFORD, WEST YORKSHIRE AN HISTORICAL AND ARCHITECTURAL SURVEY

## HISTORIC BUILDINGS REPORT

Allison Borden and Colum Giles

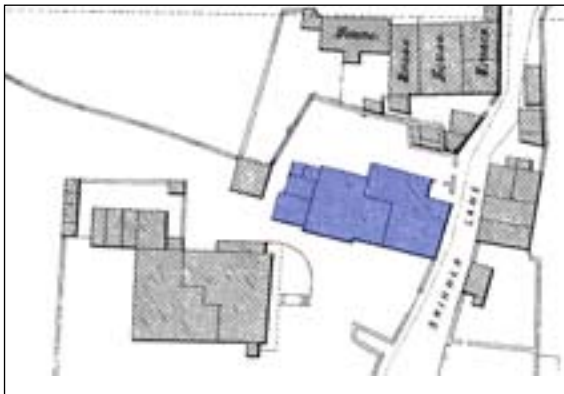
Fig 2: Excerpt from Gott's map (1878)

Important visual evidence for the form of the house before major alterations of the late 19th century is provided by a map of 1878 and by a sketch published in the *Illustrated Weekly Telegraph* in 1889.<sup>13</sup> The 1878 map (Fig 2) shows the plan of the house as a range lying on the west side of Skinner Lane, with a slight projection from the south elevation for the west cross wing and additions of minor structures against the west and north sides of the early building. The plan also shows that the house was then subdivided into two dwellings. The 1889 view (Fig 3) is what appears to be an accurate representation of the south elevation of the house, showing it to be of hall-and-cross-

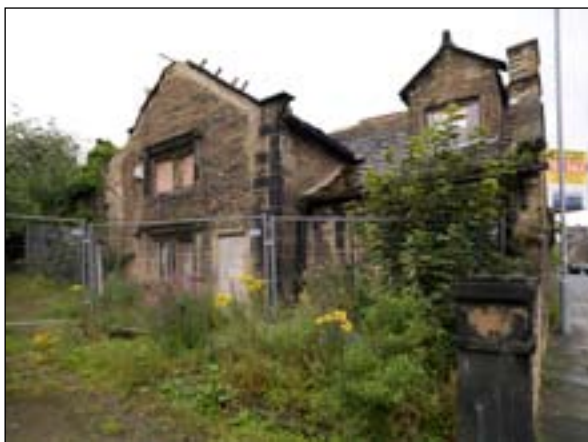
Fig 5: Old Manor House from the south (DP065450 © English Heritage)

The Old Manor House is a stone house, largely of 17th-century date, incorporating fragments of an earlier building, probably timber-framed and of aisled form, dating

perhaps to the early 16th century (Fig 5). Substantial alterations were made to the house in the 19th century when its east end was demolished and when additions were made to the rear. Originally set in a rural location, perhaps the focus of a modest agricultural holding in Manningham township, the house has been surrounded by later buildings signifying the township's incorporation into greater Bradford during the city's growth as a major manufacturing centre.

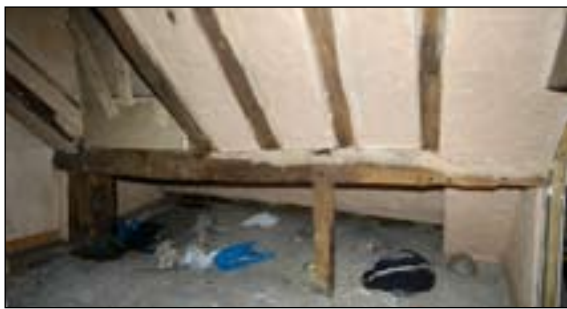
*Fig 6: south arcade plate, view from north*  
(DP071430 © English Heritage)

The arcade plates run in an east-west direction, spanning between the later end wall of the house to the east and the 17th-century cross wing to the west. Keyed scarf joints (see sketch detail, Appendix) at the east end of both arcade plates indicate that the plates continued further east, into that part of the building which was lost when Rosebery Road was created (Figs 6, 7). Both plates show a consistent pattern of pegged mortices in their soffit: approximately one-third along their length from the west is a single-pegged

mortice for the tenon of a main post (see Appendix, a, b on plan) demarcating a bay division, and double-pegged mortices, angled on the side towards the post, took braces between post and plate. A further angled mortice at the east end of both plates, close to the scarf joints, shows the position of a brace down to a main post (c, d on plan), lost when the east end of the building was demolished. Each plate shows, on its upper side above the positions of the lost posts, shouldered dovetail seatings for tie-beams (a-b and c-d on plan). Bay divisions in this range were, therefore, marked by main posts and tie-beams, and the plates indicate that within the surviving building there was a full-width bay and, at the west end, a part bay, approximately one-third the length of the full bay.

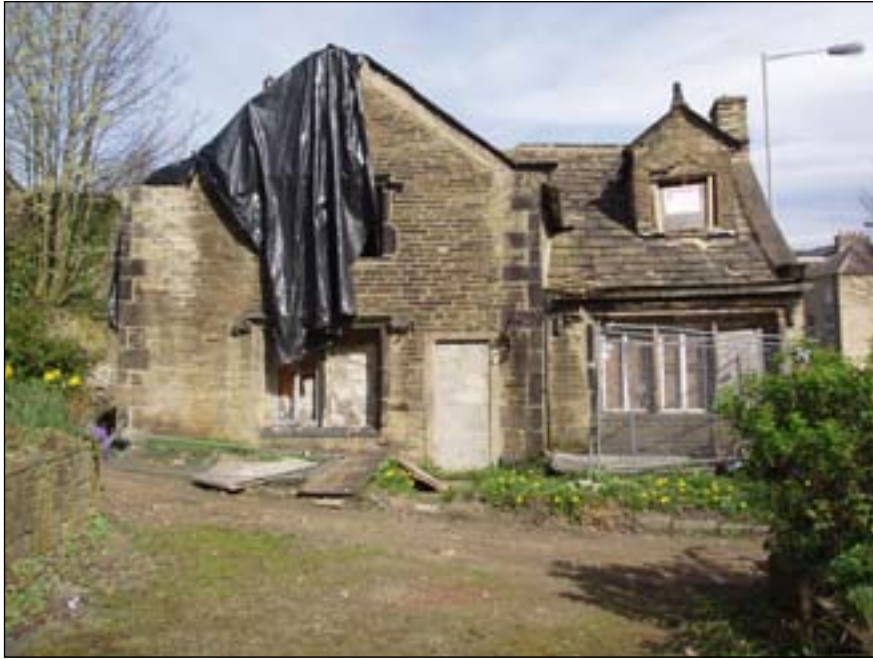
*Fig 9: south elevation, with cross wing to left and housebody to right (© English Heritage)*

The 17th-century house survives substantially in the area of the housebody and upper cross wing (Fig 9). The cross wing projects slightly from the main range and is gabled to north and south, and the main range has, on the south front, a long stone-slate roof rising from the low eaves above the housebody window. The masonry of both ranges is of shallow-coursed sandstone with gritstone quoins to the corners of the wing, and the wing has shaped kneelers on the main elevation (Fig 10). The bonding of the masonry at the junction of main range and wing indicates that the two parts were rebuilt at the same time. The windows, where they survive in part on the south front, have gritstone surrounds and simple hood moulds. On the south elevation ground-floor windows were

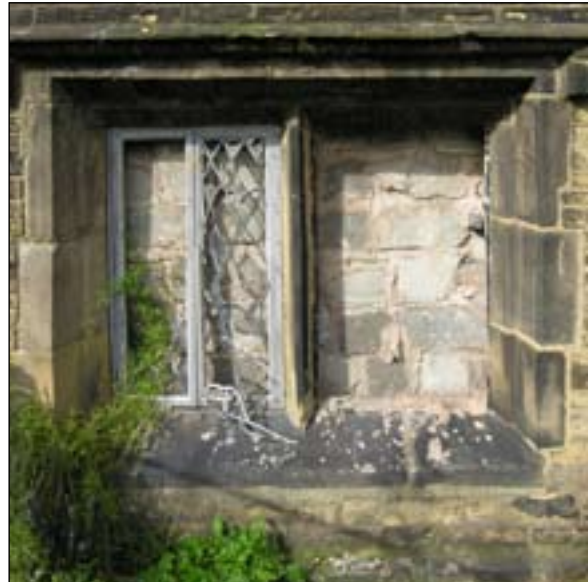
*Fig 11: west wing, south wall: formerly mullioned and transomed window (© English Heritage)*

mullioned and transomed, but the first floor was lit by simple mullioned windows. The surrounds indicate that mullions and transoms were deeply recessed rather than flush with the wall face (Fig 11).

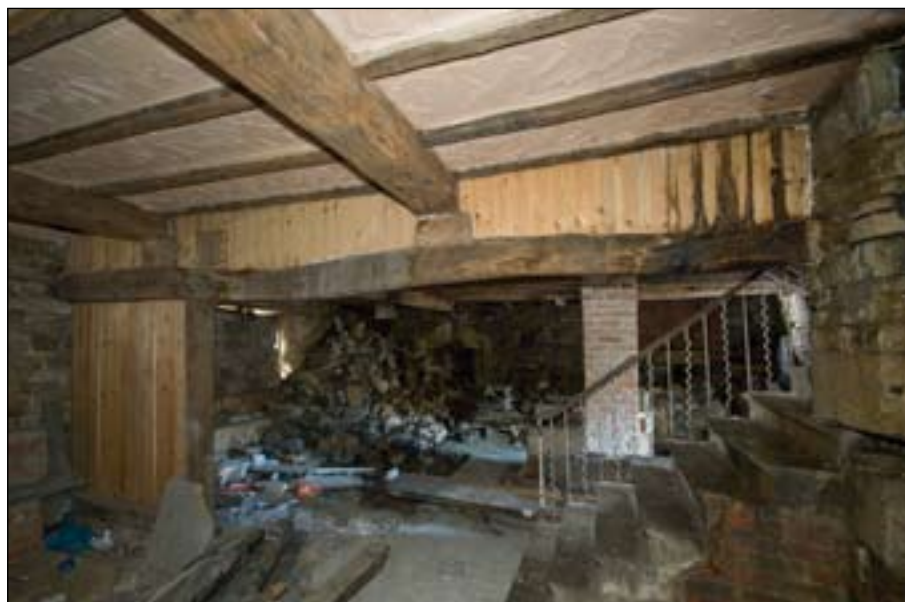
*Fig 12: the housebody, view to west into parlour wing (DP071447 © English Heritage)*

single-storey room. The ceiling is formed of spine beams, stop-chamfered at their west ends, and plain unchamfered joists (Fig 12). The arcade posts of the aisled structure were removed to clear space, although - certainly to the front, perhaps also at the rear - the area of the former aisle was included as part of the room. Perpetuating the likely layout of the medieval room, the housebody was heated by a fireplace or firehood at its lower (east) end, the fire area being lit by the two-light mullioned and transomed window shown on the 1889 sketch. This end of the room was lost on the truncation of the building when Rosebery Road was created. It is likely that the housebody continued to provide the principal living room of the house, albeit in modernised form, just as it had done in the medieval period: in the absence of an identifiable kitchen elsewhere in the house in its 17th century form, it is probable that the housebody also retained the principal cooking hearth.

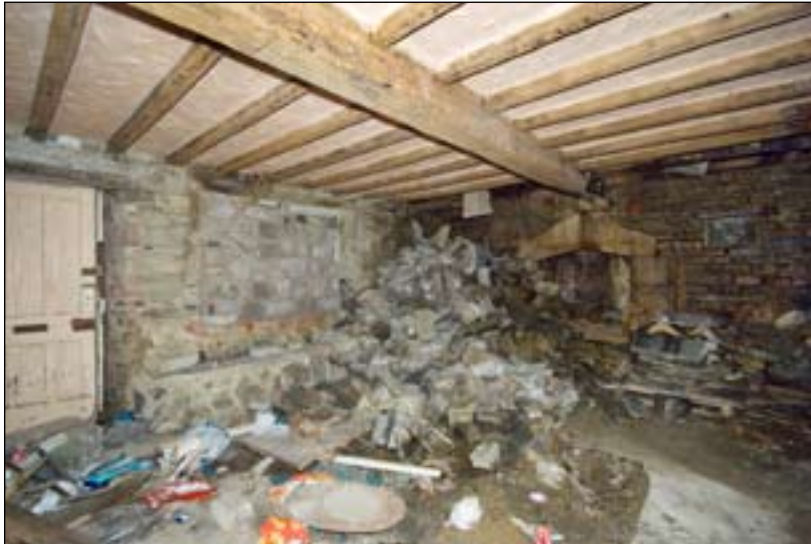
*Fig 13: west wing, parlour, showing fireplace on west wall (DP071440 © English Heritage)*

on the west wall: the fireplace survives and has a straight-arched head within a massive triangular lintel and a moulded surround over lintel and jambs (Figs 13, 14). The single ceiling beam is stop-chamfered at both ends. It is likely that a timber screen divided the parlour from the northern bay of the wing: a re-set ceiling beam in this area has a groove in its soffit for such a screen and may well have been part of this dividing wall. The northern bay provided a small unheated room to the west and a stair to the east. The western room has received many later modifications but may originally have been a small unheated parlour or service room. Within its western wall is a timber lintel for a wooden-mullioned window (Fig 15), possibly re-set in its present position but if in its original site indicating that the superior fenestration of the south elevation, where ground-floor windows had deeply recessed stone mullions and transoms, was not carried round to the sides and rear of the house. The stair area, in the north-east corner of the wing immediately beside the connecting door to the housebody, was lit by a small rectangular window, now blocked, in the wing's north wall (Fig 16). The original stair has been replaced, but its position, close to the housebody, is a well-established plan feature giving easy access between the main living room and the chambers.

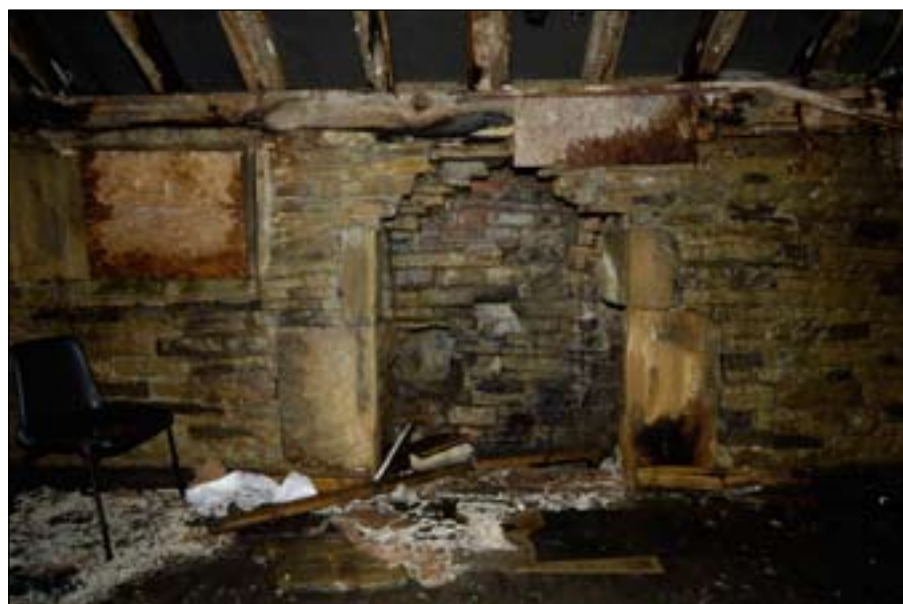
*Fig 17: west wing, south chamber: detail of fireplace (DP071424 © English Heritage)*

however, the division is centrally placed, giving bays of equal size to north and south of the main roof truss. The tie-beam of the truss has a groove in its soffit for a plank screen, the groove ending to allow a doorway connecting the stair landing with the main chamber. This room is heated by a fireplace in the west wall: the fireplace surround has a simpler finish to that of the parlour fireplace, having a plain broad chamfer. The fireplace lintel has been removed (Fig 17).

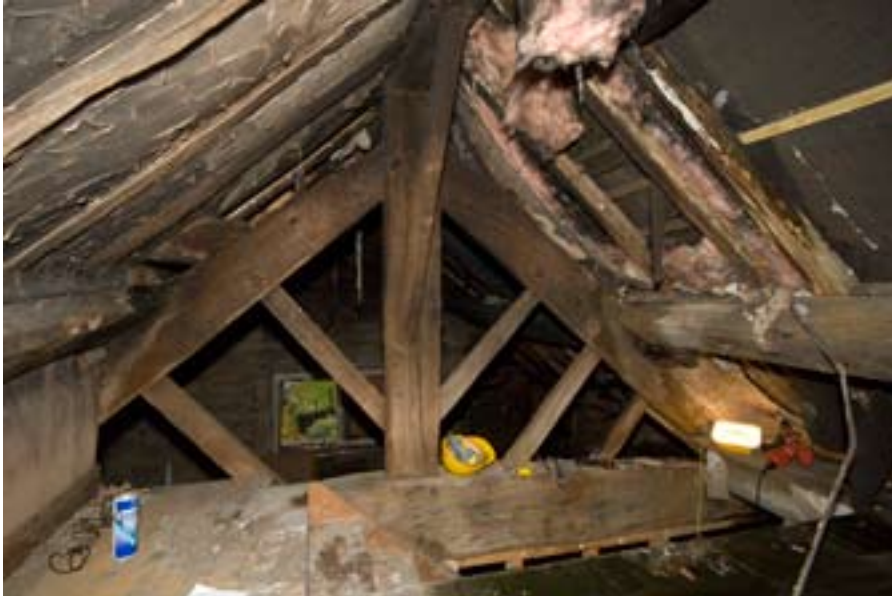
*Fig 18: west wing,  
central roof truss,  
view from north  
(DP071455 ©  
English Heritage)*

The wing is roofed in two bays with a substantial central king-post truss. The truss has heavy principal rafters, three raked struts, and a brace from king post to ridge. The joints are all unpegged apart from those at the junction of king post and principal rafters (Fig 18).

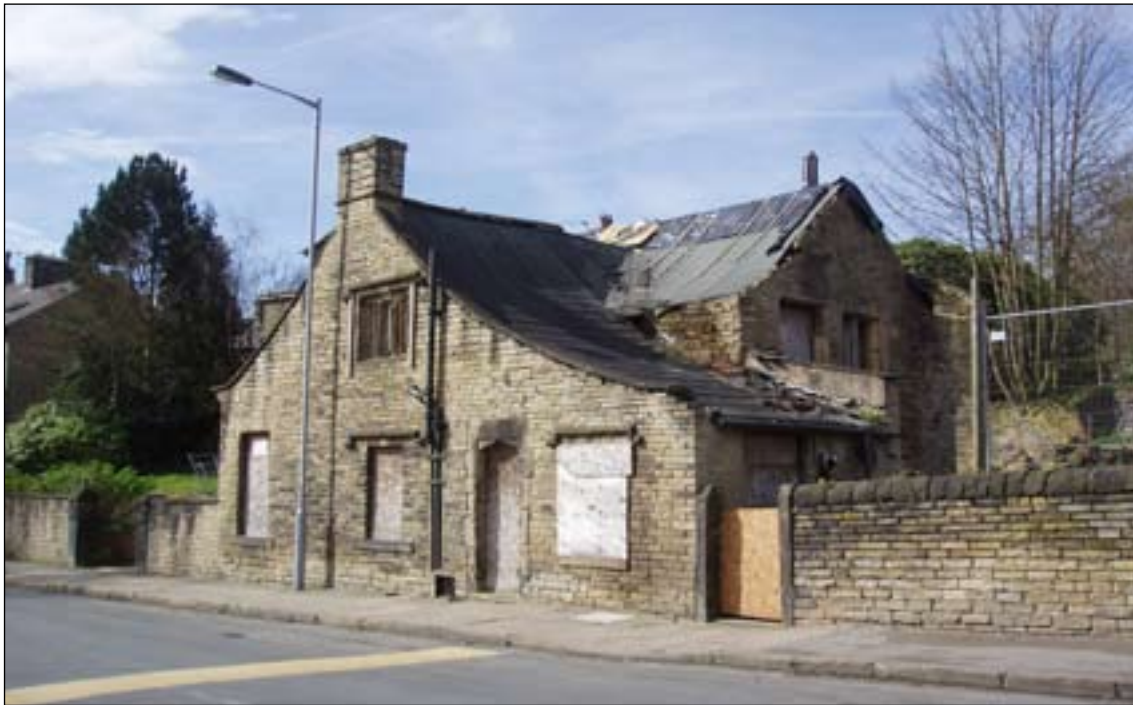
*Fig 19: Old Manor House from north-east: the aisled structure of the medieval house was retained in the 17th century rebuilding in the area of the housebody: the roof sweeps down to single-storey height to both north and south (© English Heritage)*

in stone. The form of the medieval aisled house was, however, perpetuated in part: despite the removal of the arcade structure, the front aisle was contained within the housebody and the sweeping roof line of the medieval house was retained on both north and south roof slopes in the surviving housebody bay (Fig 19). Because the south wall of the housebody was not raised to two-storey height, the newly-created chamber was contained within what was, effectively, the roof space, akin to an attic. It provided adequate headroom only in the central area and was clearly a room of low status. If a firehood heated the housebody below, the chamber must have been unheated, and may have been used principally as a storeroom, a common use for housebody chambers in local houses. The 1889 sketch, however, suggests that heating was later provided, for the chimney stack serving the central range has two chimney pots, one certainly serving the housebody fireplace and the other probably for a fireplace in the chamber. How the chamber was lit is not clear. A dormer window in the south roof slope provides lighting today, but on the evidence of its stonework this appears to date only from the 19th century (Fig 20). It is likely that it replaced an earlier means of lighting the room. Also unclear is the means of access to the chamber. Present-day access from the west wing is a later contrivance, created by inserting a doorway in the wing's side wall (necessitating the removal of part of the timber wall and the cutting of the wing's wall plate). It is probable, therefore, that the

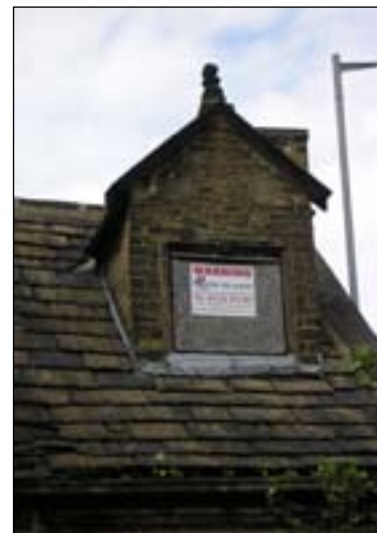
*Fig 20: detail of dormer window lighting housebody chamber (© English Heritage)*

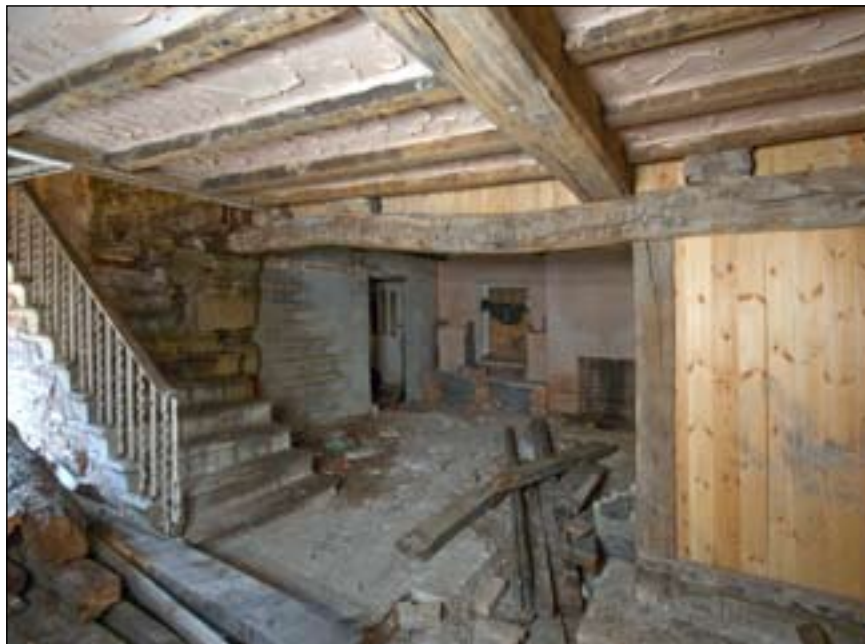
*Fig 23: west wing, view to north-east showing inserted stone stair with iron balusters (DP071458 © English Heritage)*

a divided dwelling was the replacement of the original stair in the west wing with a larger stair in the same position (Fig 23). A new and larger stair window was inserted in the north wall of the wing, above the earlier smaller window which was blocked at the same time (Fig 24). The stair itself has stone steps with a rounded-nose profile, a rounded handrail, and a balustrade with alternate straight and wavy iron balusters of slender section. The balusters are not convincingly of 19th century date, but the stair itself, and its stair window, are credibly of this date, but later in the century rather than earlier. It is possible that this alteration was made either very late in the period of the house's subdivision, or perhaps even after the loss of the east end of the house, when the reduced Old Manor House may have reverted to single occupation.

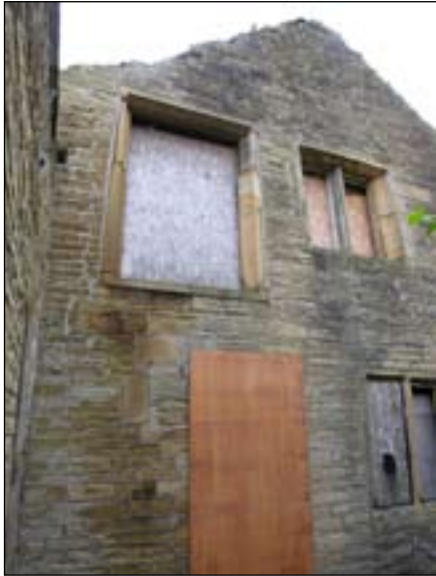
*Fig 24: large stair window in west wing, north wall (© English Heritage)*

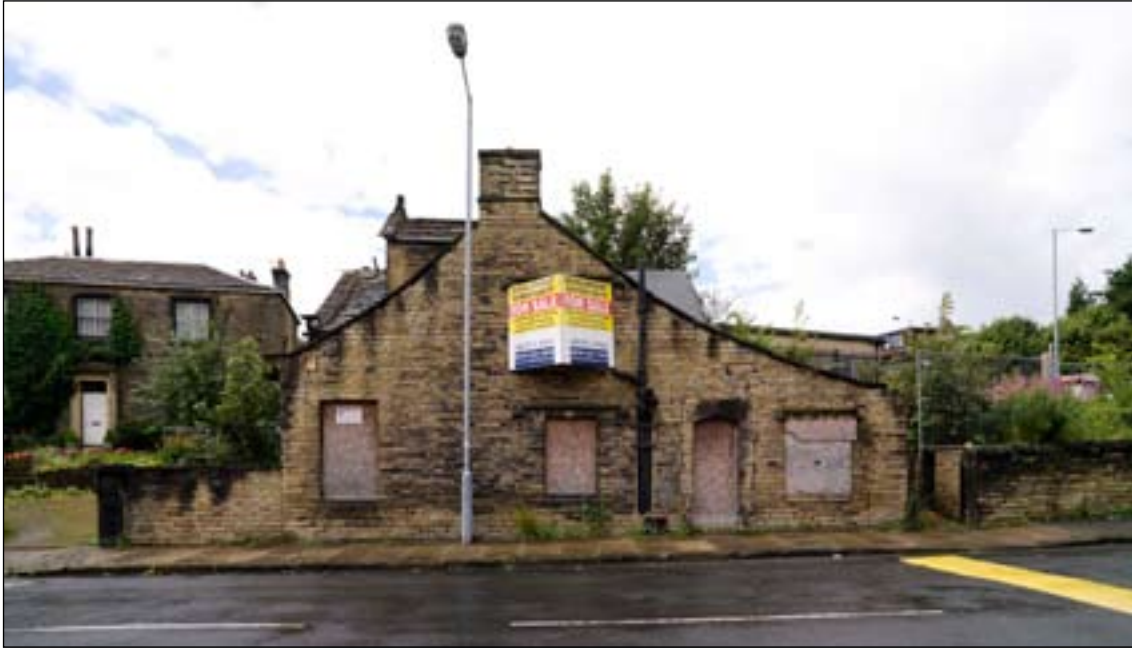
The major change to the house in the late 19th century was the loss of its eastern end on the occasion of the widening of Rosebery Road c.1890. The cross wing and part of the housebody range shown on the 1889 sketch were removed at this date. A new east wall was constructed to close the truncated building; the wall includes a re-set 17th-century doorway. The main range retained its aisled form at the rear, but the north wall was rebuilt to provide a larger outshut behind the former housebody (Figs 25, 26). This alteration may have caused the re-positioning at a higher level of the north arcade plate of the medieval structure, but the medieval roof was retained.

Fig 25: east wall, built on the truncation of the house c.1890 (DP065452 © English Heritage)
