HAILES ABBEY, STANWAY, GLOUCESTERSHIRE HAILES ABBEY CULVERT EVALUATION ASSESSMENT REPORT

Hailes Abbey Culvert Evaluation Assessment Report

NGR: SP 0503 3001

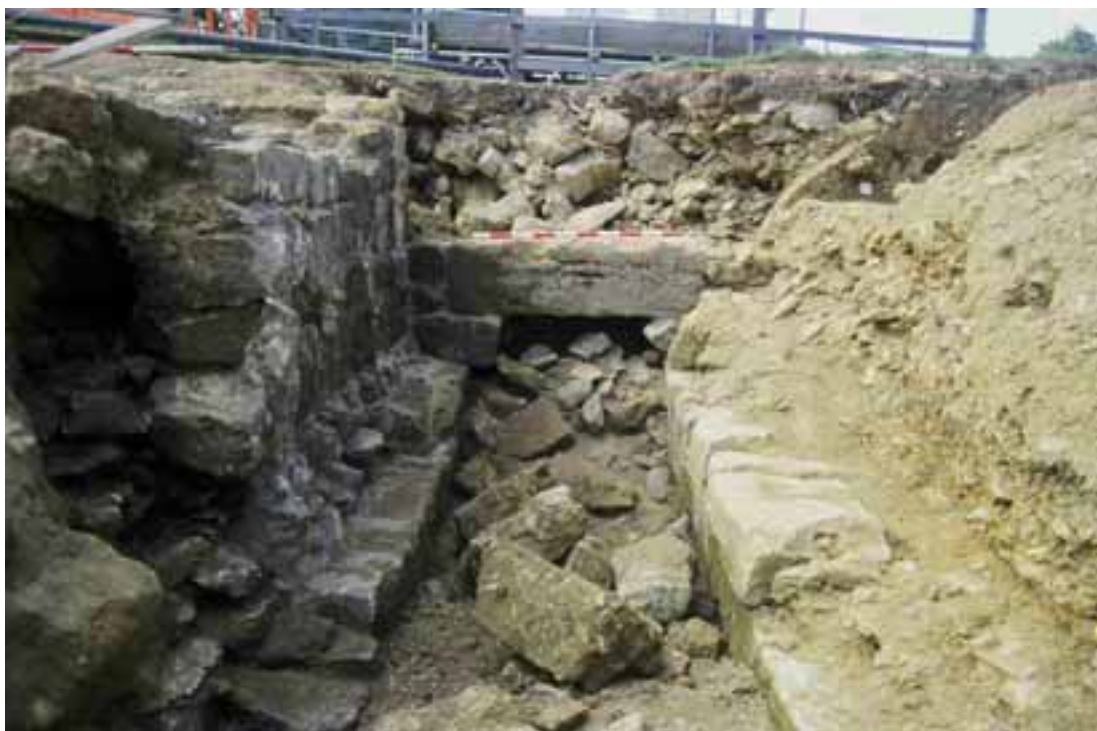
Figure 7: Excavated culvert (looking north-west), showing culvert walls [1052] (left) and [1051] (right), with re-pointed section of culvert wall [1053] on the left; modern rubble fill [1001] is in the centre (photo by D Stirk)

Facing stones for the south side of the culvert (context [1052]) were missing from that part of the wall south-east of the re-pointed section. The fact that the rubble core was

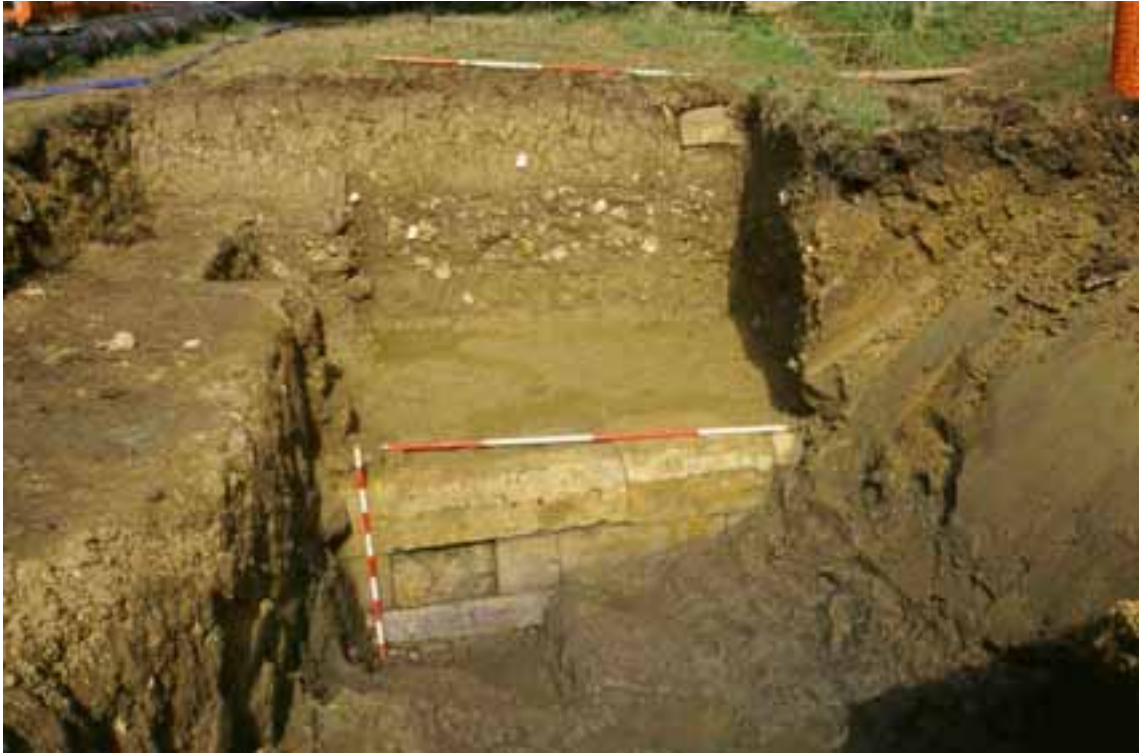
Figure 11: Contexts [4032] (masonry) and [4007] (soil bank) (looking north)

Four courses of masonry, context [4032], were exposed during the excavation of the first test pit in Trench D, aligned north-east to south-west. The top of the masonry lay at 102.13mOD, about 1.4m below the modern ground surface. The exposed portion of the wall consisted of alternating chamfered and vertically faced courses. The lowest course of this wall was not seen. All the blocks showed signs of chisel dressing, and some were stained by the leaching of iron in the ground water. It is possible that there may have been one or more courses of masonry above those seen during excavation, but which have been robbed away. Context [4032] appears to be the masonry front or revetment to a dam and is almost certainly medieval in date (see Figure 10 and Figure 11).

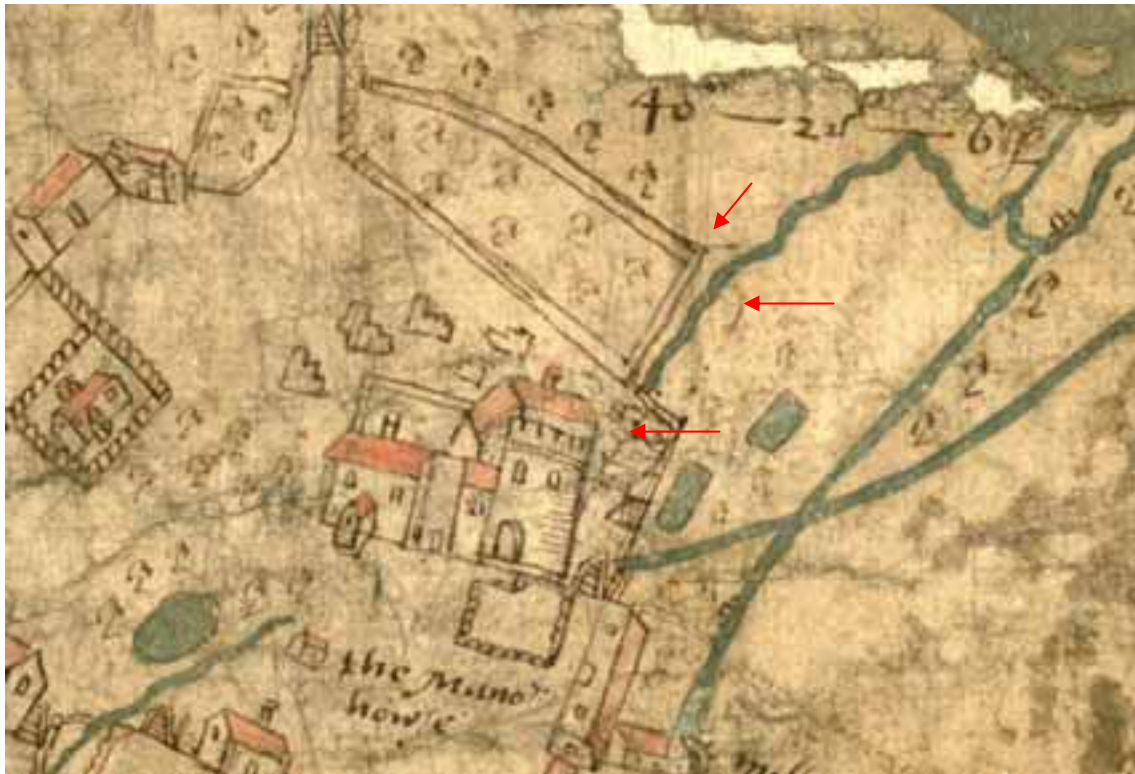
Figure 13: Detail from Treswell's 1587 map (MF/1/59, The National Archives UK), showing possible outline of former pond and line of culvert. North is to the left of the image

Trench B seems to be located directly over the south-east corner of the walled enclosure shown on the 1587 map (see Figure 13). The dry-stone walls noted above were probably flattened once Hailes was abandoned as a manor house. The rubble from wall [2018],

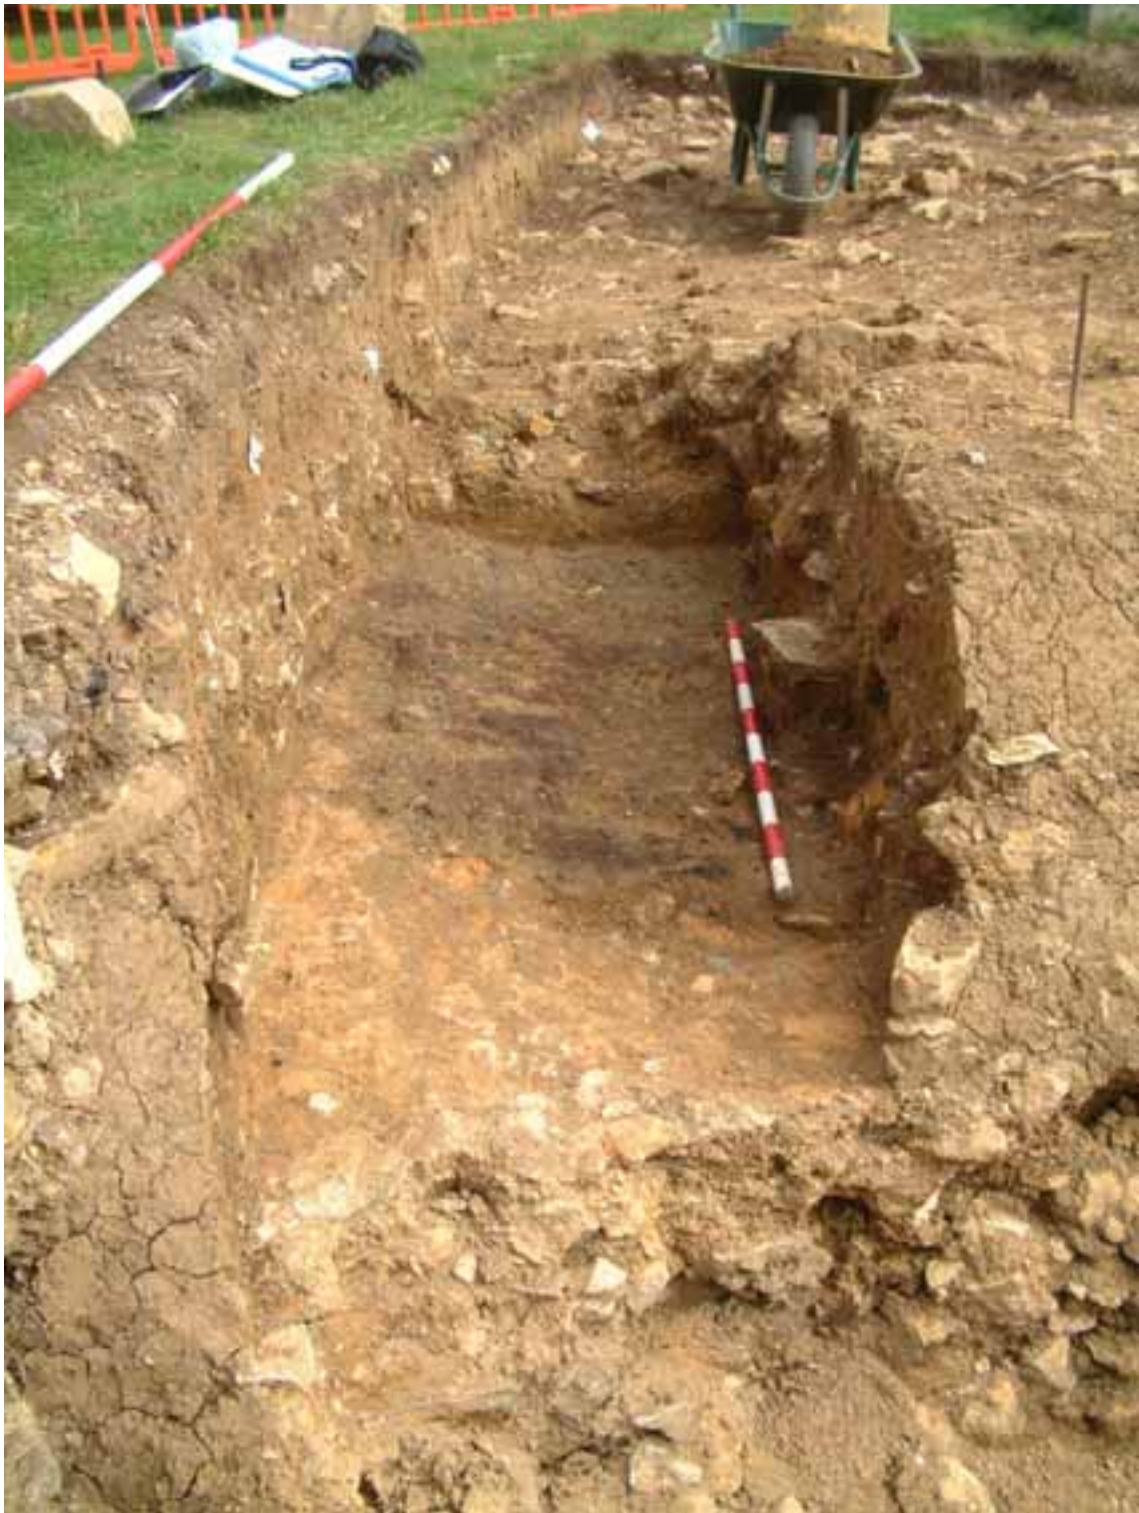
Figure 16: Context [1034] (darker soil) (looking north-east) (photo by D Stirk)

As noted above, the finds assemblage from Hailes Abbey is almost exclusively post-medieval in date and included some metalworking waste, primarily from context [1034]. This context was an ashy, possible occupation layer over what may have been a mortar floor.

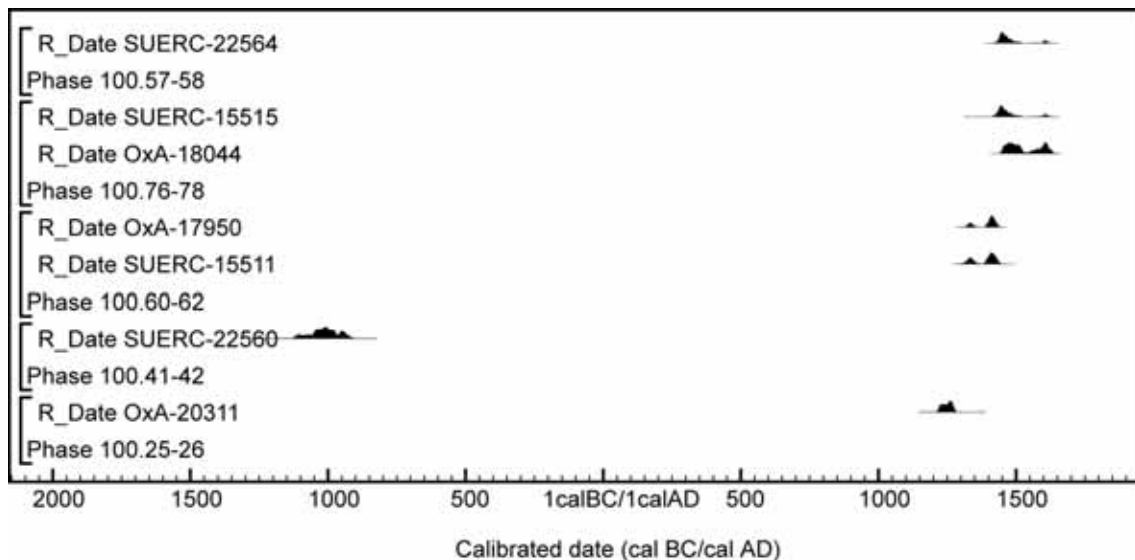
Figure 19: Calibration by the probability method (Stuiver and Reimer 1993) of radiocarbon results. The height of each distribution is proportional to the probability that the sample is of the corresponding calendar date (prepared by J Meadows)

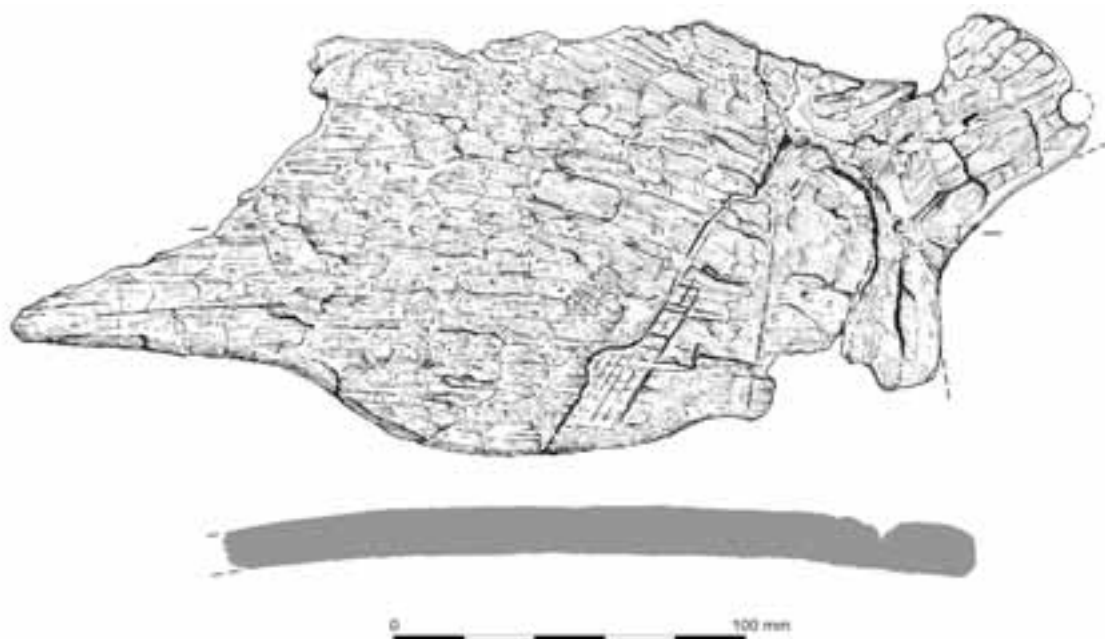
Figure 21: Wood fragment, Small Find 576, after conservation (drawn by C Evans)

The object is a wooden plank, 310mm in length, 100-125mm in width and 15-32mm high, recovered from context [4012]. There are 'cut-marks' visible, as well as one treenail or wooden peg-nail hole (see Figure 21). One possible interpretation is that the object is a fragment or repair patch 'tingle' (Allen *et al*/2005, 293) of clinker-built boat planking, re-used as part of a water control mechanism between the pond and culvert.

All the edges of the fragment have been substantially altered by decay although one face survives with only moderate weathering and is shown in Figure 21. The fragment is c 0.31m long by c 100-125mm wide and 15-32mm thick. The grain and macroscopic character shown that it is tangentially faced, rather knotty and of one of our two oaks or a hybrid. The parent tree was fairly fast-grown which is typical of much late medieval timber. At first, from a view of the drawing it looked as if the opposed sloping marks on the best preserved face were those left by the later medieval practice of see-sawing (Goodburn 1992, 115). However, on close examination the saw marks were seen to be fine cut marks such as would have been left by using the plank fragment as a cutting board. Another explanation might have been the use of the fragment as a support to hew another timber on in a carpenter's yard. The thin straight marks could also have been left by a broad axe.

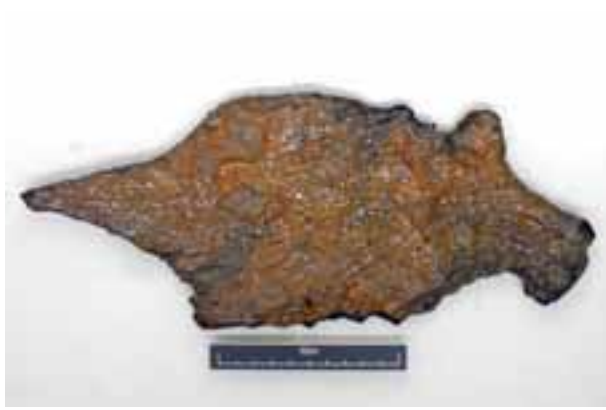
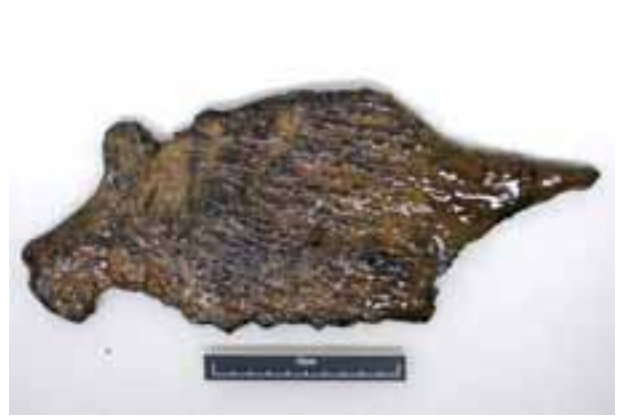
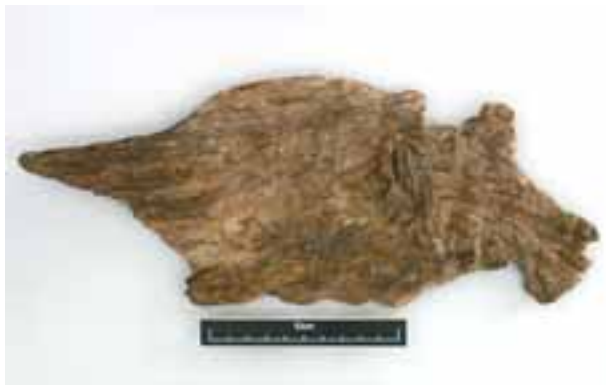
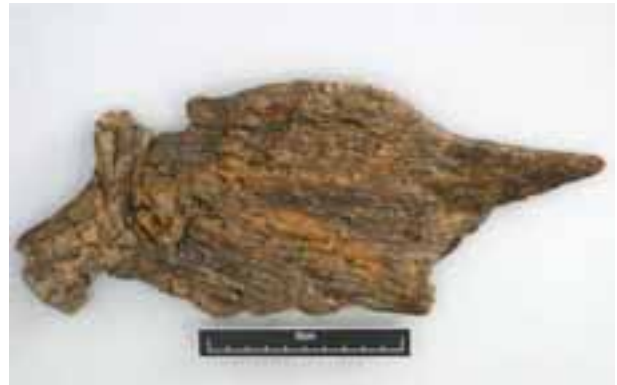
Figure 24: Small Find 576 before and after conservation treatment (photos by K Graham)

SF576 was recommended for remedial conservation, ie, stabilisation prior to deposition. Following an assessment by Sandra Rowntree and preliminary illustration by Chris Evans, the wood was conserved in 2011 as part of a waterlogged wood programme being undertaken by the Archaeological Conservation Team. The conservation involved a two-stage pre-treatment with Polyethylene Glycol (PEG) and freeze drying (see Appendix IV).
