CHURCH OF ST PETER, WEST LISS, HAMPSHIRE

TREE-RING DATING OF TIMBERS

SCIENTIFIC DATING REPORT

Alison Arnold and Robert Howard

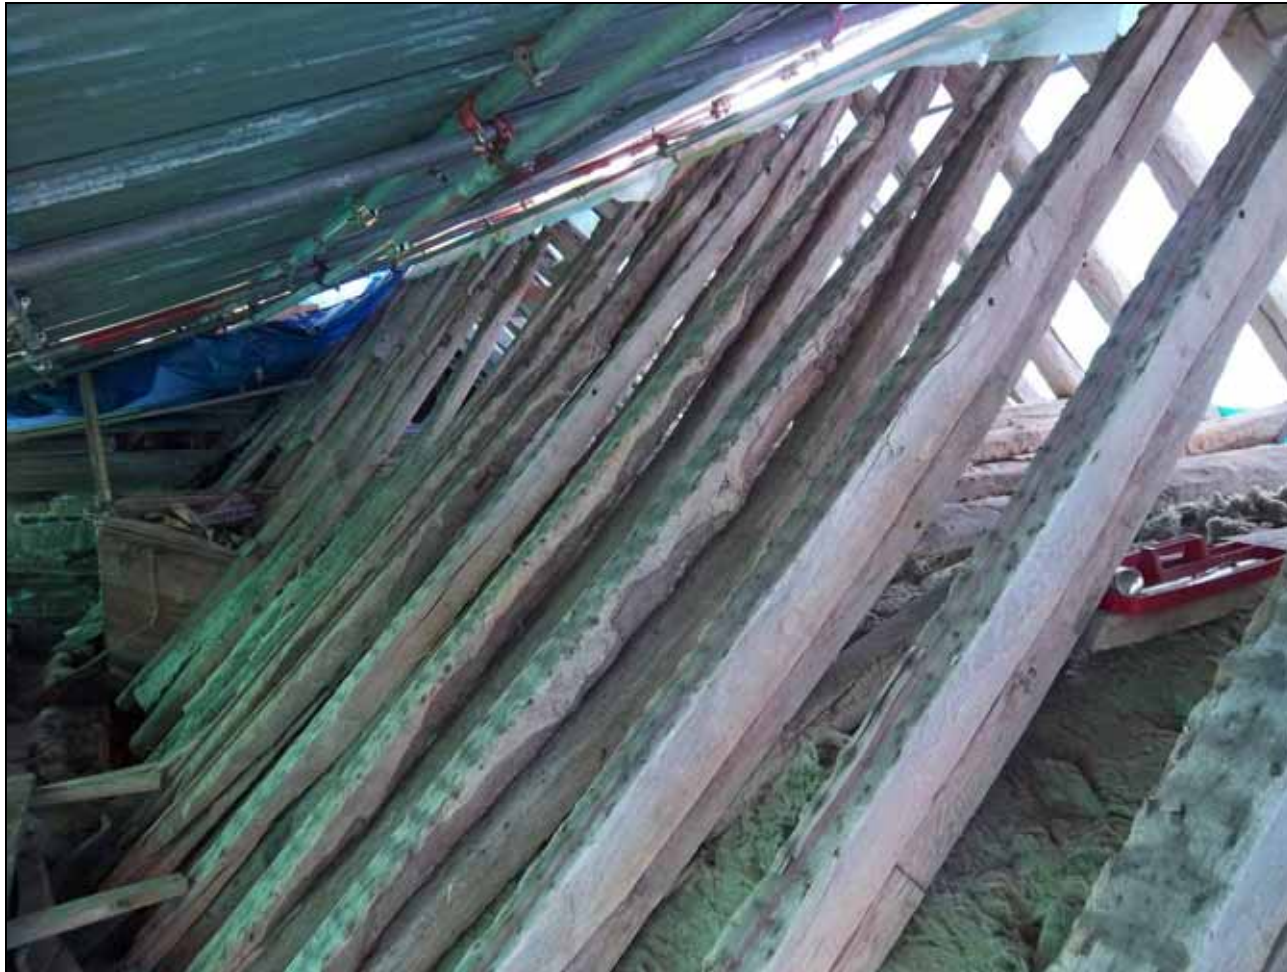
Figure 4: Nave roof showing the backing rafters (photograph taken from the south-east). Photograph Robert Howard

The roof consists of 19 frames of common rafters with collars, and arch braces. At some point 'backing rafters' have been attached to the rear of the common rafters on the south side, presumably for strengthening purposes (Fig 4). Some of the timbers are thought to be reused. This roof is thought to date from the early thirteenth century.

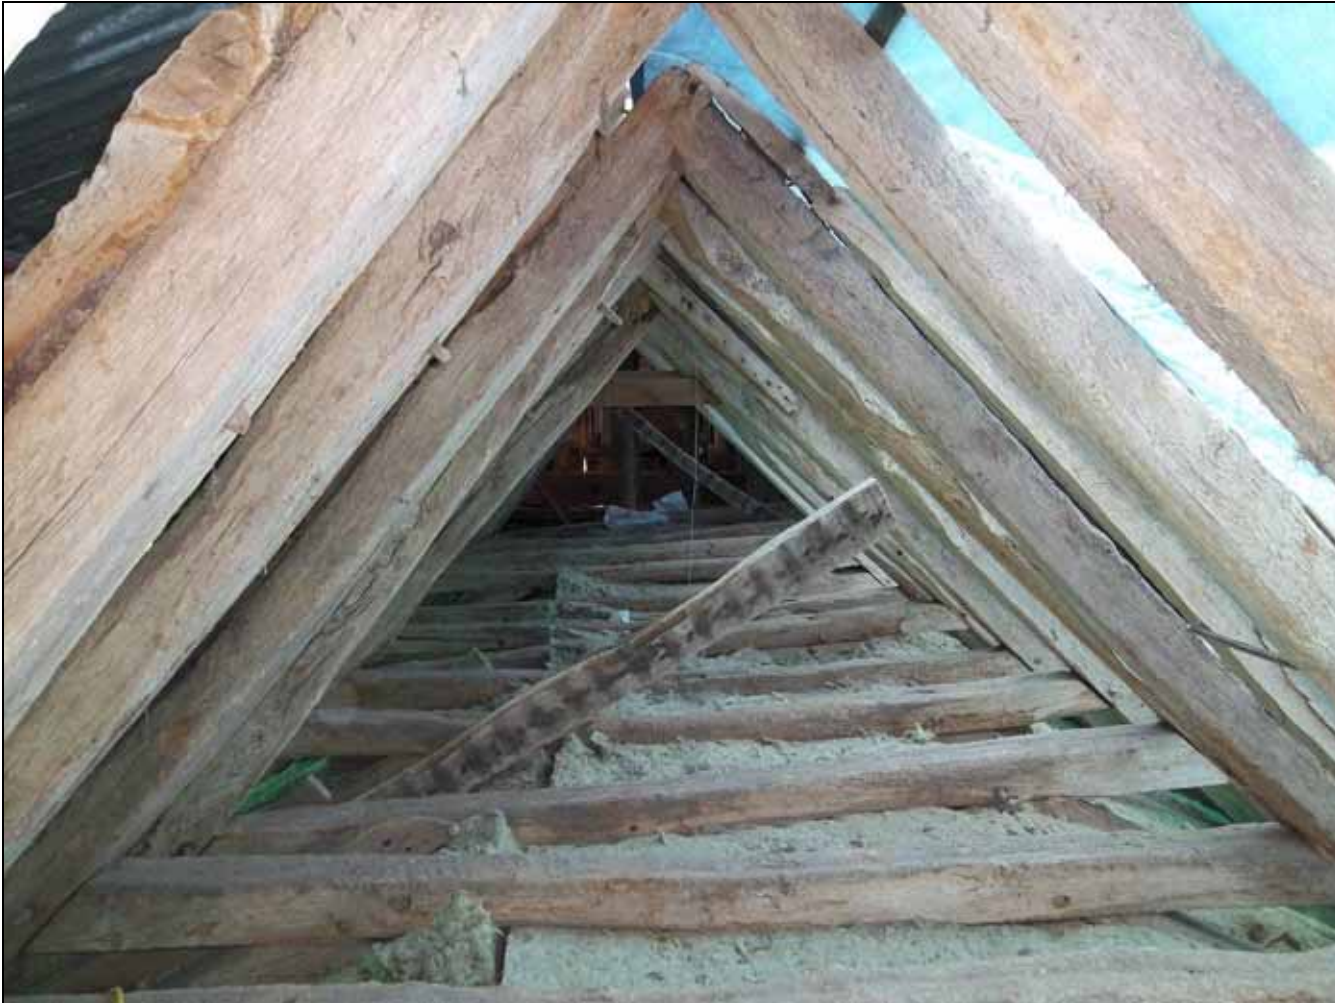
Figure 5: South aisle roof (photograph taken from the west). Photograph Robert Howard

The construction of this roof is similar to that of the nave, with each of the 26 frames again consisting of common rafters, collars, and arch braces (Fig 5). Some of these rafters also have the strengthening 'backing rafters and higher 'modern' collars. Some of the rafters show signs of reuse in the form of empty mortices. This roof is believed to be late-thirteenth century in date.

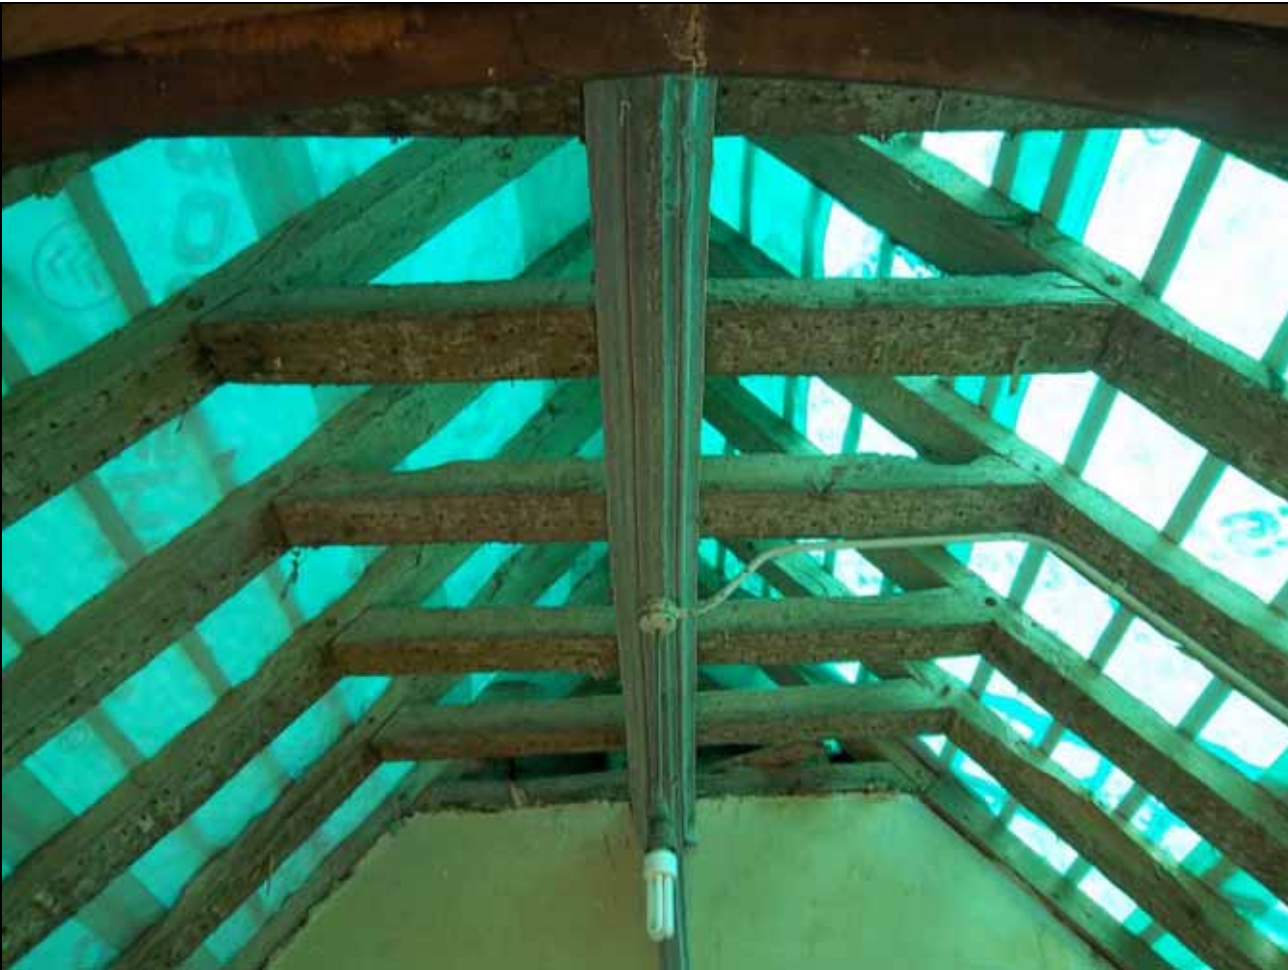
Figure 6: Porch roof (photograph taken from the south). Photograph Robert Howard

This very simple roof has six frames of common rafters and collars. The seventh (most northernmost frame) also has a tiebeam with empty mortices from which arch braces may have once run to now removed posts (Fig 6). The south porch has an inscribed date of '1639' commemorating its gift by Henry James.

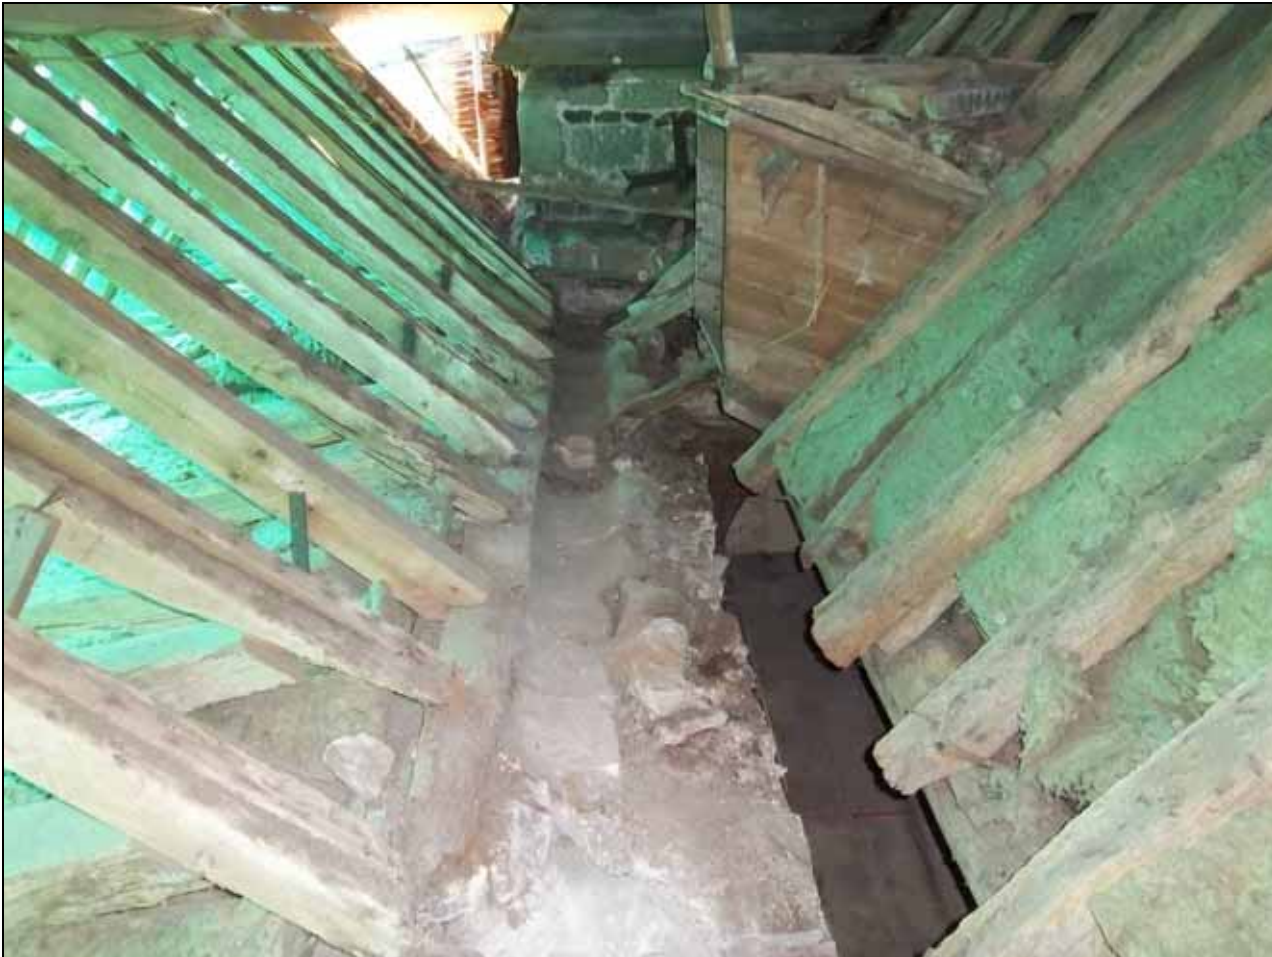
Figure 7: Stone gully between south aisle (to left) and nave (to right) roofs. Photograph Robert Howard

The timber which supported the valley gutter between the nave and south aisle roofs has been dated to AD 1581–1606 and is hence clearly broadly coeval with reused collars from the nave roof.

By association with the south aisle roof the unusual stone valley gutter it is suggested that this is pre *c* AD 1616 but it is not possible to conjecture how much earlier this could have been due to the lack of significantly earlier timbers being identified in either the nave or south-aisle roofs.

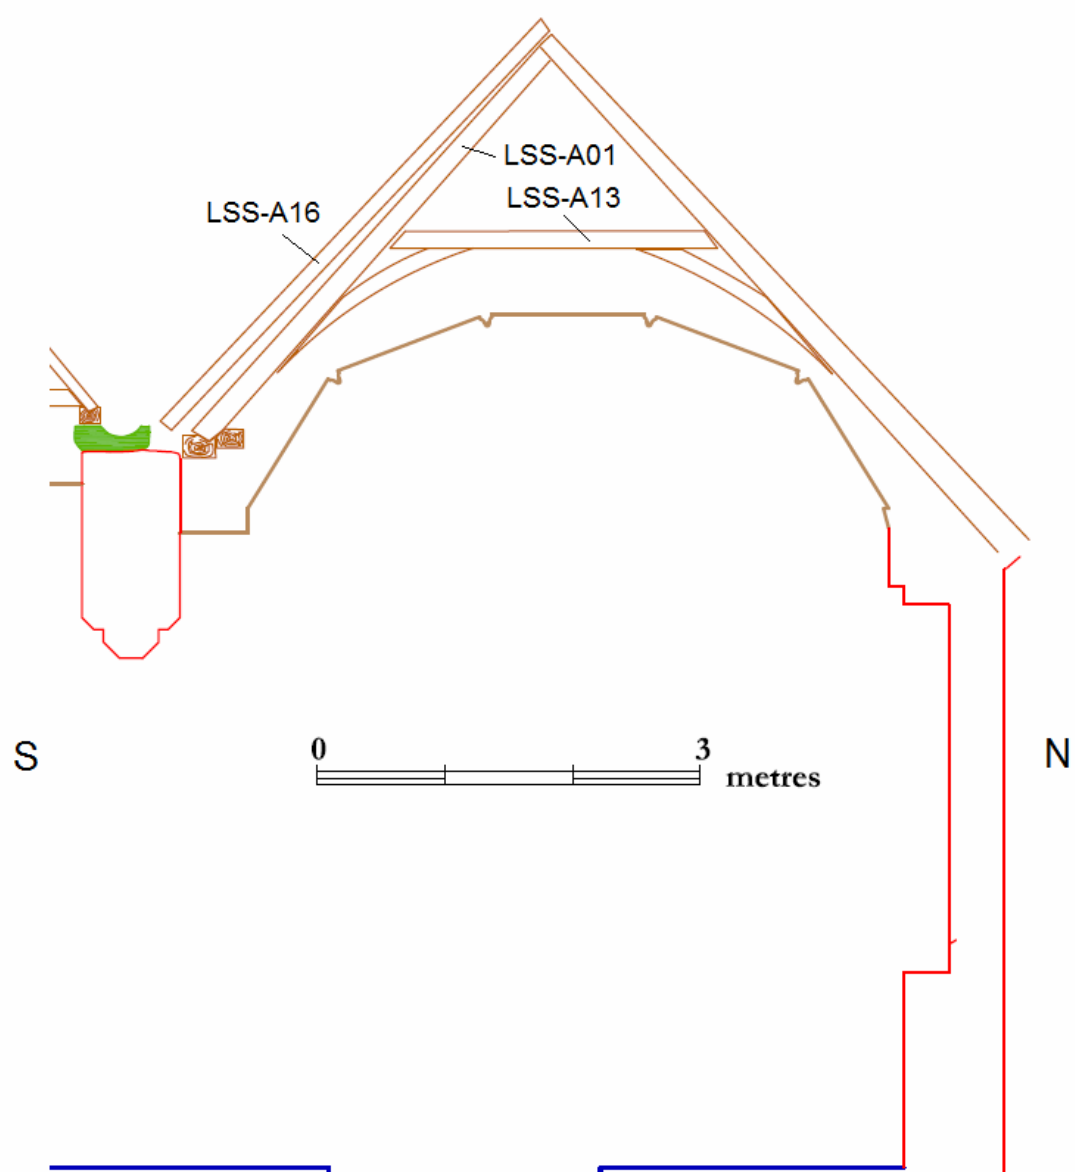
Figure 8: Nave; frame 2, showing the location of samples LSS-A01, LSS-A13, and LSS-A16 (John Crook)

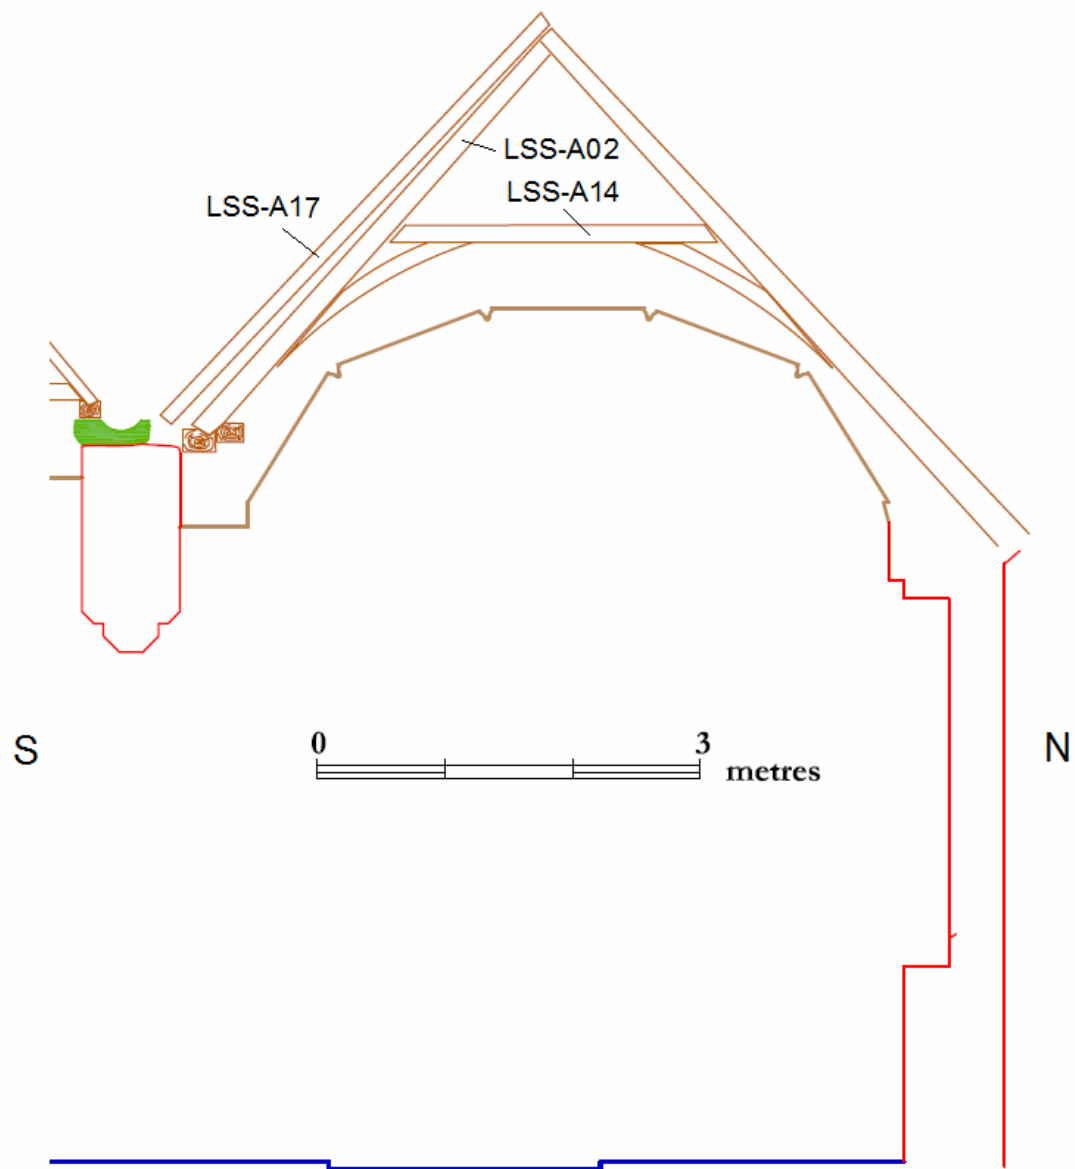
Figure 9: Nave; frame 3, showing the location of samples LSS-A02, LSS-A14, and LSS-A17 (John Crook)

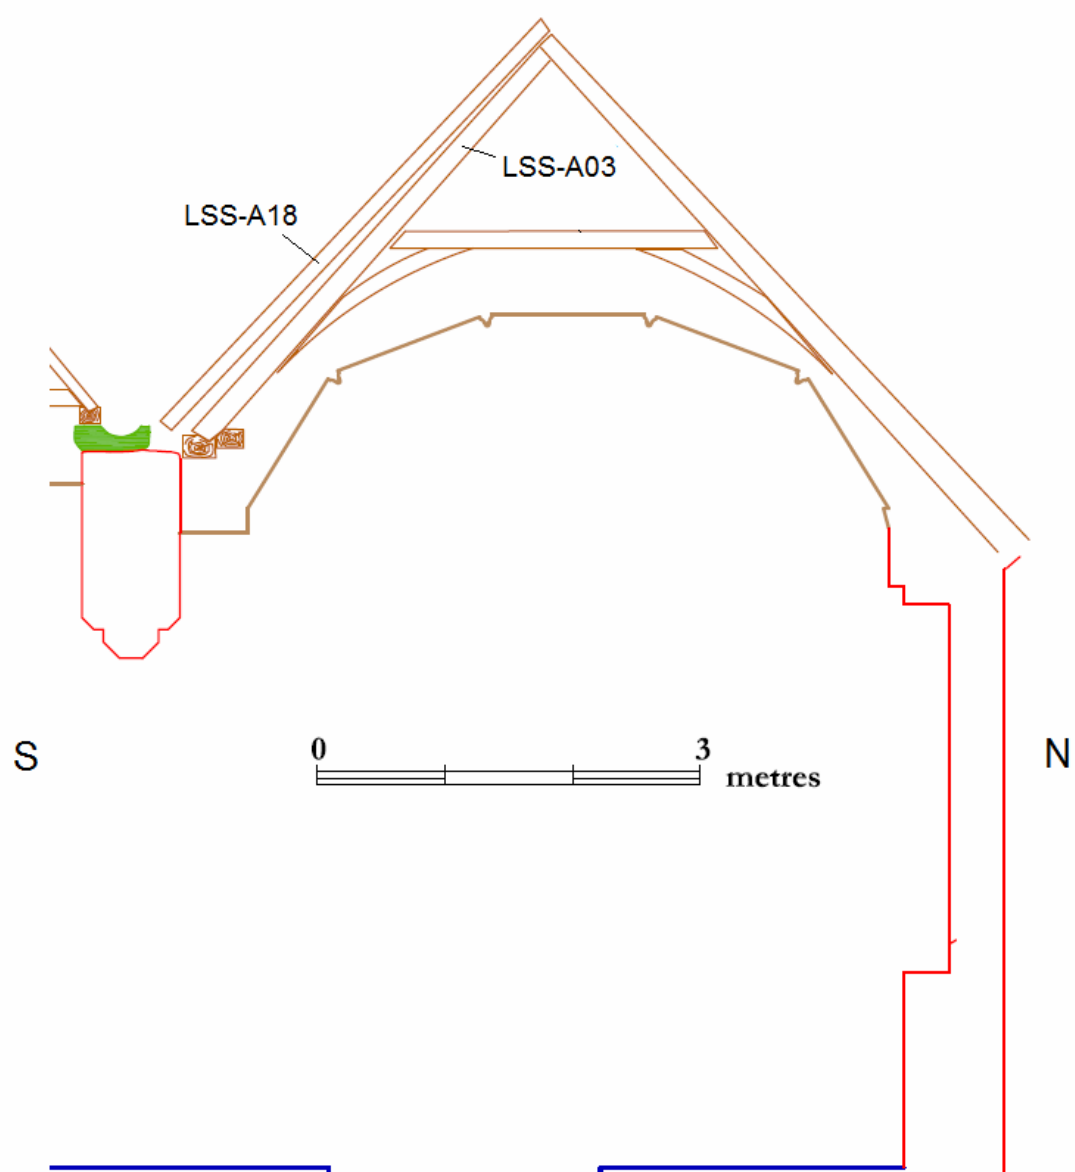
Figure 10: Nave; frame 4, showing the location of samples LSS-A03 and LSS-A18 (John Crook)

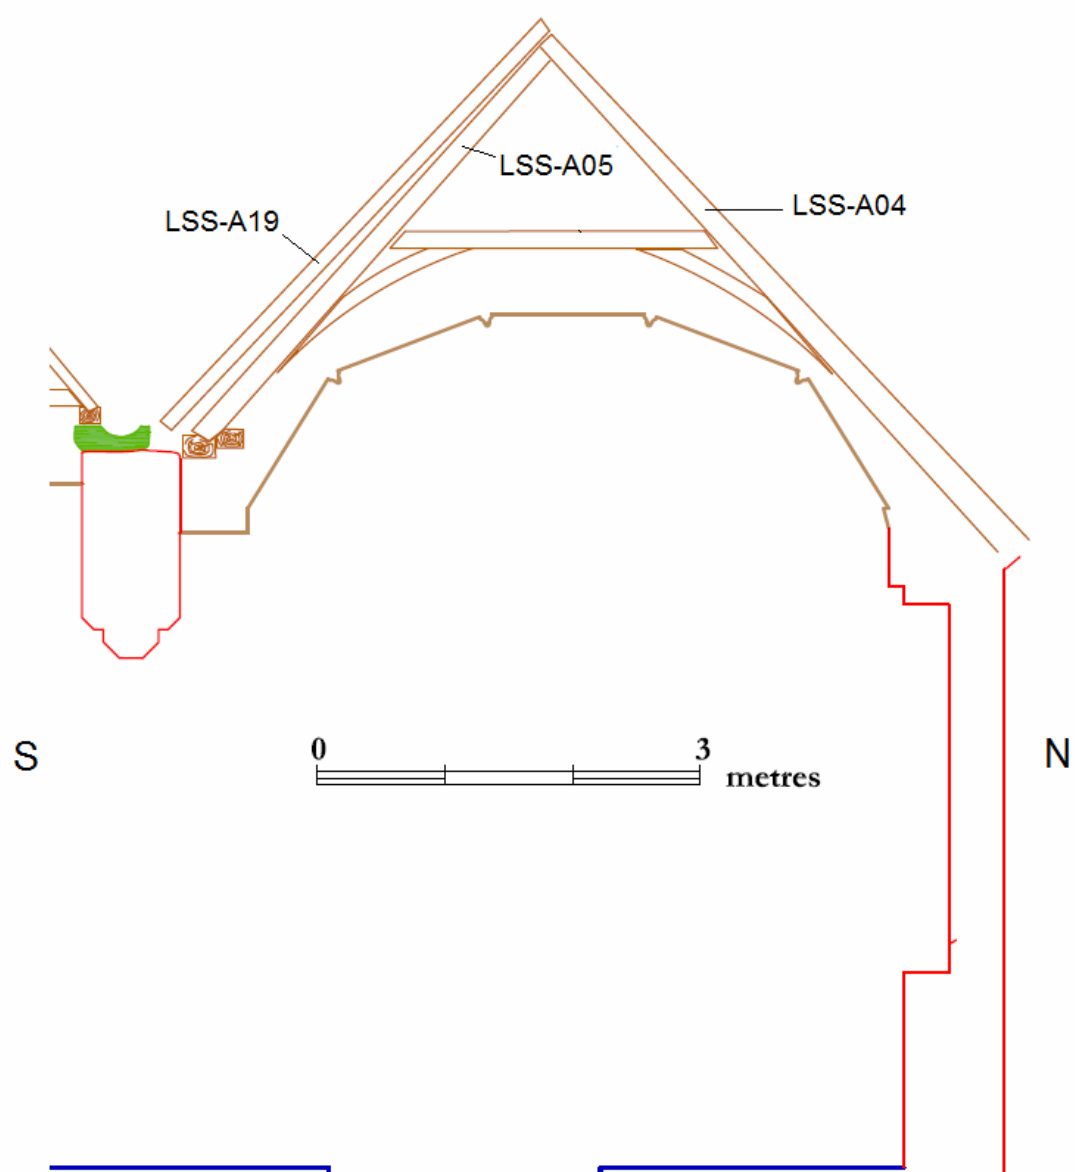
Figure 11: Nave; frame 5, showing the location of samples LSS-A04, LSS-A05, and LSS-A19 (John Crook)

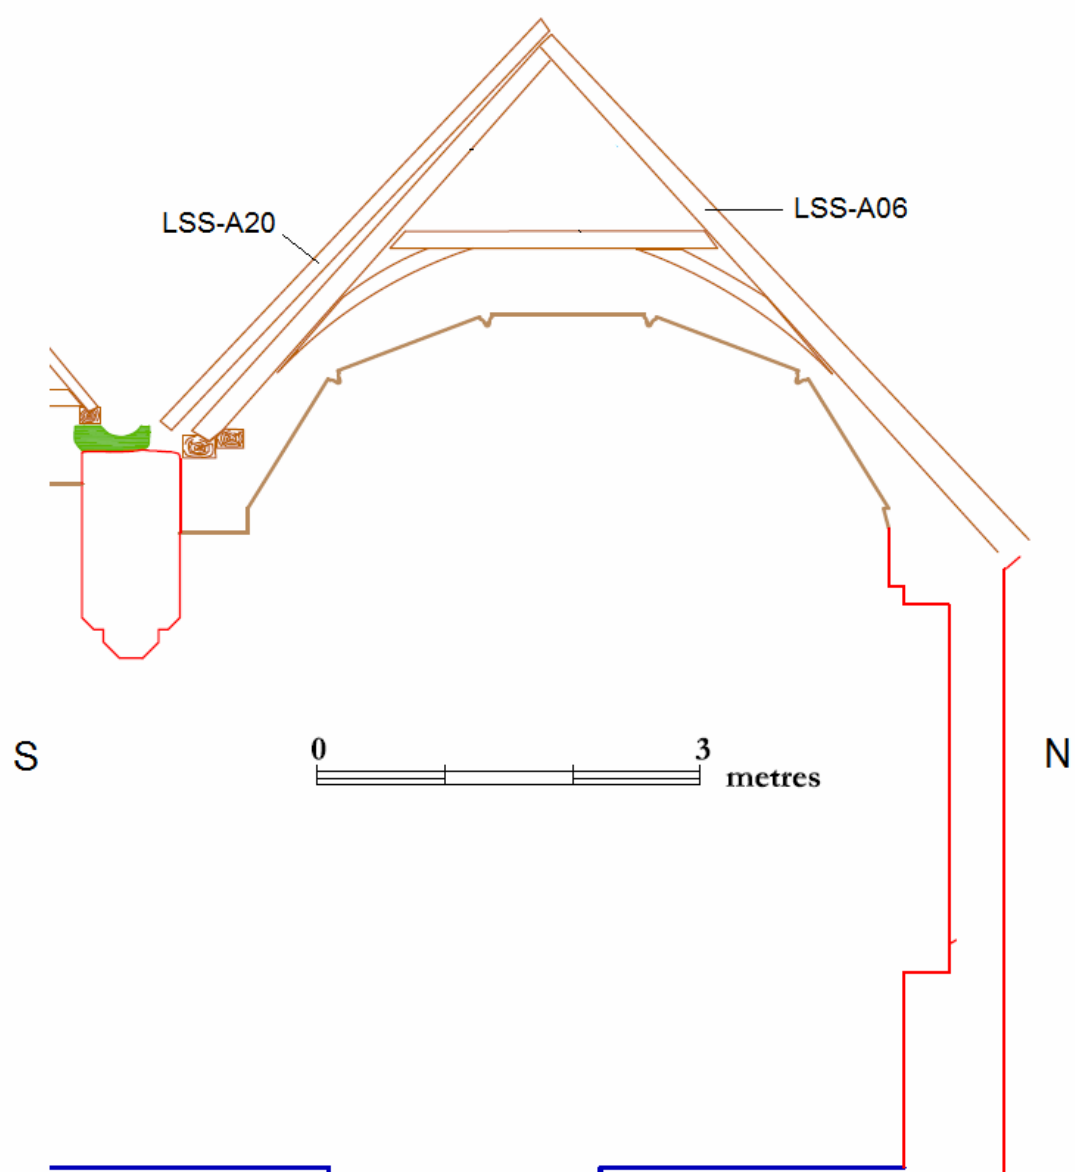
Figure 12: Nave; frame 6, showing the location of samples LSS-A05 and LSS-A20 (John Crook)

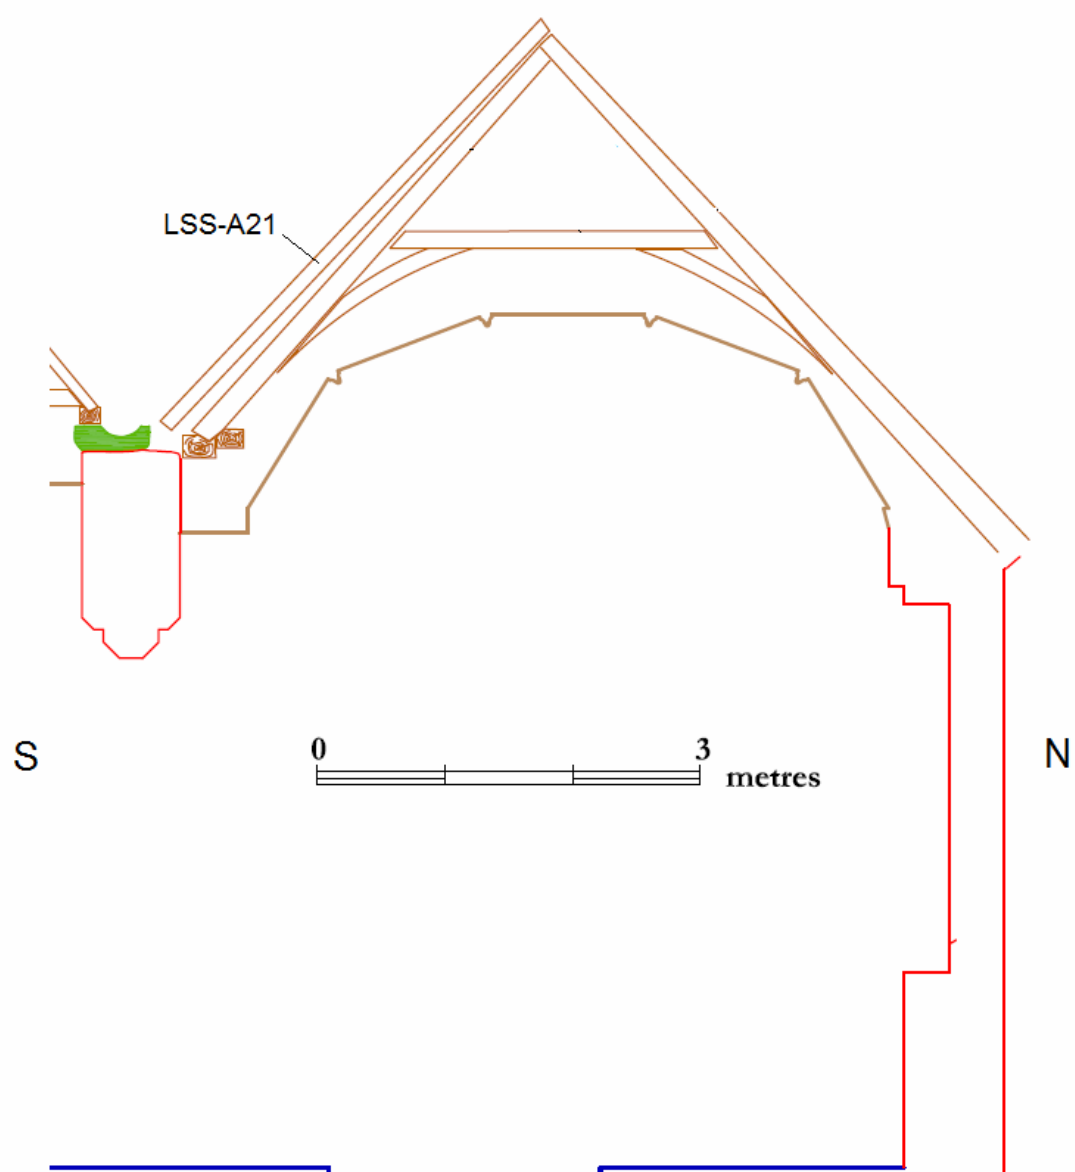
Figure 13: Nave; frame 7, showing the location of sample LSS-A21 (John Crook)

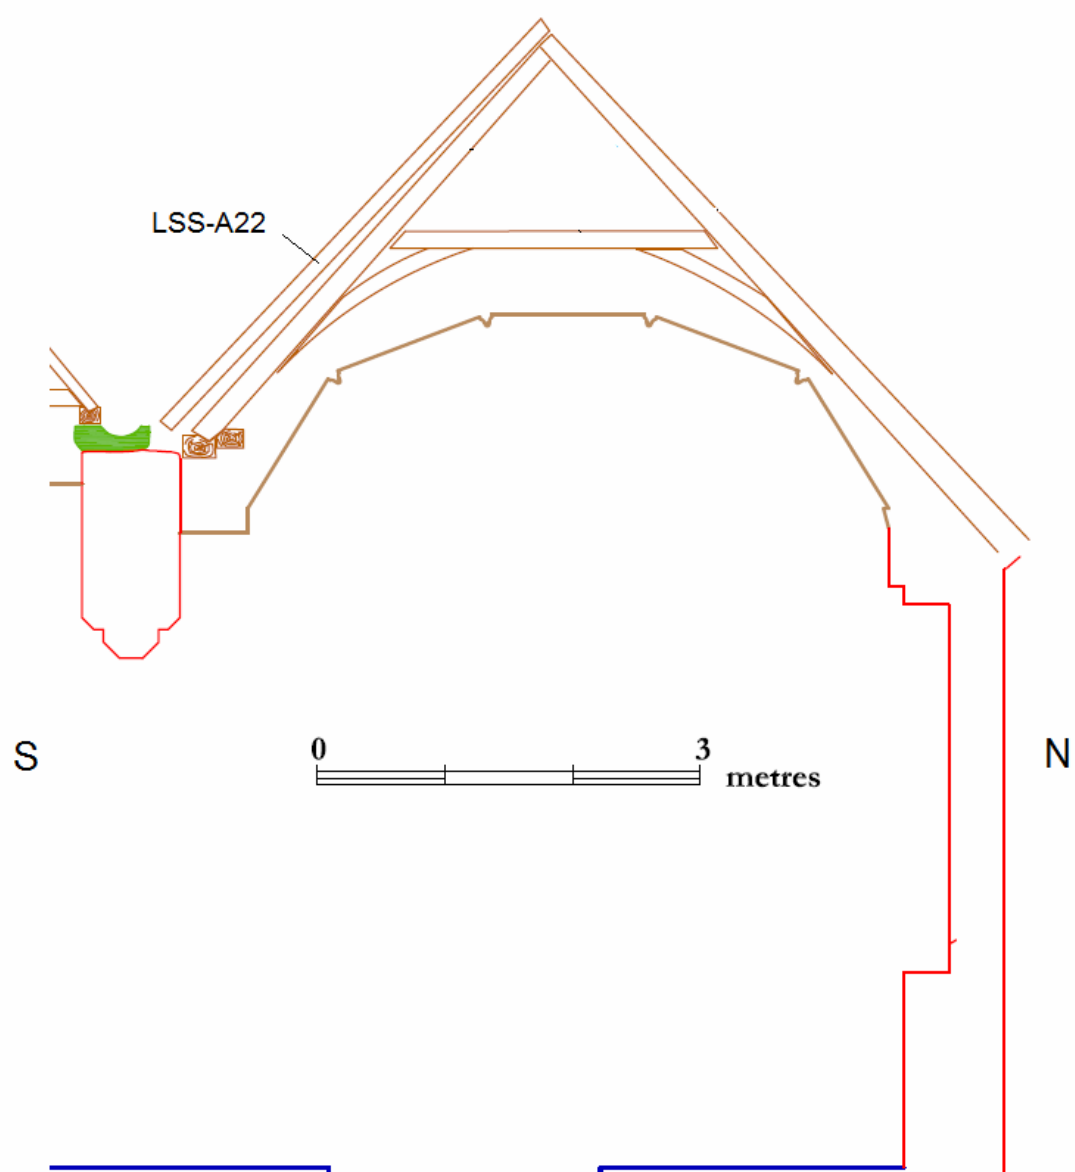
Figure 14: Nave; frame 8, showing the location of sample LSS-A22 (John Crook)

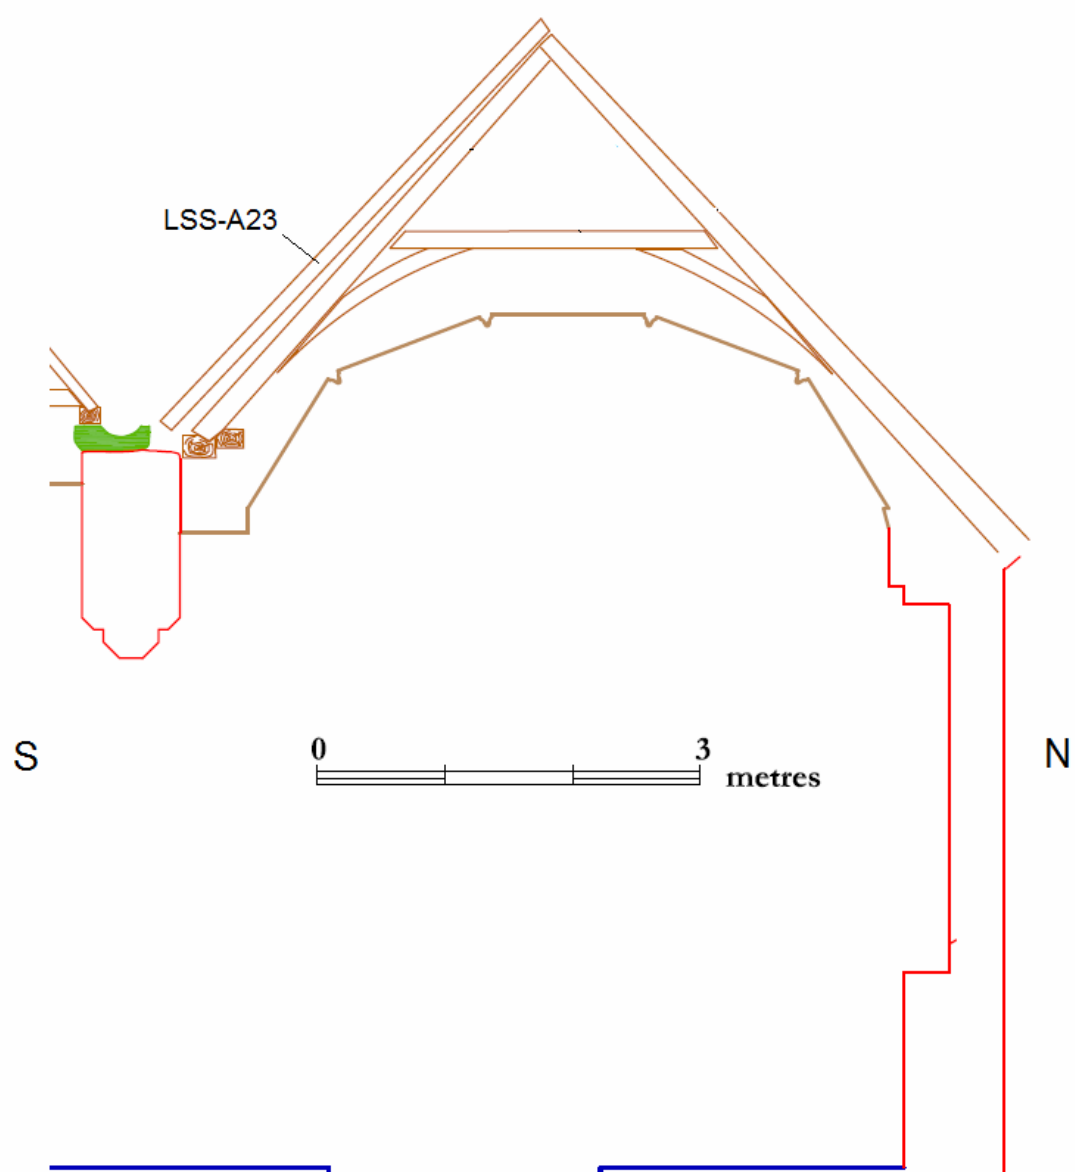
Figure 15: Nave; frame 9, showing the location of sample LSS-A23 (John Crook)

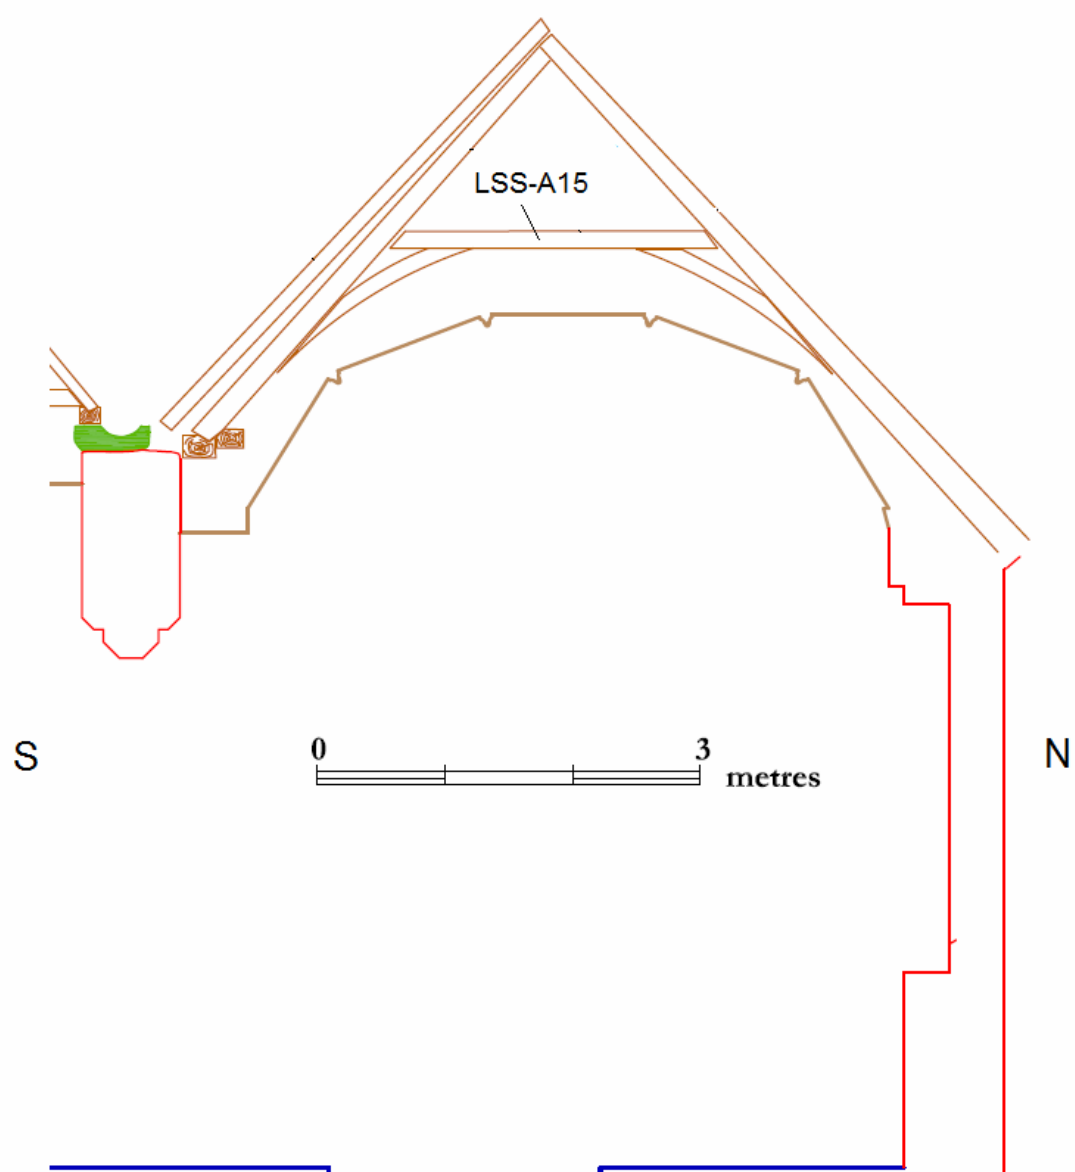
Figure 16: Nave; frame 11, showing the location of sample LSS-A15 (John Crook)

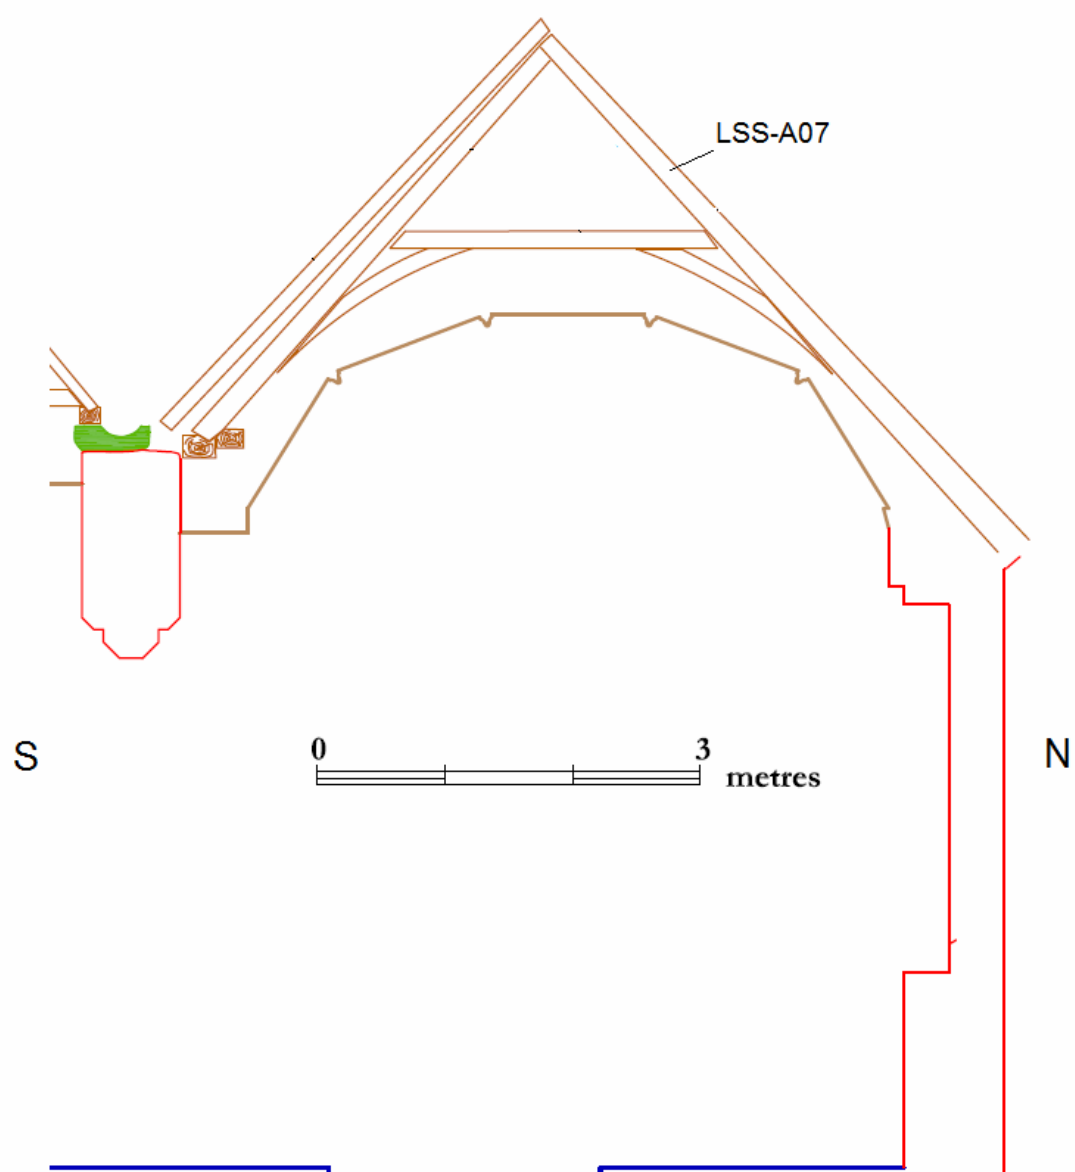
Figure 17: Nave; frame 12, showing the location of sample LSS-A07 (John Crook)

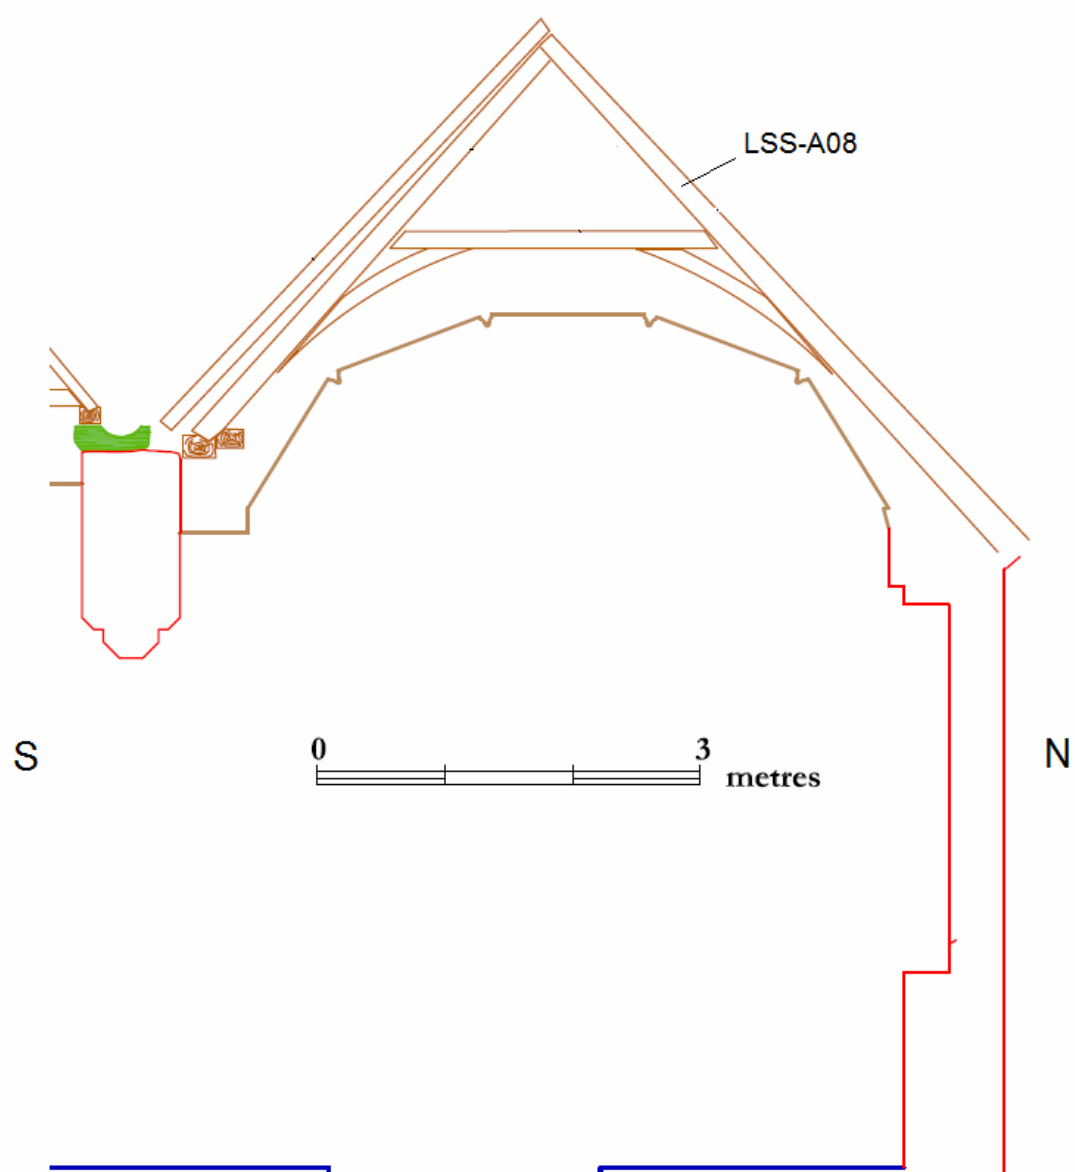
Figure 18: Nave; frame 14, showing the location of sample LSS-A08 (John Crook)

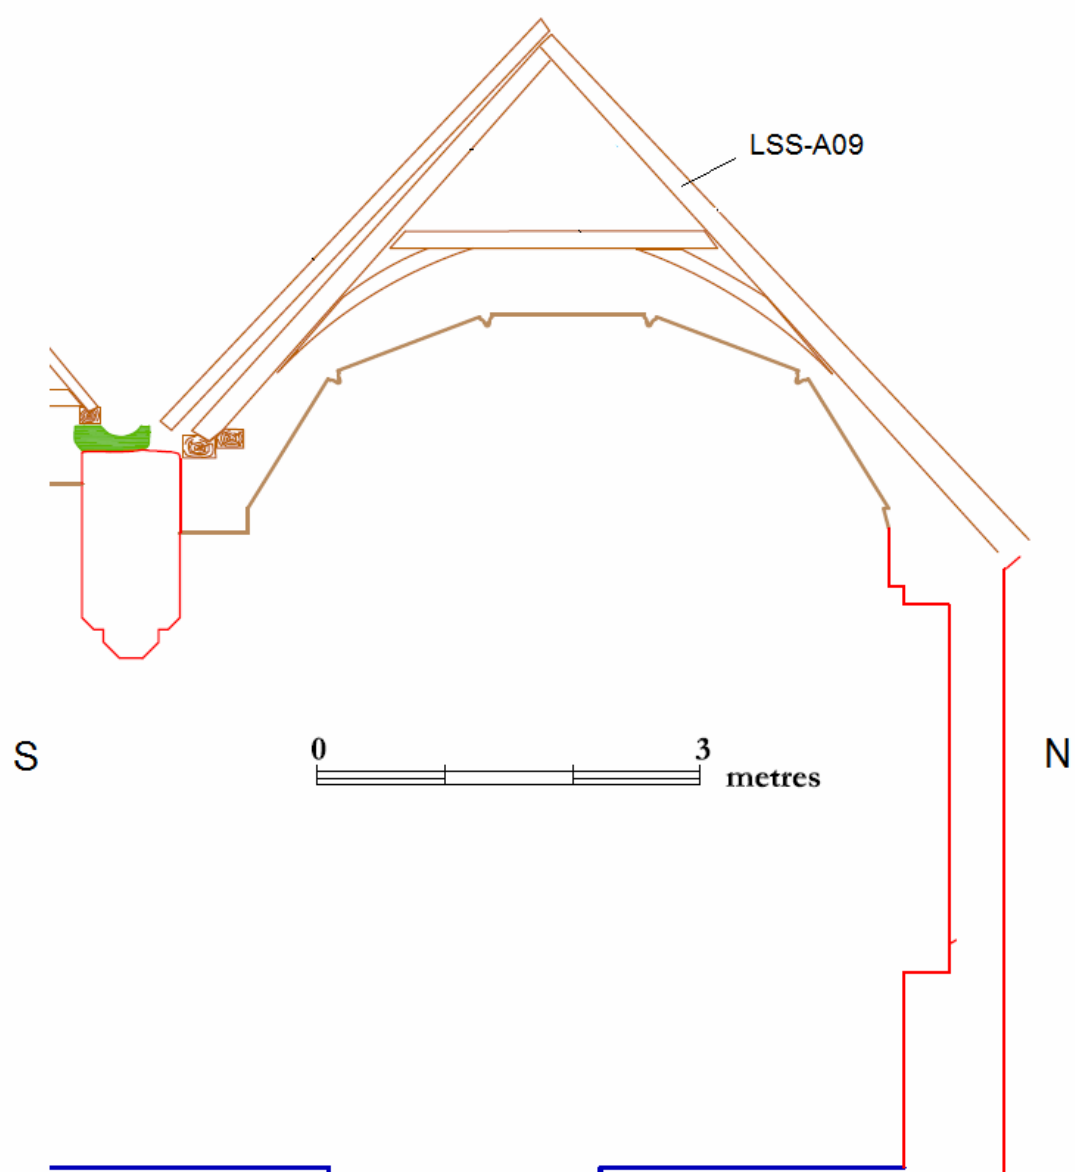
Figure 19: Nave; frame 15, showing the location of sample LSS-A09 (John Crook)

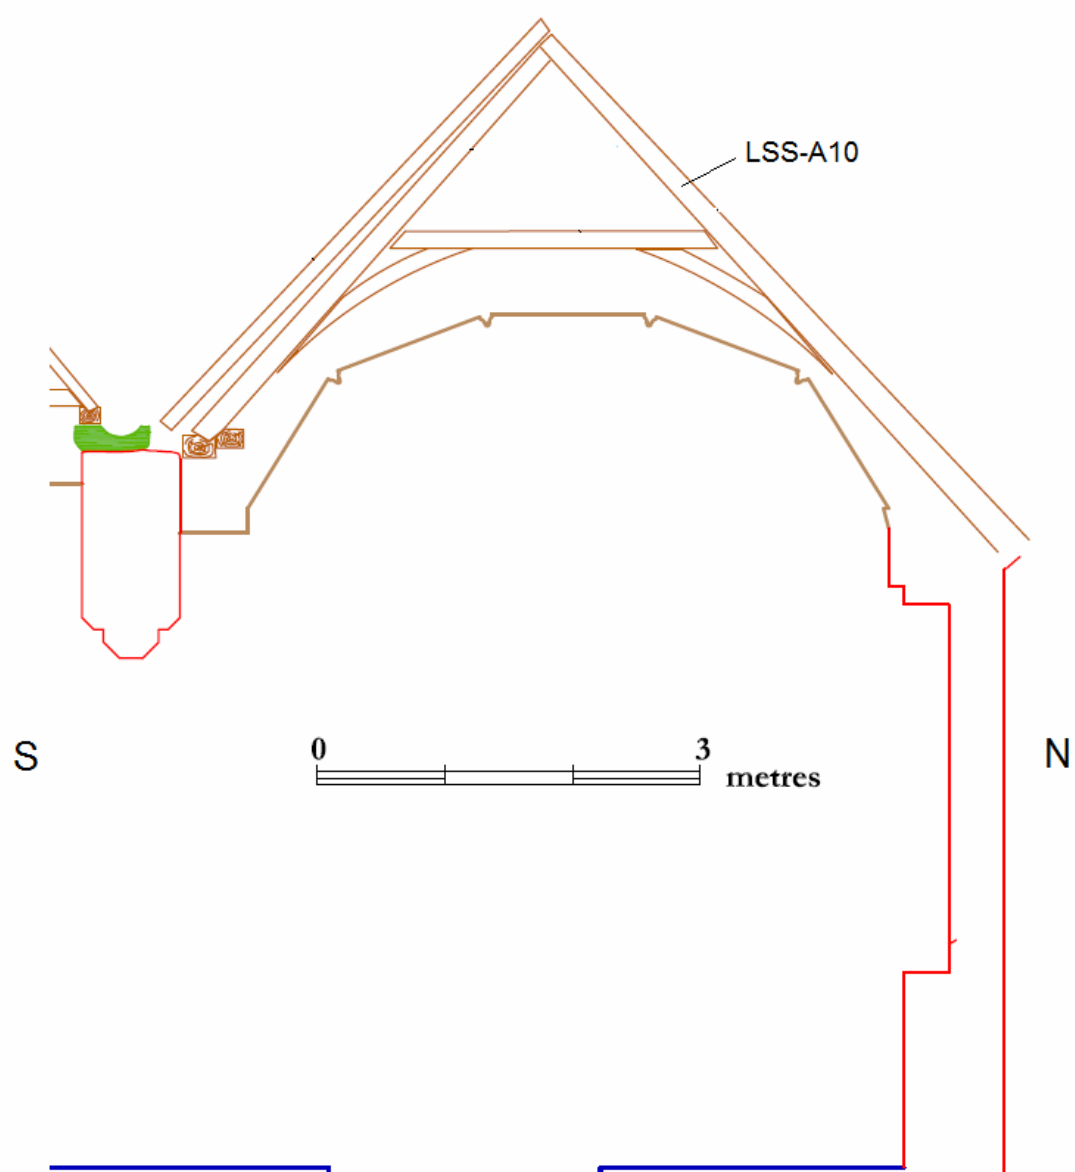
Figure 20: Nave; frame 17, showing the location of sample LSS-A10 (John Crook)
