CHURCH OF ST PETER, WEST LISS, HAMPSHIRE

TREE-RING DATING OF TIMBERS

SCIENTIFIC DATING REPORT

Alison Arnold and Robert Howard

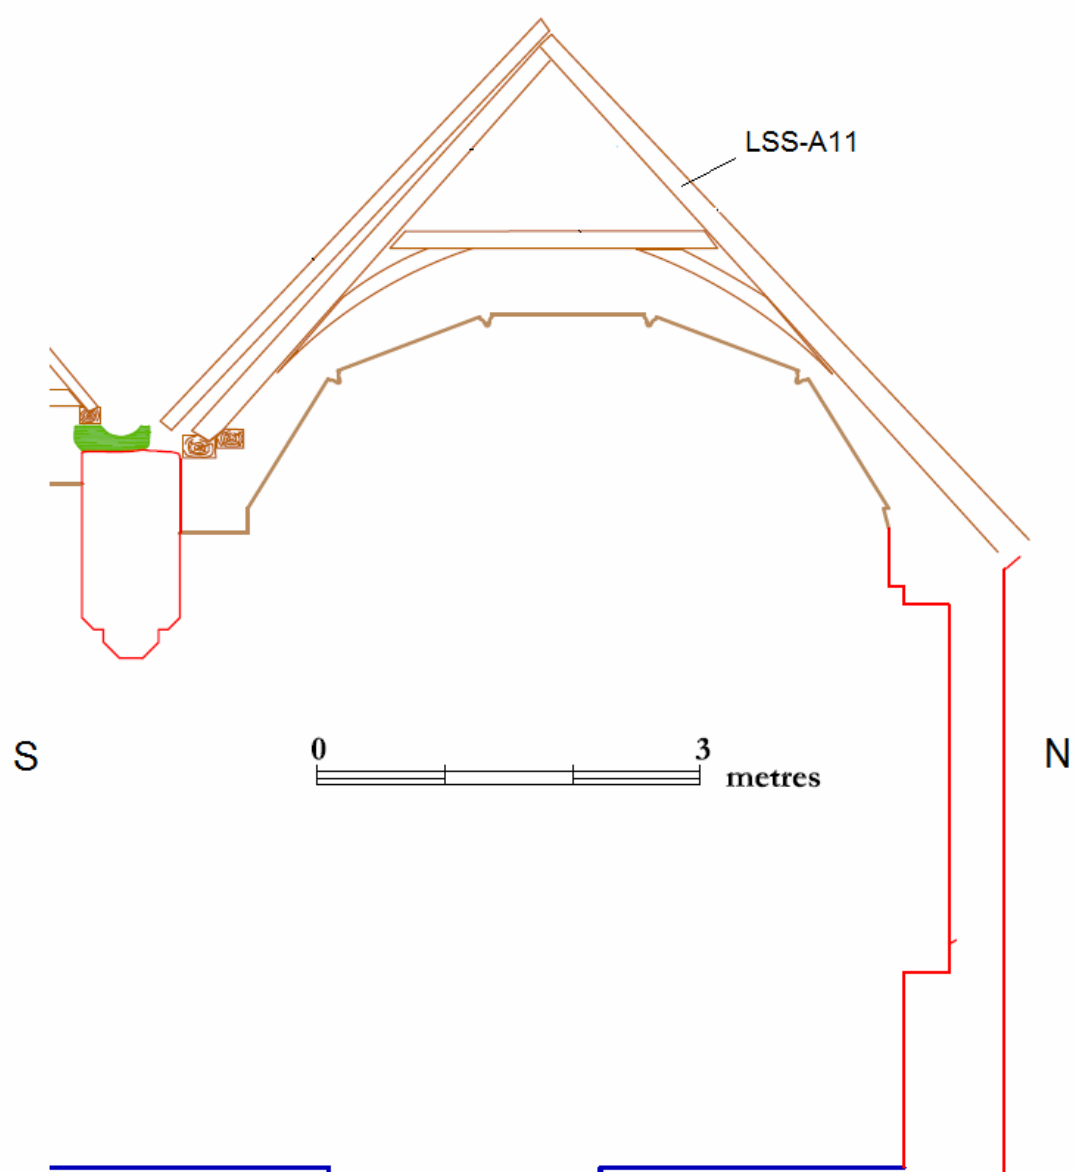
Figure 21: Nave; frame 18, showing the location of sample LSS-A11 (John Crook)

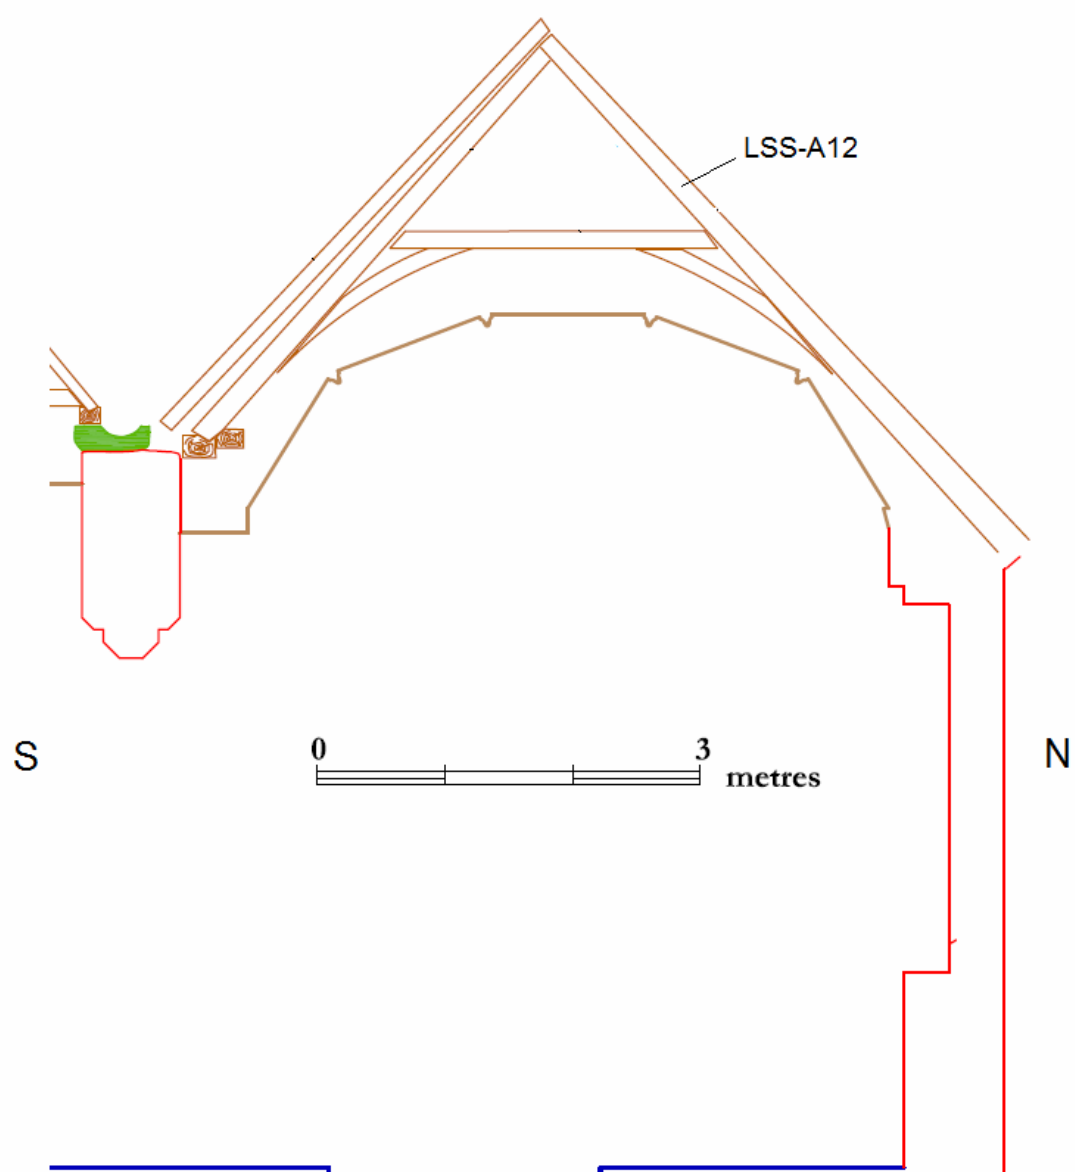
Figure 22: Nave; frame 19, showing the location of sample LSS-A12 (John Crook)

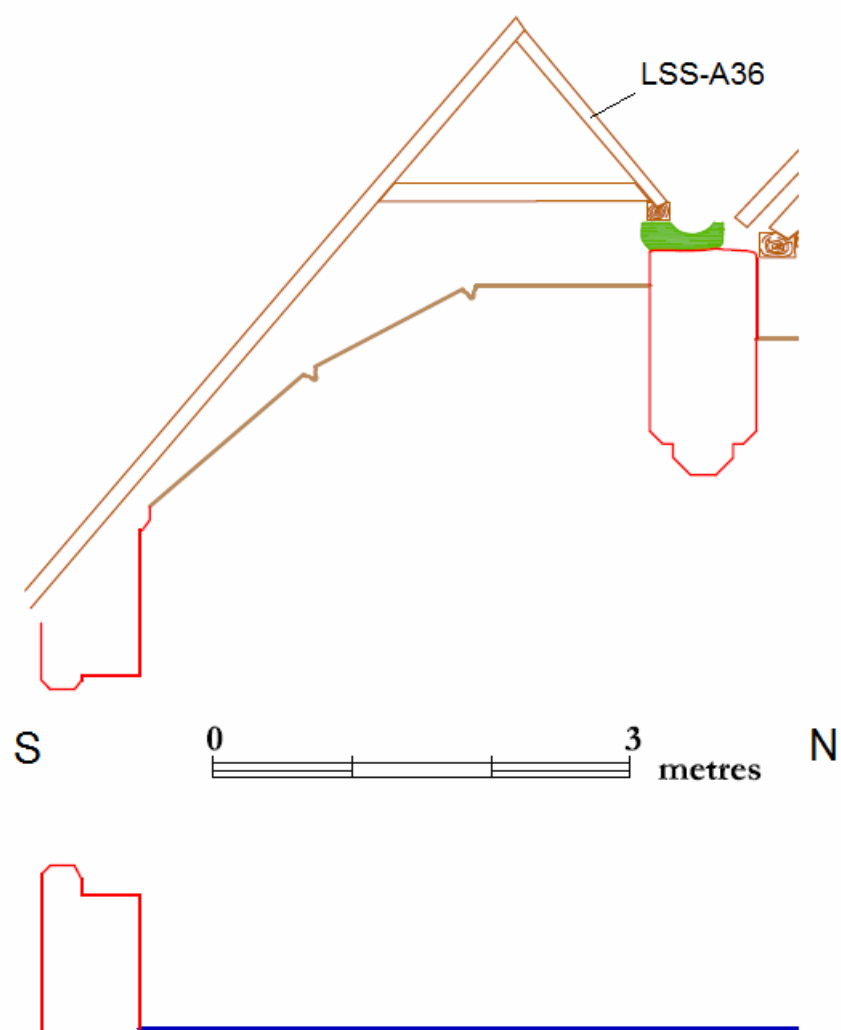
Figure 23: South aisle; frame 3, showing the location of sample LSS-A36 (John Crook)

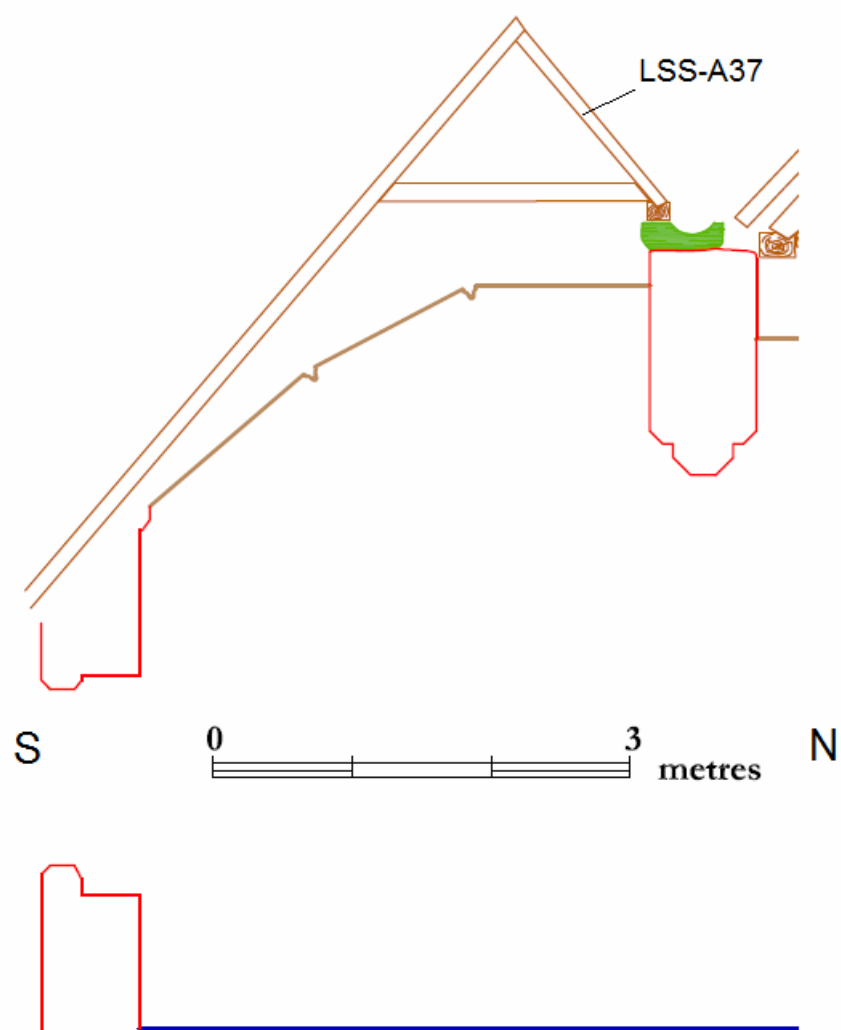
Figure 24: South aisle; frame 4, showing the location of sample LSS-A37 (John Crook)

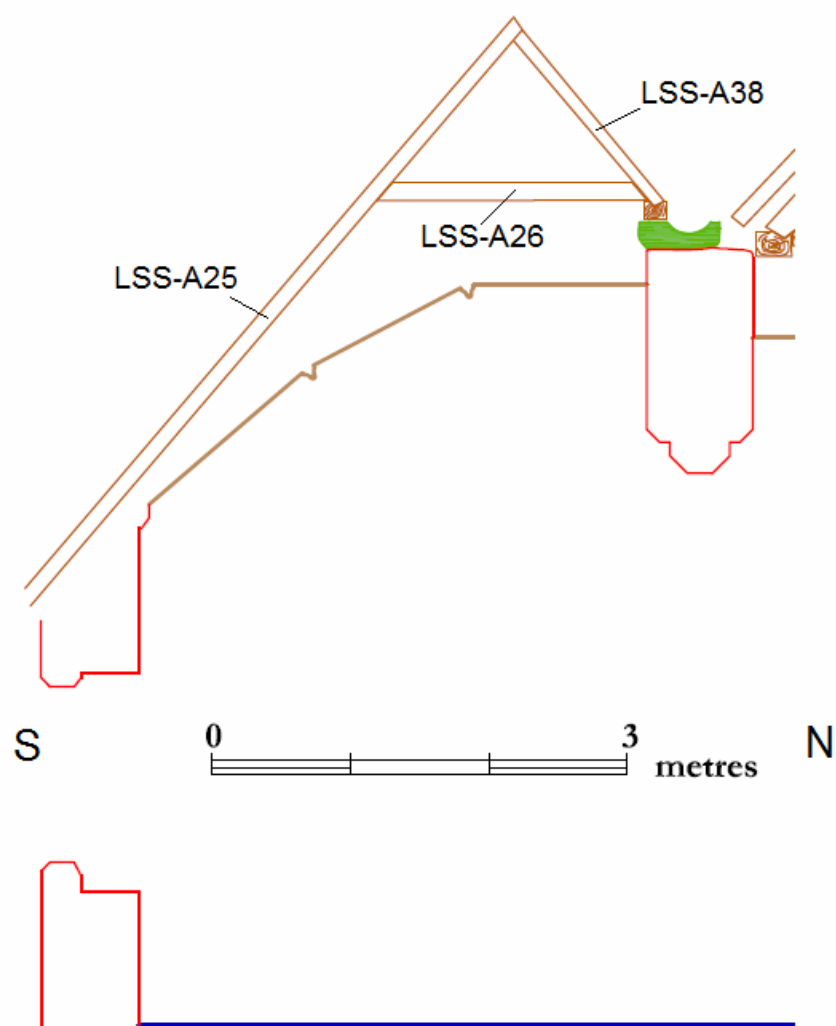
Figure 25: South aisle; frame 5, showing the location of samples LSS-A25, LSS-A26, and LSS-A38 (John Crook)

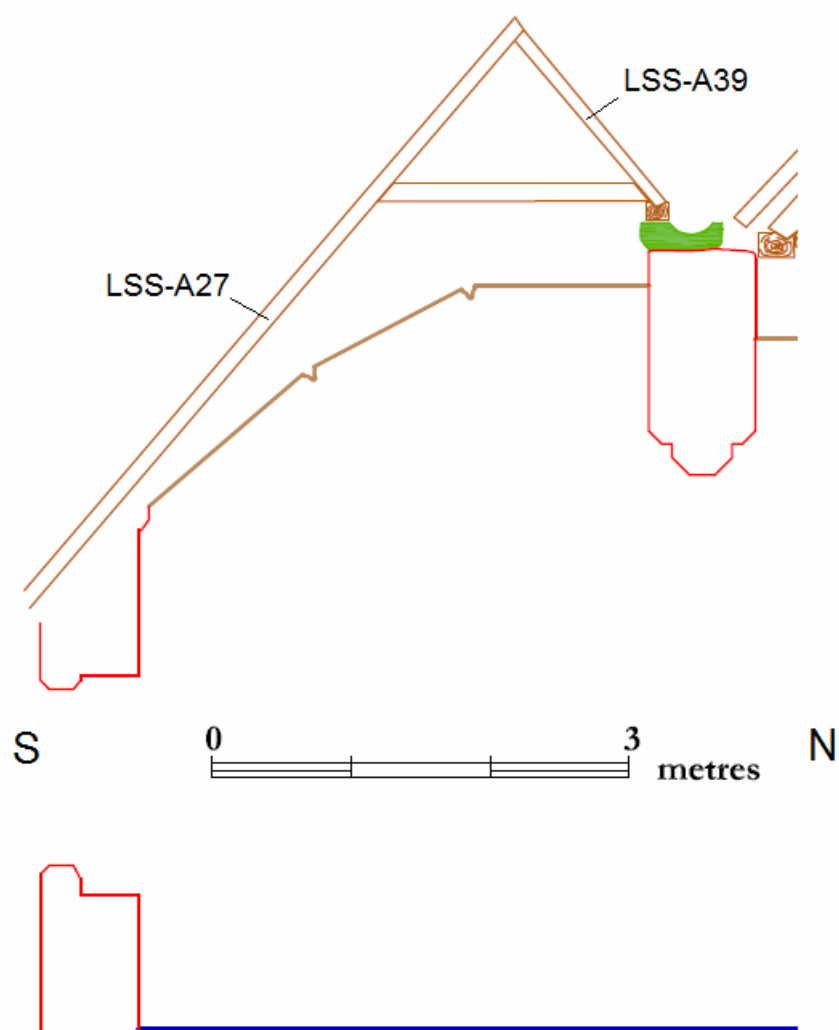
Figure 26: South aisle; frame 6, showing the location of samples LSS-A27 and LSS-A39 (John Crook)

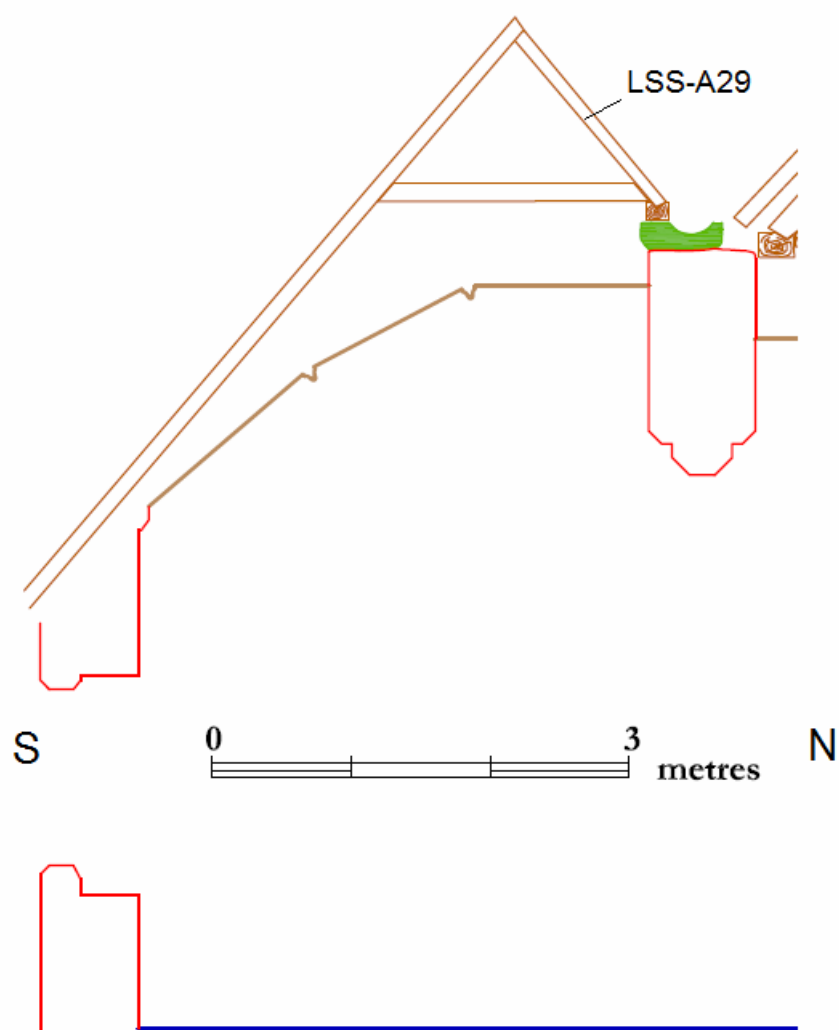
Figure 27: South aisle; frame 8, showing the location of sample LSS-A29 (John Crook)

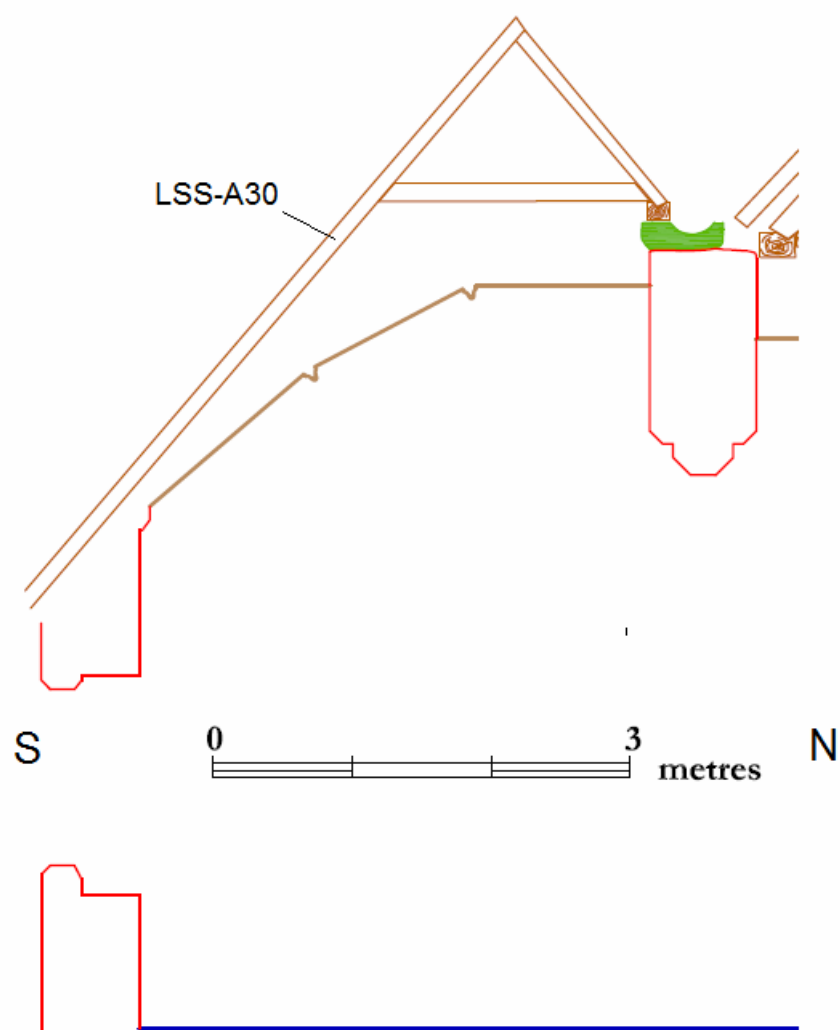
Figure 28: South aisle; frame 9, showing the location of sample LSS-A30 (John Crook)

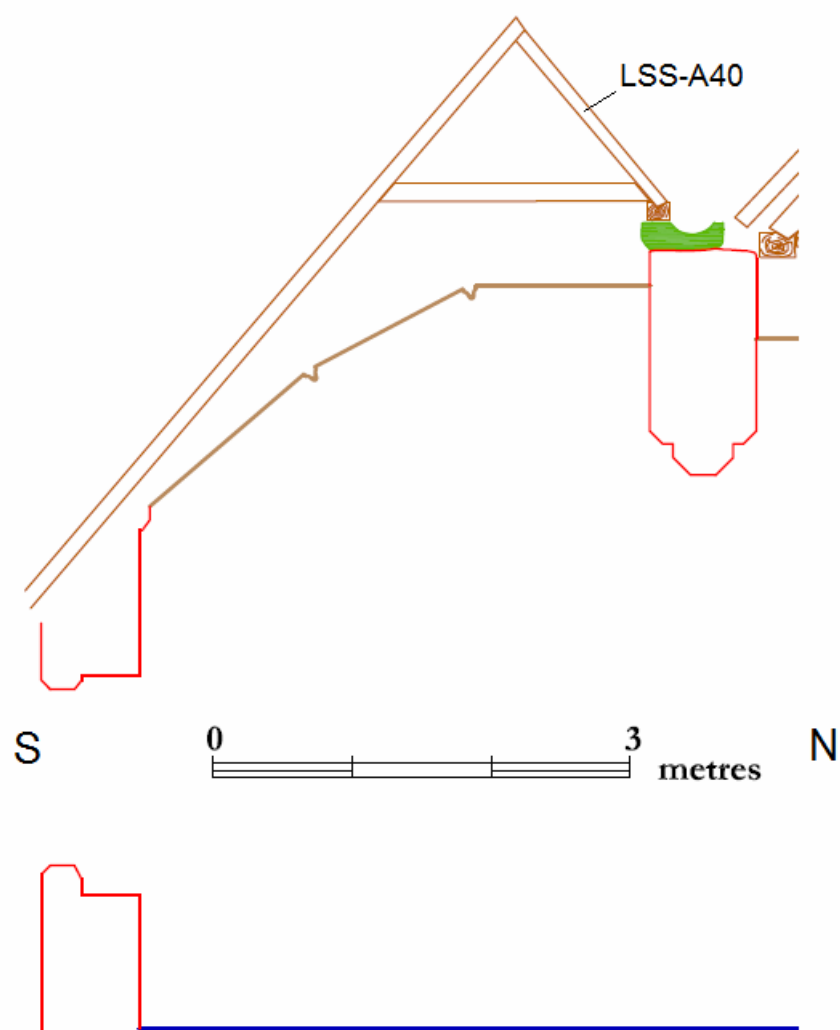
Figure 29: South aisle; frame 12, showing the location of sample LSS-A40 (John Crook)

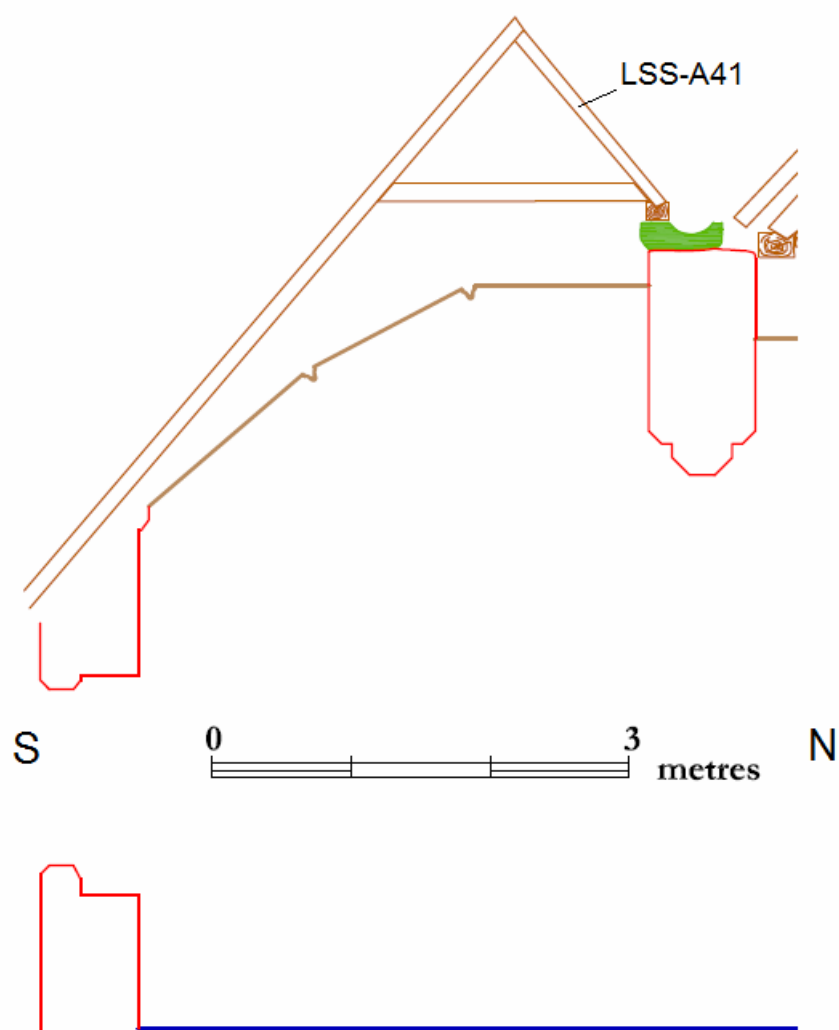
Figure 30: South aisle; frame 14, showing the location of sample LSS-A41 (John Crook)

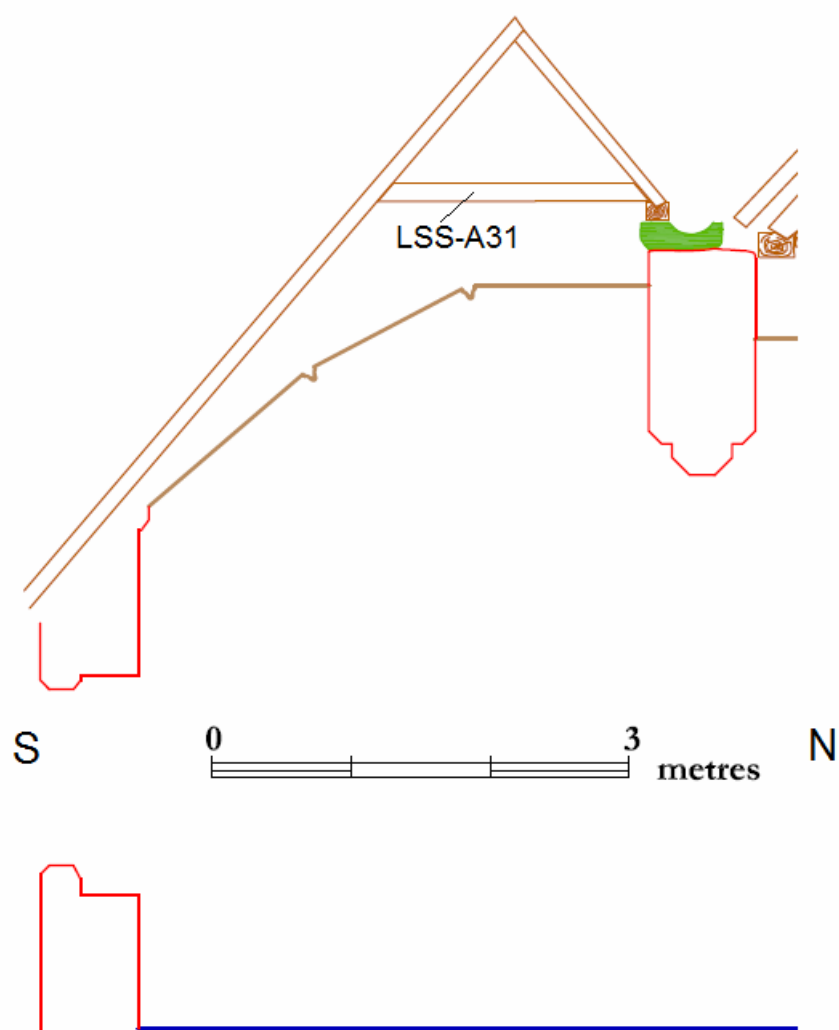
Figure 31: South aisle; frame 15, showing the location of sample LSS-A31 (John Crook)

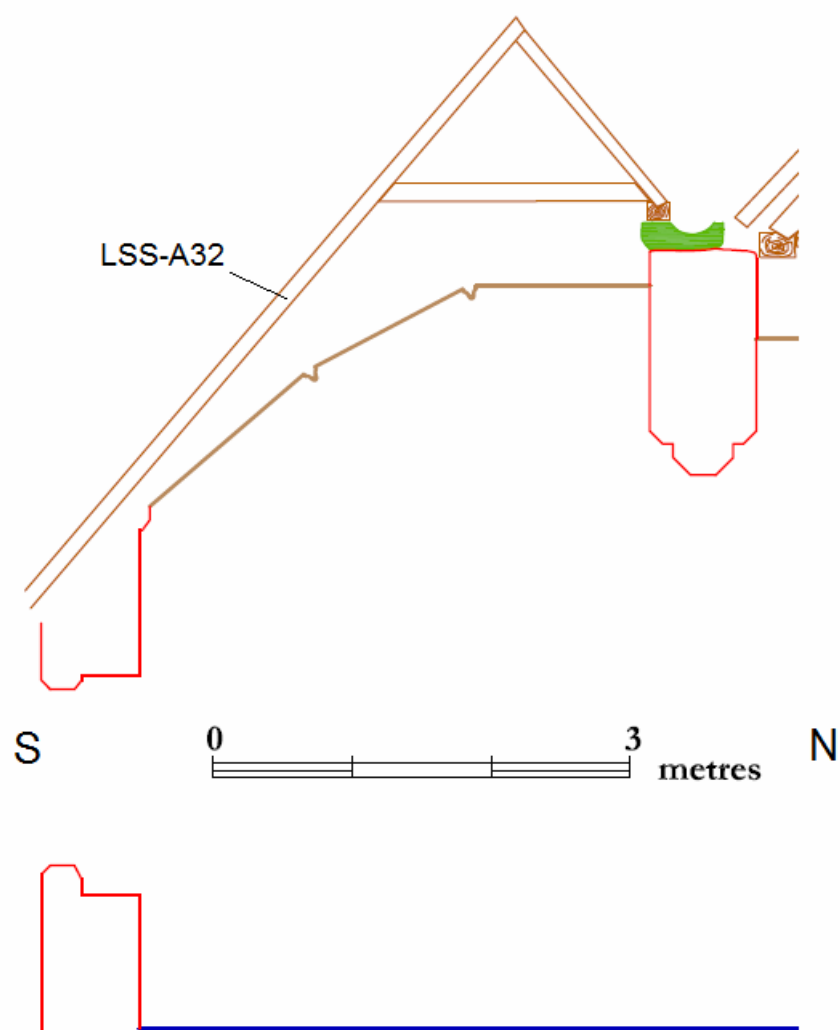
Figure 32: South aisle; frame 17, showing the location of sample LSS-A32 (John Crook)

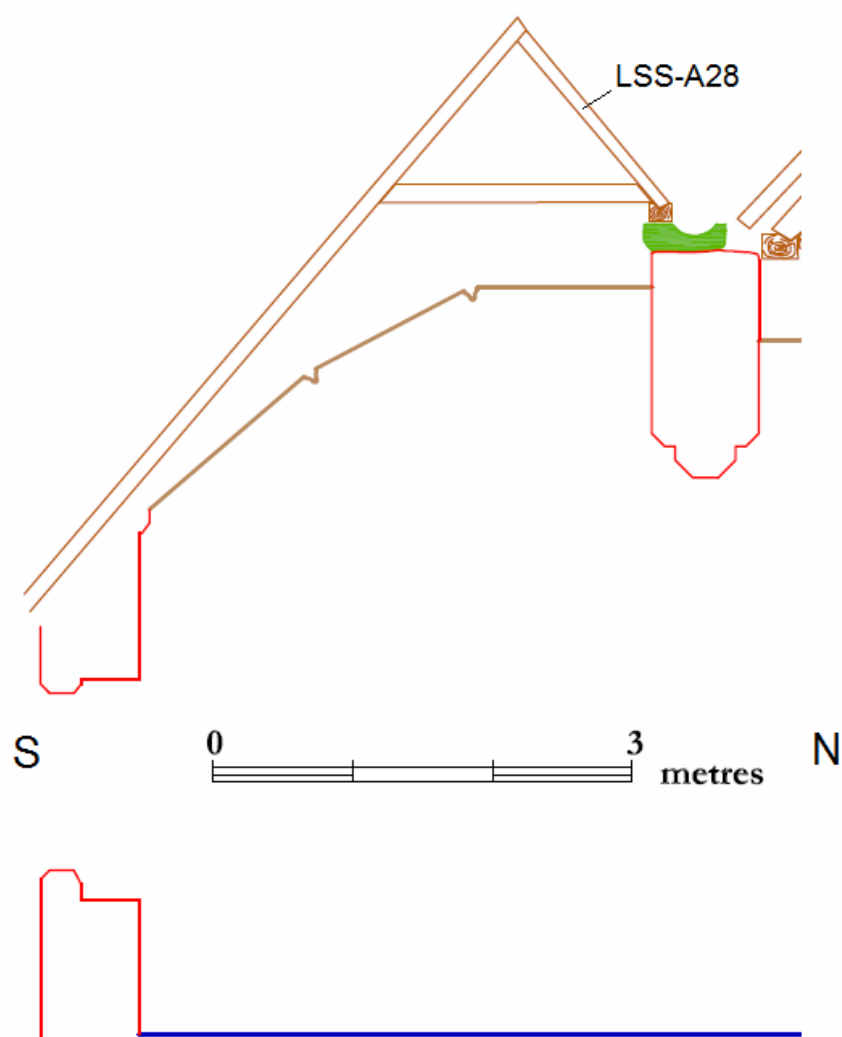
Figure 33: South aisle; frame 18, showing the location of sample LSS-A28 (John Crook)

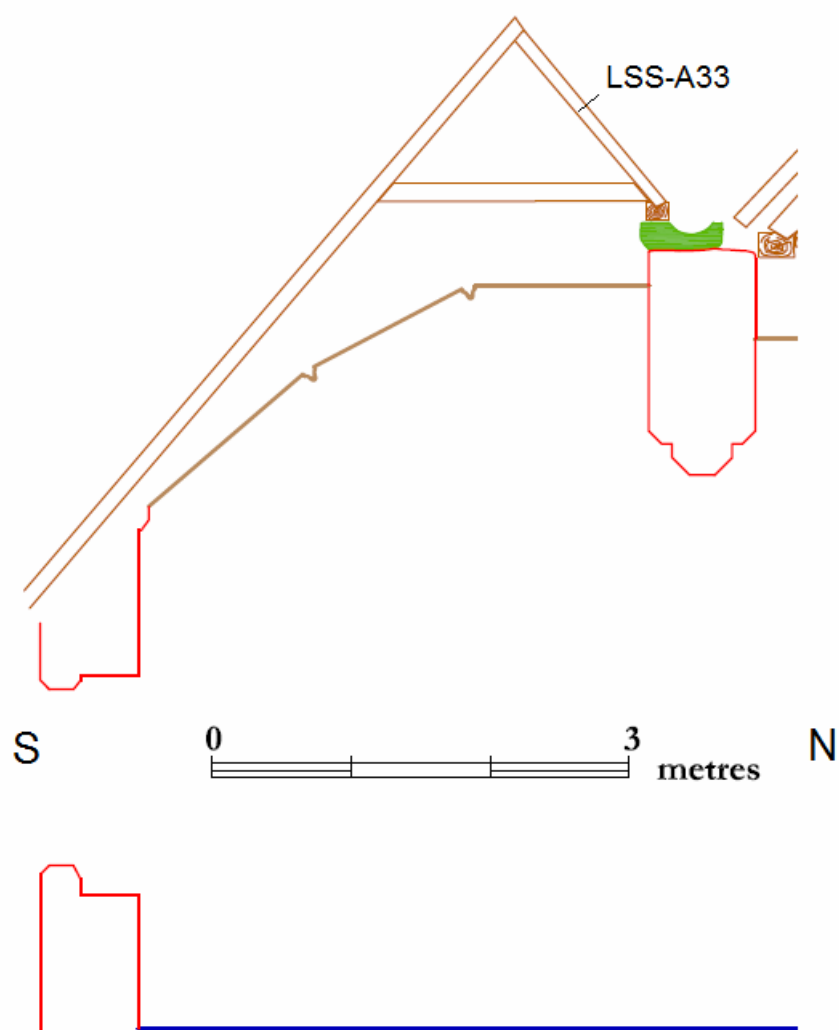
Figure 34: South aisle; frame 21, showing the location of sample LSS-A33 (John Crook)

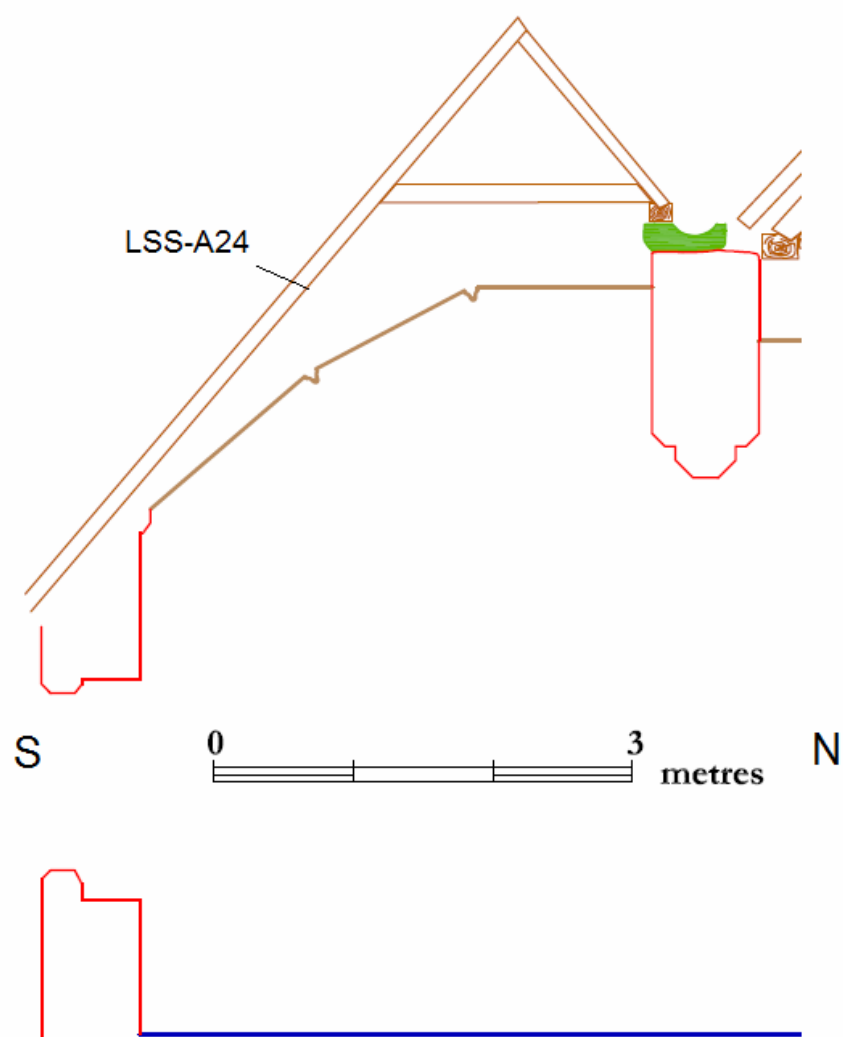
Figure 35: South aisle; frame 22, showing the location of sample LSS-A24 (John Crook)

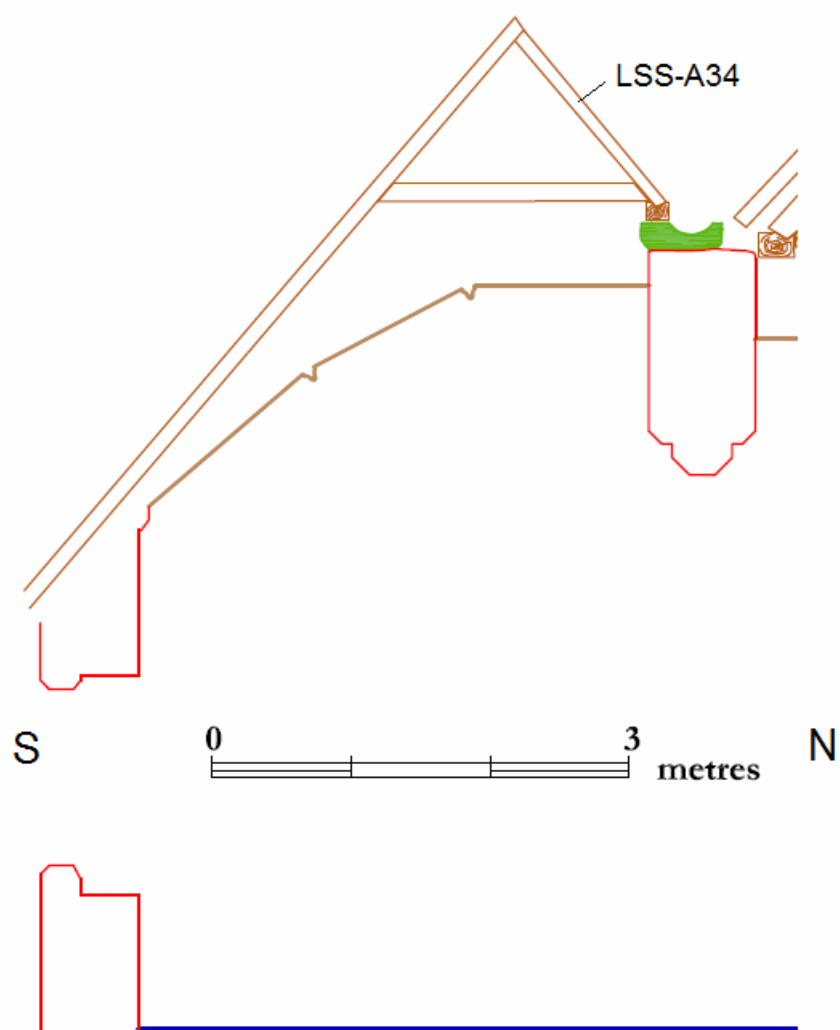
Figure 36: South aisle; frame 23, showing the location of sample LSS-A34 (John Crook)

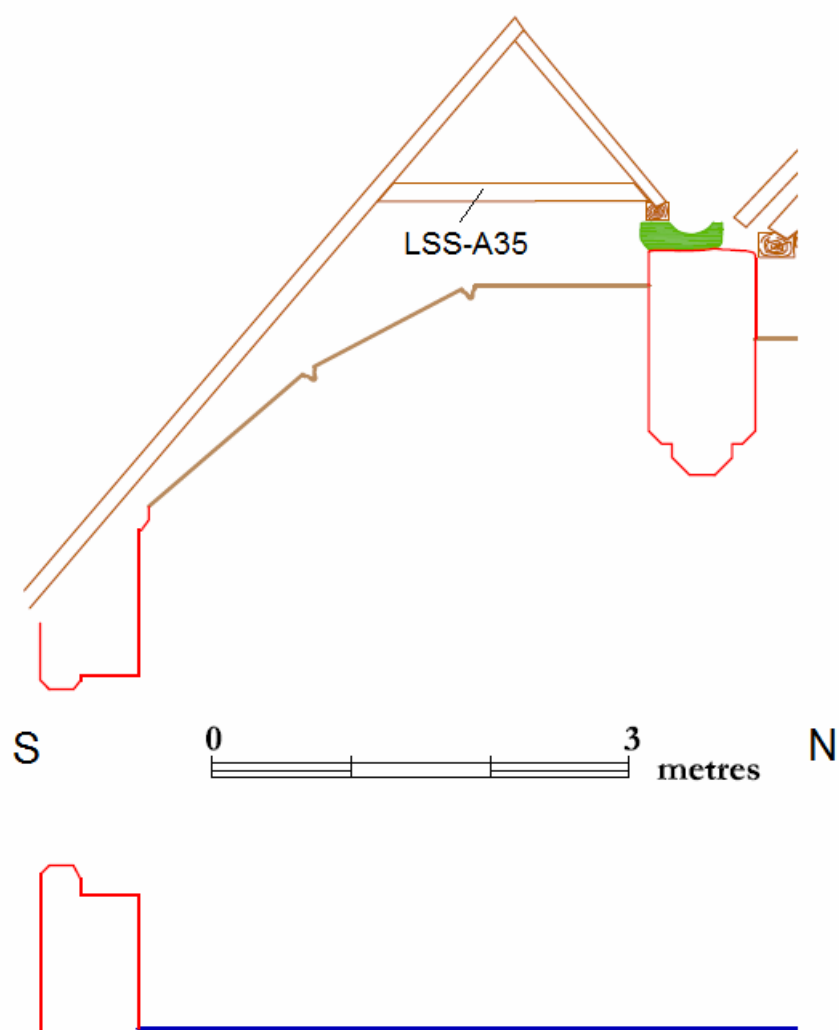
Figure 37: South aisle; frame 25, showing the location of sample LSS-A35 (John Crook)

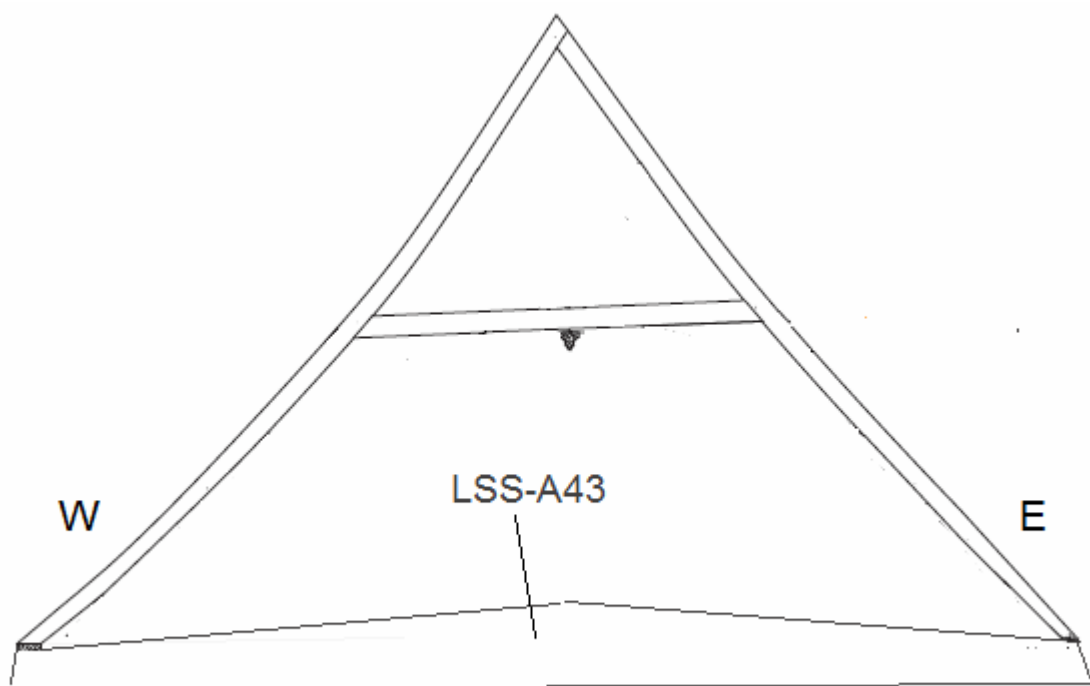
Figure 38: Porch; frame 1, showing the location of sample LSS-A43

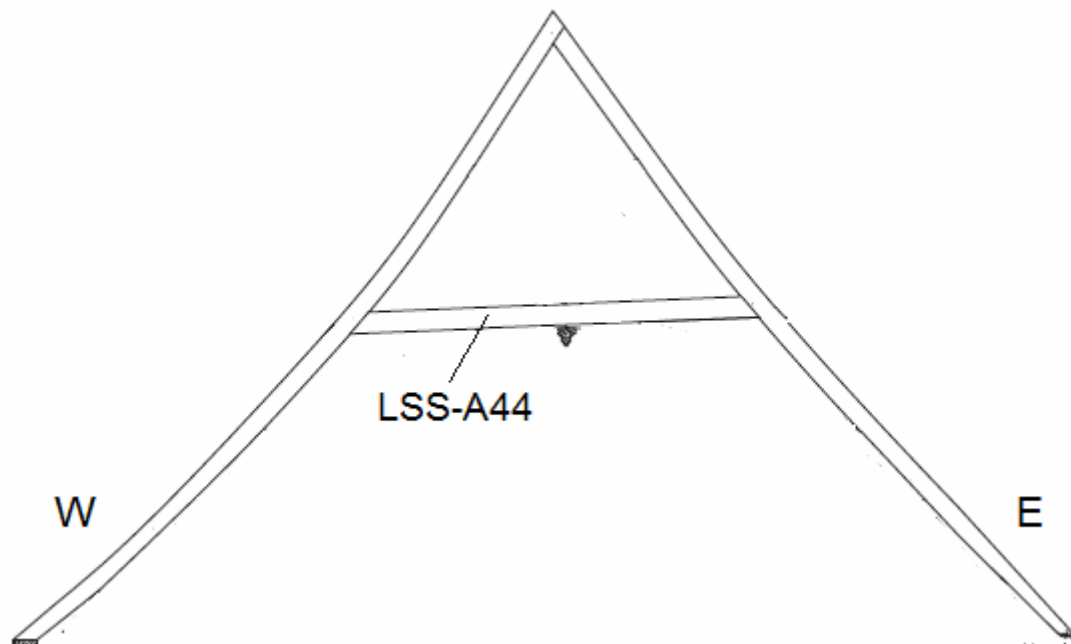
Figure 39: Porch; frame 2, showing the location of sample LSS-A44

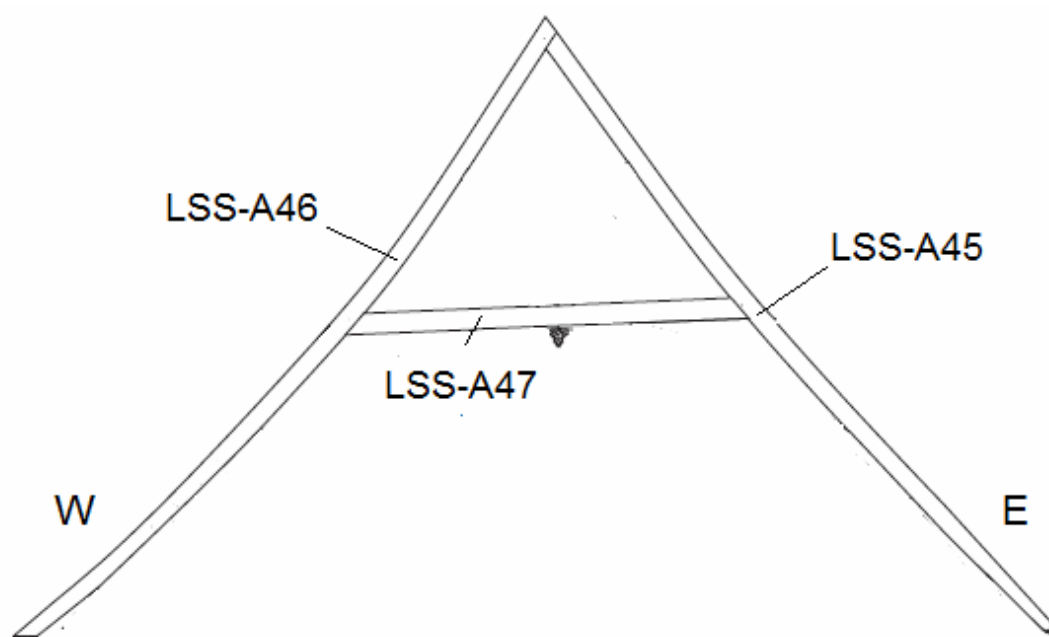
Figure 40: Porch; frame 3, showing the location of samples LSS-A45–7

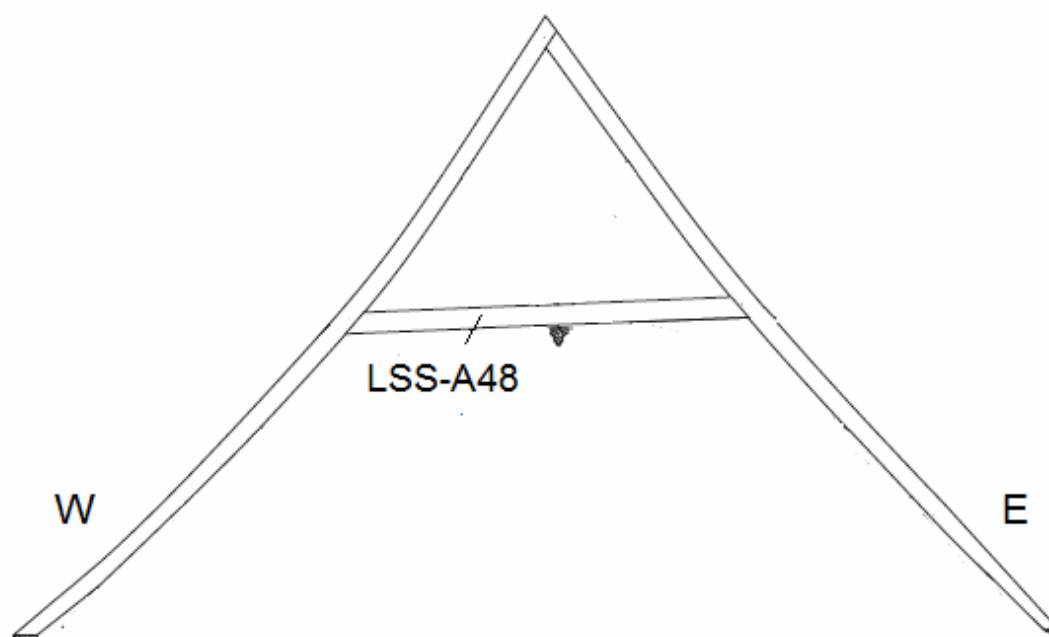
Figure 41: Porch; frame 4, showing the location of sample LSS-A48

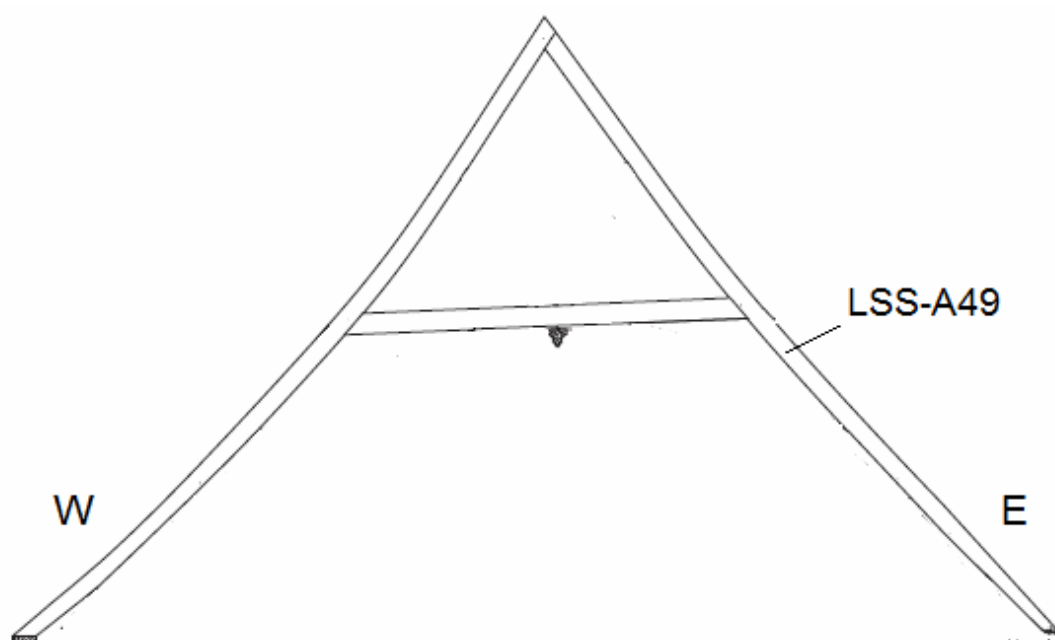
Figure 42: Porch; frame 5, showing the location of sample LSS-A49

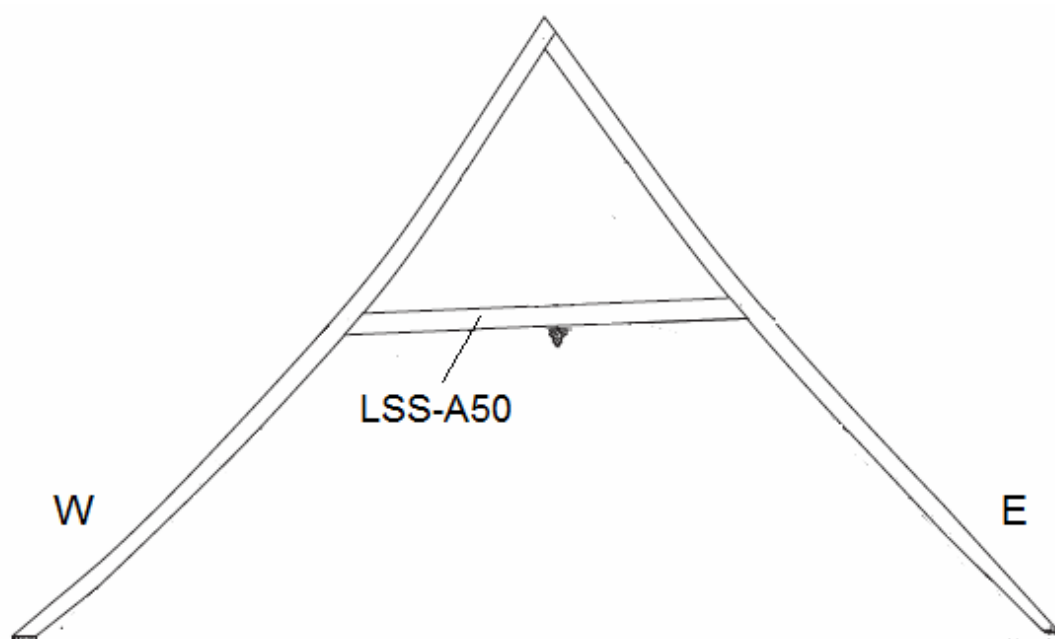
Figure 43: Porch; frame 6, showing the location of sample LSS-A50

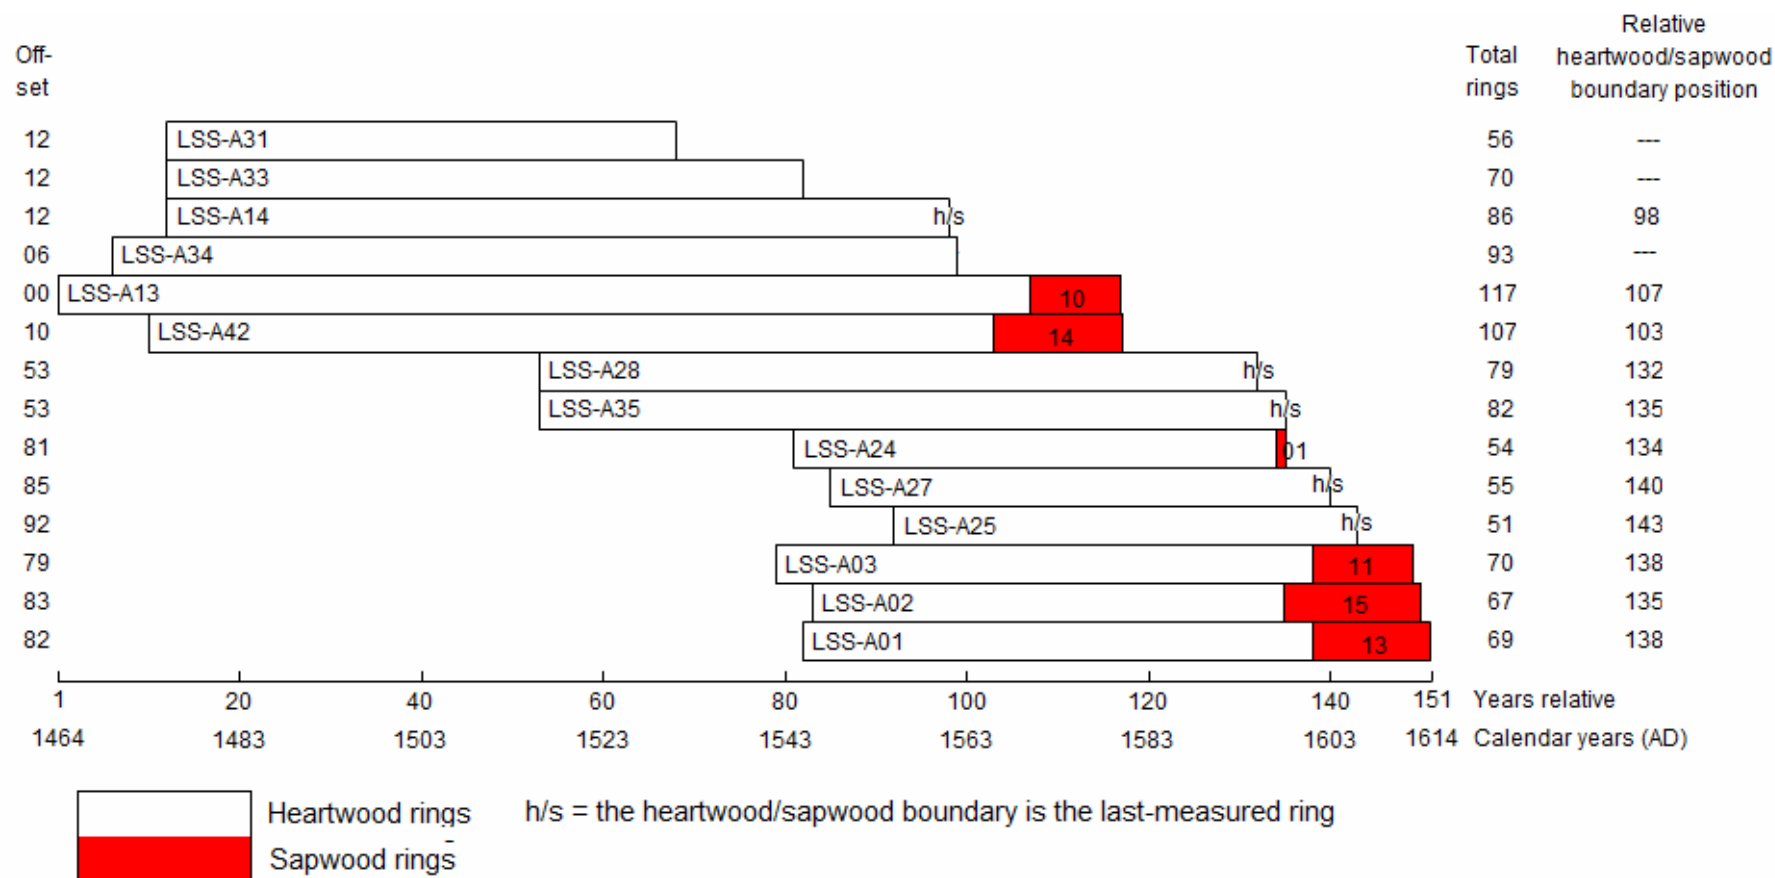
Figure 44: Bar diagram of samples in site sequence LSSASQ01

Firstly, 14 samples matched each other and were combined at the relevant offset positions to form LSSASQ01, a site sequence of 151 rings (Fig 44). This site sequence was compared against a series of relevant reference chronologies where it was found to match consistently and securely at a first-ring date of AD 1464 and a last-measured ring date of AD 1614. The evidence for this dating is given in Table 2.

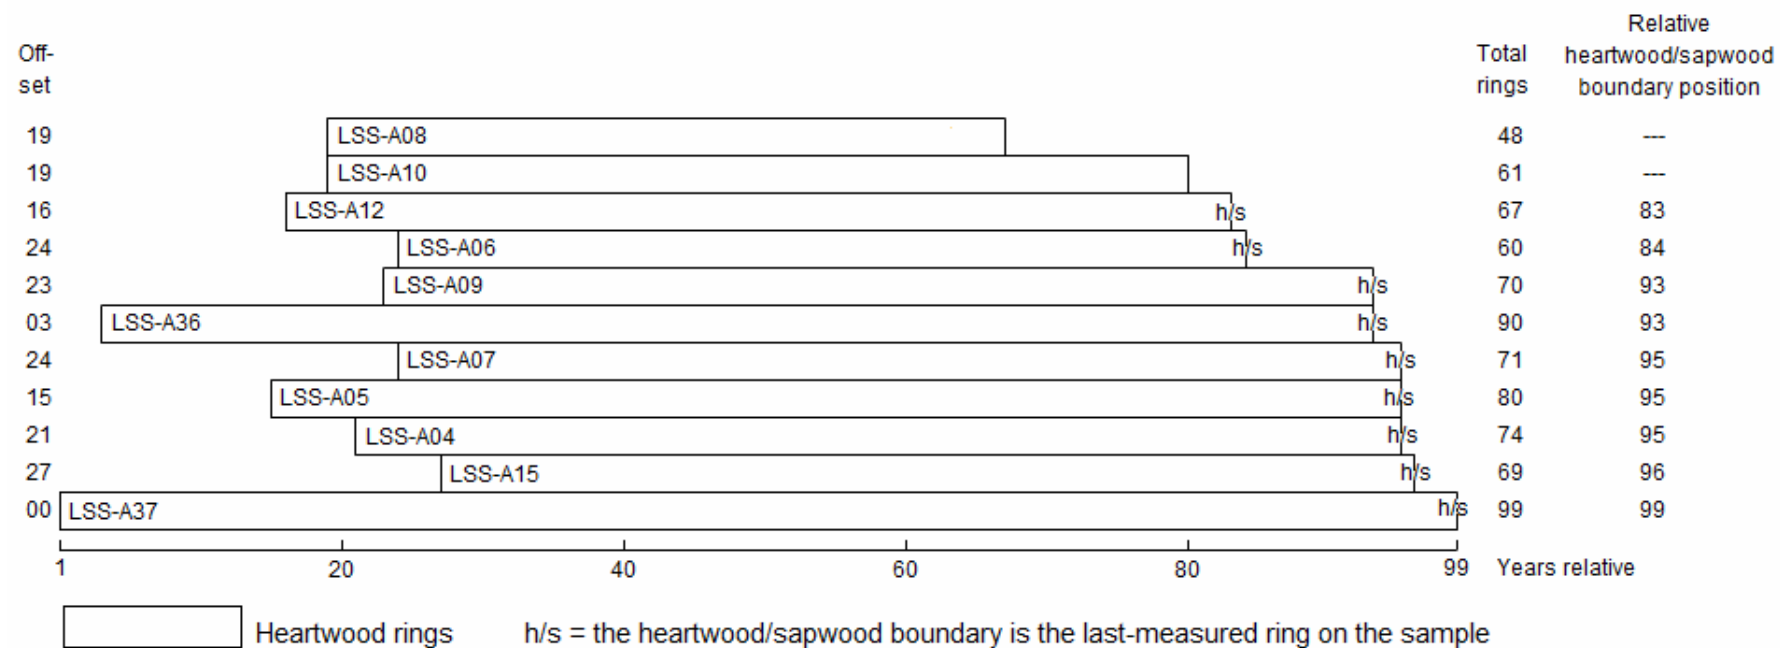
Figure 45: Bar diagram of samples in undated site sequence LSSASQ02

A further 11 samples matched each other and were combined at the relevant offset positions to form LSSASQ02, a site sequence of 99 rings (Fig 45). This site sequence was compared against a series of relevant reference chronologies for oak but no conclusive matching could be found and it therefore remains undated.
